6 *Bankers Trust Building*

6.1 Introduction

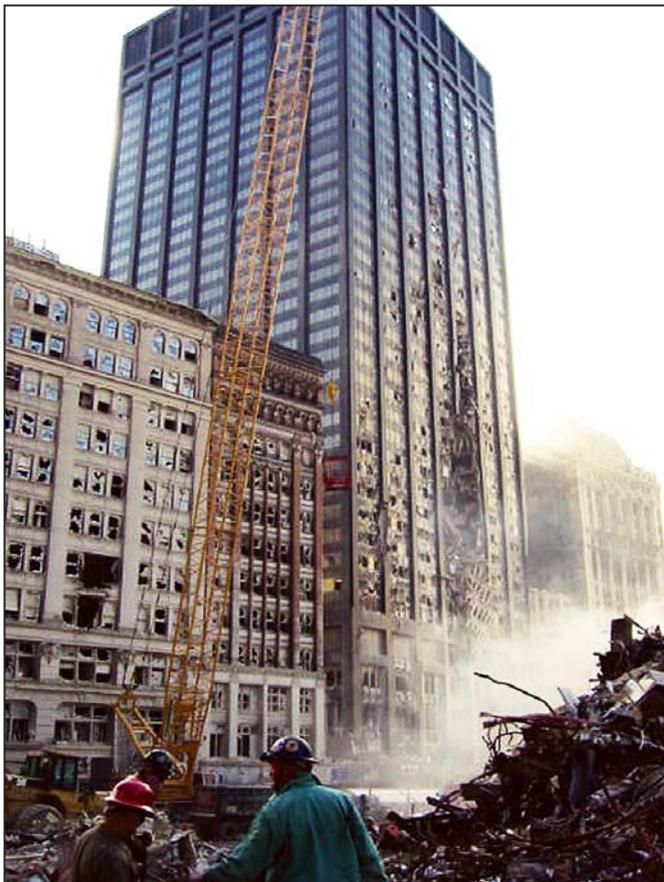
Figure 6-1
North face of Bankers Trust building with impact damage between floors 8 and 23.

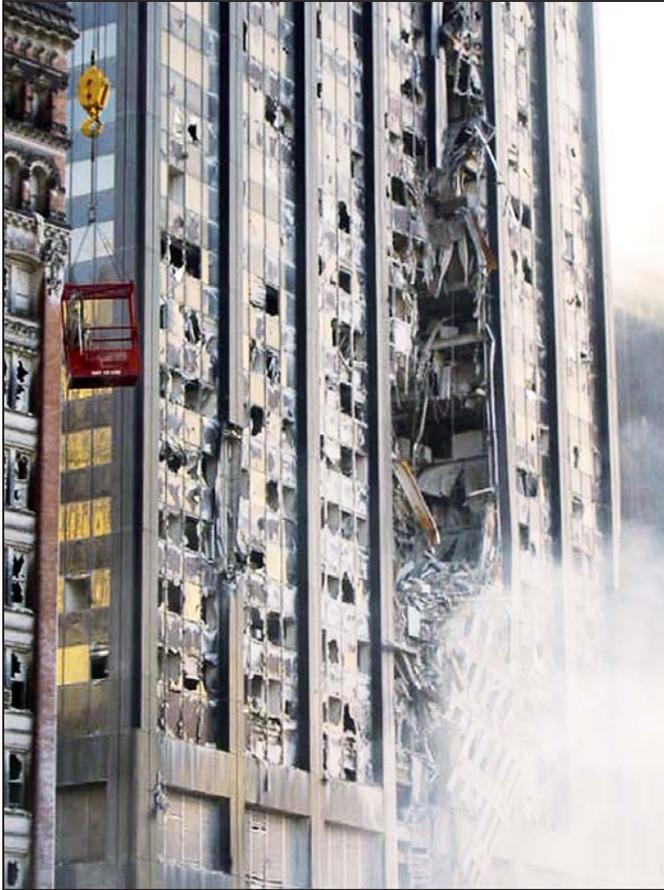
Figure 6-2
Closeup of area of partial collapse. Note debris accumulated at the bottom of the damage area, resting on the 8th floor. Area of initial impact is not shown in this photo.

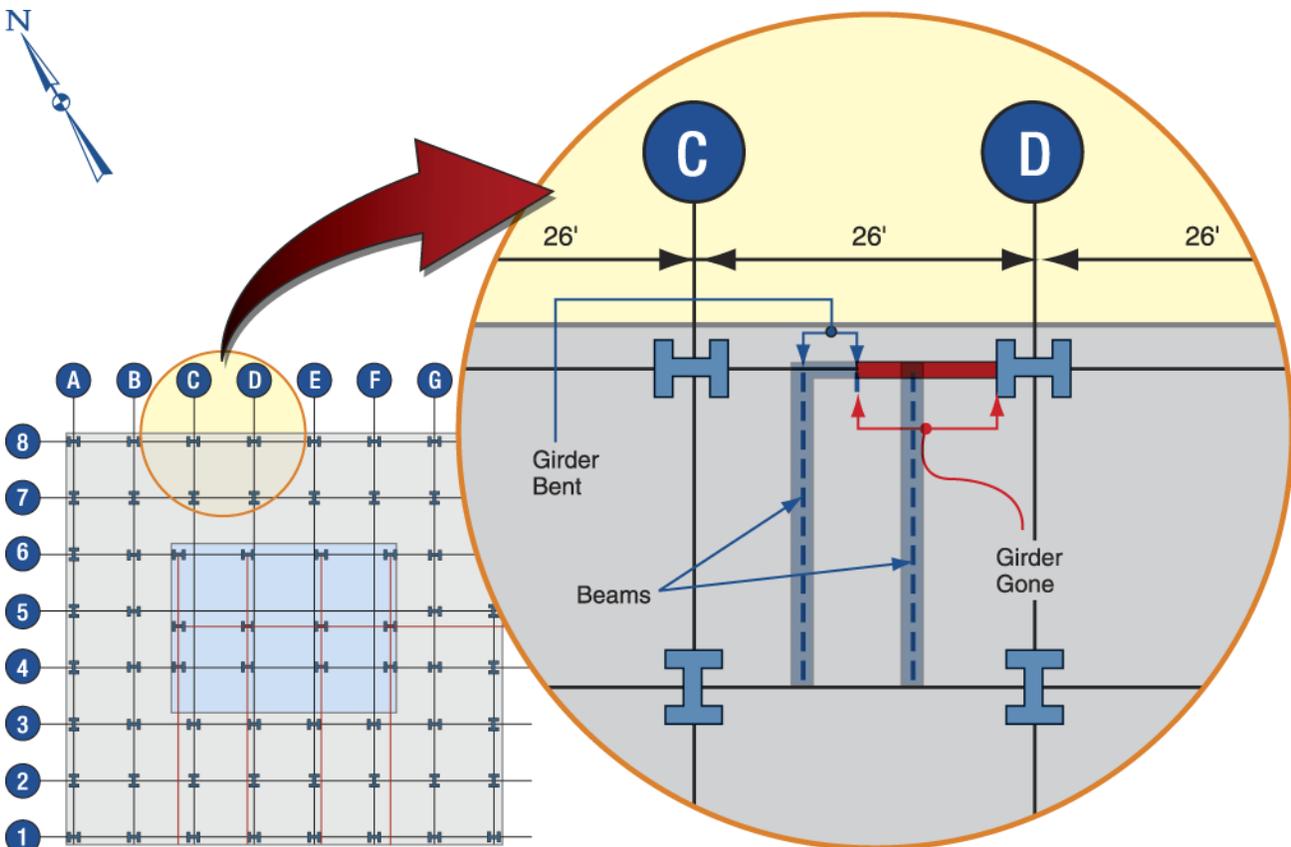
It appears that the direction of motion of the falling debris from WTC 2 was steeply angled down and to the east-southeast. As the falling debris smashed through the 23rd floor spandrel between column lines C and D, it and the debris it created at each floor continued to dive deeper into the building, causing more structural damage. Between the 19th and 22nd floors, the floor areas between column lines 7 and 8, and C and D were damaged or destroyed (Figure 6-5). The damage zone increased to include portions of the area between column lines D and E from the 18th floor down to the 9th floor (Figure 6-5).

Figure 6-4 Area of initial impact of debris at the 23rd floor.

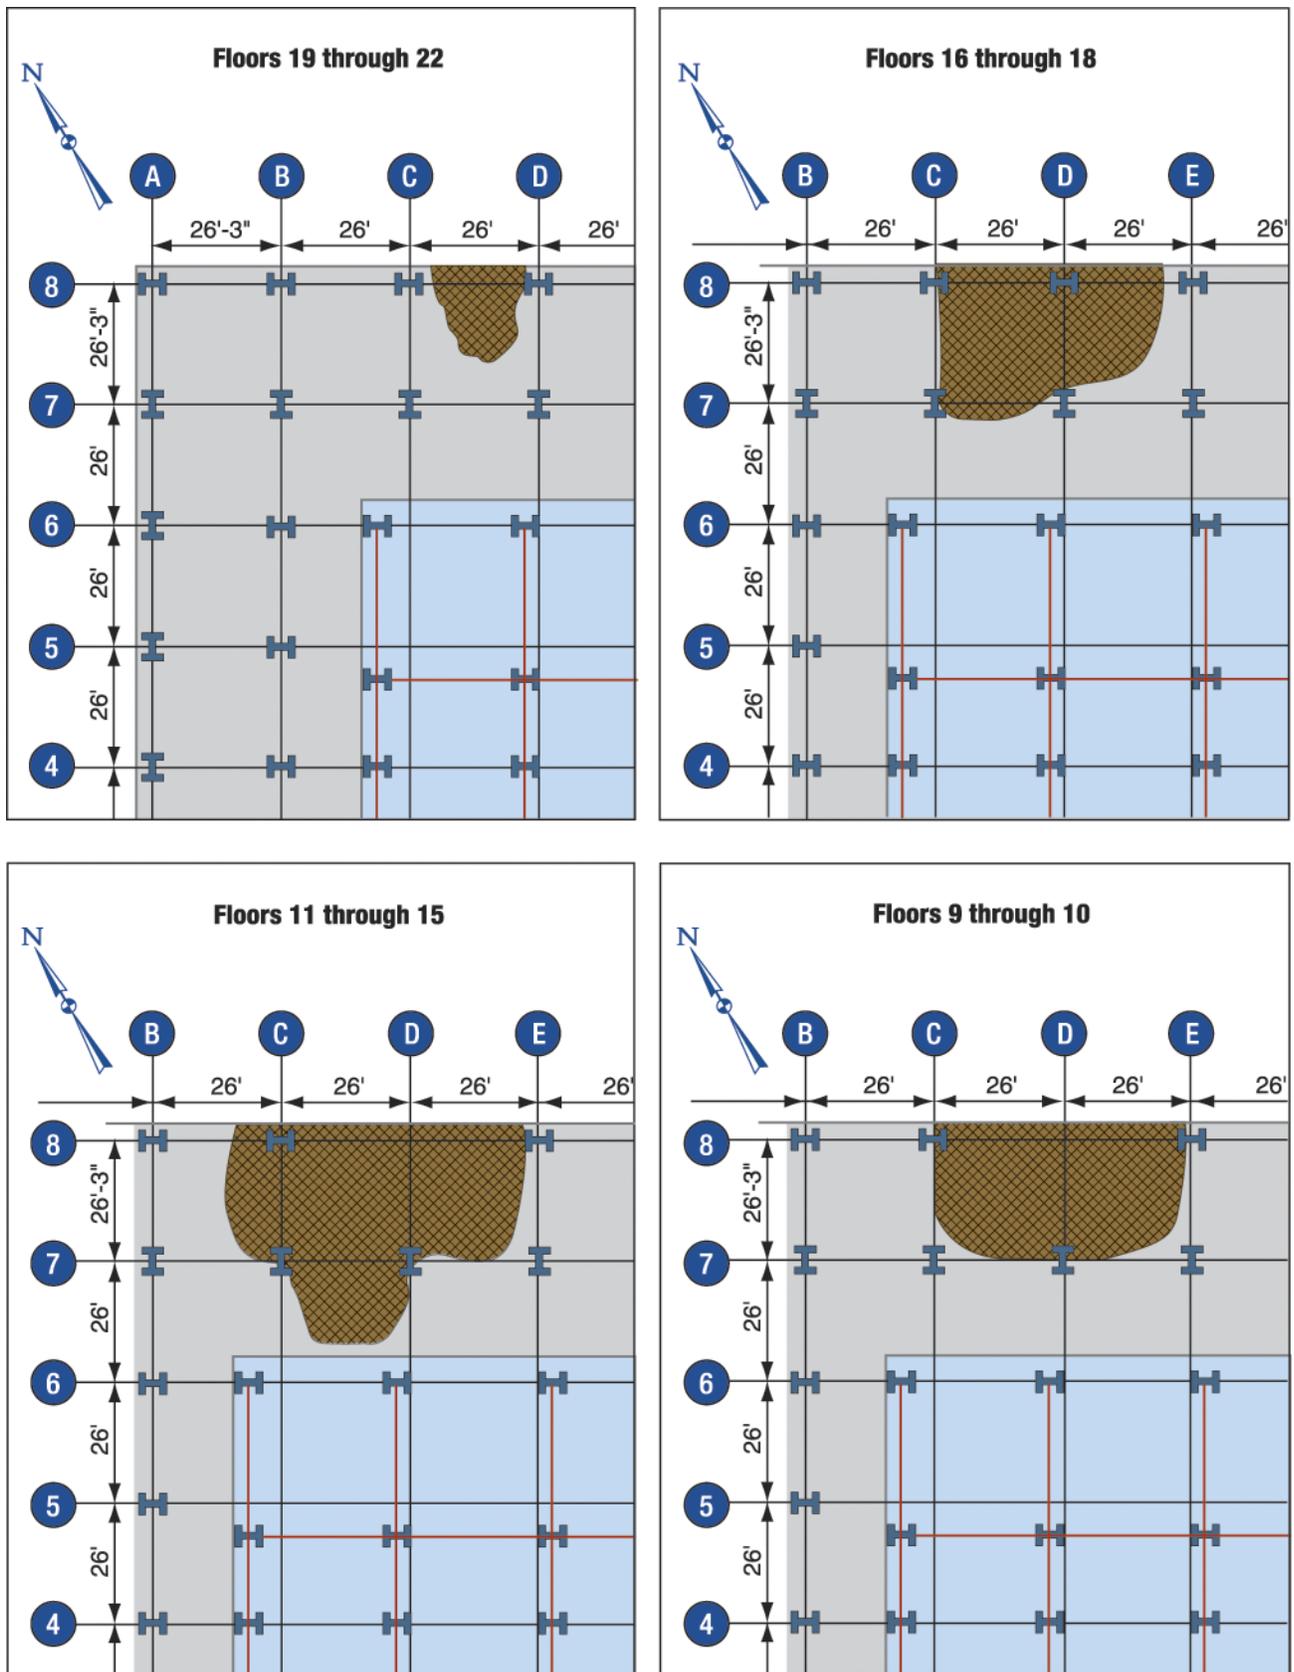
Figure 6-5 Approximate zones of damage – 19th through 22nd floors, 16th through 18th floors, 11th through 15th floors, and 9th through 10th floors.

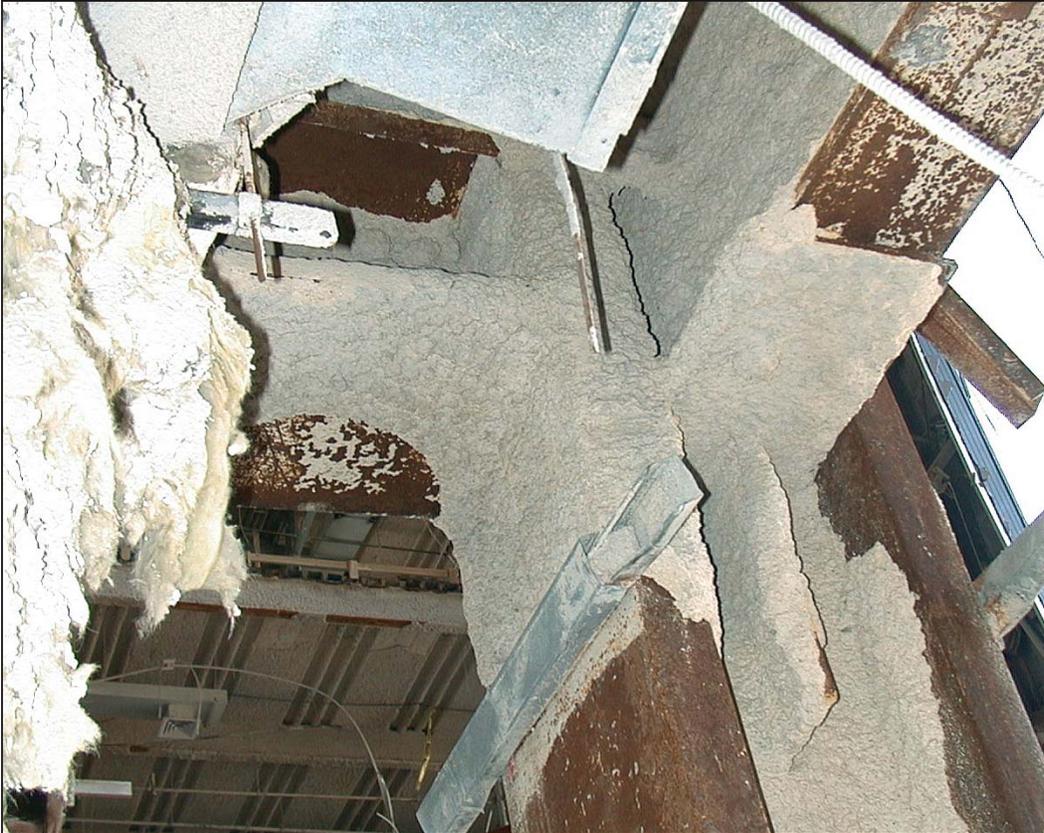
Figure 6-6 *Moment-connected beams to columns.*

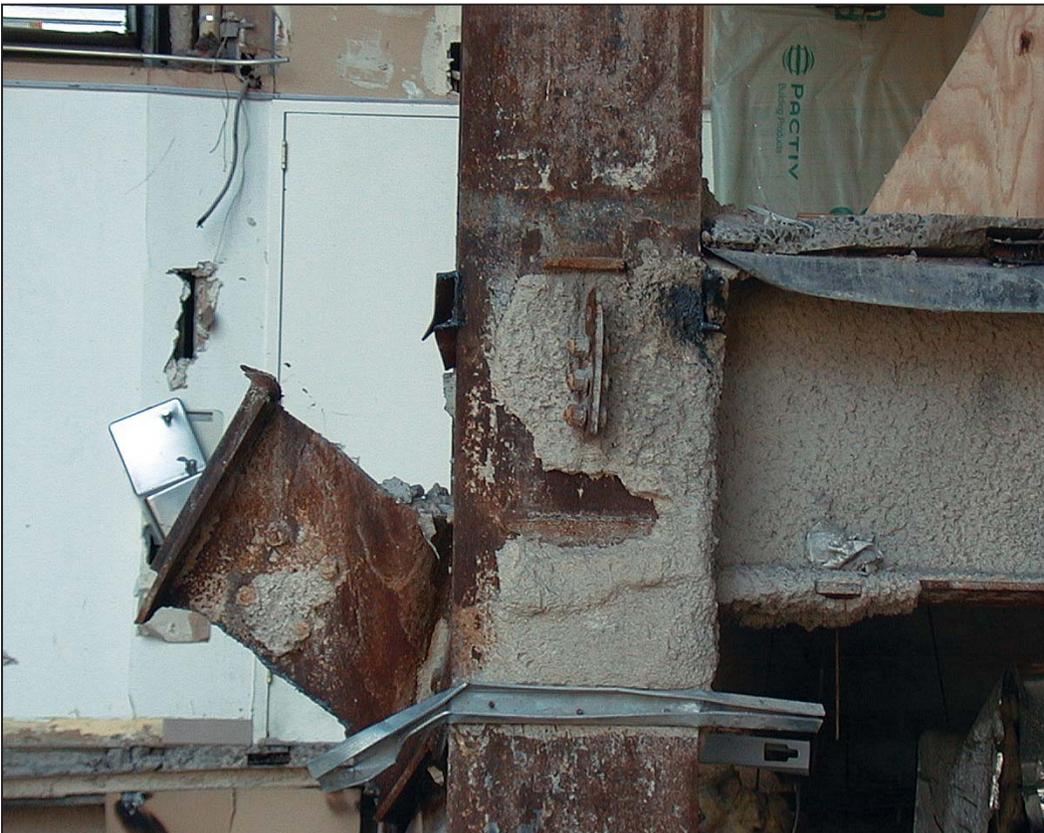
Girders that were connected to the column web had their top flange plate overloaded in tension at the weld zone interface. Normally, a crater was created where the top flange plate was welded to the column web. The bottom flange sat on a stiffened seat. Typically, the seated connection was left in place; however, the beam pulled off of the seat, separating at the fillet welds and leaving behind the fillet welds that attached the beam flange to the seat top plate. Figure 6-6 shows the stiffened seat at the weak axis side of the column. Figure 6-7 shows that the shear connection remains on the flange side, but only a piece of beam remains hanging on the web side.

Figure 6-7 *Column with the remains of two moment connections.*

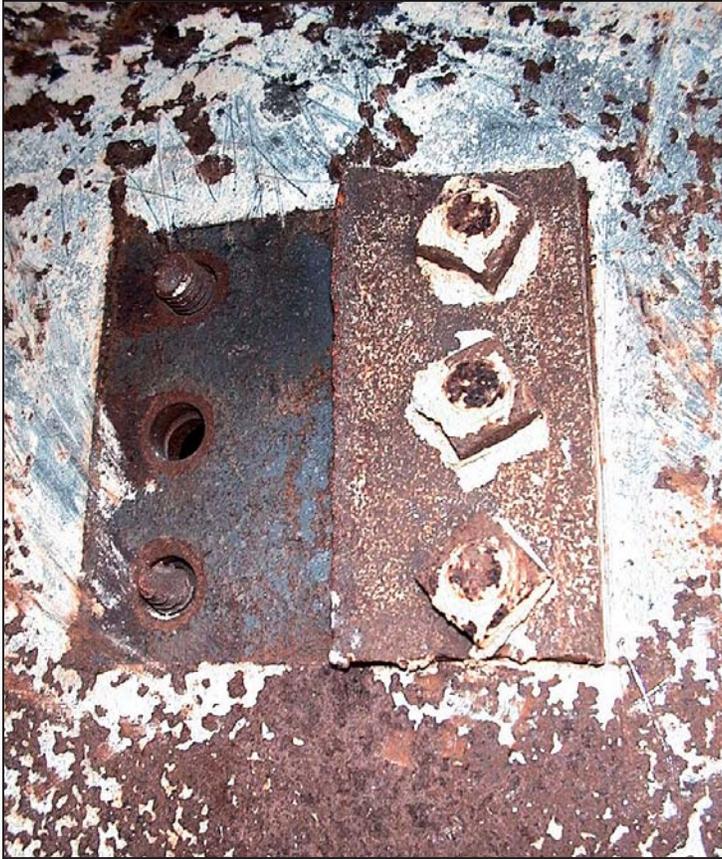
Floor-beam-to-girder connections typically used a partial-depth end plate welded to the floor beam web and bolted to the girder with A307 bearing bolts. Typically, failure occurred in one of two modes, either the bolts were overloaded in tension and the connection pulled off, or the partial end plate sheared at or near the weld line. At most of the connections, it appears there was some amount of bolt failure. Figure 6-8 shows a shear connection with half of the end plate remaining in place.

Figure 6-8
Failed shear connection of beam web to column web.

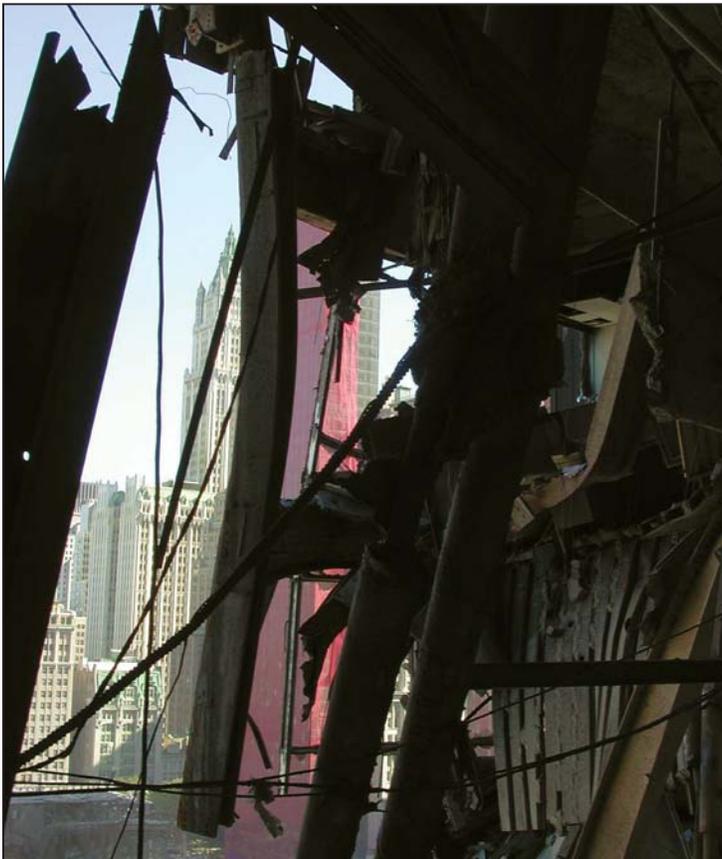
Figure 6-9
Suspended column D-8 at the 15th floor. Note separation at column splices.

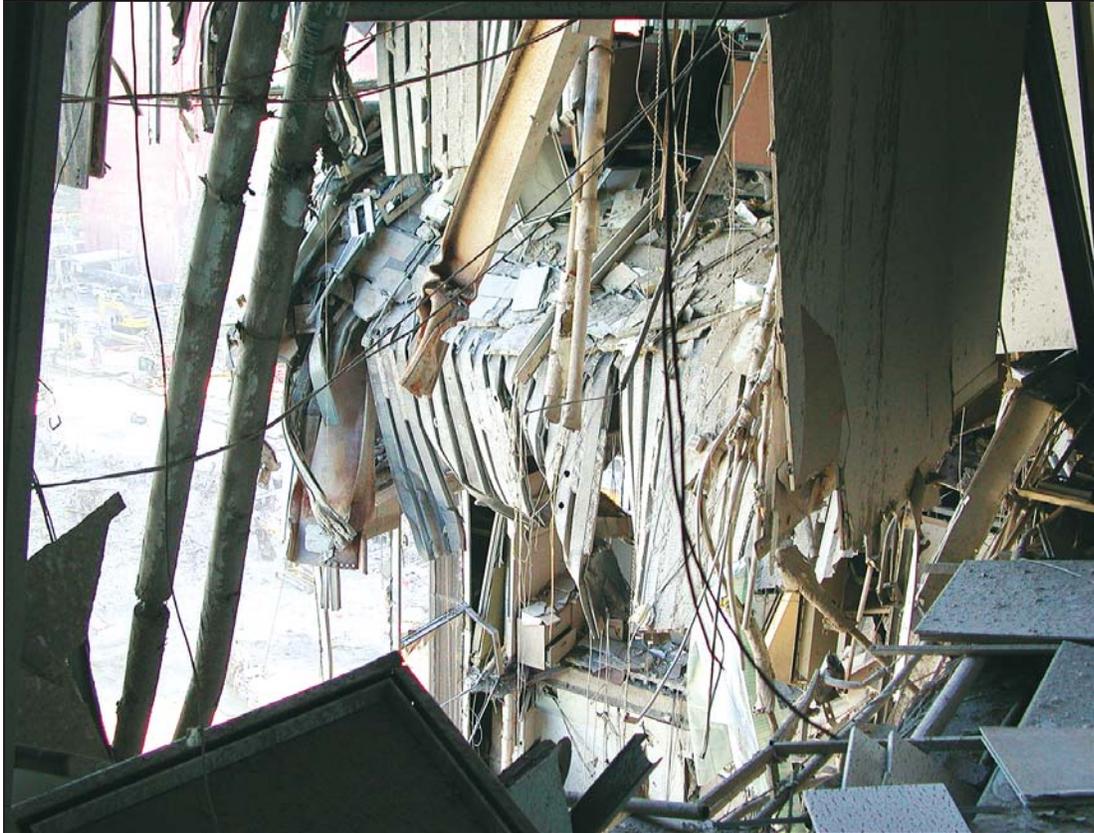
Figure 6-10 Area of collapsed floor slab in bays between C-8, E-8, C-7, and E-7, from the 15th floor.

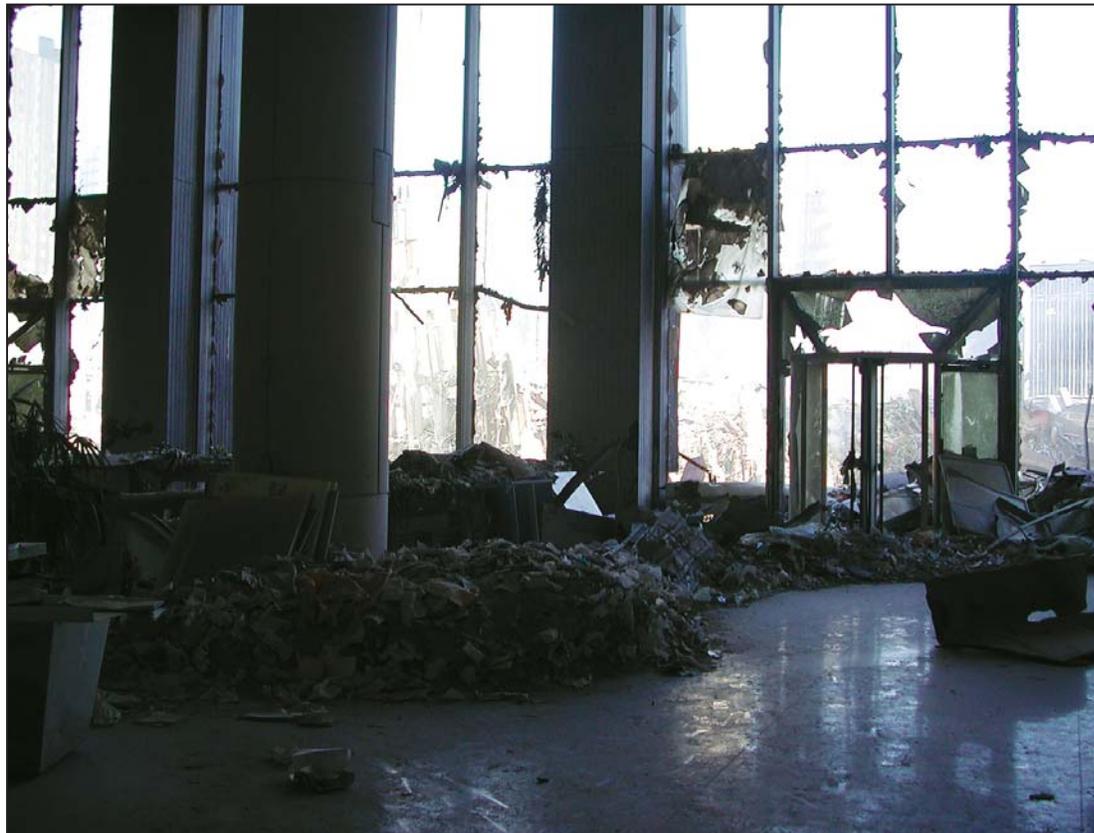
As the spandrel connections failed and the floor slabs collapsed, a portion of the rubble accumulated into a two-story pile while the remainder fell out of the building onto the low-rise roof on the north side of the building. The impact debris finally came to rest on the two-story-deep pile of debris that was on the 8th floor. Figures 6-9 and 6-10 illustrate the damage. A major component of WTC 2, approximately 40 feet tall by 30 feet wide, remained lodged in the debris pile and was clearly visible as it hung from the face of the building. Yet despite this weight, the floor supporting the debris deflected a maximum of 6 inches. Figure 6-11 shows the extent of debris in the lobby of the building.

Figure 6-11 Bankers Trust lobby (note debris has been swept into piles).

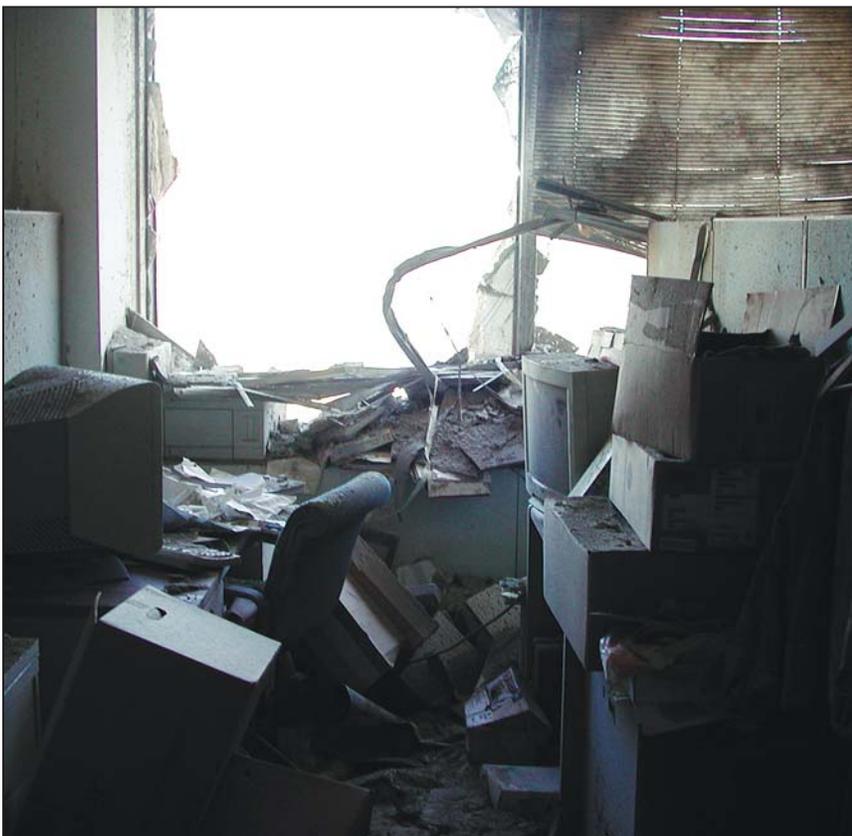
After the exterior glazing was penetrated by the debris, the dust cloud resulting from the collapse of the towers deposited a layer of dust an inch or more thick throughout the northern part of the building. The 2nd floor lobby area had extensive broken glass, general debris, and dust (Figure 6-11). Figure 6-12 shows a typical office near the collapsed area at the 8th floor.

*Figure 6-12
Office at the north side of the 8th floor.*
