**Engineering and Organizational Issues Related to
The World Trade Center Terrorist Attack**

**Reconnaissance and Preliminary
Assessment of a Damaged Building
Near Ground Zero**

**Volume 2:
Reconnaissance and Preliminary Assessment of a
Damaged Building Near Ground Zero**

April 2002

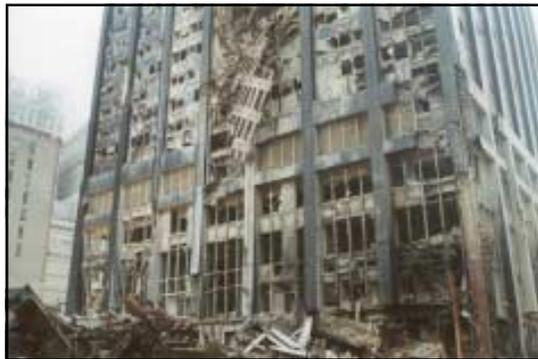
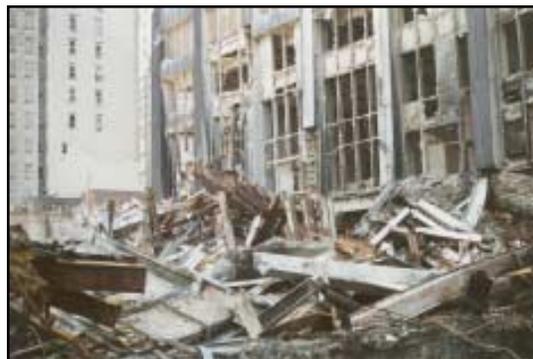
Figure 2.1. Damage to the 130 Liberty Plaza building from the exterior

Parts c. and d. of Figure 2.1 show damage to the lower levels of the building on its north face. Burning debris ignited small fires in the lower levels of the building but these fires appeared to have been confined to the perimeter of the building. Most of the windows in the lower levels, especially below the mechanical plant room at the 5th floor level, were broken but it is not known how many of these windows were broken on purpose by the rescue teams to eliminate falling glazing hazards to the rescue workers operating to the immediate south of WTC 2. Part d. of the figure shows the debris pile to the immediate north of the building, 10 days after the terrorist attacks. Much of the debris was from WTC 2.

c. View of lower 10 stories of northern facade

d. Damage to the northern façade at the entry level

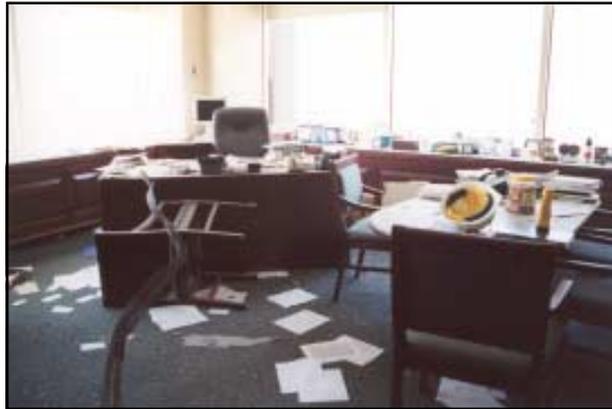
b. Typical damage in office space

Figure 2.4. Office space damage above Tenant Level 29

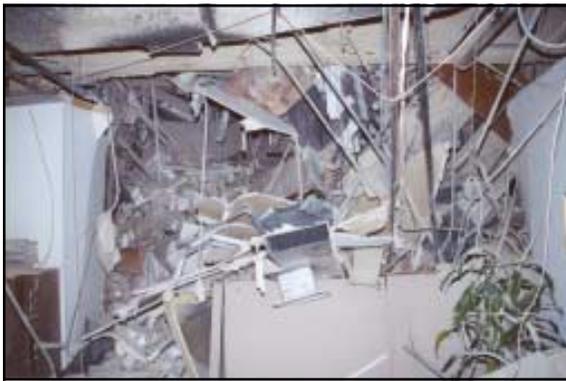
Figure 2.10 shows the damage at TL 9. Figure 2.10a shows the complete destruction of one zone of the floor immediately adjacent to the northern face of the building. Part b. shows the interior face of the section of WTC 2 façade, seen in Figures 2.1a and 2.9b, that caused much of the damage to the building.

a. Complete destruction of one zone of the building

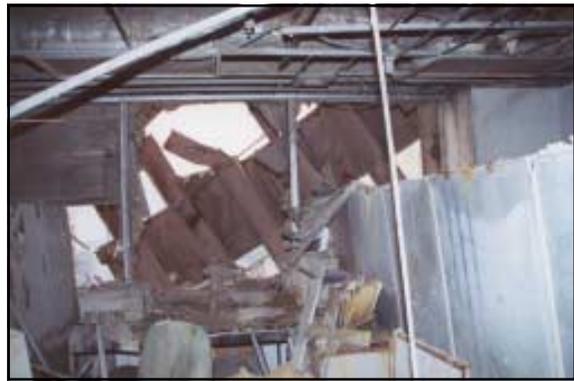
b. View of inside face of WTC 2 façade element
