Memorandum 7/28/2000, Regarding
Radiation Safety Survey One WTC

TO: George Tabeeek, Project Manager
FROM: Paul W. Mitchell
DATE: July 28, 2000
SUBJECT: RADIATION SAFETY SURVEY - ONE WORLD TRADE CENTER

Heitmann & Associate Curtain Wall Evaluation

Curtain Wall Evaluation
6 November 2000

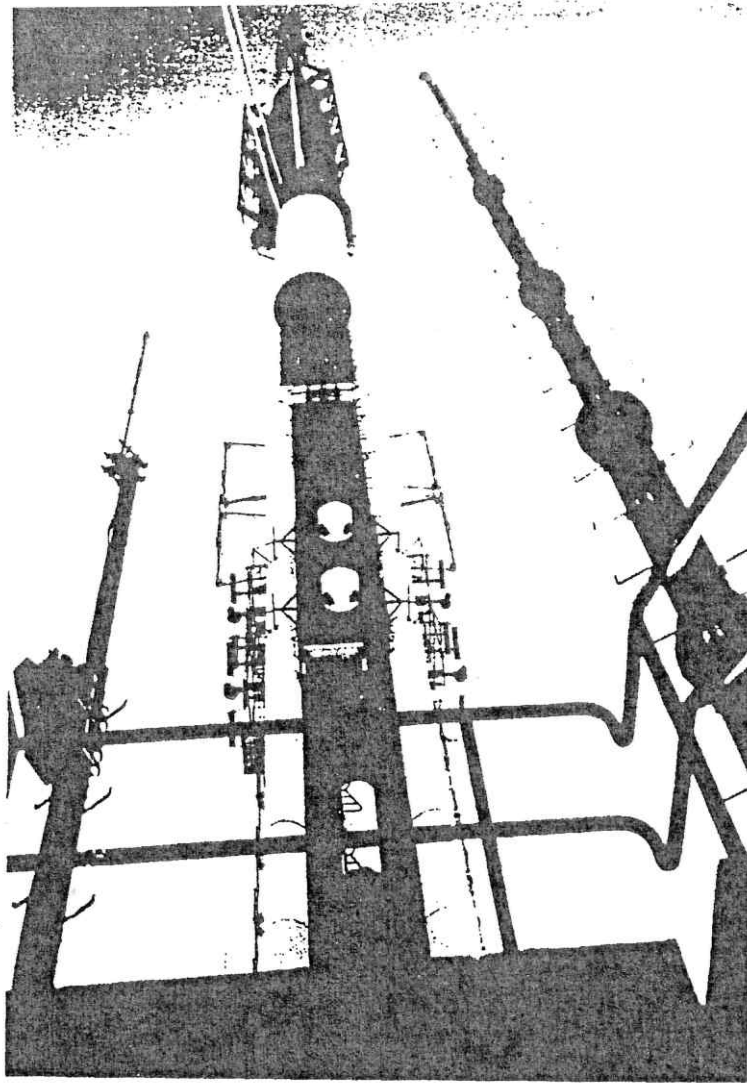
Photo #1:
360-Foot antenna
mast on One World
Trade Center.

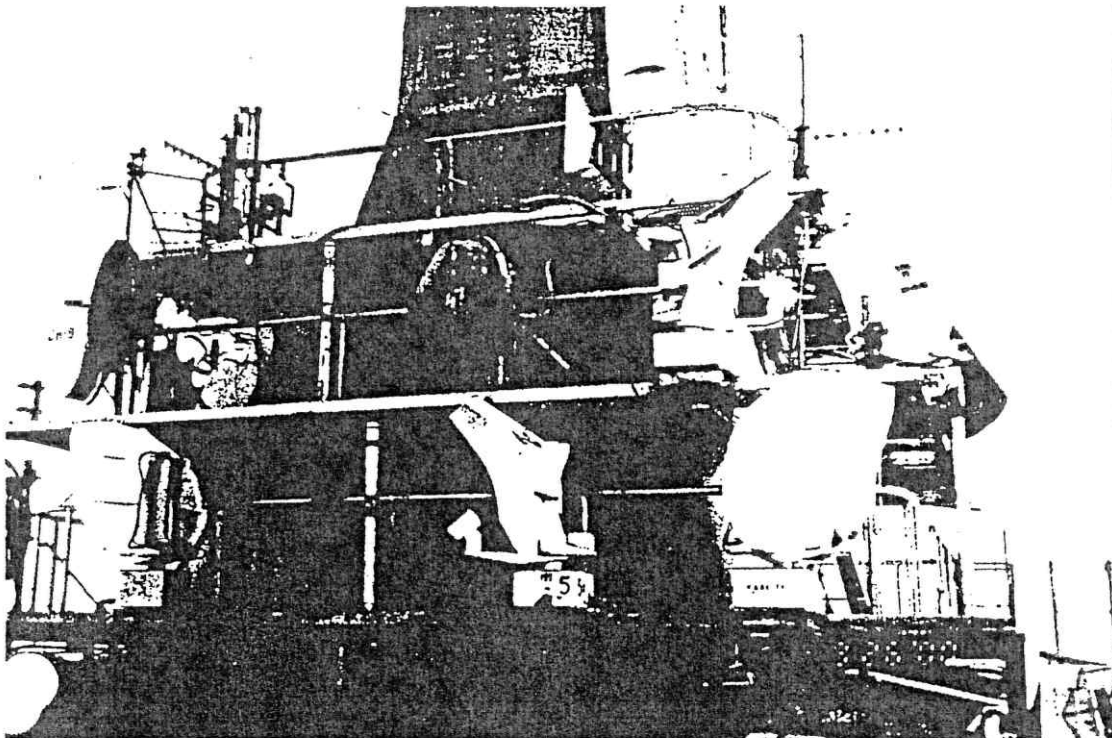
Photo #2: Base
of antenna mast
on One World
Trade Center.

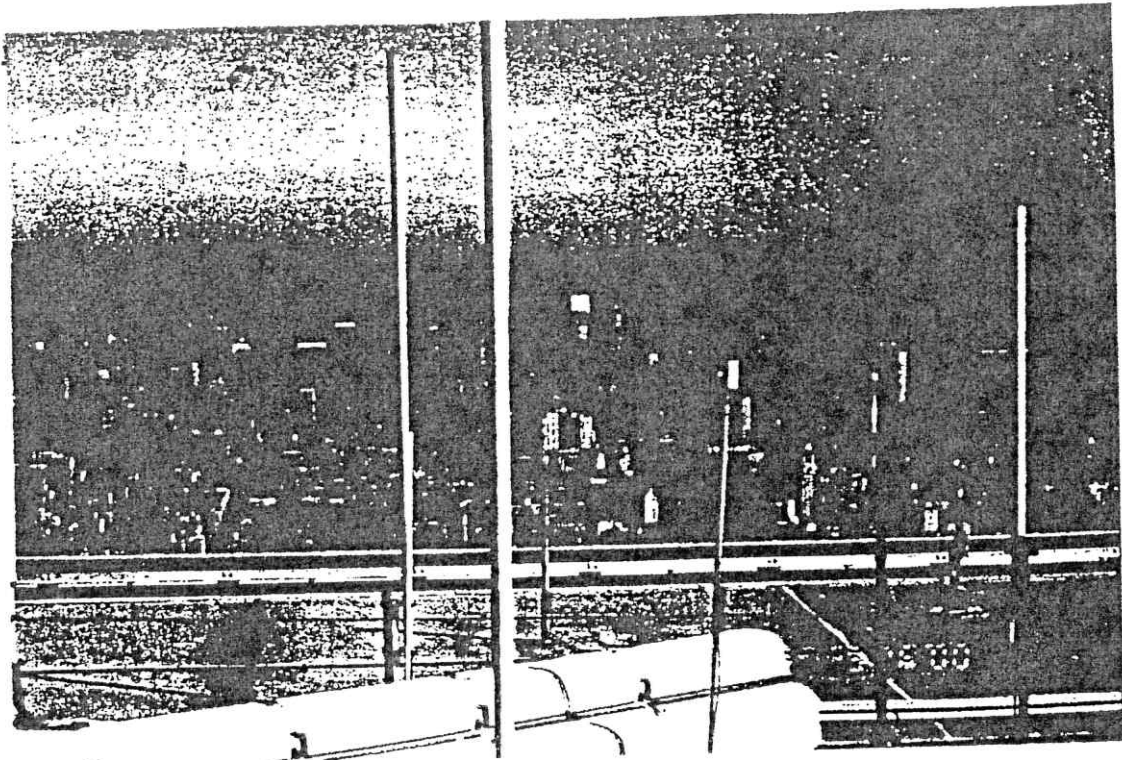
Photo #3: Roof – One World Trade Center.

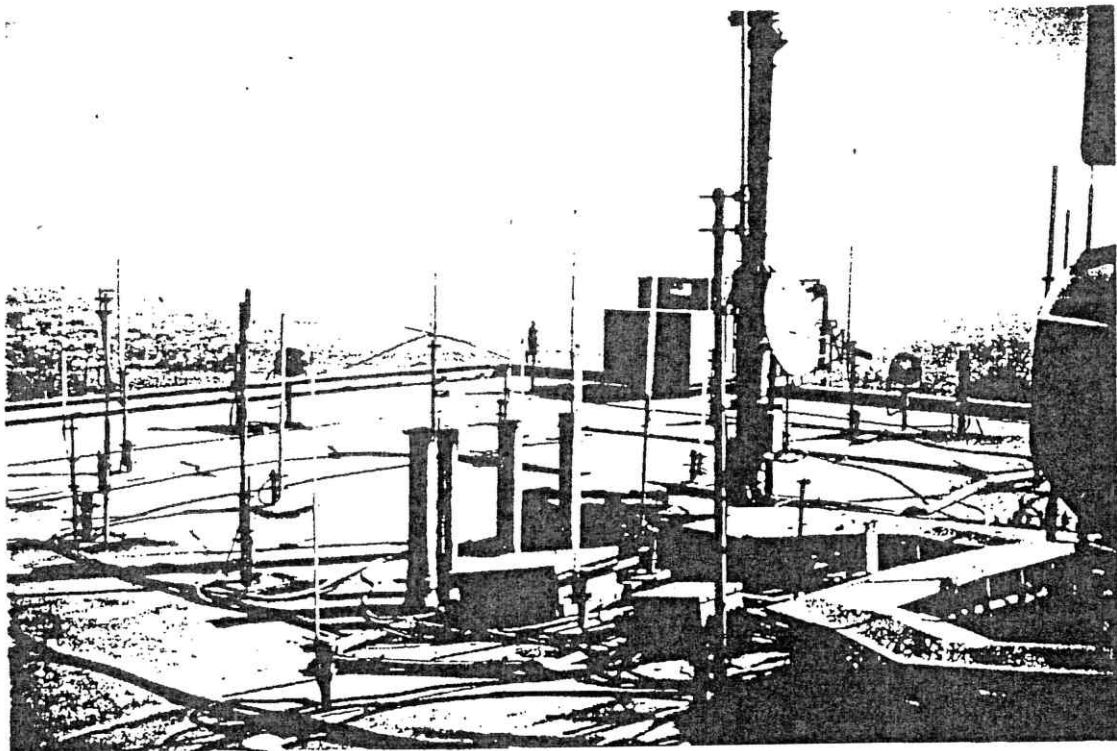
Photo #4: Roof – One World Trade Center.

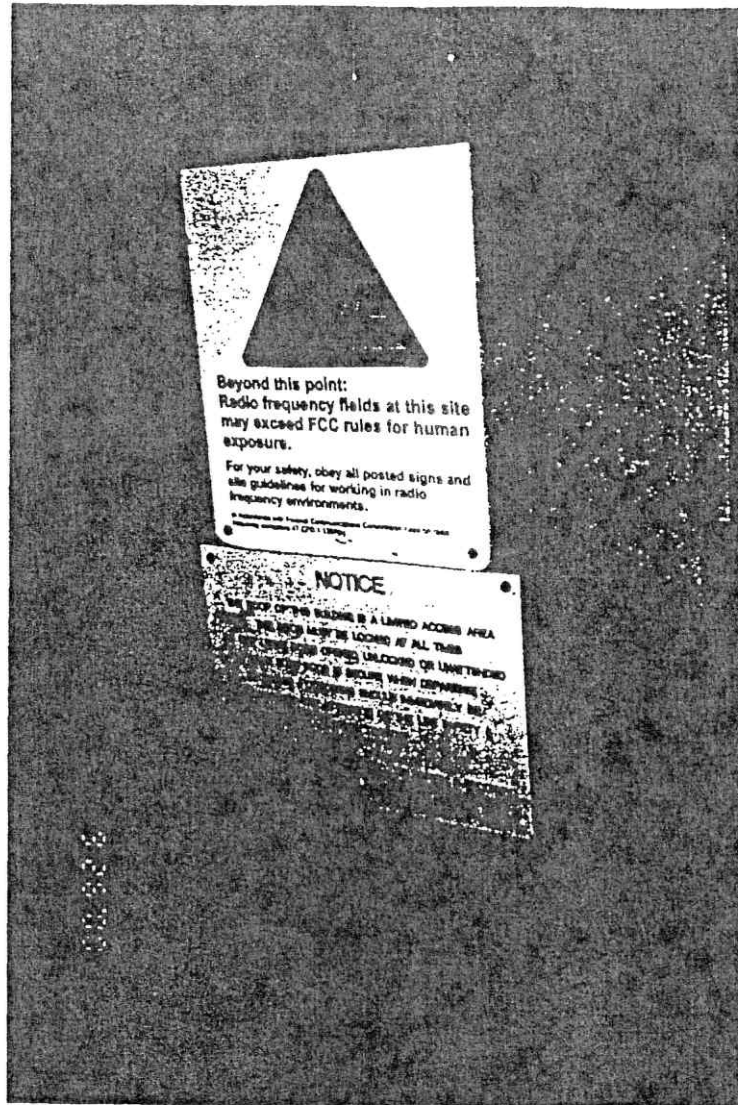
Photo #5: Signage at door to roof – One World Trade Center.
