## HEITMANN & ASSOCIATES, INC.

Curtain Wall Observation Report

6 November 2000

Project :	One World Trade Center New York, New York
Project Number:	20063.00
Observation Dates:	Various dates between September 13, 2000 and October 25, 2000
Report Prepared By:	William G. Young

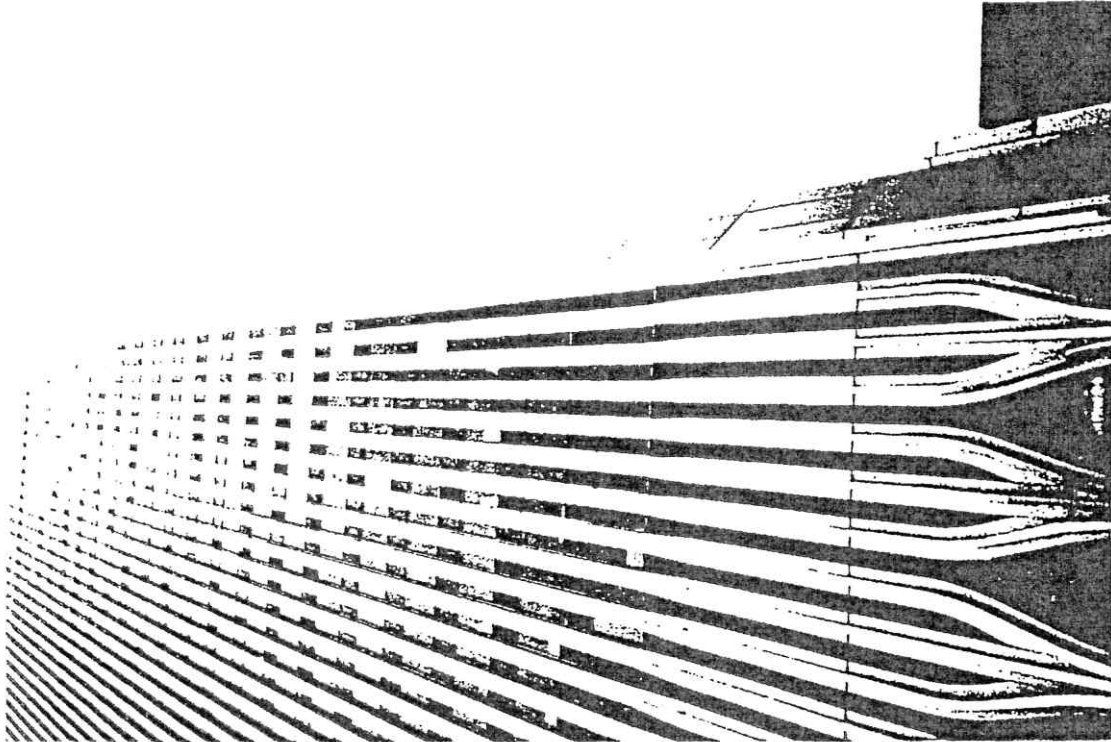
1

- B. The curtain wall system consists of vertical strip windows set between tightly spaced aluminum clad building columns (Refer to photographs 1, 2 and 3). Within the vertical strip windows, aluminum spandrel panels occur at each floor line. Aluminum panels are used to clad the four chamfered corners of the tower and the sloped parapet of the main roof (Refer to photograph 3). The finish on the curtain wall framing, aluminum column cladding, corner panels and parapet panels is a clear or natural anodize. The finish on the spandrel panels is darker and could be a light bronze anodized finish.

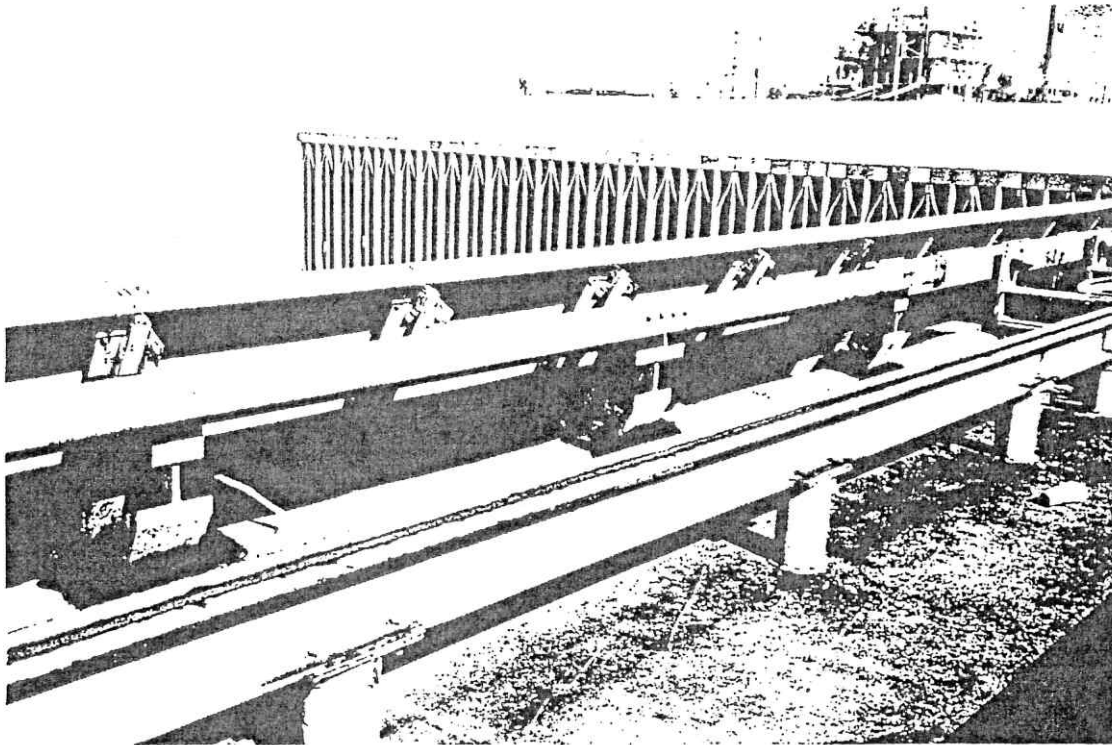
5

- E. The sloped parapet panels at the top of the tower are primarily decorative as the concrete slabs and roofing system below provide the main water barriers (Refer to photograph 5). The parapet panels are supported by steel framing anchored to the building the structure. The steel framing is exposed to the weather.

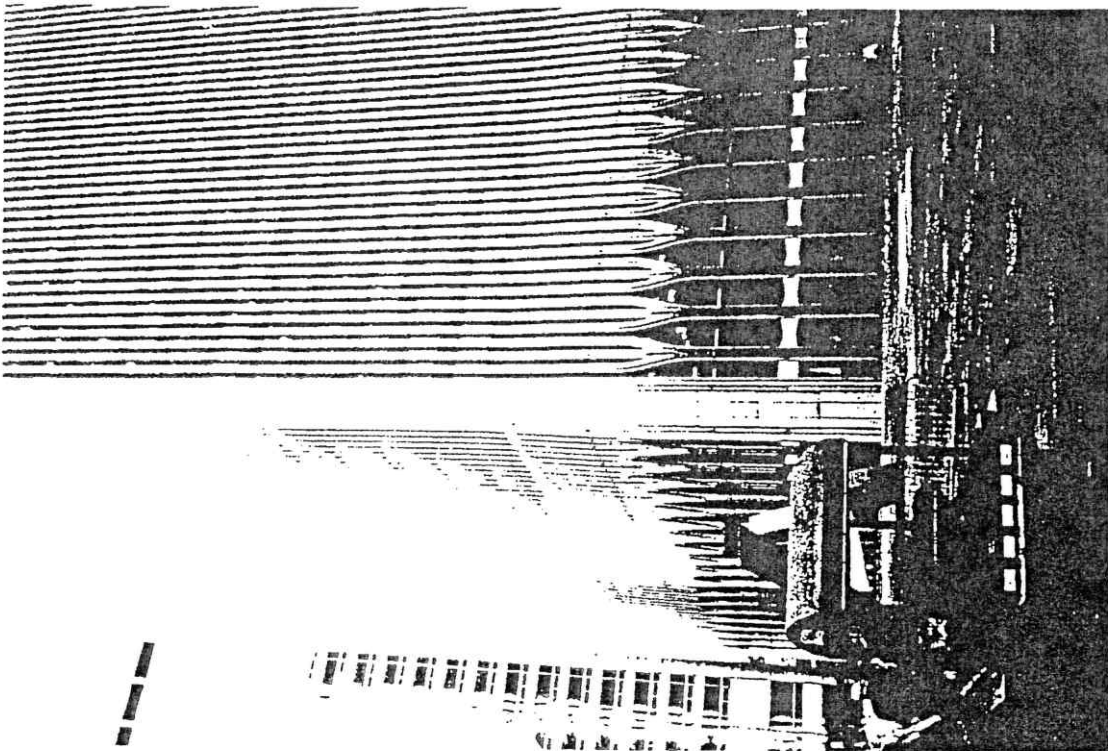
6

- F. The basic curtain wall design is maintained throughout the height of the tower. The appearance of the curtain wall at the mechanical floor and the top of the tower is modified by changing the width of the column cladding and adding components to increase the depth of the system. The curved elements at the top of the tower are add-on members (appliques) that serve no structural purpose (Refer to photograph 3). The base of the curtain wall provides large expanses of glass by combining three typical building columns into one (Refer to photograph 6).
