Heitmann & Associate Curtain Wall Evaluation

### Two World Trade Center New York, New York

Curtain Wall Evaluation  
6 November 2000

### Curtain Wall Observation Report

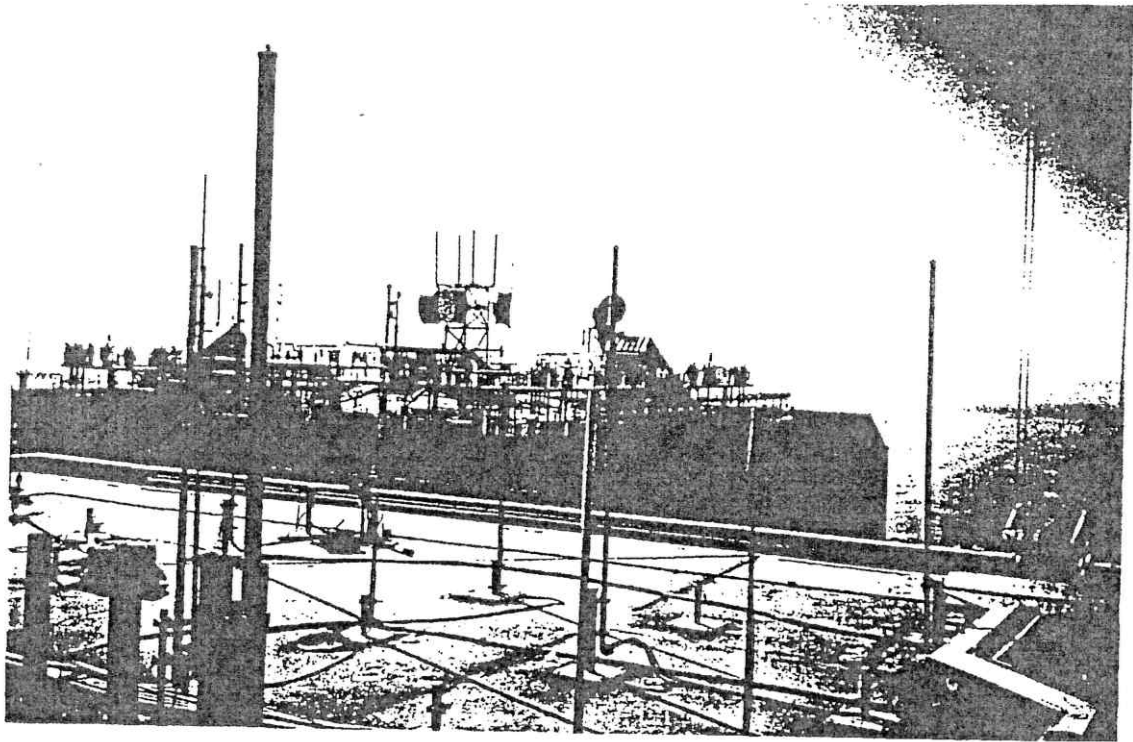
Photo #1: Roof of One World Trade Center  
with Two World Trade Center in background.

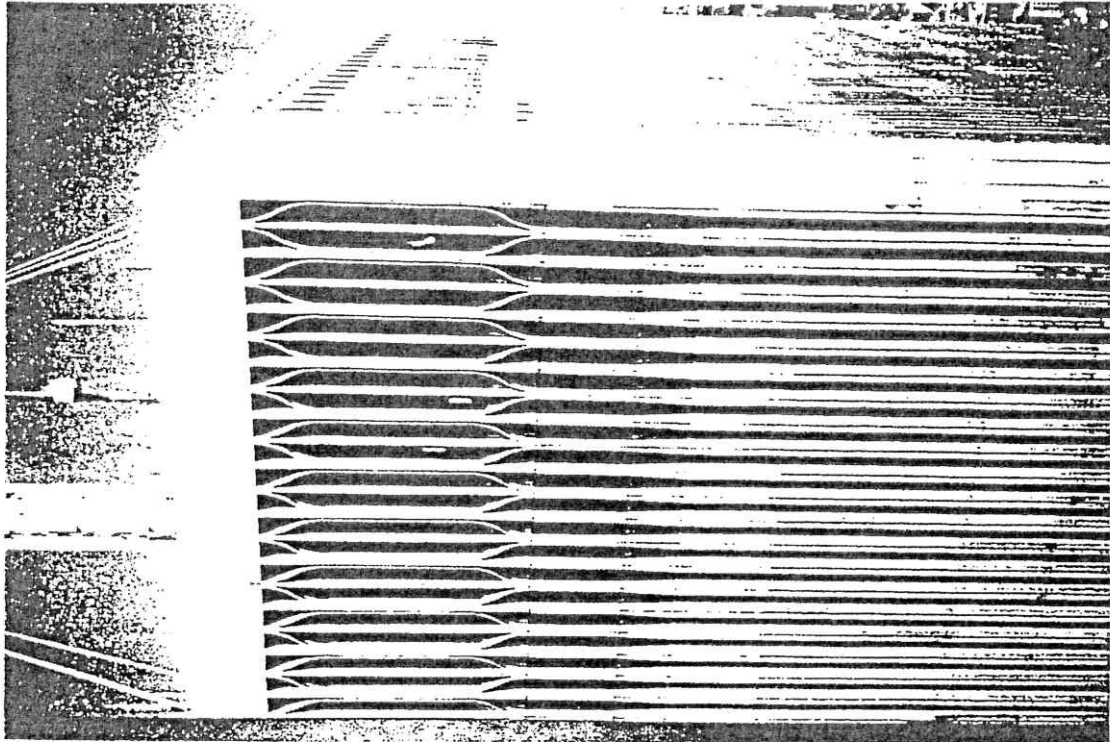
3

- B. The curtain wall system consists of vertical strip windows set between tightly spaced aluminum clad building columns (Refer to photographs 1, 2 and 3). Within the vertical strip windows, aluminum spandrel panels occur at each floor line. Aluminum panels are used to clad the four chamfered corners of the tower and the sloped parapet of the main roof (Refer to photograph 3). The finish on the curtain wall framing, aluminum column cladding, corner panels and parapet panels is a clear or natural anodize. The finish on the spandrel panels is darker and could be a light bronze anodized finish.

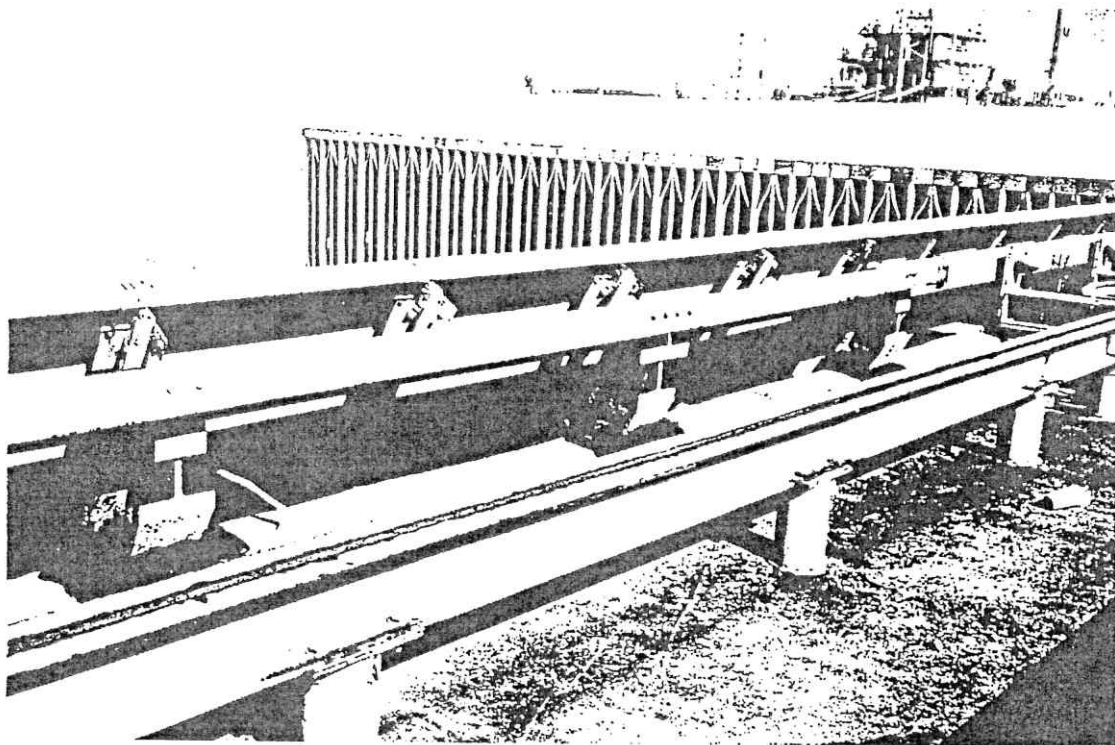
5

- E. The sloped parapet panels at the top of the tower are primarily decorative as the concrete slabs and roofing system below provide the main water barriers (Refer to photograph 5). The parapet panels are supported by steel framing anchored to the building the structure. The steel framing is exposed to the weather.

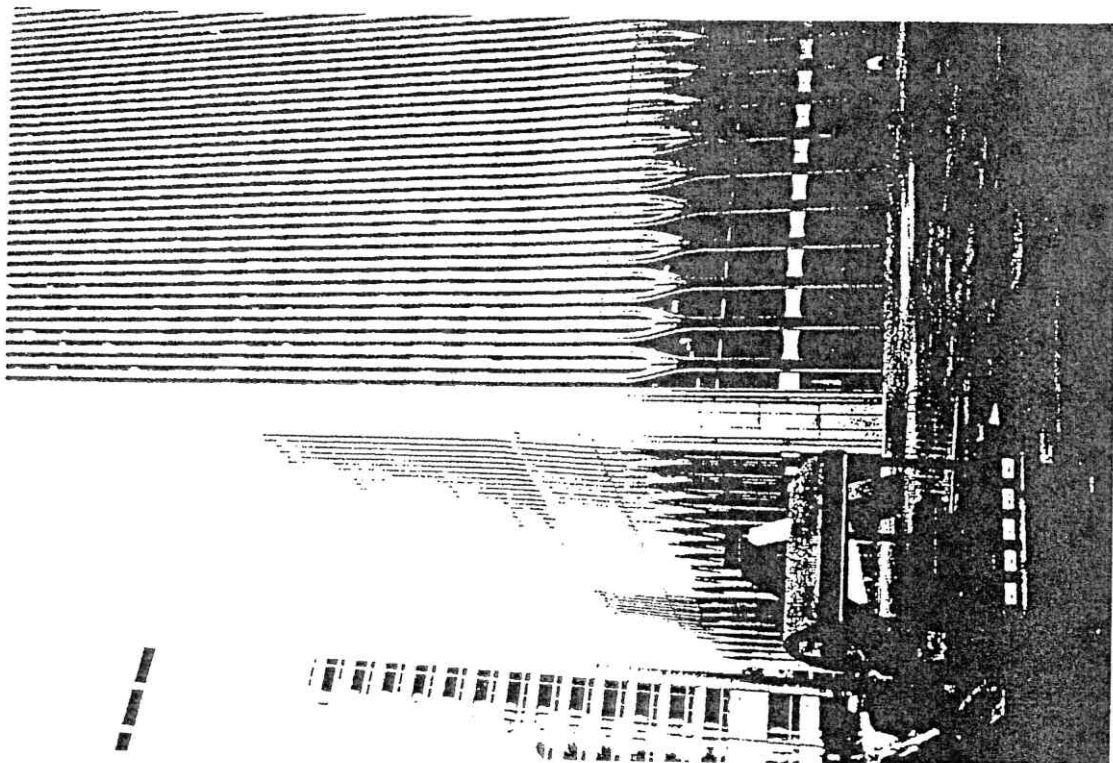
6

- F. The basic curtain wall design is maintained throughout the height of the tower. The appearance of the curtain wall at the mechanical floor and the top of the tower is modified by changing the width of the column cladding and adding components to increase the depth of the system. The curved elements at the top of the tower are add-on members (appliques) that serve no structural purpose (Refer to photograph 3). The base of the curtain wall provides large expanses of glass by combining three typical building columns into one (Refer to photograph 6).

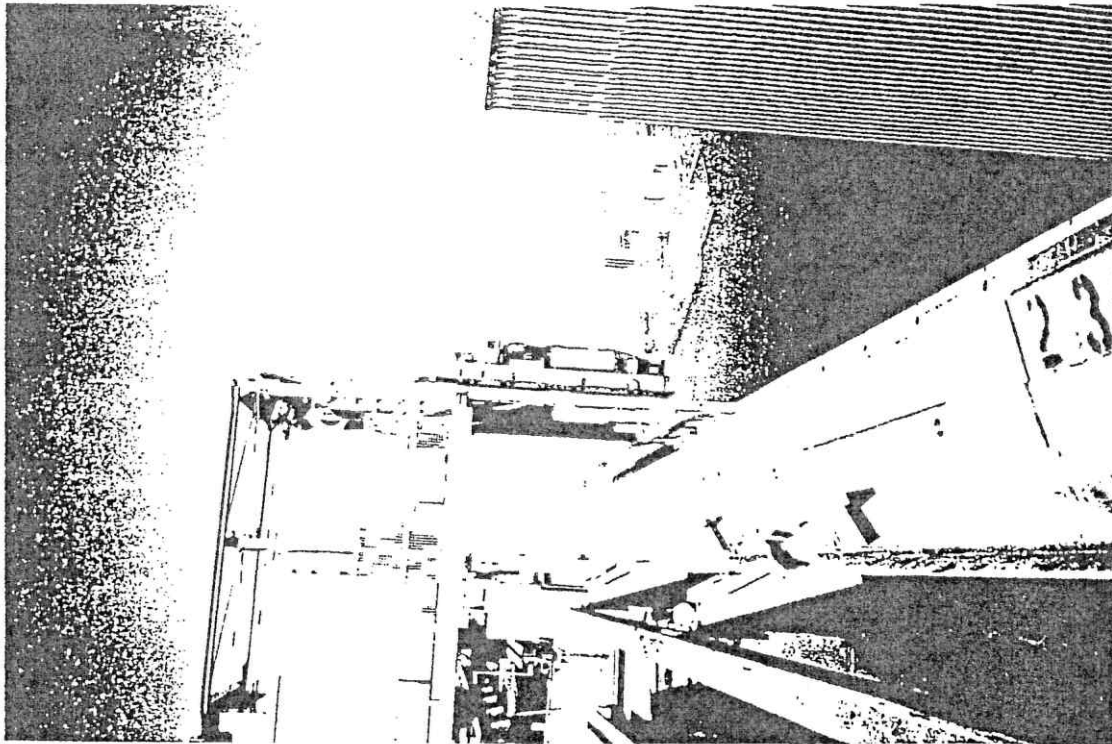
7

- G. The glass panels are cleaned by a robotic washer that is lowered from a roof car (Refer to photograph 7). The robotic washer is guided by stainless steel tracks set into a recess on the face of the column cladding. The roof car can access the full perimeter of the tower via a system of rails and turntables mounted on the roof. The roof car also incorporates a maintenance platform for retrieving the robotic washer should it become inoperative. The maintenance platform is also used to inspect and maintain the curtain wall system.

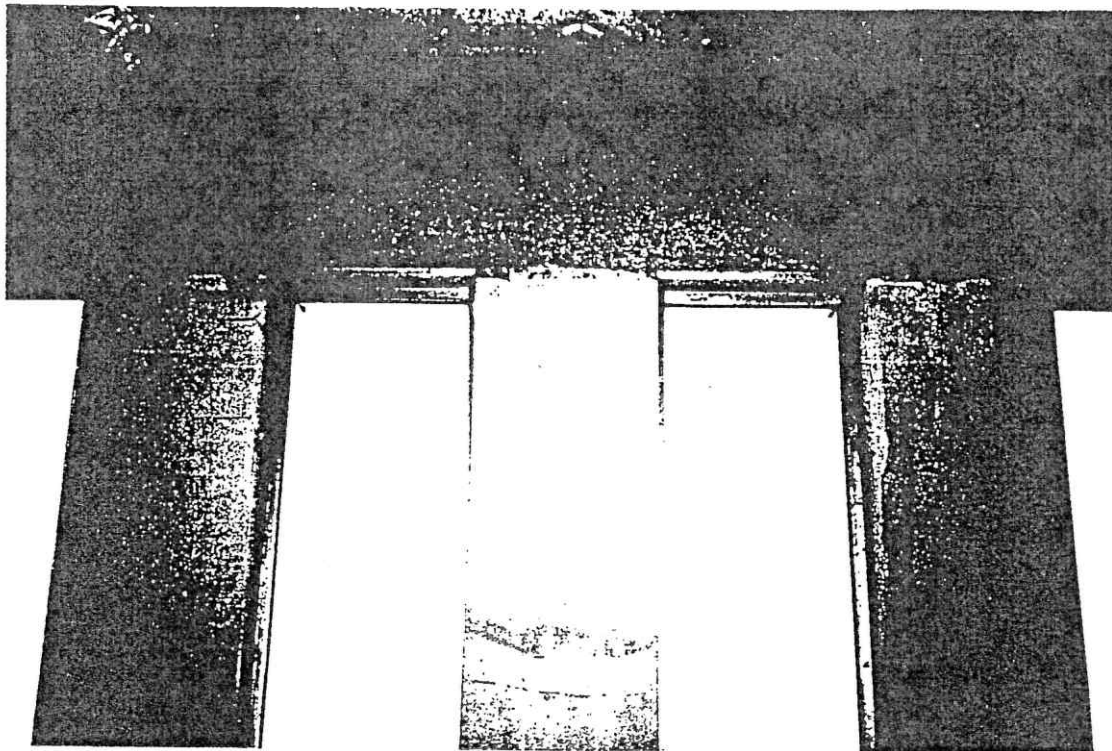
8

- a. No signs of water leakage were noted at any of the finished spaces. At some of the unfinished/unoccupied spaces there was staining and efflorescence noted on the plaster finish at the interior side of the column enclosures (between the vision panels) (Refer to photograph 8). These stains could be the results of water leakage through the curtain wall or condensation that formed on the interior surface. It was reported by Port Authority personnel that during certain conditions condensation did form on the inside surface of the curtain wall. This condition is possible as the curtain wall shop drawings that we have reviewed do not indicate any significant amount of thermal insulation within the system.

- D. Our recommendations regarding the issues noted during our inspections are summarized as follows.
1. Water leakage - As there does not appear to be any significant or typical water leakage problems, we recommend that water leaks continue to be addressed as they are reported. A remedial program that addresses sealant repair and replacement for the entire tower would reduce the potential for future water leakage.

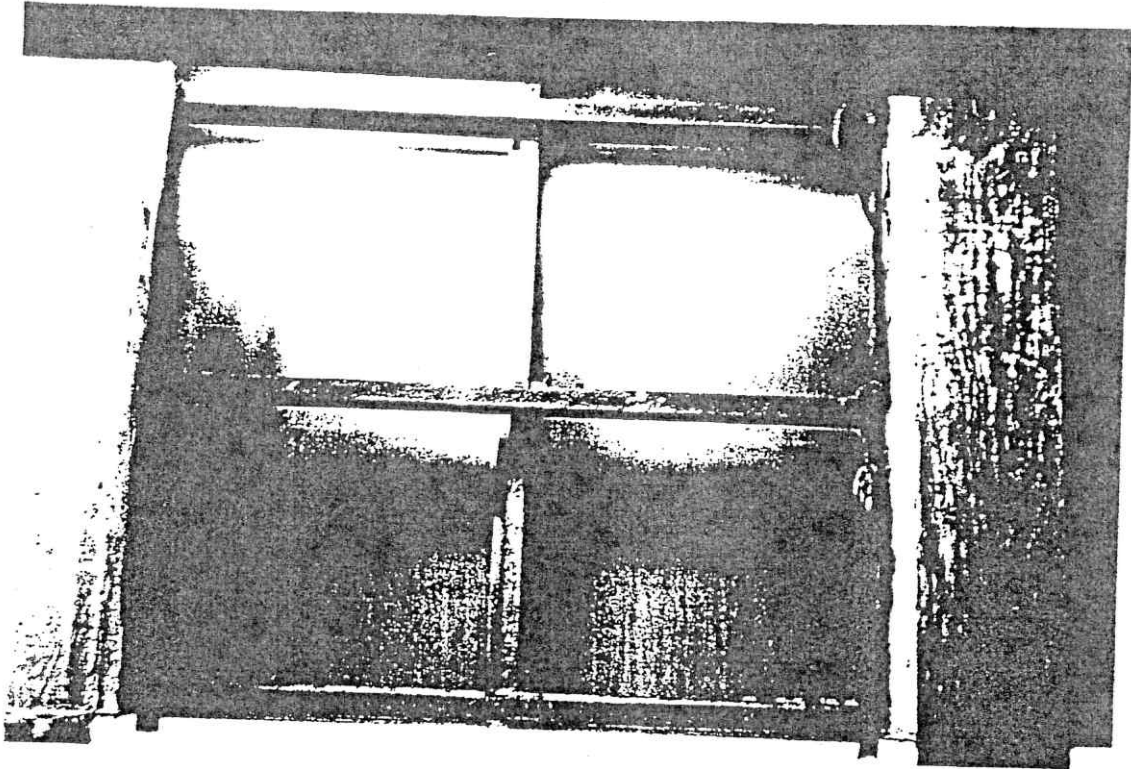
- d. From the roof level it was noted that the steel framing that supports the sloped parapet panels is lightly rusted (Refer to photographs 13 and 14). The base of the steel framing is supported on a pedestal that comes up from the building structure below. Steel shim plates used between the steel framing the pedestal to adjust the level are severely rusted (Refer to photograph 15). This condition is similar to the deterioration of the shim plates used between the pedestal and roof rails for the window washing equipment (Refer to photographs 5 and 16). At the time of our observations the shim plates below the roof rails were being replaced.

6. Rusted steel framing - While the rusting of the steel framing for the sloped parapet panels is mild at this point, we recommend that the steel framing be cleaned, primed and painted to prevent further deterioration. The rusting of the steel shims is more severe and should also be addressed. The mild steel shims should be replaced with galvanized or stainless steel shims and the pedestals cleaned, primed and painted.
