## Chapter 9

# FIRE BEHAVIOR IN WORLD TRADE CENTER 2

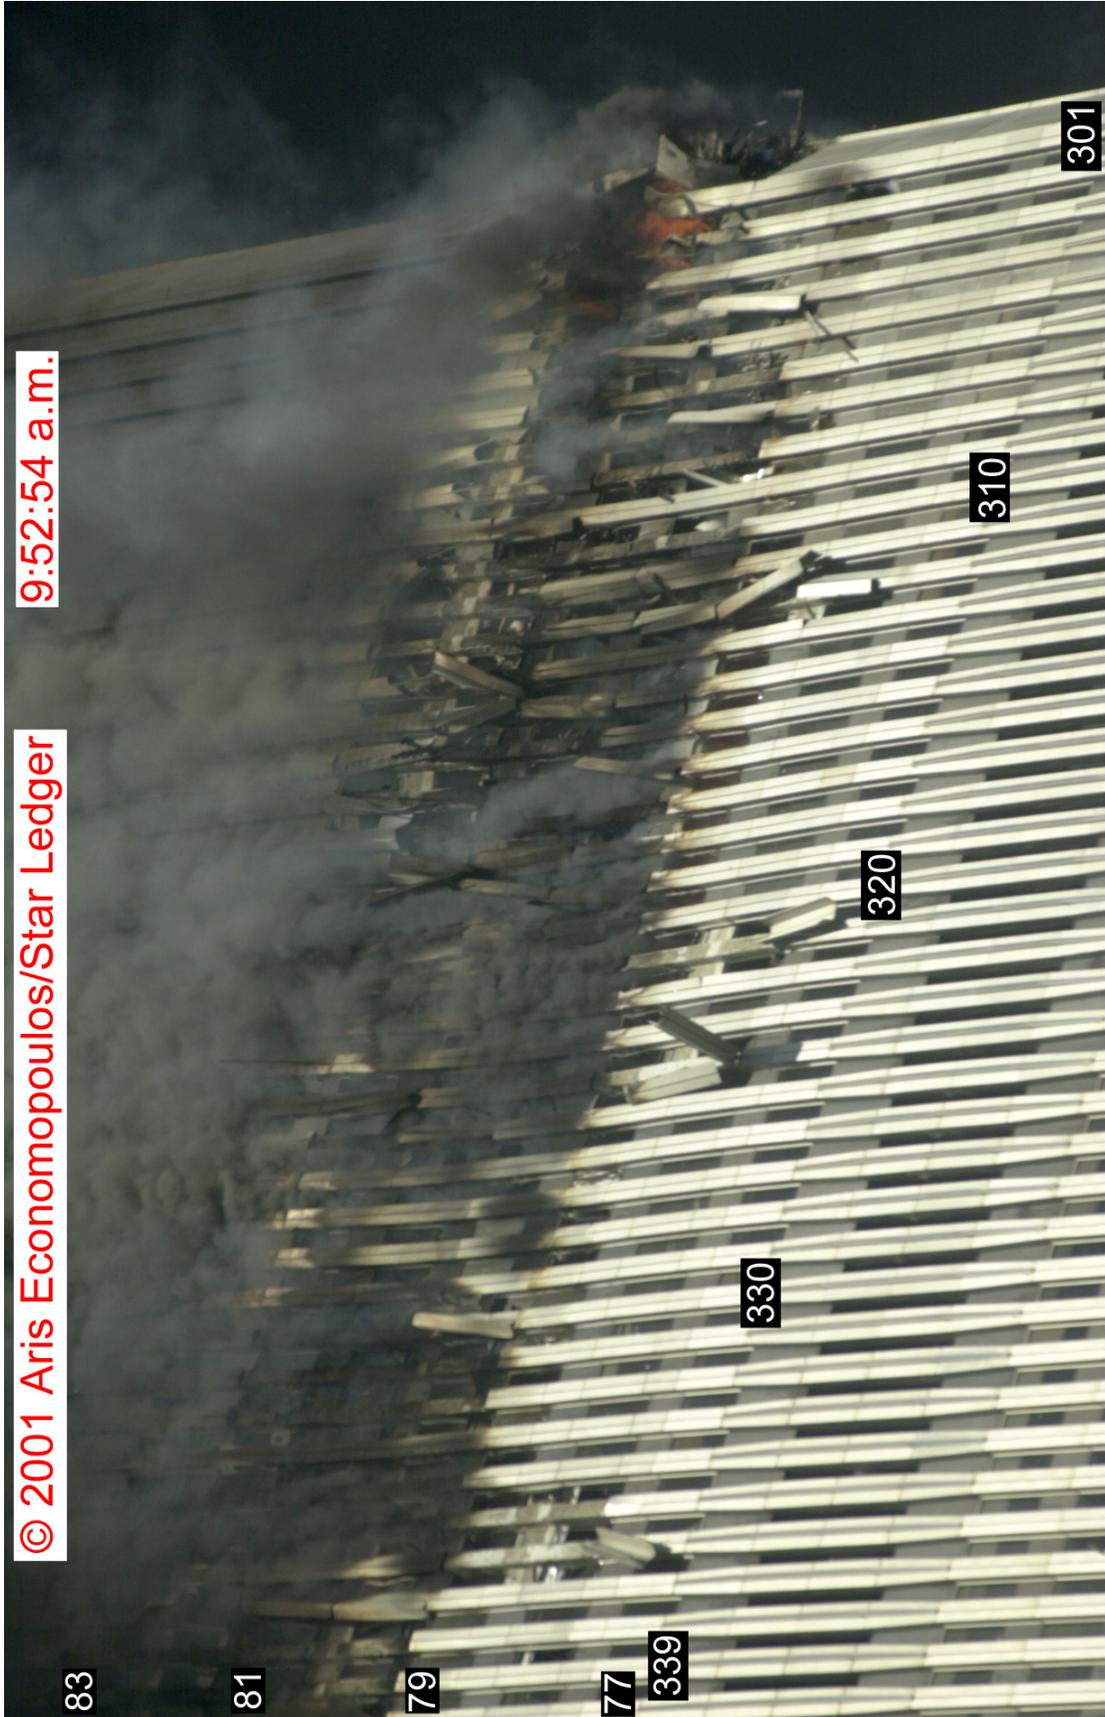
In Figure 9-67 heavy smoke was flowing from windows 79-314 to 79-320 on the 79th floor, and flames were extended from a number of these windows. In Figure 9-80 relatively light smoke is coming from windows 79-319 to 79-321, and there is no indication of external flaming. Apparently, the fires present in this area roughly 5½ min earlier have died down considerably. Carets at the tops of the covers for columns 79-312 to 79-324 indicate the relative local intensities of the fire that burned in this area earlier. In the photograph taken at 9:47:10 a.m. (Figure 9-67) the most intense burning at the northern edge of the 82nd floor was in windows 82-306 and 82-307. At the later time flames are only visible in window 82-303. On the other hand, the flames on the northern edge of the 81st floor are clearly more intense at the later time. Overall, the number and intensities of the fires on the east face appear to be at their lowest levels since the aircraft impact 50 min earlier.

Figure 9-80. This cropped photograph shows a view of the east face of WTC 2 at 9:52:54 a.m. The intensity levels have been adjusted, and column and floor numbers have been added.

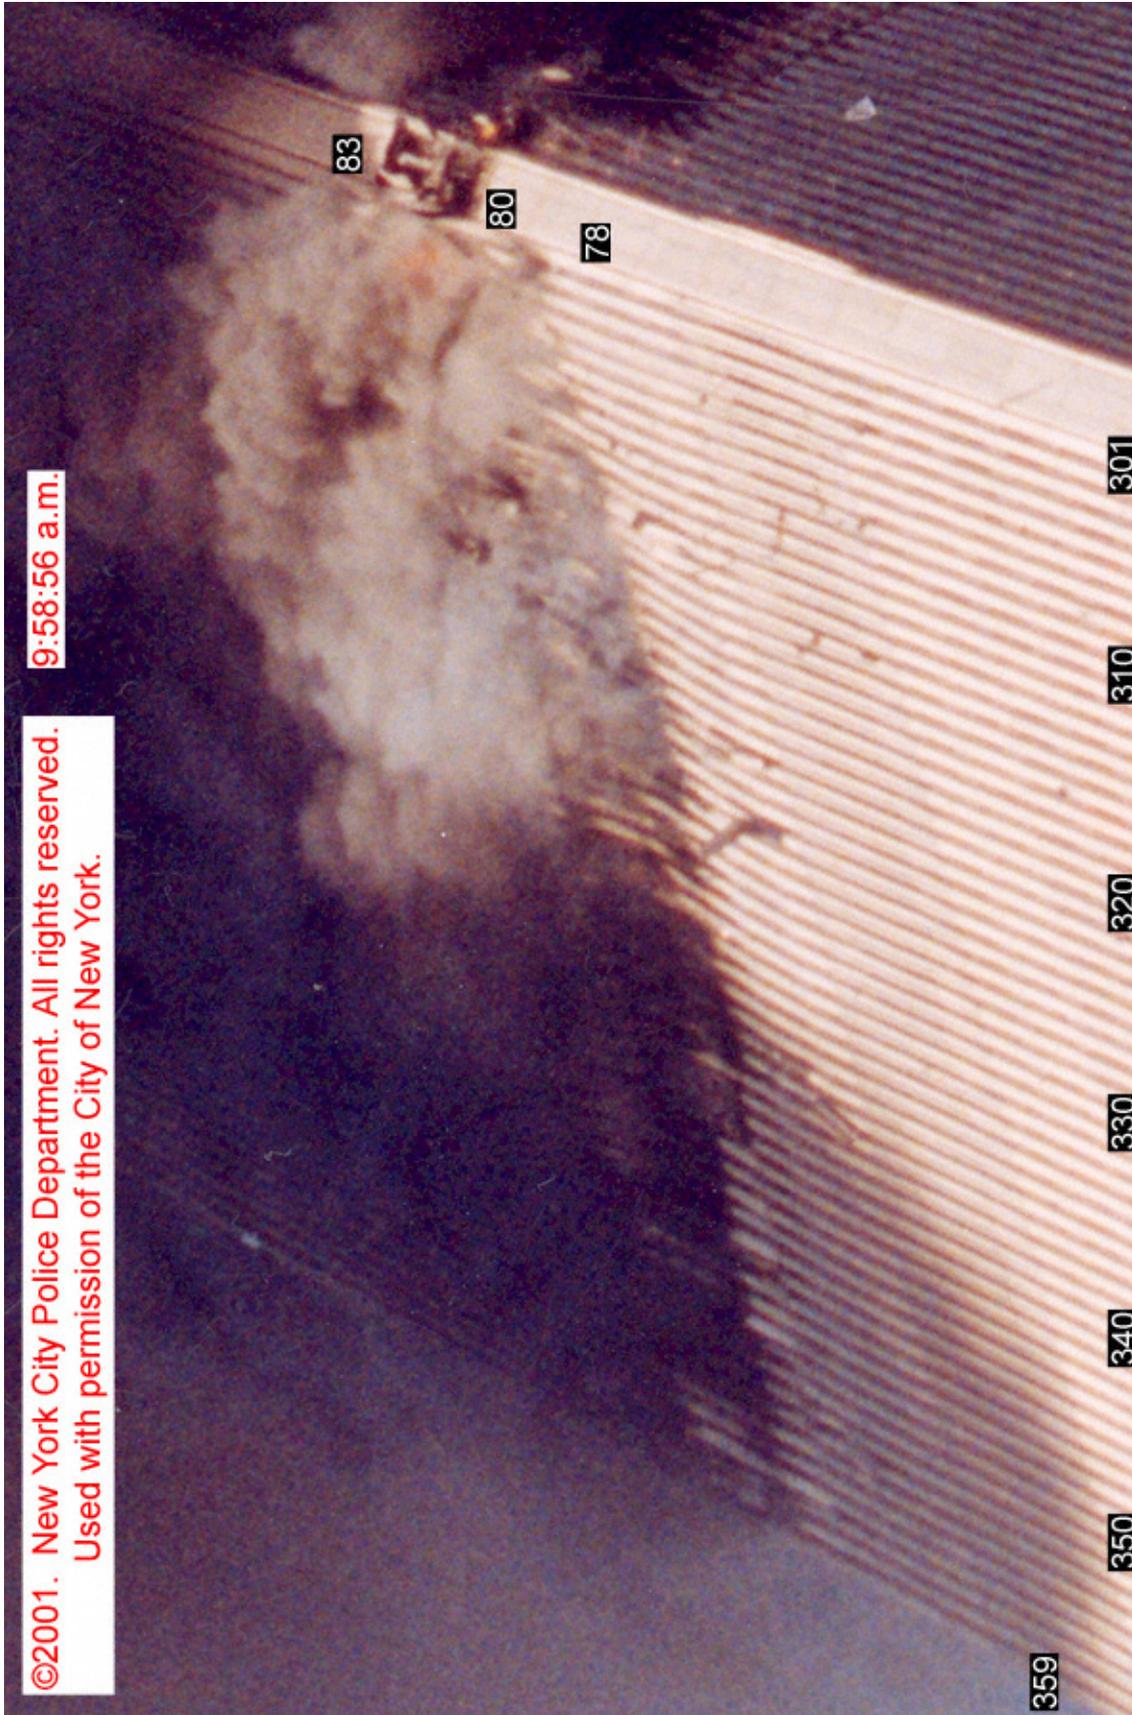
Figure 9-83. This cropped image shows the east face of WTC 2 at 9:58:56 a.m. The intensity levels have been adjusted, and column and floor numbers have been added.
