**Federal Building and Fire Safety Investigation of the
World Trade Center Disaster**

**Structural Fire Response and
Probable Collapse Sequence of
World Trade Center Building 7**

VOLUME 1

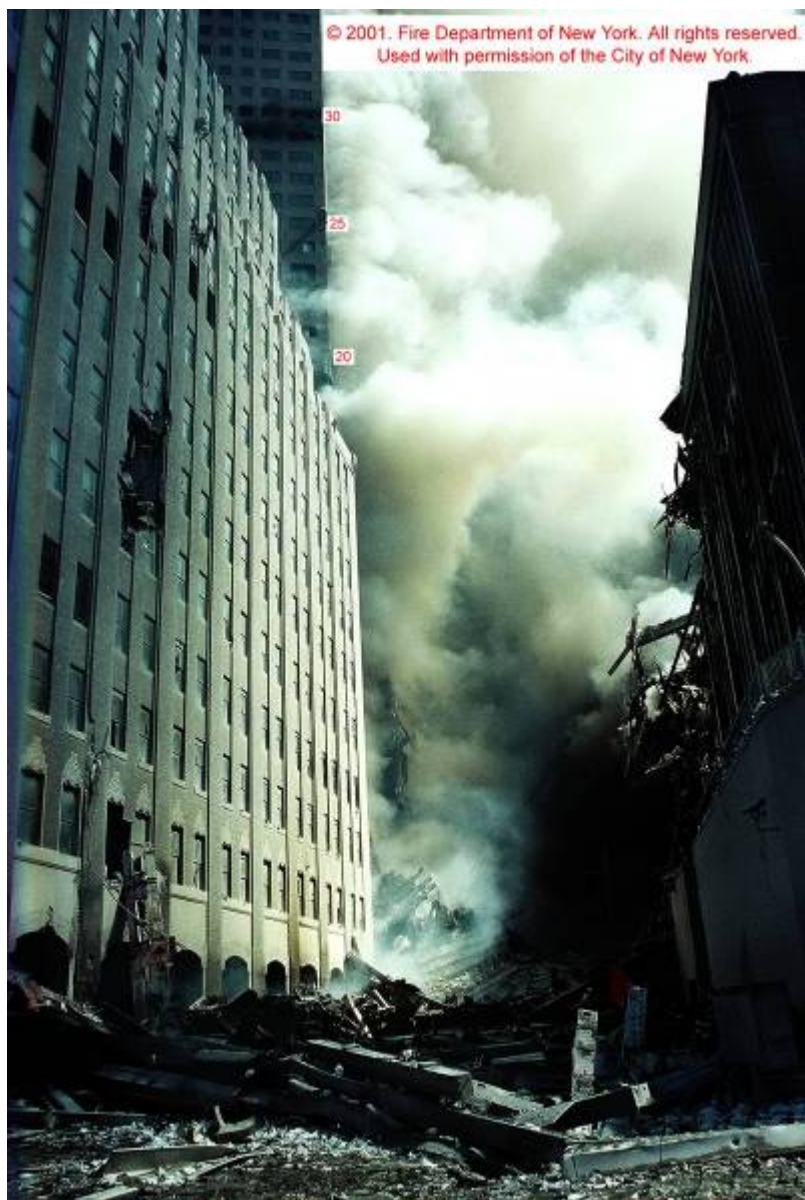
Figure 5–56. Photograph of damage on the south face of WTC 7, shot looking down Vesey Street between the Verizon Building (left) and WTC 6 (right), shortly after 1:30 p.m.

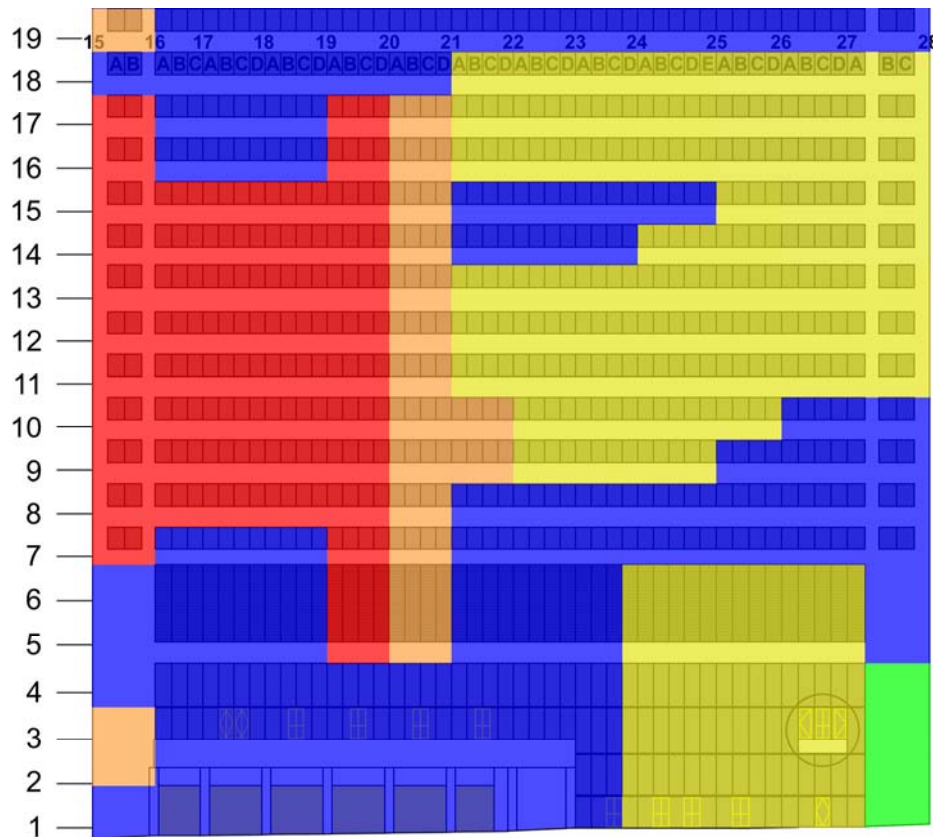
Figure 5–73. Summary of observed damage for the lower 19 floors on the south face of WTC 7 following the collapse of WTC 1.

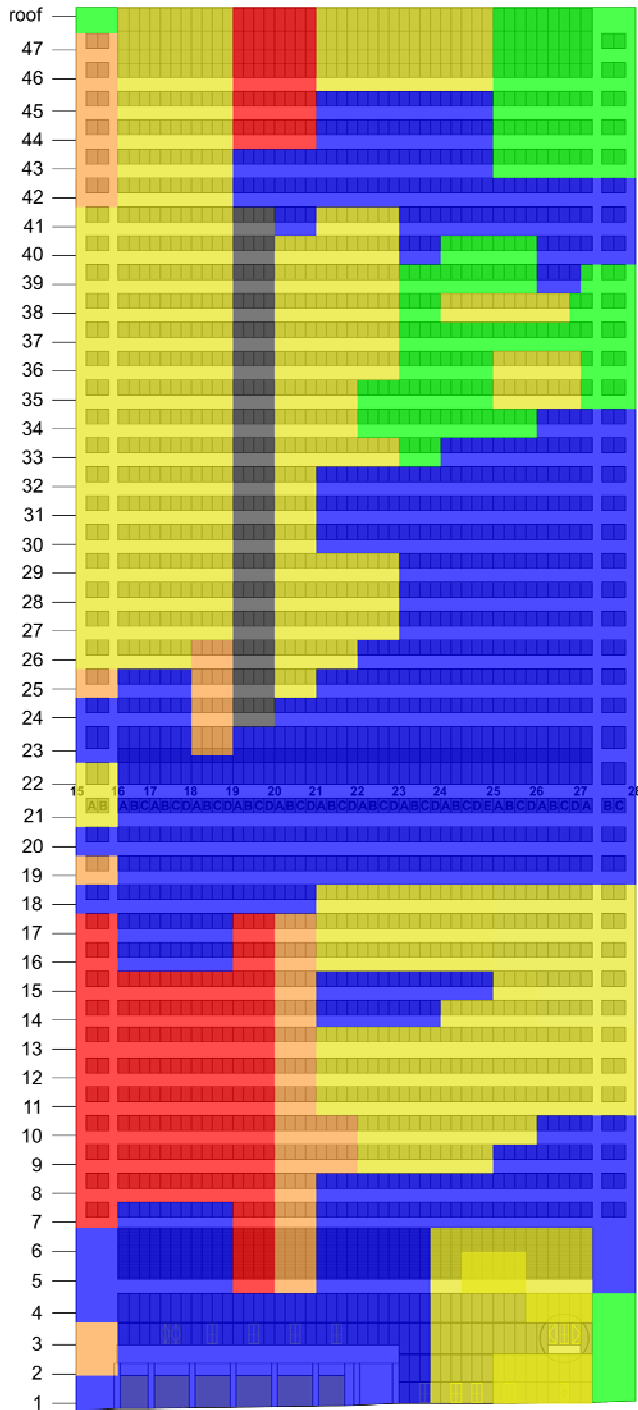
Figure 5–83. Observed damage on the south face of WTC 7 following the collapse of WTC 1.

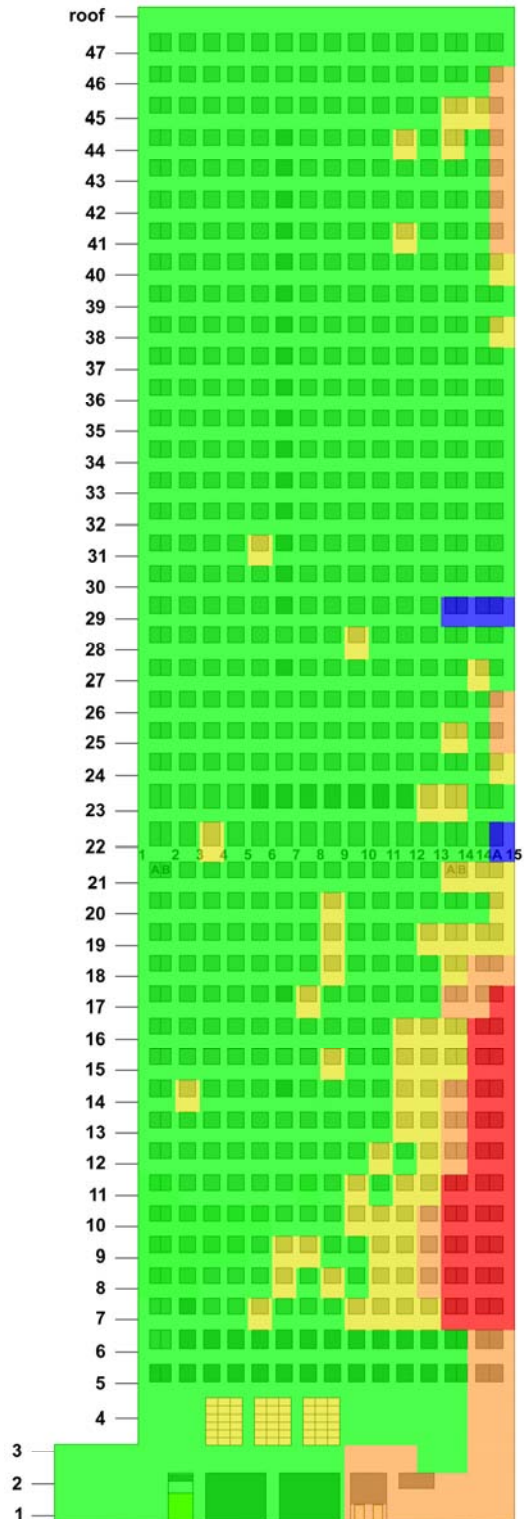
Figure 5–89. Observed damage on the west face of WTC 7 following the collapse of WTC 1 is shown.

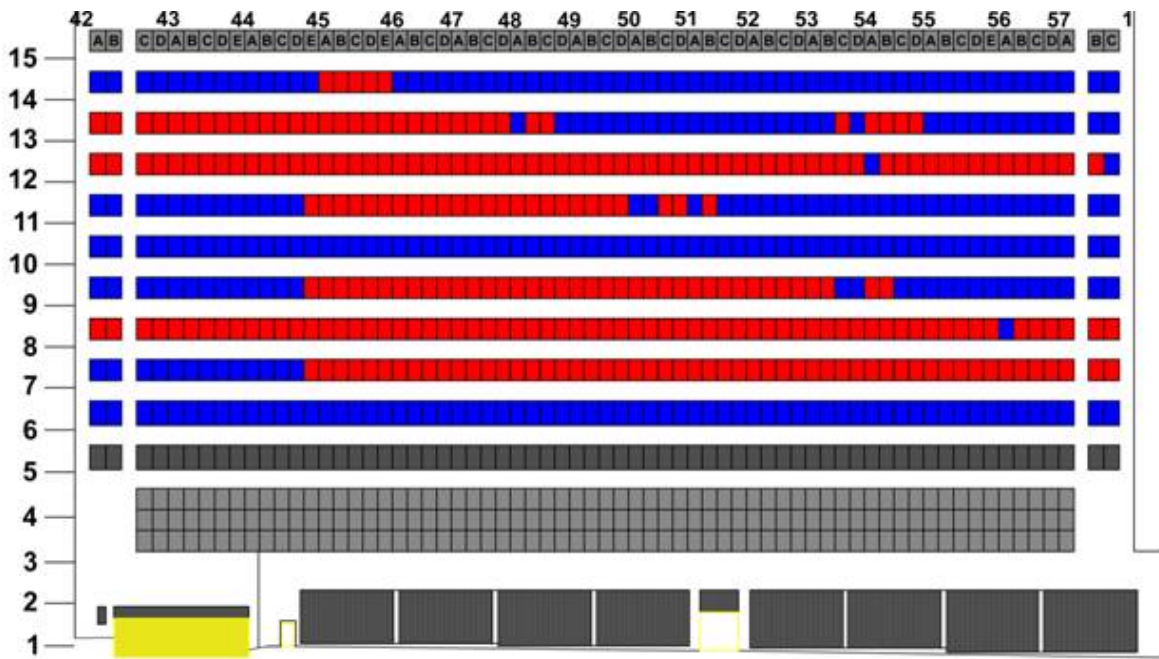
Figure 5–180. Façade map of the north face of WTC 7 showing where windows were broken and/or fire was observed during the period when fire first appeared on the face shortly before 3:00 p.m. until the building collapsed at 5:20:52 p.m.

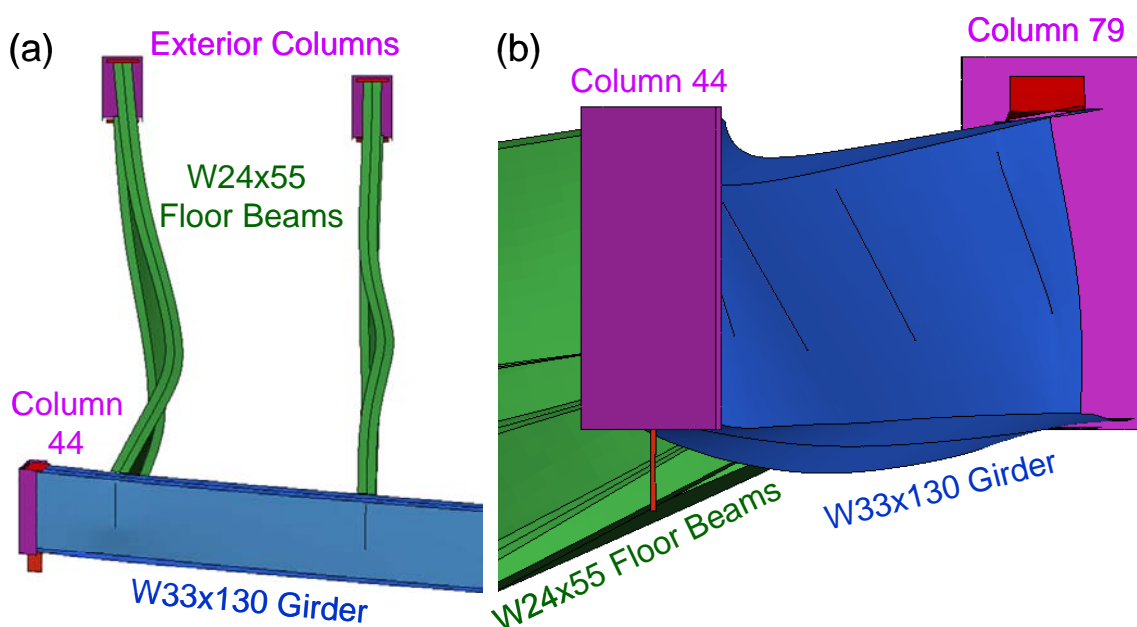
Figure 8–27. Buckled floor beams shown from above (a) and along girder (b).
