**Federal Building and Fire Safety Investigation of the
World Trade Center Disaster**

**Structural Fire Response and
Probable Collapse Sequence of
World Trade Center Building 7**

VOLUME 2

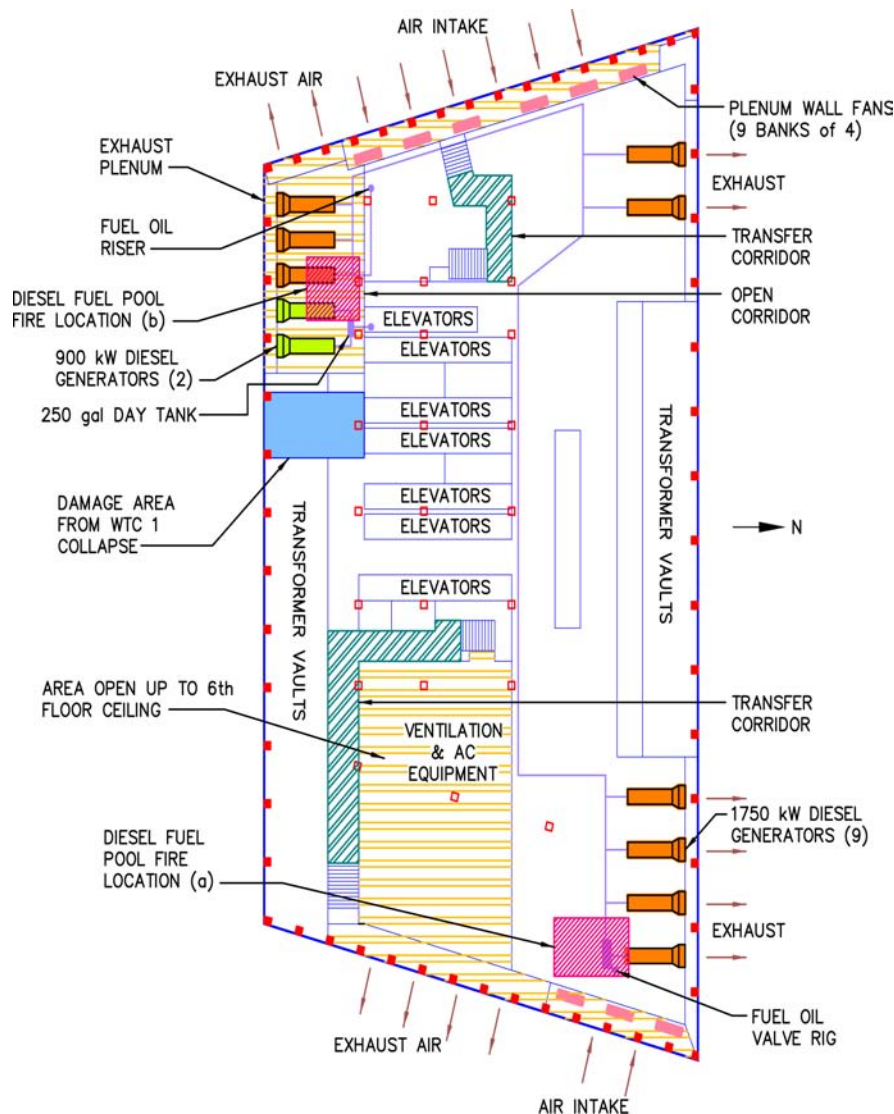
Figure 9–1. Plan view of the 5th floor, including estimated debris damage from WTC 1.²

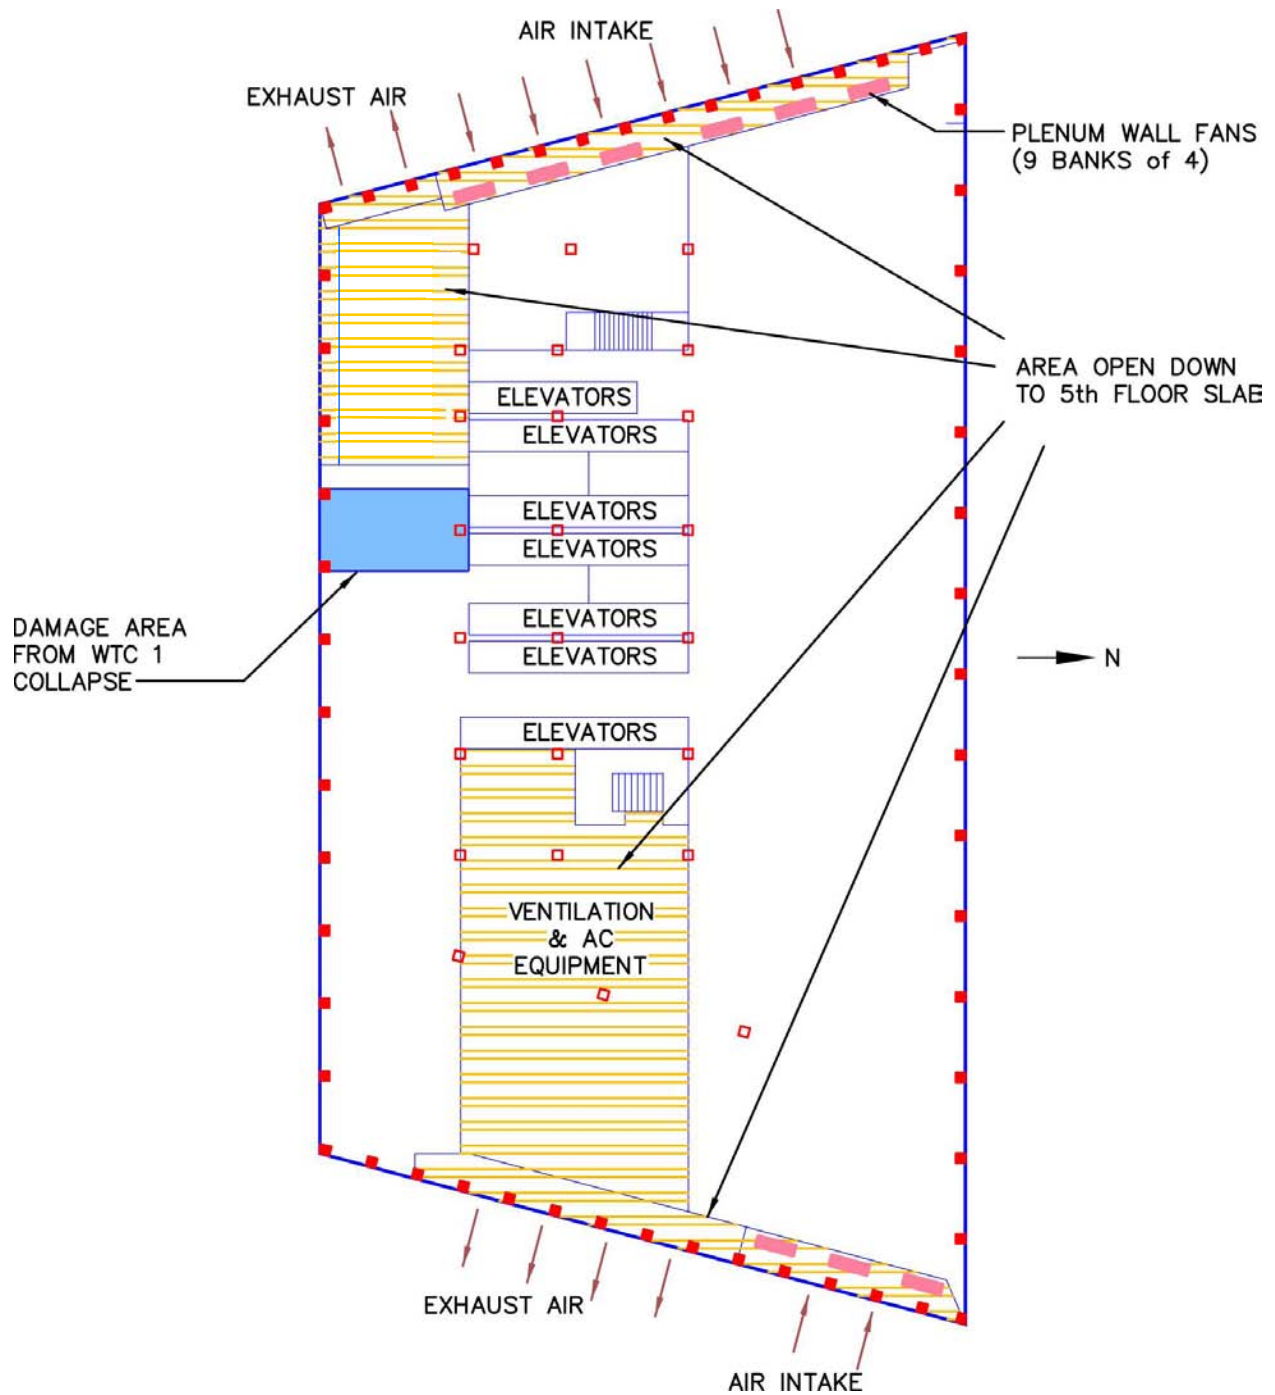
Figure 9–2. Plan view of the 6th floor, including estimated debris damage from WTC 1.²

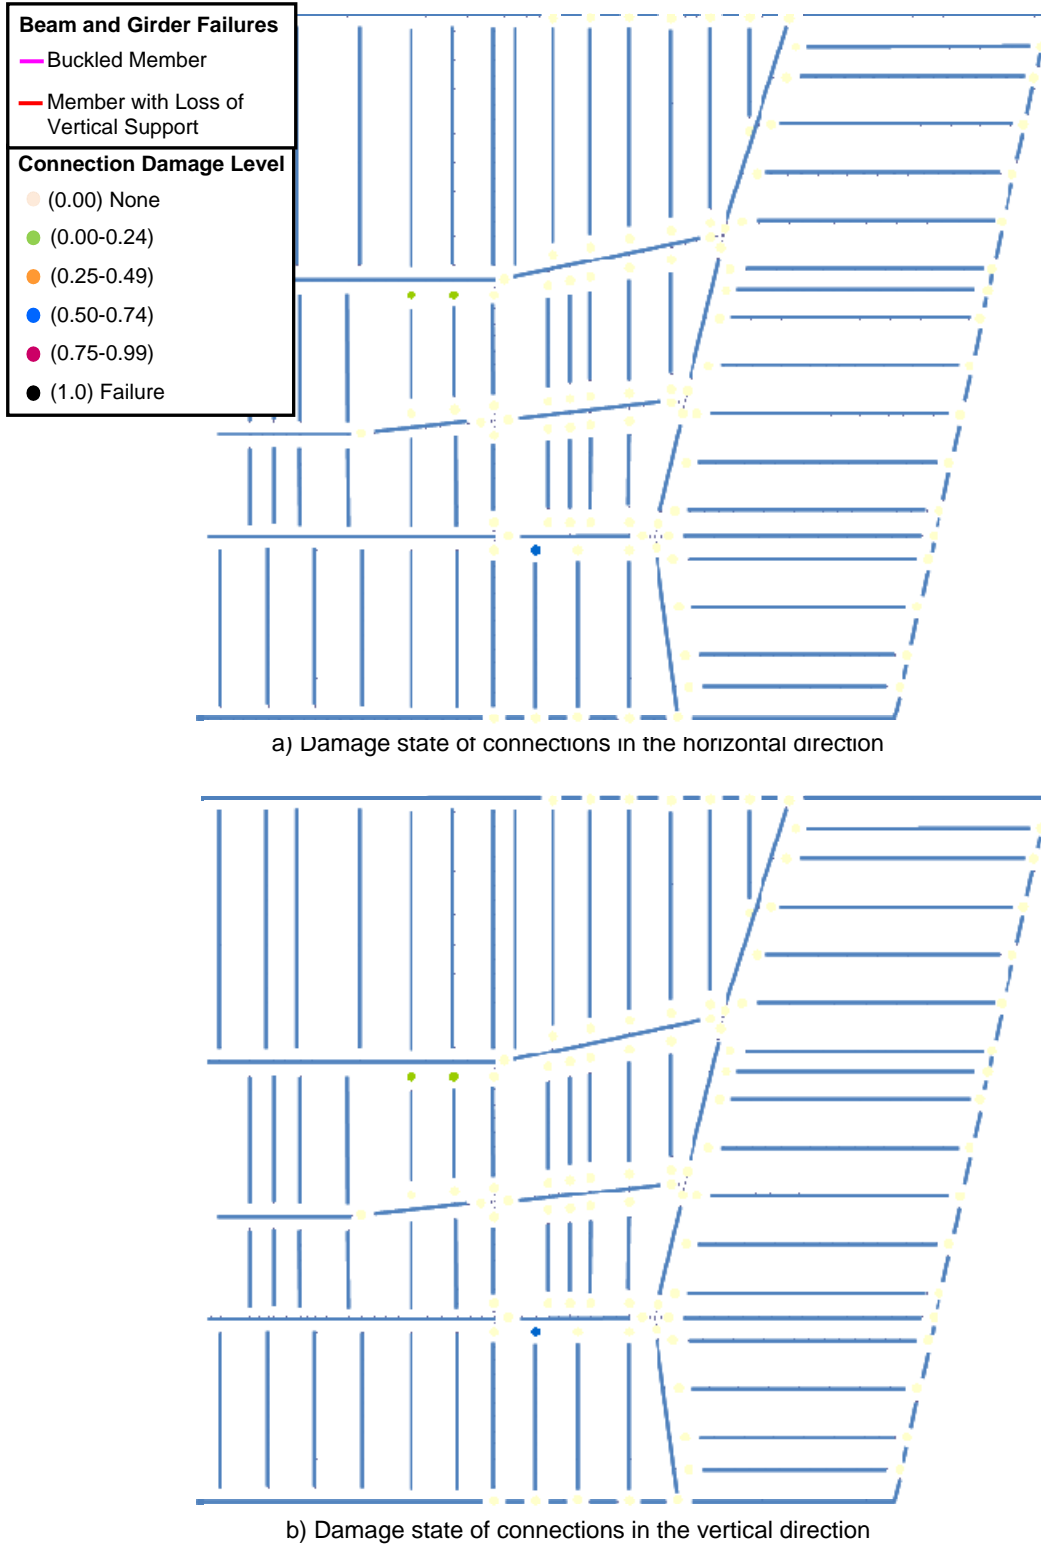
Figure 11–23. Damage state of connections, beams, and girders in Floor 9 at 3.5 h for Case B temperatures.

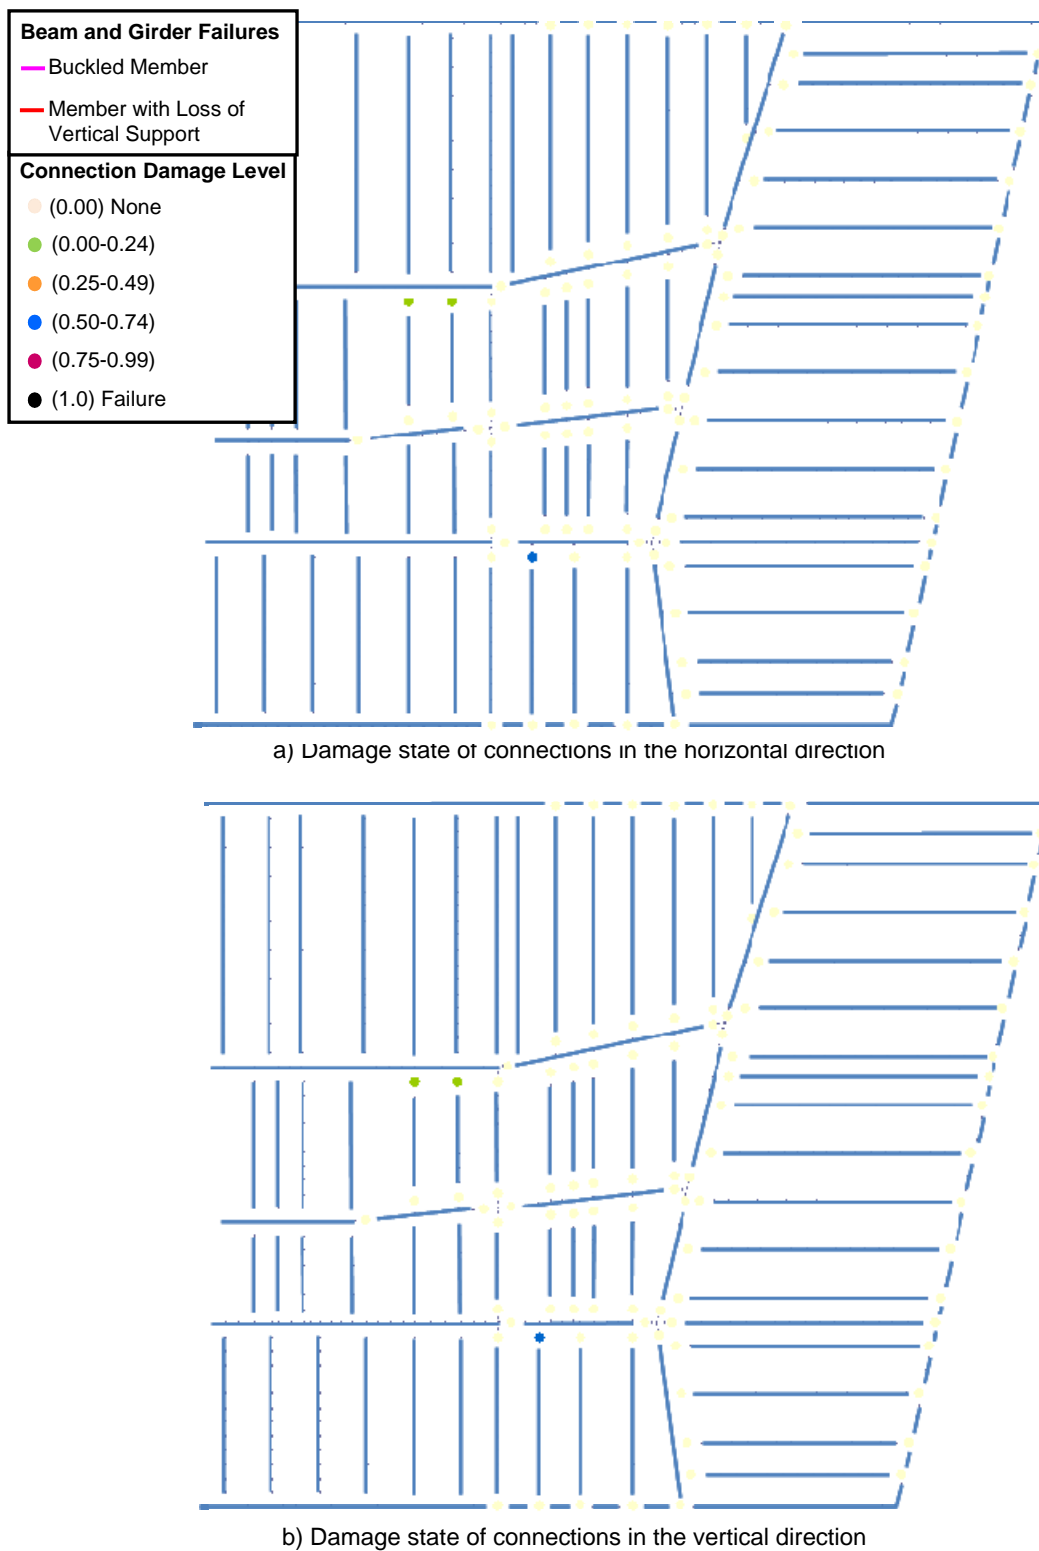
Figure 11–24. Damage state of connections, beams, and girders in Floor 10 at 3.5 h for Case B. temperatures.

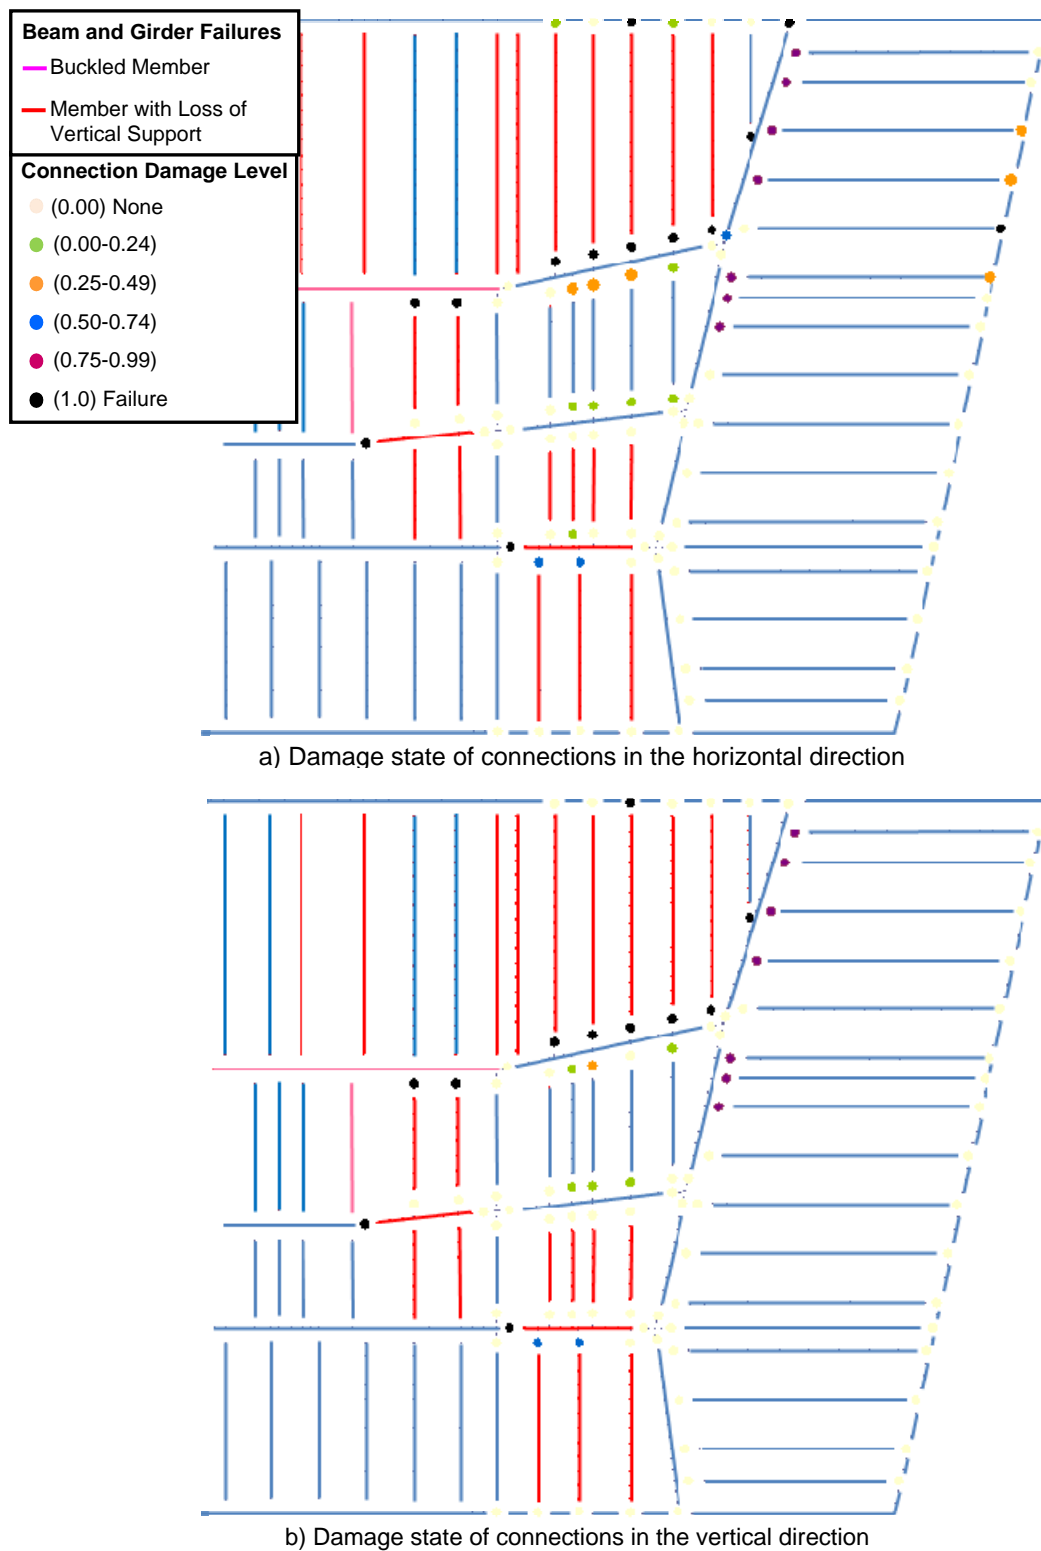
Figure 11–30. Damage state of connections, beams, and girders in Floor 8 at 4.0 h for Case B temperatures.

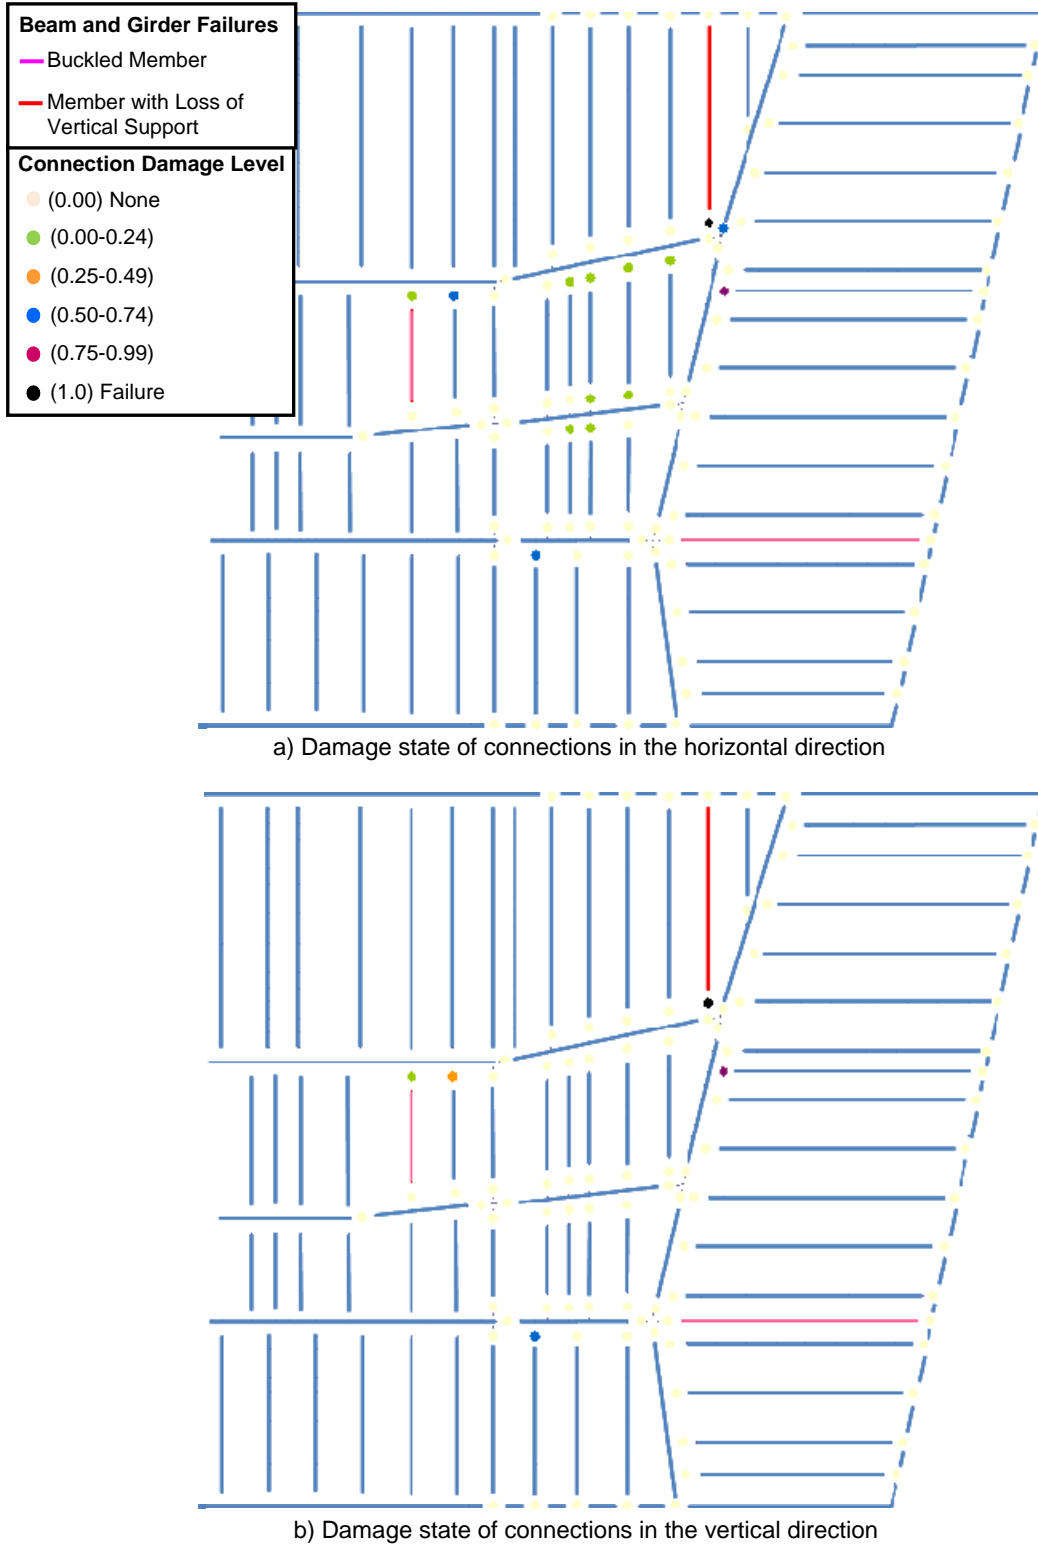
Figure 11–31. Damage state of connections, beams, and girders in Floor 9 at 4.0 h for Case B temperatures.

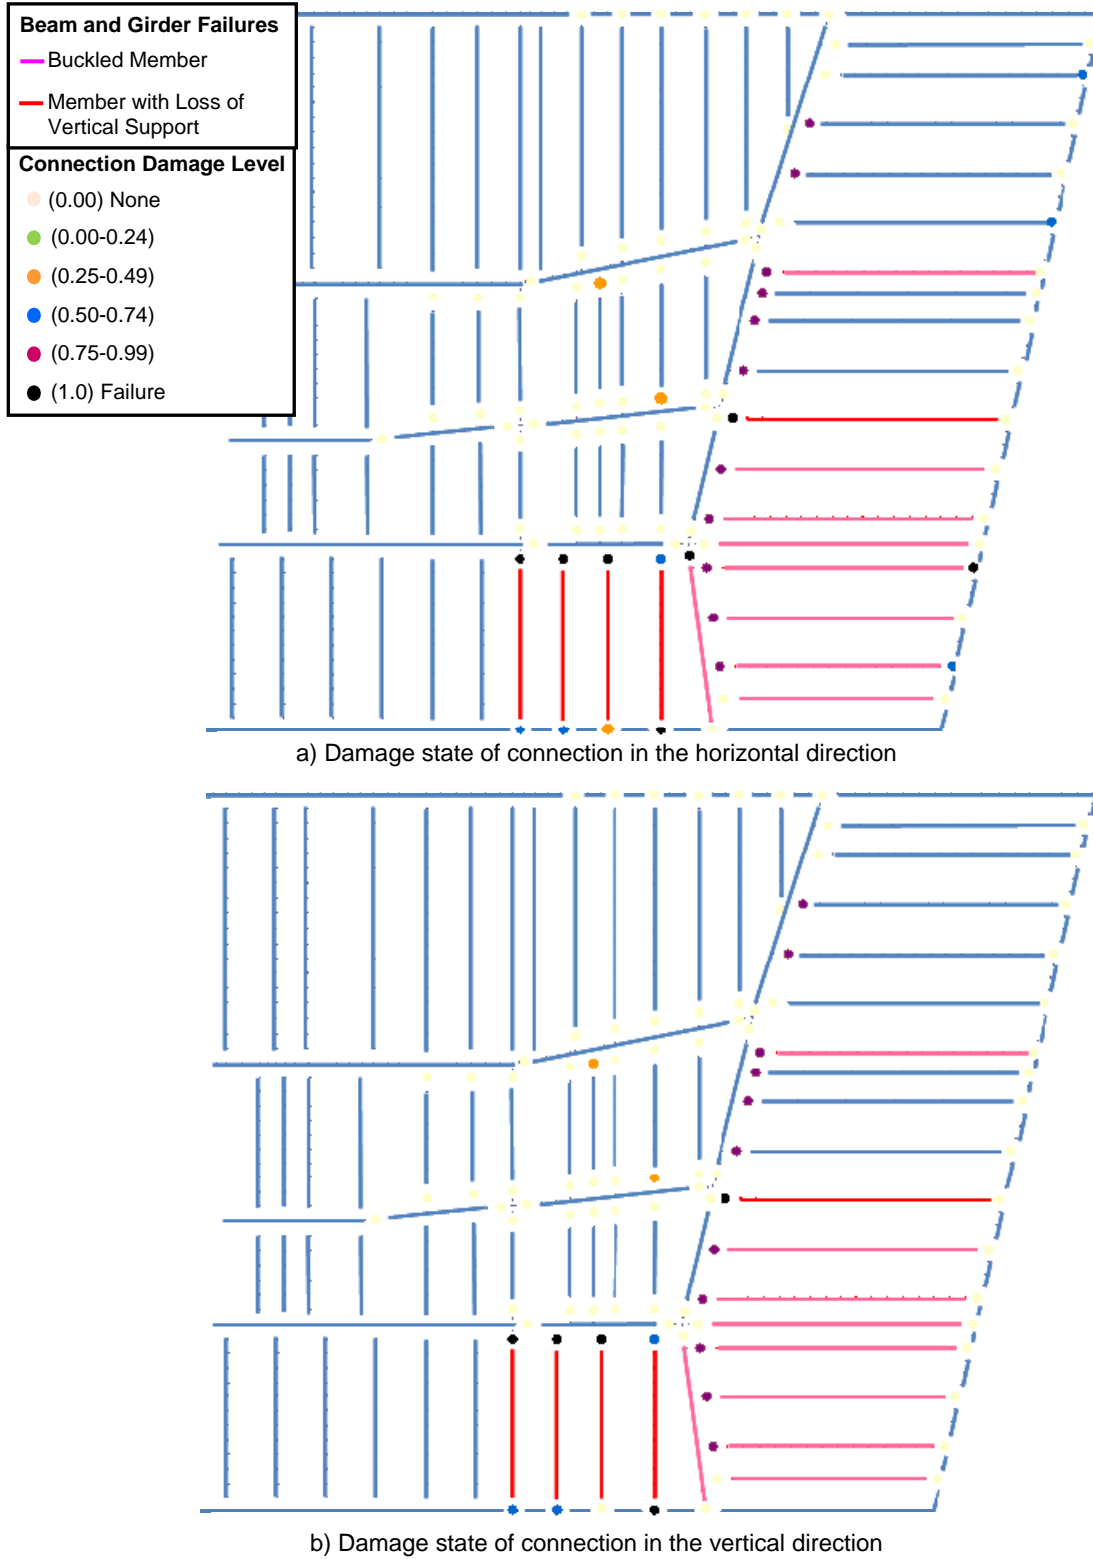
Figure 11-42. Damage state of connections, beams, and girders in Floor 12 at 4.0 h for Case C temperatures.

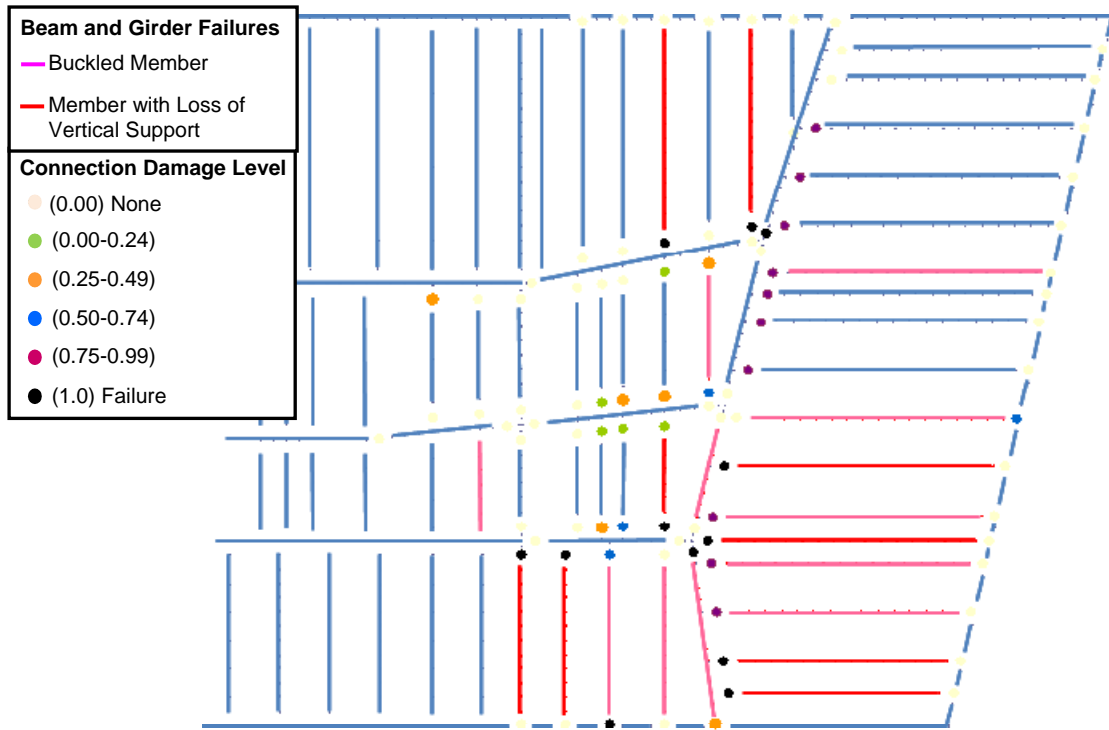
a) Damage state of connection in the horizontal direction

Figure 11–44. Damage state of connections, beams, and girders in Floor 14 at 4.0 h for Case C temperatures.

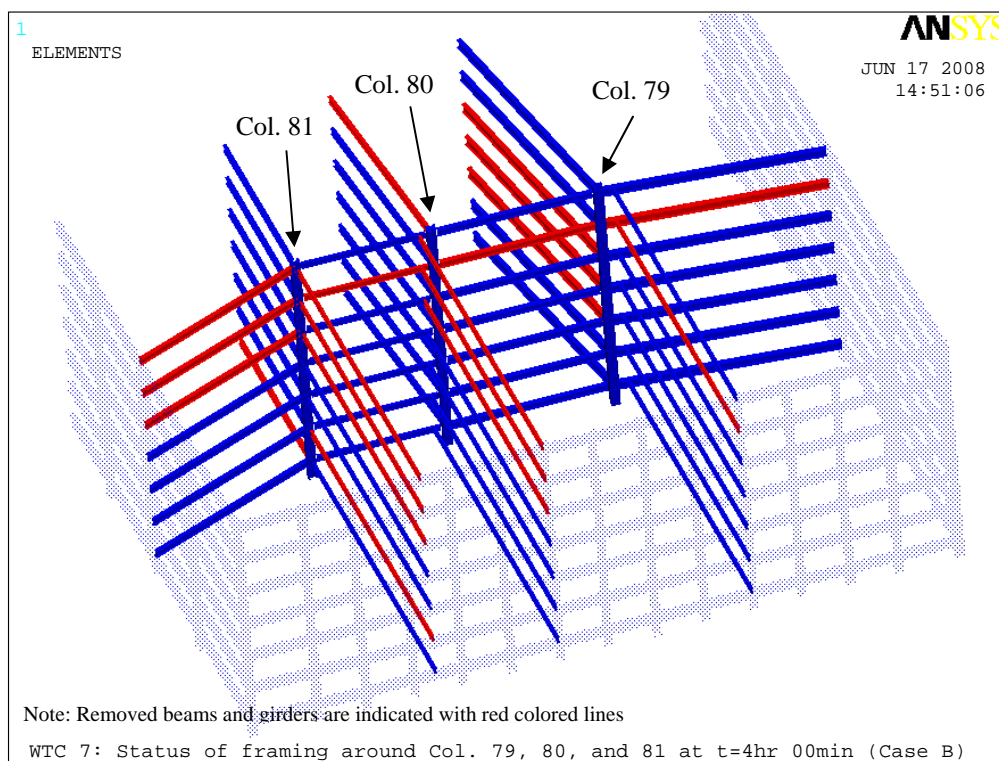
Figure 11–49. Beam and girder failures around Columns 79, 80, and 81 at 4.0 h for Case B temperatures.

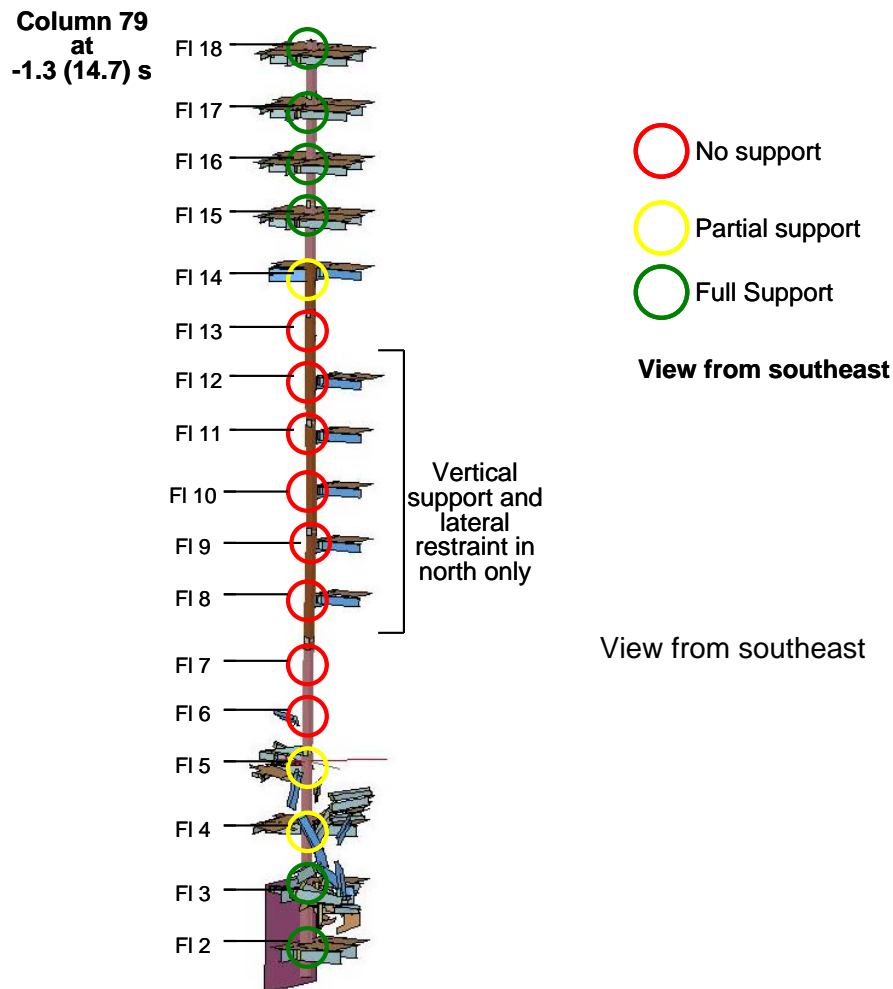
Figure 12–44. Column 79 lateral support status at time of buckling initiation.

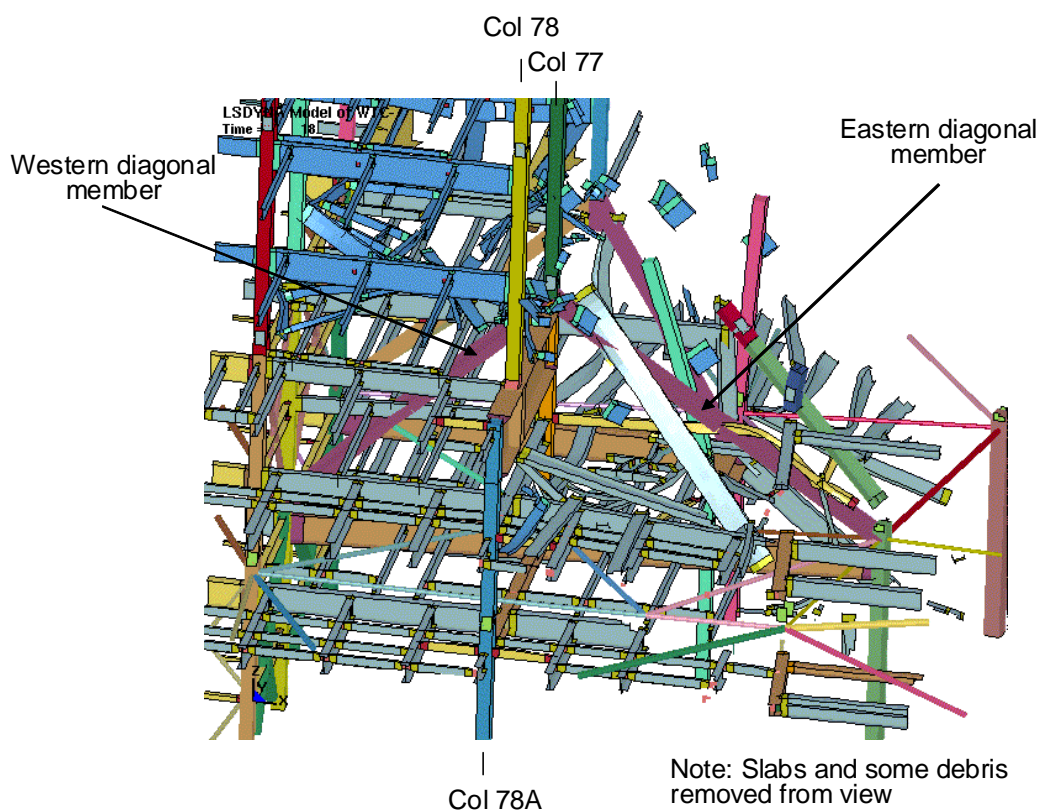
Figure 12-50. Failure of Truss 2 east diagonal. View from southeast and above.

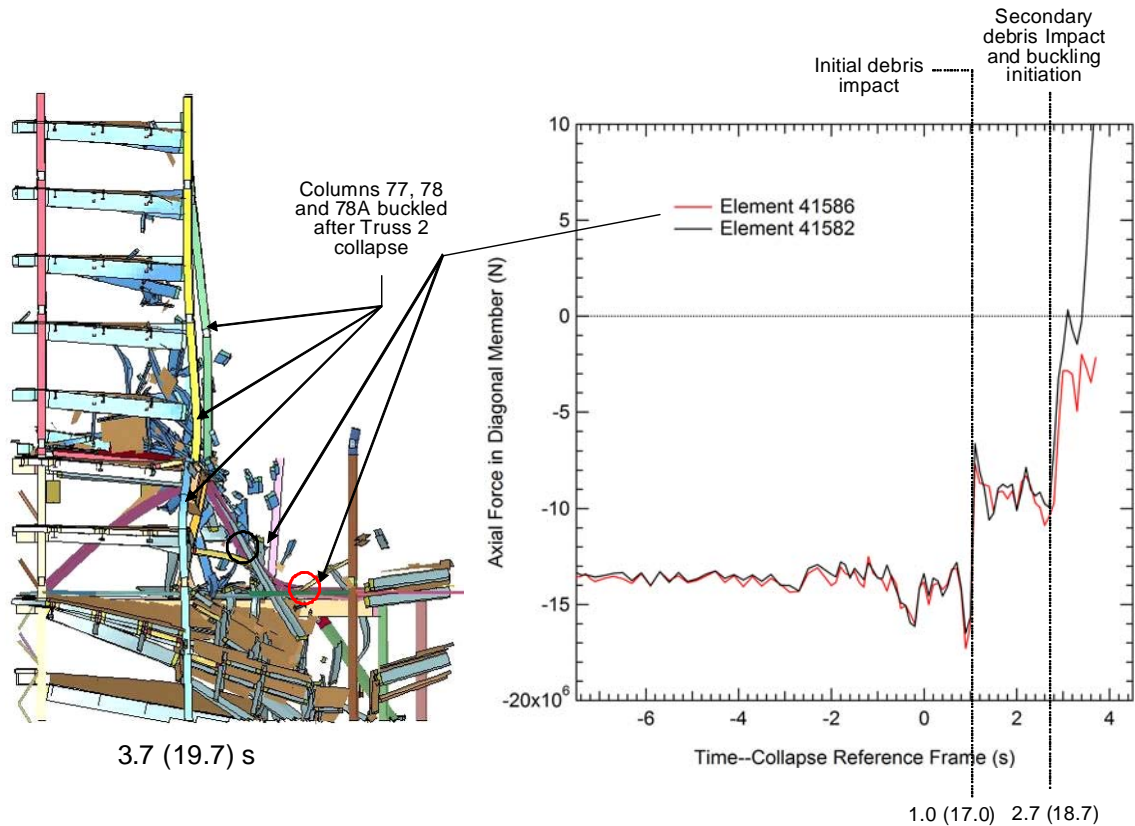
Figure 12–51. Truss 2 collapse. View from south (most of debris removed from view).

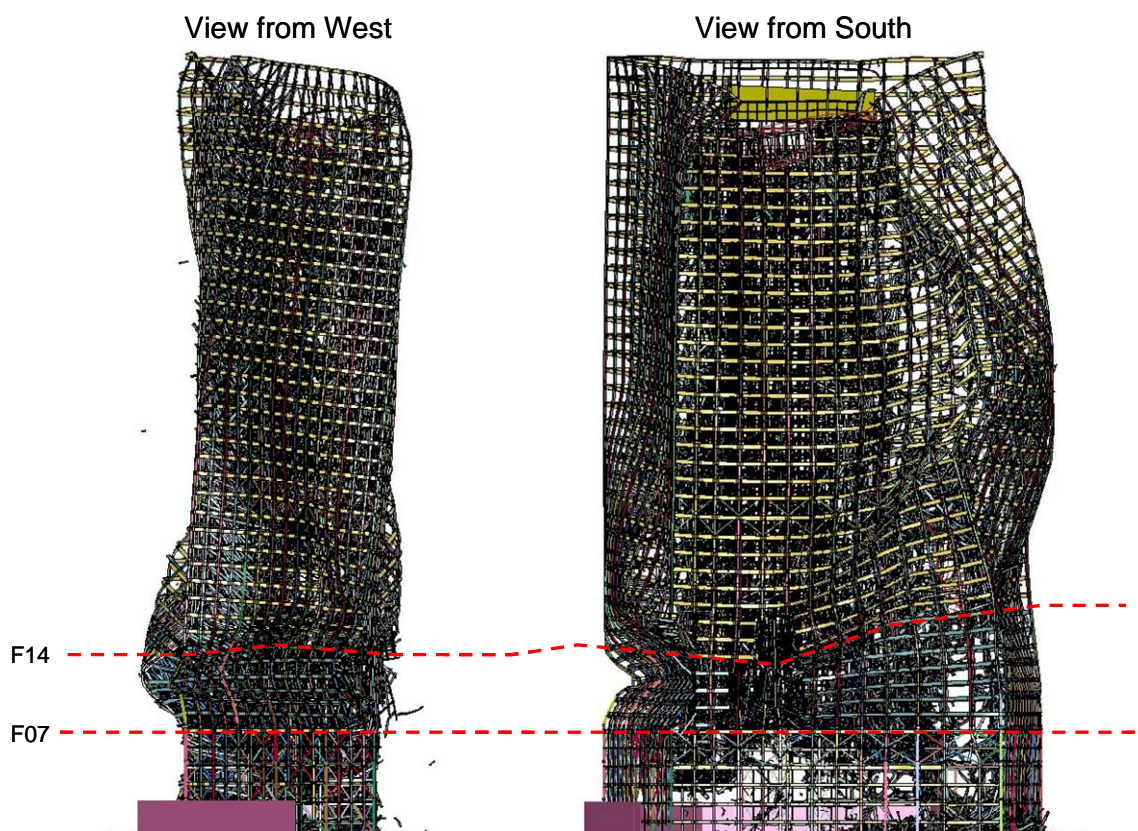
Figure 12–62. Exterior column buckling after initiation of global collapse with debris impact and fire-induced damage (slabs removed from view).
