Engineering and Organizational Issues Related to the World Trade Center Terrorist Attack

# Overview of Damage to Buildings Near Ground Zero

By Michel Bruneau, Andrew Whittaker and Andrei Reinhorn

March 2002

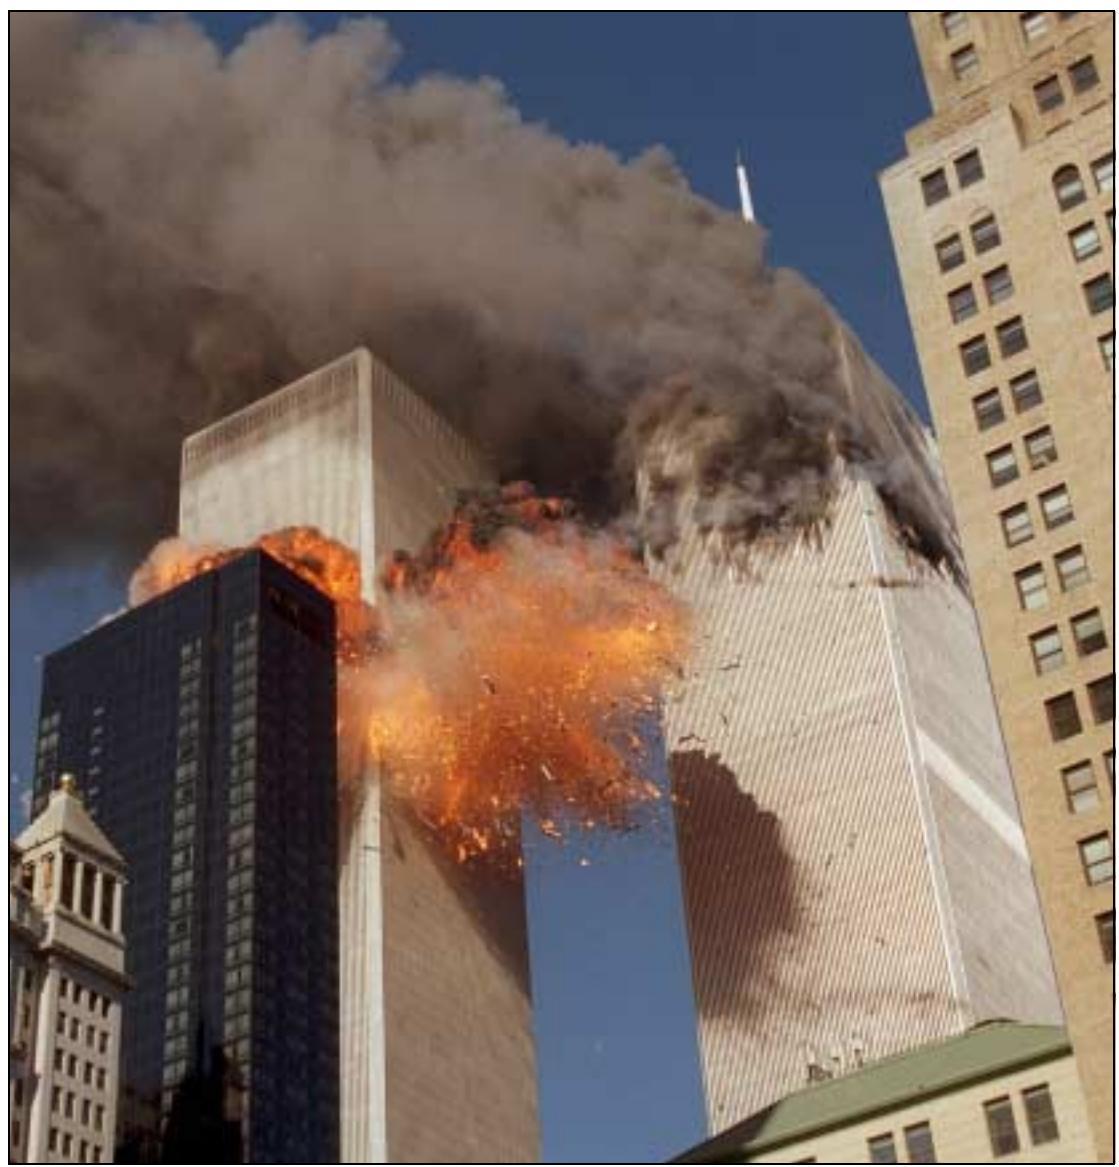
In both cases, jet fuel ignited at impact. Debris from the planes and the buildings were ejected into the adjacent space and buildings, principally in the directions of impact. Some of these debris were ablaze (see Figure 2.1). The fuel-fed fires raged at the stories where the collisions occurred, and propagated to the stories above. The extent of the spread and intensity of the fires are unknown.

Figure 2.1. Explosion following the plane impact into the South Tower

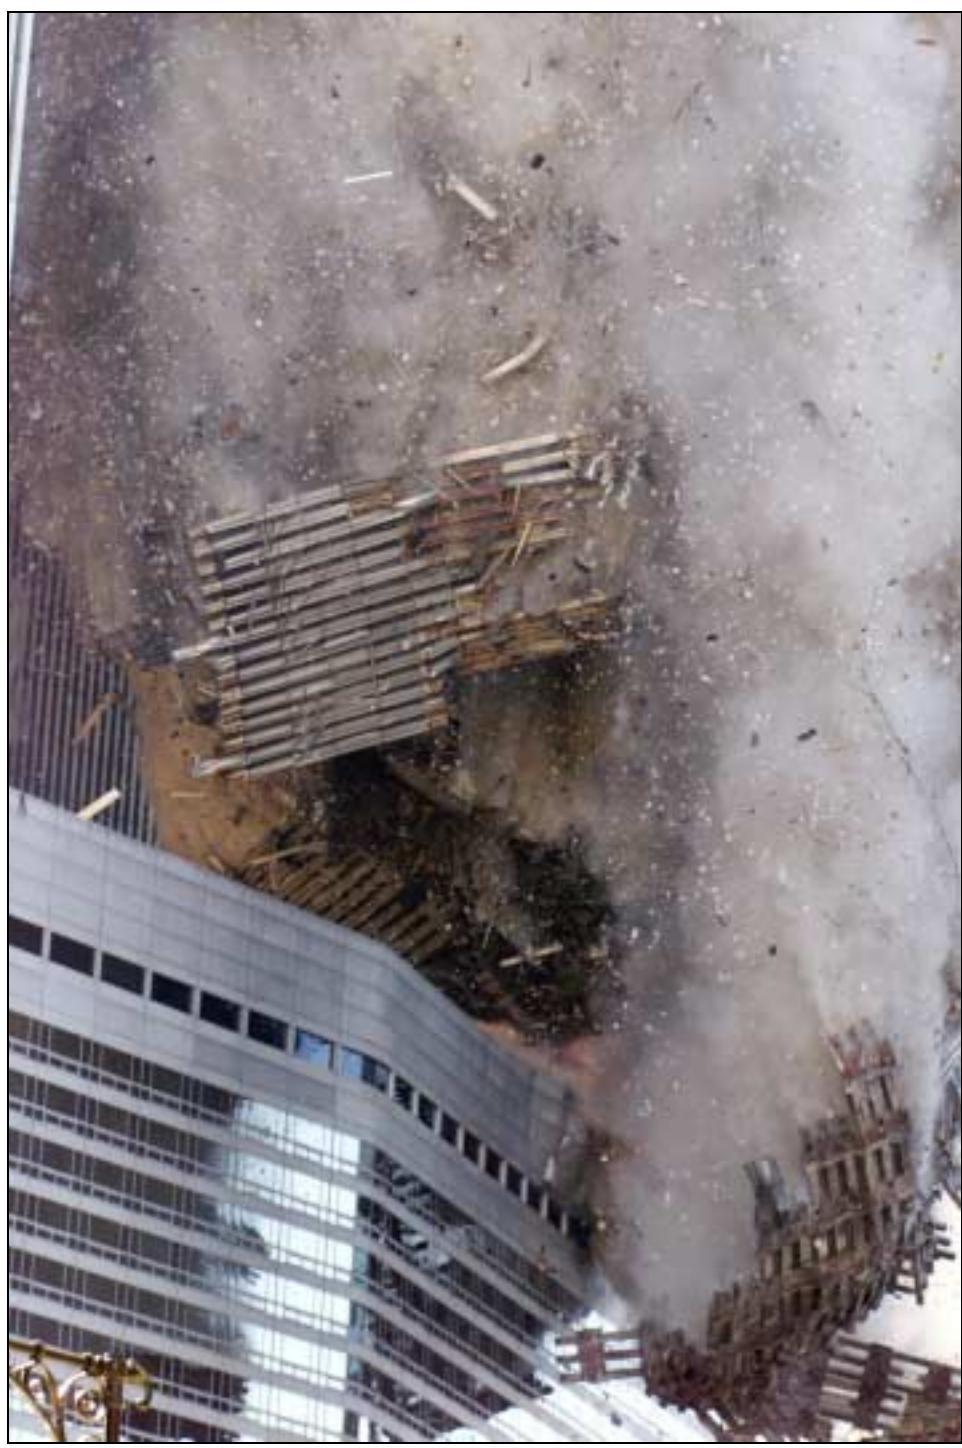
Figure 2.2. Large segments of the World Trade Center perimeter frame fell on adjacent buildings during the collapse of the towers

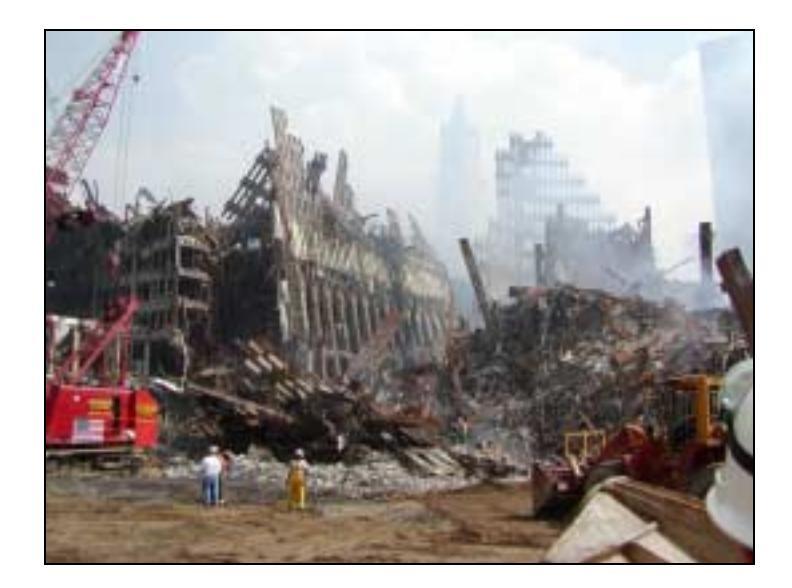
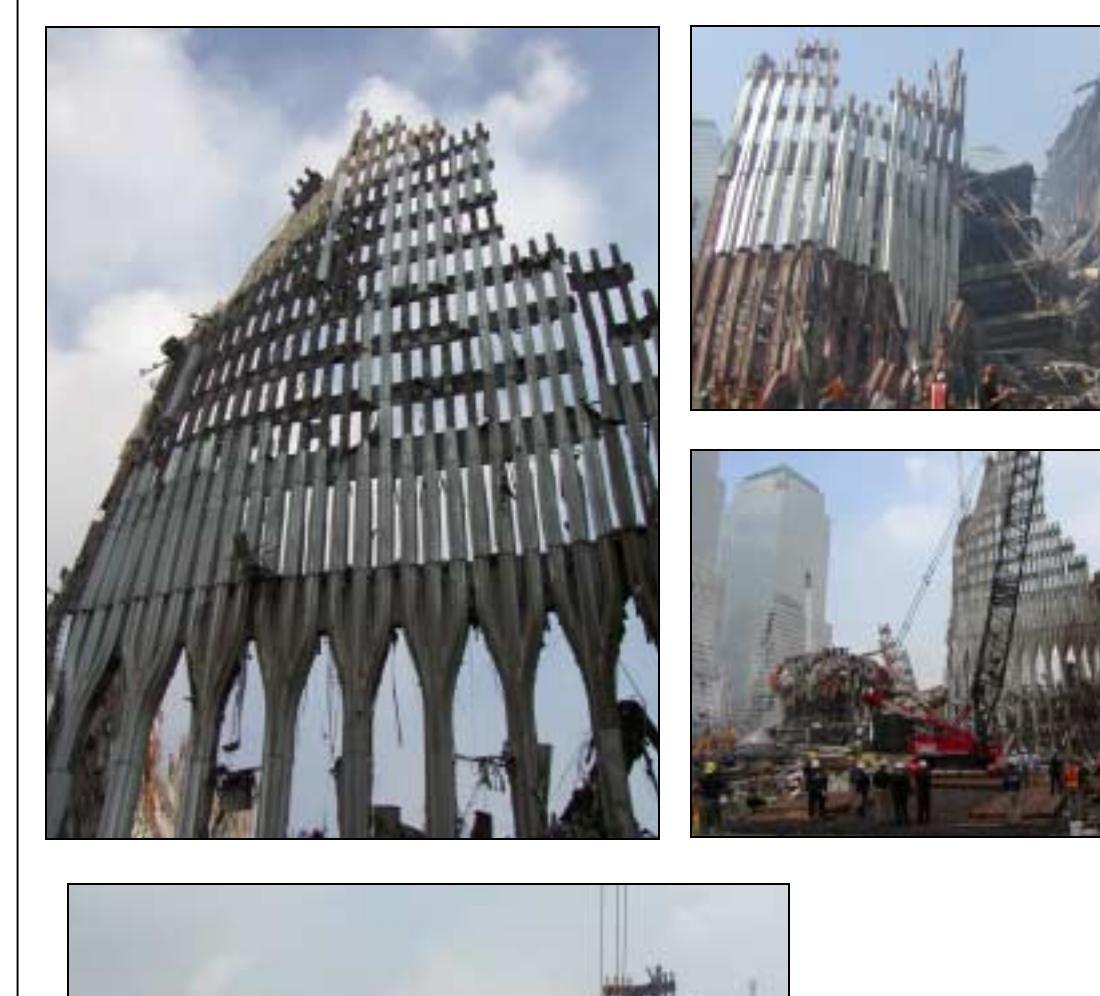
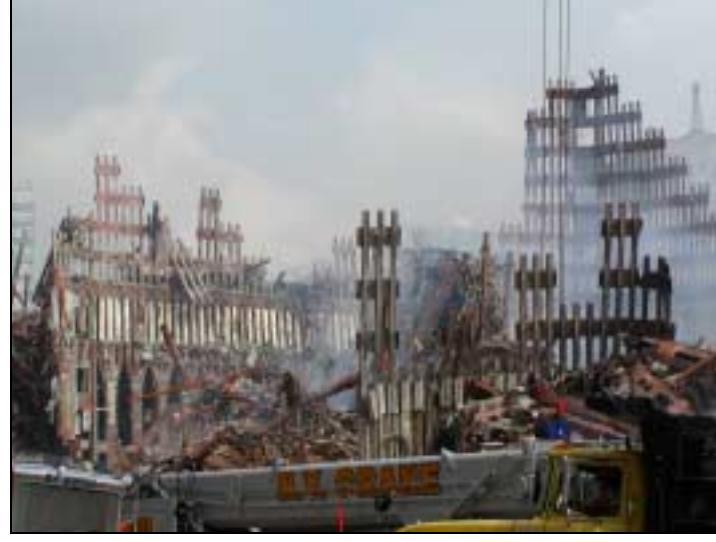
The only recognizable portions of WTC 1 and 2 on September 21, 2001, were parts of the exterior tube described above that remained standing in the debris pile (Figure 3.5). Some evidence of the building modular construction described in the previous paragraph could be observed from these parts of the building structural shell (Figure 3.6). The typical four-bolt column splices could be also observed (Figure 3.7), along with the hole on the side of each hollow rectangular column that provided access for erection of the frames (Figure 3.7, bottom photograph). As will be seen in the subsequent sections, some of these three-column modules became multi-ton projectiles that impacted and damaged adjacent buildings as the towers collapsed. The interior of the building shell (see Figure 3.6, top photographs) shows some evidence of where the supporting seats were located for the floor joists.

Figure 3.5. Portions of the perimeter tubes of WTC 1 and 2 remained standing in the debris pile (as of September 21, 2001)

Figure 3.5. (continued). Portions of the perimeter tubes of WTC 1 and 2 that remained standing in the debris pile (as of September 21, 2001)

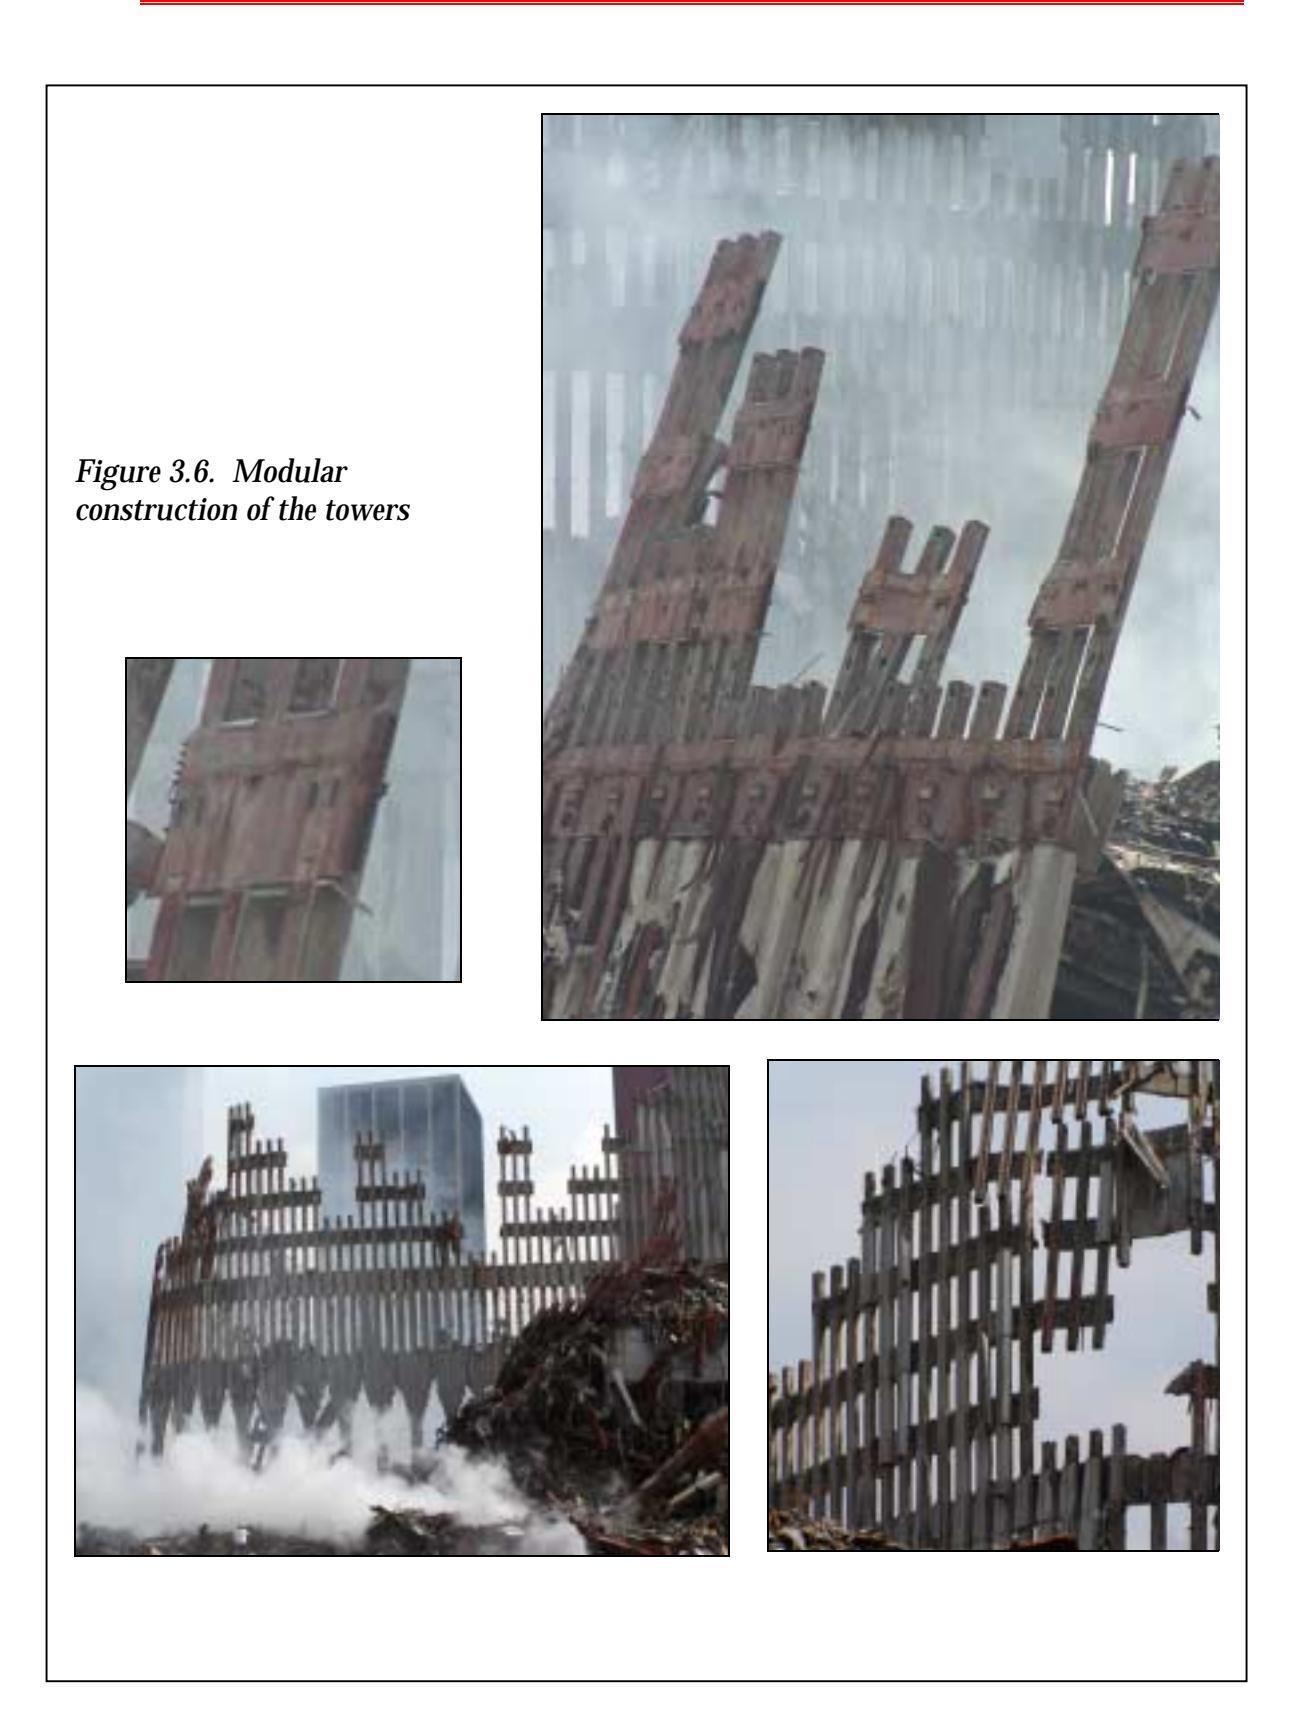
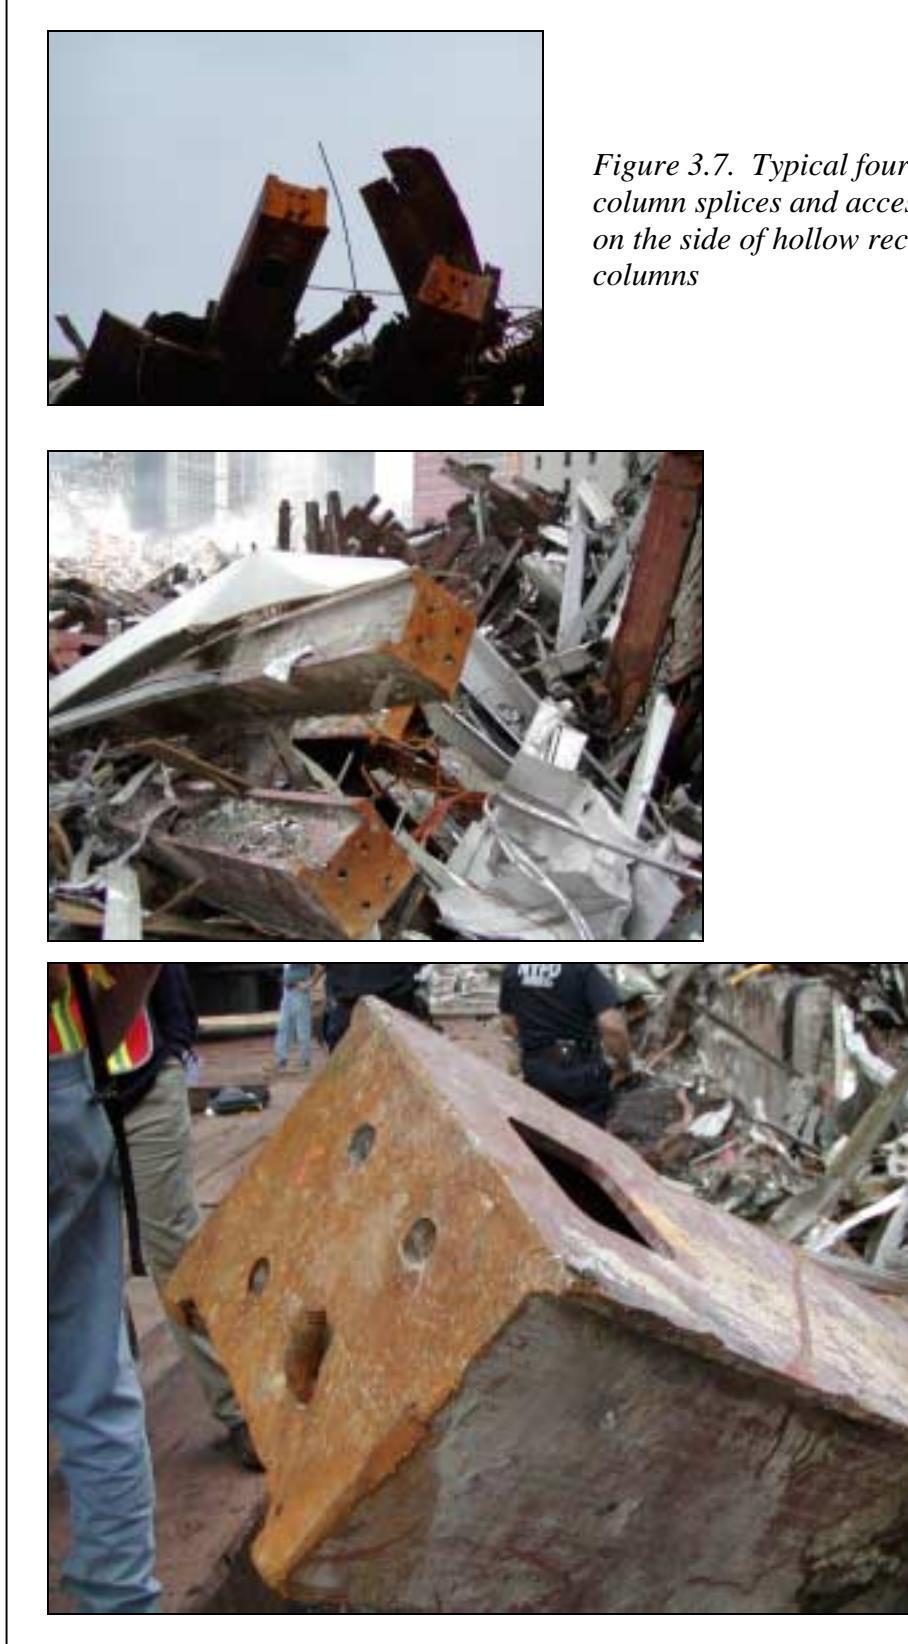
Figure 3.7. Typical four-bolt column splices and access holes on the side of hollow rectangular columns

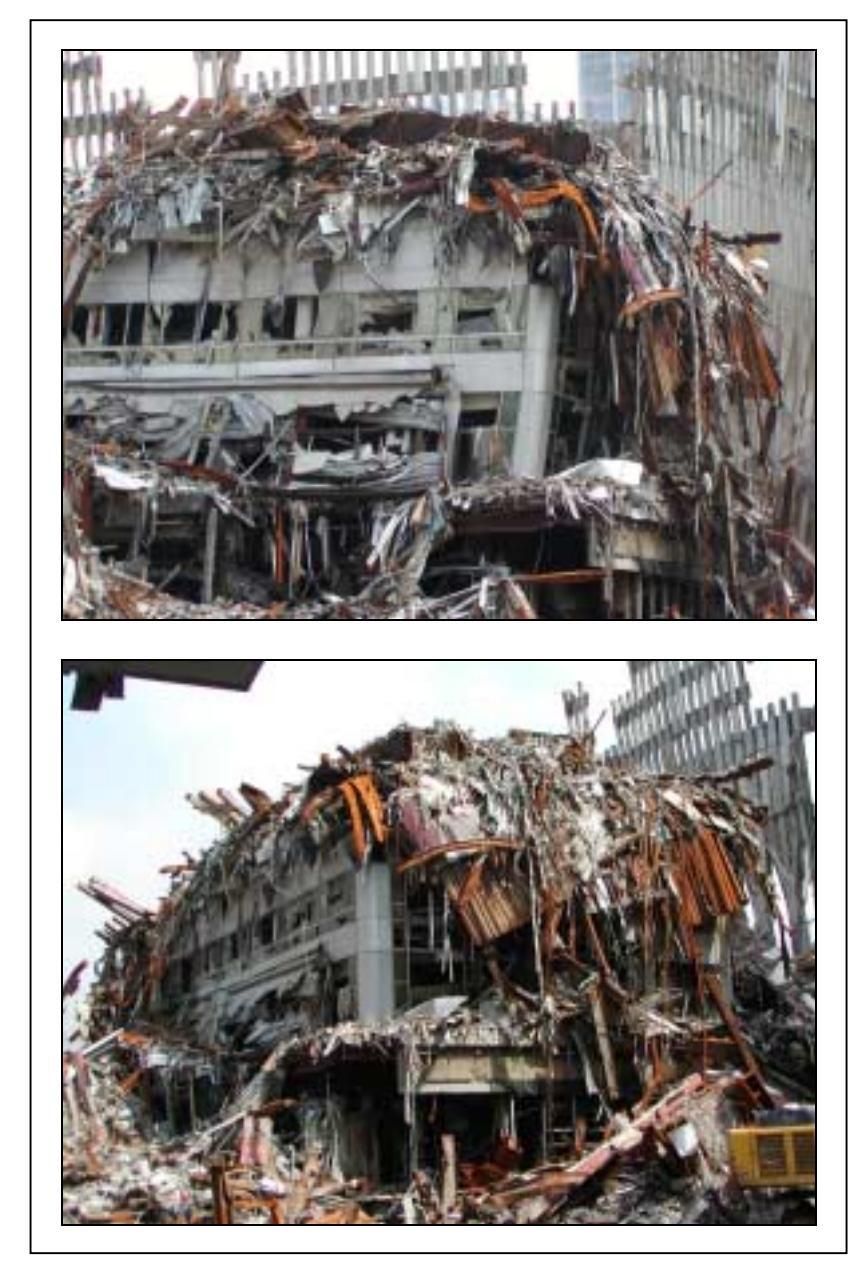
World Trade Center 3 (WTC 3) served as the Vista Hotel (formerly the Marriott hotel), and was located at the base of the two twin towers, immediately adjacent to and to the west of WTC 2 and to the south of WTC 1. It was effectively destroyed by falling debris from the collapse of the towers (see Figure 3.8). Although the building was a total loss, the fact that stories remain standing, albeit in a state of extreme damage, instead of being totally destroyed, could be partly due to the fact that the falling debris from the collapsing towers, for the most part, remained within their plan footprints.

Figure 3.8. Debris falling destroyed WTC 3

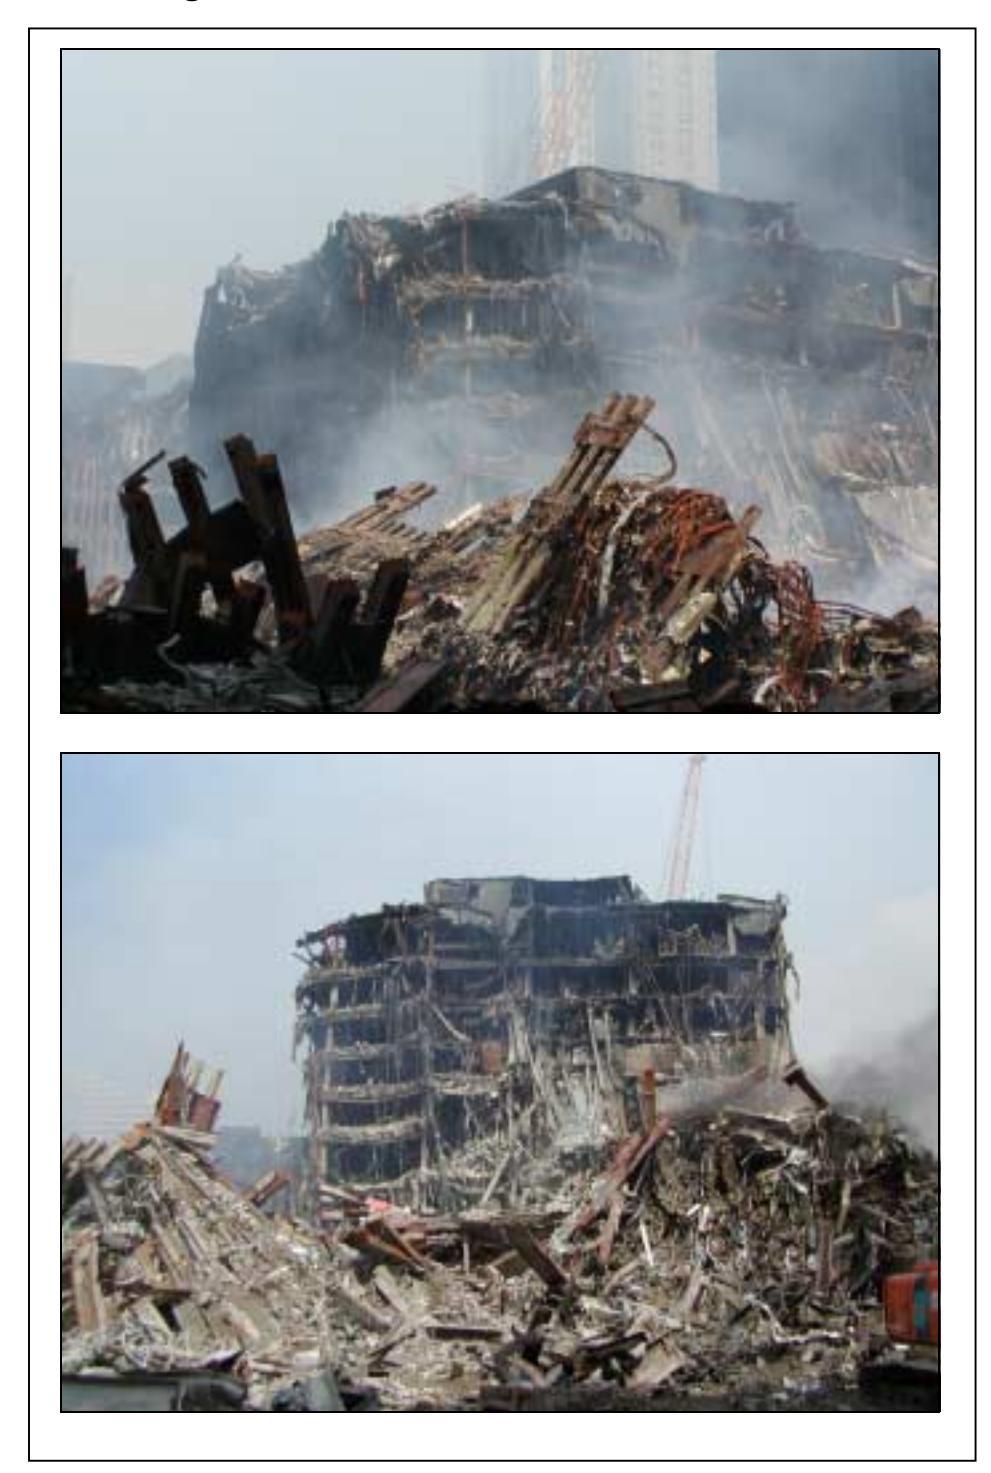
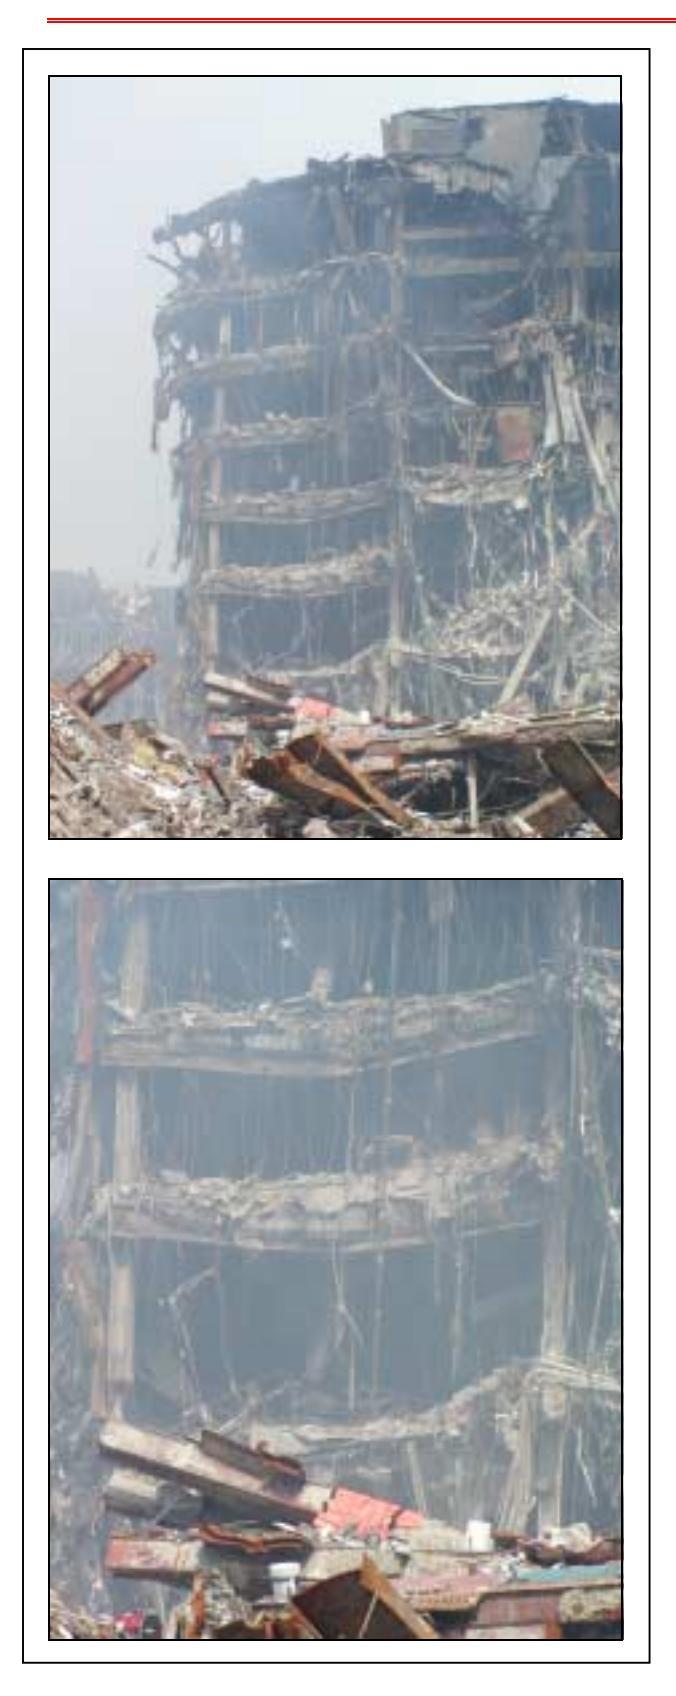
World Trade Center 4 (WTC 4) was similarly impacted by falling debris. The large permanent deformations (sagging) of many beams in that building (Figure 3.9) can be attributed to a combination of impact forces from falling debris and extensive fire damage.

Figure 3.9. Falling and burning debris destroyed WTC 4

Figure 3.9. (continued). Falling and burning debris destroyed WTC 4

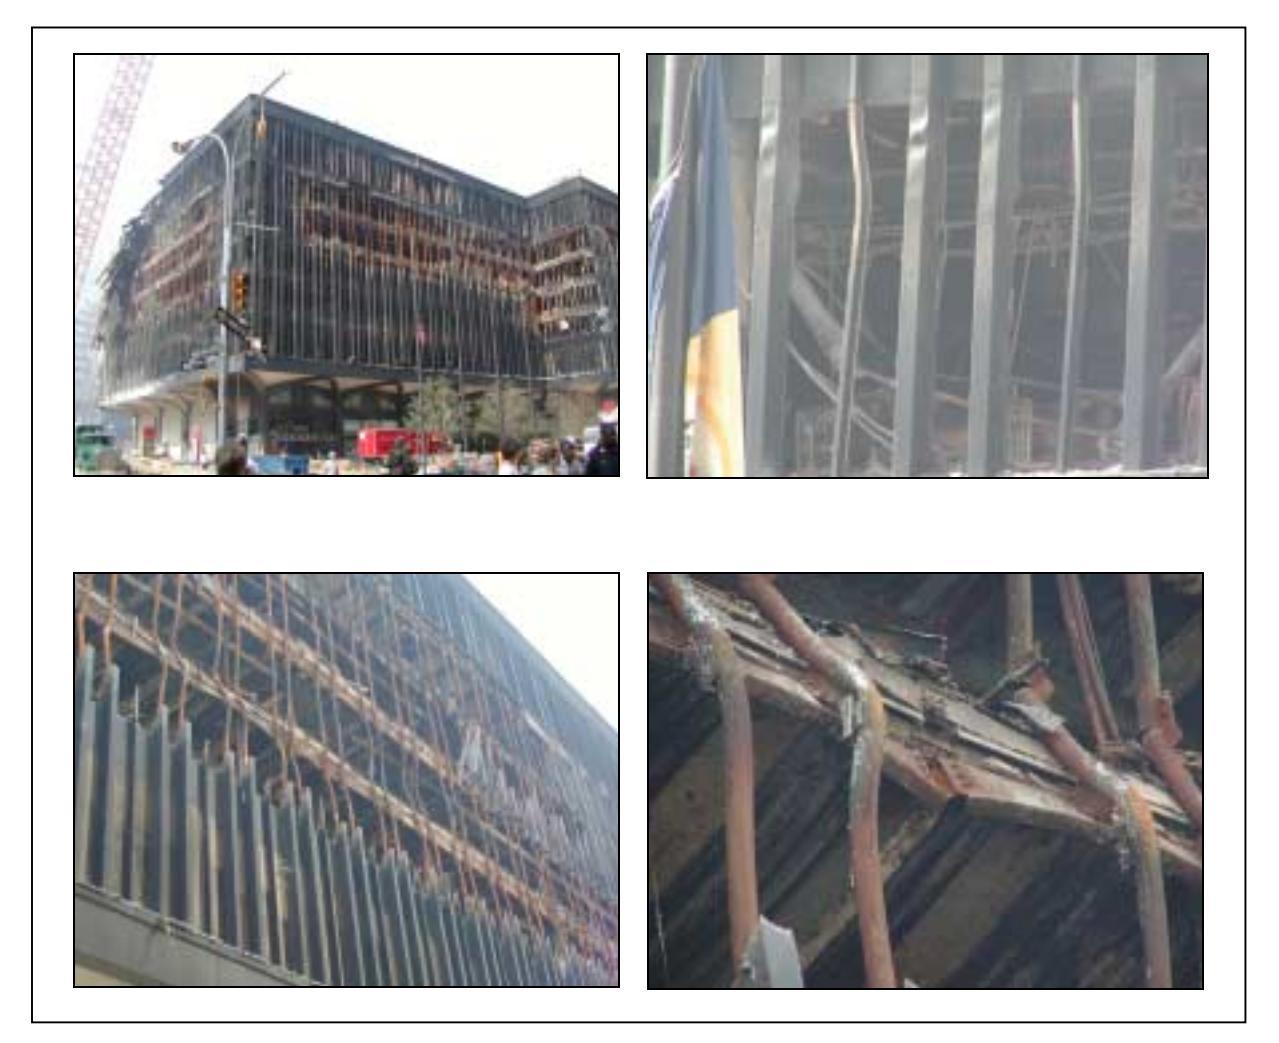
World Trade Center 5 (WTC 5) was located somewhat further from the towers than WTC 3 and 4, and was likely not showered by as much falling debris as these buildings were. However, parts of the building were still severely impacted. World Trade Center 6 (WTC 6) was immediately adjacent to WTC 1, and suffered tremendous damage. Both buildings were apparently hit by burning debris following the plane impact, and extensive fire-related damage was observed. Large heat distortion of structural members was observed in WTC 5 (Figure 3.10). Similar damage was also observed in WTC 6 (Figure 3.11).

Figure 3.10. Fire related damage to WTC 5

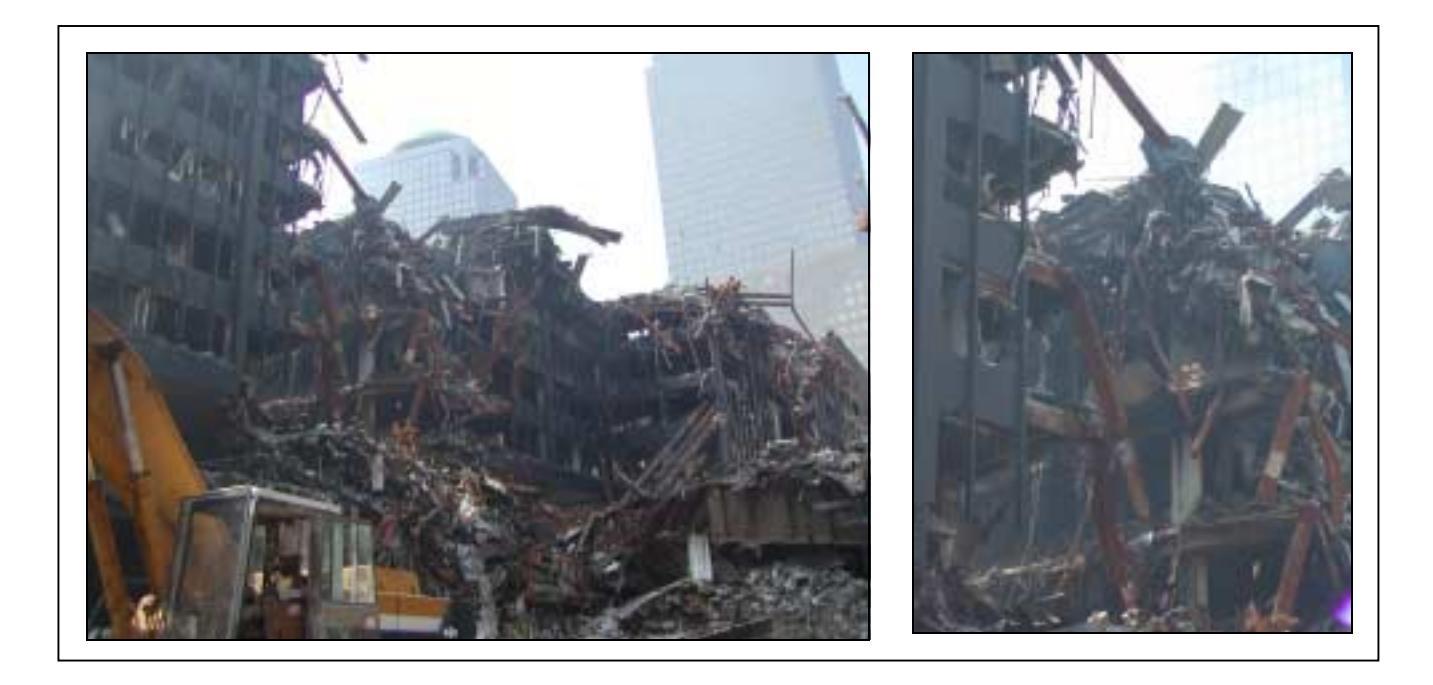
Figure 3.11. Impact and fire-related damage to WTC 6

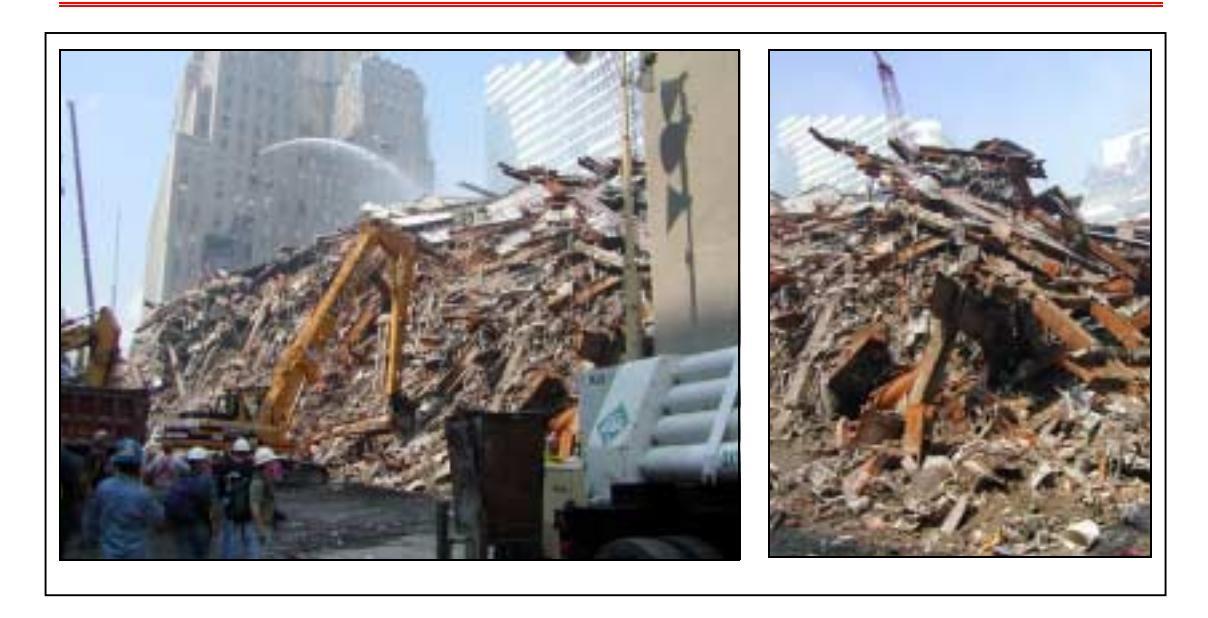
At 5:25 p.m. on September 11, 2001, WTC 7 collapsed as a consequence of damage and uncontrolled fire. The resulting debris pile was approximately seven stories high (Figure 3.12). Little reliable information on the collapse sequence can be surmised from the debris. Portions of conventional steel moment-resisting frames were observed in the debris pile (Figure 3.13), as well as distorted segments of beam stubs welded to columns with bolted splices a few feet away from the columns (Figure 3.14).

Figure 3.12. WTC 7 collapsed as a consequence of damage and uncontrolled fire

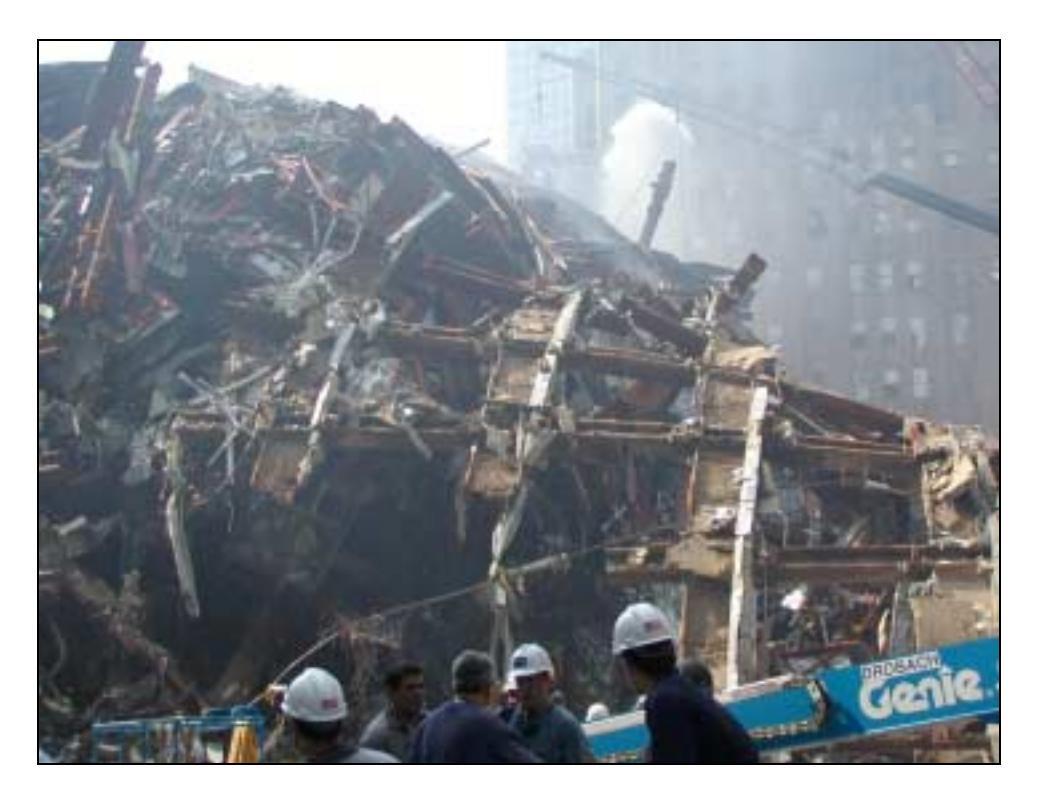
Figure 3.13. Portions of conventional steel moment-resisting frames were observed in the debris pile

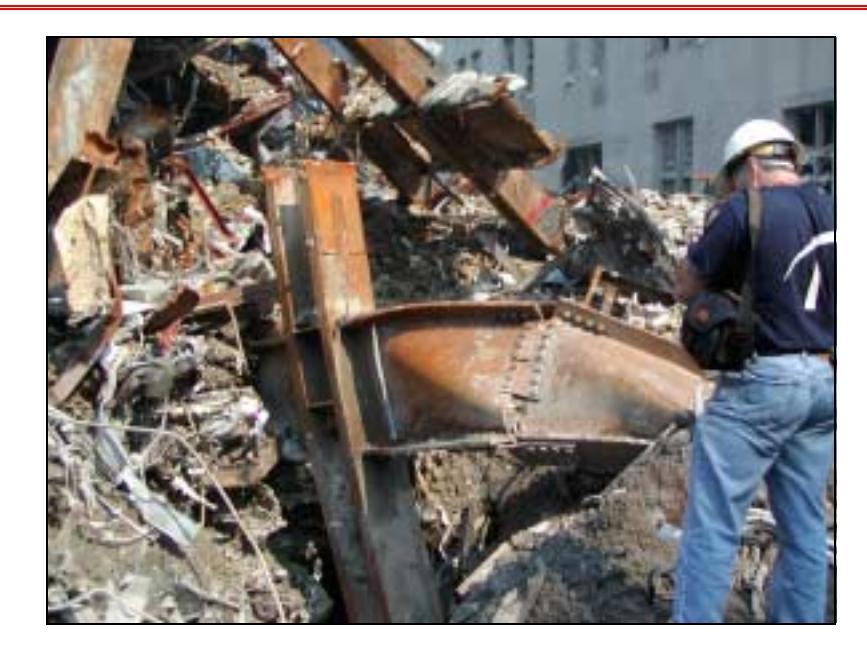
Figure 3.14 Distorted segments of beam stubs welded to the columns

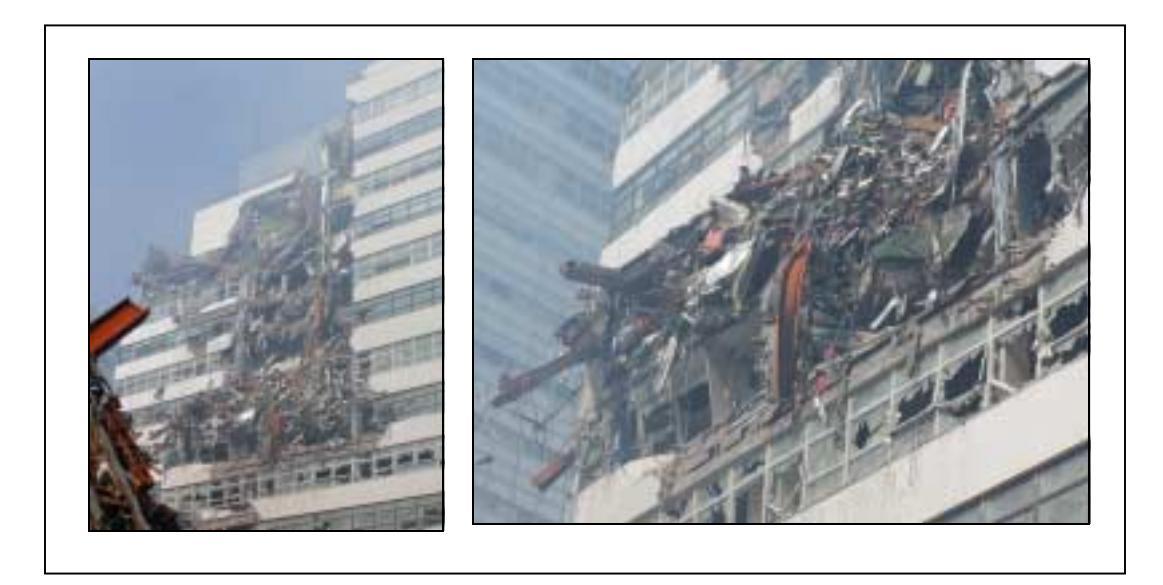
As WTC 7 collapsed, it fell partly on an adjacent building at 30 West Broadway, causing significant damage (Figure 3.15, south face and Figure 3.16, west face). Beams were permanently distorted by the impact (Figure 3.17).

Figure 3.15. Damage to the south face of a building at 30 West Broadway due to impact from the collapse of WTC 7

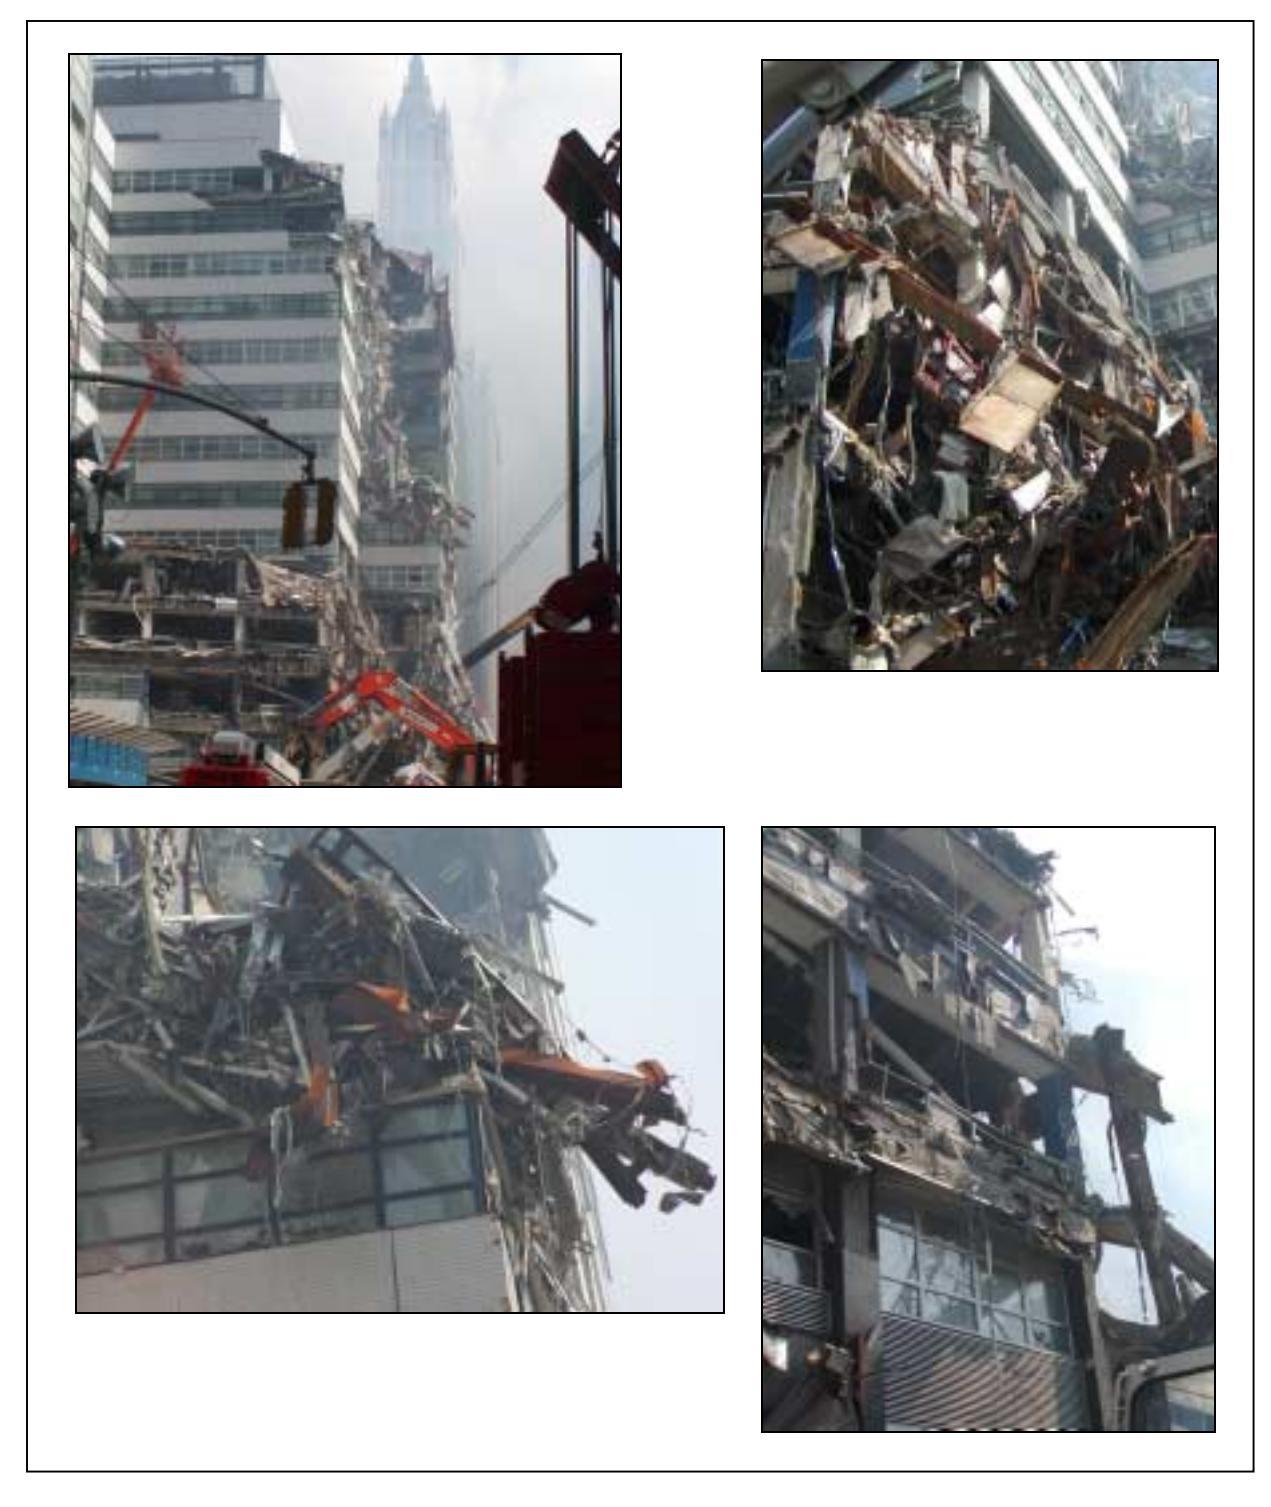
Figure 3.16 Damage to the west face of a building at 30 West Broadway due to impact from the collapse of WTC 7

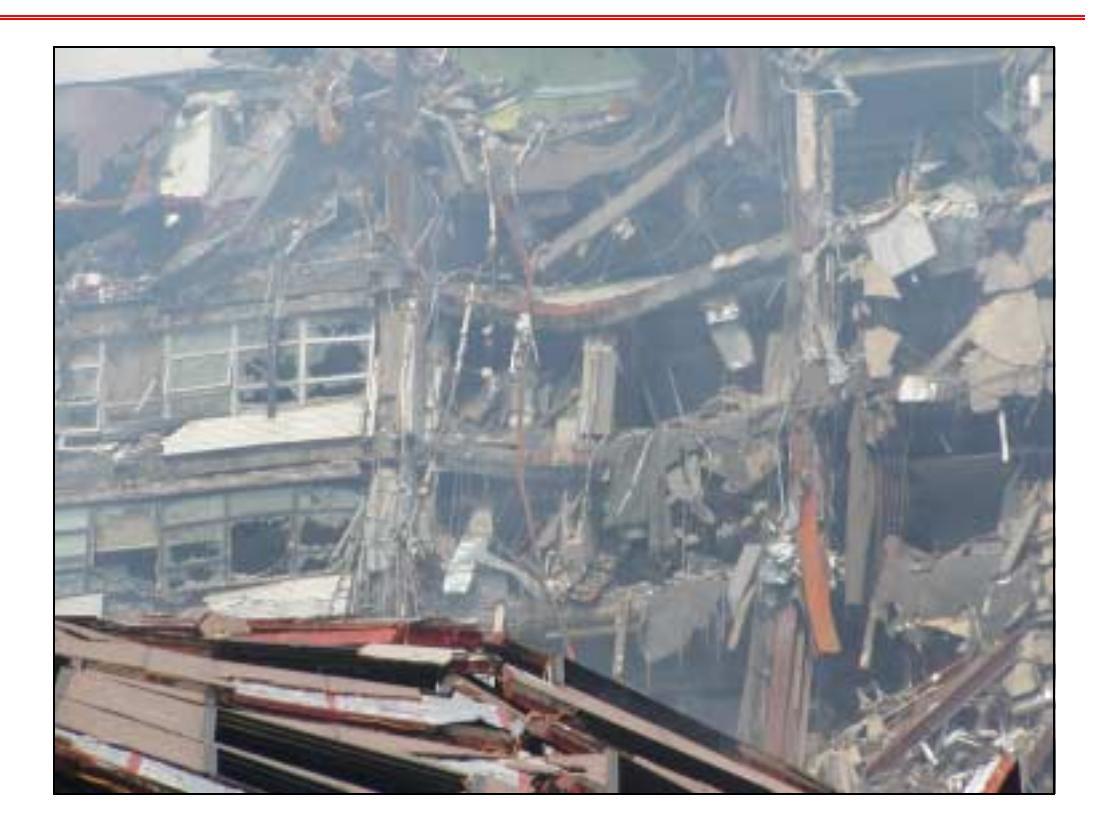
Figure 3.17. Beams in the building at 30 West Broadway were permanently distorted by the impact of falling debris
