Engineering and Organizational Issues Related to the World Trade Center Terrorist Attack

# Overview of Damage to Buildings Near Ground Zero

By Michel Bruneau, Andrew Whittaker and Andrei Reinhorn

March 2002

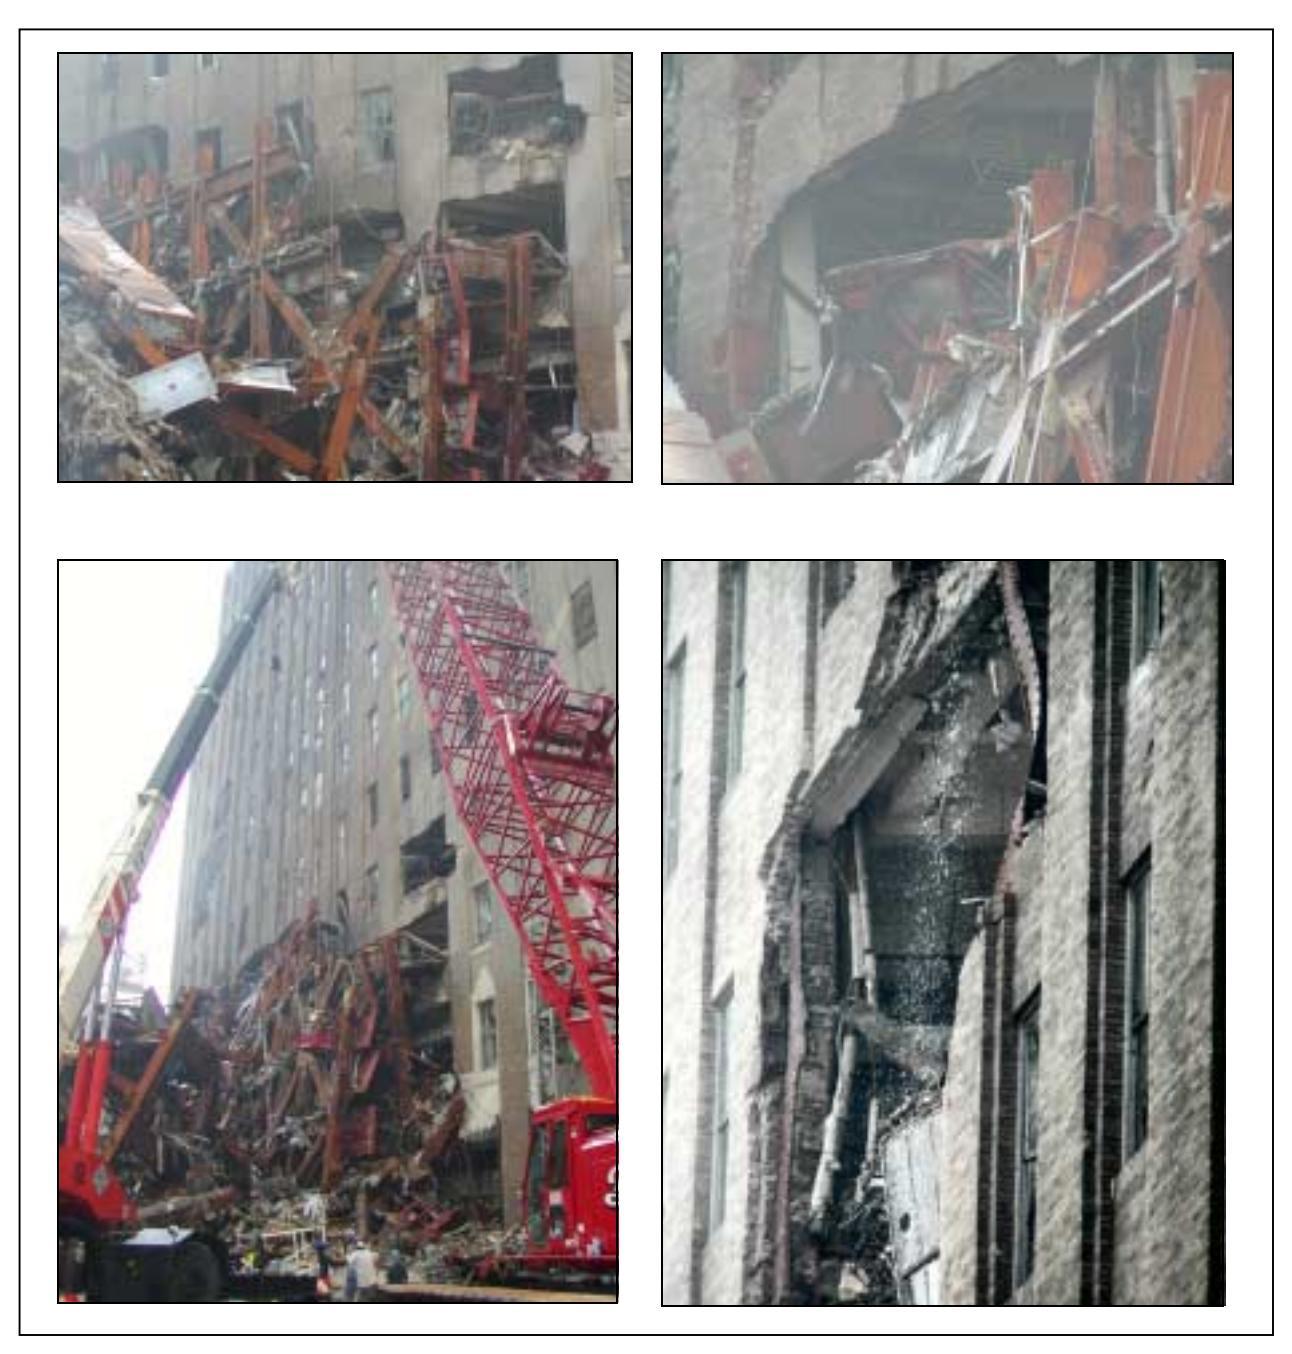
The collapse of World Trade Center 7 damaged the adjacent Verizon building. Damage to the west façade of that building is shown in Figure 3.18. Large segments of the WTC 7 braced framing were lodged against the Verizon building, which also suffered notable perforations in its framing and cladding. In particular, a steel column was severely distorted, presumably by debris impact (Figure 3.18, bottom right photo).

Figure 3.18. Damage to the west façade of the Verizon Building

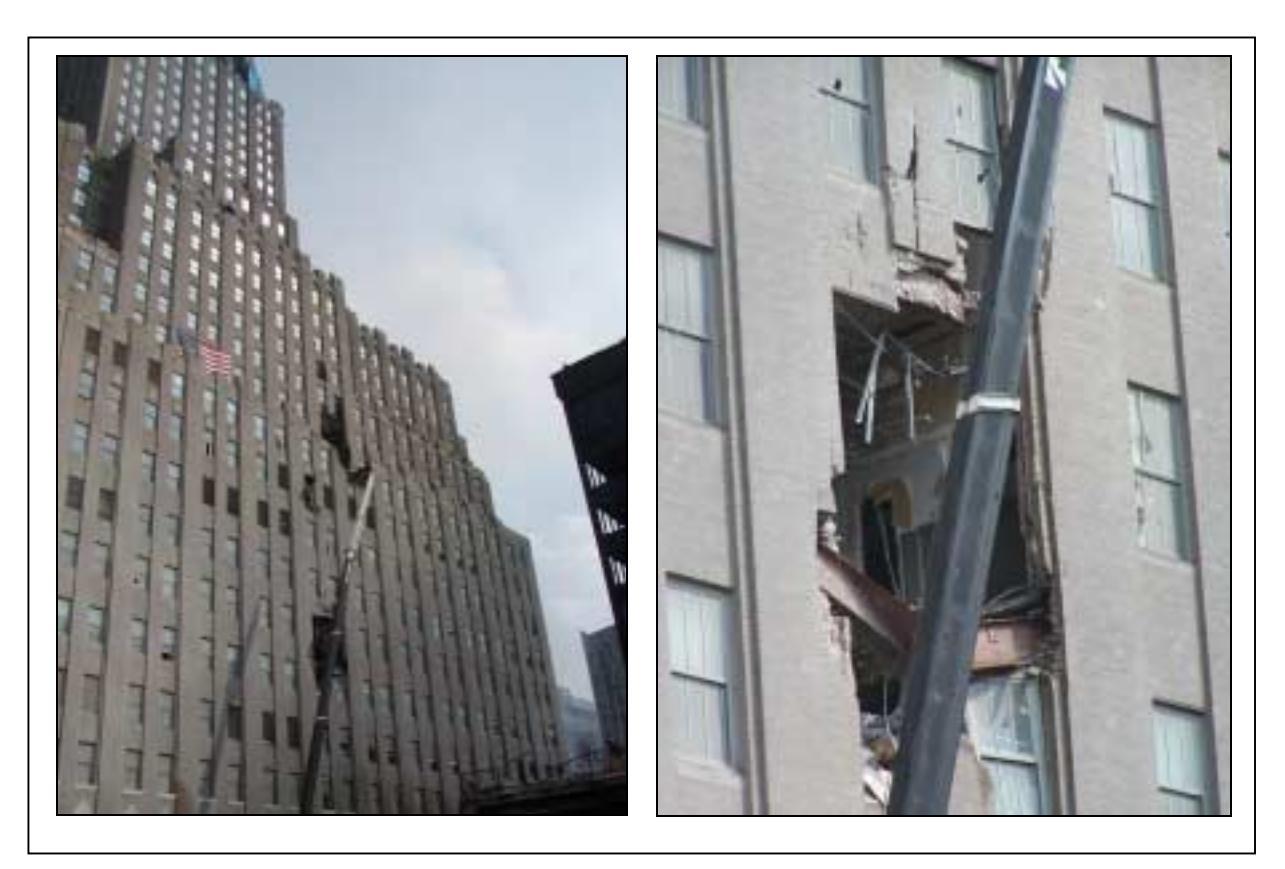
Limited relatively minor damage was also observed to the south façade, possibly produced by debris from the collapse of WTC 1 (Figure 3.19).

Figure 3.19. Minor damage to south façade of the Verizon building

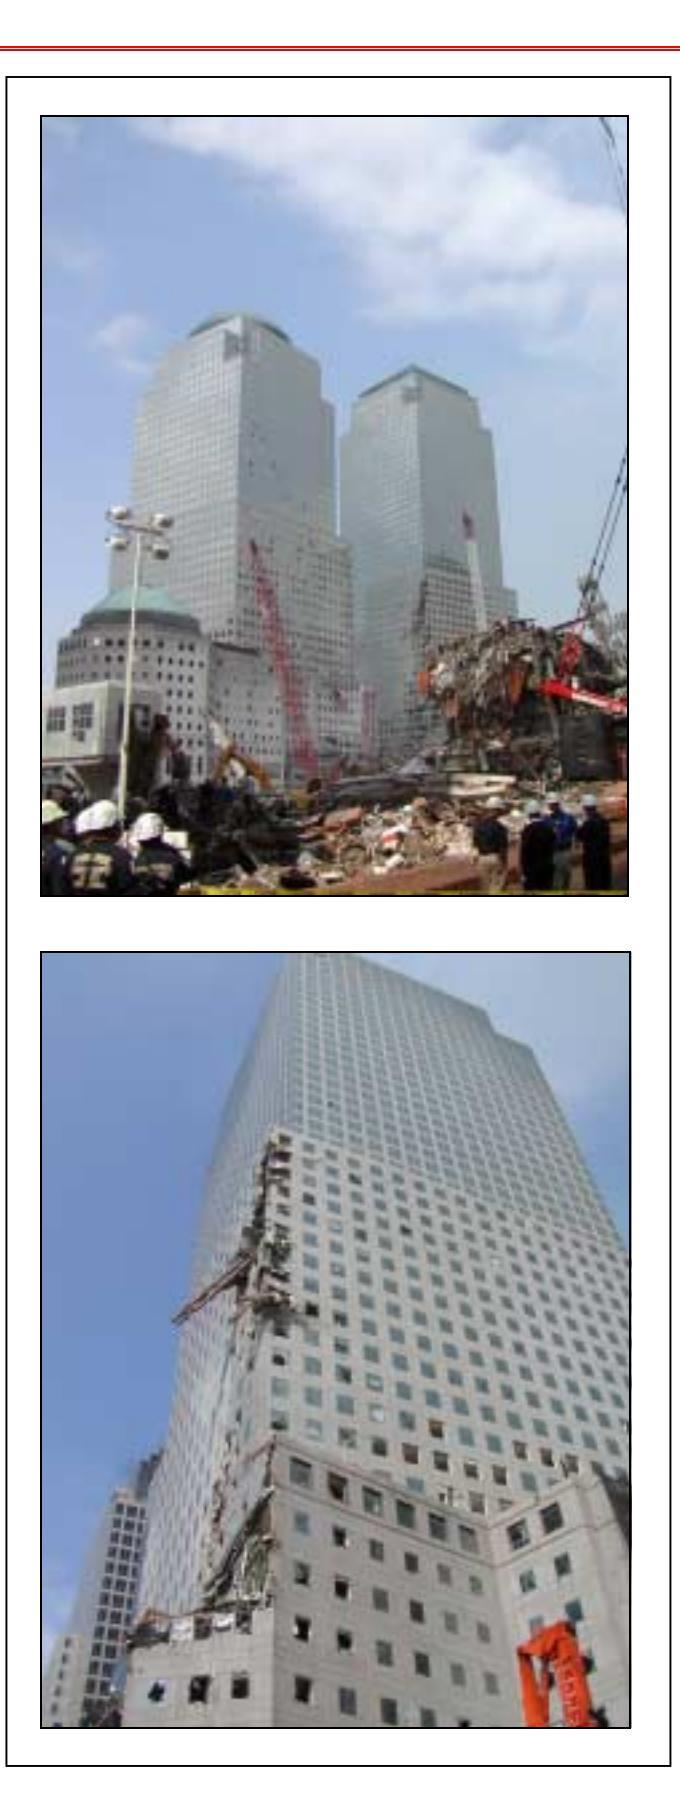
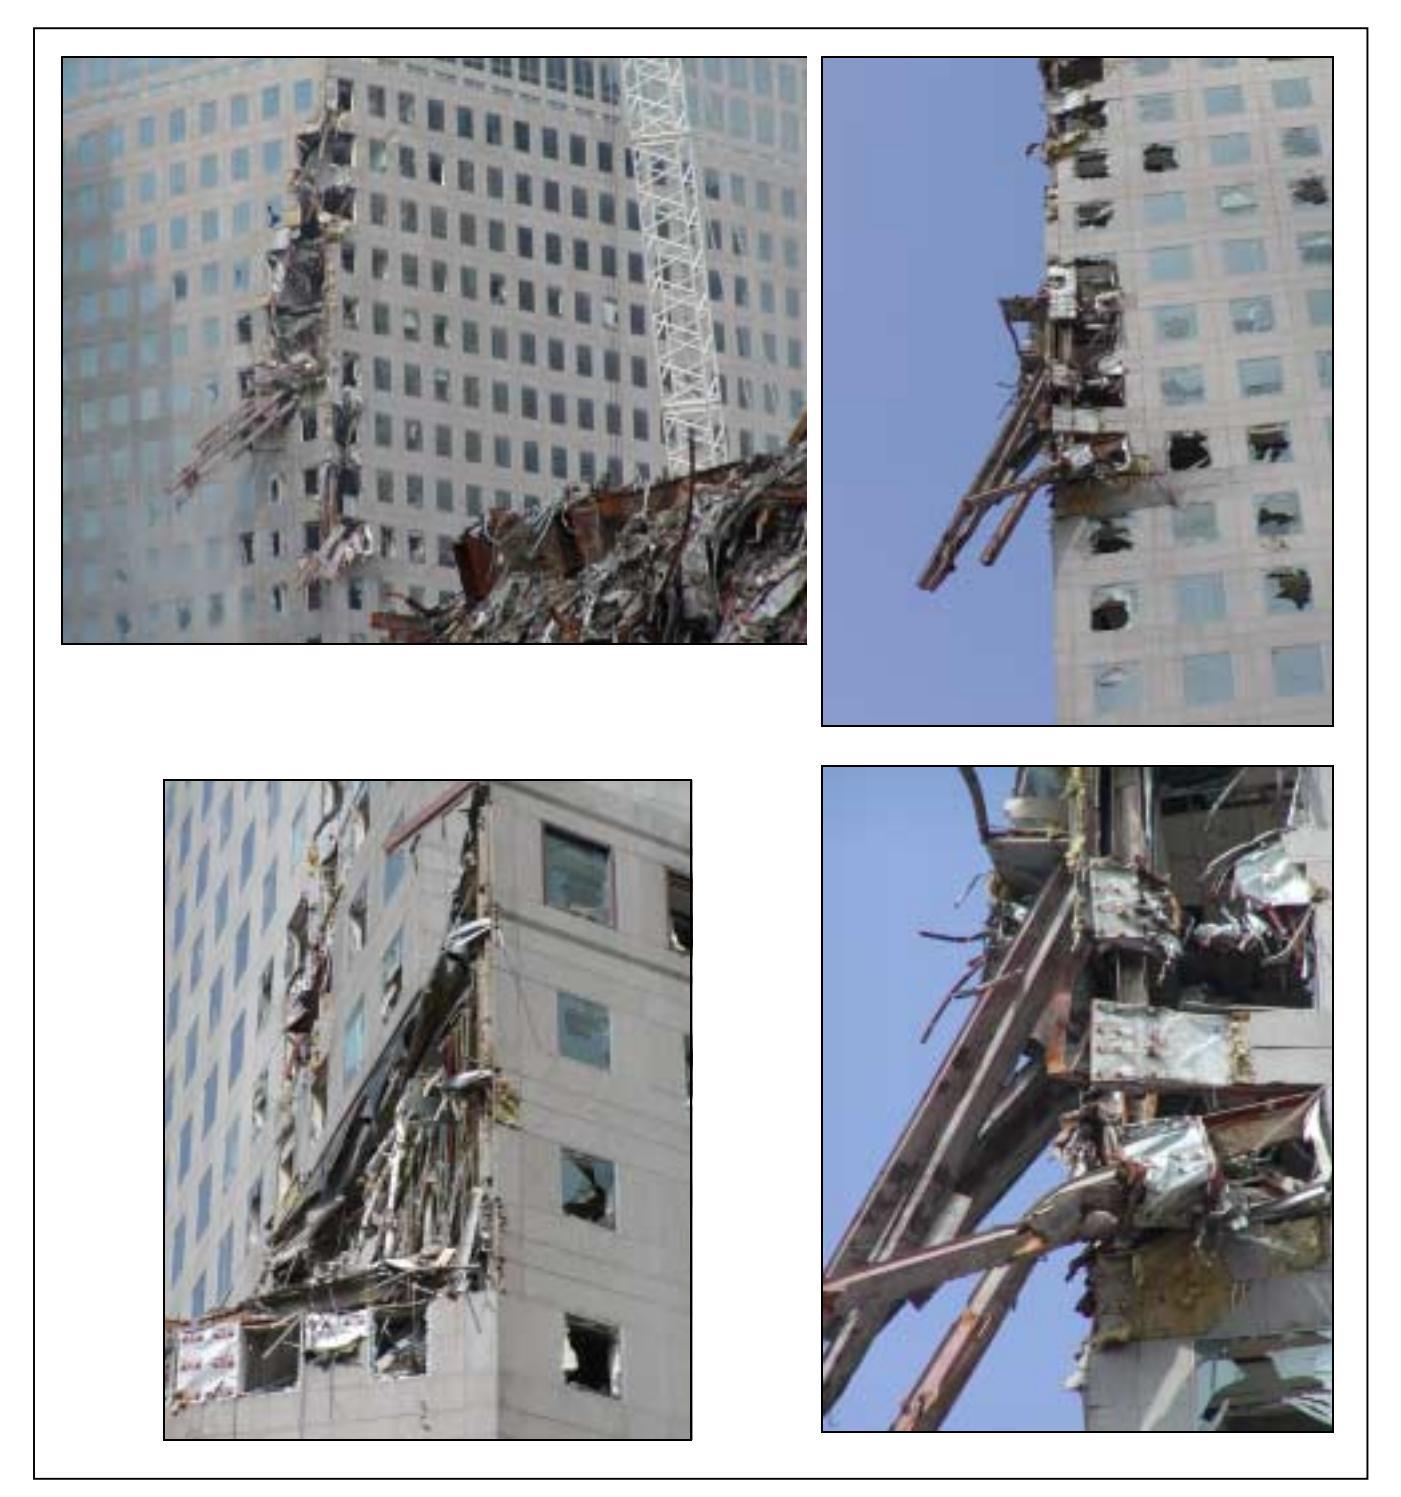
A number of the perimeter column modules (see Figure 3.2) from the collapsing towers penetrated the façade of 3 World Financial Center, significantly damaging the building's outer shell (see Figure 3.20). Parts of perimeter-column modules from one of the towers were still protruding from the façade of the World Financial Center tower during the two site visits. These pieces of debris had been secured to the building at the time of the first visit on September 21, awaiting a solution to remove them without jeopardizing the integrity of the gravity-load-resisting system.

Figure 3.20. Damage to the façade of 3 World Financial Center

Figure 3.20. (continued) Damage to the façade of 3 World Financial Center

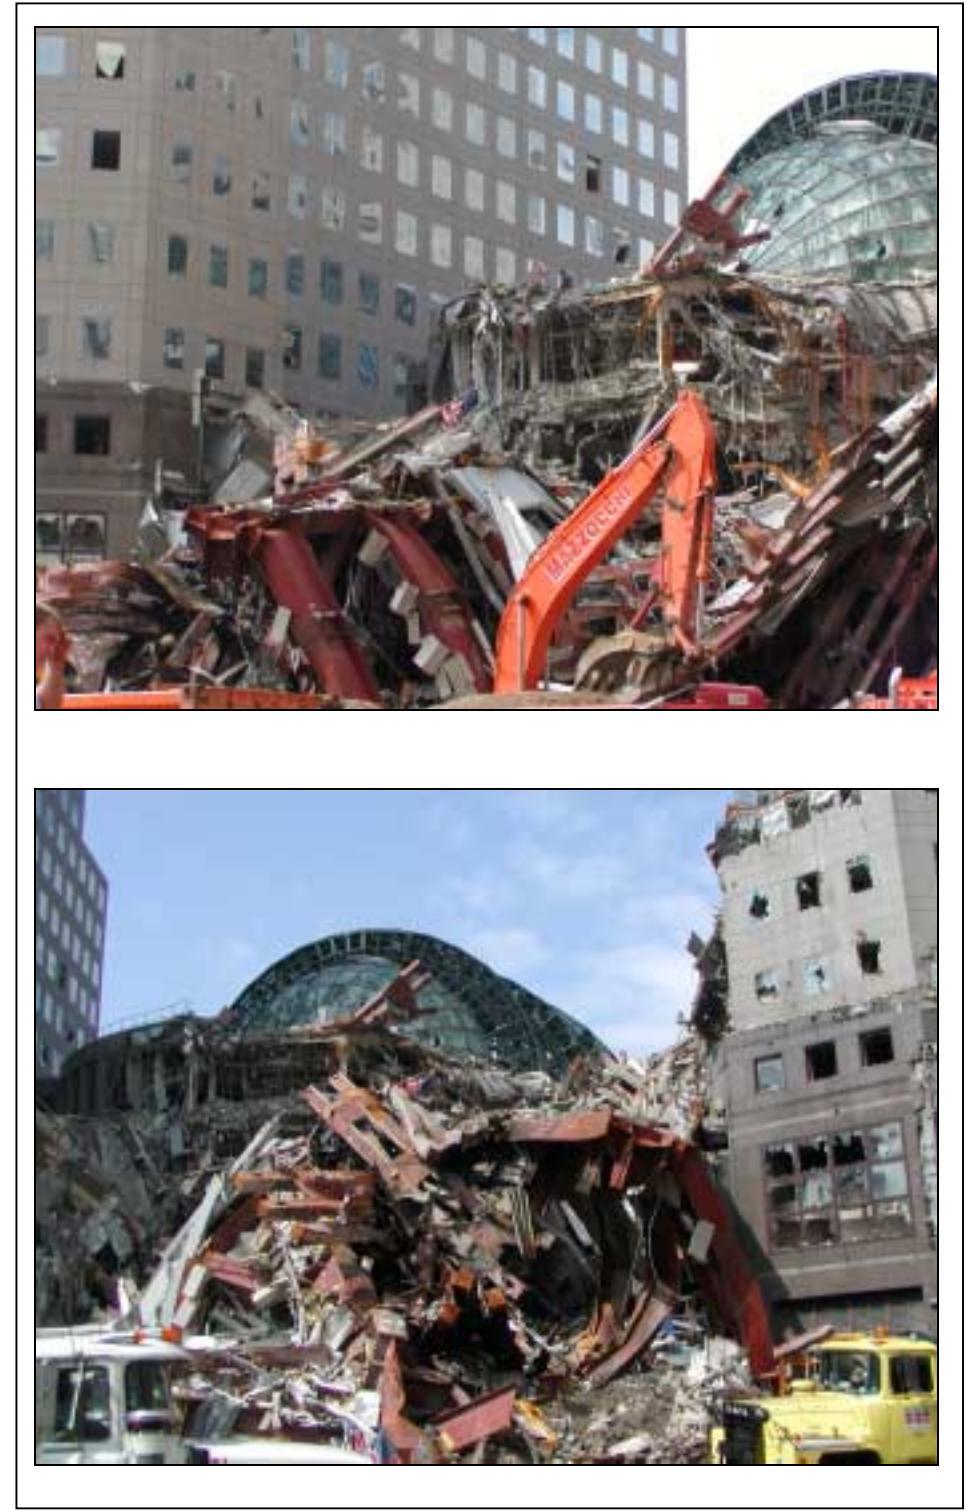
The Winter Garden, located between the two towers of World Financial Center, was severely damaged as numerous pieces of debris penetrated the glass-ceiling of this steel-framed building (see Figure 3.21).

Figure 3.21. Severe damage to the east side of the Winter Garden

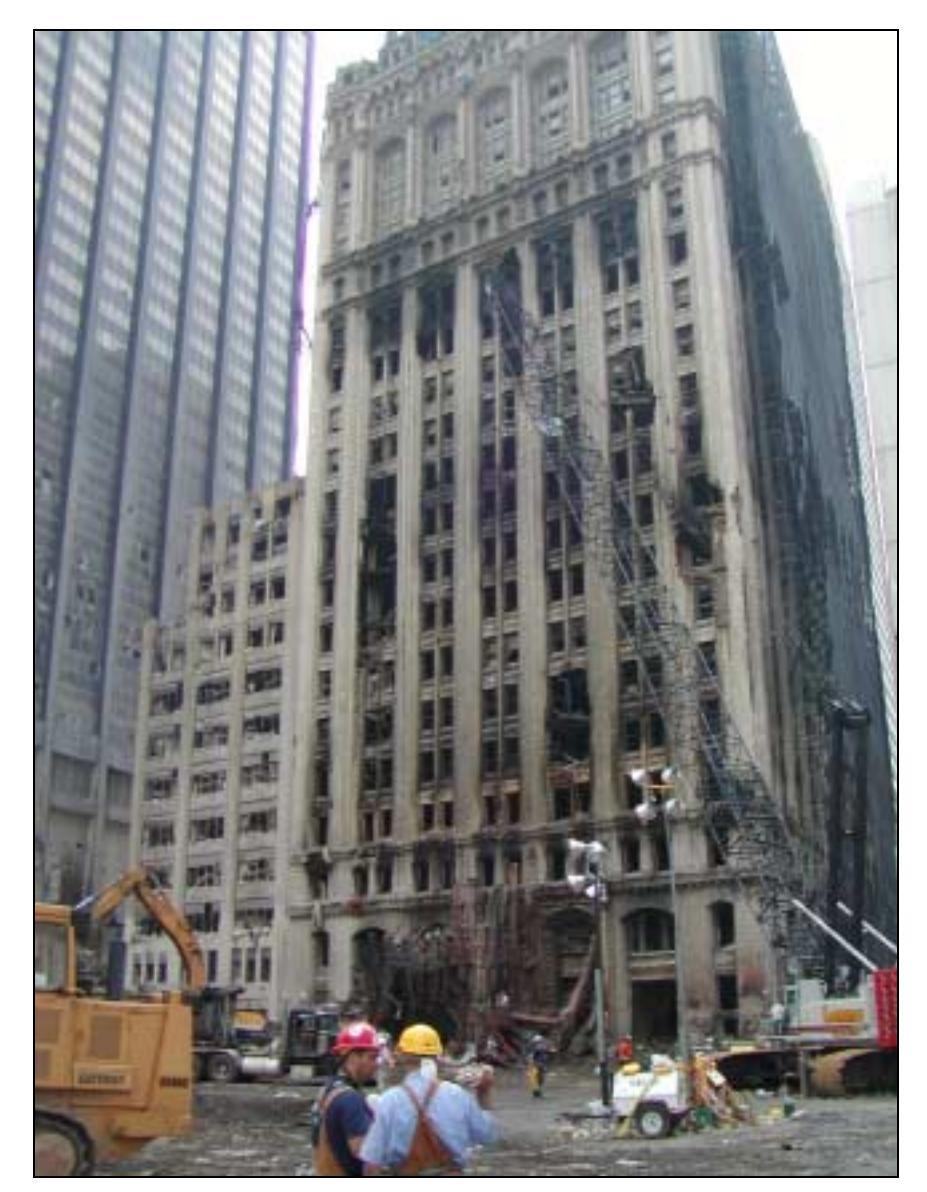
The 90 West Street building was hit by burning debris from the collapse of World Trade Center 2, which started a number of small fires as evinced by damage to the façade (Figure 3.22). A large multi-ton segment of the façade of WTC 2 lodged at the base of the building, but caused only modest damage to the building (Figure 3.23).

Figure 3.22. 90 West Street building

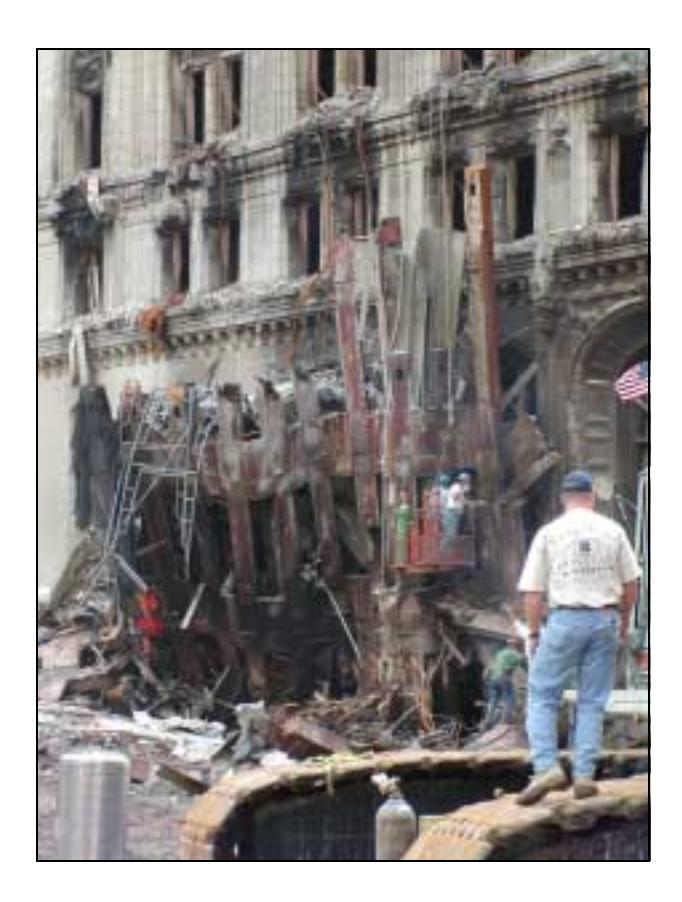
Figure 3.23. Large multi-ton segment of the façade of the WTC 2 lodged at base of the 90 West Street building

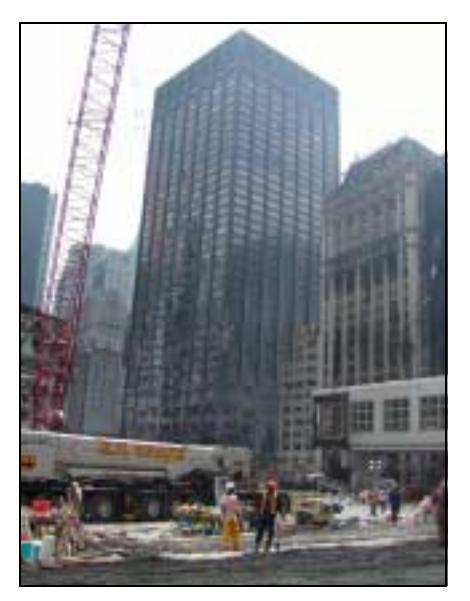
The Banker's Trust Building at 130 Liberty Street was badly damaged by falling debris from the collapse of World Trade Center 2 (Figure 3.24). A large piece of debris, a perimeter column module from WTC 2, that was still lodged in the 6<sup>th</sup> story of the building at the time of the site visits, ripped a twenty story gash in the north façade of the building, from the 26<sup>th</sup> to the 6<sup>th</sup> story (see Figure 3.25), obliterating a column from the perimeter frame at that location, with much interior damage (see Figure 3.26).

Figure 3.24. Banker's Trust Building, 130 Liberty Street

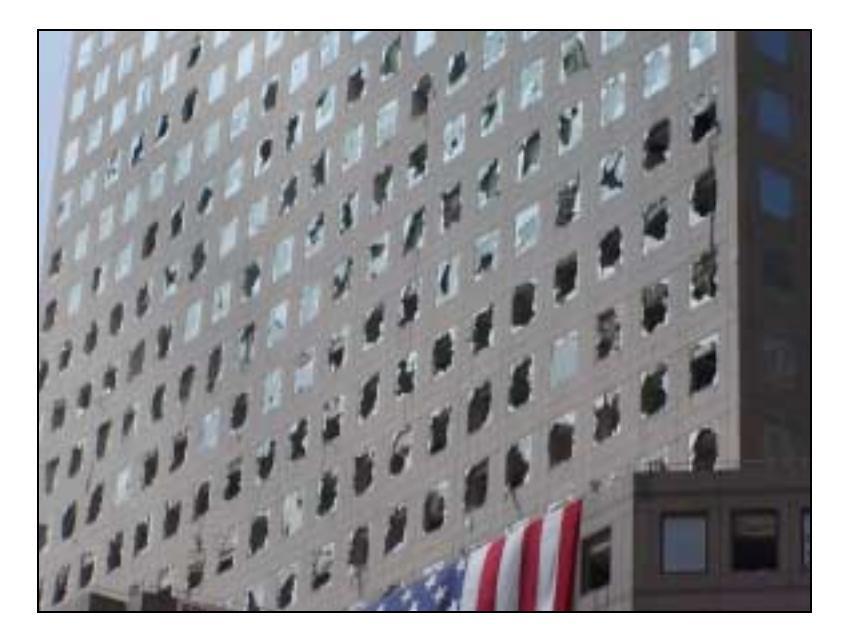
In some instances, extensive nonstructural damage was observed in the absence of visible structural damage. For example, all the windows were broken in a building immediately located across from the collapsed World Trade Center 7. Two World Financial Center exhibited similar damage (Figure 3.27). However, in some instances, many of these windows were also broken by the fire-fighting crews. The Millennium Hilton, across Church Street from WTC 5, suffered major cladding damage, but appeared to be otherwise structurally sound (Figure 3.28).

Figure 3.27. Broken windows in 2 World Financial Center

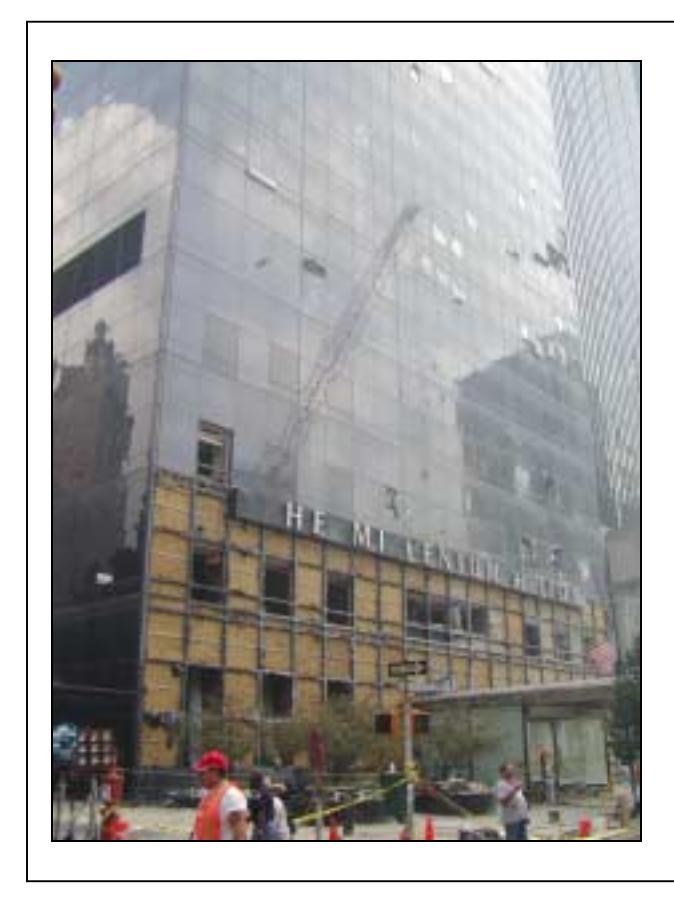
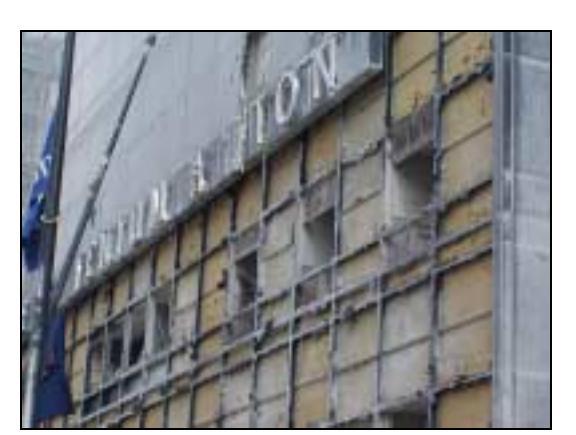
Figure 3.28. Cladding damage to the Millennium Hilton

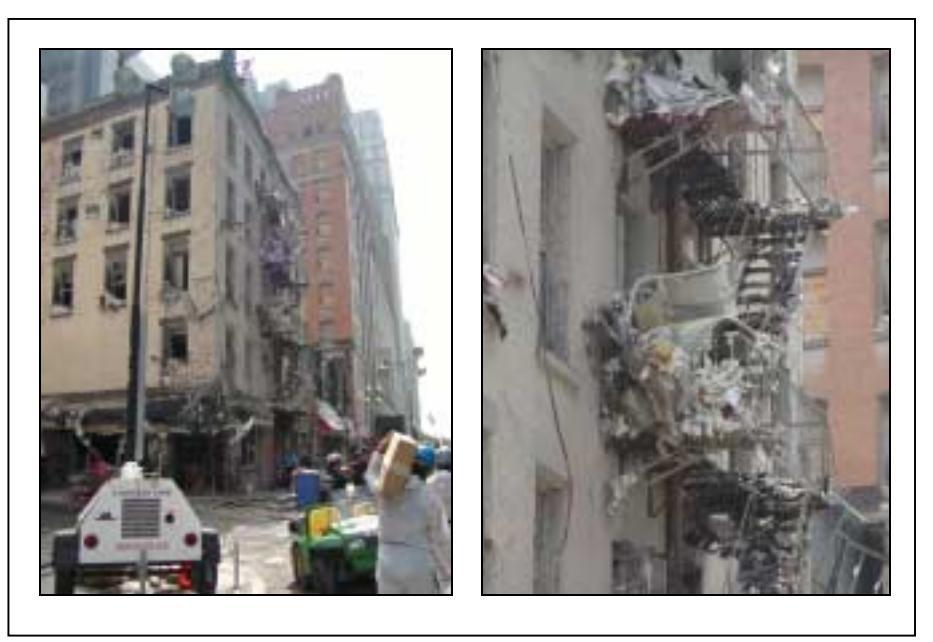
Finally, although the miscellaneous debris were removed from the street by the time of the reconnaissance visit, some assessment of the quantity of dust and miscellaneous debris that probably littered the entire site on September 11 was provided by the amount of such debris still present at less accessible locations, such as in the emergency stairs of a small building adjacent to Ground Zero (Figure 3.29). Among the debris from the towers was a substantial amount of paper, which accumulated on the outside windows of buildings in the area.

Figure 3.29. Debris in the emergency stairs of a small building near Ground Zero
