NIST NCSTAR 1-6A

Federal Building and Fire Safety Investigation of the World Trade Center Disaster

Passive Fire Protection

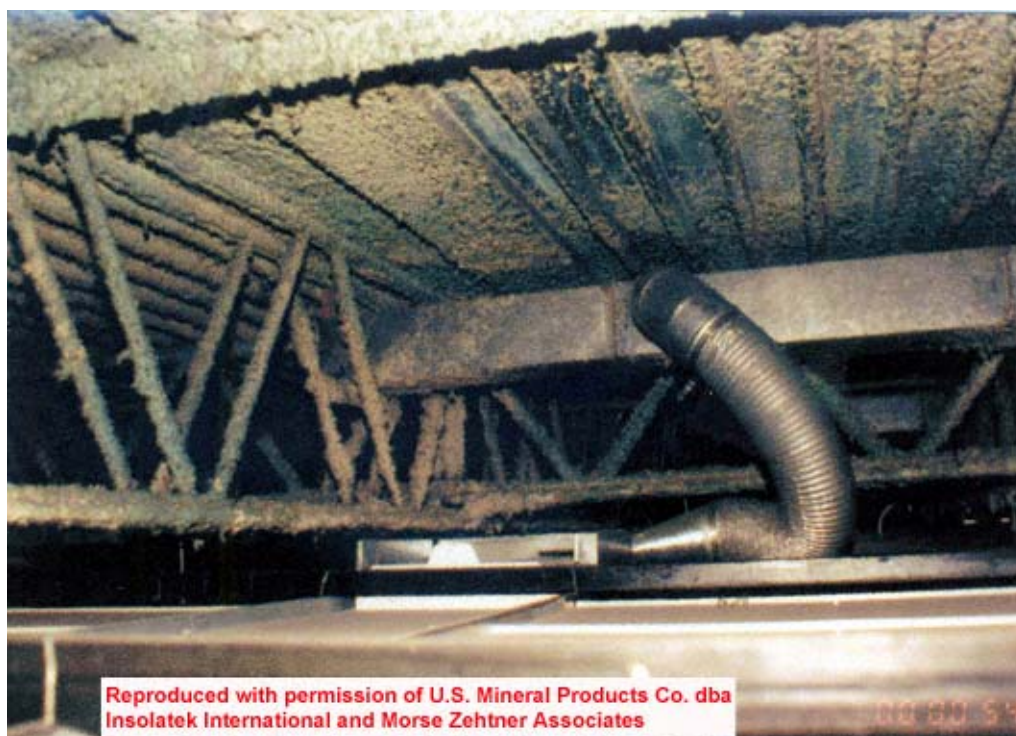
Figure 3–9. Intersection of main truss and bridging truss showing thin SFRM on the ends of some web bars; SFRM was not applied to the metal decking.

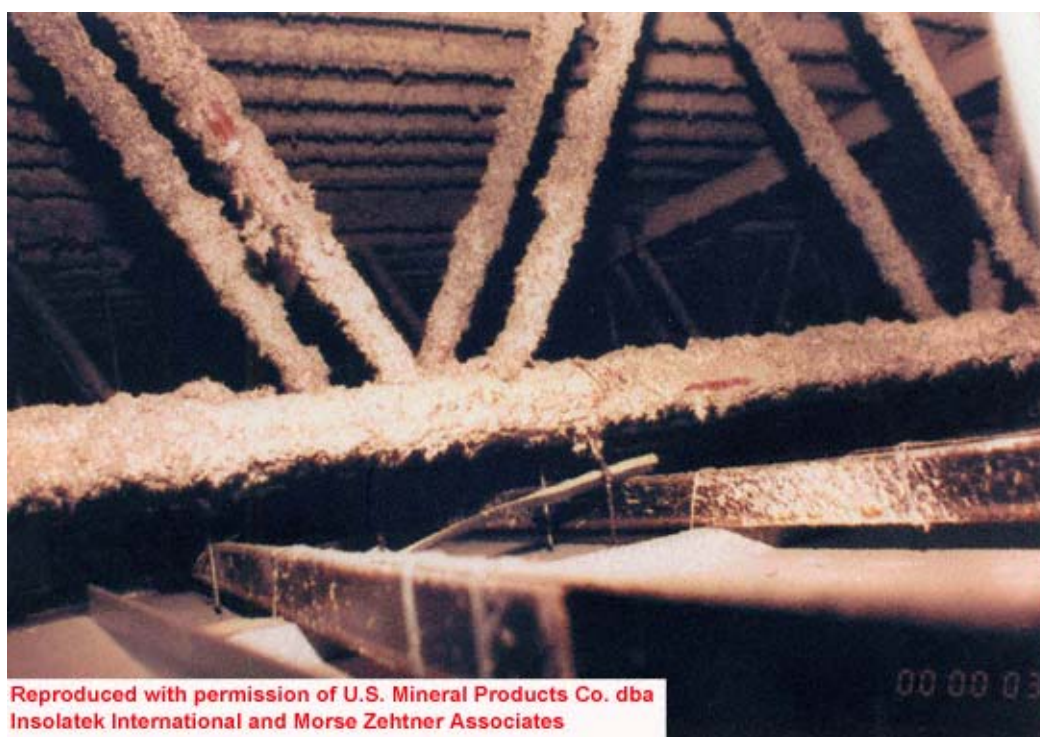
Figure 3–10. Example of damage to SFRM during installation of utilities.

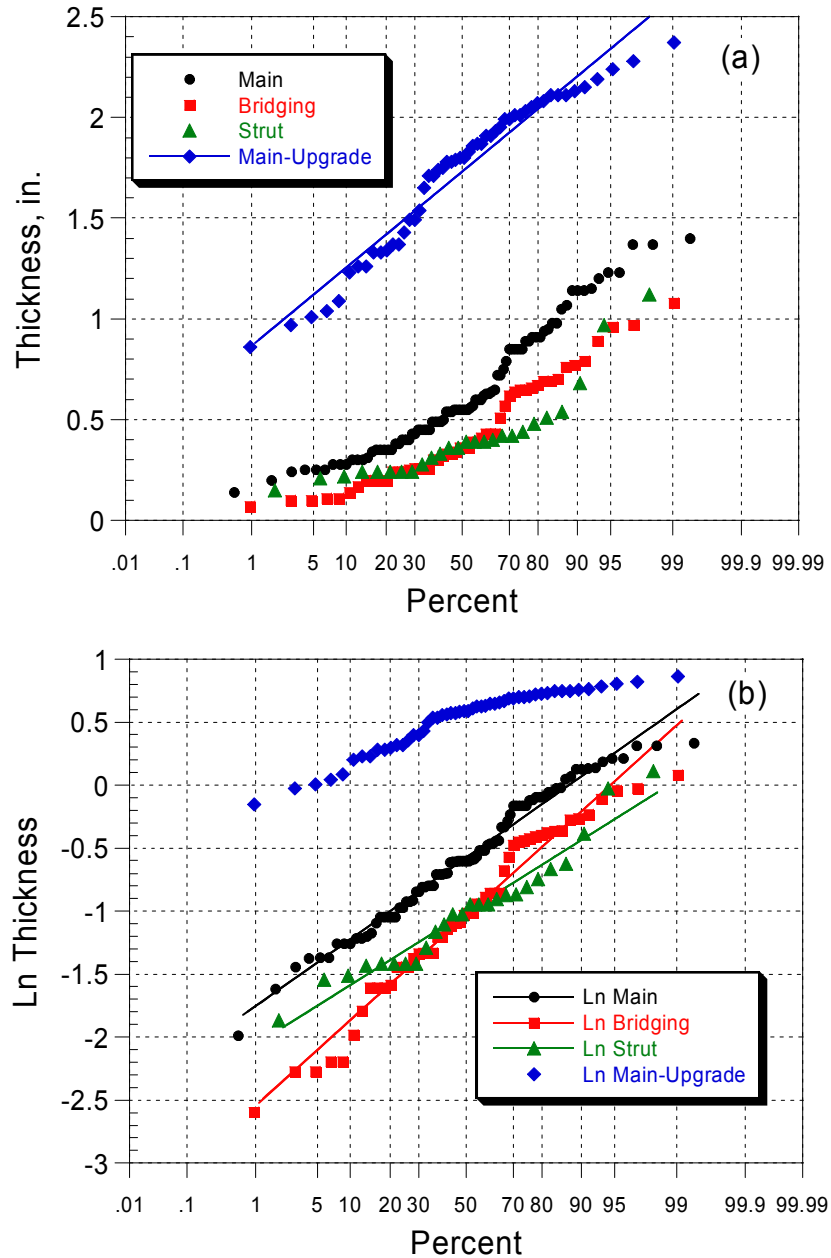
Figure 4-3. (a) Normal probability plot of estimated SFRM thickness based on photographs, and (b) normal probability plot of natural logarithms of thickness (Data provided by PANYNJ).

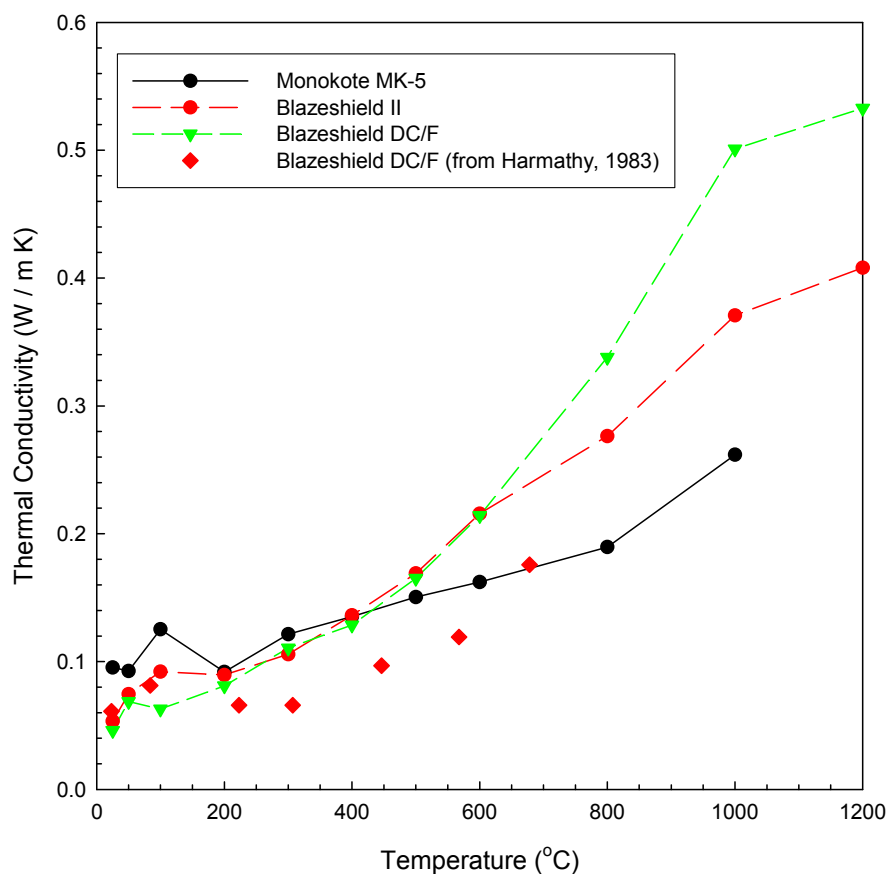
**Figure 6–4. Thermal conductivities of the three SFRMs as a function of temperature.**

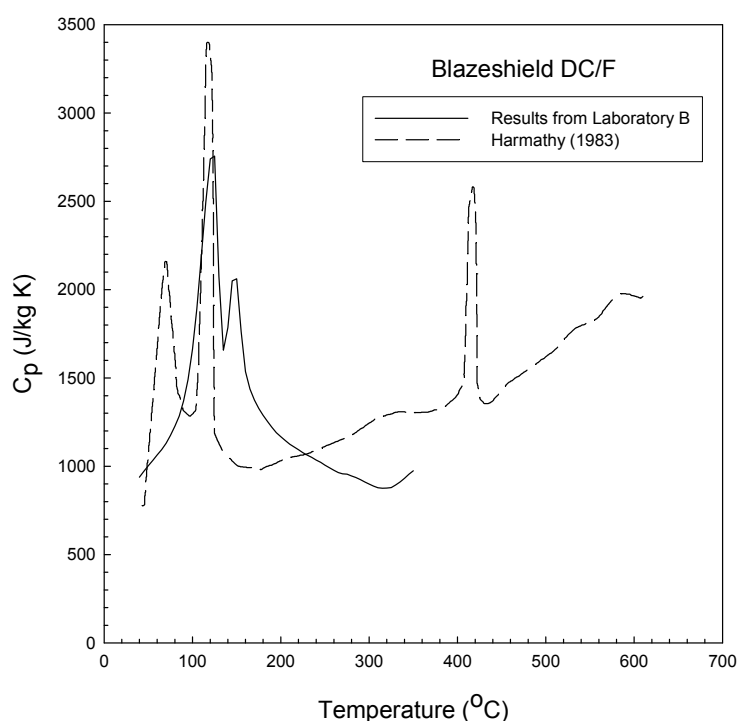
Figure 6–7. Comparison of specific heat capacity measurements for BLAZE-SHIELD DC/F from Laboratory B with the results from Harmathy (1983).

Figure 6-7 shows a comparison of specific heat capacity data for BLAZE-SHIELD DC/F from Harmathy (1983) with the results from Laboratory B. For temperatures up to 350 °C, both results exhibit two peaks although their locations occur at different temperatures, and their magnitudes are different. In general, an increase in the heating rate results in a shift of the peaks toward higher temperatures and in increases of maxima or minima of peaks with narrowing peak widths. Both studies used the same heating rate of 5 °C/min, however, other procedural and operational factors could have affected the measurements. Since milligram quantities of SFRM are used in DSC, assurance of specimen homogeneity and representativeness of the bulk sample in the specimen holder is essential to the validity of the measurements, especially for inhomogeneous materials like SFRMs. In addition, mass loss from the specimen holder during heating could interfere with the measurements.

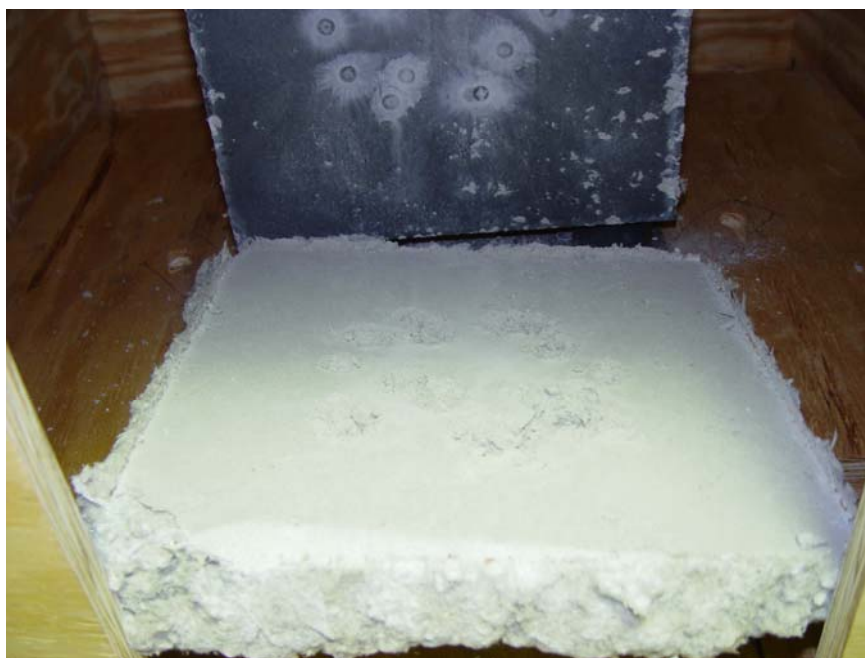
Figure C-4. Photograph showing damage to the SFRM after a ballistic impact at 0 degree. The SFRM layer completely separated from the steel plate.

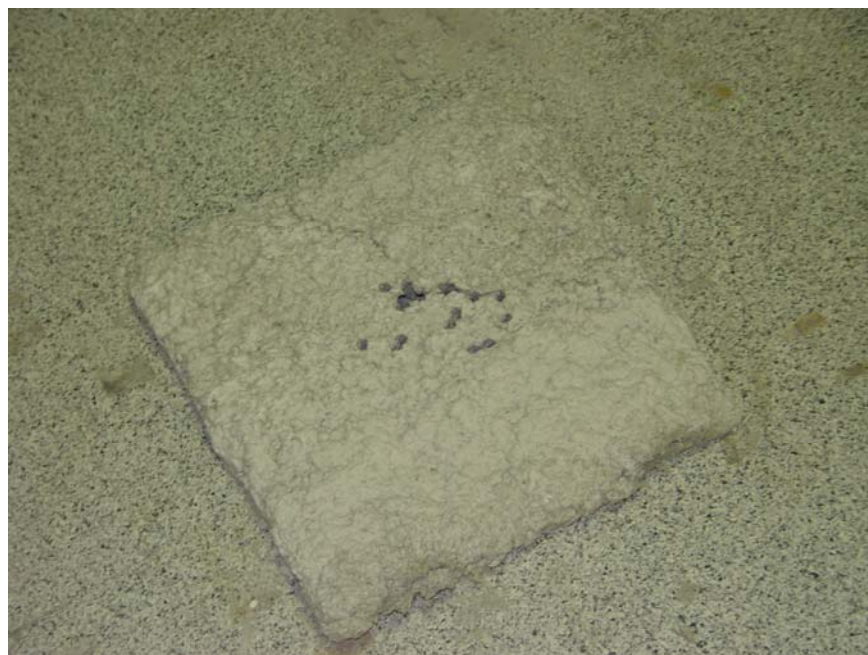
Figure C-5. Photograph showing damage to the SFRM after a ballistic impact at 20 degree. The SFRM layer completely separated from the steel plate and landed on the floor.

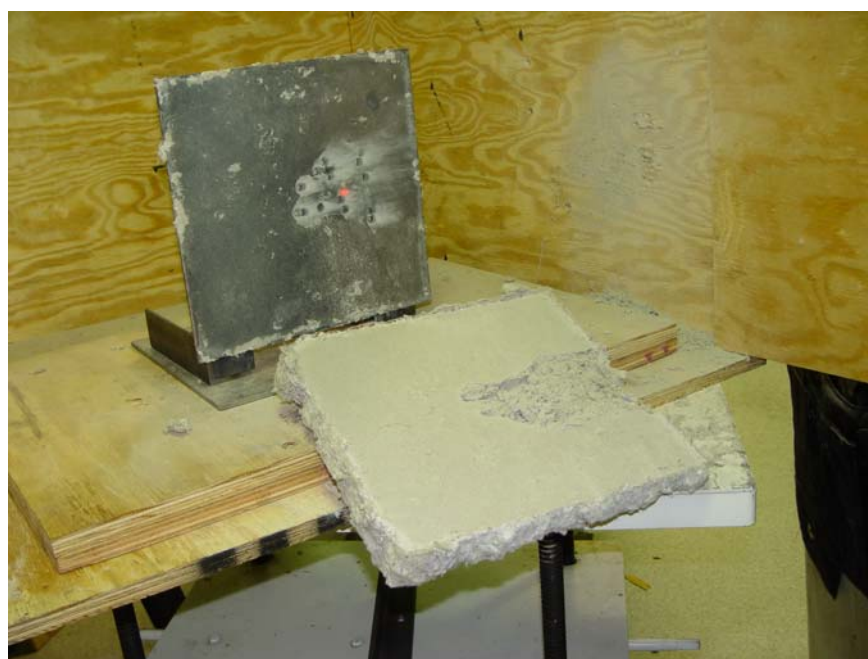
Figure C-6. Photograph showing damage to the SFRM after a ballistic impact at 40 degree. The SFRM layer completely separated from the steel plate.

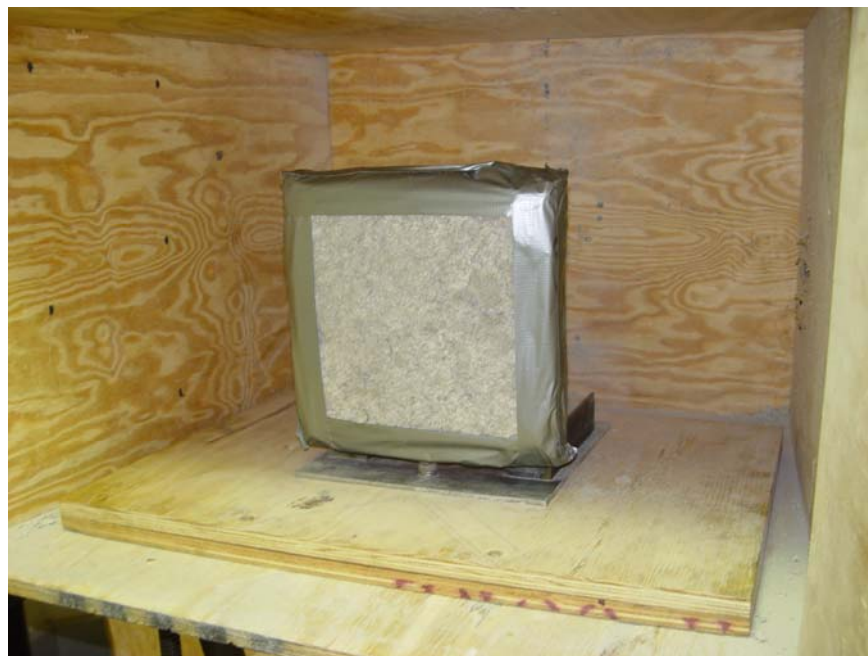
Figure C-8. Photograph showing the edges of the SFRM duct taped to the steel plate before the ballistic tests at 0 degree.

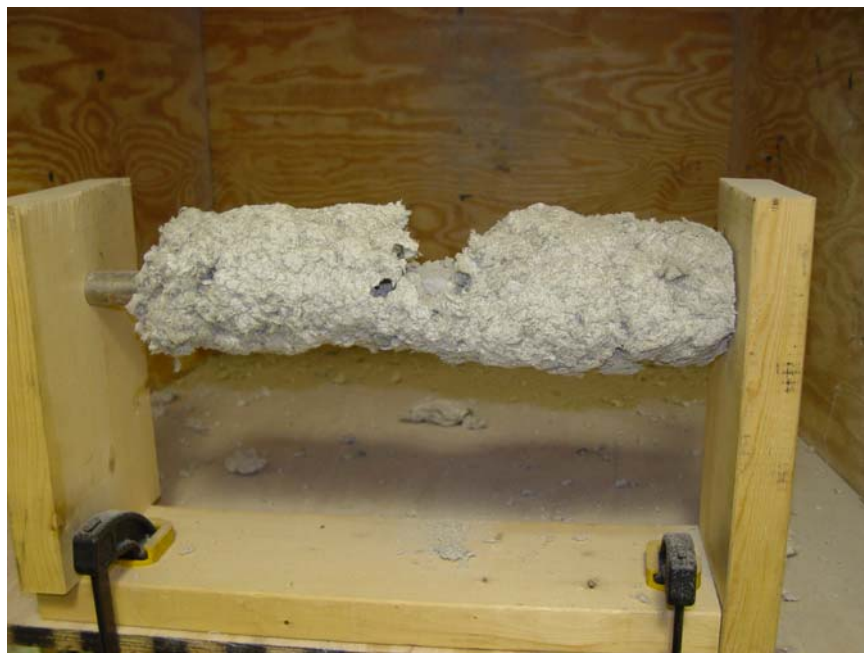
Figure C-9. Photograph showing damage to the SFRM on an unprimed steel bar (BAR01) after a ballistic impact at 0 degree using the small universal receiver.

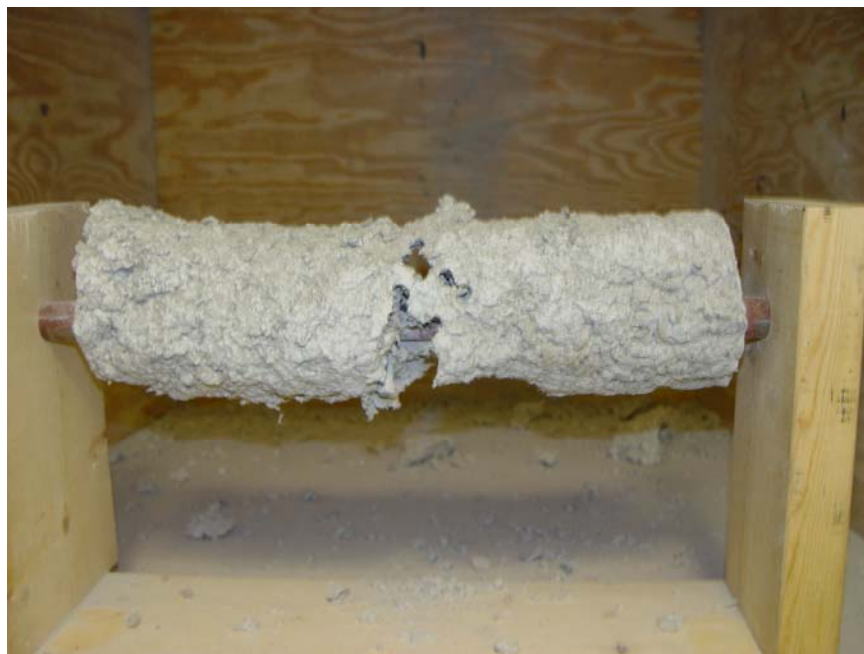
Figure C-10. Photograph showing damage to the SFRM on a primed steel bar (BAR02) after a ballistic impact at 0 degree using the small universal receiver.

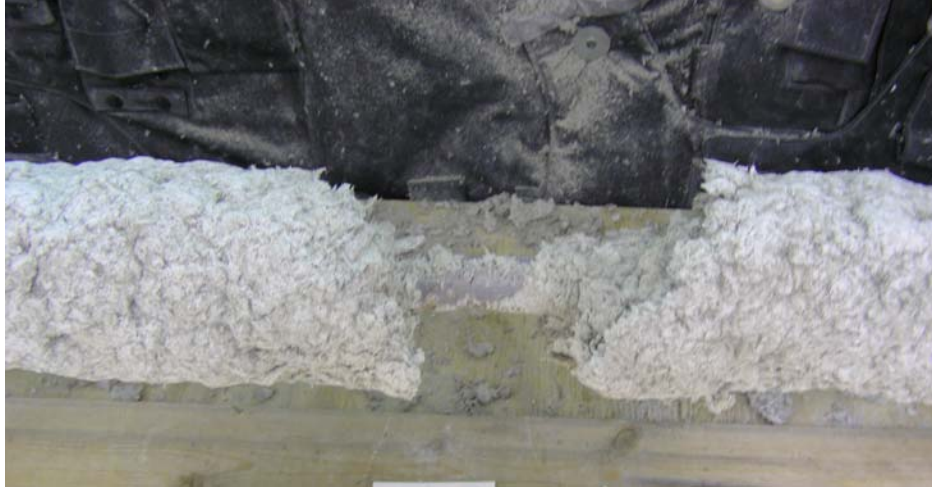
Figure C-11. Photograph showing damage to the SFRM on unprimed steel bar (BAR04) after a debris impact at 0 degree using the large universal receiver.

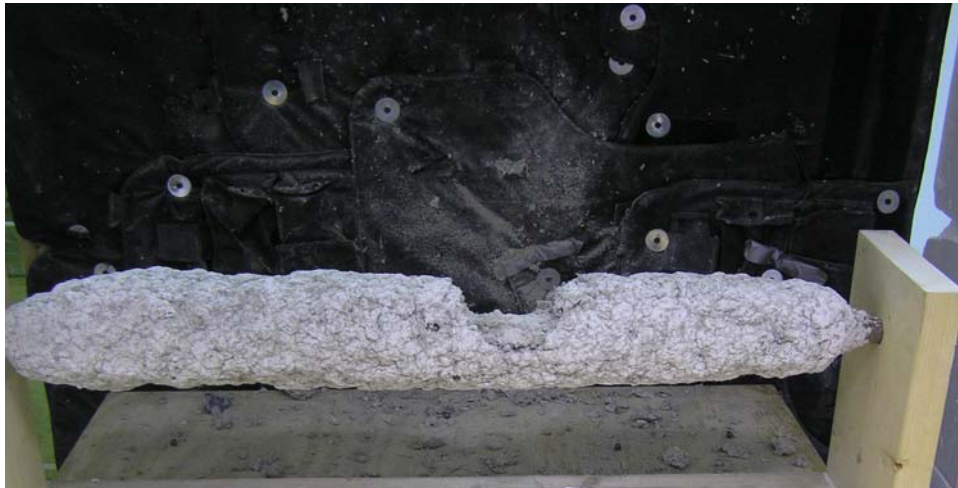
Figure C-12. Photograph showing damage to the SFRM on unprimed steel bar (BAR05) after a debris impact at 0 degree using the large universal receiver.
