6 *Bankers Trust Building*

6.1 Introduction

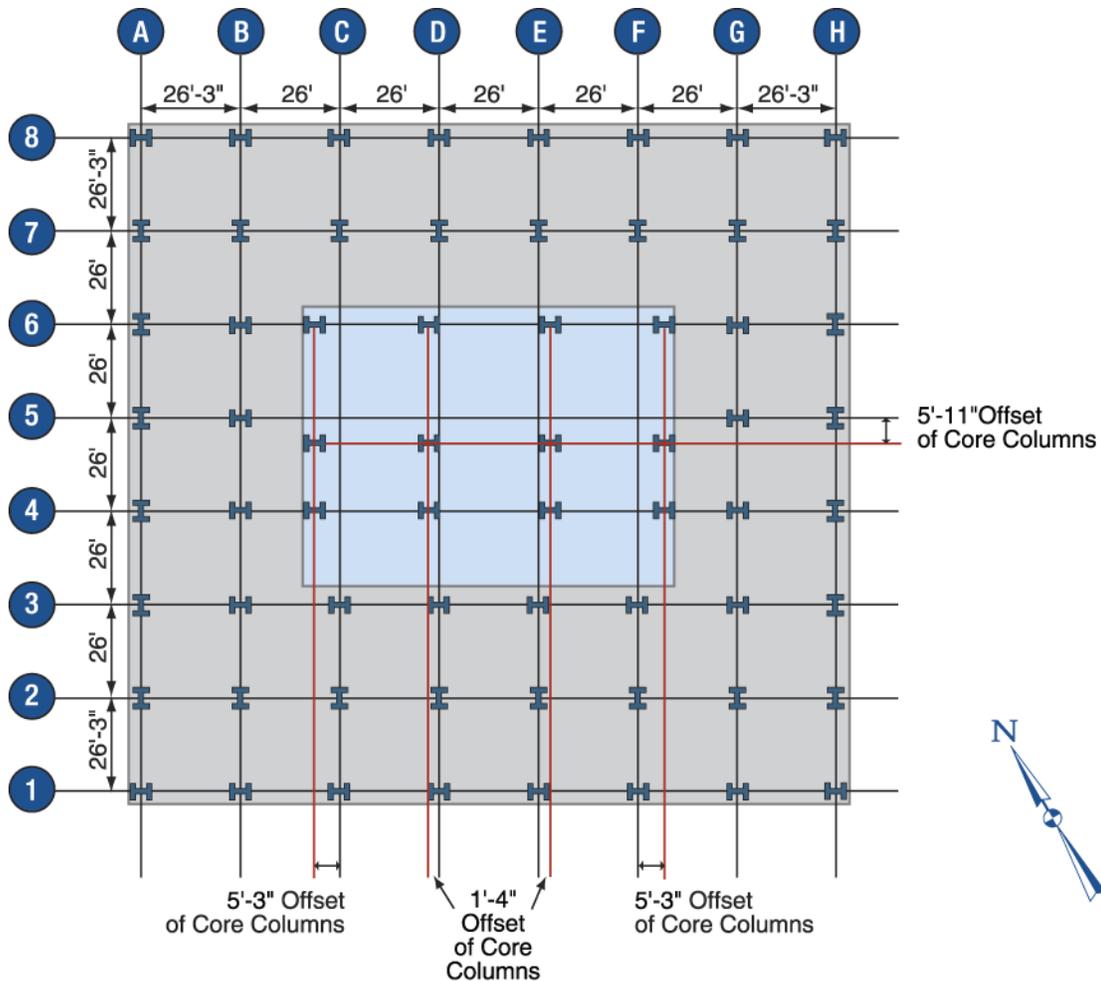
Above the second floor level, the building is essentially square in plan shape, with overall dimensions (centerline of exterior column lines) of 183 feet square. At the perimeter of the building, layout of columns in both the north-south and east-west directions consists of an exterior bay on each end that is 26 feet 3 inches wide and five interior bays that are 26 feet 0 inches wide. Interior column spaces vary slightly from this to accommodate the central elevator core (see Figure 6-3).

Figure 6-3 Floor plan above the 2nd level (ground floor extension not shown).

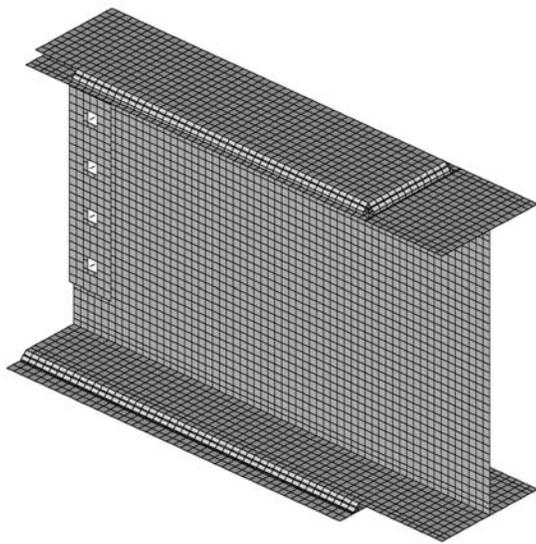
Both connections were modeled in three dimensions in ANSYS, using shell, beam, and continuum elements. All weld material was simulated with a bilinear kinematic hardening material with brittle fracture capabilities at a specified ultimate strain. Figures 6-13 and 6-14 illustrate the details of the finite element models of the two different connection details.

Both models were subjected to numerous load combinations to determine the overall behavior of the connection. The weld material was assumed to have a nominal yield strength of 50 ksi. Each model was then subjected to a monotonically increasing moment about the transverse axis of beam bending (M_y) and the principal strains in the welds were evaluated at the end of each load increment. If the strains in any of the weld elements exceeded the specified ultimate strain, the weld element was considered to have fractured and the modulus of elasticity was reduced by several orders of magnitude. Because the ultimate strain in the weld corresponding to fracture is an unknown quantity, several values were assumed in order to determine the connection behavior. Values of 0.5 percent, 1.0 percent, 10 percent, and 20 percent strain were assumed, and the moment curvature relations for the connection were developed. Based on these calculations, it was observed that the welds fracture before plastic hinges occur when the ultimate strain in the welds is assumed to be less than 1 percent. Furthermore, the connection was observed to degrade very quickly with the onset of weld fracture. The first onset of yielding in the welds was observed at a M_y value of 1,000 kip-in and 1,400 kip-in, for the shear plate and seat connections, respectively. In the absence of wind moments, the connections were found to be able to support a considerable increase in gravity loads over their dead and live load design values. However, the connection offered little resistance to torsional loads and a significant reduction in capacity of the connection with respect to out of plane bending.

Figure 6-13
3-D ANSYS model of flange and shear plate moment connection.

The computed results show a sensitivity of the moment curvature relations to the ultimate strain of the weld material and the out-of-plane moments that may have been applied to the connections. The connection sensitivity to out-of-plane and twisting moments significantly influenced the capacity of the connection to resist abnormal loading. The significant reserve capacity of these connections to gravity loads, over an order of magnitude by some estimates, are quickly eroded when the connection is subjected to out-of-plane bending. Therefore, as members were twisted by the collapse of adjacent bays, the connections were less able to withstand the weight of the accumulated debris. This phenomenon may explain why many connections failed and may also explain the sequence of weld fracture. This in turn may have influenced the modes of failure in different connections.

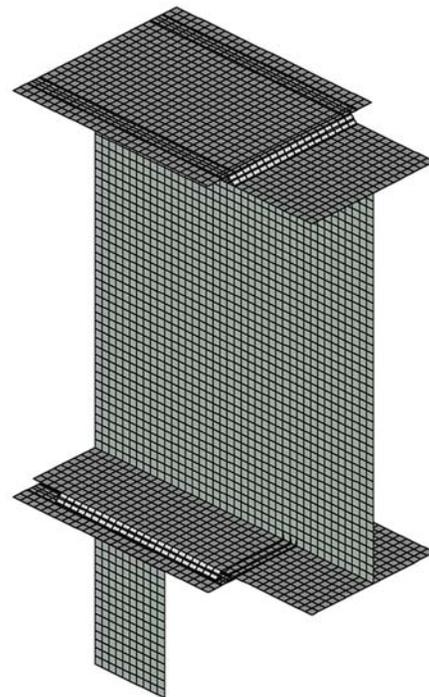
Figure 6-14
3-D ANSYS model of flange and seat moment connection.
