Engineering and Organizational Issues Related to the World Trade Center Terrorist Attack

# Overview of Damage to Buildings Near Ground Zero

By Michel Bruneau, Andrew Whittaker and Andrei Reinhorn

March 2002

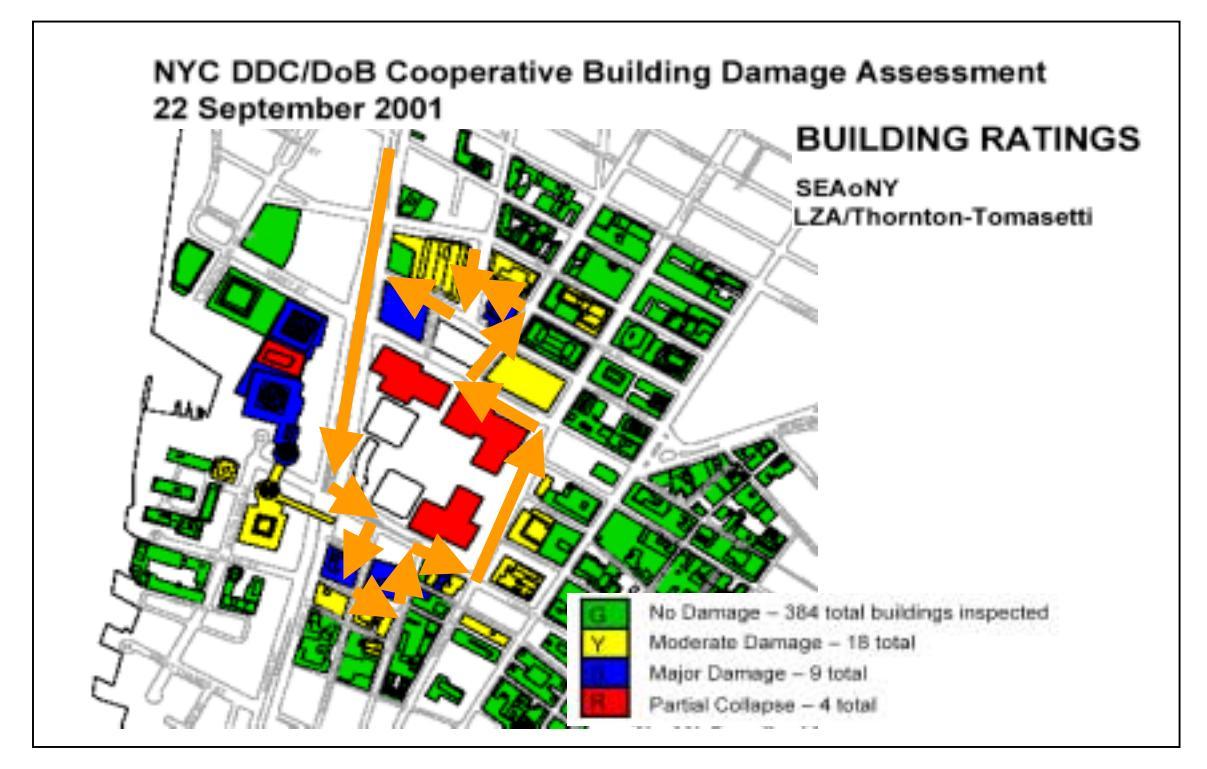
The arrows in Fig. 3.1 indicate the route followed by the MCEER reconnaissance team on September 21, 2001. This route follows the edge of the debris pile at Ground Zero. Fig. 3.1 also provides an overview of damage as reported by a team from the Structural Engineers' Association of New York (SEAoNY), who conducted a rapid evaluation of buildings near Ground Zero. This rapid inspection was conducted for the New York City Department of Design and Construction/Department of Buildings (DDC/DoB) by members of SEAoNY and coordinated by LZA/Thornton-Tomasetti to establish which buildings were safe to reoccupy. For those buildings rated as having suffered damage, no distinction was made between structural and architectural damage in the figure.

Figure 3.1. Arrows indicate the route followed by the MCEER reconnaissance team, superimposed on top of a map of the street layout by SEAoNY, LZA/Thornton-Tomasetti
