**Engineering and Organizational Issues Related to
The World Trade Center Terrorist Attack**

**Reconnaissance and Preliminary
Assessment of a Damaged Building
Near Ground Zero**

**Volume 2:
Reconnaissance and Preliminary Assessment of a
Damaged Building Near Ground Zero**

April 2002

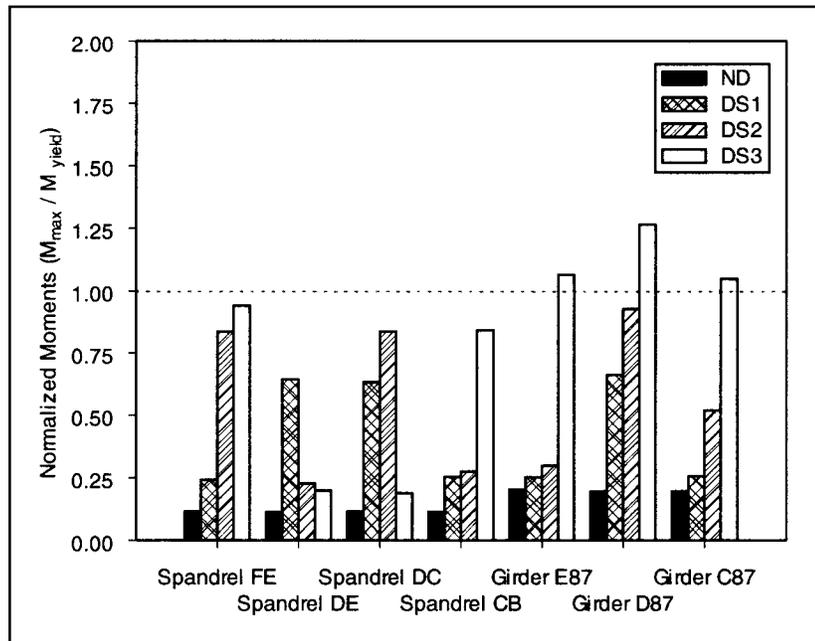
Figure 3.4. Demand-to-capacity ratios for three-dimensional linear elastic analysis

Figures 3.3 and 3.4 present some of the results of the two- and three-dimensional analyses, respectively. Shown in these figures are moments normalized by the yield moment for the assumed beam section sizes at TL 25; the floor level immediately above the observed damage. The spandrel beam designation (e.g., DE) refers to the grid lines between which the beam spans (e.g., Lines D and E). The girder designation (e.g., E87) refers to the grid line along which the girder is aligned (e.g., Line E) and the grid lines between which the girder spans (e.g., Lines 8 and 7). Such normalized moments represent demand-to-capacity (D/C) ratios for these elements, albeit not exactly, because M_{yield} is used in lieu of $\phi \cdot M_{nx}$ and each beam is assumed to be fully braced.

The mathematical models for damage states DS2 and DS3 were prepared to evaluate the robustness of a building frame with characteristics similar to those of 130 Liberty Plaza, where robustness herein is judged by the ability of the framing system to support gravity loads following the loss of multiple perimeter columns. The results of the two-dimensional analysis of the DS2 model (see Figure 3.3) show that the frame on Line 8 would have been compromised by the loss of columns on Lines D and E unless the moment-resisting connections were ductile (i.e., possessed some degree of inelastic rotation capacity). Review of the three-dimensional analysis results of Figure 3.4, however, shows that using the results of the two-dimensional analysis leads to conservative conclusions and that the moment-resisting framing perpendicular to Line 8 also participated in the redistribution of load around the lost columns on Lines D and E. Analyses for both the two- and three-dimensional models of DS3 (the loss of columns on Lines C, D, and E) show modest overloads in both instances. For the three-dimensional analysis, the D/C ratios are greatest in the framing perpendicular to Line 8, namely, Girders C87, D87, and E87.
