## Chapter 9

# FIRE BEHAVIOR IN WORLD TRADE CENTER 2

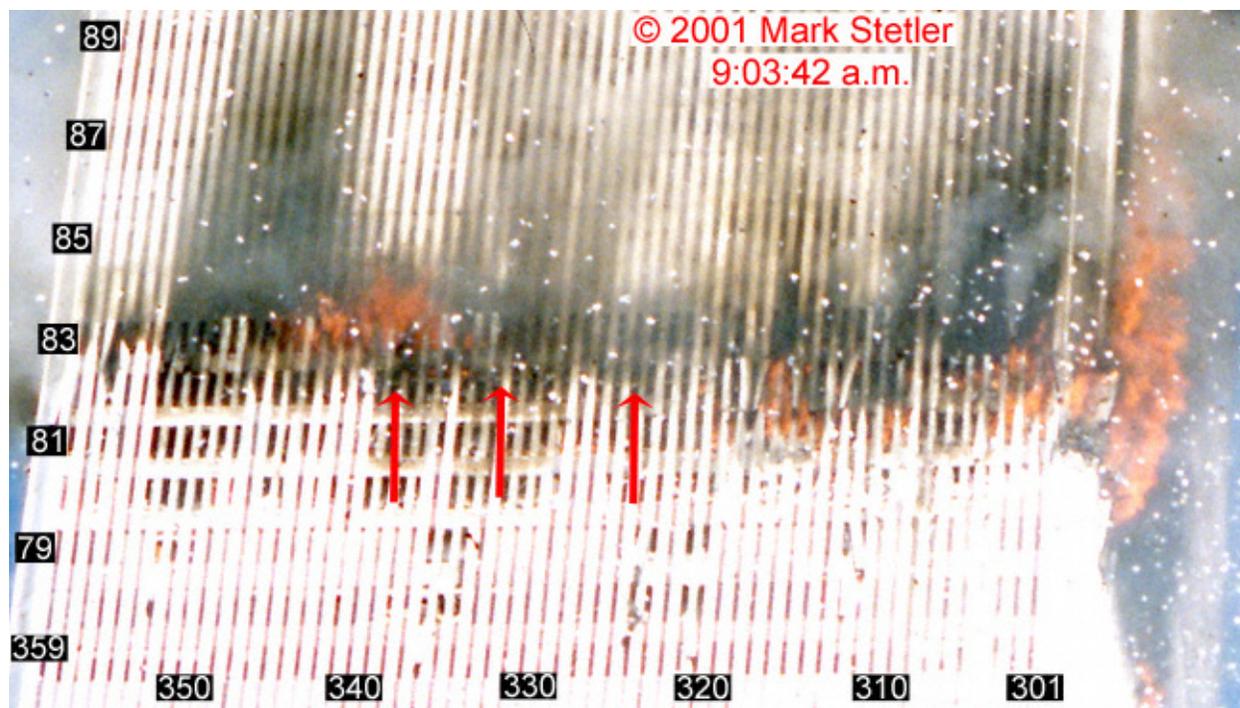
Figure 9–1 shows an image of the east face of WTC 2 recorded at 9:03:42 a.m., which was 43 s after the aircraft impact. The numerous white dots are pieces of paper that were expelled from the building due to the aircraft impact and subsequent fireballs. Extensive fires are visible on the 81st, 82nd, and 83rd floors. On the two lower floors, intense fires, which fill the windows with flame, appear to be nearly continuous from around windows 81-321 and 82-322 to the north edges of the floors. On the 83rd floor, the fires are intense, with considerable flaming outside of windows between windows 83-335 and 83-346. There is also a region with a lower intensity fire nearer the center of the face on the 81st floor, and there is an indication of a small fire near window 80-313 on the 80th floor. Despite the numerous fires present, the amount of smoke being released is relatively small, and it is possible to see most of the east face above the fires.

The intensity levels of the photograph in Figure 9–1 were adjusted to enhance the visibility of an object that is identified by the arrows added to the photograph. A blowup of the area of the photograph including the arrows is provided in Figure 9–2. The object appears as a narrow line that has been draped inside windows on the 82nd floor extending from at least window 82-321 to window 82-339. This hanging object will be observed numerous times in images to be shown below. While it is difficult to identify the object with certainty, the evidence will be strong that it is the end of a part of the 83rd floor concrete floor slab that has been dislodged from the spandrel located above the 82nd floor and has settled downward several feet to appear below the spandrel.

Figure 9-1. A view of the east face of WTC 2 recorded at 9:03:42 a.m. is shown. The original photograph has been rotated, cropped, and enhanced by adjusting intensity levels. Column and floor numbers have been added. The arrows highlight a hanging object observed through open windows on the 82nd floor.

Closer inspection of Figure 9–1 and Figure 9–2 shows that small flames are visible above the object at the tops of windows 82-335 to 82-337. While not as clear as in these windows, similar fires appear to be present elsewhere along the top of the line. Heavy flames are coming from windows on the 83rd floor immediately above this area. This suggests that the flames observed at the tops of windows on the 82nd floor are burning at the base of a fuel source located on top of the hanging object that is fueling the much larger flames visible on the 83rd floor. It is likely that this fuel is on top of the concrete floor slab that was originally attached to the spandrel above the 82nd floor.

The visual evidence supports a conclusion that a substantial length of the concrete floor slab for the 83rd floor along the east facade of the WTC 2 has been dislodged and has come to rest below the spandrel. The edge of the object appears to be continuous, suggesting that even though the floor slab has dropped down, it is essentially intact and is still acting as a single system.

In Chapter 7 it was also noted that a substantial flash fire lasting several seconds occurred on the 82nd floor due to the release of aviation fuel. The sudden appearance of this fire is believed to have generated an overpressure, that may have been on the order of several psi on the floor (see the discussion in Section 6.5). This overpressure was likely responsible for the removal of large sections of the curtain wall on the north and east faces, and it drove additional atomized fuel from the building, resulting in the formation of fireballs. It is possible that the separation of the 83rd floor slab from the spandrel was due to the generation of sufficient overpressure on the 82nd floor to push the 83rd floor slab upward off of its seats, allowing it to then settle down below the spandrel.

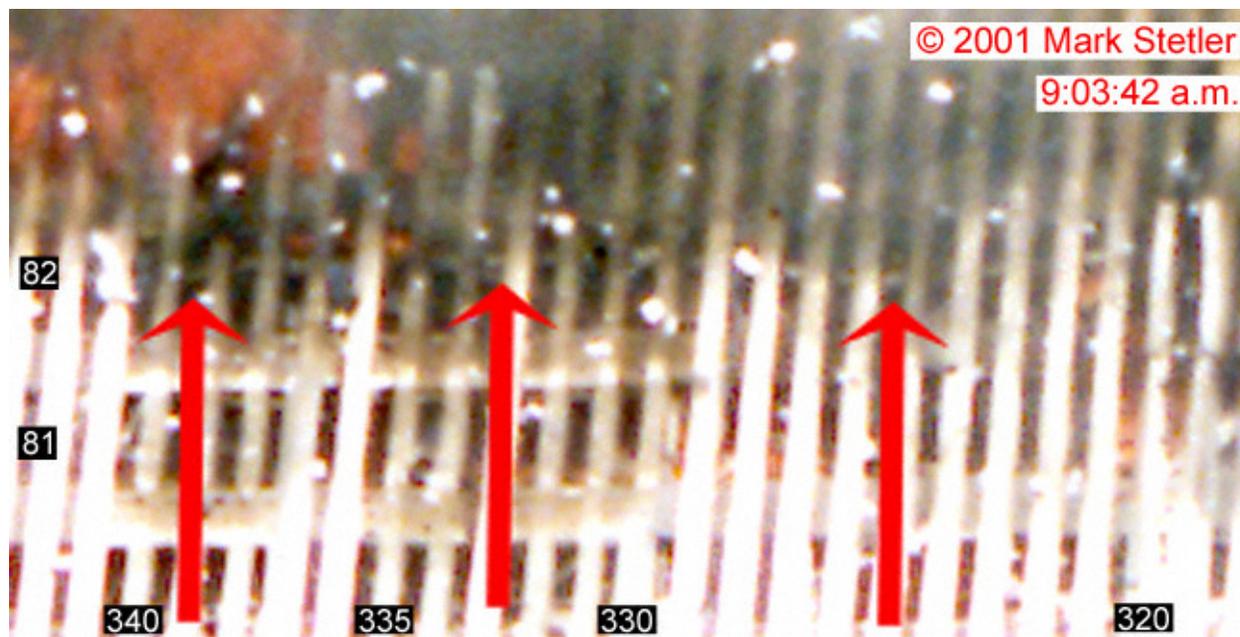
Figure 9-2. A section of the image shown in Figure 9-1 is blown up. The arrows point to the location of an object that is visible through open windows on the 82nd floor on the east side of WTC 2.

The hanging object on the 81st floor is now visible through windows 81-331 to 81-335 and windows 81-338 to 81-342. Windows further to the north remain obscured. Comparison of the location of the object with the image reproduced in Figure 9-1 and Figure 9-2, which was recorded at 9:03:42 a.m., shows that the object is at roughly the same height in the windows and has a similar shape.

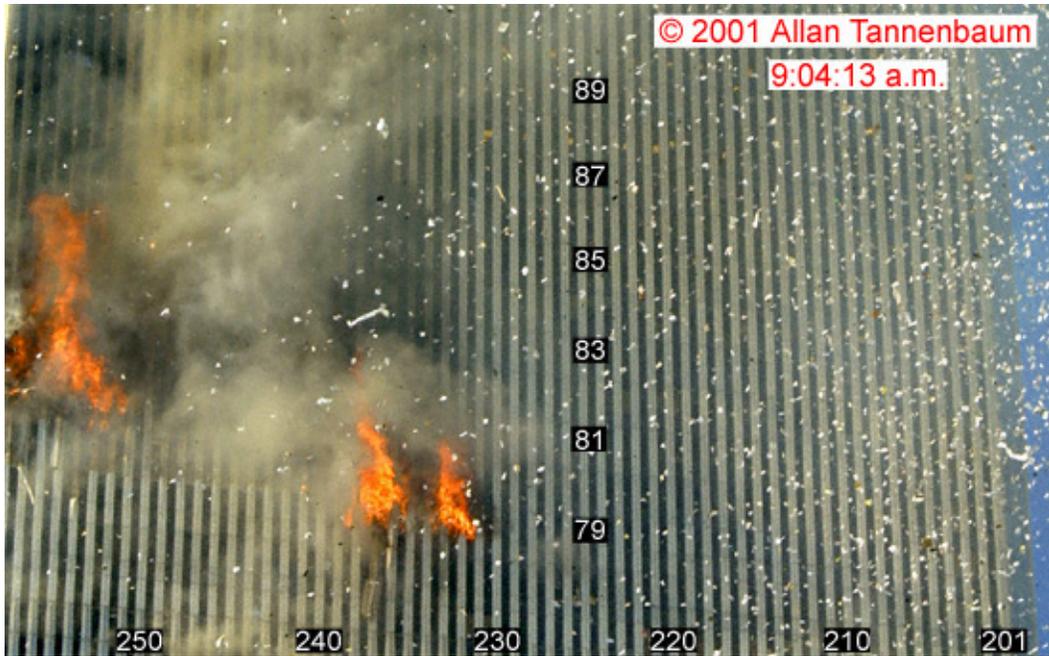
A view of the north face of WTC 2 recorded at 9:04:13 a.m. is shown in Figure 9–3. The large amount of paper expelled from the tower due to the aircraft impact and subsequent fires is apparent. Two areas of intense fire are seen. One of these is located near the east edge of the face on the 81st floor, and the second is on the 79th floor, extending from roughly windows 79-231 to 79-238. In Chapter 7 visual evidence was shown indicating that large piles of debris, presumably a mixture of aircraft and building debris, were present at these two locations. Evidently, these debris piles were ignited during the aircraft impact and subsequent fireballs and continued to burn intensely. Even though there is a large amount of dust evident, there does not appear to be a substantial fire in the region between the two burning areas.

Figure 9-3. This cropped photograph of the north face of WTC 2 was recorded at 9:04:13 a.m. The image intensity levels have been adjusted. Column and floor numbers have been added.

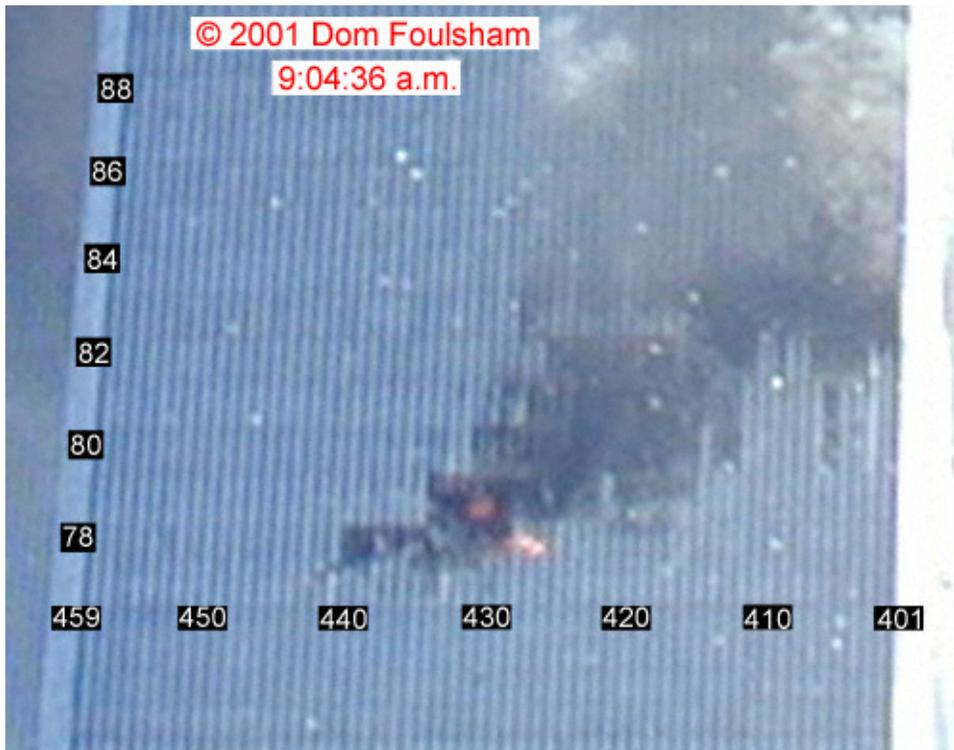
A view of the south face of WTC 2 recorded at 9:04:36 a.m. is shown in Figure 9–4. It was taken 97 s after the aircraft impact on this face. A number of sheets of paper are also visible on this side of the building. The most prominent feature is the damage caused by the aircraft impact. Two areas of bright flame are evident in the image on the 78th and 79th floors. On the 78th floor, the fire is located just to the right of the cavity generated by the aircraft impact, while on the 79th floor the fire appears to be burning within the cavity. On the 82nd floor there appears to be an orange glow from windows 82-420 to 82-425, suggesting that a fire is present in this area as well.

Figure 9-4. This cropped photograph shows the south face of WTC 2 at 9:04:36 a.m. Column and floor numbers have been added.

There is relatively little smoke coming from windows on the south face at this time. For later comparison purposes, note that the entire lengths of the 81st and 82nd floors can be seen and that very little smoke is evident coming from windows on these floors. The only significant plume of smoke is coming from the 83rd floor near the east edge of the face.

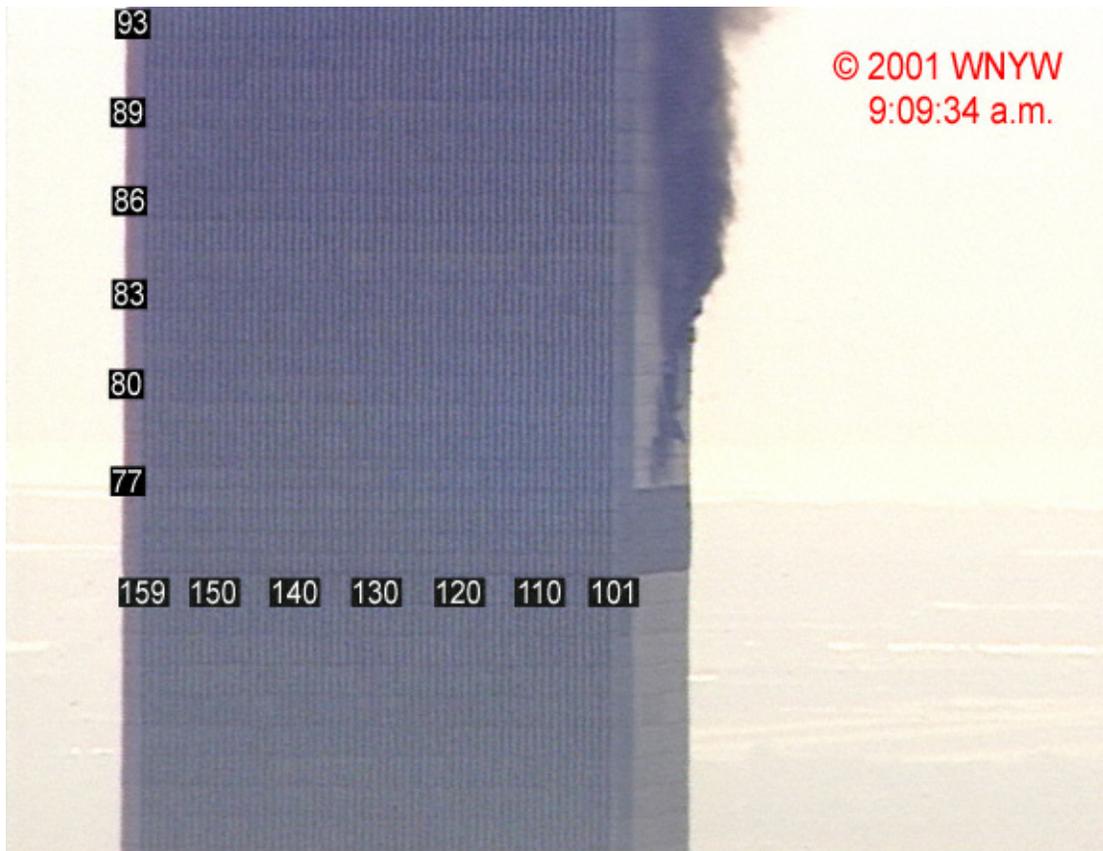
The database does not contain clear images of the west face of WTC 2 in the early period following the aircraft impact. Figure 9–5 shows an image of the face taken from a video recording made from a news helicopter at 9:09:34 a.m. At this time there was no visible smoke or fire on the face. This is consistent with the conclusion in Chapter 7 that the aircraft impact and subsequent fireballs caused no visible damage to the west face of WTC 2.

**Figure 9-5. This image of the west face of WTC 2 was captured from a video shot from a news helicopter at 9:09:34 a.m. Column and floor numbers have been added.**

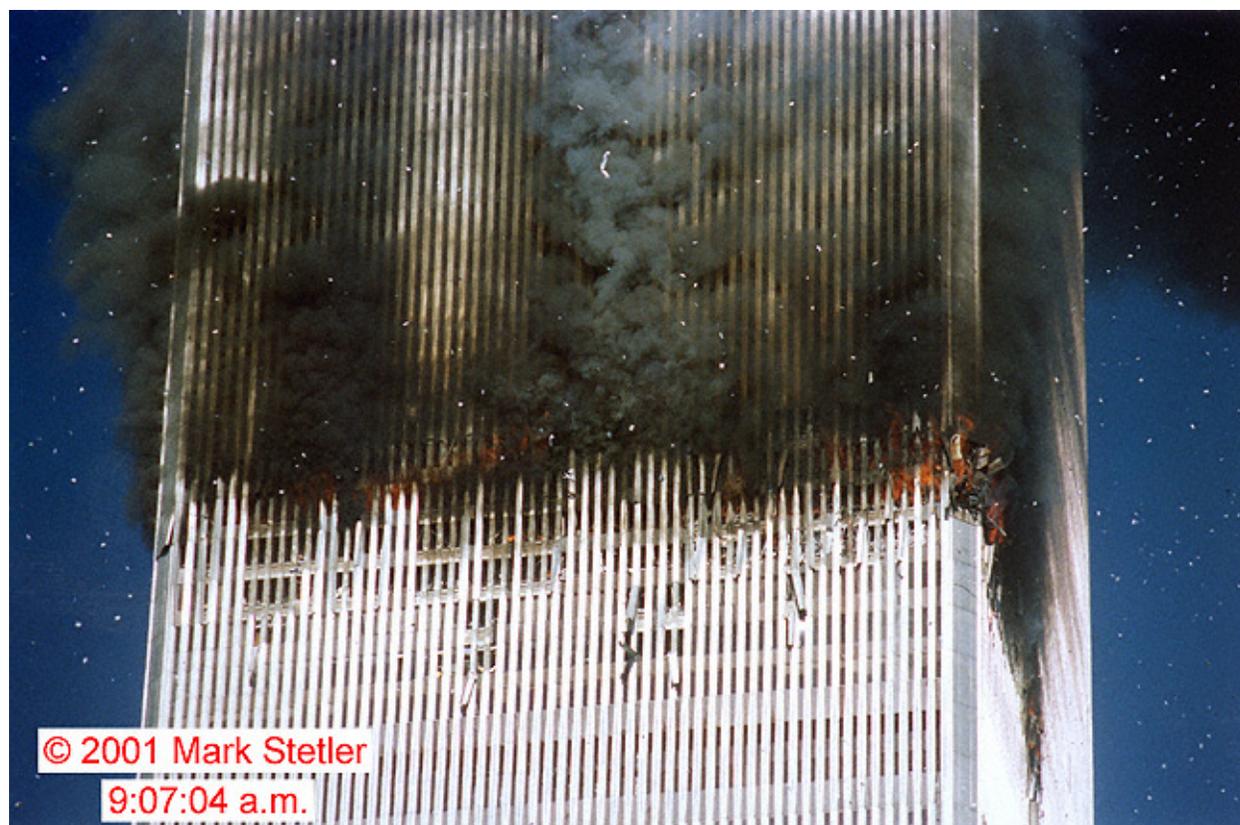
**Figure 9-6. This photograph showing the east face of WTC 2 was recorded at 9:07:04 a.m.**

A close-up view of the east face of WTC 2 recorded at 9:07:04 a.m. is shown in Figure 9–6. During the 3 min 20 s since Figure 9–1 was taken, the fire distribution on the face has changed. The large fires that were burning earlier on the 81st, 82nd, and 83rd floors appear to have died down somewhat. A new area of intense fire has appeared on the 82nd floor just to the south of where the large fire was visible on the 83rd at the earlier time.

A substantial increase in the amount of smoke coming from open windows is evident when the two photographs of the east face are compared. The smoke appears to be coming from two separate locations on the 82nd floor. Videos of the east face show that heavy smoke appeared first from the area on the south side of the face, increasing rapidly around 9:04:30 a.m. The smoke flow coming from windows just to the north of the center of the face increased markedly about 50 s later.

The image in Figure 9–6 provides a great deal more resolution than is evident from the way it has been sized. Figure 9–7 shows blowups taken from the photograph of the northern and southern halves of the east face for the floors where fires were present. The north side is at the top of the figure. In this image the damage to the aluminum façade is evident. The debris that has been piled along the east wall in the northeast corners on the 80th and 81st floor is visible. There is also a large amount of debris protruding from the opening created by removing the aluminum panel from the northeast corner of the 81st floor.

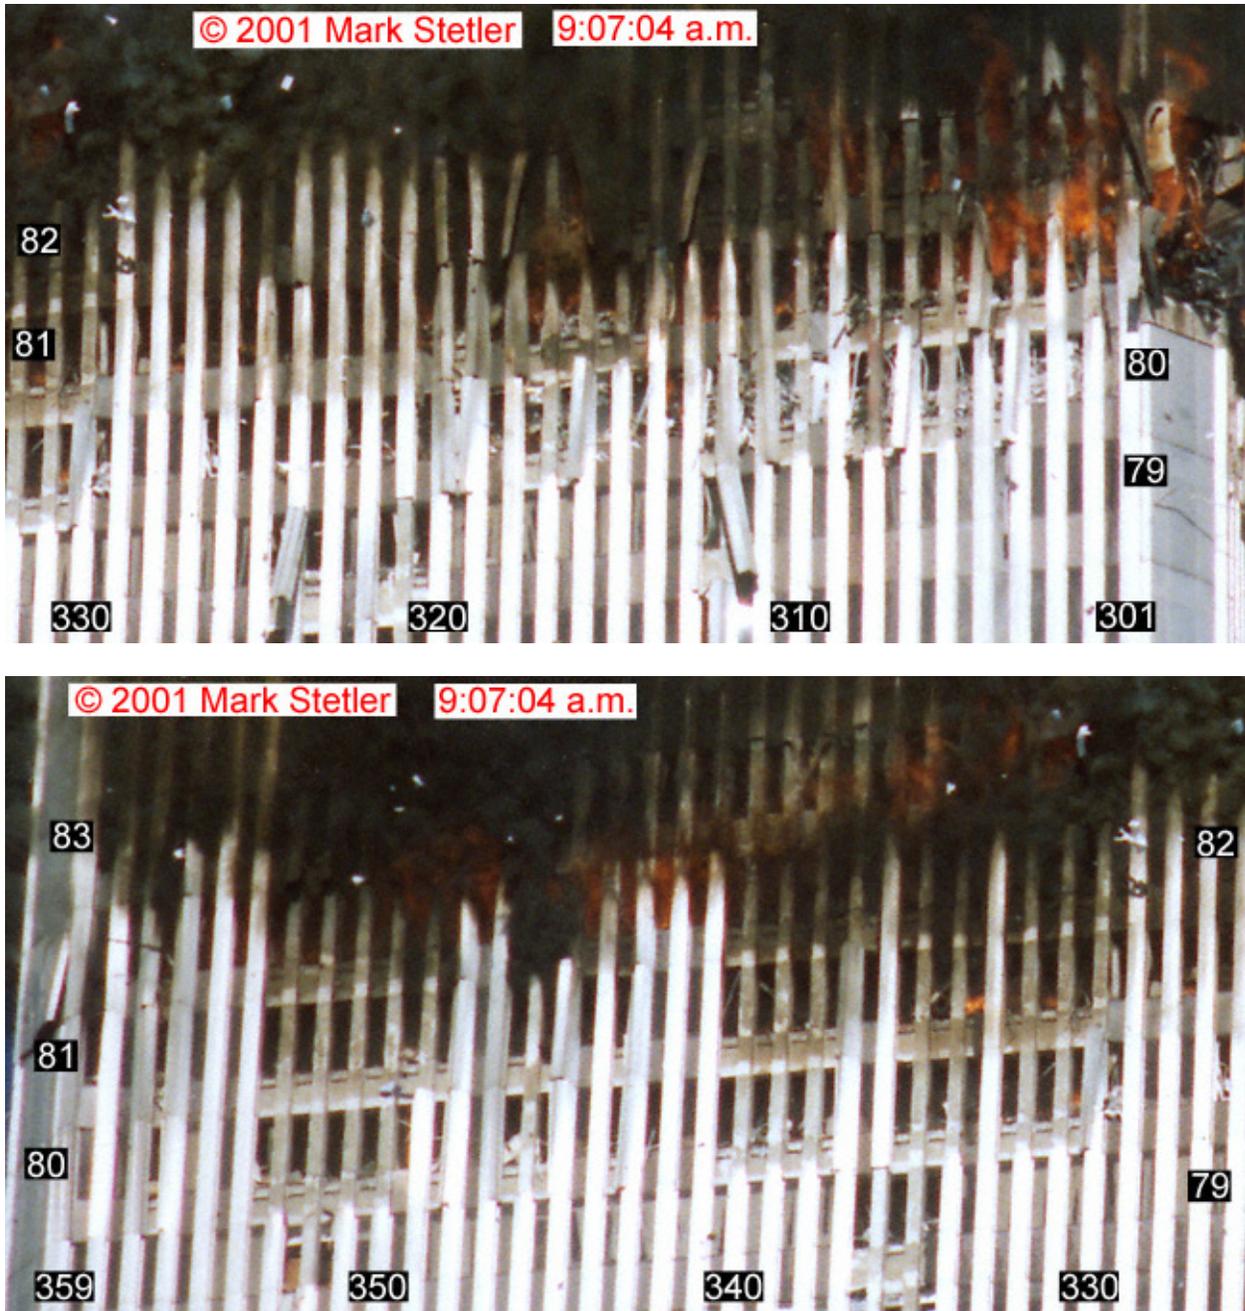
**Figure 9-7.** These two images show blowups of the north and south sides of the east face of WTC 2 taken from the photograph included in Figure 9-6, which was shot at 9:07:04 a.m. Column and floor numbers have been added.

Heavy fires are burning in the northeast corners of the 81st and 82nd floors. On the 81st floor flames are coming from windows 81-301 to 81-304 as well as from the northeast corner where the aluminum panel has been removed. Lower intensity flames are evident in many windows further to the south, extending at least as far as the last visible window, 81-332. It is likely that the fire is continuous across this entire length. On the 82nd floor flames are coming from windows 82-301 to 82-309. Flames further to the south do not appear to be as widespread as on the 81st floor, but there is much more smoke coming from open windows on this floor. The smoke flow is particularly heavy from windows 82-323 to 82-332. The

A blowup of the southern side of the fire floors is included at the bottom of Figure 9–7. Flames are visible on the 83rd floor over a length from near window 83-331 to window 83-338. The intensity of these flames has died down considerably from that observed at the earlier time in Figure 9–1. It can be seen that a considerable amount of the aluminum facing on this floor has been removed.

On the 81st floor the last window to the south where a low-intensity fire is observed is window 81-333. It is interesting that despite the fact that there is a great deal of damage to the aluminum façade on this floor, there are several windows for which the glass is still in place. The small spot fire present in window 80-330 can be seen in the overlapping lower image as well. Several window panes are also still in place on this floor. No fire or smoke is visible on this half of the 79th floor.

The close up views of the north side of the east face shown at the tops of Figure 9-7 and Figure 9-15 look very similar. There appears to have been a slight decrease in the intensity of the fires burning in the northeast corners of the 81st and 82nd floors. Two small spot fires burning on the 80th floor also seem to have grown smaller.

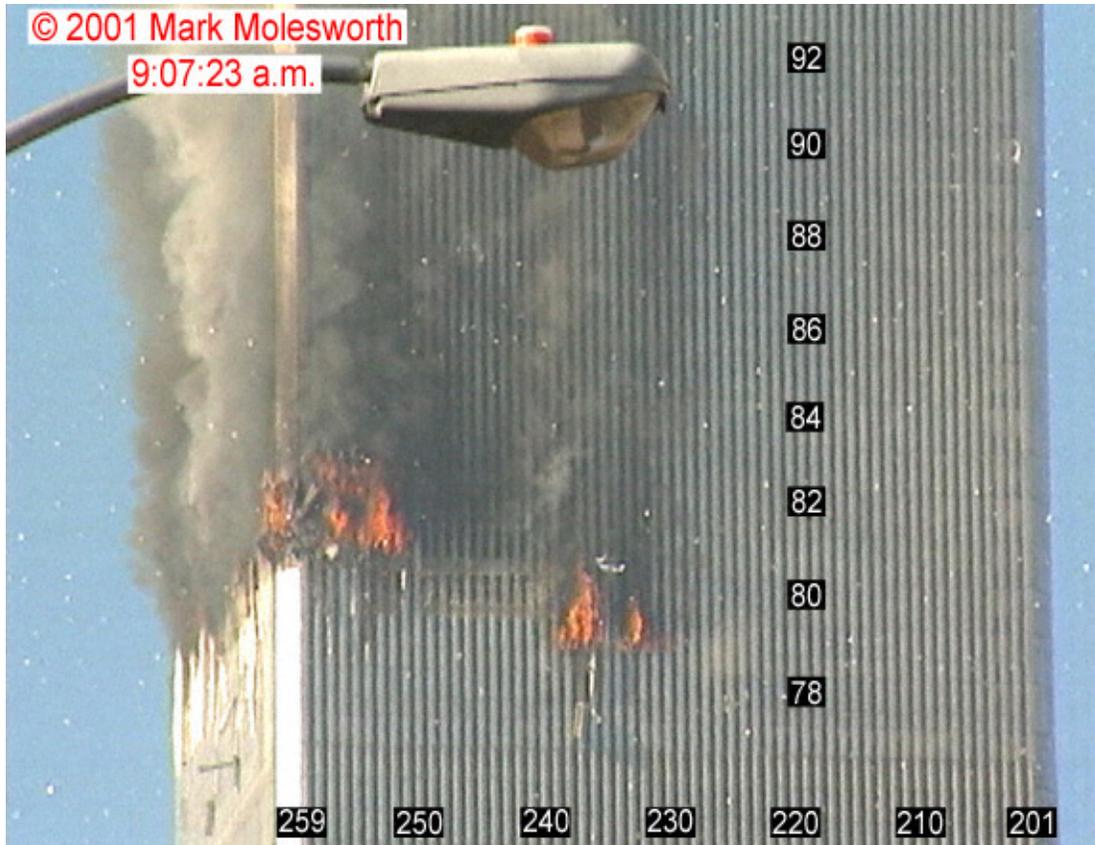
Figure 9–8 shows the north face of WTC 2 at 9:07:23 a.m. This is 3 min and 10 s later than the image of the north face included in Figure 9–3. The view of the fires in the current image is more complete due to the angle and distance from which it was shot. The two large fires that were observed on the 79th and 81st floors at the earlier time continue to burn vigorously. The fire on the 79th floor still consists of two large tongues of flame at the same locations however, flames are visible further to the west than at the earlier time, now reaching at least as far as window 79-228. In the earlier photograph, windows 79-228 and 79-229 appeared to have intact glass. The intense fire on the east edge of the 81st floor is in roughly the same location as earlier. In Figure 9–3 it was not possible to determine whether the 82nd floor was burning. It is clear in the later image that there is a fire on the 82nd floor, with flames coming from windows 82-252 to 82-258. It was difficult to see this area immediately following the aircraft impact because of the amount of debris released and the large flames present on the 81st floor. A review of images indicates that the 82nd floor was burning in this corner as early as 9:04:25 a.m.

**Figure 9-8. This image captured from a video shows the north face of WTC 2 at 9:07:23 a.m. Column and floor numbers have been added.**

Figure 9–8 provides a good view of much of the north face with sufficient resolution to resolve details on the face. For instance, the open windows on the 78th floor near window 78-225 can be discerned. There is no indication of fire or smoke at locations removed from the area that was originally damaged during the aircraft impact and subsequent fireballs.

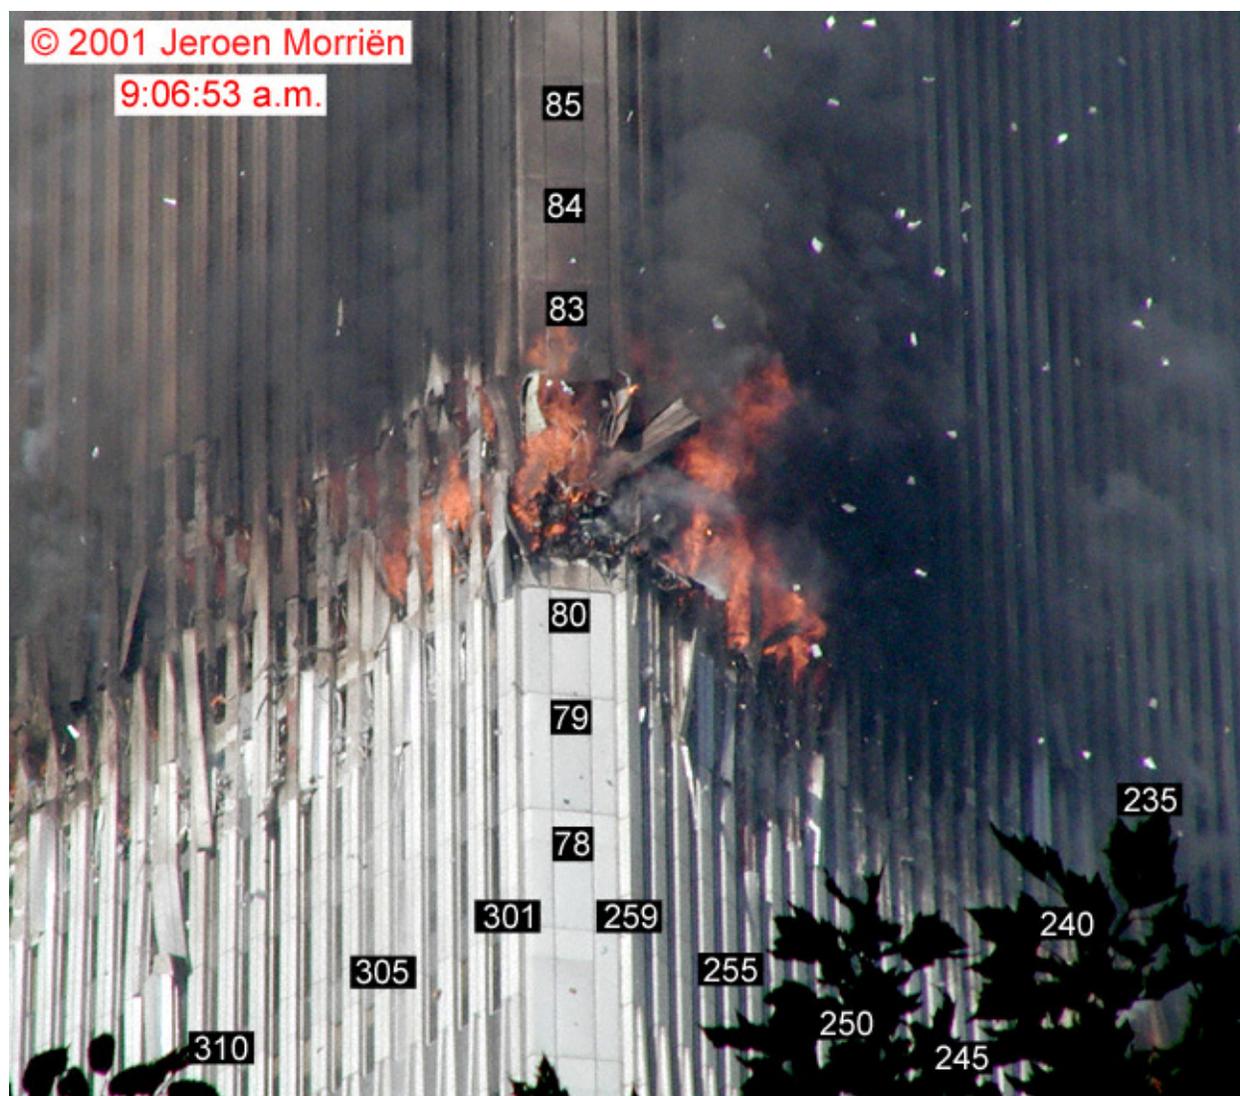
An image of the fires on north and east faces shot from the northeast at 9:06:53 a.m. is shown in Figure 9–9. It provides a good view of the debris that was protruding from the northeast corner of the 81st floor, as well as an indication of the actual extent and intensity of the fires burning in the northeast corners of the 81st and 82nd floors. The cold spot on the north face is easily identified from this angle.

**Figure 9-9.** This cropped photograph showing the northeast corner of WTC 2 was taken at 9:06:53 a.m. The image has been enhanced by adjusting the intensity levels. Column and floor numbers have been added.

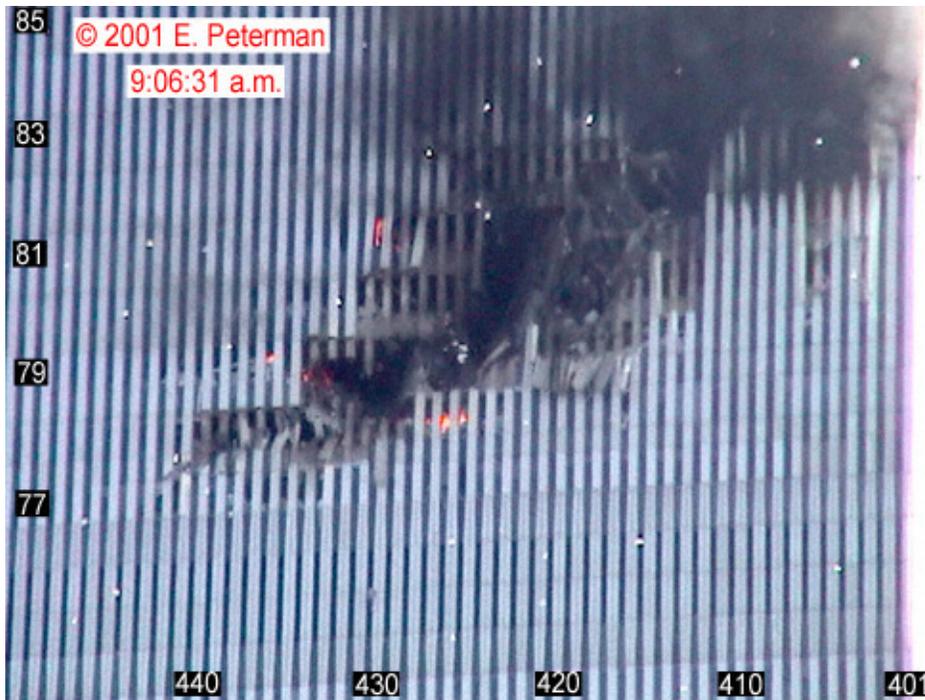
An image of the south face of WTC 2 taken from a video recorded at 9:06:31 a.m. is shown in Figure 9–10. This is slightly less than two minutes later than the image shown in Figure 9–4. Even though the latter image is clearer and shows more detail, it can still be seen that the appearance of the face has changed somewhat during this short period. A new fire has appeared on the 81st floor near window 81-430 that was not apparent earlier. The fire that was burning within the cavity created by the aircraft impact on the 79th floor seems to have moved toward the west and can now be seen on top of a pile of debris through open window 81-436, as well as at multiple locations on the debris within the impact cavity. In the later image there is no indication of a fire burning on the 82nd floor above the aircraft impact cavity.

In Figure 9–10, smoke is coming from open windows to the east of the aircraft impact cavity on the 81st floor, and there is an indication of flames in the area. In the earlier photograph, this area was clear of smoke, and some details on this floor as well as the one above could be identified. Apparently, a fire has grown quickly on the 81st floor in this area. Interestingly, a photograph of the east face taken around this time (see Figure 9–7) shows very little smoke and no visible flame near the south edge of the face. This suggests that the fire growing at this location was ignited near the aircraft impact location and is moving toward the east.

Figure 9-10. This image showing the south face of WTC 2 is a frame captured from a video recorded at 9:06:31 a.m. It has been enhanced by adjusting the intensity levels, and column and floor numbers have been added.

Comparison of Figure 9-10 and Figure 9-18 indicates that the fires ignited at other locations within and immediately adjacent to the aircraft impact cavity have continued to grow and spread slowly. At the earlier time, the glass in window 81-431 appeared to be intact, while in Figure 9-18 flames are coming from this window and are visible in window 81-432 as well. The appearance of the fire burning on the debris pile located at the western edge of the aircraft impact cavity on the 79th floor is similar to that seen earlier, while the fire on the 78th floor seems to be slowly spreading across debris piled within the cavity.

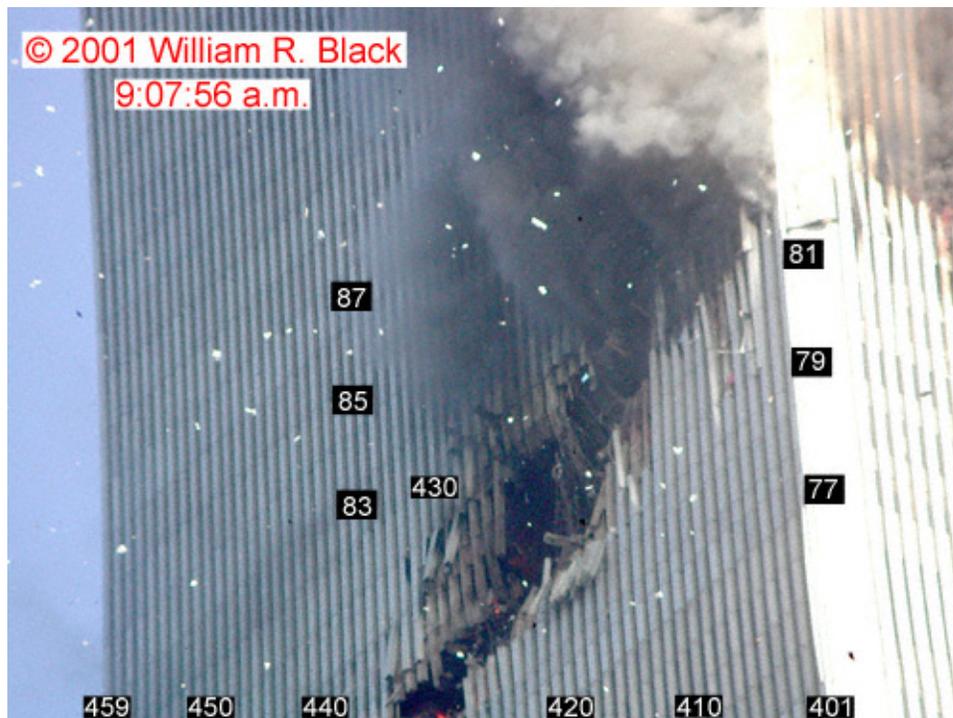
Another view of the south face at roughly the same time is shown in Figure 9–11. It was shot from further east than Figure 9–10. From this angle fires are visible at multiple spots inside the aircraft impact cavity, including locations corresponding to the 78th, 79th, and 80th floors. The smoke coming from the windows to the east of the aircraft impact cavity on the 81st floor is also visible. Apparently, the fires

Figure 9-11. This photograph of WTC 2 was taken at 9:07:56 a.m. from the southeast and shows the south face and a portion of the east face. The intensity levels have been adjusted, and column and floor numbers have been added.

growing on this floor are also venting through the aircraft impact cavity since a large amount of smoke is flowing from the opening just to the west. This photograph confirms that little smoke and no flames are visible coming from windows on the 81st floor of the east face that are adjacent to this area.

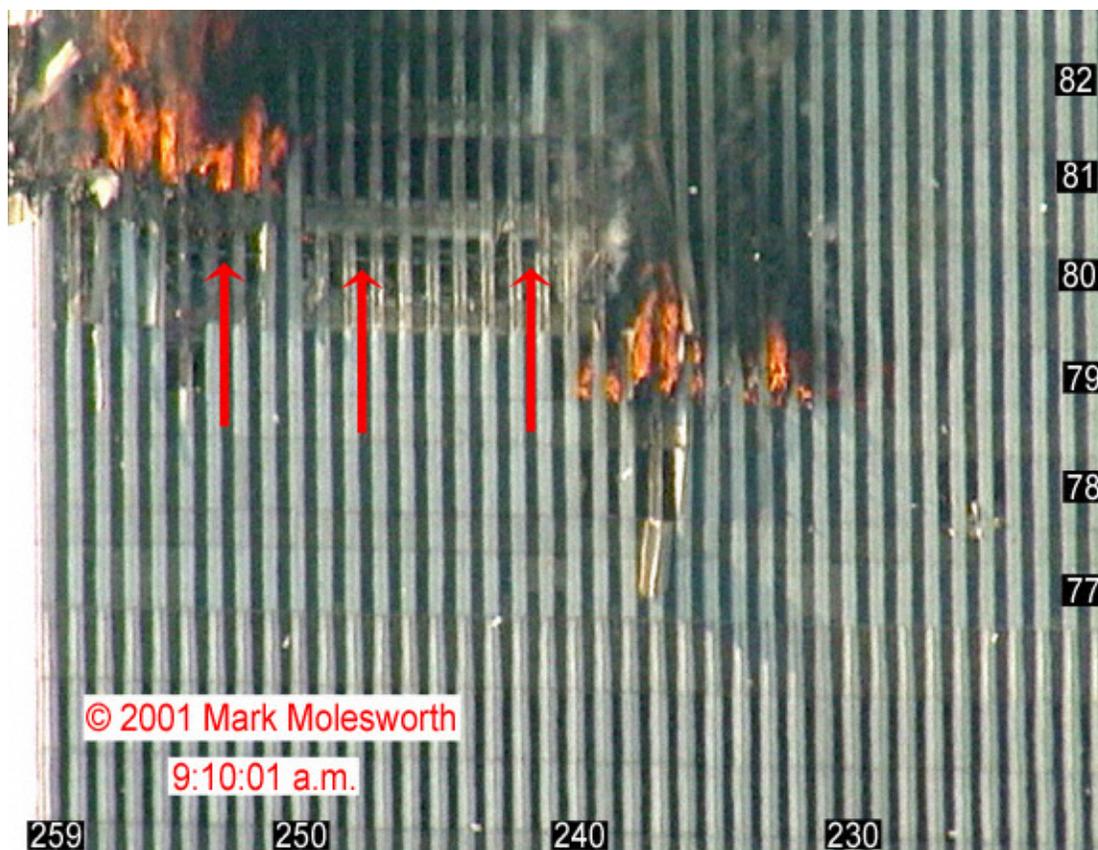
At 9:10:01 a.m. a videographer recorded a closer view of the north face of WTC 2 than those presented thus far. Figure 9–12 shows a frame captured from this video. The image shows that the fires burning on the 79th, 80th, and 81st floors have not changed markedly since 9:07:23 a.m. (see Figure 9–8). The cold spot is also distinct. The increased resolution of Figure 9–12 allows a detail to be resolved that was not easily identified in the earlier images. There appear to be two objects hanging across a length of open windows on the 80th floor. The arrows added to the image indicate these objects. One of the objects appears as a line running from at least window 80-255 to window 80-243. The second object also appears as a curved line. It is visible above the first object starting near the top of window 80-247 and extending west to at least window 80-241.

**Figure 9-12.** An image of the north face of WTC 2 captured from a video recording at 9:10:01 a.m. is shown. The intensity levels of the image have been adjusted, and column and floor numbers have been added. The arrows highlight hanging objects observed through open windows on the 80th floor.

Closer inspection of Figure 9–12 shows that flames are visible above the first object in windows 80-249, 80-252, and 80-253. These fires have similar locations and appearances to the numerous fires that were observed at the tops of windows in WTC 1 (see Chapter 8) and were attributed to burning thermal insulation located above the windows. In this case this explanation seems unlikely since the aluminum façade has been removed from the columns adjacent to these windows. Using Figure 9–12 as a guide, Figure 9–8 was reviewed more carefully to look for indications of these objects and fires. It is possible to barely discern the first of the objects, and the fires above the objects are clearly visible at the earlier time.

Even though the later image has higher resolution and shows more detail, a comparison of Figure 9-12 and Figure 9-16 indicates that the locations of the hanging objects identified in Figure 9-12 have not shifted appreciably during the 4 min period between the photographs. There are additional hanging objects resolved in the later photograph (seen most clearly in Figure 9-17) that are not easily identified in Figure 9-12. In addition to the two hanging objects on the 80th floor that were previously described, there is another similar object visible on the 81st floor near the tops of windows 81-239 to 81-242. This hanging object appears to consist of two closely spaced lines. There is yet another object in windows 80-251 to 80-254 that is below the much longer object that is visible hanging across window 80-242 to window 80-256.

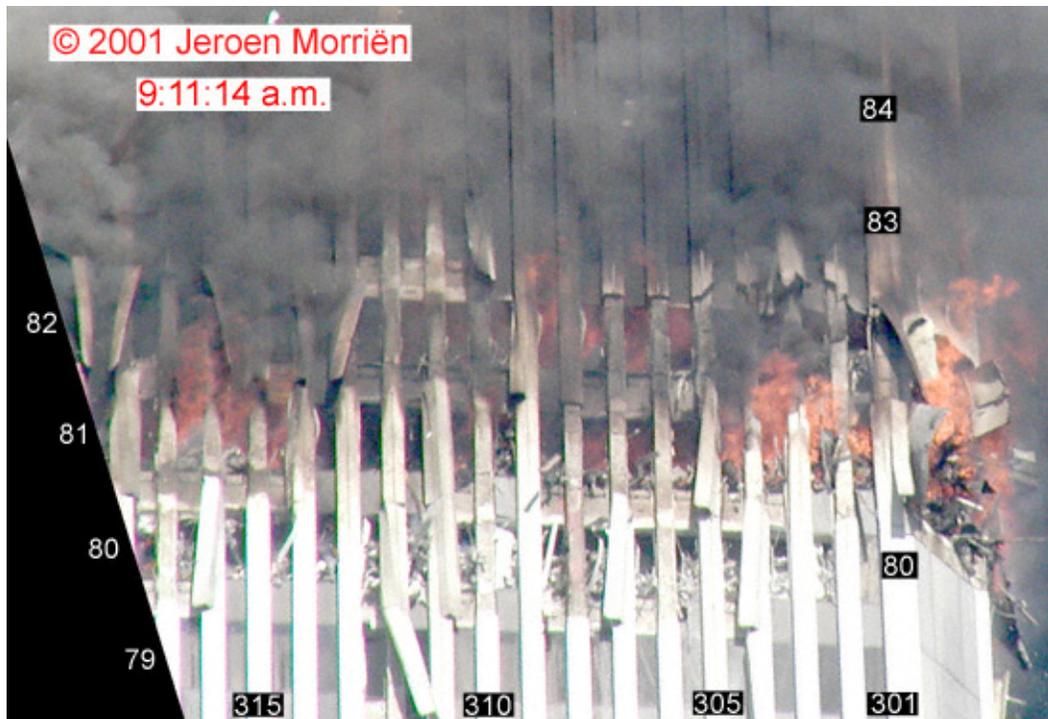
A close-up view of the northern portion of the east face of WTC 2 at 9:11:14 a.m. is shown in Figure 9–13. The debris piles on the 80th and 81st and in the opening on the northeast corner of the 81st floor are particularly clear. The fires on the 81st and 82nd floors continue to burn intensely. The only fire visible on the 80th floor is in window 80-317. Most of the glass is intact for windows on the 79th floor.

Figure 9-13. This photograph shows the northern portion of the east face of WTC 2 at 9:11:14 a.m. The image has been cropped and rotated, and the intensity levels have been adjusted. Column and floor number have been added.

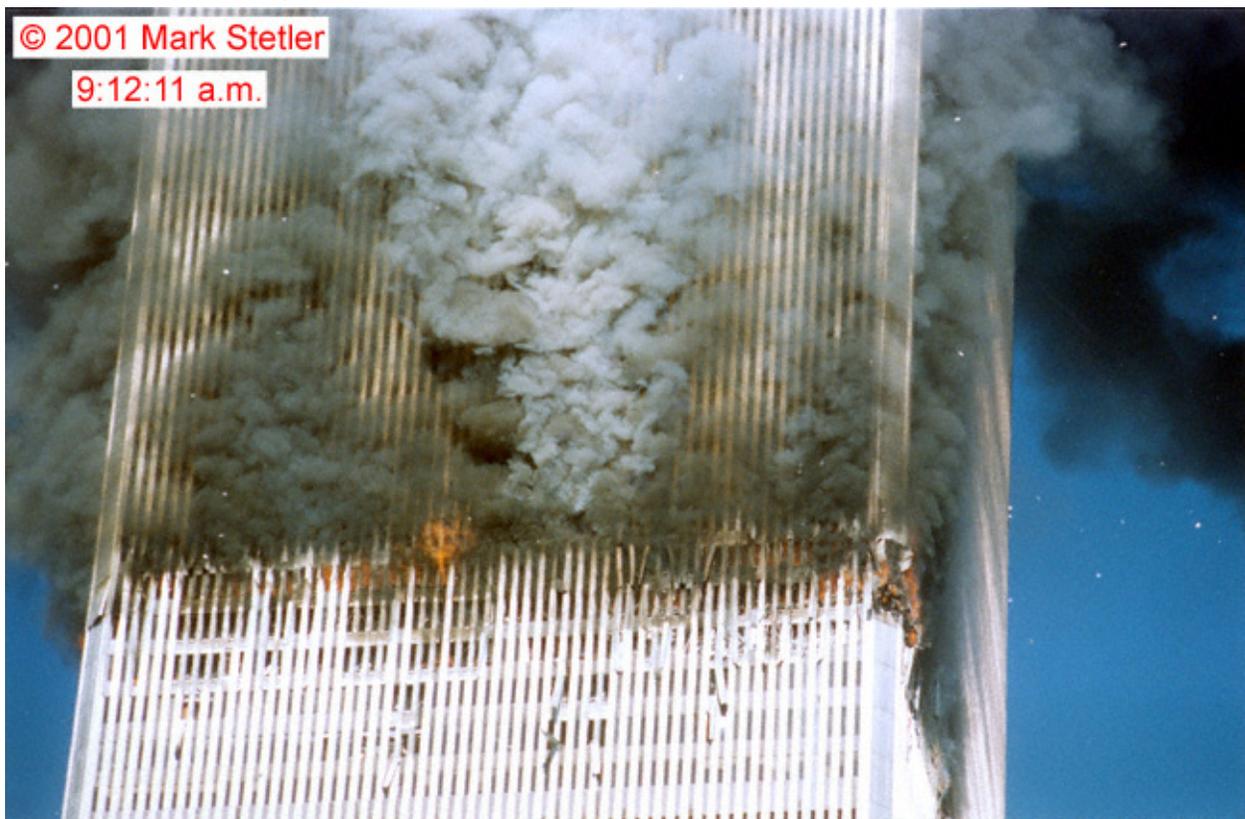
Another photograph of the east face of WTC 2 taken at 9:12:11 a.m. is shown in Figure 9–14. Figure 9–15 includes blowups of the north and south sides of the fire floors from this photograph. Comparison of Figure 9–14 with the similar photograph in Figure 9–6, which was taken just over 5 min earlier, shows that the heavy smoke flows from near the center and closer to the southern edge of the face have continued. In Figure 9–14, it appears as if a portion of the smoke flow near the center may be coming from the 83rd floor. It can also be seen that the fire burning on the southern half of the 81st floor has grown substantially.

Figure 9-14. This photograph showing the east face of WTC 2 was recorded at 9:12:11 a.m.

The fires on the northern edges of the 81st and 82nd floors and in the opening on the northeast corner continue to burn intensely at a level comparable to that seen at 9:12:11 a.m. in Figure 9-14. There is still very little indication of a fire near the southern edge of the 81st floor. A small fire remains on the 80th floor near window 80-335. Heavy flows of smoke continue from the southern side of the 83rd floor and from near the center of the 82nd floor.

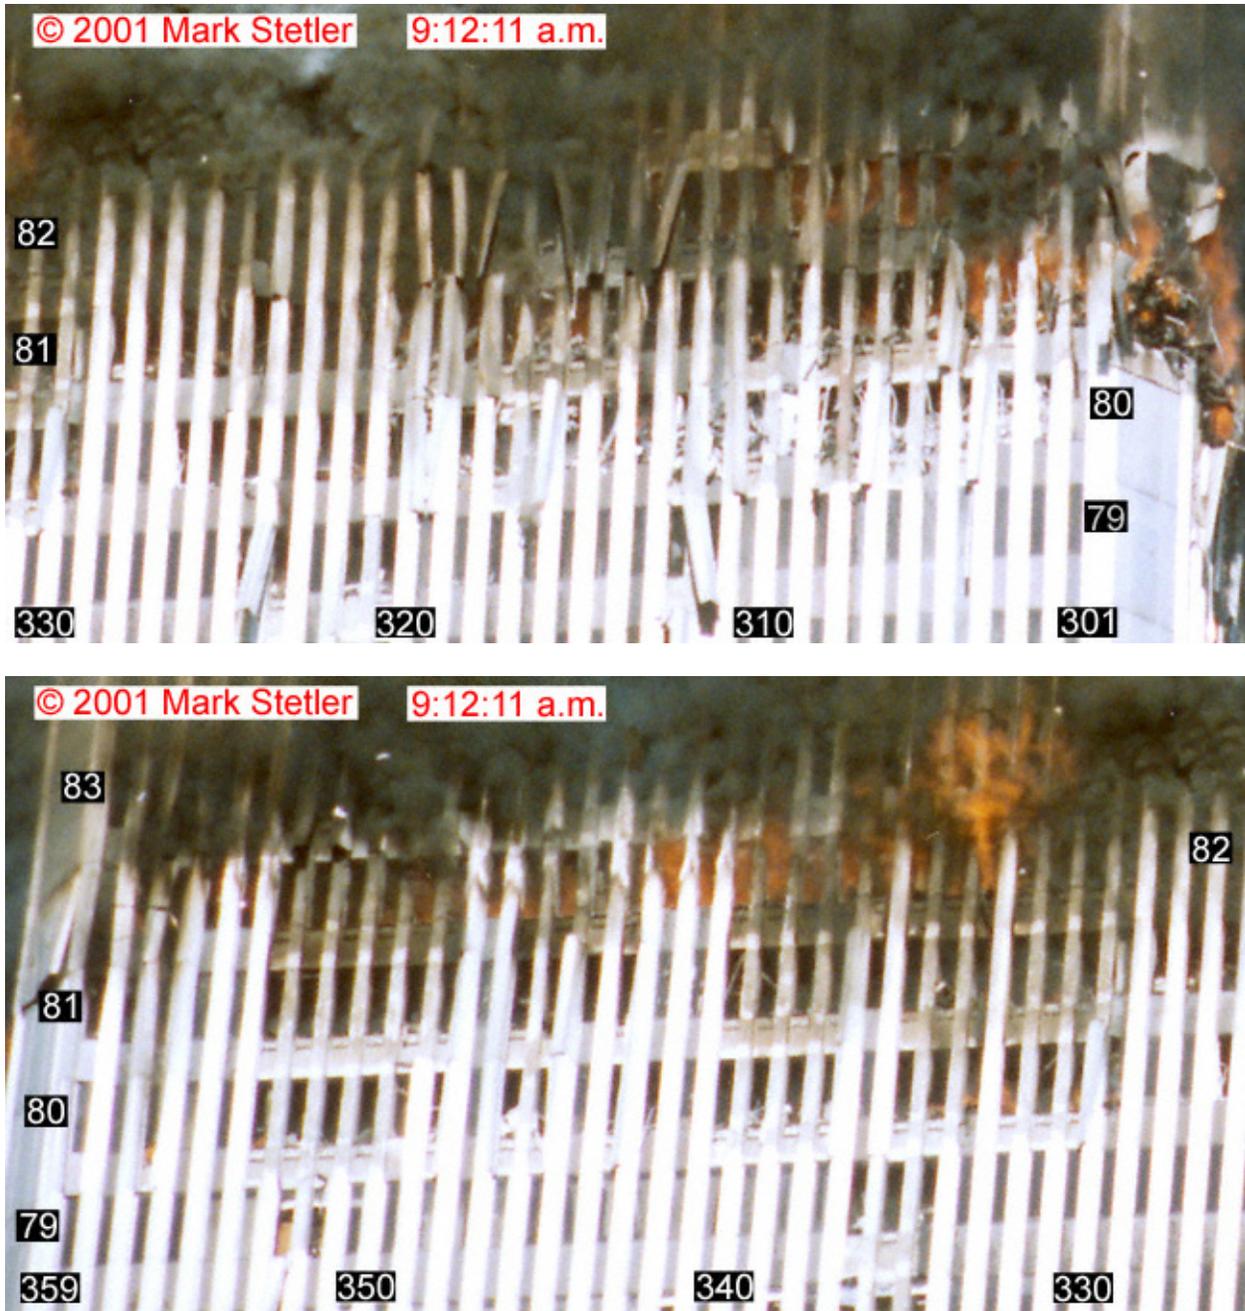
**Figure 9-15.** These two images show blowups of the north and south sides of the east face of WTC 2 taken from the photograph included in Figure 9-14, which was shot at 9:12:11 a.m. Column and floor numbers have been added.

The fire spread during the period is more easily characterized by comparing the blowups of the southern part of the face shown in Figure 9-7 and Figure 9-15. At the earlier time, flames were visible on the 82nd floor in windows 82-341 to 82-349. By 9:12:11 a.m., the flames had spread to cover a length of the floor, running from window 82-332 to window 82-350. At the earlier time, smoke was coming from some of the windows where fire has now appeared. This is likely an indication that growing fires were near these windows at 9:07:04 a.m. As the fires to the north have grown larger, the earlier fires in windows 82-341 to 82-349 have decreased in intensity, as reflected by their external flame lengths. This
