## Chapter 9

# FIRE BEHAVIOR IN WORLD TRADE CENTER 2

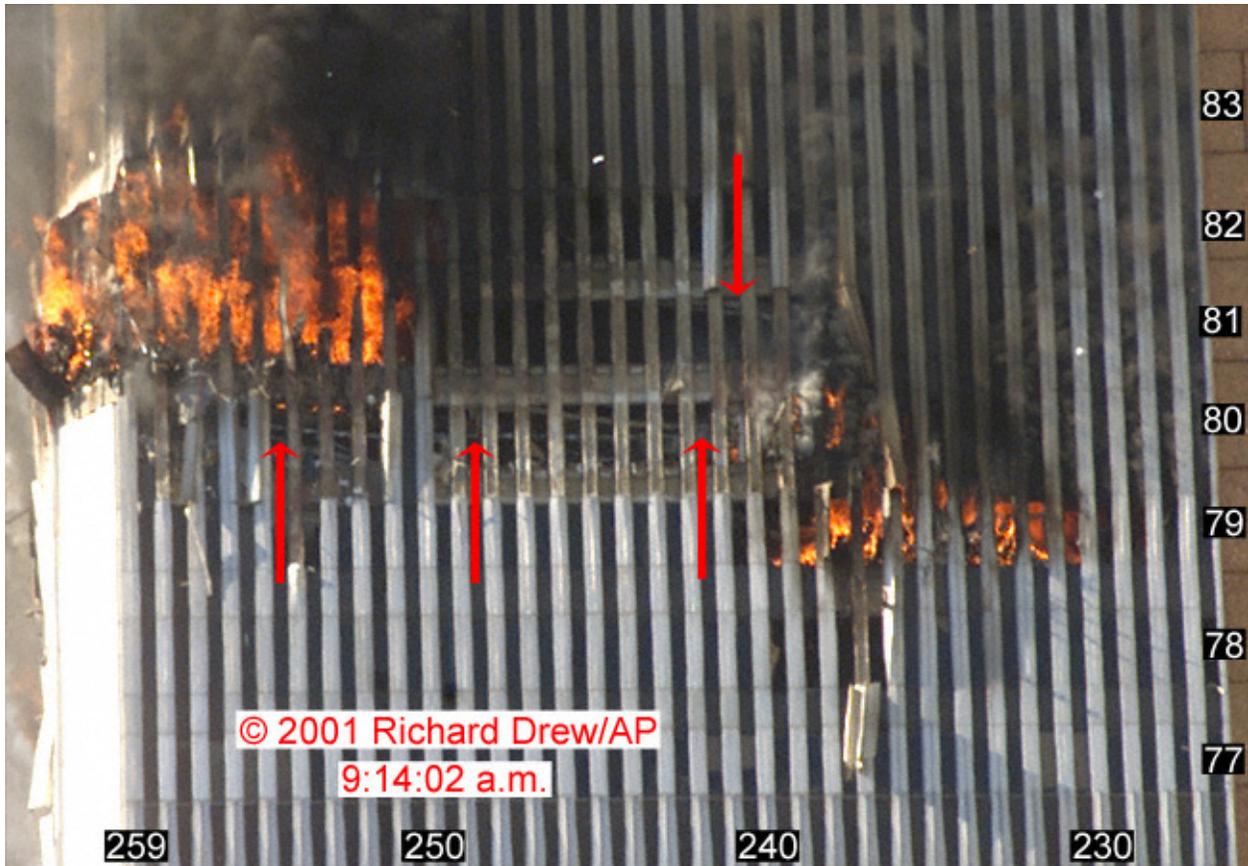
Figure 9-16 shows a close-up view of the north face of WTC 2 taken at 9:14:02 a.m. This is just over 4 min later than the image shown in Figure 9-12. This photograph provides somewhat higher resolution than the earlier image. The arrows point to objects that appear to be hanging across open windows on the 80th and 81st floors. The area of the image containing the arrows is blown up in Figure 9-17.

Even though the later image has higher resolution and shows more detail, a comparison of Figure 9-12 and Figure 9-16 indicates that the locations of the hanging objects identified in Figure 9-12 have not shifted appreciably during the 4 min period between the photographs. There are additional hanging objects resolved in the later photograph (seen most clearly in Figure 9-17) that are not easily identified in Figure 9-12. In addition to the two hanging objects on the 80th floor that were previously described, there is another similar object visible on the 81st floor near the tops of windows 81-239 to 81-242. This hanging object appears to consist of two closely spaced lines. There is yet another object in windows 80-251 to 80-254 that is below the much longer object that is visible hanging across window 80-242 to window 80-256.

In Figure 9-16 and Figure 9-17, small fires are visible above the longest hanging object seen through windows on the 80th floor at the tops of window 80-248 and windows 80-252 to 80-254, again suggesting that fuel located on top of the hanging objects is burning. The large fires nearest the eastern edge on the 81st and 82nd floors and in the opening on the northeast corner continue to burn intensely in the same windows as earlier. In Figure 9-16, it appears as if a fire is burning on the 83rd floor in window 83-257, but it is possible that these flames are an extension from the large fire on the 82nd floor. There is evidence in the photograph for strong heating of the façade at the base of the 83rd floor in this area. The lower portions of the aluminum covers on columns 83-256 to 83-259 are missing, and the bottom edges of the remaining aluminum have an inverted “v” shape. These observations indicate that these aluminum column covers have been melted by the intense heat coming from below.

**Figure 9-16.** This close-up image of the north face of WTC 2 was taken at 9:14:02 a.m. The original photograph has been cropped and rotated, and the intensity levels have been adjusted. Column and floor numbers have been added. The arrows highlight hanging objects observed through open windows on the 80th and 81st floors. The brown area to the right is the eastern edge of WTC 7.

Most of the cold spot continues to be smoke and fire free. In the lower right-hand corner of the area a small fire is now visible on the 80th floor in windows 80-238 to 80-240, burning on a debris pile. The image in Figure 9-16 has sufficient resolution to determine the condition of windows. All of the windows on the 83rd floor immediately above the cold spot have glass in place while windows 79-241 to 79-249 on the 79th floor below the spot were also closed at this time.

The debris pile on the 79th floor continues to burn vigorously. Comparison of Figure 9-12 and Figure 9-16 shows that flame lengths are decreasing slowly. This fire is visible in the same windows as earlier and does not appear to be spreading in either direction along the north side of the building.

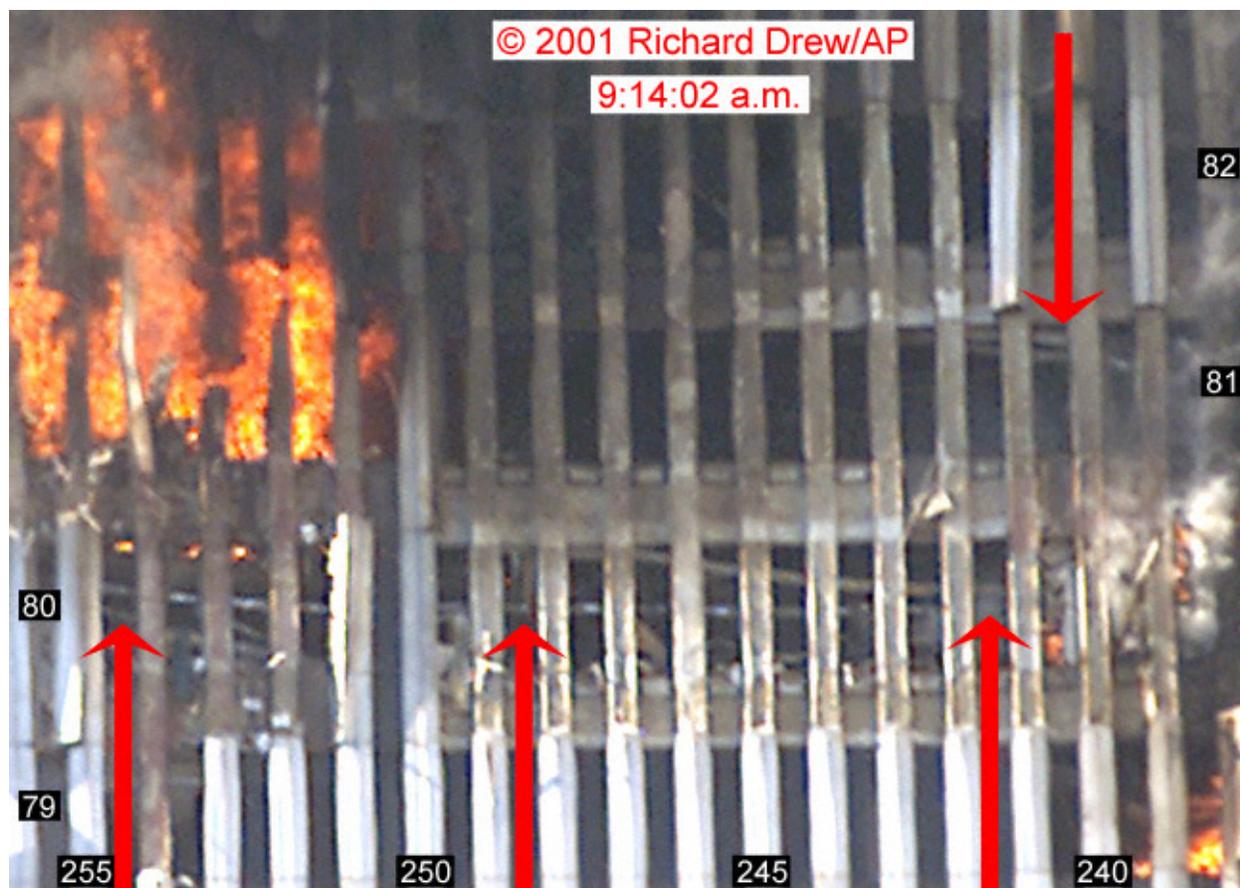
**Figure 9-17. A section of the image shown in Figure 9-16 is blown up. The arrows point to the locations of hanging objects that are visible through open windows on the 80th and 81st floors on the north side of WTC 2.**

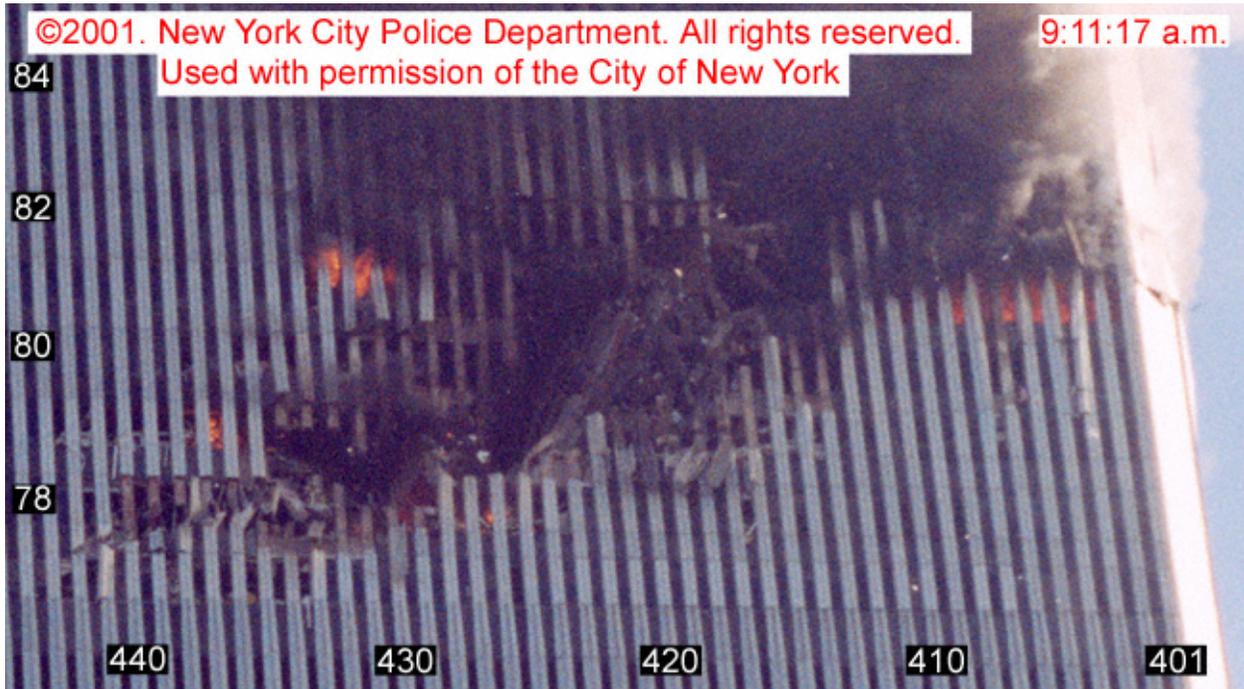
A view of the south face of WTC 2 at 9:11:17 a.m. is shown in Figure 9-18. It was taken approximately 4 min after the images shown in Figure 9-10 and Figure 9-11. During this time a large fire has appeared on the 81st floor to the east of the aircraft impact cavity. Flames are now visible on this floor in windows 81-401 to 81-409, and heavy smoke is coming from the area. Given the apparent intensity of this fire, it is noteworthy that there continues to be no indication of a fire, i.e., smoke and/or flame, from adjacent windows on the east face at this time. Figure 9-15, which was taken nearly a minute later, shows that this is the case.

Comparison of Figure 9-10 and Figure 9-18 indicates that the fires ignited at other locations within and immediately adjacent to the aircraft impact cavity have continued to grow and spread slowly. At the earlier time, the glass in window 81-431 appeared to be intact, while in Figure 9-18 flames are coming from this window and are visible in window 81-432 as well. The appearance of the fire burning on the debris pile located at the western edge of the aircraft impact cavity on the 79th floor is similar to that seen earlier, while the fire on the 78th floor seems to be slowly spreading across debris piled within the cavity.

**Figure 9-18. This cropped photograph shows the south face of WTC 2 at 9:11:17 a.m. The image has been rotated and enhanced by adjusting the intensity levels. Column and floor numbers have been added.**

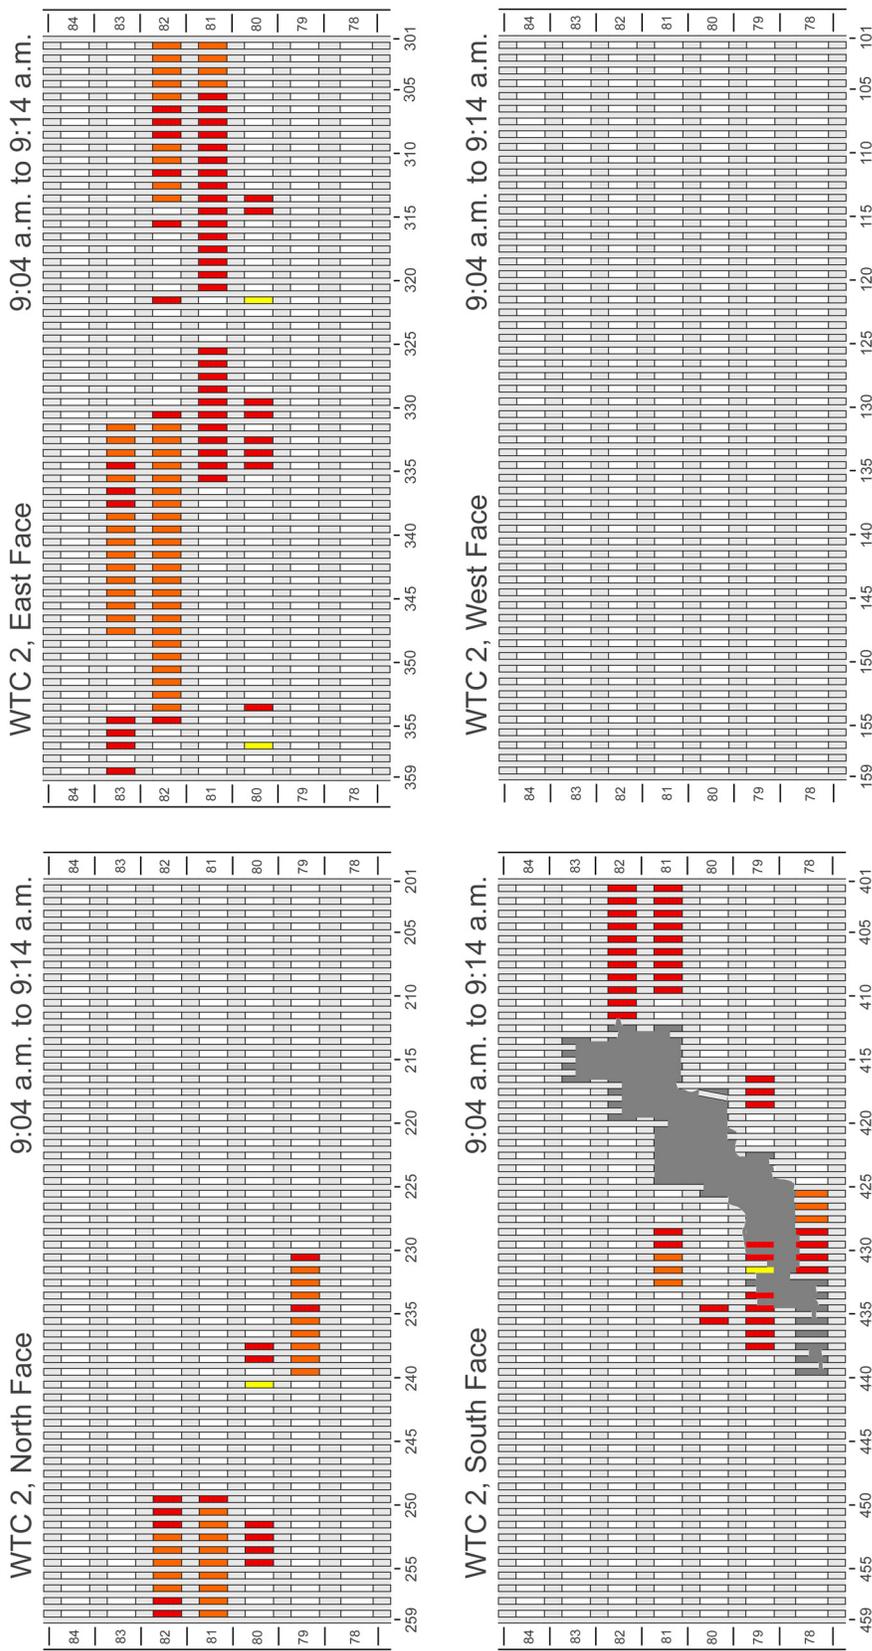
Major observations concerning the fire behavior in WTC 2 during the initial twelve minutes following the aircraft impact are summarized here. The datasheets for the fires have been integrated by identifying the most intense fire observed in a given window during the period. The results are shown graphically in Figure 9-19 for the four faces of WTC 2. The same cautions concerning datasheet accuracy apply as discussed in the preceding chapter with regard to WTC 1. Nevertheless, Figure 9-19 should prove

On the north face large fires were initially ignited on the eastern edges of the 81st and 82nd floors and at a location more toward the center on the 79th floor. On the 79th and 81st floors these fire were burning on large piles of debris located just inside the façade. These fires continued to burn intensely during the entire period. There was little indication of fire spread or additional growth. Little smoke and flame were observed in an area of the façade, covering the 80th, 81st, and 82nd floors and extending from column 238 to column 250, lying between the fires on the 81st and 82nd floors and the fire on the 79th floor. This area is referred to as the cold spot.

Immediately following the aircraft impact, extensive fires were visible on the east face over the northern halves of the 81st and 82nd floors and on the southern portion of the 83rd floor. An intense fire was also burning within the debris-filled opening created in the northeast corners of the 81st and 82nd floors by the aircraft impact. Smaller isolated fires were present on the 80th floor. The fire on the southern side of the 83rd floor died down rapidly, while a large fire appeared and rapidly grew on this side of the 82nd floor. The fires on the northern ends of the 81st and 82nd floors and in the northeast corner continued to burn vigorously during the entire period. Only small fires were visible on lower floors.

**Figure 9-19. Maps of integrated fire observations between 9:04 a.m. and 9:14 a.m. are shown for the four faces of WTC 2. Colors represent the highest intensity fire observed in a window using the color scale defined in Figure 5-1.**

Several small fires were visible on the south face shortly following the aircraft impact. These fires were located within the aircraft impact cavity and immediate adjacent areas. During the period considered here, these fires spread and grew relatively slowly. The only visible area of extensive fire spread was on the eastern side of the 81st floor, where a large fire grew between 9:07 a.m. and 9:11 a.m., and immediately above on the 82nd floor, where a fire was observed just prior to 9:15 a.m., after the fire on the 81st floor had died down.

No flames or fire were evident on the west face of WTC 2 for over seven minutes following the aircraft impact. After this time, a flow of smoke appeared well above the fire floors. This observation has been attributed to windows being broken open by people.

With the exception of the fire burning on a debris pile near the center of the north face and a small fire on the south face, there were no indications of extensive fires on the 79th floor during the period. This is somewhat unexpected since the analysis in Chapter 7 suggested that much of the aviation fuel from the aircraft's port tank was dispersed on this floor, and widespread ignitions might have been expected.

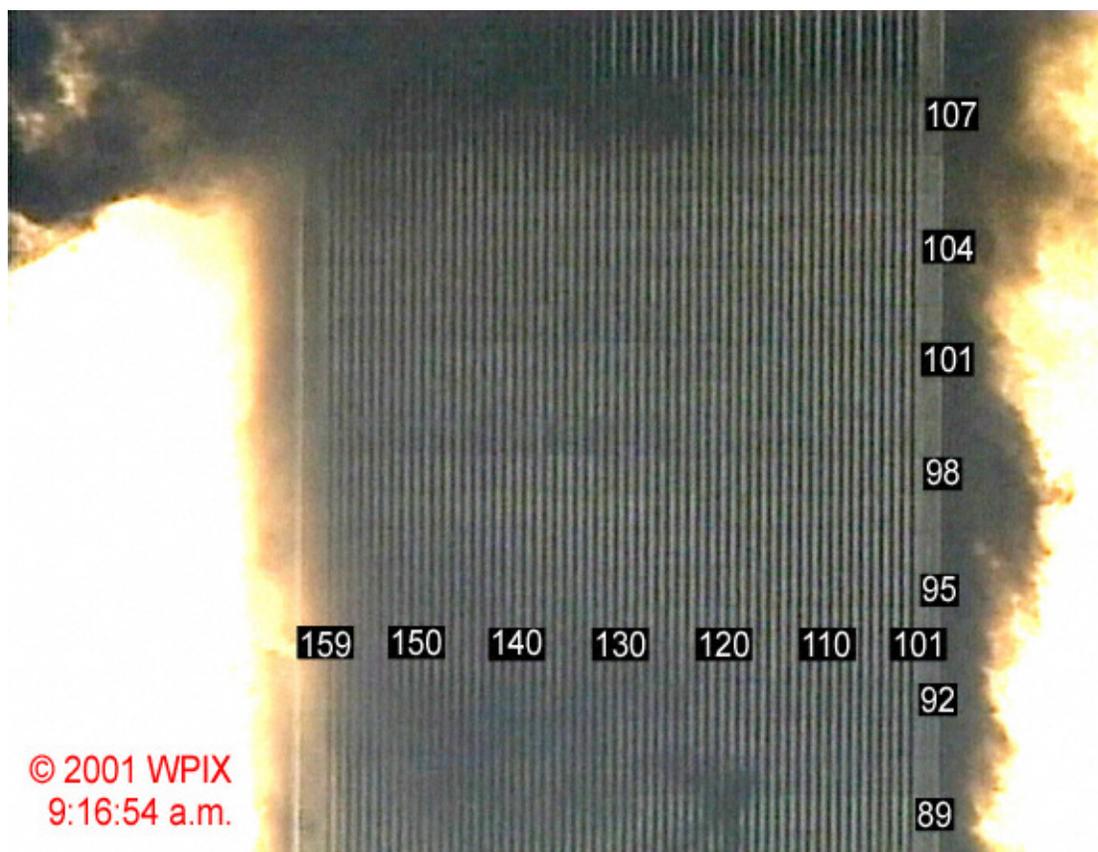
The observations from the video indicate that several additional windows located on the 86th floor had broken out since 9:10:29 a.m. It also appears that heavy smoke had traveled to the top of the tower, and people on the 107th floor broke out windows.

**Figure 9-20.** This image of the west face of WTC 2 was captured from a video shot from a news helicopter at 9:16:54 a.m. It has been enhanced by adjusting the intensity levels, and bright areas to the right and left of the tower are saturated. Column and floor numbers have been added.

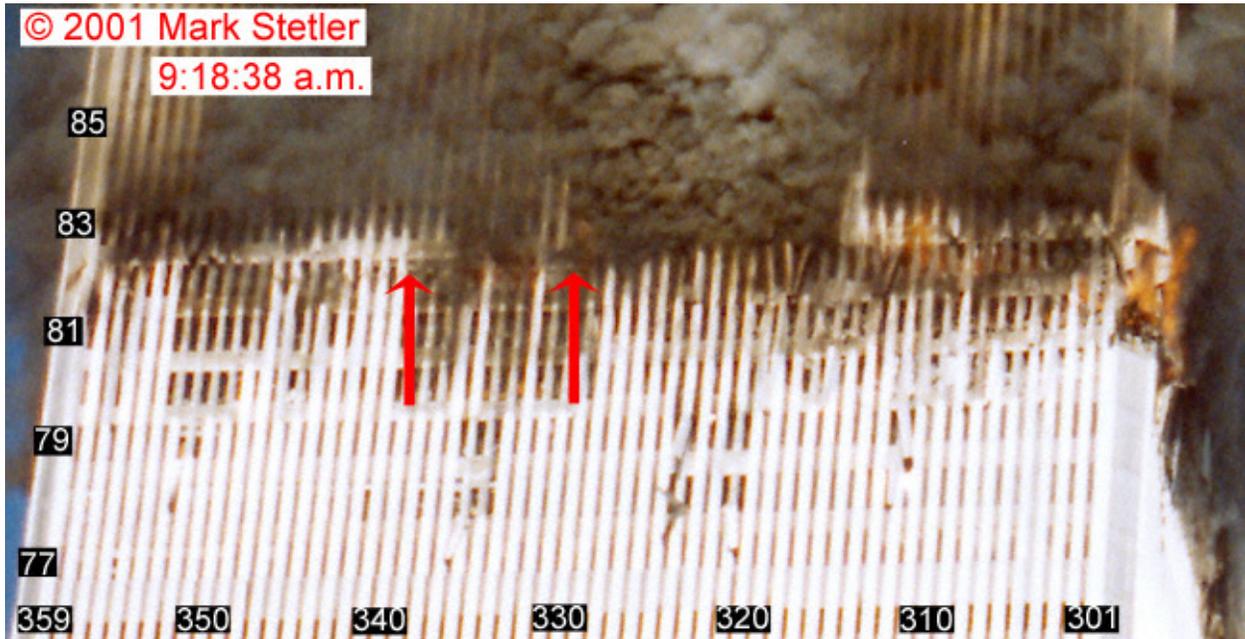
A photograph of the east face of WTC 2 at 9:18:38 a.m. is shown in Figure 9–21. It was taken almost 6½ min after the photograph reproduced in Figure 9–14 and Figure 9–15. Comparison with the earlier images indicates that the fire burning on the southern side of the 82nd floor has subsided during the intervening time. At the earlier time, intense flames completely filled windows 82-333 to 82-342 and hid the hanging object that had been visible in this area shortly after the aircraft impact. As indicated by the arrows added to Figure 9–21, the object was once again visible at 9:18:38 a.m. A review of photographs and videos recorded during the intervening period indicated that the view of this area had gradually

The hanging object on the 81st floor is now visible through windows 81-331 to 81-335 and windows 81-338 to 81-342. Windows further to the north remain obscured. Comparison of the location of the object with the image reproduced in Figure 9-1 and Figure 9-2, which was recorded at 9:03:42 a.m., shows that the object is at roughly the same height in the windows and has a similar shape.

The fires on the northern edges of the 81st and 82nd floors and in the opening on the northeast corner continue to burn intensely at a level comparable to that seen at 9:12:11 a.m. in Figure 9-14. There is still very little indication of a fire near the southern edge of the 81st floor. A small fire remains on the 80th floor near window 80-335. Heavy flows of smoke continue from the southern side of the 83rd floor and from near the center of the 82nd floor.

In the photograph taken at 9:18:38 a.m. there is no indication of significant smoke flow on the east face from windows lower than the 82nd floor. This was generally true around this time, but was not always the case. Starting around 9:12:45 a.m. a series of short-lived, apparently coordinated smoke releases were observed in which smoke was pushed out of multiple open windows on the 79th, 80th, and 81st floors.

**Figure 9-21. View of the east face of WTC 2 recorded at 9:18:38 a.m. The original photograph has been cropped and enhanced by adjusting intensity levels. Column and floor numbers have been added. The arrows highlight a hanging object observed through open windows on the 82nd floor.**

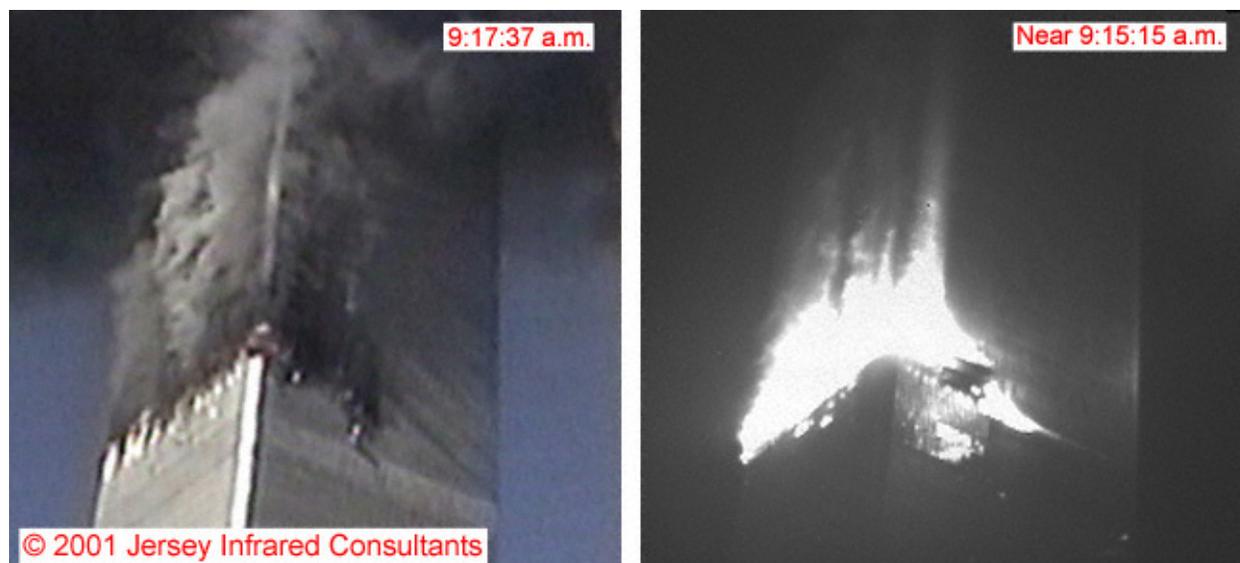
The most striking feature in the infrared image shown in Figure 9–22 is the dark region between the two bright areas on the north face. The low level of infrared emission coming from the dark region indicates that the temperature of this portion of the facade is close to the outside ambient temperature. By comparing the infrared image with normal images of the north face, such as that shown in Figure 9–16, it can be seen that the unheated region is located in the same area of the face that has been identified as the cold spot. It is clear that not only is the cold spot mostly free of smoke and fire, but that it is very nearly at room temperature, despite the presence of nearby fires on either side. The area is indeed a “cold spot” relative to its immediate surroundings.

Figure 9-22. This figure compares an infrared photograph (on the right) and an image of WTC 2 captured from a video that was shot from the same vantage point and scaled and oriented to match the infrared shot. The north and east faces of the tower are visible. The video frame was shot at 9:17:37 a.m., and the infrared image was taken around 9:15:15 a.m. (an uncertainty of 15 s has been assigned).

The cold spot does not appear to have a completely rectangular shape in Figure 9–22. There is a slightly heated area at the upper left corner that is most likely due to the flames on the 82nd floor that are visible in window 82-249 in Figure 9–16. Similarly, there is small heated region in the lower right corner on the 80th floor that is most likely associated with the small fire burning on the debris pile in window 80-241.

By using the heated areas within the cold spot as markers, it is possible to correlate other parts of the infrared image with Figure 9–16. The bright area below and to the west of the cold spot is the fire visible over many windows on the 79th floor. The narrow lighter line that extends westward from the brightest region indicates that heat is being transported across the floor, even though imagery indicates that these windows were still in place in the area. Similar heating is also apparent on this floor below the cold spot. A narrower bright region above the 79th floor reflects the fire burning on the pile of debris on the 80th floor that can be seen in Figure 9–16.

Individual open windows to the left of the cold spot on the 80th floor appear as points of light, indicating that some hot gases are likely flowing through the openings. The image is saturated immediately above these openings due to the intense fires burning on the 81st and 82nd floors. Interestingly, there also appears to be significant heating above the cold spot on the 83rd floor. In Figure 9–16 the windows on this part of the 83rd floor appear to have glass in place, suggesting that heat is being transported to this location from elsewhere on the floor. Finally, there is a bright region on the north face that is located well below those discussed thus far. Comparison with the video frame in Figure 9–22 indicates this heat source is located at the mechanical floors, i.e., the 75th and 76th floors. Apparently, this area was either heated earlier by the smoke and dust observed coming from these floors (see the discussion in Chapter 7), or heated gases are still being released from the mechanical floors.

The heated area on the mechanical equipment room floors is at a location where there is an exhaust spill louver for the ventilation system on the 76th floor between columns 242 and 258 (see the ventilation diagram in Figure A-6 in Appendix A). The heated area appears to cover roughly half of the length of the spill louver on the west side. Most of the heating seems to be on the 76th floor, but there is also evidence for heating at the 75th floor level. The amount of air allowed to pass through the spill louvers was varied depending on conditions. It is possible that a portion of the louvers were closed on September 11, 2001, which could explain the heat distribution. The presence of heating on the mechanical equipment room floors suggests that the exhaust ventilation system may possibly have continued to operate after the aircraft impacted WTC 2.

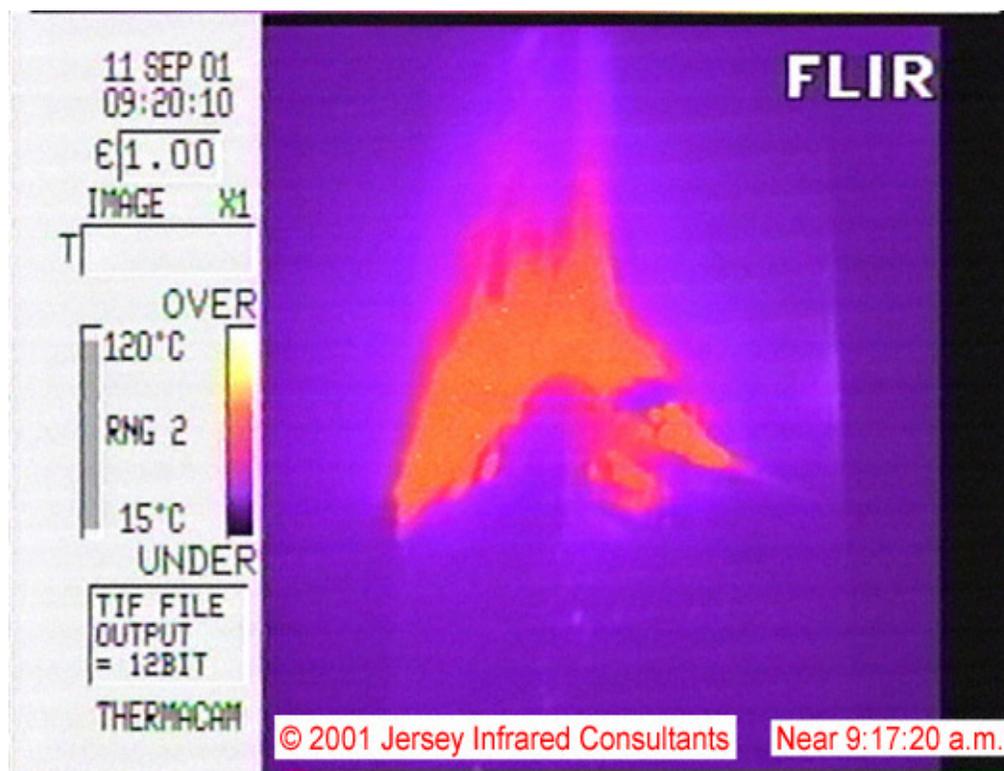
Figure 9–22 and Figure 9–23 include infrared images of WTC 2 that were shot around 9:15:15 a.m. and 9:17:20 a.m., respectively, from northeast of the WTC site. Time uncertainties are estimated as 15 s. Figure 9–22 also includes a frame taken from a standard video that was shot from the same vantage point at 9:17:37 a.m. The size and orientation of the video frame has been adjusted to match the infrared photograph, allowing relative locations on the infrared photograph to be identified. The image in Figure 9–23 was created by connecting the output of the infrared camera to the input of a standard video camera. The infrared camera was set to output a false-color scale for temperature, unlike the grey scale used for the image in Figure 9–22. Recall from the discussion in Section 8.1 that the temperature scales for the infrared images are not quantitative and that they provide only a relative indication of the amount of heating at a given location. Much of the heated area is saturated in the infrared images.

Figure 9-23. This image shows a frame from the false-color output of an infrared camera that was connected to a standard video camera. The time was around 9:17:20 a.m. (an uncertainty of 15 s is assigned). Blue represents the coolest temperatures and red the warmest temperatures.

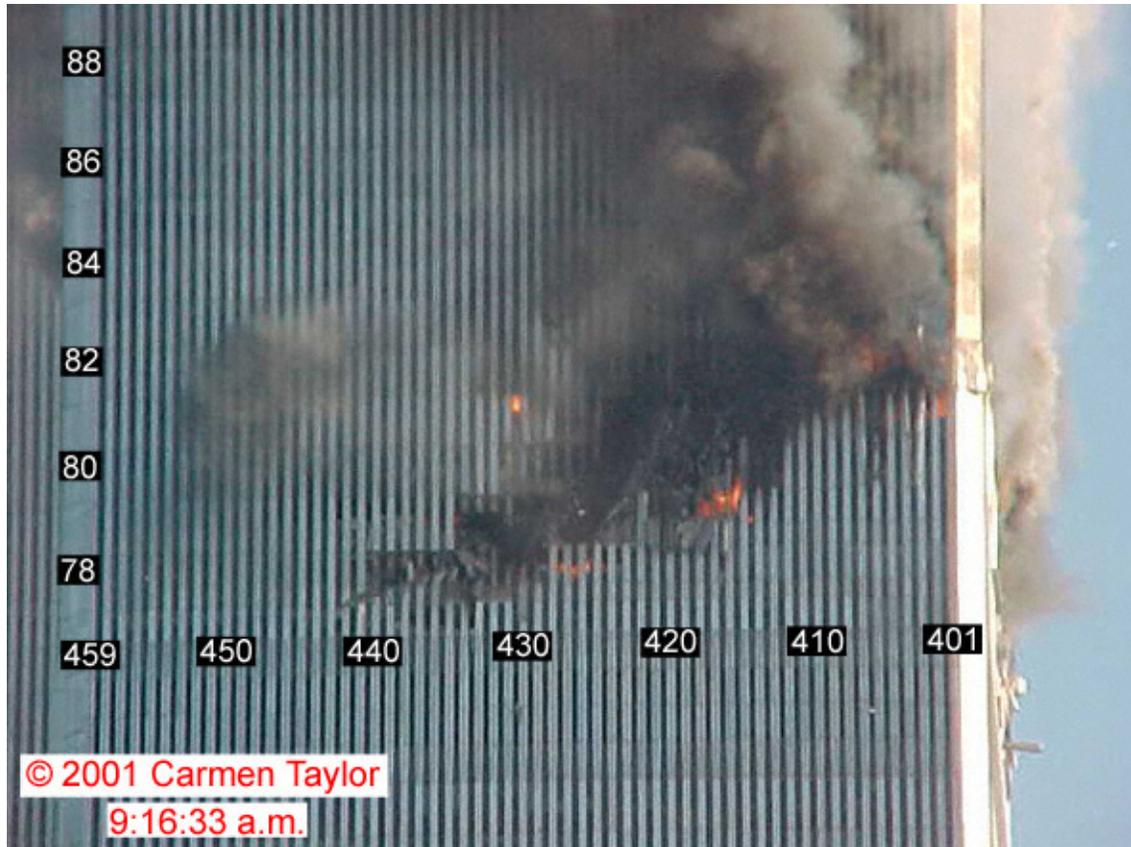
Figure 9-25. This photograph shows the south face of WTC 2 at 9:16:33 a.m. The south face of WTC 1 is visible to the left of the western edge of WTC 2. Column and floor numbers have been added.

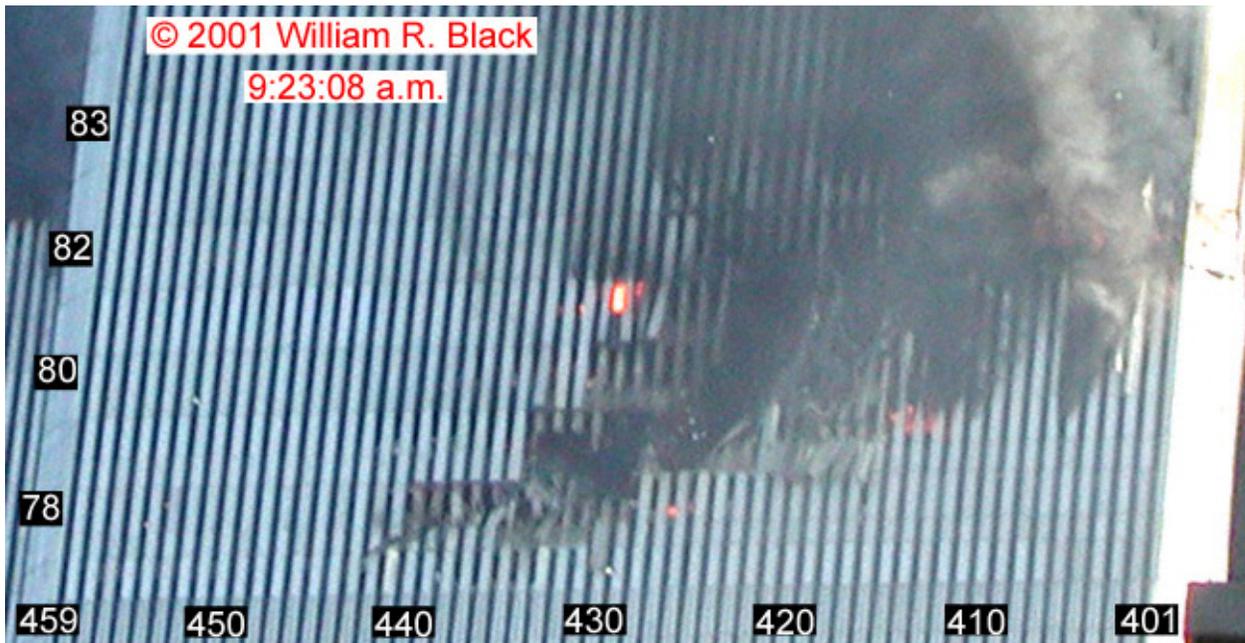
A later view of the south face taken at 9:23:08 a.m. is shown in Figure 9–26. During the nearly seven minutes since Figure 9–25 was shot, the fire that had appeared on the east side of the aircraft impact cavity on the 79th floor has grown and spread toward the east. The most intense flames are now observed in windows 79-413 to 79-415, and heavy smoke is coming from windows 79-411 and 79-412. At the earlier time flames were coming out of windows 79-415 to 79-417, and heavy smoke was coming from windows 79-412 to 79-414. A heavy smoke flow is also coming from window 79-406 at the later time.

The fires on the east sides of the 81st and 82nd floors have similar appearances in the two photographs. The same is true for the lower intensity fire burning on the 78th floor just to the east of aircraft impact cavity. The small fire to the west of the aircraft impact cavity on this floor is still, just barely, visible. The fire higher up on the 81st floor has grown brighter and now extends over windows 81-429 to 81-433. Comparison with Figure 9–10 and Figure 9–18, which were shot at 9:06:31 a.m. and 9:11:17 a.m., respectively, indicates that this fire has not spread significantly, but that its intensity seems to fluctuate with time.

Figure 9-26. This cropped photograph shows the south face of WTC 2 at 9:23:08 a.m. The image has been rotated and enhanced by adjusting the intensity levels. Column and floor numbers have been added.

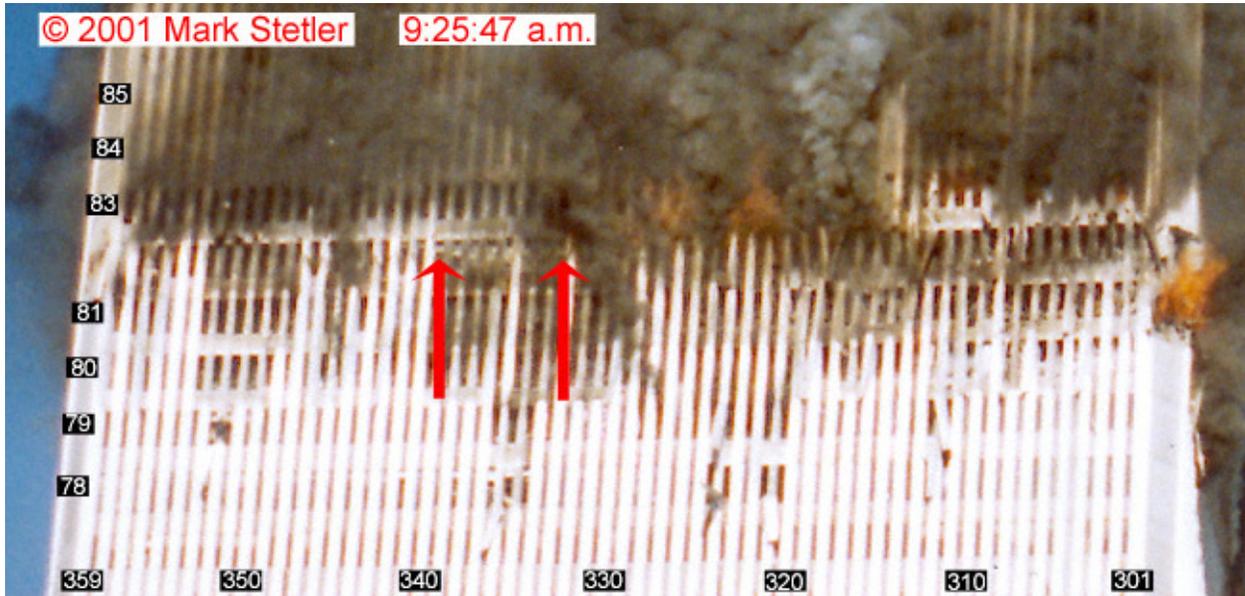
A photograph of the east face of WTC 2 at 9:25:47 a.m. is shown in Figure 9–27. This image was taken 7 min and 9 s later than the similar photograph reproduced in Figure 9–21. Arrows added to the figure indicate the hanging object observed earlier through windows on the 82nd floor. Its appearance has changed substantially from earlier times (compare with Figure 9–1, Figure 9–2, and Figure 9–21). In the vicinity of window 82-336, it is now visible lower down in the open windows. The hanging object no longer has the appearance of a thin line, but now looks like a curved sheet since the top of the object has been revealed. On either side of the dip the object remains high in the windows and still has the appearance of a line.

**Figure 9-27. View of the east face of WTC 2 recorded at 9:25:47 a.m. The original photograph has been cropped and enhanced by adjusting intensity levels. Column and floor numbers have been added. The arrows highlight a hanging object (floor slab) observed through open windows on the 82nd floor.**

By comparing Figure 9–6, Figure 9–14, and Figure 9–21 with Figure 9–27, it is apparent that the fire that grew on the south side of the east face on the 82nd floor shortly after the aircraft impact has continued spreading to the north. Intense flames are now coming from windows 82-321 to 82-329, while the fires have died down in windows further to the south. Heavy smoke is coming from windows as far north as window 82-316.

The fire distributions also changed at other locations on the east face between the times when Figure 9–21 and Figure 9–27 were taken. At the earlier time there was a large fire visible on the 82nd floor in windows 82-305 to 82-312 on the north side. By 9:25:47 a.m. this fire appears to have died down, and flames are no longer evident in this area. A flaming region is now present immediately above on the 83rd floor. Flames are visible on this floor in windows 83-302 to 83-312. In the earlier photograph heavy smoke was coming from these windows, but flames were not as evident. The fire burning in the northeast corner of the 81st floor appears to have decreased somewhat in intensity during the period. The heaviest flames are now coming primarily from the opening on the northeast corner of this floor. Even in this area, the flame lengths have decreased somewhat. It is now possible to barely discern the corner column 82-300, which is still in place, through the opening on the 82nd floor.

In Figure 9–27, the heaviest smoke is coming from windows on the 82nd and 83rd floors, and the lower floors are visible. A smoke plume is flowing from one of the windows, 79-227, on the 79th floor where there appears to be some flame visible, and light smoke can be seen exiting from a few other windows on the lower floors. Nevertheless, the general impression is that of little smoke flowing from floors lower than the 82nd. As mentioned above, this conclusion is somewhat misleading since brief periods of smoke release from lower floors had been observed starting before 9:13 a.m. Review of videos and photographs showed that these smoke releases increased in both frequency and the amount of smoke released as time progressed.

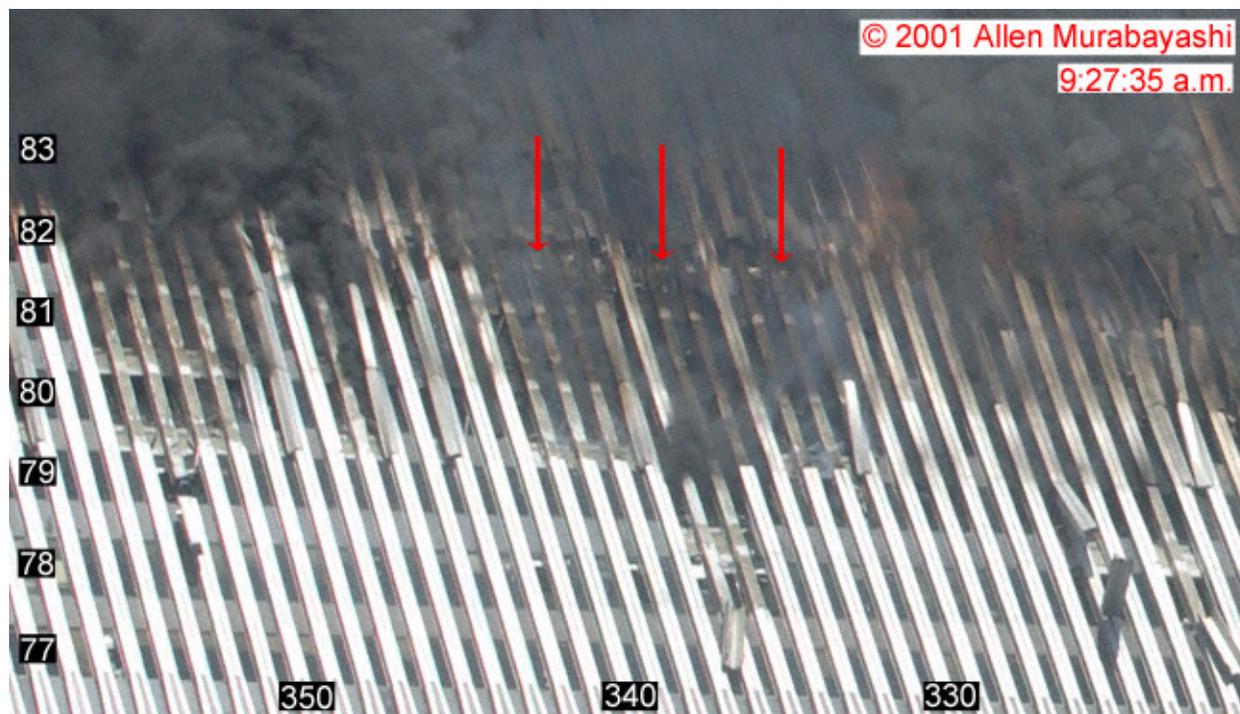
Another view of this object, shot from a different angle, is shown in Figure 9–28. This photograph was taken from a location on a nearby street to the southeast of the tower. As a result, the photograph is looking up at the hanging object from below. The arrows indicate the object. An enlarged view of the area with the object is shown in Figure 9–29. From this angle the object also has a sheet-like appearance, but, unlike in Figure 9–27, the underside of the object is in view. This is most easily seen in window 82-332. The sheet-like structure of the object is that which would be expected if the hanging object were a portion of the 83rd floor slab that, after having been dislodged from the east perimeter wall, had settled down further below the open windows on the 82nd floor. This closer view shows that the object was visible as far south as window 82-342 at this time. At earlier times the object was visible further to the north than in Figure 9–27, but these windows remain hidden by dark smoke.

Figure 9-28. This cropped photograph shows the east face of WTC 2 at 9:27:35 a.m. The original image has been rotated, and column and floor numbers have been added. The arrows highlight a hanging object observed through open windows on the 82nd floor.

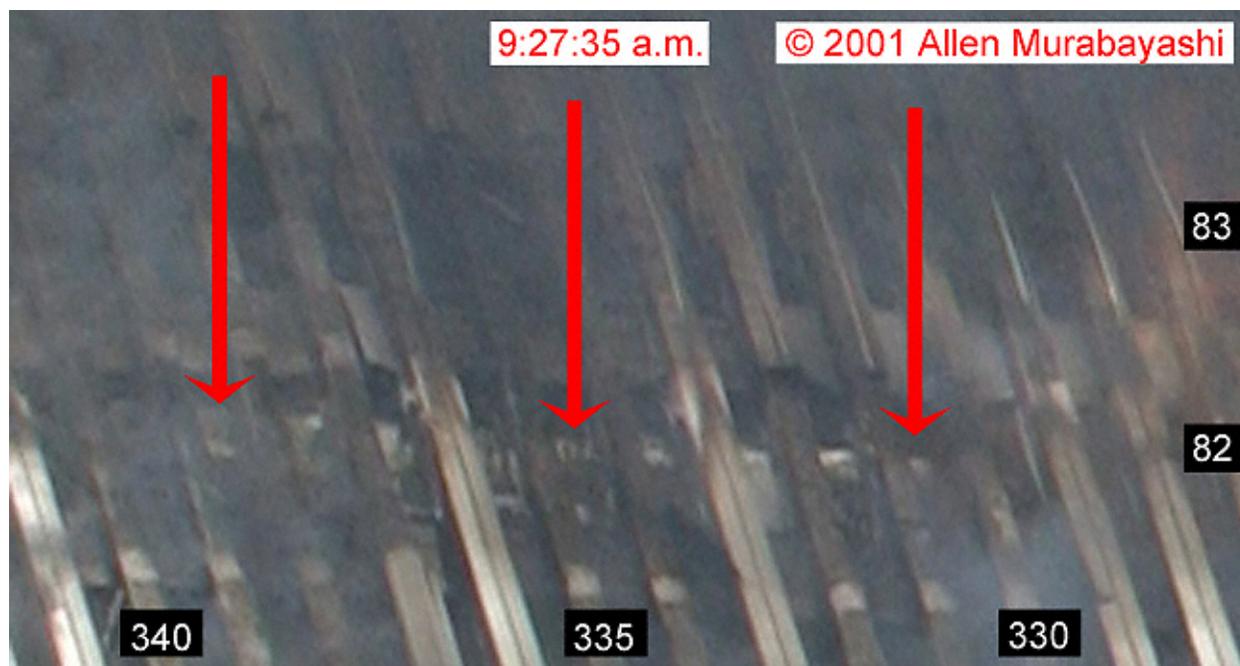
Figure 9-29. This image is an enlargement of a portion of Figure 9–28 showing the east face of WTC 2, where a hanging object is visible through open windows on the 82nd floor. Column numbers have been added.

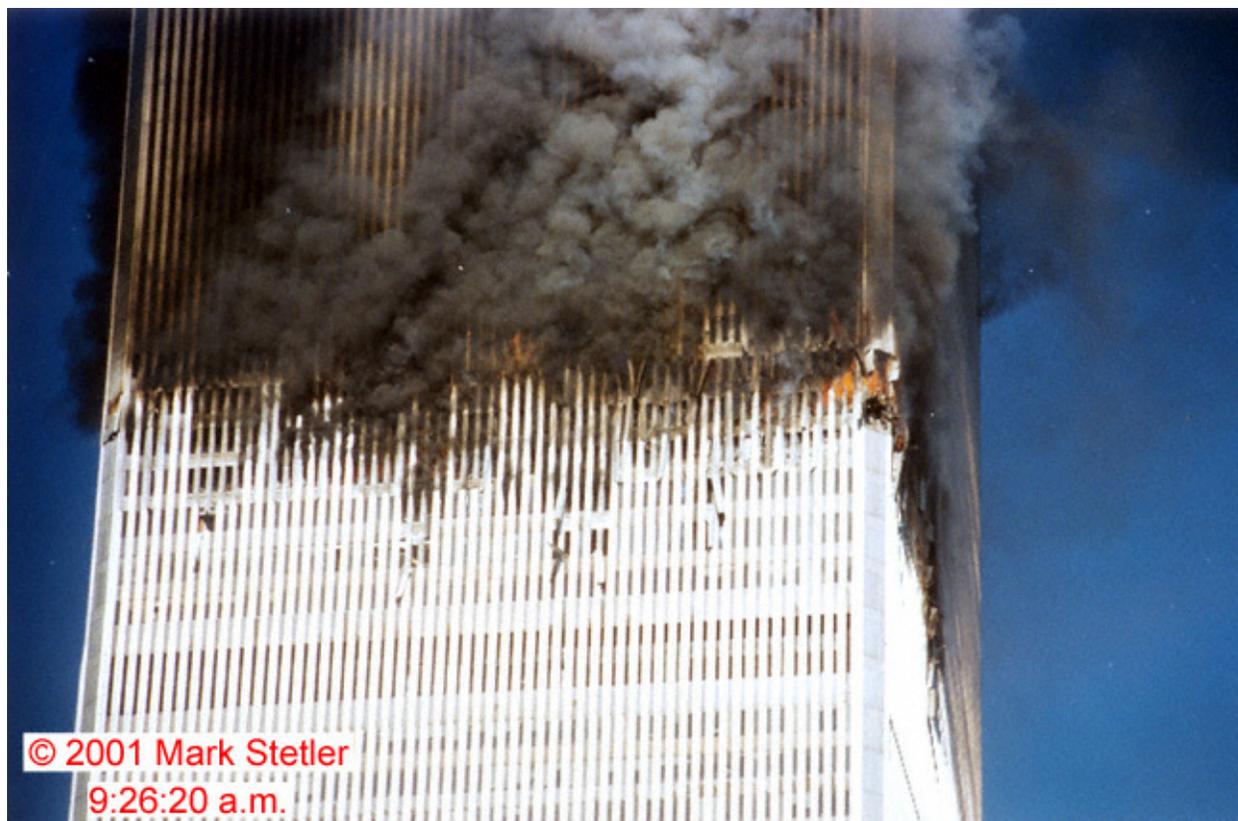
Comparison of Figure 9–27 with Figure 9–30 and Figure 9–31 provides an indication of how quickly the appearance of the east face could change during the smoke release events. In Figure 9–30 heavy smoke almost completely obscures the hanging object seen clearly less than a minute earlier through the 82nd floor windows. This smoke had been pushed out of open windows on the 79th through 82nd floors. In the blowup of the south side of the face in Figure 9–31, the hanging object is just visible at the tops of windows 82-329 through 82-333, as indicated by the arrow placed on the lower image in Figure 9–31. A small fire is visible at the top of window 82-229 above the object.

**Figure 9-30.** This photograph showing the east face of WTC 2 was taken at 9:26:20 a.m.

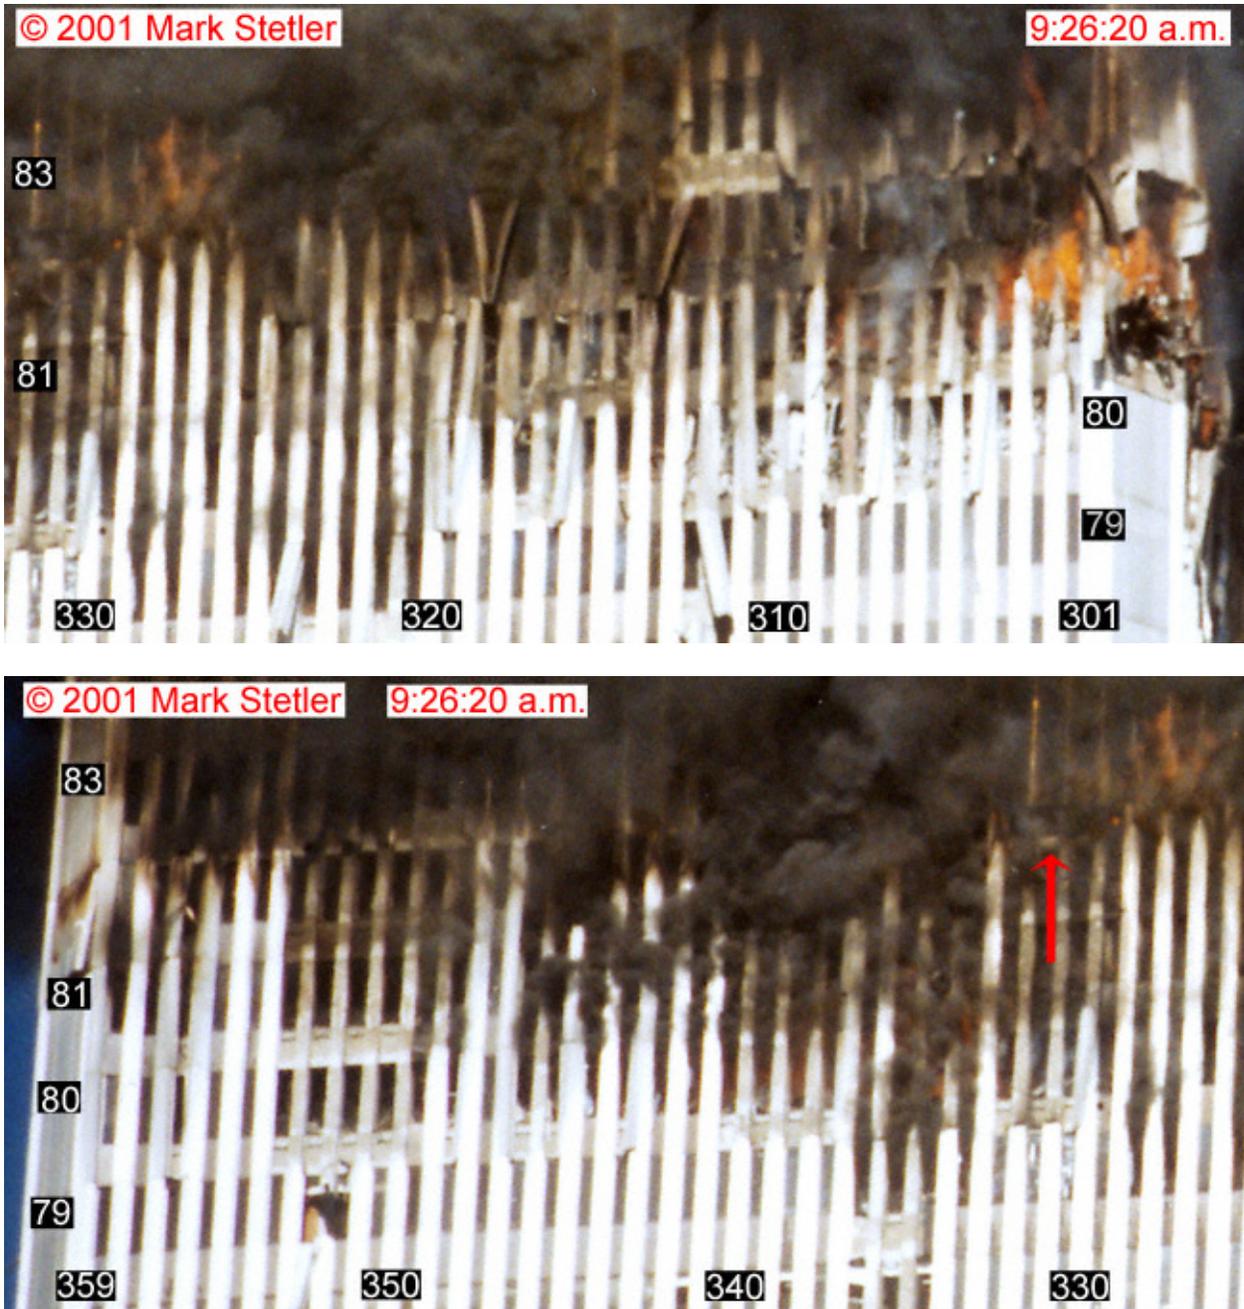
In this photograph (see lower image in Figure 9–31) the heaviest smoke flow on the 79th floor is from windows 79-333 to 79-336, but lighter smoke is also flowing from windows 79-320 to 79-325, 79-327, and 79-328. The glass is still in place for the intermediate windows where no smoke is observed, as well as on either side of windows 79-320 and 79-336. A long-distance video of the smoke release indicates that the relative density of smoke flowing from these windows varied rapidly with time and location and that heavy smoke was pushed from the other open windows during a portion of this release.

In Figure 9–31 smoke is also coming from open windows at the southern end of the east face on the 80th, 81st, and 82nd floors. Unlike on the 79th floor, flames as well as smoke are visible on the 80th floor in windows 80-333 to 80-340. Fire was present in this vicinity as early as 9:07:04 a.m. (see Figure 9–7). It has apparently grown slowly during the intervening 20 min. A small fire is also visible in window 81-335 on the 81st floor.

The heavy flames coming from windows 82-321 to 82-329 on the 82nd floor 33 s earlier in Figure 9–27 have retreated back into the windows. In Figure 9–31 extended flames are only visible in windows 82-326 and 82-327. The intense fire on the northern edge of the 83rd floor in Figure 9–27 has also died down. In particular, the flames that filled windows 83-310 to 82-312 earlier appear to have completely dissipated in Figure 9–31. The appearance of the fire burning on the northeast corner of the 81st floor has also changed. At the earlier time large flames were visible coming from the opening on the northeast corner. Thirty-three seconds later, the fire covered a much broader extent of the debris in the corner, while the flames in the northeast corner opening appeared to have died down. A long-distance video of this corner around this time shows that the intensity of the fire on the 81st floor was highly variable.

**Figure 9-31.** These two images show blowups of the north and south sides of the east face of WTC 2 taken from the photograph included in Figure 9-30, which was shot at 9:26:20 a.m. Column and floor numbers have been added. The arrow highlights a hanging object visible through open windows on the 82nd floor.
