## Chapter 9

# FIRE BEHAVIOR IN WORLD TRADE CENTER 2

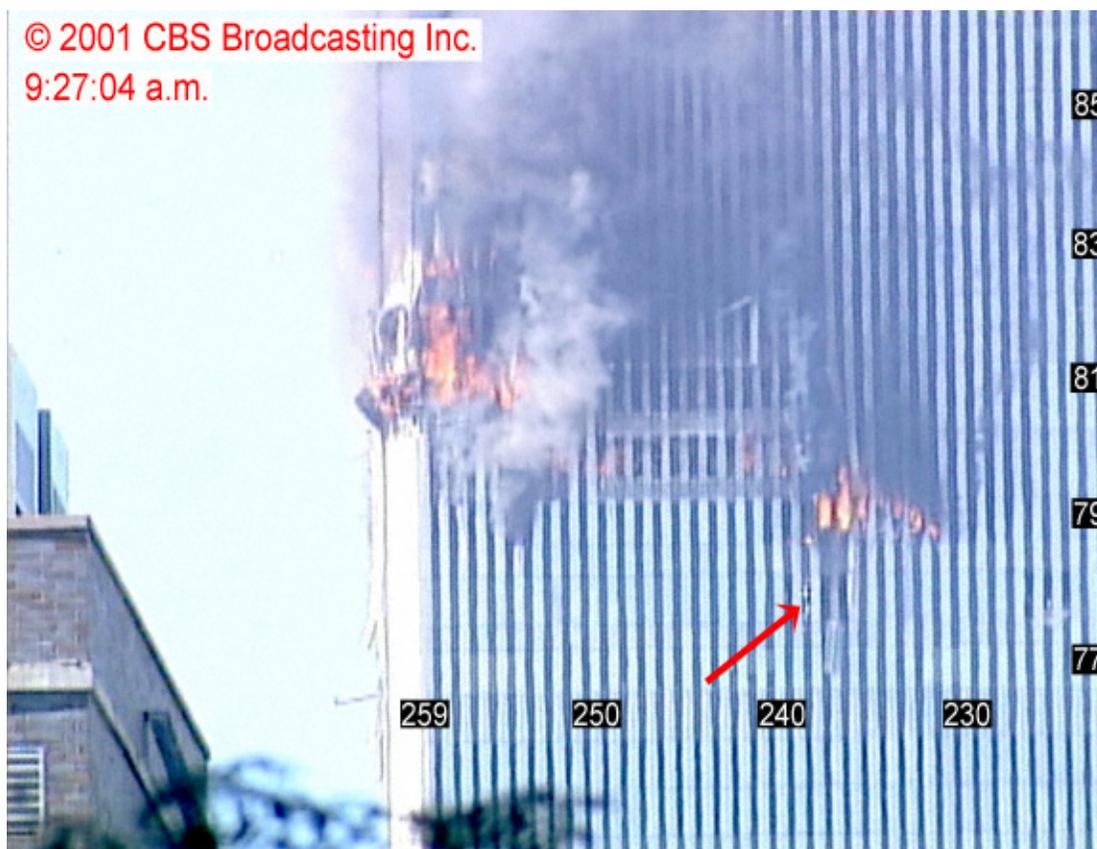
A view of the north face recorded at 9:27:04 a.m. is shown Figure 9–32. It was shot nearly 8 min after the image shown in Figure 9–24. The fire distribution on this face has changed very little during this period. The intense fires ignited immediately following the aircraft impact on the east edges of the 81st and 82nd floors continue to burn, even though the fire intensity on the 82nd floor has continued to decrease. The fire in the northeast corner opening on the 81st floor also decreased in size. The column in the corner of the 82nd floor, column 82-300, which was hidden by flames in Figure 9–24, is now fully visible.

The fire burning on the 79th floor to the west of the cold spot remains in the same location and is burning with a comparable intensity to the earlier time. Flames are visible in both of the lower corners of the cold spot on the 80th floor in Figure 9–32. Due to the lower image quality of Figure 9–24, it is difficult to determine whether these flames have grown more intense during the 8 min period.

**Figure 9-32.** This captured video frame showing the north face of WTC 2 was recorded at 9:27:04 a.m. The intensity levels have been adjusted, and column and floor numbers have been added. The arrow indicates a stream of liquid-like material that was observed on the 78th floor falling in window 78-238.

There are some distinct differences between the two images. In the earlier photograph it is difficult to identify whether there is fire on the eastern edge of the 83rd floor due to the height of the flames on lower floors. At 9:27:04 a.m. fire is visible in windows 83-257 and 83-258. No other flames are visible on the north side of the 83rd floor. In the later image heavy smoke is coming from windows 79-253 and 79-254 on the 79th floor, while the area is clear in Figure 9–24. Review of videos shows that the smoke flows from these windows, as well as windows 79-257 and 79-256, were intermittent around this time and

Closer inspection of Figure 9–32 shows what appears to be a shiny silver string (indicated by a red arrow) passing from the top to the bottom of one of the windows, 78-238, on the 78th floor. In the video from which this image was taken, the material actually appeared to be a liquid pouring intermittently from the top of the window and splashing at the window base. The liquid looked as if it was glowing. It was only observed during the six seconds that this video recorded this area of the tower. In Section 9.5, a flow of similar material from windows 80-255 and 80-256 on the 80th floor of the north face will be described. It will be hypothesized that the material was most likely aluminum from the aircraft that had melted and was pouring down through an opening from the floor above. This is also a plausible explanation for the current observation. If correct, it suggests that the pile of debris located on the 79th floor above this window may have contained aluminum from the aircraft. Recall that a pile of debris in this area of the 79th floor was present immediately following the aircraft impact. An intense fire had been burning on this debris since the impact that would have provided the heat necessary to melt the aluminum.

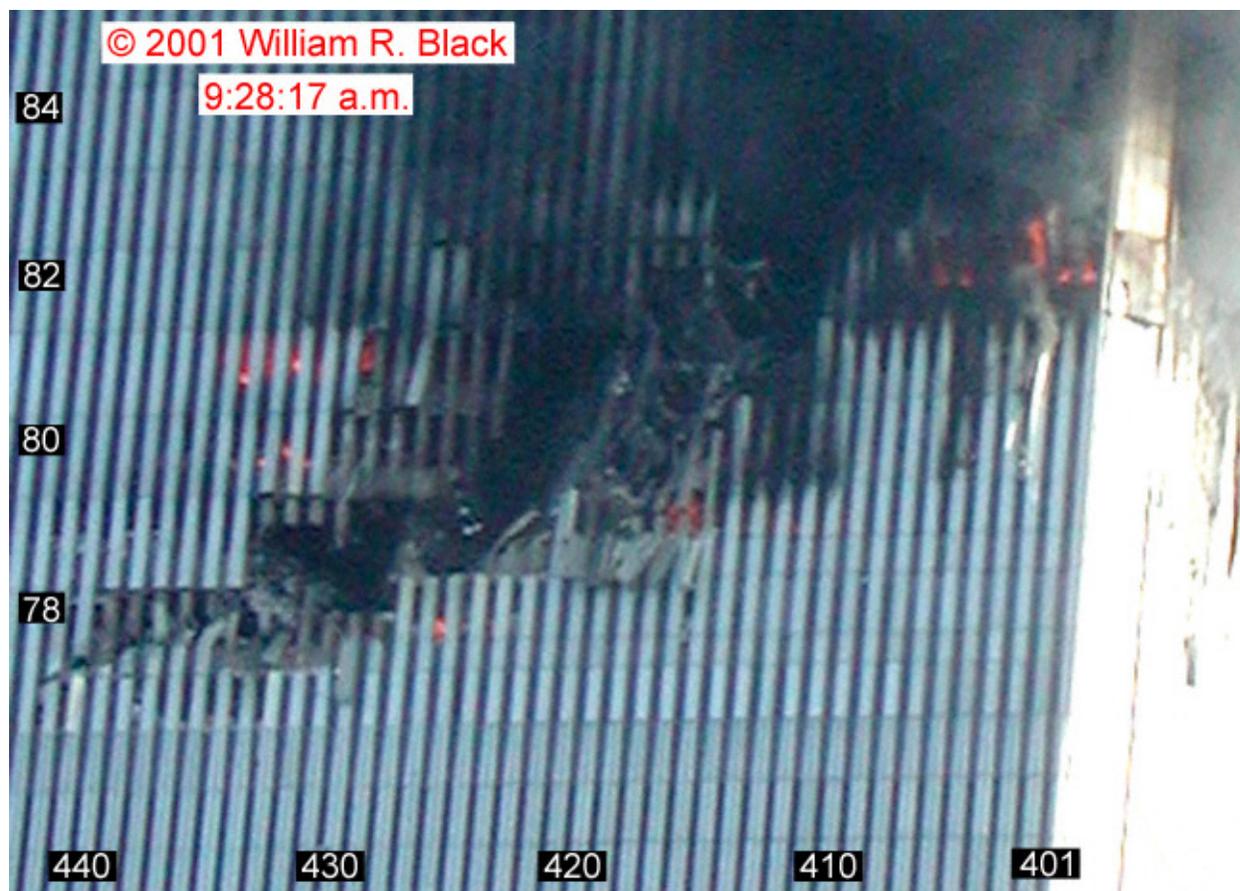
**Figure 9-33.** This cropped photograph showing the south face of WTC 2 was shot at 9:28:17 a.m. The image has been rotated, and the intensity levels have been adjusted. Column and floor numbers have been added.

A view of the south face of WTC 2 at 9:30:19 a.m. is shown in Figure 9–41. It was taken just over 2 min later than the image of the face in Figure 9–33. One difference between the images is immediately apparent. Smoke is coming from windows to the west of the aircraft impact cavity on the 79th, 80th, and 82nd floors that was not present in the earlier photograph. The flames visible on the 81st floor are also much brighter. This picture was taken during one of the smoke releases identified on the east face, and the presence of smoke and increased flame is likely associated with the same event.

In Figure 9-41, flames are visible on the 83rd floor in window 83-424. This is the first visual evidence of a fire burning on the 83rd floor on the south face. The fire on the 82nd floor between the aircraft impact cavity and the east edge has decreased in intensity, and the smoke has cleared up since Figure 9-33 was taken. Part of the 83rd floor is now visible. It appears as if the spandrel covers at the base of this floor are missing below windows 83-401 to 83-407. There does not appear to be an active fire on this part of the 83rd floor. The small fires burning elsewhere around the aircraft impact cavity have similar appearances to those observed at the earlier time.

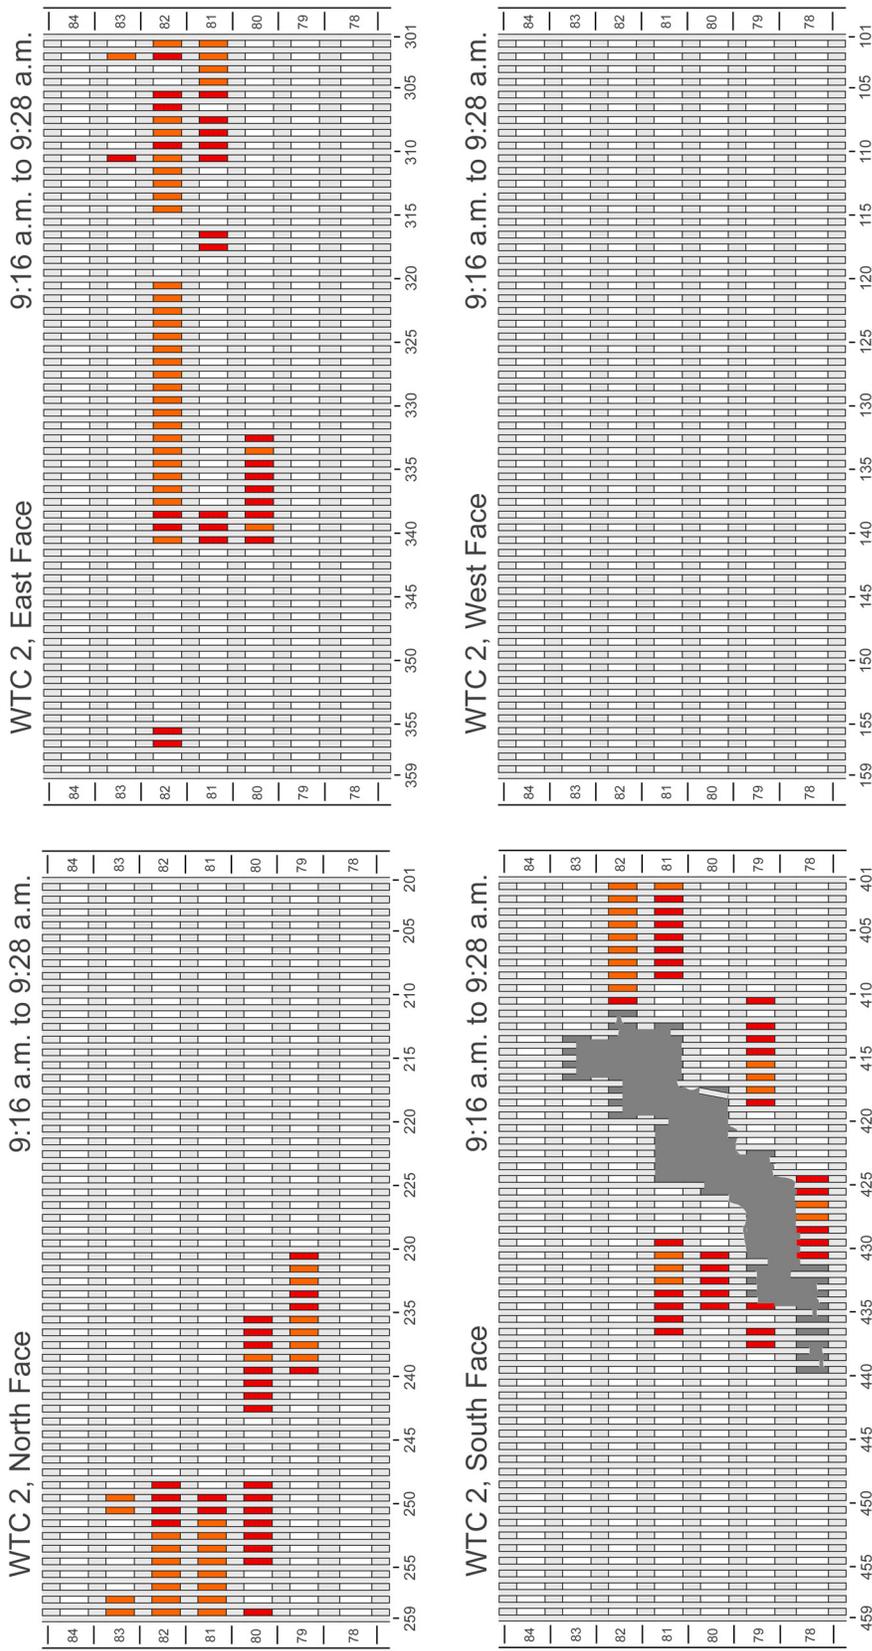
Major observations concerning WTC 2 between 9:15 a.m. and 9:29 a.m. are summarized here. Visual representations of integrated fire intensities over the period for the four faces are shown in Figure 9–34. Changes in fire distributions during the period can be tracked by comparing the results with Figure 9–19, which shows similar maps for the first time period. It should be kept in mind that the integrated fire maps for this period incorporate some very rapid changes in fire distribution.

On the north face, the primary observation was the continued burning of fires on the 81st and 82nd floors on the east side of the cold spot and on the 79th floor to the west side. These fires were ignited during the aircraft impact and subsequent fireballs and appeared to be burning on piles of debris that resulted. While still substantial, these fires appeared to decrease in intensity during the period. Infrared images recorded near the start of the period confirmed that temperatures in the cold spot on the north face were near ambient. While some fires were observed at various corners of the rectangular cold spot, in general, the area remained smoke and fire free. Near the end of the period, flames were observed in windows near the east side of the 83rd floor. The appearance and positions of the numerous hanging objects visible through open windows on the north face, some of which may be floor slabs that have dropped down from the floor above, did not change noticeably during the period.

**Figure 9-34. Maps of integrated fire observations between 9:15 a.m. and 9:29 a.m. are shown for the four faces of WTC 2. Colors represent the highest intensity fire observed in a window using the color scale defined in Figure 5-1.**

On the east face a large fire that had started on the south side of the 82nd floor spread slowly to the north, going through a cycle of initial growth to an intense burning phase, followed by decline. Fires that were ignited on piles of debris located in the northeast corners of the 81st and 82nd floors continued to burn over the period, but their intensities decreased as did the intensity of a fire burning in the opening in the northeast corner on these two floors. During the period, a substantial fire was observed briefly near the east edge of the 83rd floor. Infrared images recorded during the early part of the period indicated that there was strong heating on the 81st floor and only regions of localized heating on the 79th and 80th floors. Over the course of the period, increasingly frequent and intense intermittent bursts of smoke were observed coming from windows on several floors of the face. Rapid variations in fire distribution were also observed.

The hanging object observed through a number of open windows on the east face at the 82nd floor dropped down lower in some of the windows during the period. This allowed oblique shots to show that it appeared to be a thin, sheet-like object, providing additional support for the hypothesis that it was a portion of the 83rd floor slab hanging down from above.

Most of the fires on the south face remained localized near the aircraft impact cavity during the period. This included fires to the west of the cavity on the 79th, 80th, and 81st floors and to the east on the 78th and 79th floors. Fires already present to the east of the impact cavity on the 81st and 82nd floors did not seem to spread to the east face. During the period, the fire on the 81st floor decreased in intensity, while the fire on the 82nd floor continued to burn vigorously. Near the start of the period, a substantial fire grew on the 79th floor to the immediate east of the aircraft impact cavity and then spread slowly to the east.

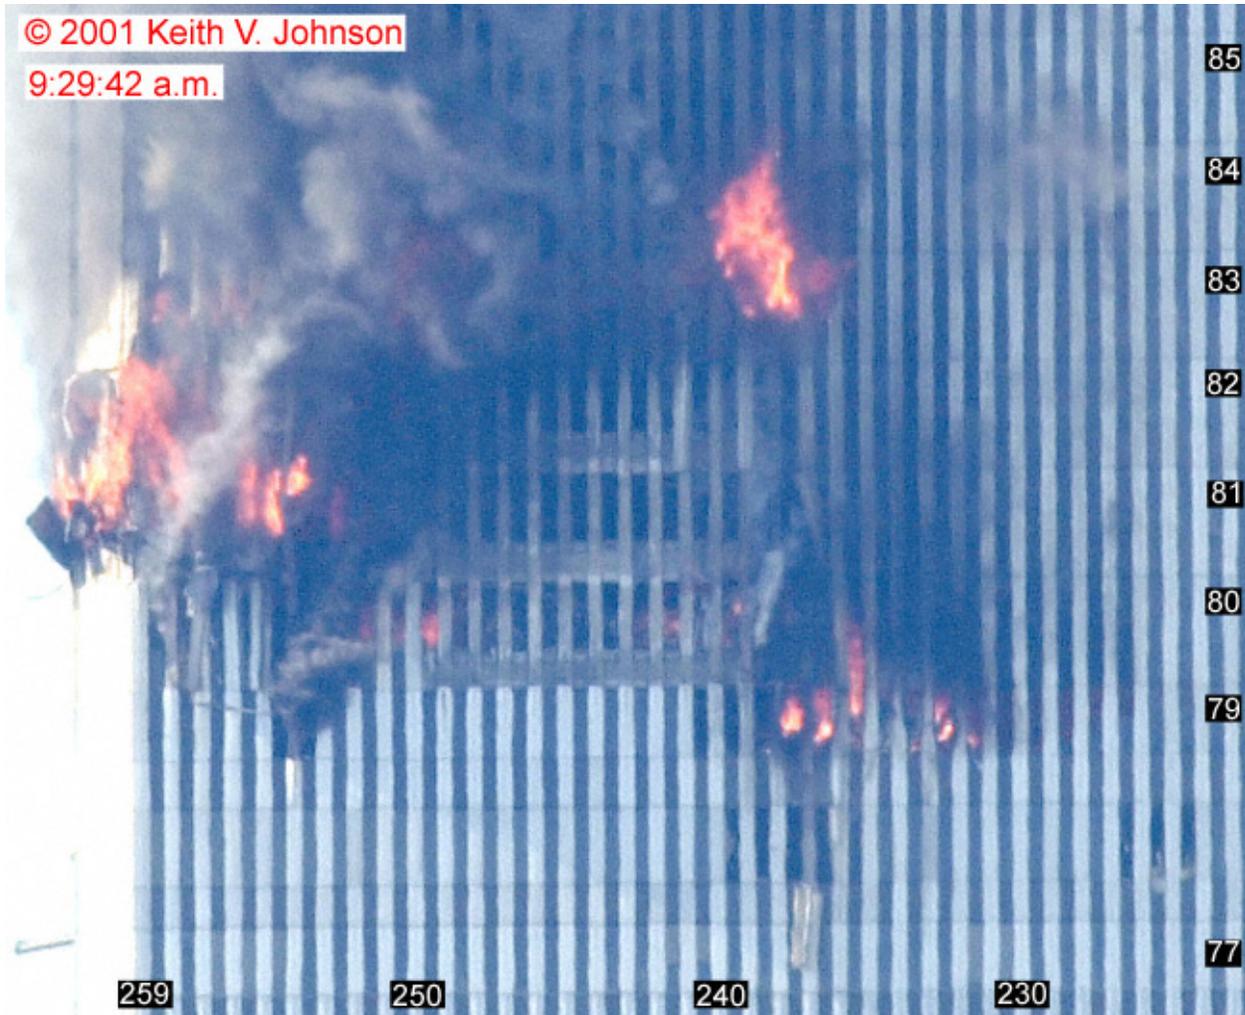
At first glance, it appears the new area of fire on the 83rd floor in Figure 9–35 is well separated from other flames on the floor. However, a dull red glow is barely visible in windows 83-240 to 83-245, suggesting there is a low intensity fire burning behind closed windows immediately above the cold spot. It seems this low intensity fire had spread further west, where it eventually broke out windows and then grew rapidly.

Comparison of Figure 9–35 with Figure 9–32, which was taken 2 min and 38 s earlier, shows how quickly the fire on the northern side of the 83rd floor grew and spread. At the earlier time there was no indication of a fire on the floor to the west of the small fires visible through windows 83-257 and 83-258. The appearance of fire at this location on the 83rd floor is the first visual evidence of significant fire spread on the north face of the tower. It took place almost 27 min after the aircraft struck the tower.

**Figure 9-35.** This cropped photograph shows the north face of WTC 2 at 9:29:42 a.m. The intensity levels have been adjusted, and column and floor numbers have been added

Elsewhere on the face, the appearance of the fires at 9:29:42 a.m. is much the same as at 9:27:04 a.m. The fires continued to burn on the debris piles at the eastern edges of the 81st and 82nd floors and closer to the center of the face on the 79th floor. The fires at the lower corners of the cold spot on the 80th floor are visible in both images. The hanging objects visible earlier in Figure 9-12 and Figure 9-16 are not immediately apparent in Figure 9-35. This is somewhat unexpected given the quality of the image.

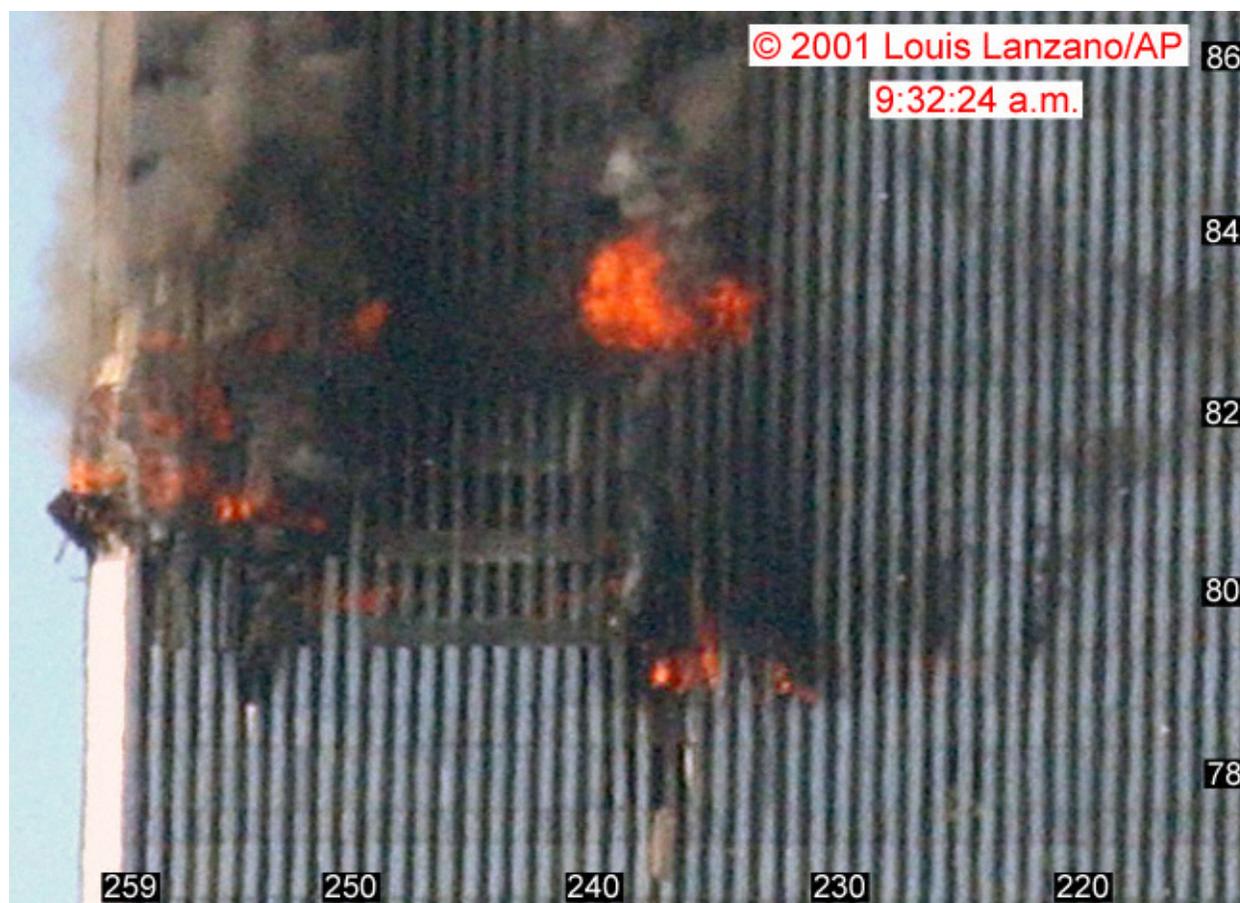
Another view of the north face taken at 9:32:24 a.m. is shown in Figure 9-36. Comparison with Figure 9-35 reveals that the intense area of fire on the 83rd floor to the west of the cold spot has spread during the 2 min and 42 s period between the times the images were taken. Long flames are now coming from a length of windows running from window 83-234 to window 83-239. Flames are also visible on this floor starting at window 93-249 and extending to the eastern edge. Flames are not visible on the floor in windows immediately above the cold spot.

**Figure 9-36.** This cropped photograph shows the north face of WTC 2 at 9:32:24 a.m. The image has been rotated and enhanced by adjusting the intensities. Column and floor numbers have been added.

Another difference between Figure 9–35 and Figure 9–36 is apparent on the 79th floor. At the later time a dull red glow is visible in windows 79-224 to 79-228, and smoke is coming from window 79-226 and window 79-222. This is evidence that the fire that has been burning on the 79th floor since the aircraft impact has begun to spread across the face toward the west.

Elsewhere on the face, the fires present in Figure 9–36 have not changed markedly for many minutes.

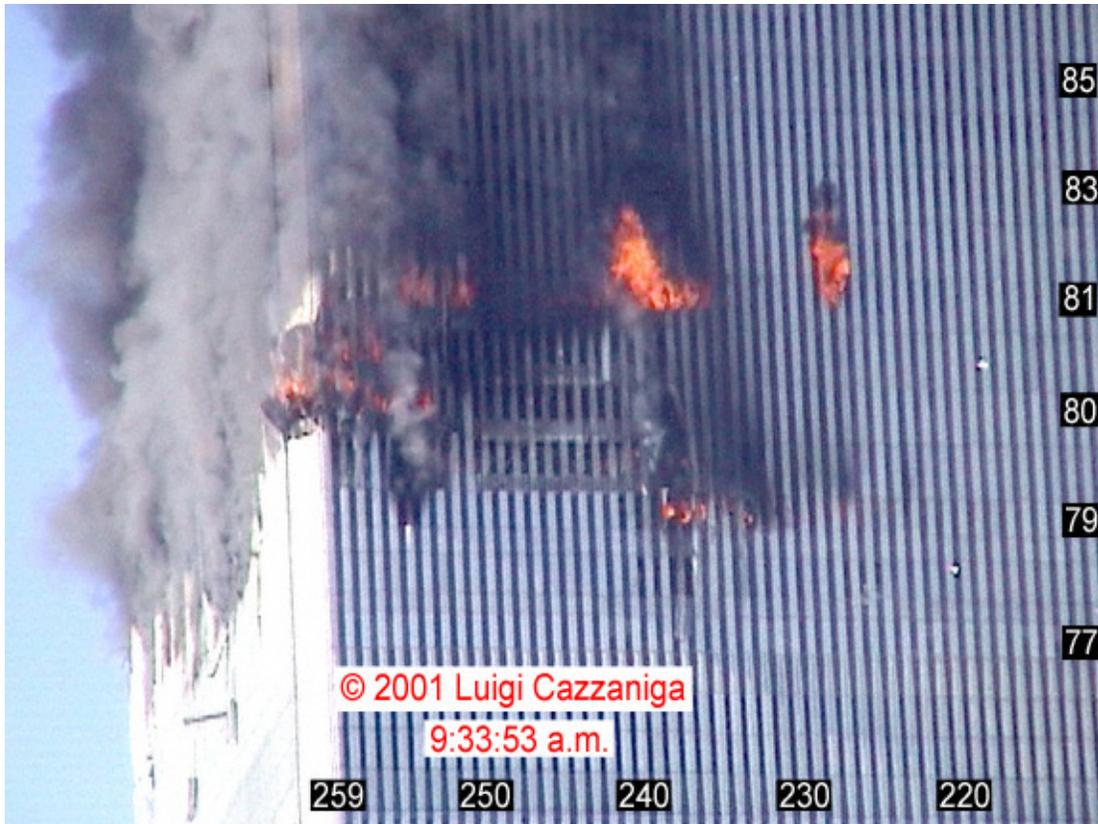
At 9:33:52 a.m. the fire burning on the 83rd floor of the north face seemed to jump several windows to the west when window 83-226 broke open, and a large flame exited. The resulting flare can be seen in Figure 9–37, which was recorded 0.9 s after the window opened. This large flame only lasted a few seconds, but after it died down heavy smoke and a shorter flame continued to come from the window.

**Figure 9-37.** This frame taken from a video shows the north face of WTC 2 at 9:33:53 a.m. The intensity levels of the image have been adjusted, and column and floor numbers have been added.

In Figure 9–37 small flames are visible in windows 83-240 to 83-244, which are located above the cold spot on the 83rd floor. This confirms that fires were present on this part of the floor. As an aside, since flames are not observed on the floor below, it also suggests that the 83rd floor slab is in place above the cold spot. The fires observed elsewhere on the face have similar distributions and intensities to those in Figure 9–32, Figure 9–35, and Figure 9–36.

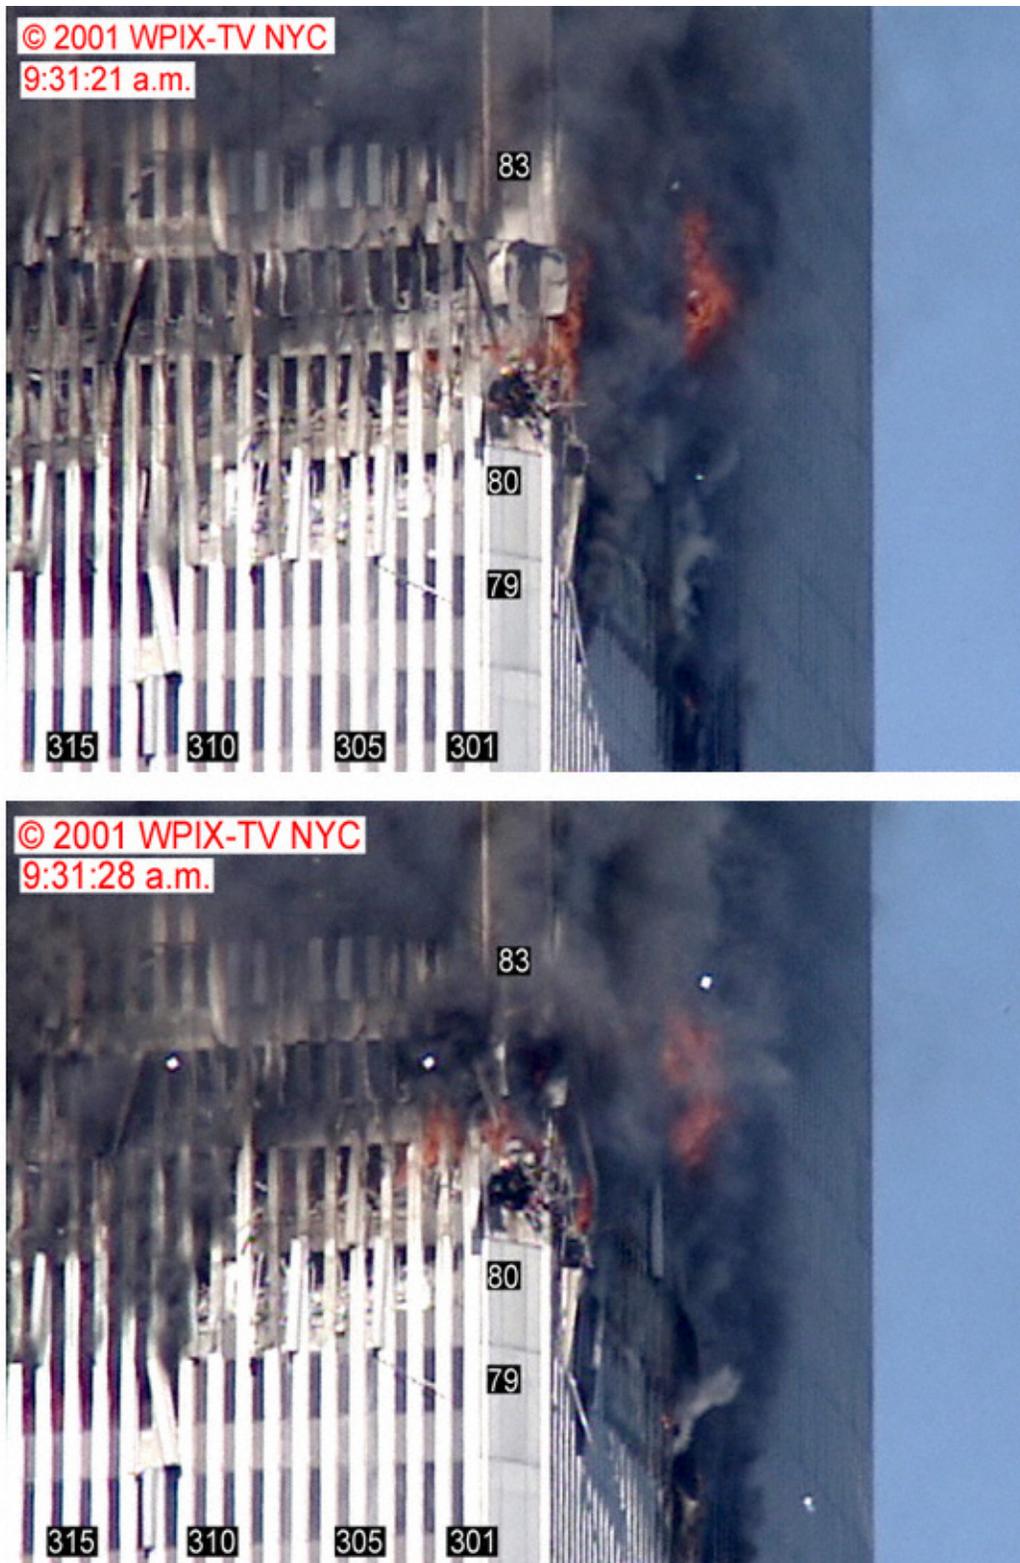
Two views of the northeast corner of WTC 2 are shown in Figure 9–38. The two images were captured from a video recording at 9:31:21 a.m. and 9:31:28 a.m. They were chosen to illustrate the appearance of the smoke puffs that had been observed periodically on the east face of WTC 2 for nearly twenty minutes. In the earlier image shown at the top of Figure 9–38, the visible portion of the east face is relatively clear of smoke. The only flame visible in windows on the east face at this time is the relatively small fire on the 81st floor in window 81-302, even though a fire continues to burn in the opening at the northeast corner of the 81st floor. Otherwise, the fires that were previously observed on this part of the east face seem to have died down. A video shot from a longer distance shows that shortly after the upper frame was recorded a smoke release occurred from multiple windows over multiple floors on the east face. This particular release was not as intense, i.e., less smoke was released, as others that were observed around this time.

Figure 9-38. Two frames captured from a video at 9:31:21 a.m. and 9:31:28 a.m. show the northeast corner of WTC 2. The intensity levels of the images have been adjusted, and column and floor numbers have been added.

The effects of the smoke release are evident in the lower image shown in Figure 9–38. Smoke has been pushed out of open windows on the 79th floor, i.e., windows 79-311 to 79-316, and can be seen rising above these windows. Comparison of the frames shows that the appearance of the smoke and fire in the vicinity of the burning corner on the 81st floor has also changed. Not only has smoke been pushed out of windows 81-301 and 81-302 and the opening on the northeast corner, but the fire intensity has also increased in the immediate area. Flames have been pushed out of windows 81-301 and 81-302. In the video it is clear that smoke was also pushed from windows on the 80th floor on the north side of the tower. In the lower image, this smoke appears as a white stream that has been pushed away from the building. In a video shot from a longer distance it was observed that smoke also appeared from windows on the 80th floor located on the south side of the east face. These observations suggest that the smoke puffs could be associated with pressure variations that were extensive enough to affect multiple floors and faces of the tower simultaneously. It should be noted that while the pressure variations that create the puffs may be the result of structural changes within the tower, the resulting pressure increases are likely to be much too small to have any impact on the structure.

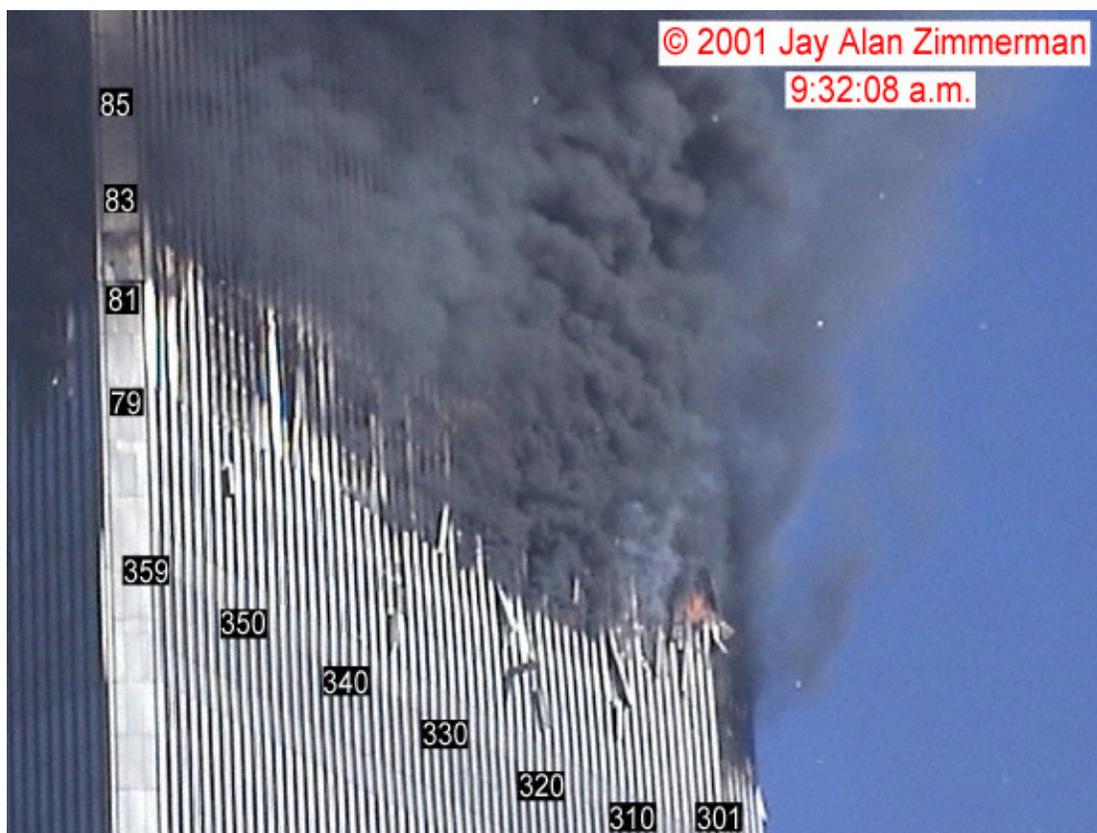
**Figure 9-39.** This view of the east face of WTC 2 is a frame from a video taken at 9:32:08 a.m. Column and floor numbers have been added. The northeast corner of WTC 1 is visible in the background.

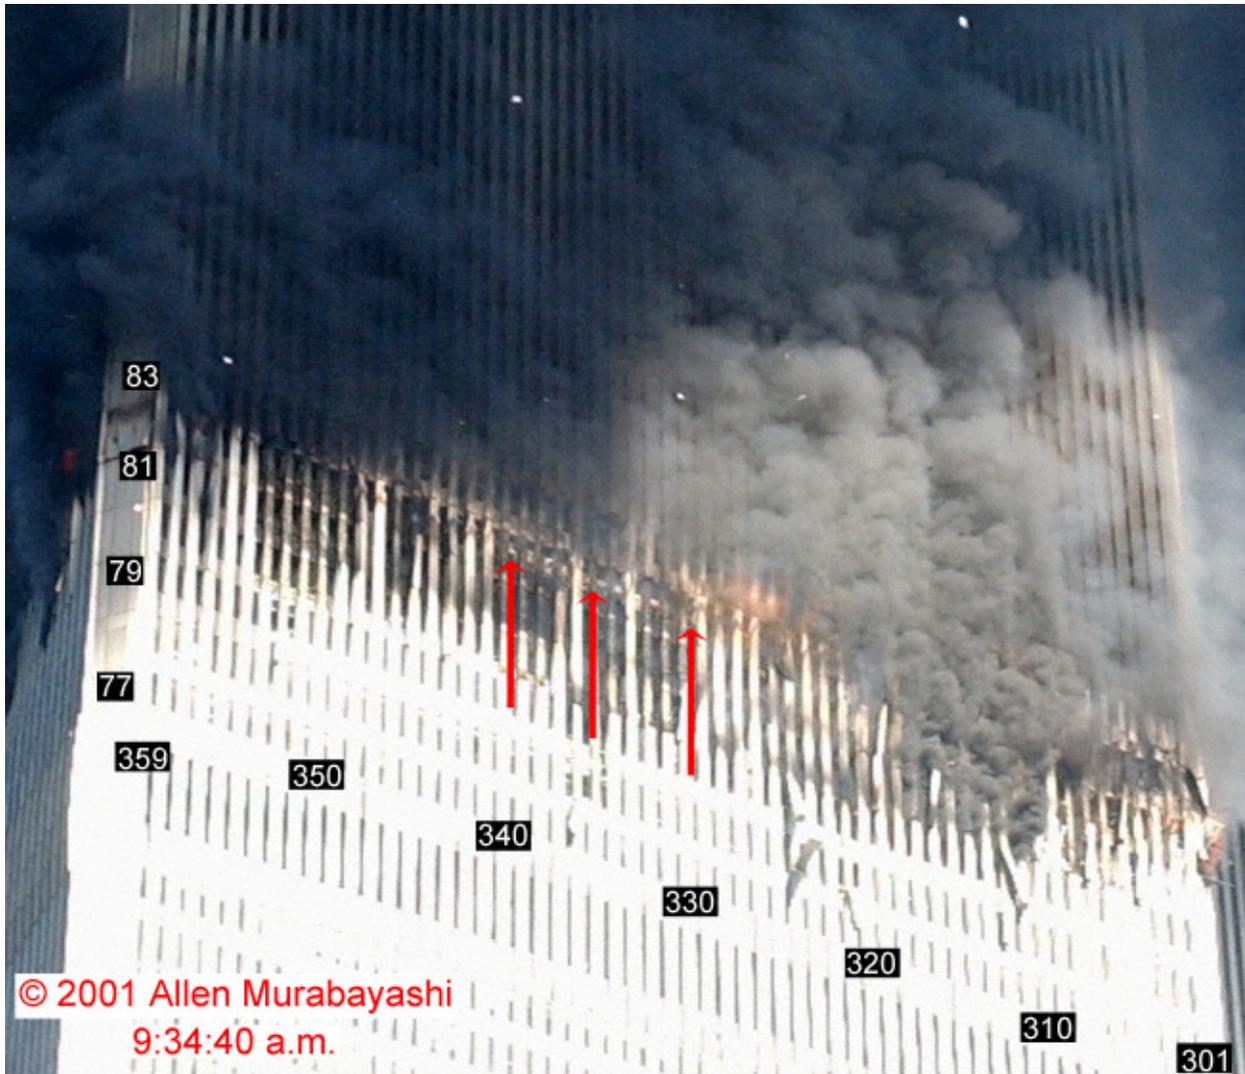
A relatively close view of the east face shot from southeast of WTC 2 at 9:34:40 a.m. is shown in Figure 9–40. This photograph was taken during a period when the flow of smoke coming from windows on the northern side of the 79th floor was fairly heavy, but when little smoke was coming from other windows below the 82nd floor. In Figure 9–27, taken at 9:25:47 a.m., windows 79-314 to 79-320 on the 79th floor had glass in place. These windows are open in Figure 9–40, suggesting that a fire must be burning nearby. The southern half of the face is visible to the tops of 83rd floor windows. Flames are

visible on the 82nd floor from window 82-322 to window 82-328. The fire on this floor has continued its spread toward the north since 9:27:35 a.m. (see Figure 9–28 and Figure 9–30 and related discussion). The fire burning in and near the northeast corner of the 81st floor is also visible in the photograph.

The arrows in Figure 9–40 indicate the hanging object that was described earlier. The appearance of the object is much the same as in Figure 9–28, which was shot from a similar angle at 9:27:35 a.m. This indicates that the portion of the object that is visible has not moved a great deal in the intervening period.

**Figure 9-40.** This cropped photograph, shot from the southeast at 9:34:40 a.m., shows the east face of WTC 2. The intensity levels have been adjusted, and column and floor numbers have been added. The arrows highlight a hanging object observed through open windows on the 82nd floor.

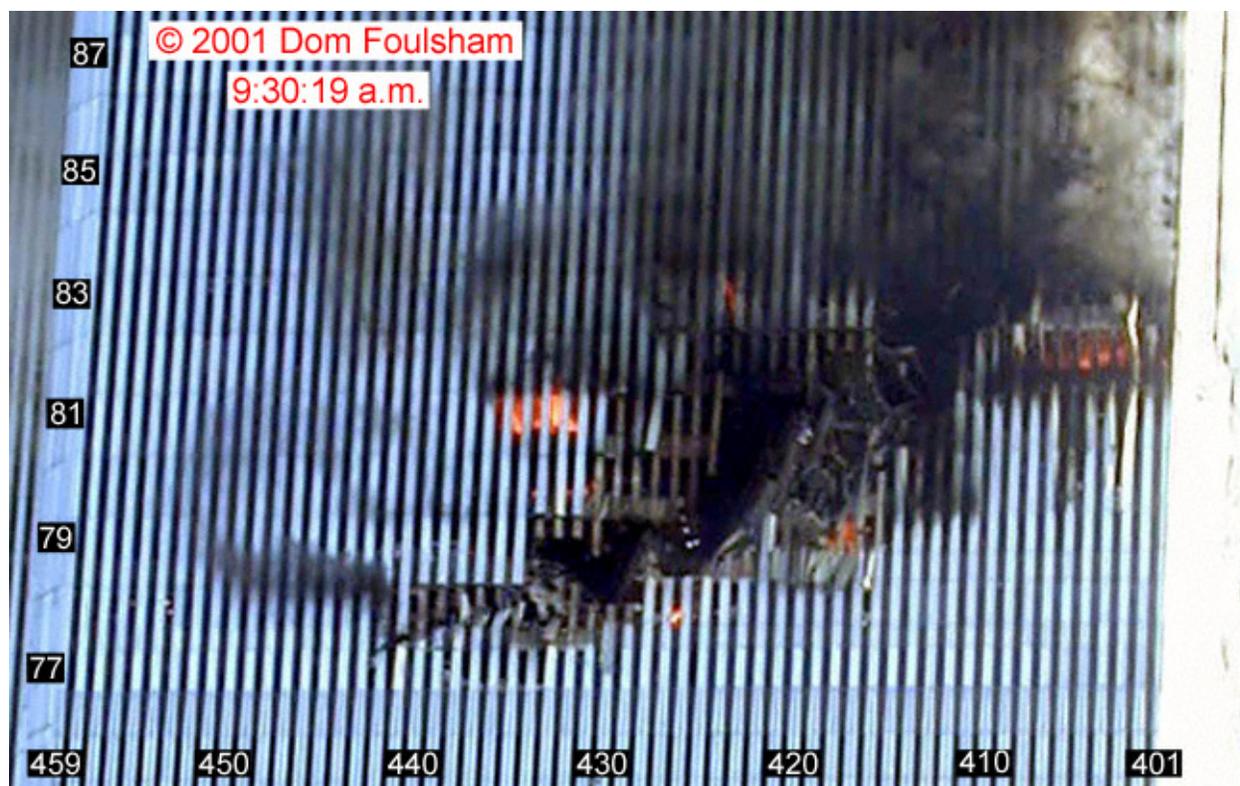
**Figure 9-41. This cropped photograph shows the south face of WTC 2 at 9:30:19 a.m. The image has been rotated, and column and floor numbers have been added.**

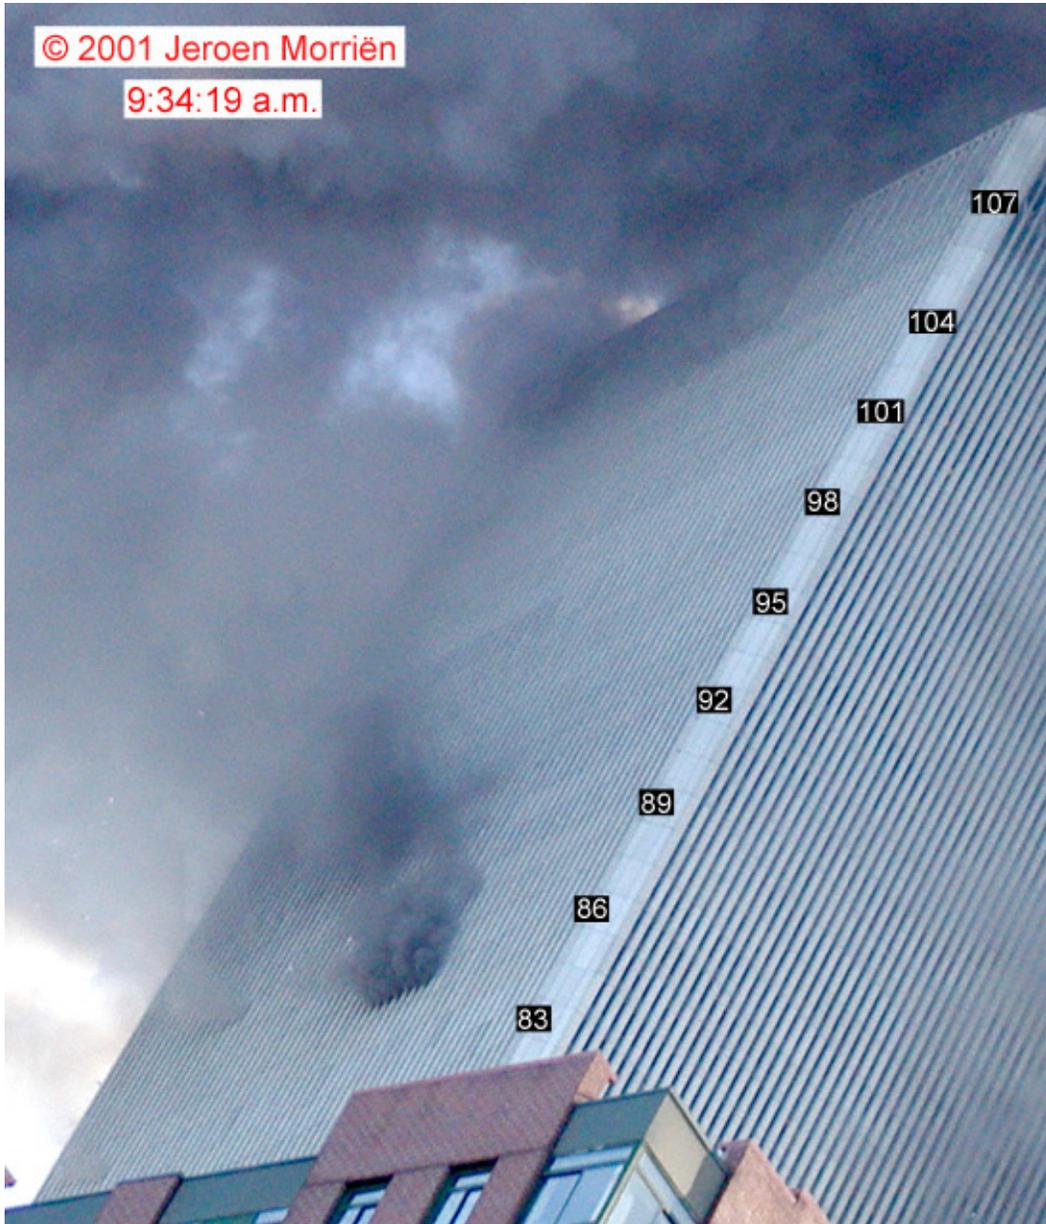
An oblique view of the west face of WTC 2 at 9:34:19 a.m. is shown in Figure 9-42. Smoke is visible at several locations on the west face. The densest smoke is flowing from windows 86-117 to 86-122 on the 86th floor. Lighter smoke is flowing from near window 88-142 and window 84-149 on the 88th and 84th floors, respectively. Smoke is also visible at two locations near the top of the tower; on the 107th floor,

where it was observed earlier, and at the top next to the southwest corner. The latter smoke flow is much lighter and is barely discernable in the photograph. In other images (not shown) it is more distinct. This smoke appears to be flowing from windows 108-101 and 108-102, which were located on the lower level of the mechanical equipment room that spanned the 108th and 109th floors. The nearest louvers to these windows are for a fresh air intake for the 107th floor observation area located opposite windows 108-101 to 108-109 (see Figure A-1 in Appendix A). This suggests that the smoke coming from the upper mechanical equipment room is back flowing through the fresh air intake for the 107th floor. Each of the locations with smoke flow on the west face is above the floors where fires have been observed, which is consistent with the possibility that people broke the glass out and released local build-ups of smoke.

**Figure 9-42.** This cropped photograph shot from the southwest shows an oblique view of the south and west faces of WTC 2 at 9:34:19 a.m. The intensity levels have been adjusted, and floor numbers have been added.

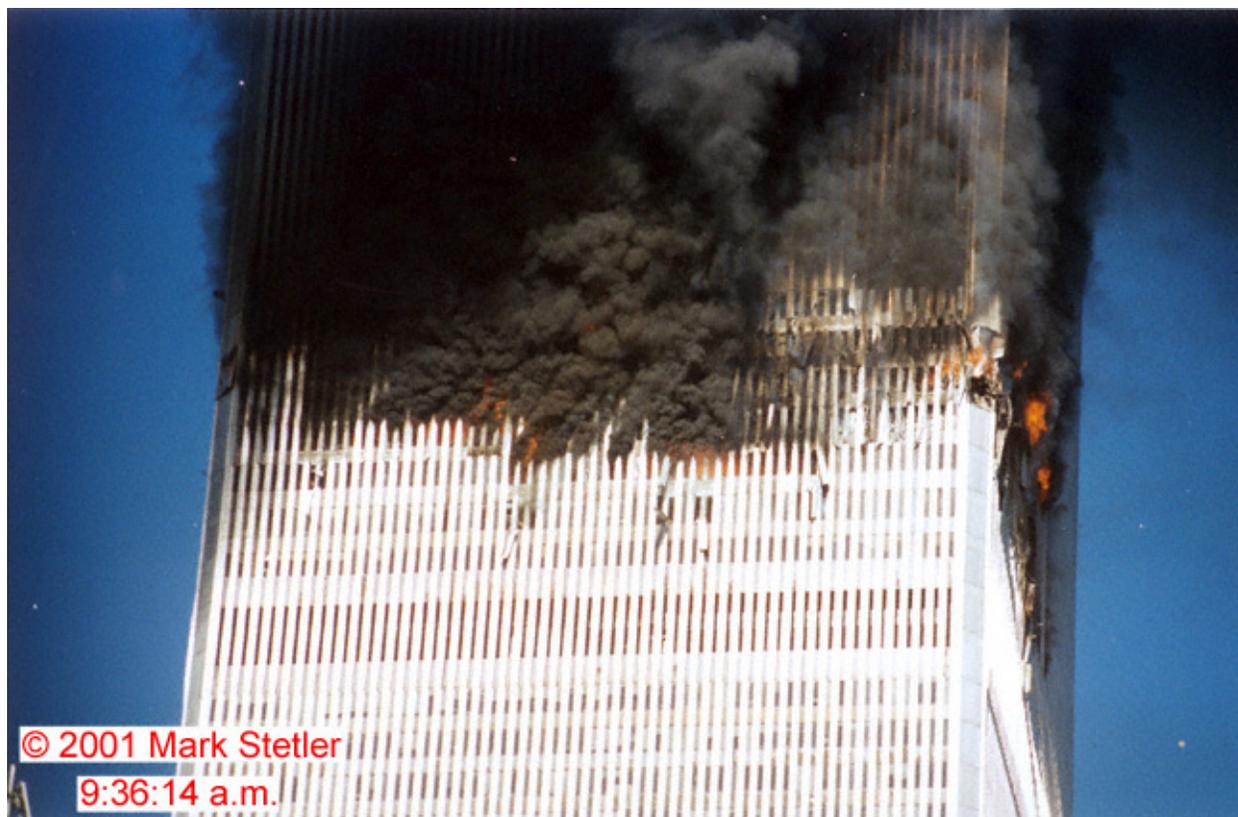
Figure 9-43 shows a photograph that was shot during this period of heavy smoke flow at 9:36:14 a.m. The northern and southern sides of the floors with smoke and fire are shown as blow-ups in Figure 9-44. The enormous increase in smoke is evident by comparing Figure 9-43 with Figure 9-40, which was shot only 1 min 34 s earlier. In the earlier photograph relatively light smoke was coming from open windows on the 79th floor roughly located between windows 79-311 and 79-317. In the later photograph smoke

flow from these windows has apparently completely halted, but now heavy smoke and fire are visible over a range of windows from window 79-318 to window 79-336. In Figure 9–44 it is apparent that smoke and, in many cases, fire are coming from every window that is open over this range. Windows 79-326, 79-329, 79-330, and 79-332 still have glass in place.

**Figure 9-43.** This photograph showing the east face of WTC 2 was taken at 9:36:14 a.m.

Heavy smoke and fire are also visible on the 80th floor from window 80-229 to window 80-249. Flames are particularly prominent in windows 80-336 to 80-343. These fires might extend over an even wider range, but many windows are hidden by smoke rising from the 79th floor. Flames are barely visible higher up on the face, which suggests that the fire on the 82nd floor continues to burn near column 330.

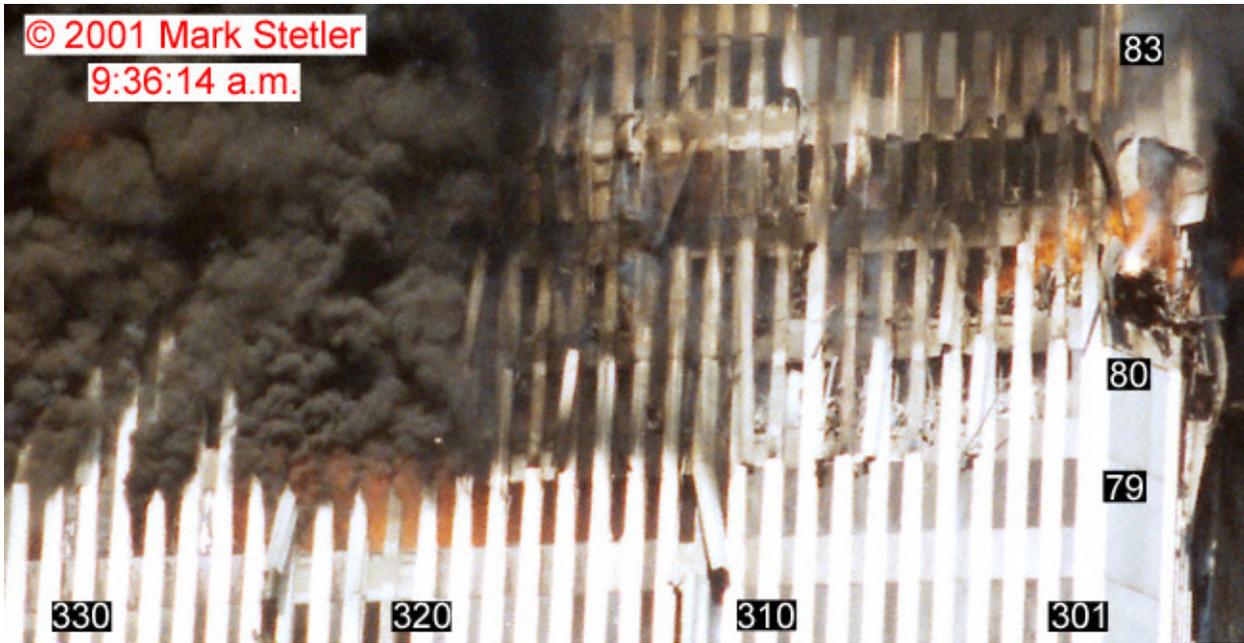
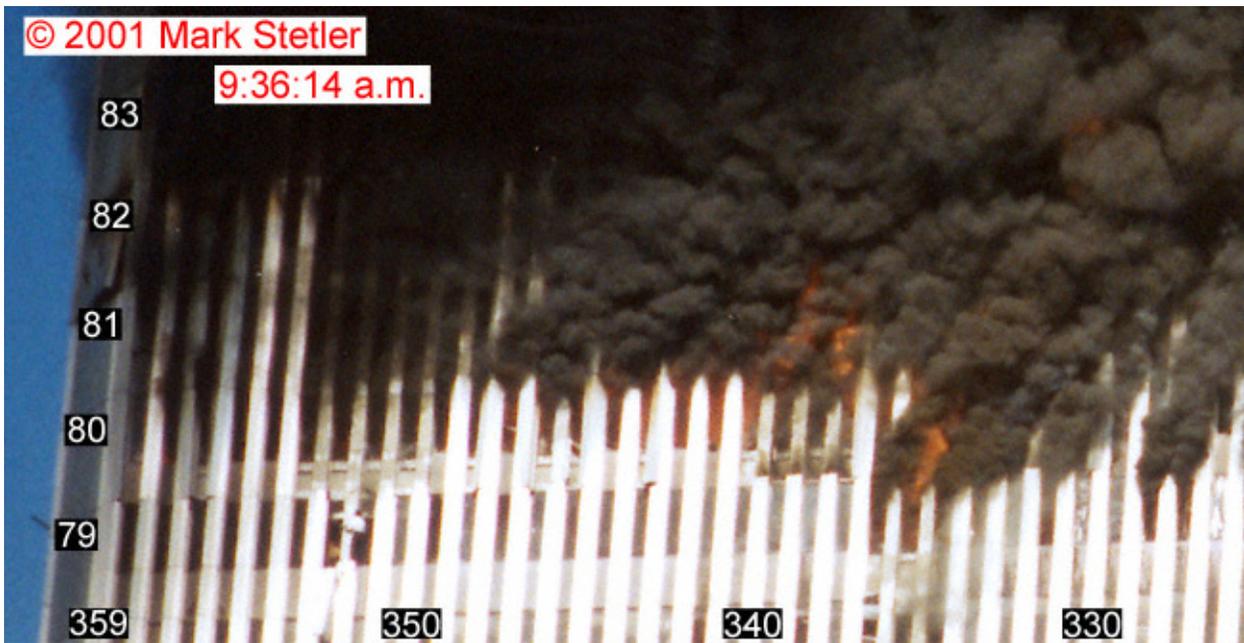
The intense fire in the northeast corner opening of the 81st floor is still present. An unusual flame is visible within this fire. In the upper photograph in Figure 9-44 a very bright white flame, as opposed to the typical yellow or orange surrounding flames, which is generating a plume of white smoke, stands out. The intensity of this flame is considerably brighter than normal flames. It was easily identified in numerous photographs and videos shot from long distances at which the surrounding “normal” flames were not visible. The brightness of the flame, along with the white smoke, suggests that some type of metal is burning. Metal combustion is known to generate much higher flame temperatures than hydrocarbon combustion, and, as a result, to burn much brighter. It is difficult to identify what type of metal is burning. Aluminum will burn, but in normal fires it usually melts instead because the metal surface is protected by an oxide layer that must be breached before ignition can take place. Aluminum oxide melts at high temperatures that are not typically reached in normal fires. There were limited quantities of other metals on the aircraft that might also burn. Whatever the metal, the ignition of a metal fire is an indication of the significant heating of the debris that took place in the northeast corner of the 81st floor due to the prolonged intense burning in this area following the aircraft impact.

**Figure 9-44.** These two images show blow-ups of the north and south sides of the east face of WTC 2 taken from the photograph included in Figure 9-43, which was shot at 9:36:14 a.m. Column and floor numbers have been added

Given the large amounts of smoke coming from the central regions of the 81st and 82nd floors on the east face, there is surprisingly little smoke at the north and south ends of these floors. With the exception of a light smoke flow from windows 78-334 and 78-335 on the 78th floor, no smoke is observed coming from below the 79th floor. Videos show that short bursts of smoke did come from other open windows on the 77th and 78th floors during the heavy smoke release.
