## Chapter 9

# FIRE BEHAVIOR IN WORLD TRADE CENTER 2

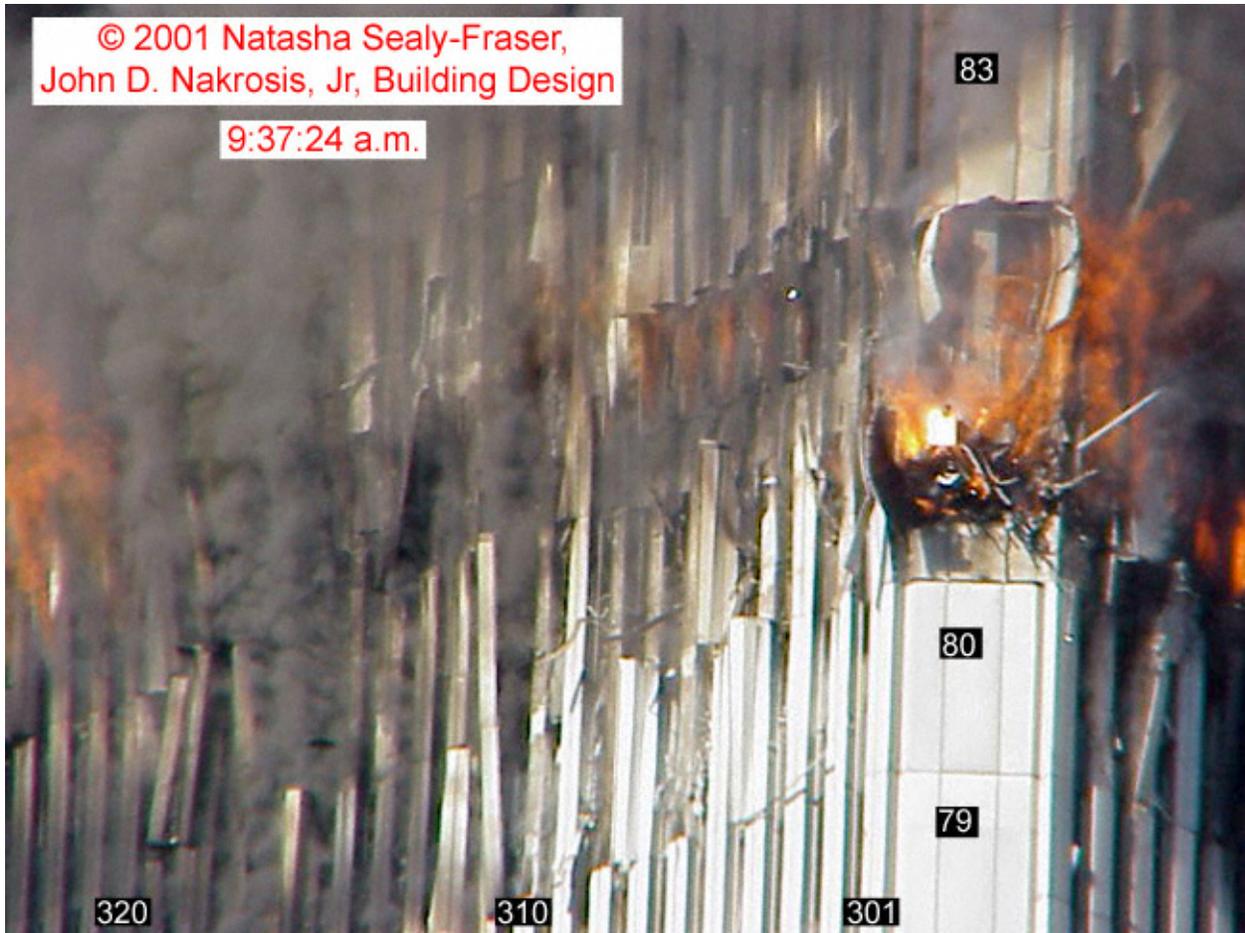
Figure 9–45 shows the northeast corner of the tower. The bright flame in the 81st floor corner opening, which has been attributed to metal combustion, stands out. A check of the original image shows that the pixels at this location are essentially saturated, providing an indication of how much brighter this flame was than the surrounding flames, which had intensities that were far from saturating the pixels. From this angle, flames are visible extending from the 82nd floor at windows 82-204 to 82-207. These windows appeared to be flame-free at 9:36:14 a.m.

**Figure 9-45.** This photograph was taken from the northeast at 9:37:24 a.m. and shows portions of the north and east faces of WTC 2. The intensity levels have been adjusted, and column and floor numbers have been added.

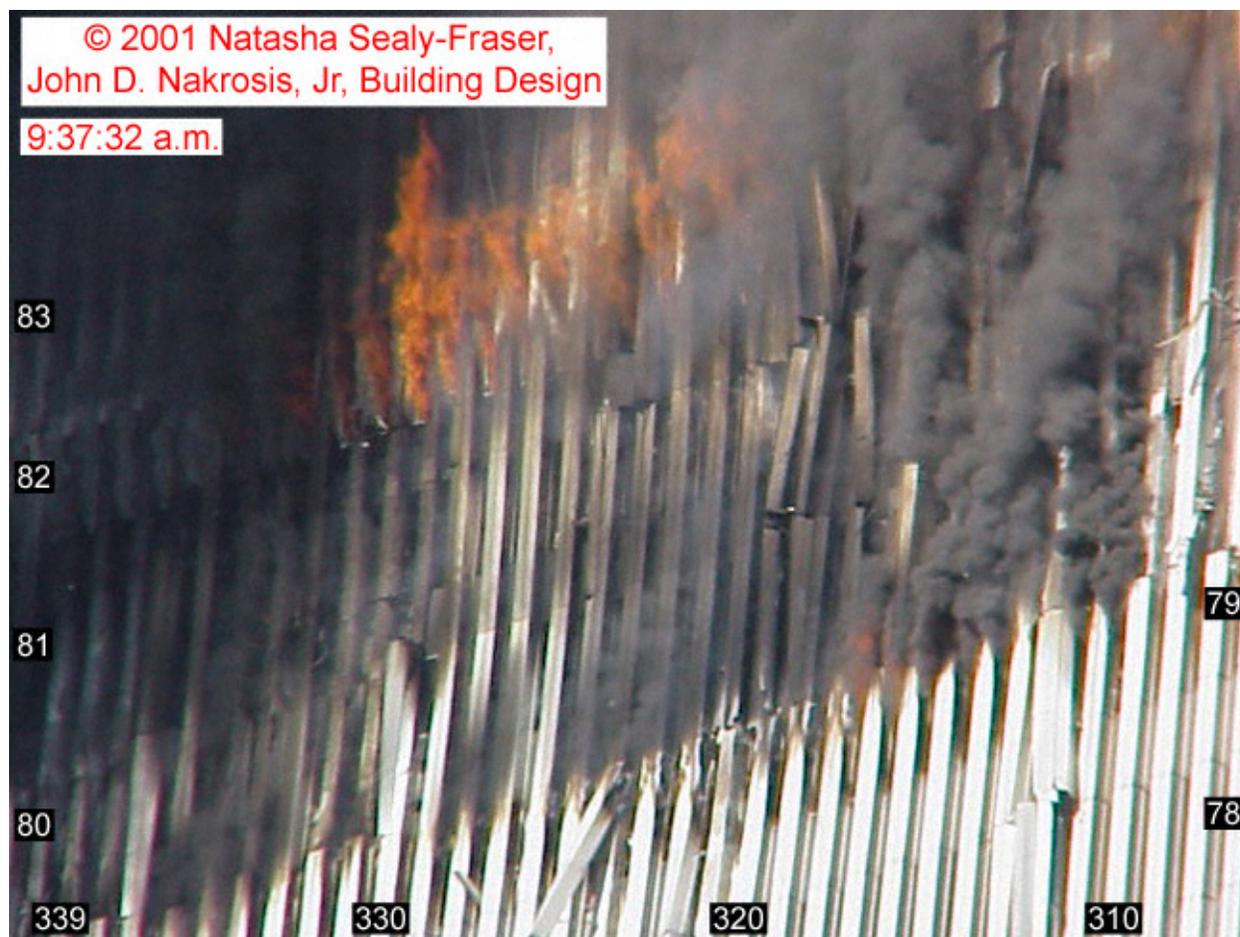
The largest changes in appearance occurred near the center of the east face. In Figure 9-46 the only heavy smoke and flames visible on lower floors is coming from windows 79-310 to 79-317 on the 79th floor. At 9:36:14 a.m. these windows appeared to be free of smoke and fire. On the other hand, the only evidence of the intense fires raging on the 79th floor seconds earlier in windows 79-318 to 79-325 are the carets visible at the tops of the adjacent column covers. Heavy smoke hid much of the upper floor façade in Figure 9-44. The only flames visible on the 82nd floor appeared to be just to the south of column 330. At the later time, large flames are coming from windows 82-320 to 82-333. Recall that intense flames became visible in this region around 9:37:18 a.m.

Closer inspection of Figure 9-46 reveals that the columns on the 80th and 81st floors on either side of column 330 appear to be bowed inward. This bowing could be identified in images taken as early as 9:21:29 a.m. Several additional photographs to be described below show a similar bowing. This indicates that columns on these floors were distorted at least 37 minutes prior to the collapse of the tower.

**Figure 9-46.** This photograph was taken from the northeast at 9:37:32 a.m. and shows the center portion of the east face of WTC 2. The intensity levels have been adjusted, and column and floor numbers have been added.

earlier, i.e., windows 79-310 to 79-320, is relatively light compared to windows further to the south on the same floor. These figures provide a good indication of how heavy the smoke flow and flames were during this particular smoke release. By the time Figure 9-46 was taken at 9:37:32 a.m., the only heavy smoke and flames visible on the 79th floor were again coming from windows between 79-315 and 79-320. The contrast between the two conditions is stark and vividly demonstrates how unusual the periods of heavy smoke release were.

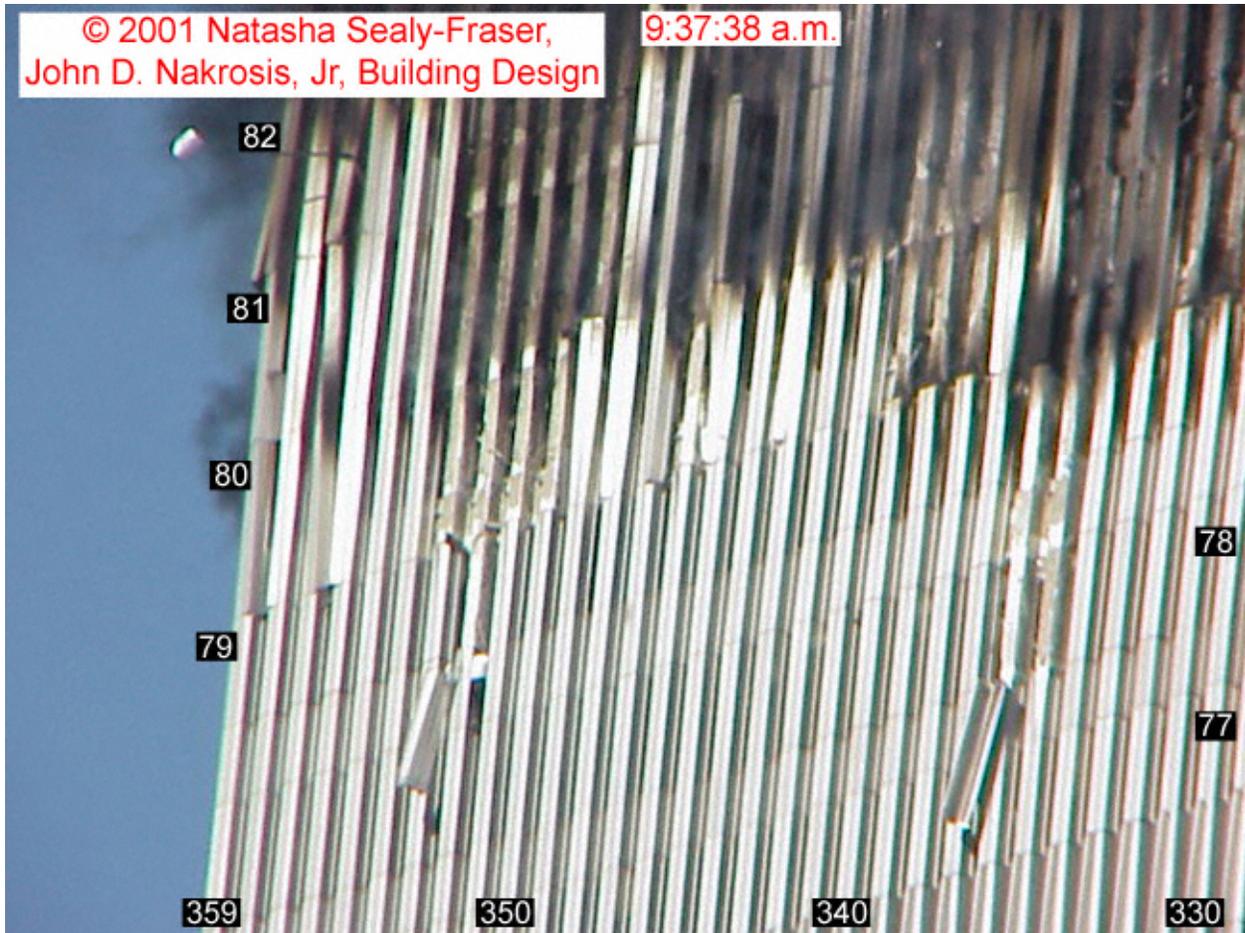
Figure 9-47 show the southern portion of the east face. There is very little smoke and no fire coming from windows in this area. This contrasts sharply with Figure 9-44, in which intense flames and large amounts of smoke were visible coming from numerous windows on the 79th and 80th floors.

**Figure 9-47.** This photograph was taken from the northeast at 9:37:32 a.m. and shows the western portion of WTC 2. The intensity levels have been adjusted, and column and floor numbers have been added.

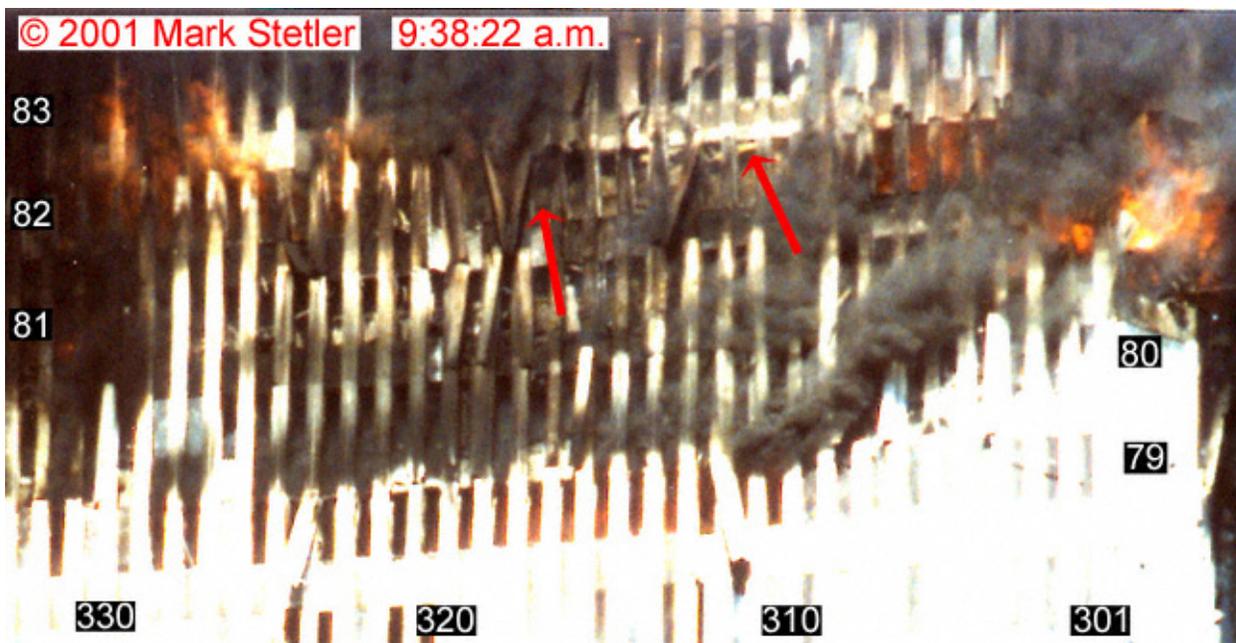
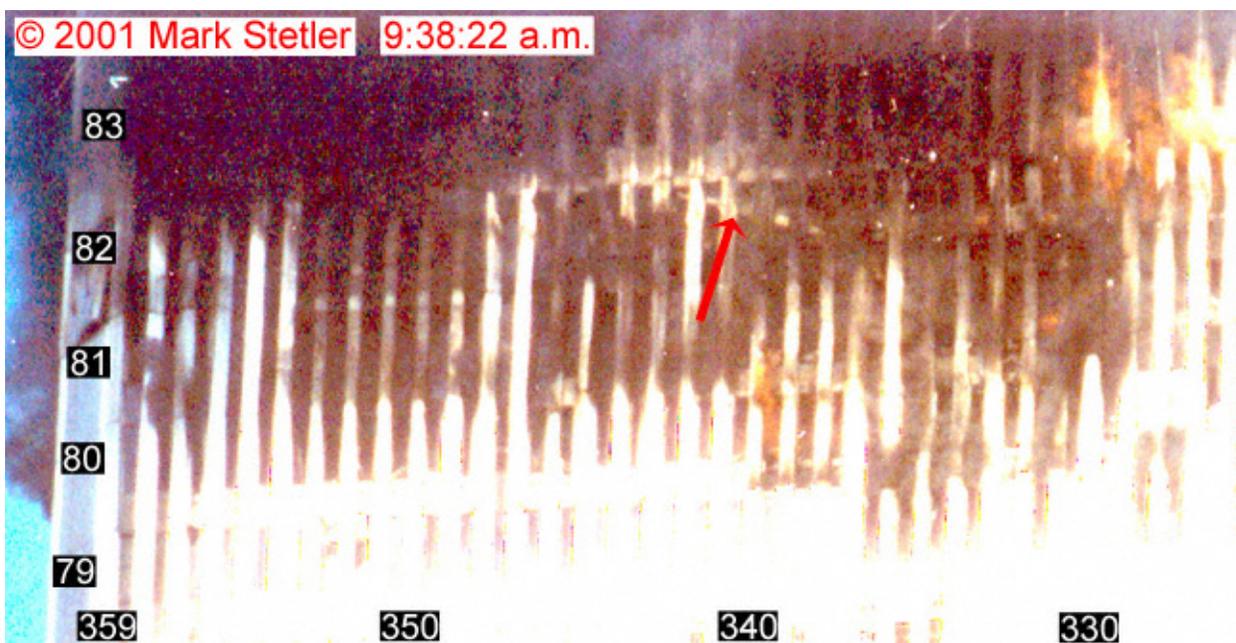
Views of the northern and southern sides of the east face enlarged from the same photograph taken at 9:38:22 a.m. from the east are shown in Figure 9-48. The intensities have been adjusted to overexpose much of the images in order to highlight the object marked with arrows. This is the same hanging object described earlier that has been tentatively identified as the 83rd floor slab. Its appearance has now changed from those seen in Figure 9-1 and Figure 9-2 (9:03:42 a.m.), Figure 9-21 (9:18:38 a.m.), Figure 9-28 (9:27:35 a.m.), Figure 9-31 (9:26:20 a.m.), and Figure 9-40 (9:34:40 a.m.). At these earlier times, the object was visible hanging near the tops of open windows 82-321 to 82-342, even though it did shift downward locally between 9:18:38 a.m. and 9:26:17 a.m. In the bottom image of Figure 9-48, it can still be seen at the top of window 82-342, but now it drops very rapidly and seems to disappear below the base of window 82-337. The object is no longer visible in windows at least as far to the right as window 82-330. Windows immediately to the north of window 82-330 are filled with fire that would hide the object even if it was above the window base.

In the top portion of Figure 9-48, the visible fire area near the center of the 82nd floor ends at window 82-318. Beyond this point, it is possible to see inside the windows again, and the hanging object (marked with arrows) is visible starting near the base of window 82-317 and rising toward the top of window 82-311. This location is 10 windows further north than where the object was seen earlier. These observations suggest that the object, which may have been the 83rd floor slab, that had been hanging near the tops of windows on the 82nd floor since shortly after the aircraft impact sank much lower sometime between 9:34:40 a.m. and 9:38:22 a.m. At some unknown time an additional length of the object became visible on the north side. The fire that had reappeared at the northern edge of the 82nd floor in Figure 9-45 continued to burn at 9:38:22 a.m.

In the top part of Figure 9-48, an extensive fire can be seen on the 79th floor between windows 79-310 and 79-320. There had been indications of a fire in this area prior to the sudden release of smoke and fire (see Figure 9-40). Isolated fires are also visible on the 81st floor at window 81-331 and on the 80th floor at windows 80-338 and 80-339, with flames extended from window 80-339. These latter fires are the only visible remnants of the large fires visible on these floors in Figure 9-43 and Figure 9-44.

**Figure 9-48. These two images show blow-ups of the north and south sides of the east face of WTC 2 taken from a photograph that was shot at 9:38:22 a.m. The intensities have been adjusted to purposefully overexpose parts of the images. Column and floor numbers have been added**

In Fig. 9-66 flames are visible on the 79th floor between windows 79-313 and 79-319 and are coming from window 82-306 to window 82-308 on the 82nd floor. At 9:38:22 a.m. (see Fig. 9-48) fires were observed at the same locations. The earlier photograph was shot in between the periods of heavy smoke flow and external flaming. This shows that these fires are well established and are not associated with the periods of heavy smoke flows and external burning. The fire in the 81st floor northeast corner continued to burn at 9:45:40 a.m.

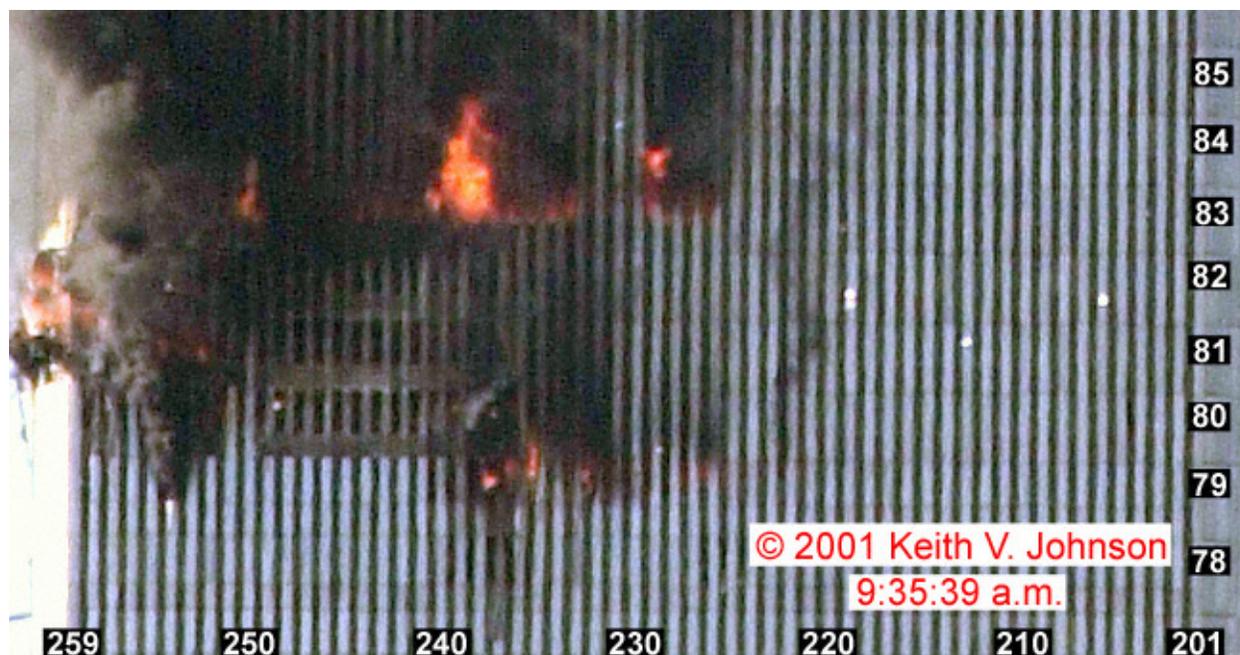
Twenty-one seconds after fire erupted from window 83-226 on the 83rd floor of the north face at 9:33:52 a.m. (see Figure 9-37), window 83-227 opened, and smoke and fire were released. By 9:34:14 a.m. windows 83-228 and 83-229 were also open, and flames were coming from all four windows. A photograph of the area taken at 9:35:39 a.m. is shown in Figure 9-49. The flames in windows 83-226 to 83-229 are visible. Flames are not visible in windows 83-230 to 83-232, but a continuous region of fire extends from window 83-233 to window 83-245. Comparison with Figure 9-36 and Figure 9-37, taken at 9:32:24 a.m. and 9:33:53 a.m., respectively, shows that this fire had died down somewhat from the earlier times and had apparently moved one window to the west. The absence of visible fire immediately adjacent to the new fire location, along with the rapid appearance of flames at multiple windows, observations that indicate flashover took place around this time, suggests that the fire seen in windows 83-226 to 83-229 was burning within an enclosed room. It is not possible to check whether a room was present at this location since floor plans are unavailable for this floor.

**Figure 9-49.** This cropped photograph shows the north face of WTC 2 at 9:35:39 a.m. The intensity levels have been adjusted, and column and floor numbers have been added.

The fire distributions elsewhere on the north face in Figure 9–49 are similar to those in Figure 9–36 and Figure 9–37. Fires were still burning at the east edge of the tower on the 81st, 82nd, and 83rd floors. The debris piles on the 78th floor and in the lower right-hand corner of the cold spot continued to burn, and fire was visible as far west as window 79-225 on the 79th floor. A plume of smoke is visible coming from window 79-222. There are no visible indicators of fire to the west of this window on any of the floors.

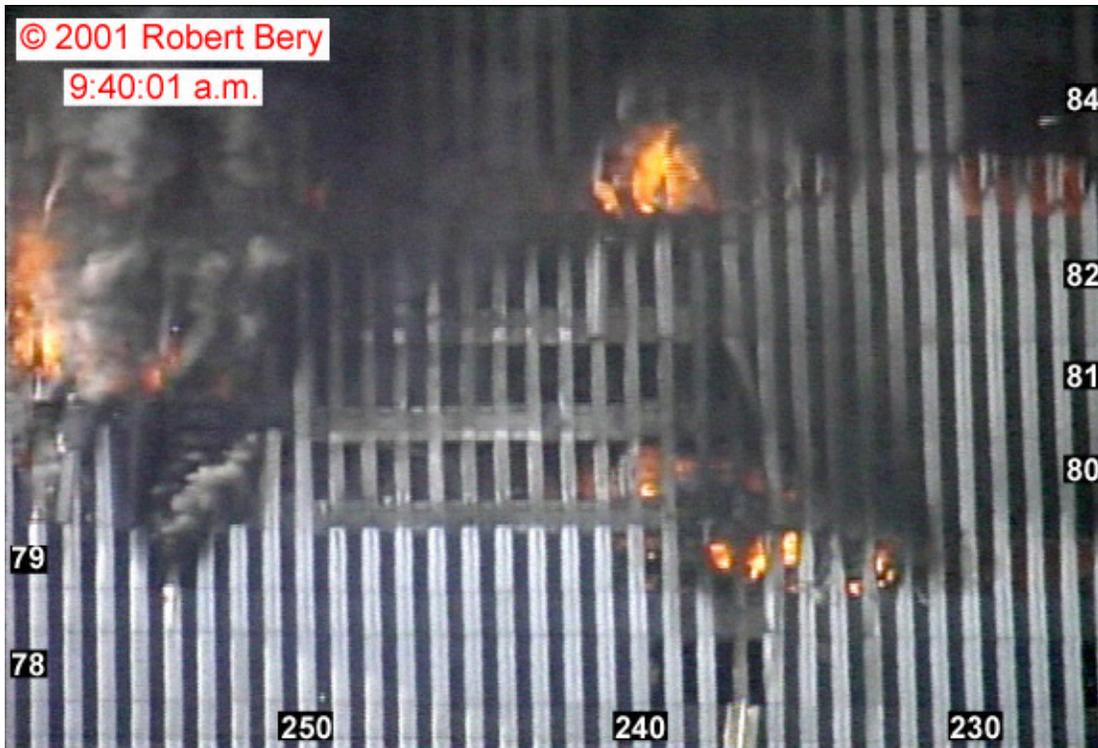
A somewhat closer view of the north face taken at 9:40:01 a.m. is shown in Figure 9–50. Even though the image contains some digital noise, it is sufficiently resolved that open and closed windows can be identified. By this time, the fire visible in windows 83-226 to 83-229 on the 83rd floor no longer had extended flames. The carets on the surrounding aluminum column covers reflect their earlier presence. The three windows immediately to the east, windows 83-230 to 83-232, appear to still have glass in place. Flames continue to extend from windows on this floor above the right-hand side of the cold spot, but flames in windows 83-234 to 83-236 have died down sufficiently that they are no longer visible. Carets around these windows indicate that extended flames were present earlier. The fire on the eastern edge of the 81st floor continues to burn vigorously, hiding the locations immediately above on the 82nd and 83rd floors. The fires burning on piles of debris on the 79th and 80th floors have comparable intensities to those seen in recent images.

**Figure 9-50.** This frame captured from a video shows the north face of WTC 2 at 9:40:01 a.m. The intensity levels have been adjusted, and column and floor numbers have been added.

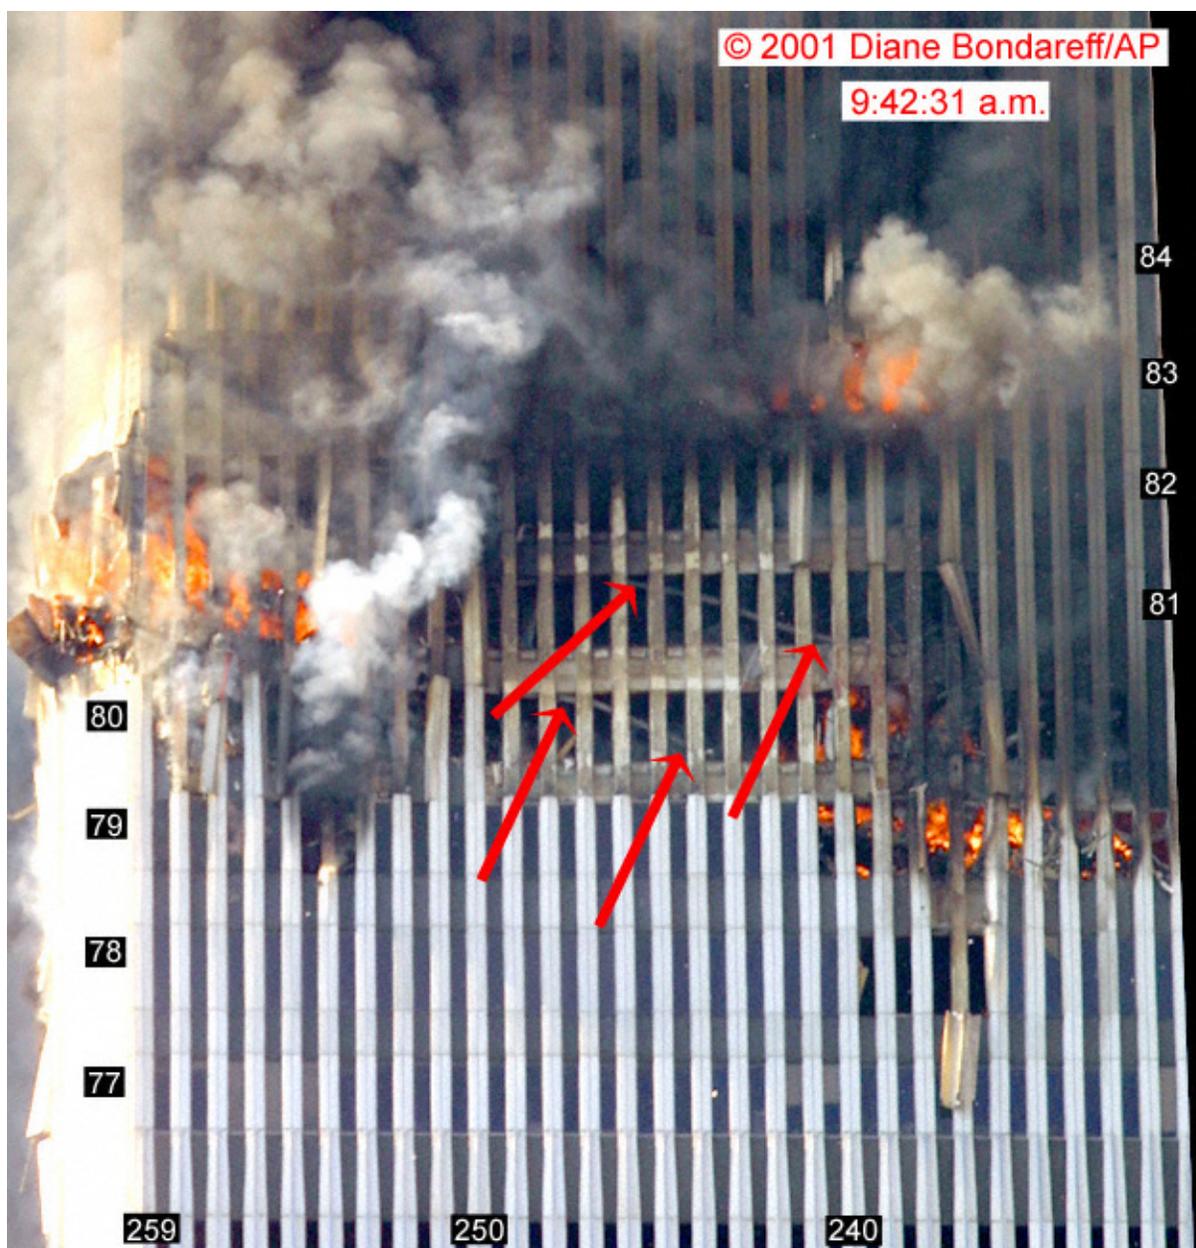
A high-resolution photograph of the area around the cold spot on the north face is reproduced in Figure 9–51. It was shot at 9:42:31 a.m. Arrows have been added to the image to indicate hanging objects that are visible through open windows on the 80th and 81st floors. The area containing the arrows is blown up further in Figure 9–52. It is instructive to compare this image with Figure 9–17, which shows a blowup of roughly the same area at 9:14:03 a.m., and Figure 9–12, which was recorded at 9:10:01 a.m.

**Figure 9-51.** This cropped photograph shows a portion of the north face of WTC 2 at 9:42:31 a.m. The image has been rotated and enhanced by adjusting the intensity levels, and column and floor numbers have been added. The arrows highlight hanging objects visible through open windows on the 80th and 81st floors.

Figure 9–51 provides good views of the fires that continued to burn on the east edge of the north face on the 81st and 82nd floors and on the piles of debris on the right side of the cold spot on the 79th and 80th floors. Flames are also visible on the 83rd floor in windows 83-238 to 83-244. All of these fires have similar appearances to those seen in recent earlier photographs.

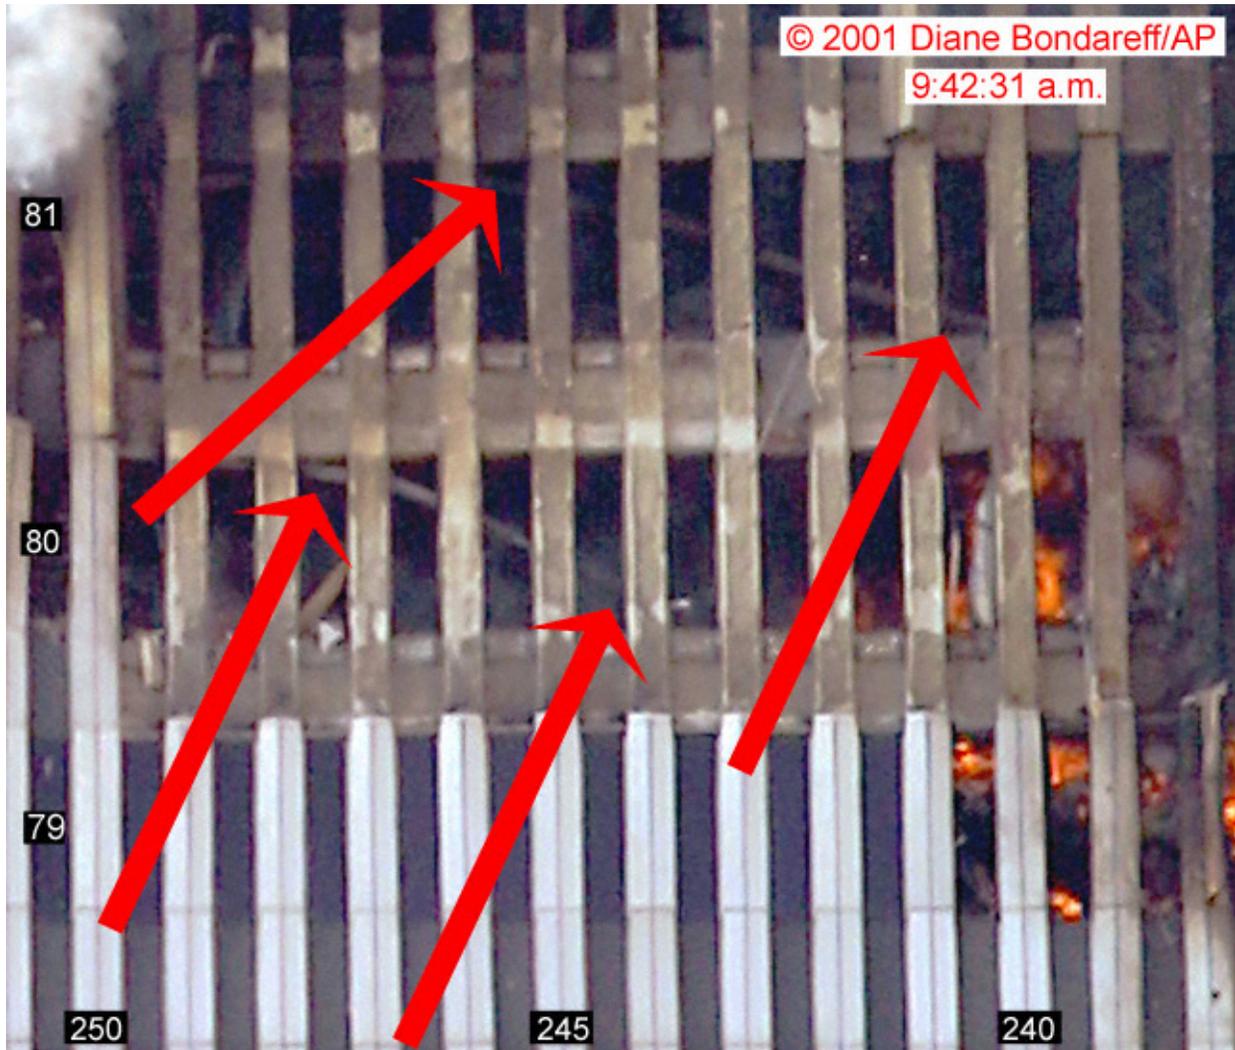
Hanging objects are visible in the two blow-ups shown in Figure 9–17 and Figure 9–52, but it is apparent that their locations and appearances have changed between the times when the two photographs were taken. At the earlier time, two objects were observed through open windows in the cold spot on the 80th floor. The first was located near the center of the windows and extended across the entire area, reaching as far east as window 80-255. The second was visible curving downward in window 80-247 and extending to near the center of window 80-242. In Figure 9–52 the lower object has apparently disappeared completely from view, and the object that was hanging higher up in the windows has dropped down. It now first appears in window 80-248 and curves rapidly downward, seeming to disappear below the spandrel at the base of window 80-243.

In the earlier blow-up there appeared to be two objects hanging in the cold spot on the 81st floor just below the tops of windows 81-239 to 81-242. In Figure 9–52 only a single object is visible through windows in this area of the 81st floor. It now first appears in window 81-245 and curves downward to the base of window 81-240. This object has also apparently shifted position.

Recognizing that the appearances of the hanging objects changed to such a large extent between 9:14 a.m. and 9:42 a.m., lower-resolution images, in which the objects were not well resolved, taken between these times were reviewed. In many of these images there are faint indications of the hanging objects, and it proved possible to narrow down the times when the changes occurred. In Figure 9-32 the objects are barely visible on the 80th and 81st floors at 9:27:04 a.m. Their locations are consistent with those seen in Figure 9-17 on both floors. This is no longer true in Figure 9-35. On the 80th floor the faint hanging object appears to have the same shape as in Figure 9-52, while on the 81st floor the hanging object seems

to be close to the top of the windows. These observations indicate that changes in the location of the hanging objects took place between 9:27:04 a.m. and 9:29:42 a.m. on the 80th floor and sometime between 9:29:42 a.m. and 9:42:31 a.m. on the 81st floor.

**Figure 9-52.** A section of the image shown in Figure 9–51 is blown up. The arrows point to the locations of hanging objects that are visible through open windows on the 80th and 81st floors on the north side of WTC 2. Column and floor numbers have been added.

In contrast to the 81st floor, the appearance of the hanging object visible through windows 80-245 to 80-248 on the 80th floor in Figure 9-79 is very similar to that seen in Figure 9-52 (taken at 9:42:31 a.m.), Figure 9-62, and Figure 9-73. Recall that this object appeared at this location sometime between 9:27:04 a.m. and 9:29:42 a.m. It has remained stable for around 30 min.

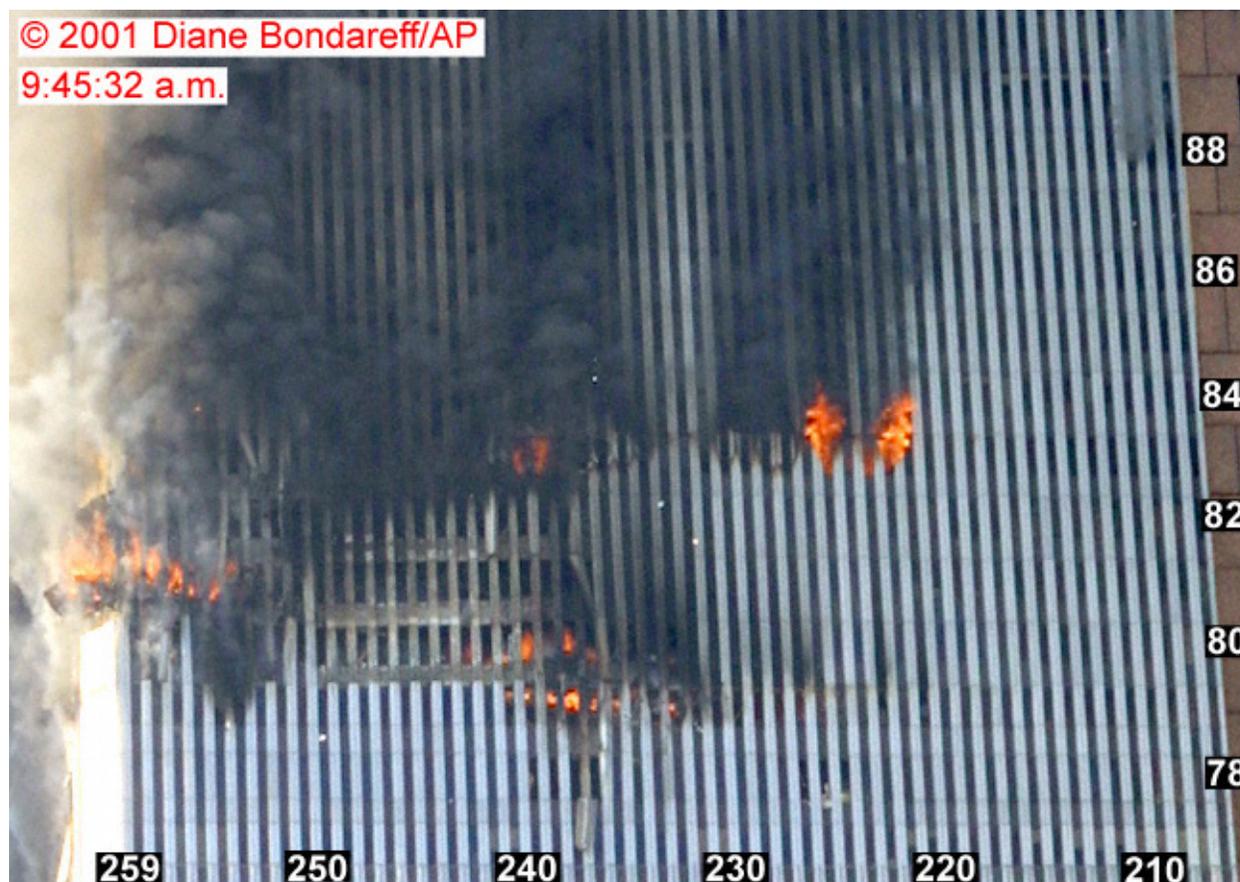
A video shows that a stream of smoke appeared from window 83-224 on the 83rd floor of the north face at 9:42:26 a.m., and a small object (window glass?) fell from the location at the same time. Twenty-seven seconds later, the smoke plume burst into flames. At 9:45:02 a.m. there was another burst of smoke and a falling object from window 83-222, followed by flames 5 s later. This flame spread to window 83-221 at 9:45:25 a.m. A photograph face taken 7 s later is shown in Figure 9–53. Two long tongues of flames are

coming from windows 83-221 and 83-224. Flames are no longer visible in windows 83-226 to 83-230, even though carets are visible on adjacent column covers. Windows 83-225, 83-231, and 83-232 appear to have glass in place. The sudden and isolated development of a fire on the 83rd floor in windows 83-221 to 83-224 suggests again that flashover within a room has occurred. The fire on this floor near the left edge of the cold spot has died down with internal flames only visible in windows 83-238 and 83-239.

**Figure 9-53.** This image of the north face of WTC 2 was taken at 9:45:32 a.m. The photograph has been cropped and rotated, and the intensity levels have been adjusted. Column and floor numbers have been added. The brown area to the right is the eastern edge of WTC 7.

The fire burning on the eastern edge of the north face on the 81st floor continues to burn vigorously, but flames are not visible in the 82nd floor windows at this time. A small fire is visible in window 83-259 on the 83rd floor. The fires on the 79th and 80th floors near the center of the north face continue to burn on the piles of debris. Fires are not evident on the 79th floor to the west of window 79-230, even though smoke marks and open windows at 79-220 and 79-222 are evidence of the earlier burning observed in this area.

In Figure 9–53 an isolated smoke plume is visible on the 88th floor coming from window 88-208. This is another location where it is possible that people have broken out a window. A photograph shot just before 9:45 a.m. showed that windows 88-201 to 88-203 were also open.

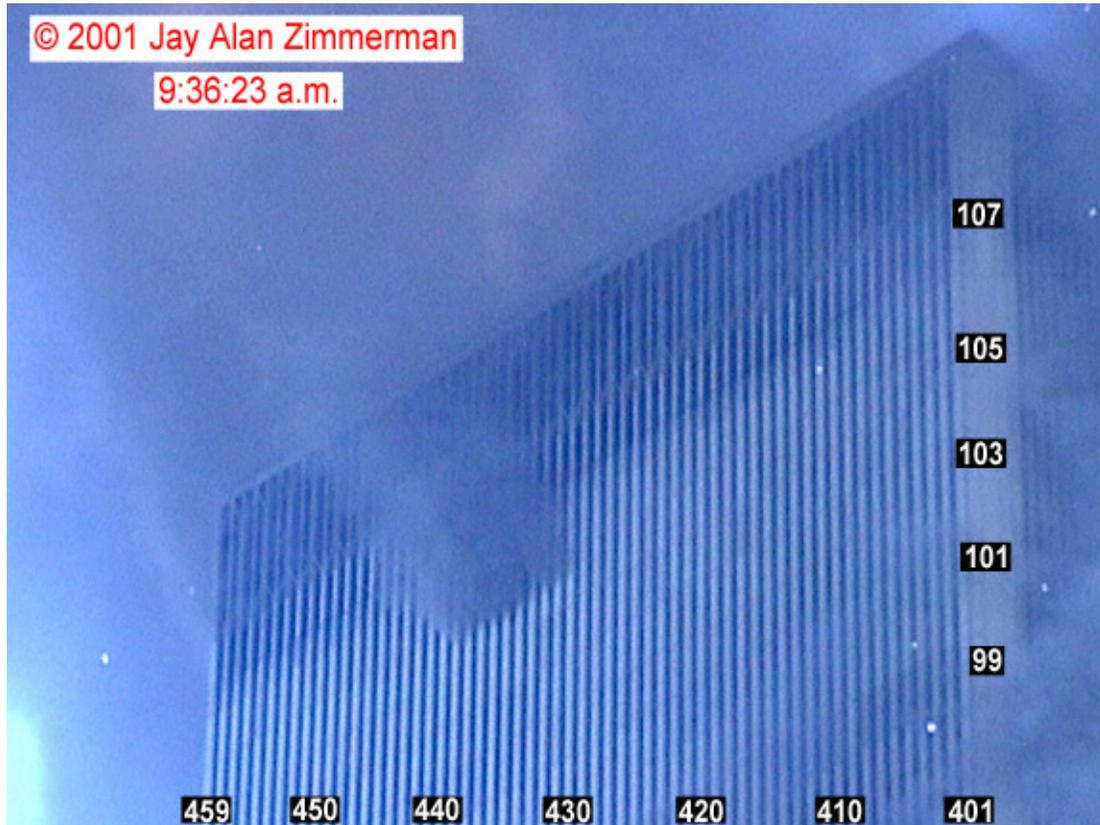
Clear close-up images of the fires on the south face of WTC 2 are limited between 9:30 a.m. and 9:38 a.m. Figure 9–54 shows a frame taken from a video of the upper portion of the south face at 9:36:23 a.m. It has been included because at this time the smoke on the face cleared sufficiently to observe that heavy smoke was coming from multiple windows, extending from roughly window 105-430 to window 105-438, on the 105th floor. This is another location where people may have broken open windows. This was the only location above the fire floors where smoke flow from open windows was evident on this face. In particular, no smoke was observed flowing from the upper mechanical equipment room floors.

**Figure 9-54.** This image is taken from a video shot from the southeast and shows the upper portion of the south face of WTC 2 at 9:36:23 a.m. The intensity levels have been adjusted, and column and floor numbers have been added.

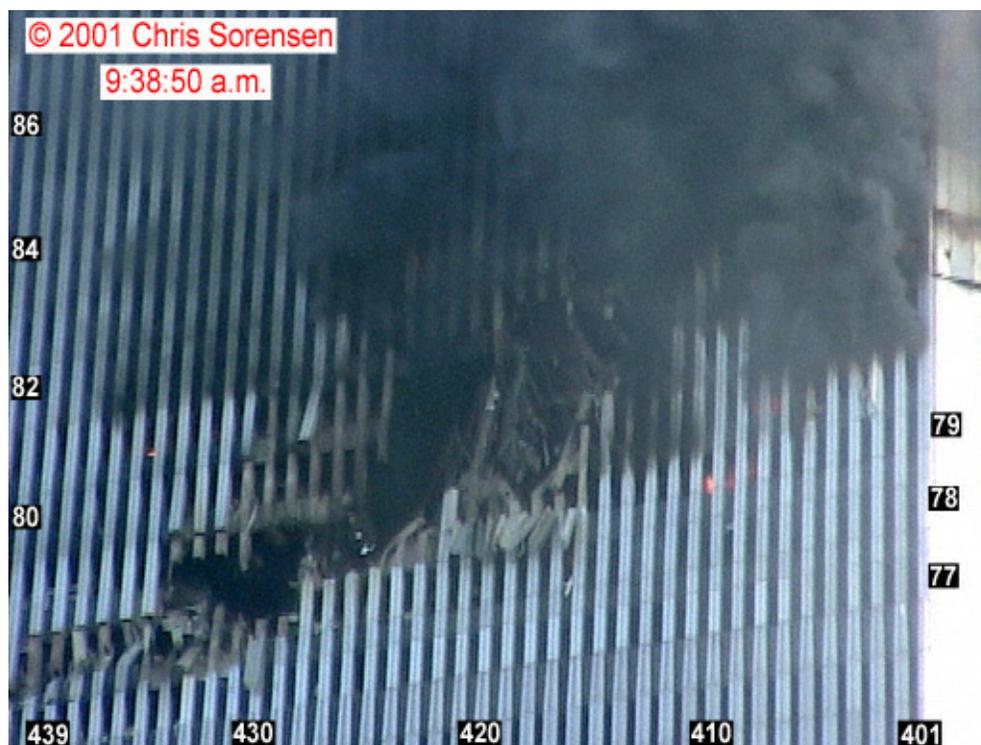
A video shows that heavy smoke began flowing from windows at the eastern edge of the south face on the 80th floor at 9:38:12 a.m. This smoke is visible coming from windows 80-401 to 80-408 in Figure 9–55, which shows a frame captured from a video recorded at 9:38:50 a.m. In the video, fire, which is visible inside windows 80-407 and 80-408, occasionally extended from these windows. The smoke coming from the 80th floor tended to hide the windows on the floors immediately above, but there were brief glimpses of a fire burning on the 83rd floor.

Comparison of Figure 9–55 with Figure 9–41, which was taken roughly 8½ min earlier, shows that changes in fire locations and intensities have taken place on the south face. In comparing the images it should be kept in mind that Figure 9–55 was shot from further east and, as a result, low intensity fires are likely to be hidden by columns. With this caveat in mind, it is clear that the large fire visible in windows 81-431 to 81-435 to the left of the aircraft impact cavity in Figure 9–41 has died down. In Figure 9–55

only a small spot fire is visible near the bottom of window 81-435. On the 79th floor, flames are no longer evident near window 79-426, but the fire has migrated to the east from this area, and burning is now visible in windows 79-408 to 79-410.

**Figure 9-55.** This image of the south face of WTC 2 was captured from a video recorded at 9:38:50 a.m. The intensity levels have been adjusted, and column and floor numbers have been added.

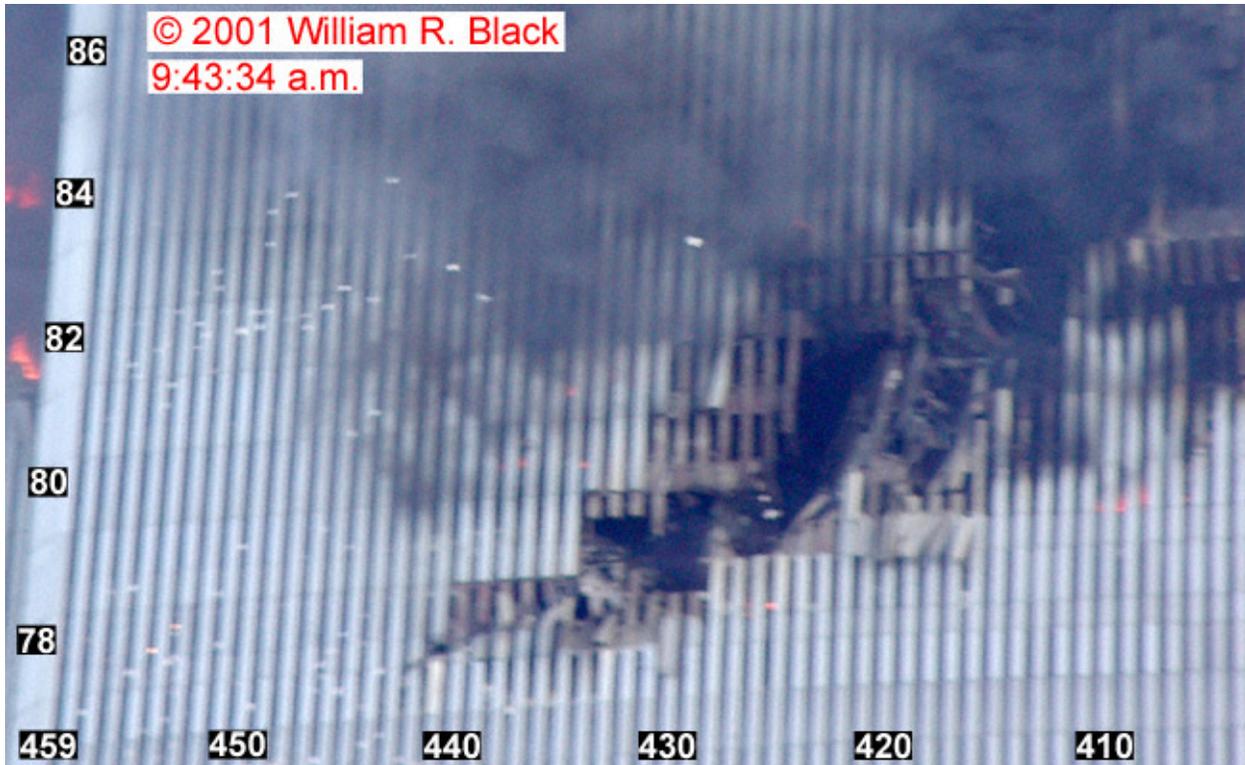
Another view of the south face taken at 9:43:34 a.m. is shown in Figure 9-56. More widespread flames are visible than in Figure 9-55 because it was shot from a location more directly to the south and further away. Low intensity fires are visible on the 80th and 81st floors to the west of the aircraft impact cavity. The fire on the 81st floor is a remnant of the intense fire seen in this area at 9:30:19 a.m. (see Figure 9-41), while the fire on the 80th floor has been burning at a low level since at least 9:23 a.m. (see Figure 9-26). A small fire, which has been burning on the 78th floor just to the east of the aircraft impact cavity since shortly after the impact, is also evident.

The fire on the east side of the 79th floor in windows 79-408 to 79-410 in Figure 9-55 was also present at 9:43:34 a.m., and there is now an indication of flame at window 79-406. The heavy smoke and fire present on the 80th floor at 9:38:50 a.m. seem to have dissipated, and it is possible to see the base of the 83rd floor on the eastern edge. Videos suggest that this change occurred around 9:40 a.m. There are now no flames visible east of the aircraft impact cavity on the 80th through 82nd floors as far east as column 404, which is the last column visible in the image.

**Figure 9-56.** This cropped, slightly out of focus photograph of the south face of WTC 2 was shot at 9:43:34 a.m. The intensity levels have been adjusted, and column and floor numbers have been added. The flames visible to the left of the western edge of WTC 2 are on the south side of WTC 1.

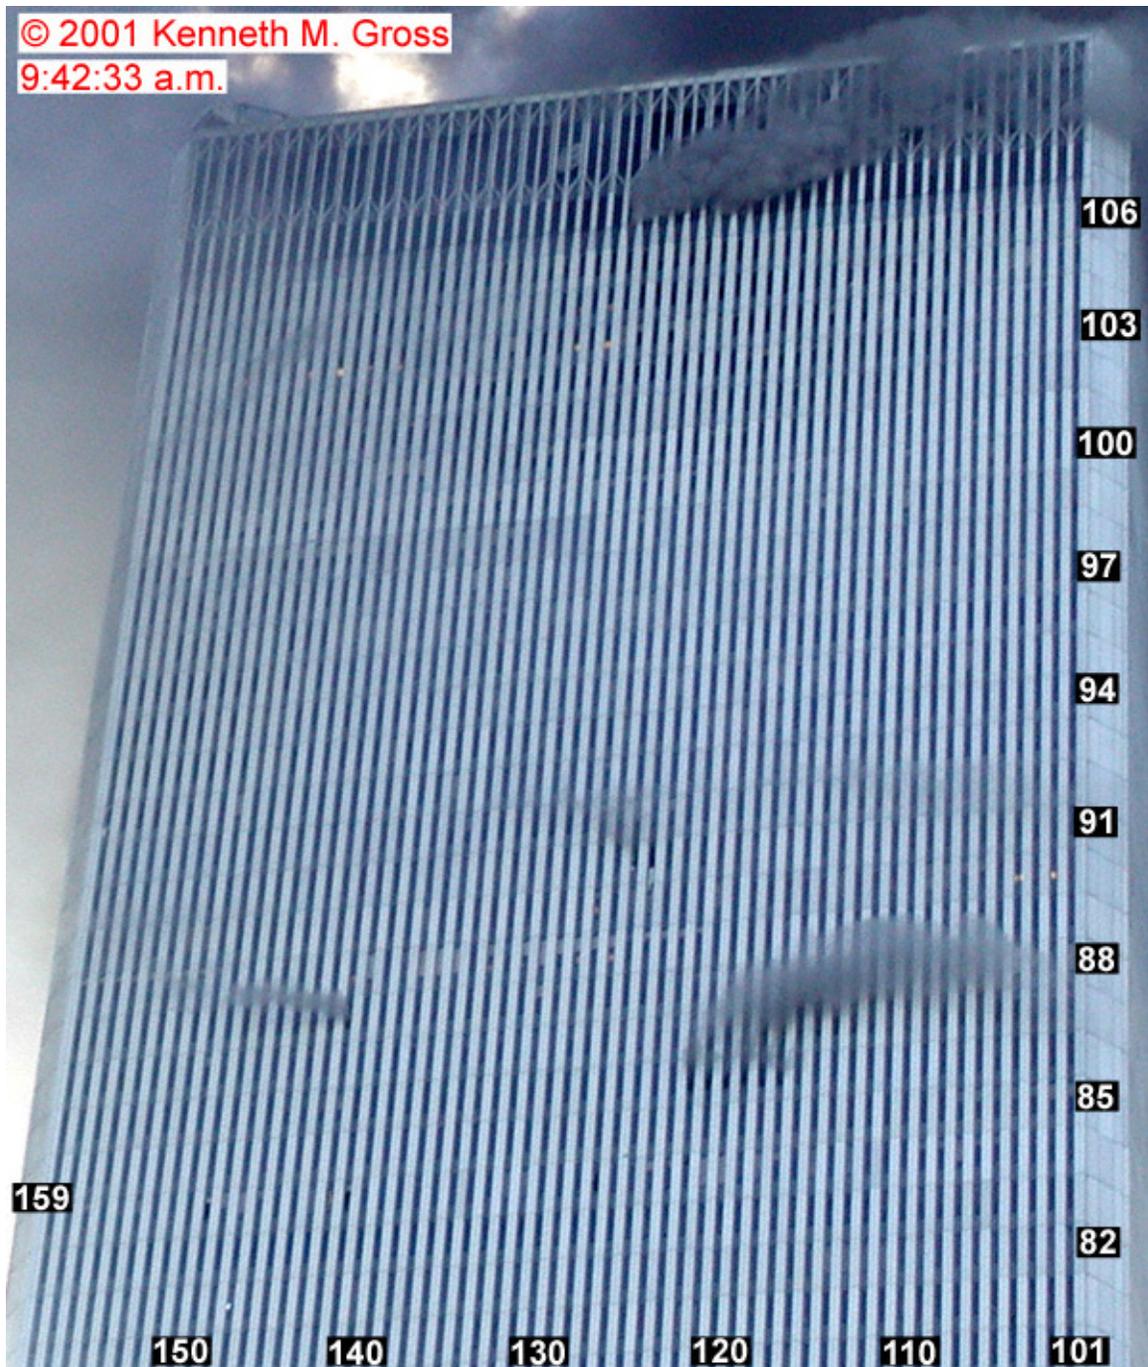
A clear view of the west face of WTC 2 at 9:42:33 a.m. is shown in Figure 9–57. Smoke is visible coming from several windows on the 86th, 88th, 91st, 105th, and 107th floors, as well as from the mechanical equipment room on the 108th and 109th floors. These locations include windows 86-117 to 86-122, 88-142, 91-125 and 91-126, 105-148, 107-123 to 107-129, and the two right-most windows on the 108th floor. Smoke was observed coming from these same locations at 9:34:19 a.m. (see Figure 9–42), with the exception of the windows on the 91st and 105th floors. These two locations had light smoke flows, and it is difficult to determine when the windows were opened.

In Figure 9–42 smoke was also coming from a window, 84-149, on the 84th floor. Smoke is not visible at this location in Figure 9–57, but the image has sufficient resolution to confirm that this window was open. Windows 84-141 and 84-127 also appear to be open on this floor. It is interesting that no smoke seems to be flowing from the open windows that are located closest to the fire floors. No other open windows are apparent on lower floors (note that the image from which Figure 9–57 was cropped extended as far down as the mechanical equipment room on the 76th floor).

On several floors electric lights are visible through windows on the west face in Figure 9–57. These include the 104th floor. The fact that lights remained on for floors well above the aircraft impact floors means that the aircraft did not cut all of the power lines running to the top of the tower as it passed through the core.

**Figure 9-57.** This cropped photograph shows the west face of WTC 2 at 9:42:33 a.m. It has been rotated and enhanced by adjusting the intensity levels. Column and floor numbers have been added.

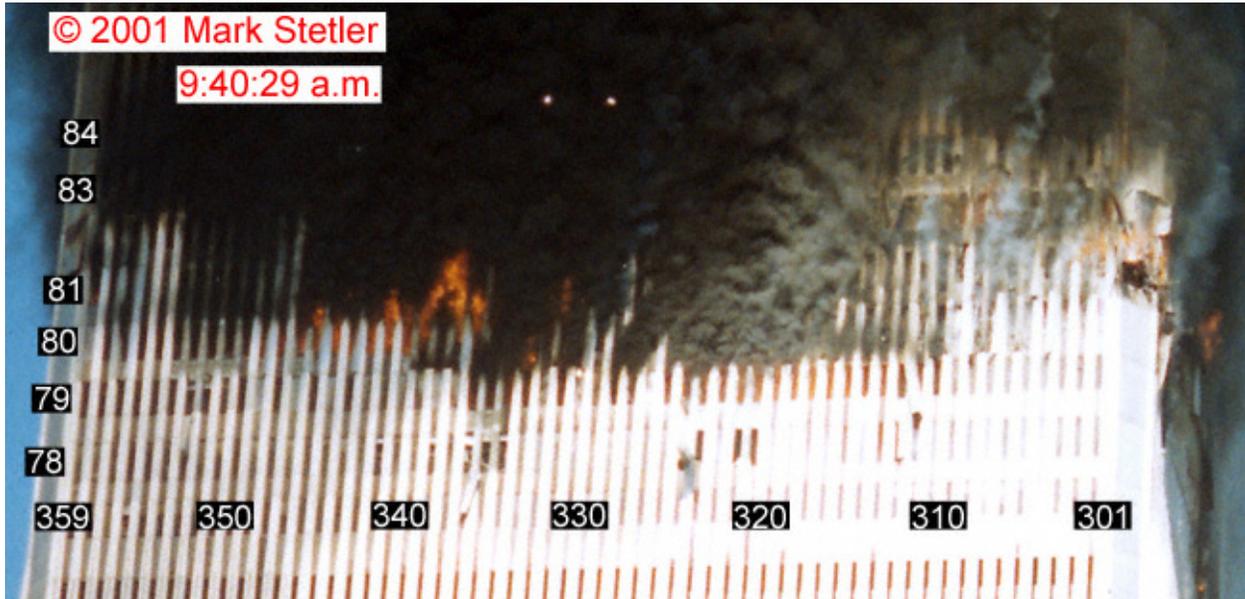
The relatively quiescent appearance of the east face at 9:38:22 a.m. is shown in Figure 9-48. Videos reveal that between 9:38 a.m. and 9:45 a.m. the fires on the east face of WTC 2 went through two additional periods, similar to that described above, in which heavy smoke and intense fires occurred for relatively short periods on the 79th and 80th floors. The first took place from roughly 9:39:53 a.m. to 9:40:41 a.m. Figure 9-58 shows a photograph of the east face taken at 9:40:29 a.m. during this time.

Fires are visible in Figure 9–58 on the 79th and 80th floors at roughly the same locations as in the photograph shown in Figure 9–43 and Figure 9–44, which was taken at 9:36:14 a.m. The fires are particularly heavy on the 80th floor near windows 80-331 to 80-339. The duration (roughly 50 s) of the heavy smoke flows and fires is comparable to that of the earlier event observed between 9:35:45 a.m. and 9:36:50 a.m. This suggests that the cause for the short-lived burning is the same. Therefore it is also tentatively attributed to the burning of a pool of aviation fuel somewhere inside the tower.

**Figure 9-58.** This cropped photograph showing the east face of WTC 2 was taken at 9:40:29 a.m. Column and floor numbers have been added.
