## Chapter 9

# FIRE BEHAVIOR IN WORLD TRADE CENTER 2

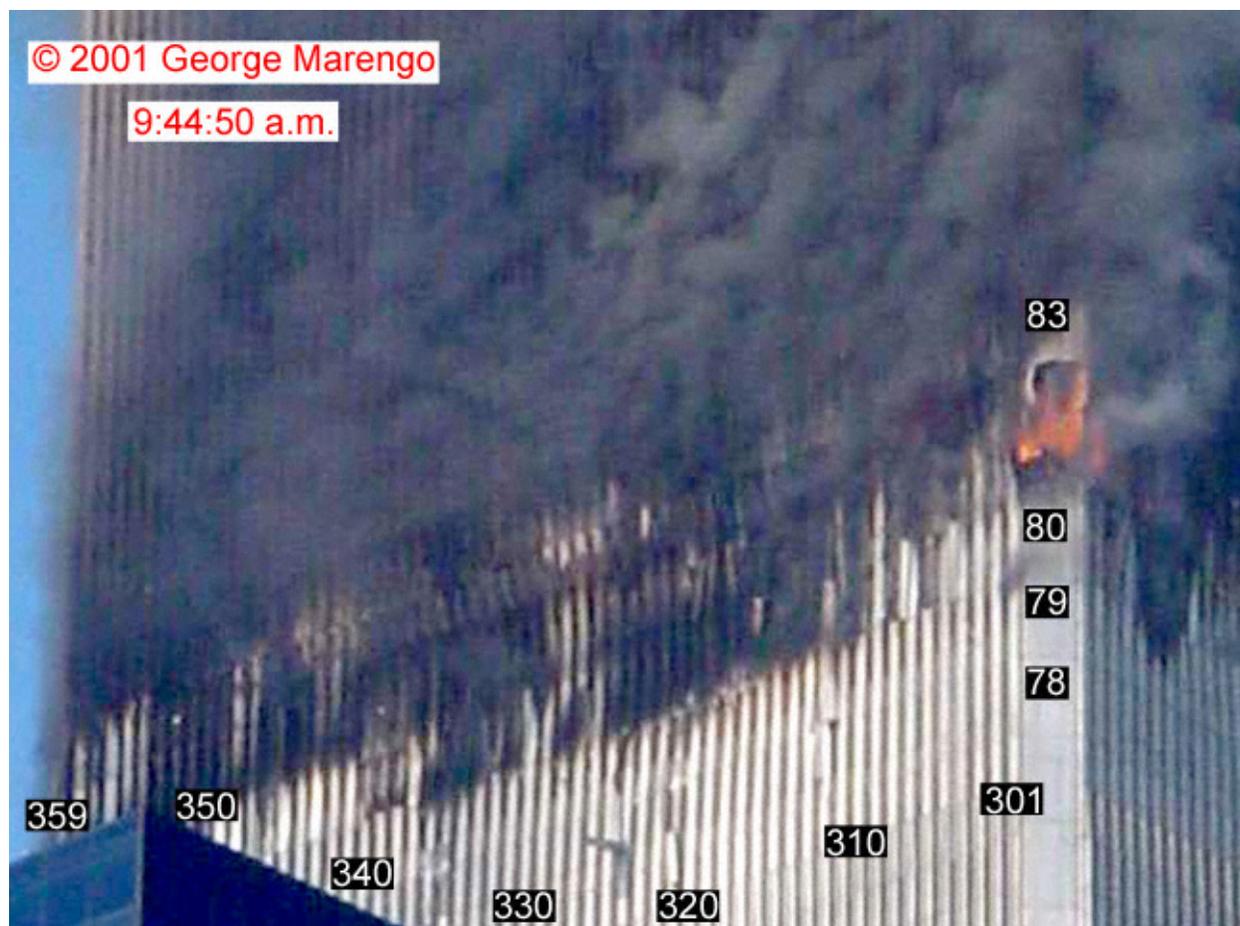
During the periods when the heavy smoke and fires were not present on the east face, its appearance was similar to that seen in Figure 9–48. Occasionally, coordinated puffs of smoke similar to those described earlier were observed coming from windows on the face. Figure 9–59 shows the east face at 9:44:50 a.m. in a photograph shot from the northeast. The amount of smoke coming from lower floors is light, and most of the face is visible. From this angle very little fire is evident, indicating that flames have receded back into the building or died down at many locations on the face. In particular, the heavy flames present near the center of the face in Figure 9–46 and Figure 9–48 seem to have died down by this time. There is evidence for a fire burning on the 82nd floor near the northern edge of the face. Fire had been observed here earlier. The fire in the northeast corner of the 81st floor continued to burn vigorously at 9:44:50 a.m. The bright flame attributed to metal combustion is still evident, but has markedly decreased in intensity.

In Figure 9–59 the columns near the center of the east face on the 80th and 81st floors appear to be bowing inward. A similar feature was identified earlier in Figure 9–46. This photograph provides additional visual evidence that the bowing was actually taking place and for its extent.

**Figure 9-59.** This cropped photograph was shot from the northeast and shows the east face of WTC 2 at 9:44:50 a.m. The original intensity levels have been adjusted, and column and floor numbers have been added.

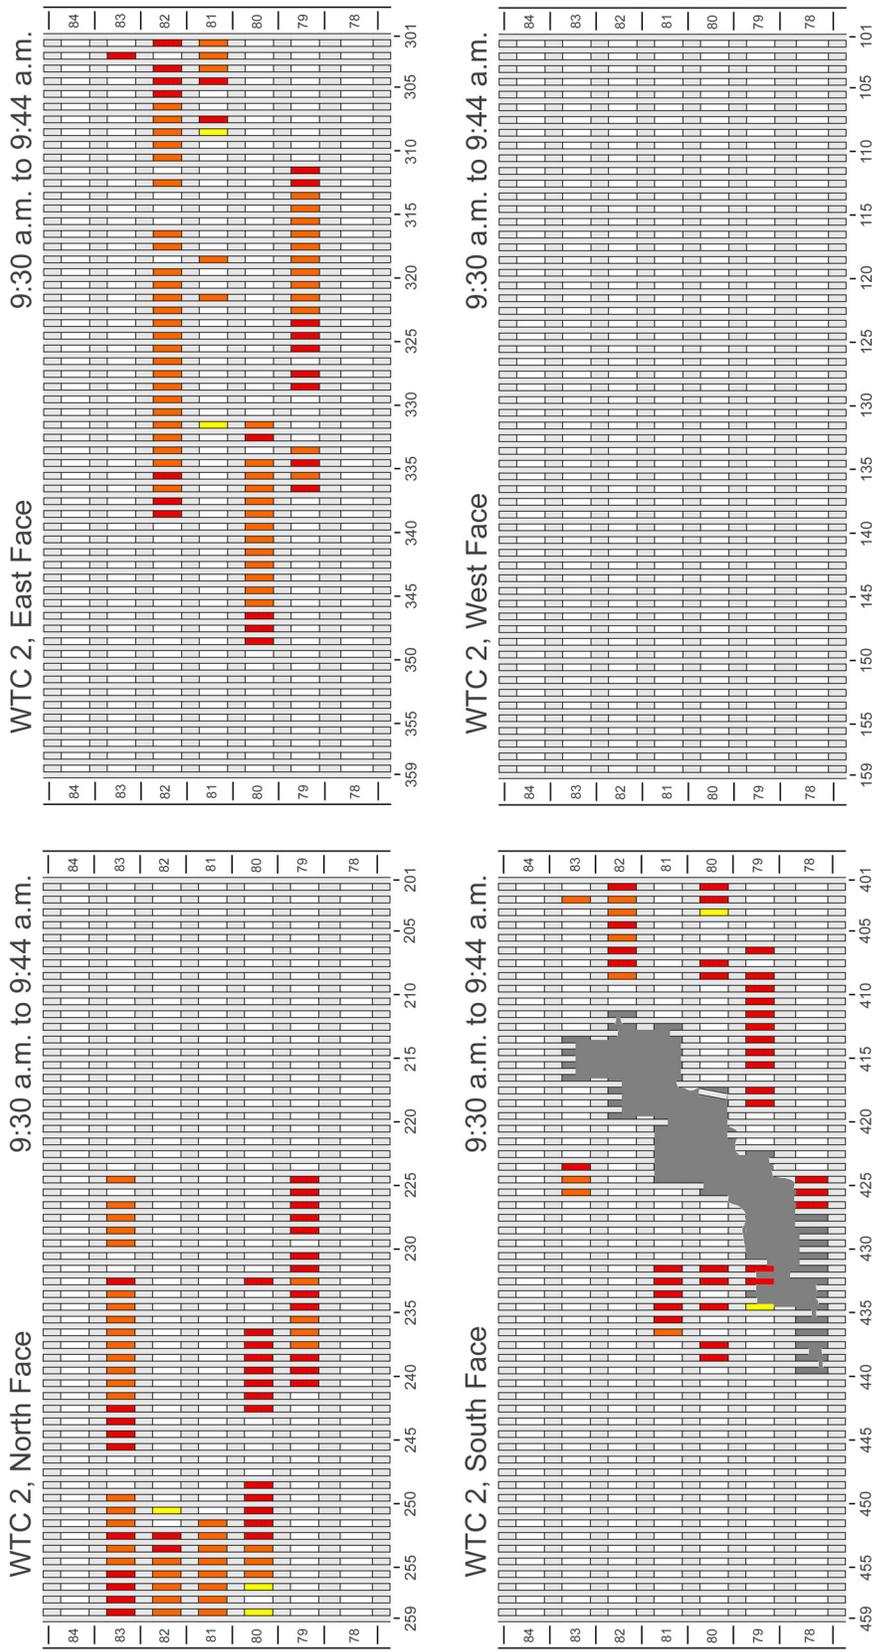
The fire behaviors and changes in distribution are more easily followed by comparing Figure 9-60, which shows integrated fire intensity maps for the four faces of WTC 2 during the period, with the corresponding maps for the period from 9:15 a.m. to 9:29 a.m. shown in Figure 9-34.

**Figure 9-60. Maps of integrated fire observations between 9:30 a.m. and 9:45 a.m. are shown for the four faces of WTC 2. Colors represent the highest intensity fire observed in a window using the color scale defined in Figure 5-1.**

Fires on the north face that were ignited on piles of debris on the 79th, 81st, and 82nd floors shortly after the aircraft impact, along with a fire that grew somewhat later on a debris pile on the 80th floor continued to burn throughout the period. At 9:29:15 a.m. a fire grew and spread rapidly on the 83rd floor just above the west side of the cold spot. During the period this fire spread to the west in two separate steps, reaching window 83-221 by 9:45:25 a.m. There was also evidence for westward fire spread on the 79th floor. Even though some small fires continued to burn at the periphery of the cold spot, the area continued to be mostly free of fire during the period. The fire behavior on the east face during this period was complex. In addition to the short periods of intense smoke release and burning on the 79th and 80th floors discussed above, a large fire with external flames burned for a short period on the 82nd floor near the center of the face. A fire on the northern edge of the 82nd floor, that had apparently died down earlier, reappeared. The 81st floor fire burning near and in the northeast corner continued to burn throughout the period. An unusually bright flame was observed in the corner that was attributed to metal combustion.

On the south face several fires on various floors around the aircraft impact cavity died down. A small fire was observed on the 83rd floor above the aircraft impact area. A new region of fire, as indicated by the presence of smoke and flame in windows 80-401 to 80-408, burned briefly on the eastern side of the 80th floor. A fire that had first appeared on the 79th floor to the east of the impact cavity around 9:15 a.m. continued to spread toward the east.

There were no indications of fire reaching the west face during the period. Smoke flow from additional open windows above the fire floors was observed and, as for earlier times, possibly caused by people breaking out the glass.

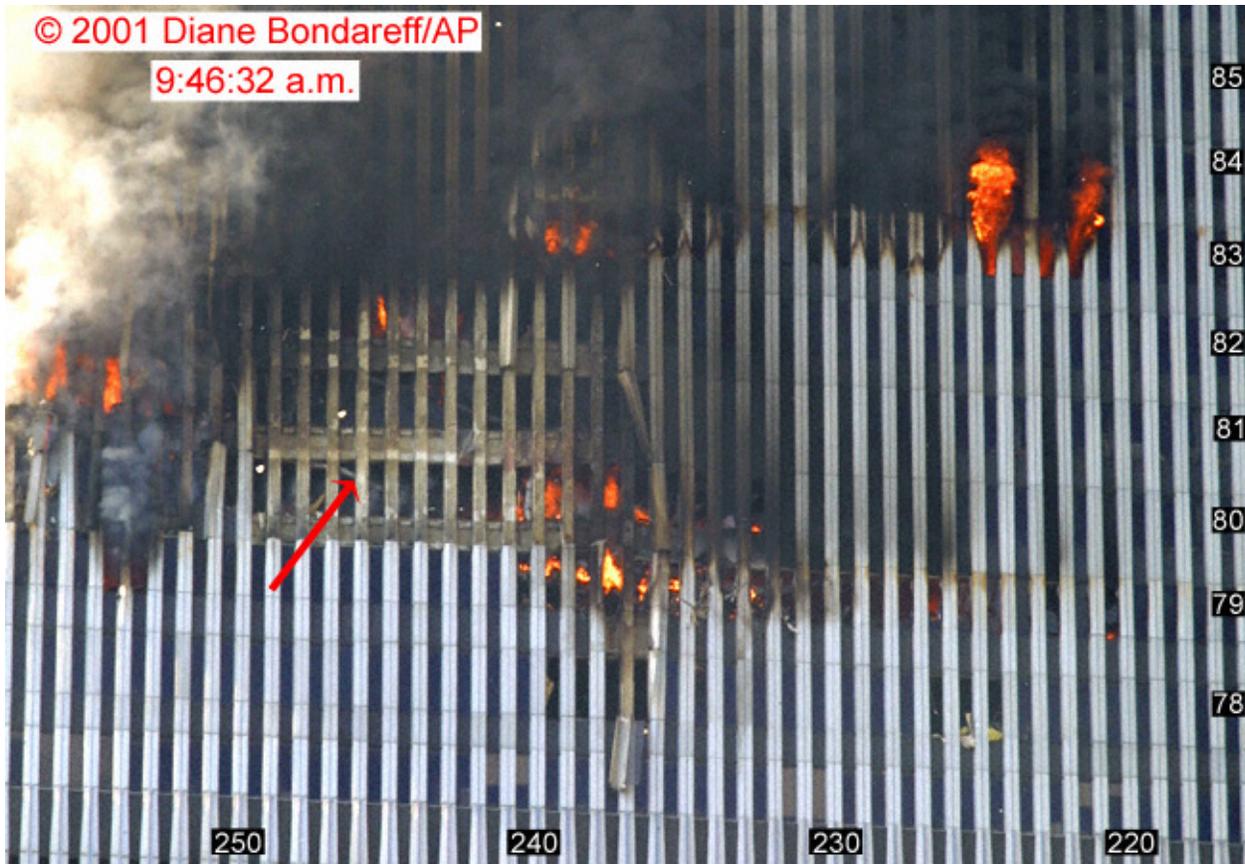
Figure 9–61 shows a photograph of the north face taken at 9:46:32 a.m. It was shot exactly 1 min after the image shown in Figure 9–53. While the fire distributions look similar in the two photographs, there has been a significant change. At 9:46:32 a.m. a substantial fire is visible near the center of the cold spot on the 82nd floor. Prior to this time, there had been no indication of a fire at this location. The photograph in Figure 9–61 was shot with high resolution and magnification. It is possible to enlarge it substantially. Two blow-ups of areas in the image are shown in Figure 9–62 and Figure 9–63. In the blow-ups the intensities have been adjusted to highlight darker regions.

**Figure 9-61.** This cropped photograph shows the north face of WTC 1 at 9:46:32 a.m. The intensity levels have been adjusted, and column and floor numbers have been added. The arrow indicates a hanging object visible through windows on the 80th floor.

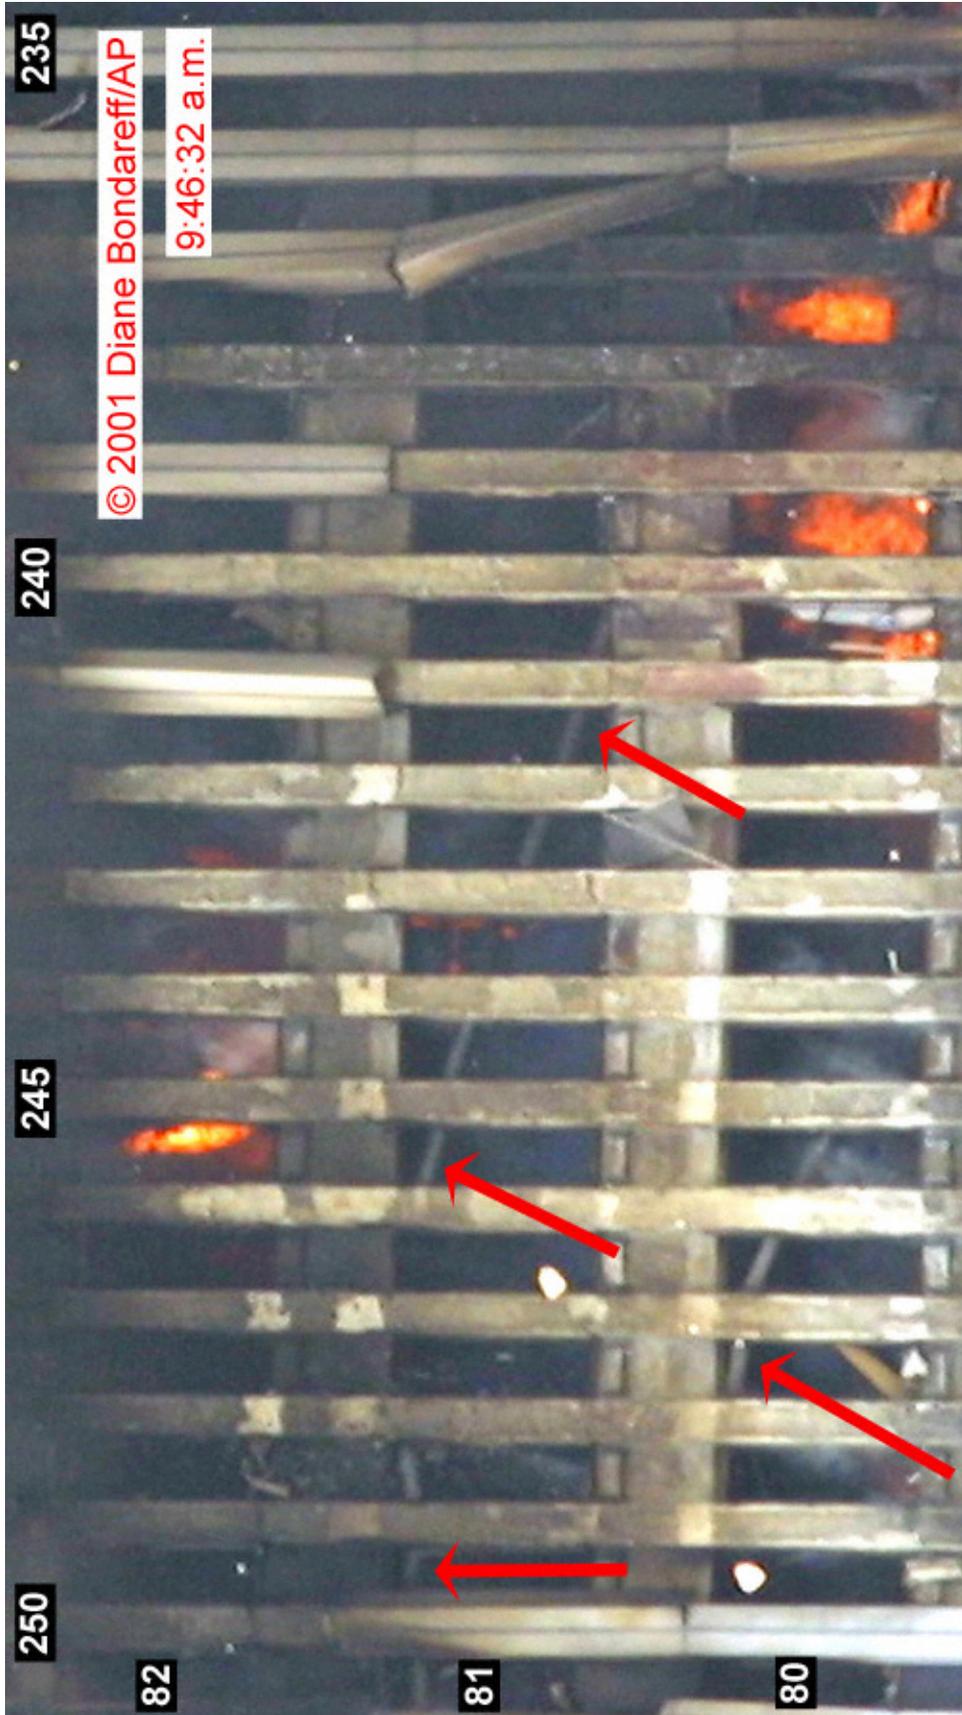
Figure 9–62 shows an enlargement of the area of the north face encompassing the cold spot. Here it can be seen that the fire that has grown on the 82nd floor consists of the bright flame visible through window 82-245 and duller flames that appear to be further back from windows 82-242 to 82-244 and 82-246. There is no indication of where this fire spread from. A hanging object, marked with arrows, is visible through the open windows on the floor immediately below the fire. This object was not immediately apparent in Figure 9–61, but became visible when the image intensities were further adjusted to highlight dark areas. This object was observed at the same location at 9:42:31 a.m. in the image shown in Figure 9–51 and Figure 9–52. Note that there is a section of the object visible near the tops of windows 81-248 to 81-250 that was not clear in Figure 9–52.

Closer inspection of Figure 9–62 shows that small dull-colored flames are visible on the 81st floor through windows 81-243 and 81-244 at the level of and above the hanging object. This suggests that a fire is burning on top of the object. It is possible that this fire is burning at the base of a debris pile that is also providing fuel for the fire visible immediately above on the 82nd floor. If true, this means that the hanging object is most likely a portion of the 82nd floor that has broken away from the spandrel at the base of the 82nd floor and settled to its current location from above.

The hanging object visible in Figure 9–62 on the 80th floor is also in the same position as observed at 9:42:31 a.m. In this closer view it has a very similar appearance to the hanging object on the 81st floor. Therefore, it appears to be a portion of the 81st floor slab that has separated from the spandrel and dropped down from above.

The fire that had been burning at the lower left-hand corner of the cold spot since before 9:15 a.m. is still burning vigorously in Figure 9–62. This long burning time suggests that the fuel is a large debris pile since typical office fuels should have burned out by this time. It may be that the 80th floor slab is missing in this area and that the fires visible on the 79th and 80th floors (see Figure 9–61) are actually burning on the same pile of debris. There is weak evidence to support such a conclusion. The arrows in Figure 9–63 have been added to highlight what may be a hanging object in windows 79-229 to 79-233 on the 79th

Figure 9-62. This image is enlarged from the photograph included in Figure 9-61 and shows the cold spot on the north face of WTC 2 at 9:46:32 a.m. The intensities have been adjusted to enhance dark areas, and column and floor numbers have been added. The arrows point to hanging objects visible on the 80th and 81st floors.

The contrast available in Figure 9–62 and Figure 9–63 is sufficient to identify whether or not glass has been broken out of windows. In Figure 9–62 the only window that is closed is window 81-235. In Figure 9–63 several windows are visible on the 79th floor in which glass has been partially removed, presumably due to heating from the nearby fire. The westernmost of these is window 79-220. A small spot fire is visible at the base of this window. On the 80th floor the westernmost open window is window 80-232. A small fire is also present in this window. The glass in the window to the immediate left, window 80-233, appears to be intact. Several open windows are visible on the 78th floor. These have been previously identified as having been broken during the aircraft impact and subsequent fireballs.

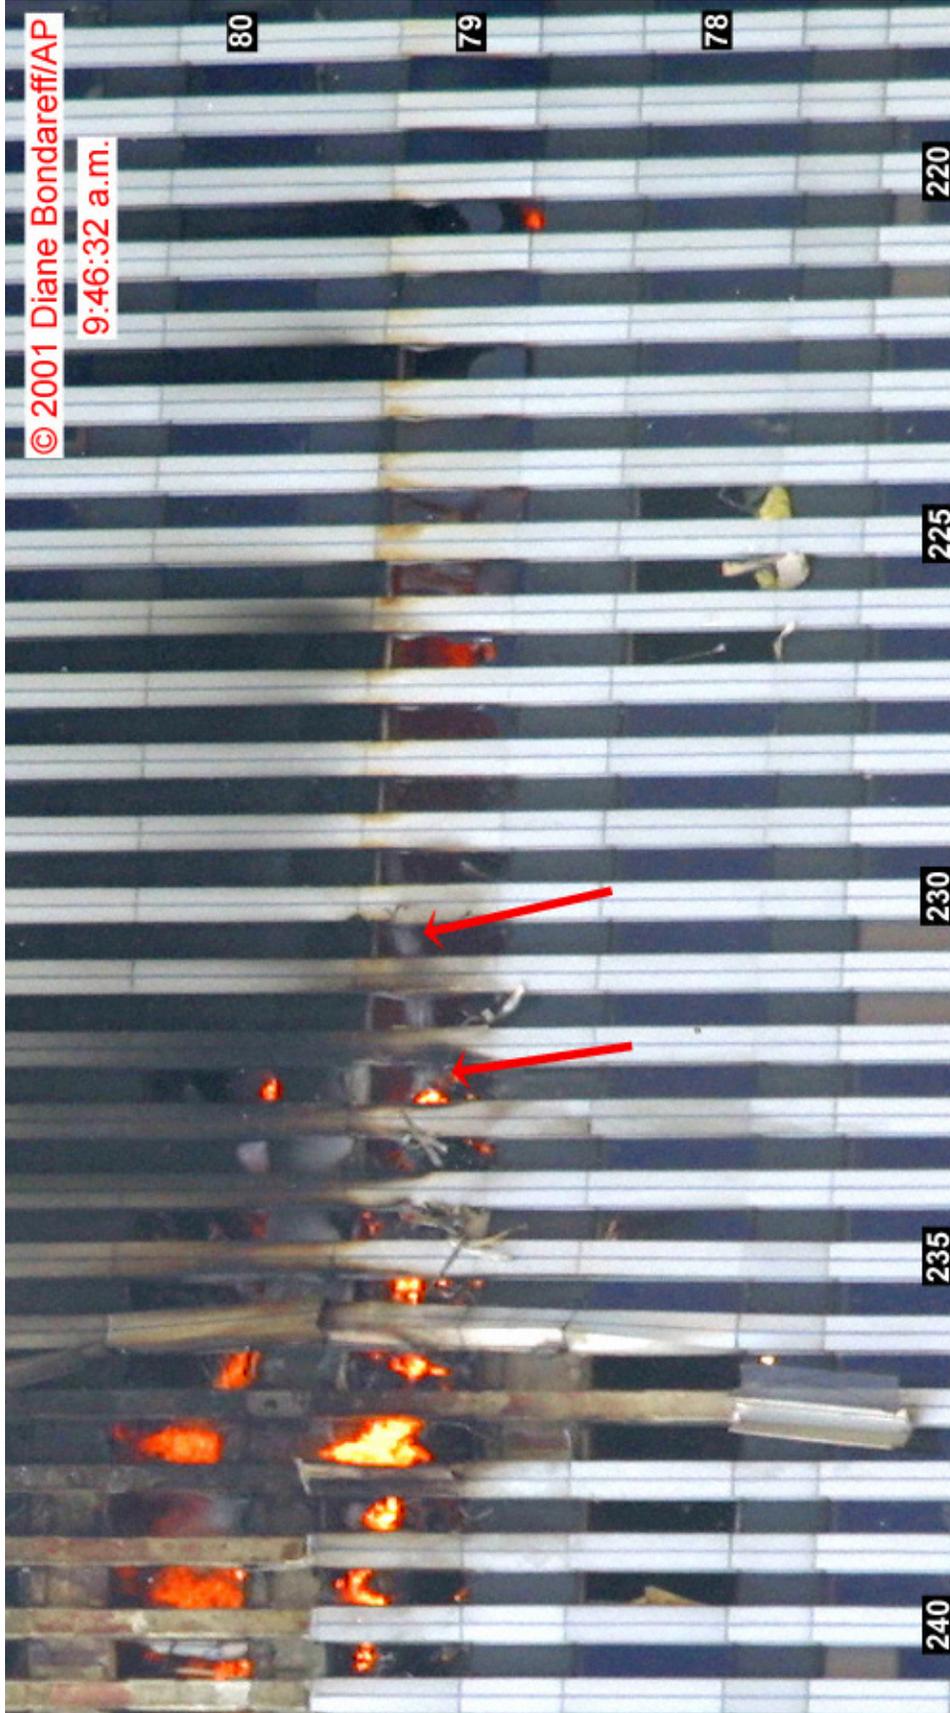
Figure 9-63. This image is enlarged from the photograph included in Figure 9-61 and shows fires near the center of the north face of WTC 2. The intensities have been adjusted to enhance dark areas, and column and floor numbers have been added. The arrows point to a hanging object visible on the 79th floor.

floor. The appearance of the object in these windows is somewhat different than those observed elsewhere on the north and east faces of WTC 2. This introduces some uncertainty into its identification as one of the hanging objects.

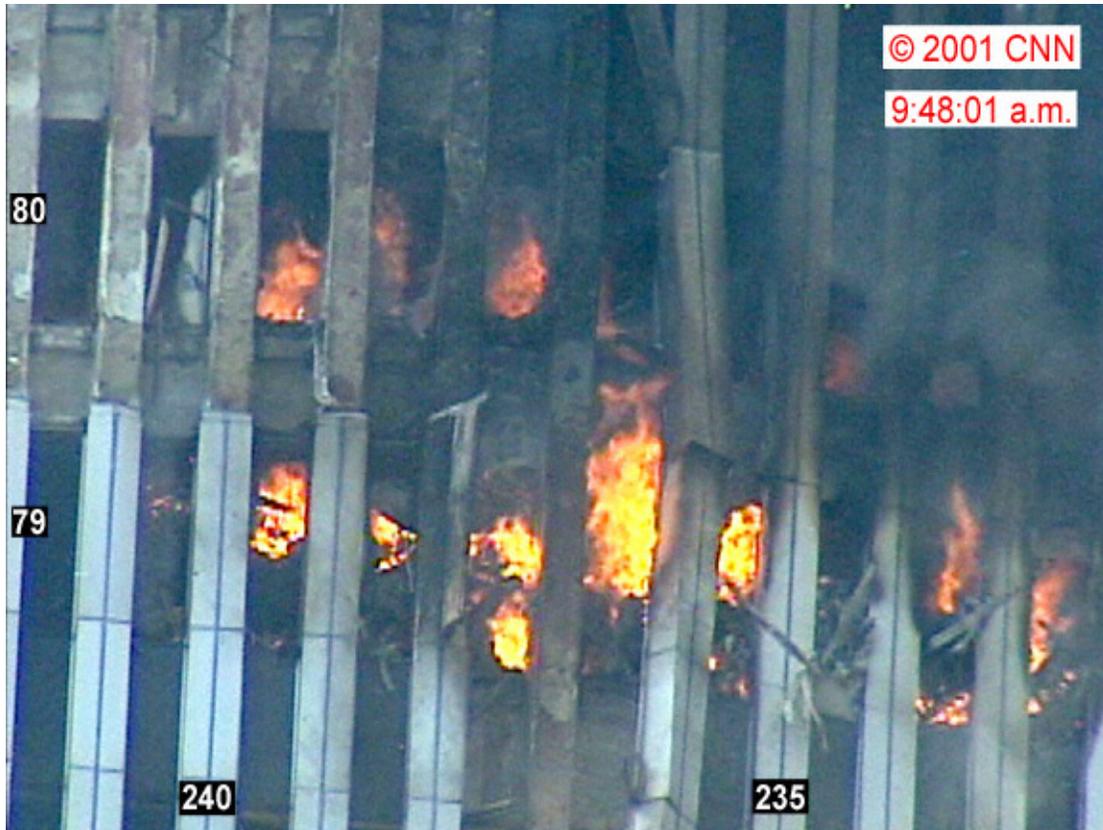
A close-up image of the burning debris pile on the 79th floor is shown in Figure 9–64. This image is a video frame that was captured at 9:48:01 a.m. The bulge in the spandrel at the base of the 80th floor is pronounced. Despite the degree of detail available in the image, it is not possible to determine whether the fires visible on the 79th and 80th floors are burning on a single large pile of debris, i.e., the intervening floor slab is missing, or there are two separate fires on the two floors.

**Figure 9-64.** This close-up image of the north face of WTC 2 was captured from a video recorded at 9:48:01 a.m. The intensity levels have been adjusted, and column and floor numbers have been added.

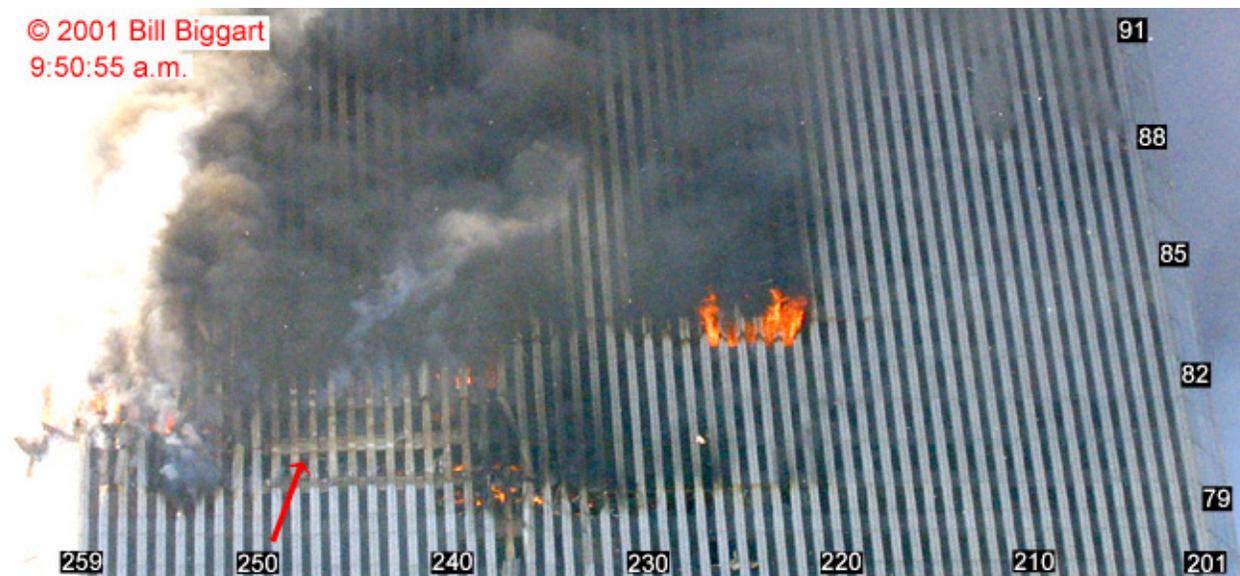
The fire on the eastern edge of the 81st floor seen in Figure 9–65 continues to burn on the debris pile in this area. The appearance of the fire that had earlier spread west on the 79th floor has not changed markedly. Earlier it was mentioned that windows on the 89th floor possibly had been broken open by people at windows 89-201 to 89-203 and window 89-208. Light smoke flows are visible coming from these windows in Figure 9–65.

The hanging object on the 80th floor is just visible in this photograph as indicated by the arrow.

**Figure 9-65.** This cropped photograph shows the north face of WTC 2 at 9:50:55 a.m. The original has been rotated and enhanced by adjusting the intensity levels. Column and floor numbers have been added. The arrow points to a ganging object visible through open windows on the 80th floor.

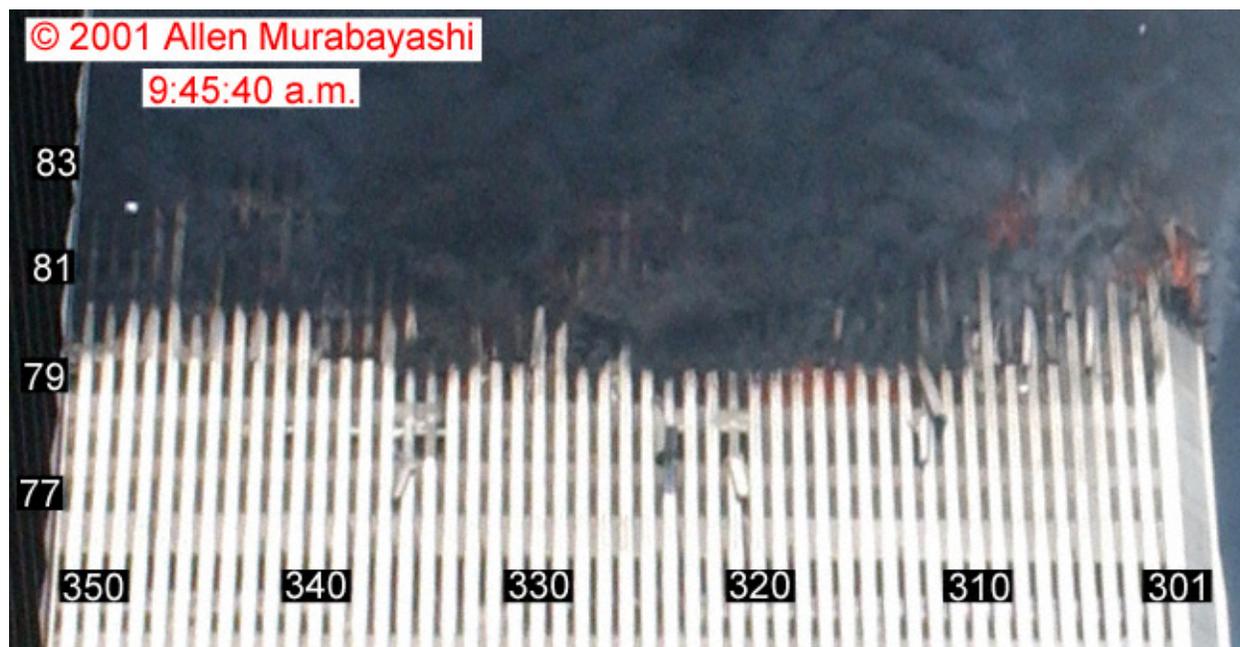
Starting around 9:44:58 a.m. there was another period during which heavy smoke flows came from numerous open windows on the 79th and 80th floors of the east face. This release lasted until approximately 9:46:05 a.m. Figure 9–66 shows an image recorded during this smoke release at 9:45:40 a.m. Comparison with Figure 9–43 and Figure 9–58 indicates that the amount of smoke flow and visible flame are much less than observed during the three similar earlier events. Nonetheless, the smoke flow obscured much of the face, and videos show that intermittent flames appeared outside of some windows. Near the end of this smoke release episode, there were two large pressure pulses at 9:45:57 a.m. and 9:46:01 a.m. that pushed large amounts of smoke out of windows on the 79th and 80th floors.

In Fig. 9-66 flames are visible on the 79th floor between windows 79-313 and 79-319 and are coming from window 82-306 to window 82-308 on the 82nd floor. At 9:38:22 a.m. (see Fig. 9-48) fires were observed at the same locations. The earlier photograph was shot in between the periods of heavy smoke flow and external flaming. This shows that these fires are well established and are not associated with the periods of heavy smoke flows and external burning. The fire in the 81st floor northeast corner continued to burn at 9:45:40 a.m.

**Figure 9-66.** This cropped photograph shows the east face of WTC 2 at 9:45:40 a.m. The image has been rotated, and the intensity range has been adjusted. Column and floor numbers have been added.

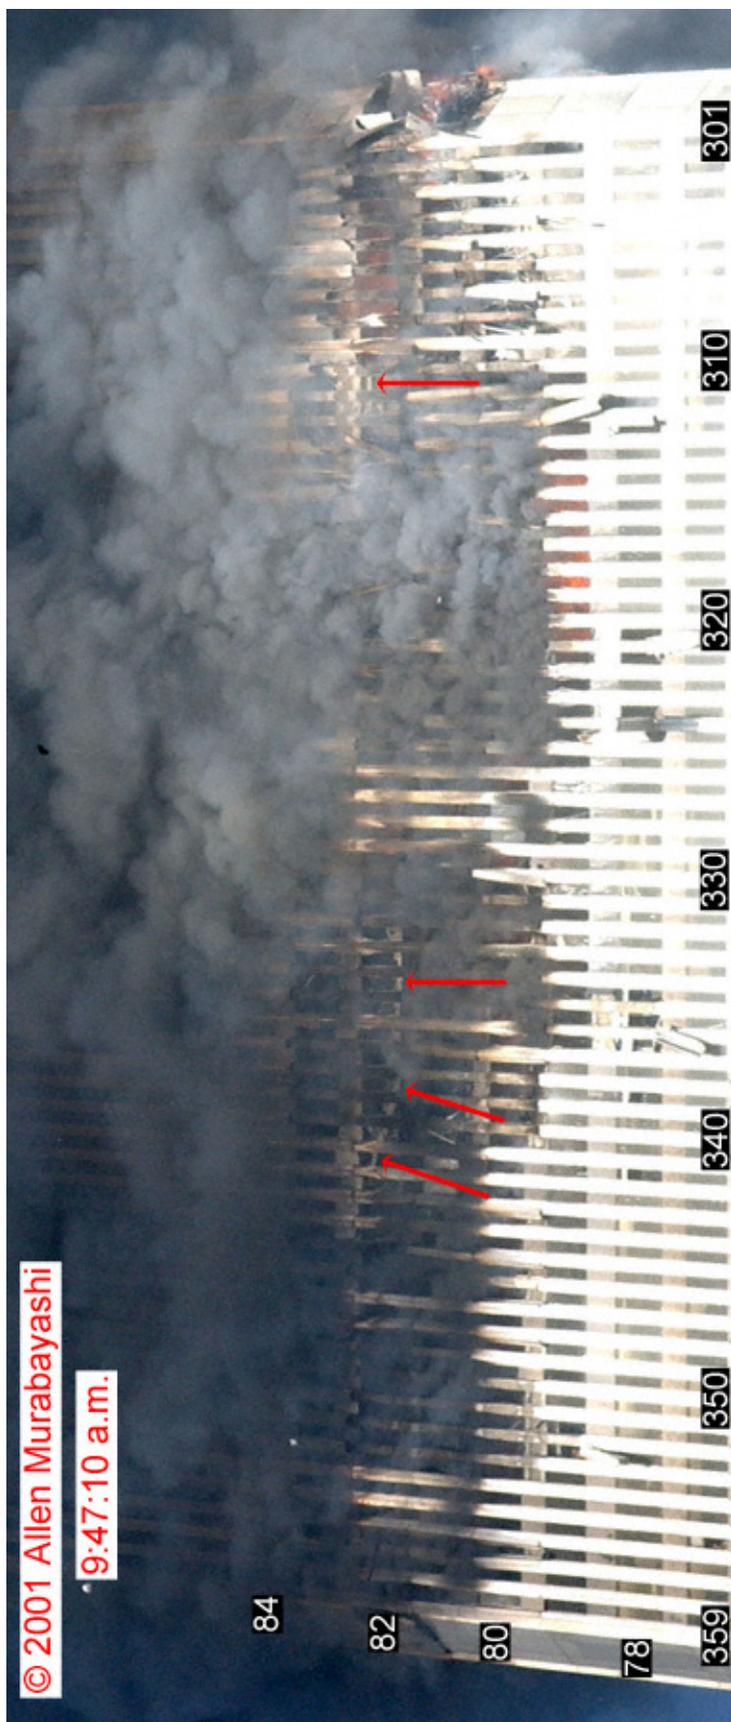
Figure 9–67 shows a higher resolution photograph of the east face taken 1½ min after Figure 9–66 at 9:47:10 a.m. The smoke has cleared up, and it is now possible to see many more windows at the south side of the face on the 80th and 81st floors, as well as higher up on the face. A substantial fire, visible in windows 79-313 to 79-320, continues to burn on the 79th floor. Flames are also present in windows 82-303 to 82-307. The fire on the 81st floor is isolated to the first couple of windows along the northern edge of the east face and the pile of debris in the northeast corner. At this time flames were not visible elsewhere on the east face.

Figure 9-67. This cropped photograph of the east face of WTC 2 was taken at 9:47:10 a.m. The original has been rotated slightly, and the intensity levels have been adjusted. Column and floor numbers have been added. The arrows highlight a hanging object that is visible through open windows on the 82nd floor.

In Figure 9-67 heavy smoke was flowing from windows 79-314 to 79-320 on the 79th floor, and flames were extended from a number of these windows. In Figure 9-80 relatively light smoke is coming from windows 79-319 to 79-321, and there is no indication of external flaming. Apparently, the fires present in this area roughly 5½ min earlier have died down considerably. Carets at the tops of the covers for columns 79-312 to 79-324 indicate the relative local intensities of the fire that burned in this area earlier. In the photograph taken at 9:47:10 a.m. (Figure 9-67) the most intense burning at the northern edge of the 82nd floor was in windows 82-306 and 82-307. At the later time flames are only visible in window 82-303. On the other hand, the flames on the northern edge of the 81st floor are clearly more intense at the later time. Overall, the number and intensities of the fires on the east face appear to be at their lowest levels since the aircraft impact 50 min earlier.

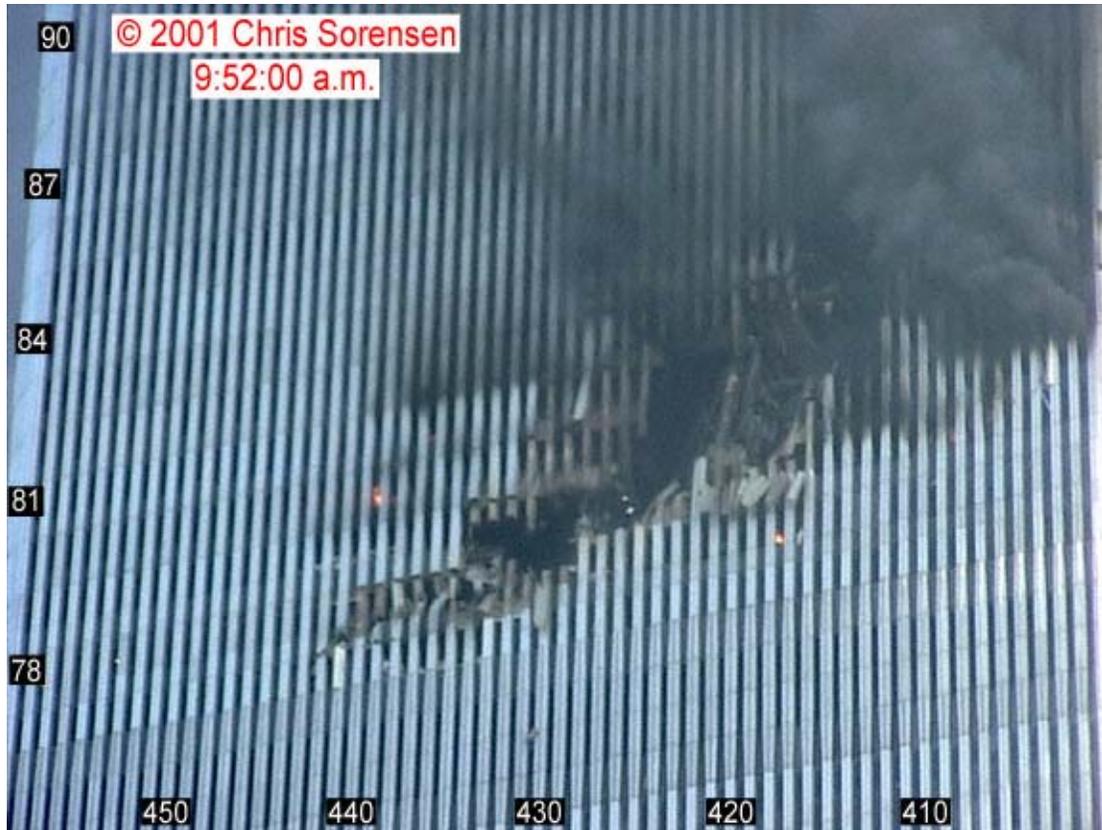
Figure 9–68 shows a view of the south face recorded at 9:52:00 a.m. It is taken from a video shot from a location to the southeast of the tower. Several small fires are visible on the 78th (window 78-418), 79th (window 79-408), 80th (windows 80-438 and 80-439), and 81st (window 81-436) floors. Heavy smoke is flowing from windows near the eastern edge of the 80th floor. There is a stream of smoke coming from the 81st floor in the same area. At this time the smoke flow from other areas of the face was relatively light. Markings on column covers near the tops of windows indicate that smoke had earlier come from windows on the 79th, 80th, and 81st floors just to the west of the aircraft impact cavity. The smoke band on the 81st floor, which extends from window 81-431 to 81-439, is the darkest. The presence of this smoke band is consistent with the recent smoke releases observed from this floor.

**Figure 9-68.** This view of the south face of WTC 2 was taken from a video recorded at 9:52:00 a.m. The intensity levels have been adjusted, and column and floor numbers have been added.

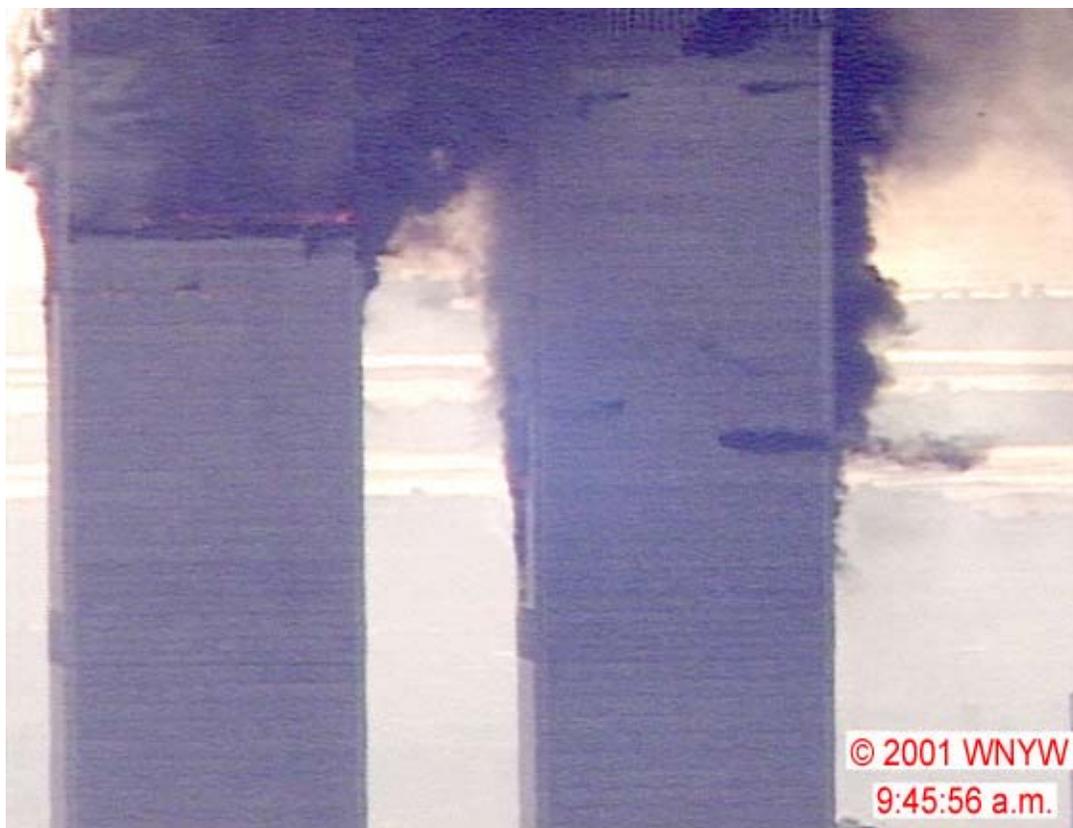
Figure 9-69 shows a long-distance view of the west face of WTC 2 at 9:45:56 a.m. Smoke streams are coming from open windows on several floors, many at the same locations observed in earlier images. The discussion associated with Figure 9-57 refers to open windows on the 84th, 86th, 88th, 91st, 105th, and 107th floors. The three lower smoke trails visible in Figure 9-69 are coming from the windows previously identified on the 86th, 88th, and 91st floor. Closer to the top of the face, three separate smoke trails are visible on the 95th floor. Slightly closer views of the area show that the northern most stream is coming from window 105-148, which is the location visible in Figure 9-57. The other two streams are from near windows 105-116 and 105-140. These two smoke flows were observed to be intermittent in videos of the west face. They were detected briefly as early as 9:43:45 a.m. The heavy smoke flow from the 107th floor observed earlier is prominent in Figure 9-69. The light smoke coming from the southern edge of the mechanical equipment room on the 108th floor is also visible.

**Figure 9-69. This west view of WTC 1 and WTC 2 is a frame captured from a news helicopter video at 9:45:56 a.m. The intensity range has been adjusted.**

Figure 9–69 provides an indication of the complexity of the wind patterns present on the west face of WTC 2 on September 11, 2001. The smoke trails on the lower floors are flowing in opposite directions. Around this time, the heavy smoke coming from windows on the 86th floor was observed streaming across the south face of the tower. A similar flow pattern is evident in Figure 9–57. Videos show that at other times the smoke from these windows would reverse direction and actually flow toward the north. Figure 9–42 shows an example of this flow at 9:34:19 a.m. As discussed in Section 4.1, these complex wind patterns developed because WTC 2 was on the leeward side of WTC 1, which shielded it from the direct impact of the ambient wind and created complex flow patterns that interacted with WTC 2.

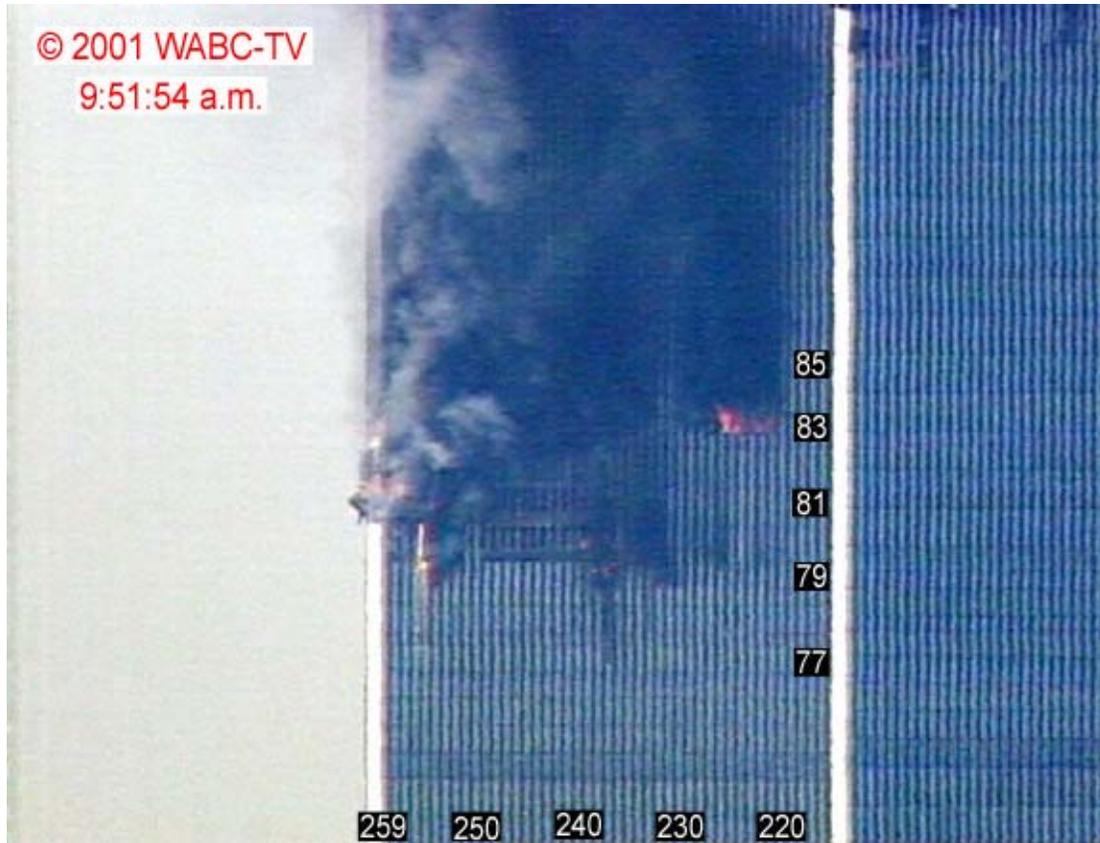
At 9:51:51 a.m. puffs of smoke and/or dust were expelled from open windows on the 79th, 80th, and 81st floors on the north face of WTC 2 near the east edge. These included windows 79-253 and 79-254, 80-257 and 80-258, and 81-254. Almost simultaneously, smoke was pushed from windows on the 79th and 80th floors of the east face. Just over a second later, a bright spot appeared at the top of one window, 80-255, on the 80th floor, and a glowing liquid began to pour from this location. As it fell, the glowing liquid struck the base of window 80-255 and splashed before falling further. Figure 9–70 shows a frame captured from a video at 9:51:54 a.m. in which the falling liquid and the splashing can be seen. This liquid flow lasted approximately 4 s before subsiding. After the flow stopped, the glowing spot was still visible at the top of window 80-255.

**Figure 9-70. This image of the north faces of WTC 1 and WTC 2 was captured from a video recorded at 9:51:54 a.m. The intensity levels have been adjusted, and column and floor numbers have been added to WTC 2.**

It has been reported in the FEMA report (McAllister 2002) as well as in the media that what appeared to be molten metal was observed pouring from the north face near the northeast corner prior to the collapse of WTC 2. This is the area where the sustained fires on the 81st and 82nd had been burning since the aircraft impact. The likely explanation for the observation of pouring liquid is that the material had originally pooled on the floor slab above, i.e., the 81st floor, and that it was allowed to pour out of the building when the floor slab in the immediate vicinity either pulled away from the spandrel or sank down to the point where the window was exposed. The puff of smoke and/or dust just prior to the first appearance of the molten material suggests that the ultimate event responsible for the release of the material occurred suddenly, in the process creating a pressure pulse that forced smoke and/or dust out of open windows over three floors.

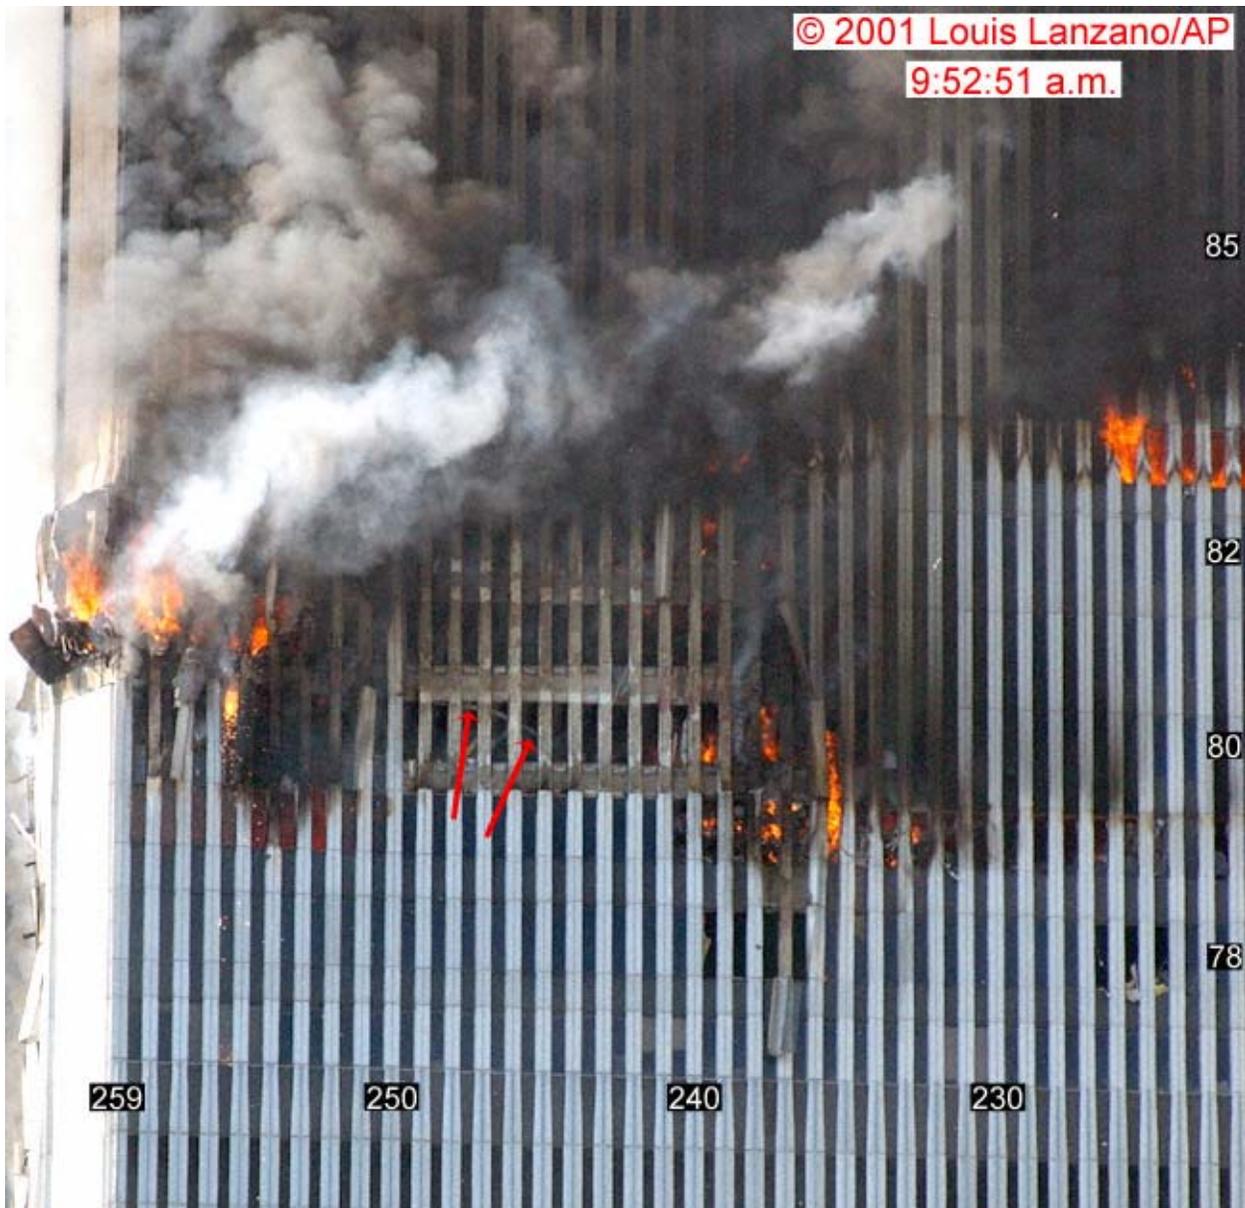
A high-resolution photograph of the north face shot at 9:52:51 a.m., i.e., just 4 s after the start of the first of the three pressure pulses, is shown in Figure 9–71. The white cloud in the photograph is the rising dust and/or smoke that was pushed from windows on multiple floors during the pressure pulse. Blow-ups of the area around window 80-255, which is the location on the 80th floor where the molten material poured from, and the cold spot are shown in Figure 9–72 and Figure 9–73, respectively.

**Figure 9-71.** This cropped photograph shows the north face of WTC 2 at 9:52:51 a.m. The image has been enhanced by adjusting the intensity levels, and column and floor numbers have been added. The arrows highlight a hanging object visible through open windows on the 80th floor.

As seen in Figure 9–71, the fire located on the 83rd floor in windows 83-221 to 83-225 continued to burn vigorously at 9:52:51 a.m. Recall that flames first appeared in this area at 9:42:53 a.m. Other images available around this time show no apparent additional spread of this fire towards the west. Carets are visible on many of the aluminum column covers between columns 83-222 and 83-236. Many of these carets are near the base of the windows, providing an indication for the intensity of the flames that were present at these locations earlier.

There appears to be a small fire burning on the 84th floor in window 84-223. This is an interesting observation because it is likely that this fire was ignited by flames coming from below, possibly through a window opened by the heat coming from the 83rd floor. If so, this would represent the clearest example of upward flame spread by an external pathway observed on September 11, 2001. On the 79th floor the fire burning on the debris pile is still visible in windows 79-232 to 79-239. The fire on this floor that had earlier spread to the west has died down and is no longer visible.

Smoke is visible coming from multiple windows near the western edge of the face on the 88th and 93rd floors. These windows have previously been identified as possibly having been broken open by people. Clearly, smoke is continuing to pass up through the core of the tower to these floors.
