## Chapter 9

# FIRE BEHAVIOR IN WORLD TRADE CENTER 2

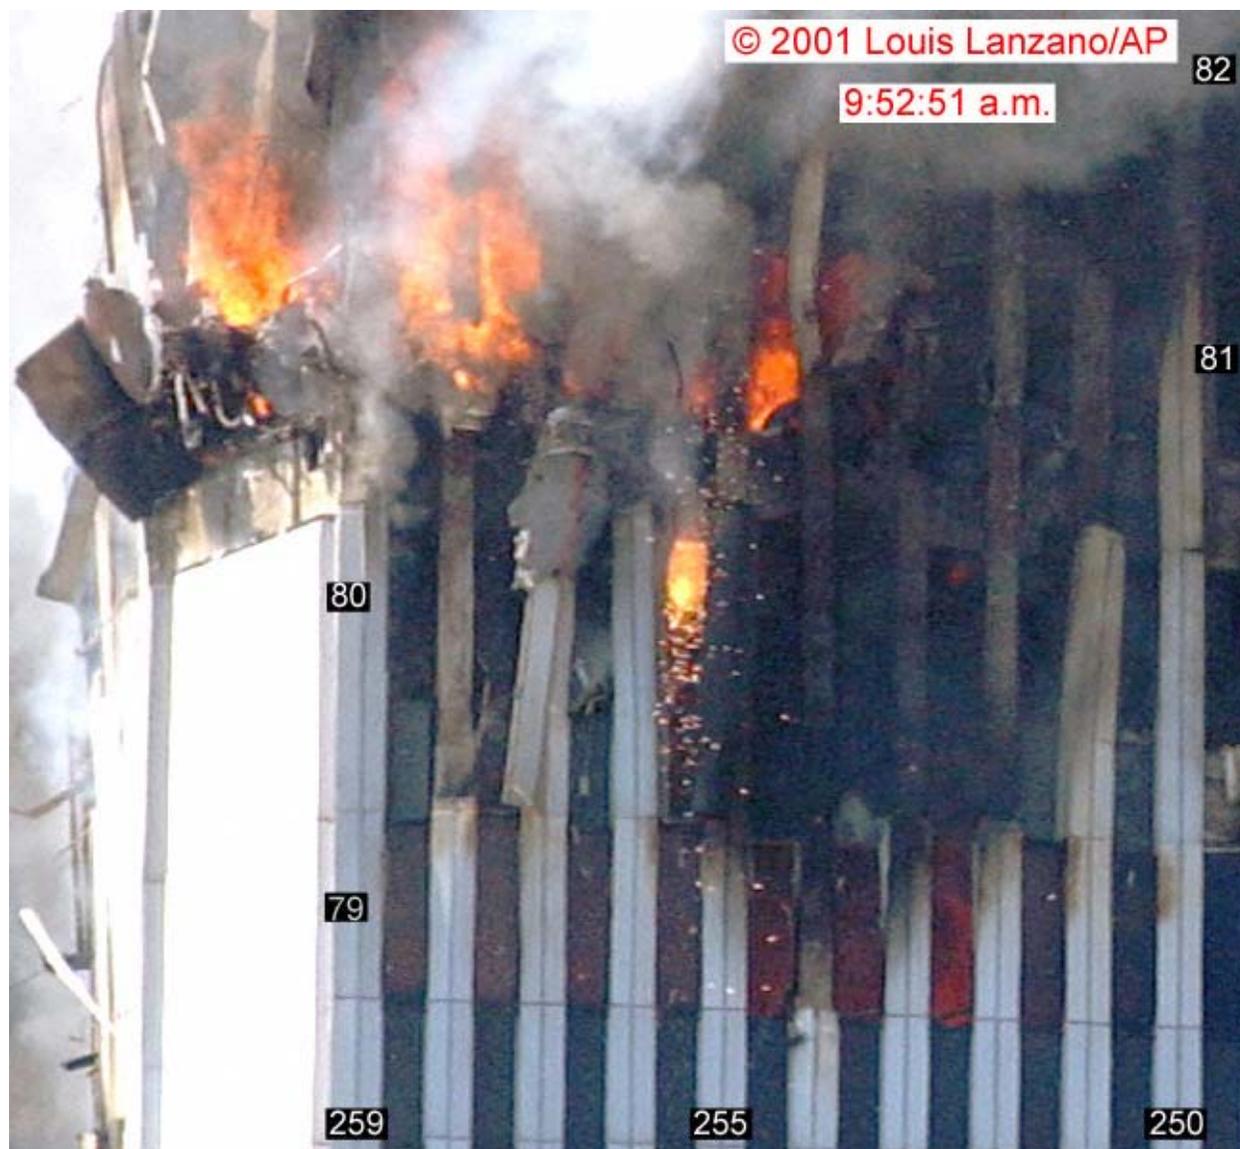
First, consider Figure 9–72. Videos show that a small amount of molten material poured from window 80-255 within a second or two after this photograph was taken. In the photograph the bright material is visible inside this window at the top. The area seems to be surrounded by a large number of glowing drops, which are likely associated with the liquid that will pour out shortly. Dull, deep-red glowing areas are just visible at the tops of windows 80-252 and 80-254. These might be an indication that the 81st floor slab has sunken below the spandrel at the base of this floor.

**Figure 9-72. This image is a blow-up of a portion of Figure 9-71 showing the north face of WTC 2 around window 80-255 at 9:52:51 a.m. Column and floor numbers have been added.**

This image provides a good view of the fire that continues to burn in the northeast corner on the 81st floor. It can be seen that column 81-254 on this floor is severely distorted. This damage may be a result of the landing gear that was identified as passing through the area during the aircraft impact (see the discussion in Section 7.4.3). Flames are also visible on the 79th floor through open windows 79-252 to 79-254. The orange color visible through the glass that remains in place in window 79-251 and windows 79-255 to 79-258 shows that fire is present behind these closed windows as well. This is one of a limited number of cases in which flames were seen through windows with glass still in place. In Figure 9-61, which was shot at 9:46:32 a.m., small flames could be seen in window 79-254. At this time the glass for window 79-252 was still intact.

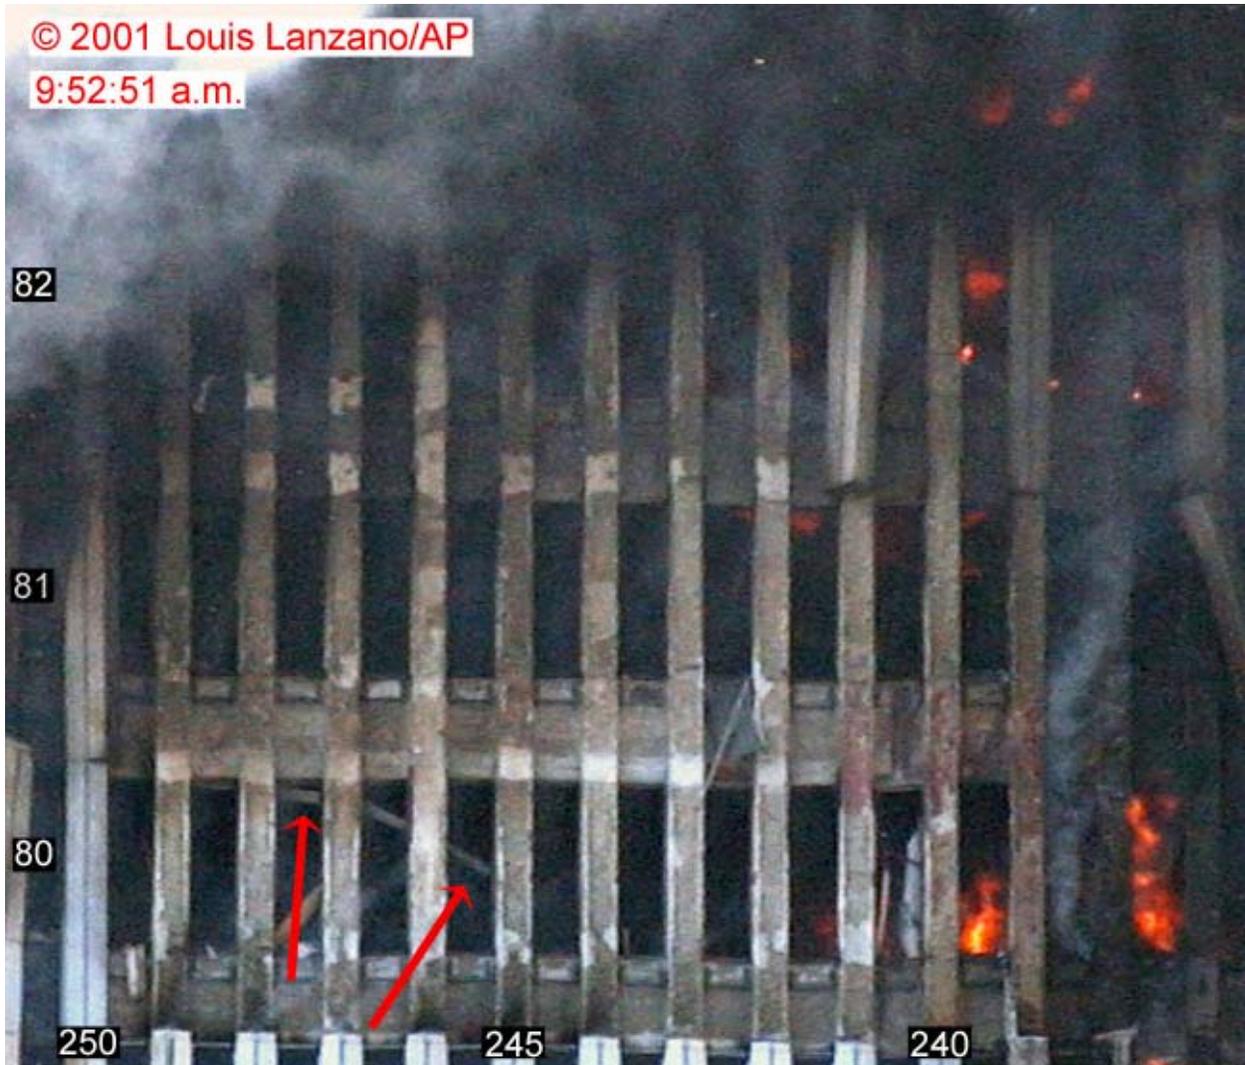
It is instructive to compare the image of the cold spot in Figure 9–73 with the close up shown in Figure 9–62, which was taken nearly 6 min and 20 s earlier. The first thing to note is that the hanging object on the 80th floor did not change position between 9:46:32 a.m. and 9:52:51 a.m. The fire burning on the west side of the cold spot on this floor has died down somewhat.

**Figure 9-73.** This image is a blowup of a portion of Figure 9–71 showing the cold spot on the north face of WTC 2 at 9:52:51 a.m. Column and floor numbers have been added. The arrows highlight a hanging object visible through open windows on the 80th floor.

The hanging object visible on the 81st floor at the earlier time is not apparent in Figure 9–73. This could simply be due to lighting, since the later photograph is somewhat darker, even though the intensities have been adjusted. In Figure 9–62 small flames were visible through window 81-243. In the later image these flames are not evident, but there is a curved region of dull red flames running from the top of window 81-242 to the middle of window 81-239. It is unclear why these flames are raised, i.e., what is holding them up in the window. One possibility is that the fuel for the fire is on top of a section of the 82nd floor slab (not visible) that became dislodged and settled below the spandrel at the base of the floor.

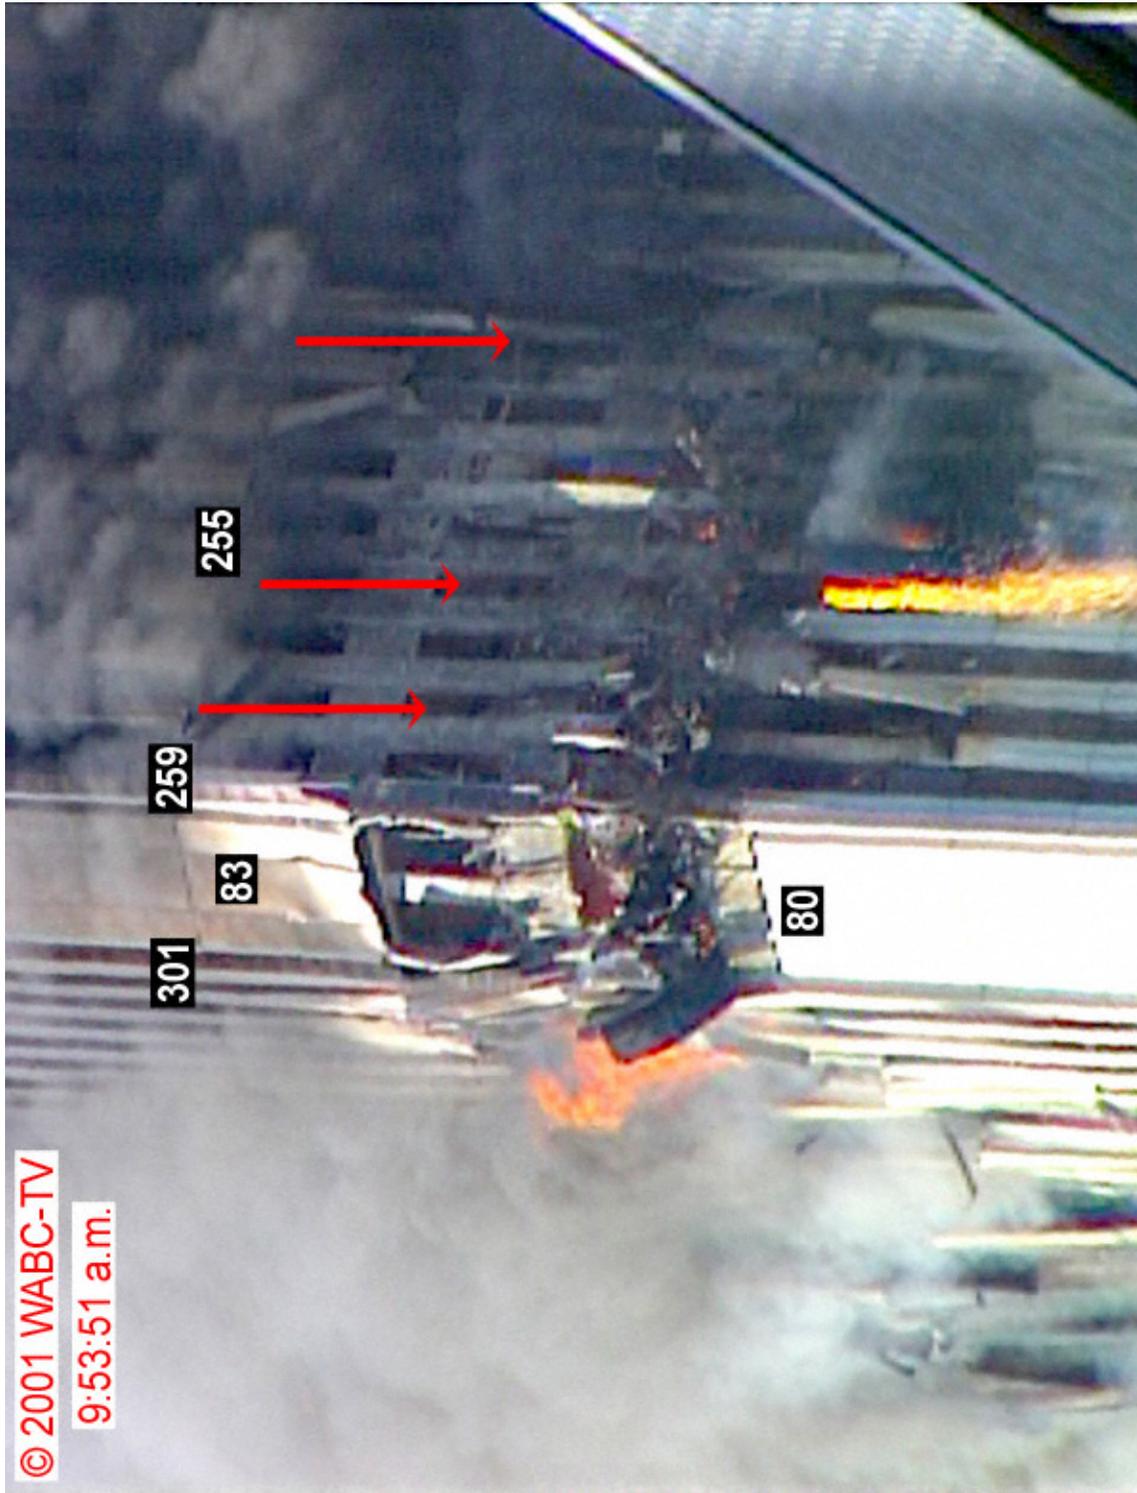
The arrows in Figure 9–75 highlight a hanging object that is visible through the open windows on the 82nd floor. In the windows nearest the east edge of the face, the object appears to have a flat surface that is being viewed from below and is drooping downward, away from the windows. The object also seems to be separated into two sections. Further to the west, the hanging object looks as if the edge of a flat object has dropped down below the top of the window from above. Its appearance is similar to the hanging objects seen elsewhere on the north and east faces of WTC 2.

Figure 9-75. This view of the northeast corner of WTC 2 is a frame captured from a video at 9:53:51 a.m. The intensity levels have been adjusted, and column and floor numbers have been added. The arrows highlight a hanging object that is visible through windows on the 82nd floor.

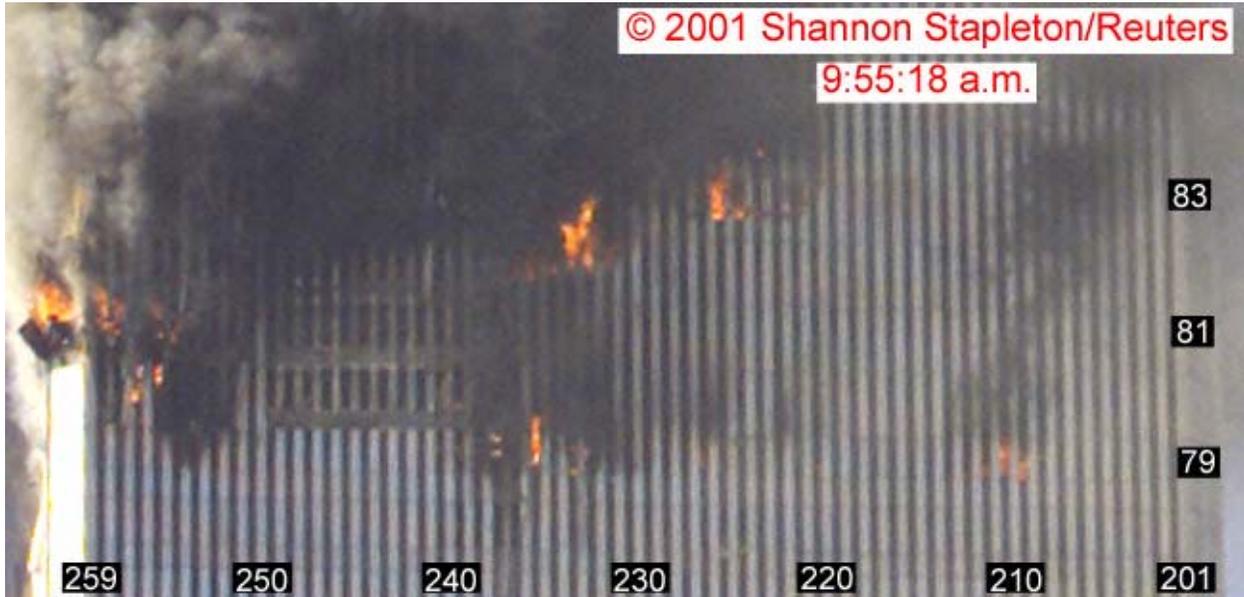
An image of the north face taken at 9:55:18 a.m. is shown in Figure 9–76. This image was shot 1 min 45 s after the one shown in Figure 9–74. The fire distributions are very similar in the two photographs, with the exception of the fire on the 82nd floor to the right of the cold spot in Figure 9–76. As discussed above, this fire was first observed at 9:53:47 a.m. burning in windows 82-234 to 82-337. At 9:55:18 a.m. flames were visible in windows 82-231 to 82-236, and flames were coming out of window 82-233. The bright spot at the top of window 80-255 is visible on the 80th floor, but there is no obvious molten liquid flow at this time. Unlike in the earlier photograph, fire is now visible in the adjacent window, 80-256.

**Figure 9-76. This cropped photograph shows the north face of WTC 2 at 9:55:18 a.m. The image has been rotated, and the intensity levels have been adjusted. Column and floor numbers have been added.**

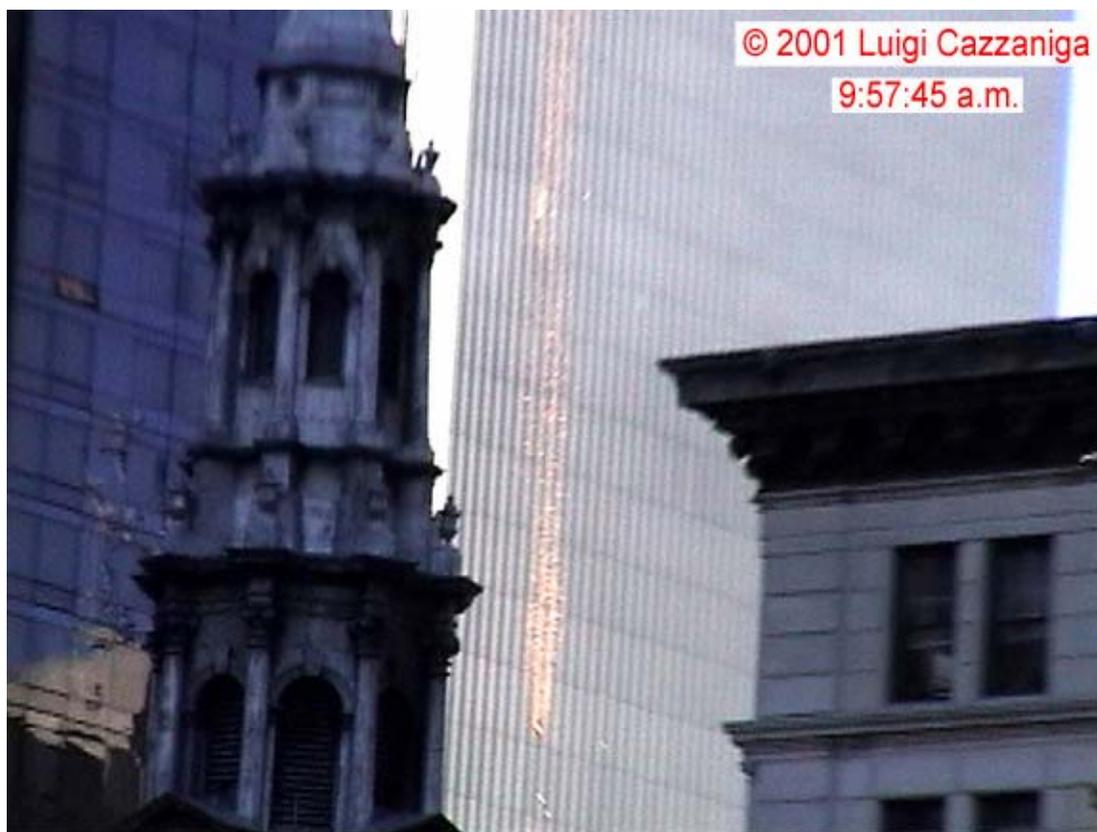
Figure 9–77 is a frame from a video that was shot at 9:57:45 a.m. It shows the falling molten metal as it was approaching the ground. The large amount of falling material is evident. Most of the molten metal seems to have broken up into small “droplets,” but there are a couple of large pieces falling as well. Apparently, the material flowing out of window 80-256 also included pieces of debris that had not fully melted. There was another very heavy flow of molten metal at 9:58:35 a.m.

**Figure 9-77. This frame showing the lower portion the north face of WTC 2 was captured from a video shot from the northeast at 9:57:45 a.m. The intensity levels have been adjusted.**

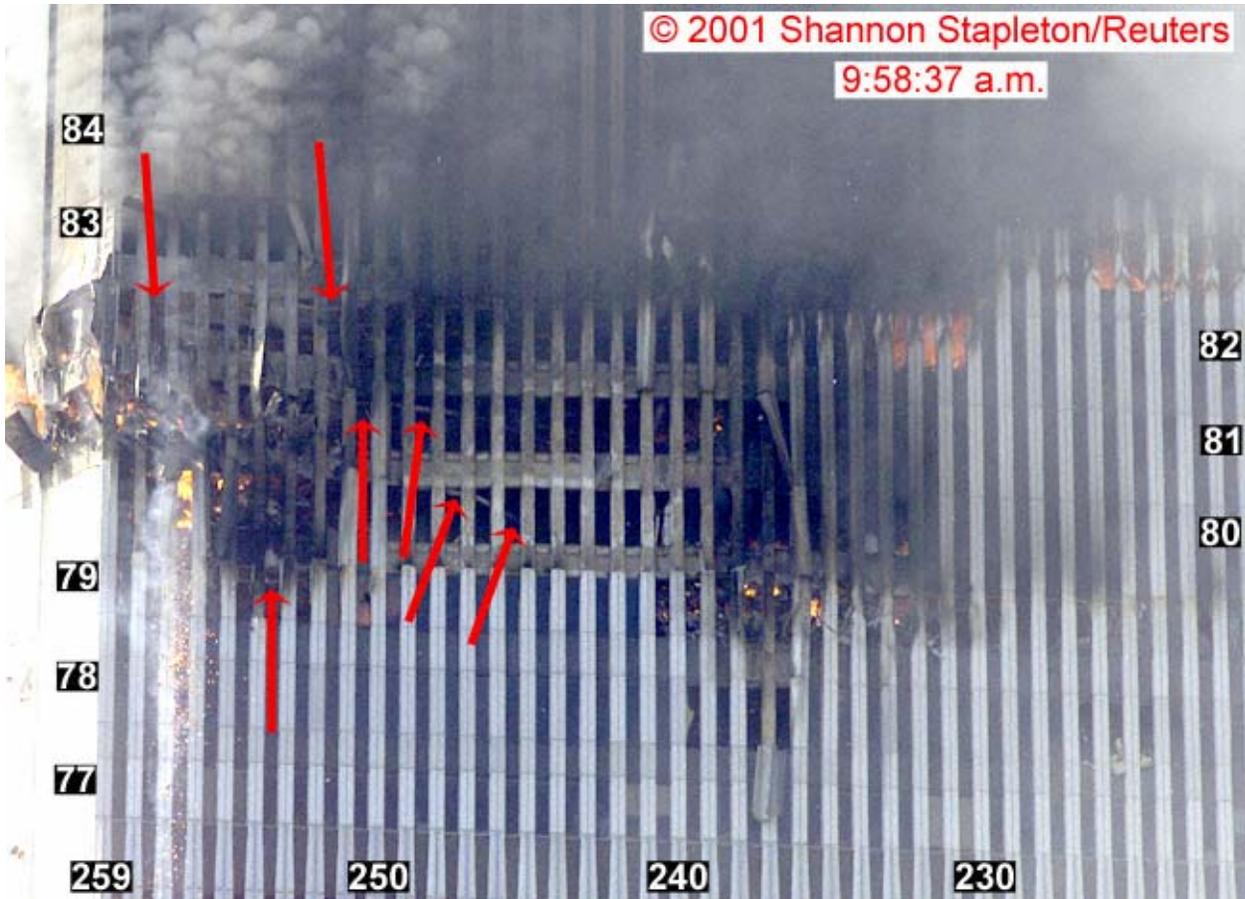
Figure 9–78 shows a photograph of the north face of WTC 2 taken at 9:58:37 a.m. The bright source of the recent molten metal flows stands out at the top of window 80-256 on the 80th floor. Some metal is visible flowing from the window at this time. An area, including this window and a portion of the cold spot, is blown up in Figure 9–79.

It is useful to compare Figure 9–78 with Figure 9–71, which was taken 5 min and 46 s earlier. Starting on the 83rd floor, it can be seen that the fire in windows 83-231 to 83-235 has died down considerably over the period between the photographs. In both cases the most intense flames are in window 83-225. Photographs and videos taken just prior to the collapse provide no indication of westward fire spread on this floor beyond window 83-220. The fire in this area grew rapidly just after 9:45 a.m. Apparently, it did not spread further after this time. The carets visible at the top of the adjacent columns show how intense the burning was in the area. The incipient fire on the floor above in window 84-223 is barely visible.

**Figure 9-78.** This cropped photograph shows the north face of WTC 2 at 9:58:37 a.m. The intensity levels have been adjusted, and column and floor numbers have been added. Arrows highlight hanging objects visible through open windows on the 79th, 80th, 81st, and 82nd floors.

The fire on the 82nd floor to the west of the cold spot, which grew rapidly just before 9:54 a.m., has continued to spread and grow. In Figure 9–71 there was no indication of this fire. At 9:58:37 a.m. flames are coming from windows 82-230 to 82-232. There are carets on the aluminum column covers around these windows, as well as on the covers next to windows 82-233 to 82-236. This fire seems to not only be spreading rapidly, but also to be going through a rapid cycle of growth and decline. Windows to the west of window 82-230 appear to have intact glass. No flames are visible in or to the east of the cold spot on this floor. At the earlier time the area was hidden by smoke.

During the period between when Figure 9–71 and Figure 9–78 were taken, the fires on the eastern edge and the northeast corner of the 81st floor have died down considerably. Prior to 9:53 a.m. intense fires had burned in these areas continuously following the aircraft impact. After this time it was observed that these fires suddenly died down and then reappeared several times. These cycles seemed to be associated with pressure pulses that pushed smoke and/or dust out of open windows on multiple floors of the north and east faces. This may be an indication that these fires died down due to changes in their local environment, e.g., a partial collapse of a floor, as opposed to simply burning out the available fuel. A low-level fire continued to burn at the western edge of the cold spot on the 81st floor. There had been no

The fires burning on the 79th and 80th floors between columns 230 and 241 have also died down. As a result, the large amount of debris piled up in windows 79-234 to 79-240 is more apparent than in earlier images. It is still not possible to identify whether the fires on these two floors were burning on a single pile of debris, i.e., the intervening floor had collapsed, or as two independent fires.

The only indication in Figure 9-78 of a fire burning on the 79th floor to the immediate west of window 79-229 is a small flame visible through a partially broken window 79-224. The fires that had been burning in this area earlier have nearly died out. Windows 79-221 and 79-223 to 79-225 still have glass. Half of the window pane is in place in window 79-222. These observations suggest that the fire that burned in this area was not too intense. Videos show that the fire that grew further west in windows 79-109 to 79-113 (see Figure 9-76) continued to burn at a comparable intensity until the tower collapsed. In Figure 9-78 it can be seen that window glass remains in place on the 80th floor in window 80-231 and windows to the west. Videos show occasional smoke coming from window 80-204 starting after 9:55 a.m. There is no indication of fire at this location. This window may have been broken earlier by a person.

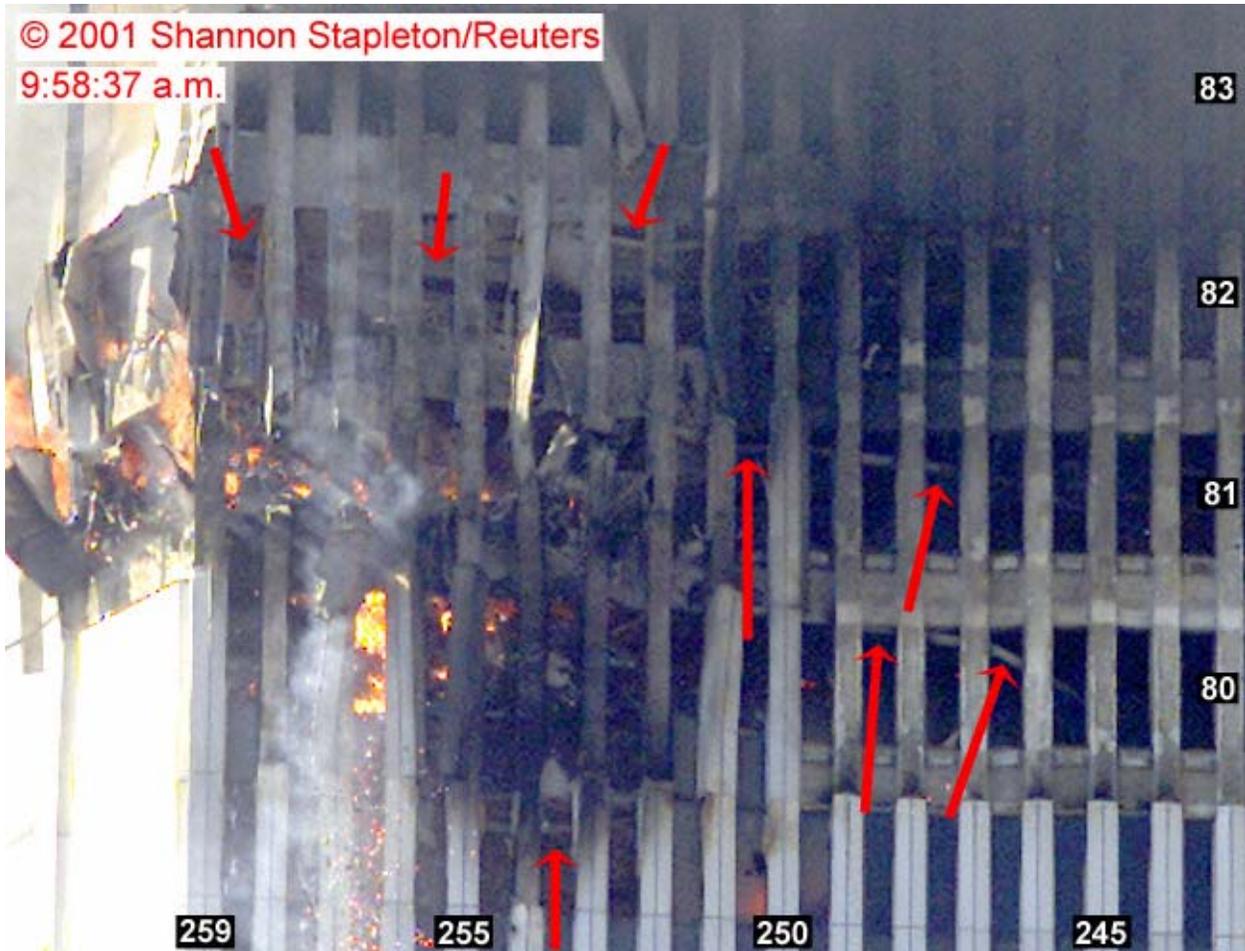
The blow-up of a section of Figure 9-78 shown in Figure 9-79 provides a closer view of the area around the 80th-floor window 80-256 and a portion of the cold spot. Since smoke is no longer obscuring the east side of the 81st floor, it is possible to see additional details concerning the damage in this area. The distortion of column 254 on the 81st floor, which was described earlier, is apparent. The column just to the west, 253, has been cut through near the top of the window. The spandrel at the base of the 82nd floor between column 251 and column 252 appears to be torn. It is not possible to say with certainty, but it is likely that this steel damage resulted from the large object observed exiting near this location during the aircraft impact (see the discussion in Section 7.4.3) and that it is not due to subsequent events.

A number of arrows have been added to Figure 9-79 to highlight hanging objects visible through open windows. These objects are possibly sections of floors slabs that became dislodged and settled down from above. The appearance of the object visible through windows 82-250 to 82-258 on the 82nd floor supports such a conclusion. This object was previously identified in a somewhat lower resolution image shown in Figure 9-75. Its appearance does not seem to have changed since 9:53:51 a.m. In windows 82-250 to 82-252 the object is hanging just above the tops of the windows. In these windows it looks like the hanging objects observed elsewhere on the north and east faces. However, further east it is apparent that a portion of the object located away from the edge has collapsed, and what is visible is the bottom of the object that is sloping away from the tops of the windows. It can be seen that the object has split into two sections in the east-west direction. This object is most likely a section of the 83rd floor that has locally collapsed and, in the process, broken along the line between two prefabricated sections. Drawings of the floor system indicate the sections were laid in this direction.

On the 81st floor a hanging object is apparent in Figure 9-79 at the tops of windows 81-247 to 81-250. A faint trace of the object in the two windows to the west indicates the object is sloping sharply downward in windows 81-246 and 81-245. This object was not visible in the close-up of the area shown in

Figure 9–73, which was taken at 9:52:51 a.m. This was true even when the intensity levels for the photograph in Figure 9–73 were adjusted to emphasize the darkest levels. Interestingly, a hanging object is visible in this same vicinity in Figure 9–62, which was taken at 9:46:32 a.m., but it was located further west and had a different shape. A detailed comparison shows that the objects in the two photographs are at roughly the same height in window 81-250, but while the object curved upwards in windows 81-249 and 81-248 and disappeared above the spandrel in window 81-247 in Figure 9–62, in the later image it slopes downward in windows 81-249 to 81-247. At the earlier time the object reappeared in window 81-245 and then sloped gradually downward toward the west. In Figure 9–79 the object nearly disappears in window 81-246 and seems to be curving strongly downward to the west.

**Figure 9-79.** This photograph is a blow-up of a portion of the photograph shown in Figure 9–78. It shows the north face of WTC 2 and includes window 80-256 and part of the cold spot. The intensity levels of the original have been adjusted, and column and floor numbers have been added. Arrows highlight hanging objects visible through open windows on the 79th, 80th, 81st, and 82nd floors.

It is difficult to understand why the object is not visible in Figure 9–73 at 9:52:51 a.m. Either it is hidden by some unanticipated optical effect or the object moved between 9:46:32 a.m. and 9:52:51 a.m. If the former is the case, it means that the object visible at 9:46:32 was obscured sometime between 9:46:32 a.m. and 9:58:37 a.m. On the other hand, if the latter is the case, it suggests that the object visible at 9:46:32 a.m. sank down out of sight between 9:46:32 a.m. and 9:52:51 a.m. and that a second object

In contrast to the 81st floor, the appearance of the hanging object visible through windows 80-245 to 80-248 on the 80th floor in Figure 9-79 is very similar to that seen in Figure 9-52 (taken at 9:42:31 a.m.), Figure 9-62, and Figure 9-73. Recall that this object appeared at this location sometime between 9:27:04 a.m. and 9:29:42 a.m. It has remained stable for around 30 min.

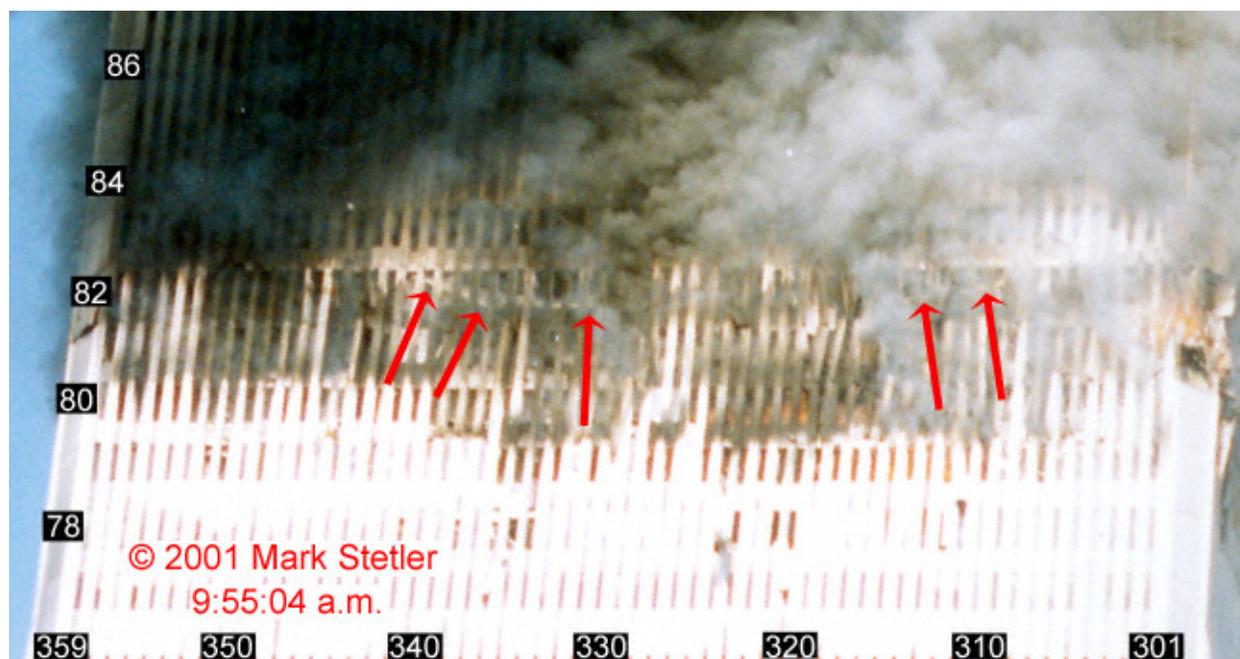
Figure 9–81 is a photograph of the east face that was taken at 9:55:04 a.m. This image was shot from a longer distance and from a higher position than Figure 9–80. In this image it is apparent that flames are present inside windows on the 79th floor over a length running from window 79-311 to window 79-319. This is roughly the same location as seen in Figure 9–67 at 9:47:10 a.m. Consistent with Figure 9–80, there is little smoke and no flame coming from the windows where fire is visible in Figure 9–81.

**Figure 9-81.** This cropped photograph of the east face of WTC 2 was shot at 9:55:04 a.m. The image has been rotated, and the intensities have been adjusted. Column and floor numbers have been added. Arrows indicate a hanging object visible through open windows on the 82nd floor.

There is also an area of flame visible on the 80th floor in Figure 9–81 extending from window 80-316 to window 80-326. Windows to the north of this length are hidden by smoke, while windows 80-327 and 80-328 on the other end still have glass in place. It is difficult to identify when this fire developed. These windows are visible in the east face view shown in Figure 9–48, which was taken at 9:38:22 a.m. At this time there was no indication of a significant fire in this area of the 80th floor, even though the fire on the 79th floor was already well developed. In similar views of the face shown in Figure 9–58 (9:40:29 a.m.), Figure 9–66 (9:45:40 a.m.), and Figure 9–67 (9:47:10 a.m.), smoke from the 79th floor hides these windows. Since the flames appear to be well inside and there is no smoke coming from the windows, it is not surprising that this fire can not be seen in Figure 9–80.

The arrows in Figure 9–81 highlight the hanging object visible through open windows on the 82nd floor. This object has been observed in a number of images, including Figure 9–67 at 9:47:10 a.m. On the southern end around window 82-340 the apparent position of the object has not changed during the almost seven minutes between the times when these photographs were taken. This is not the case at the northern end. At the earlier time the object was visible near the tops of windows 82-310 and 82-311. At 9:55:04 a.m. the object is visible at the top of window 82-309 and can be seen sloping downward across several open windows toward the left, approaching the base of window 82-315. This is another example of hanging objects, which may be dislocated floor slabs, changing position during the event.

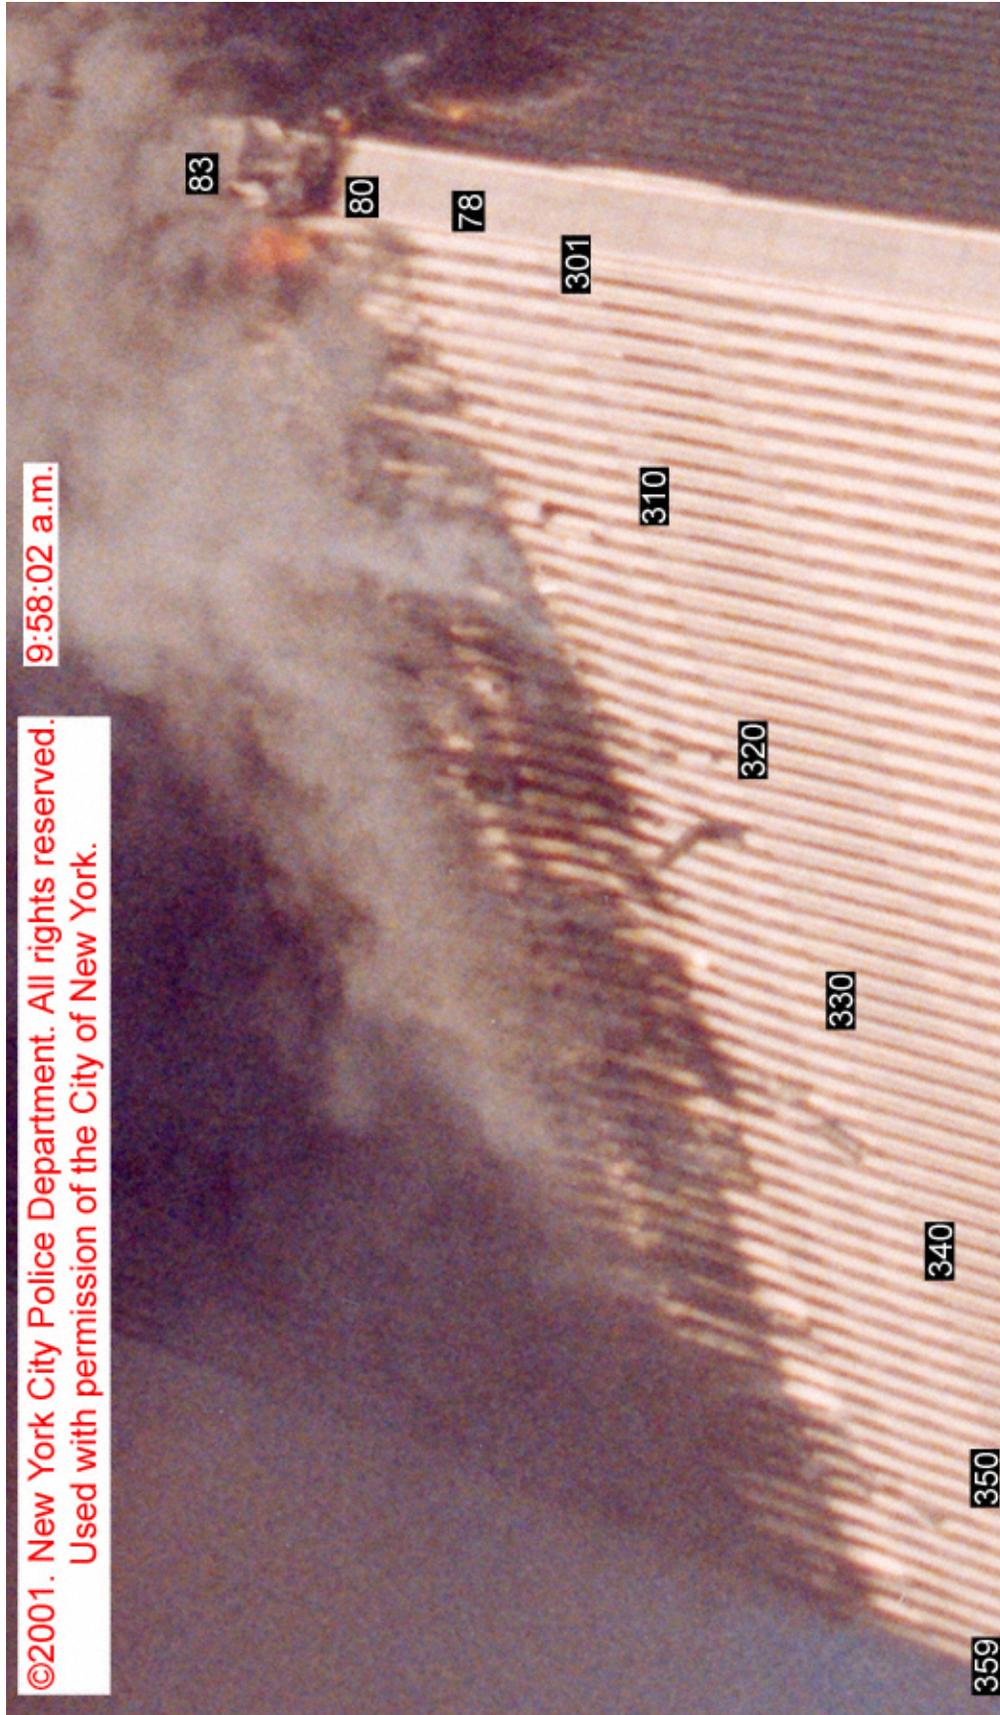
Figure 9-82. This cropped image shows the east face of WTC 2 at 9:58:02 a.m. The intensity levels have been adjusted, and column and floor numbers have been added.

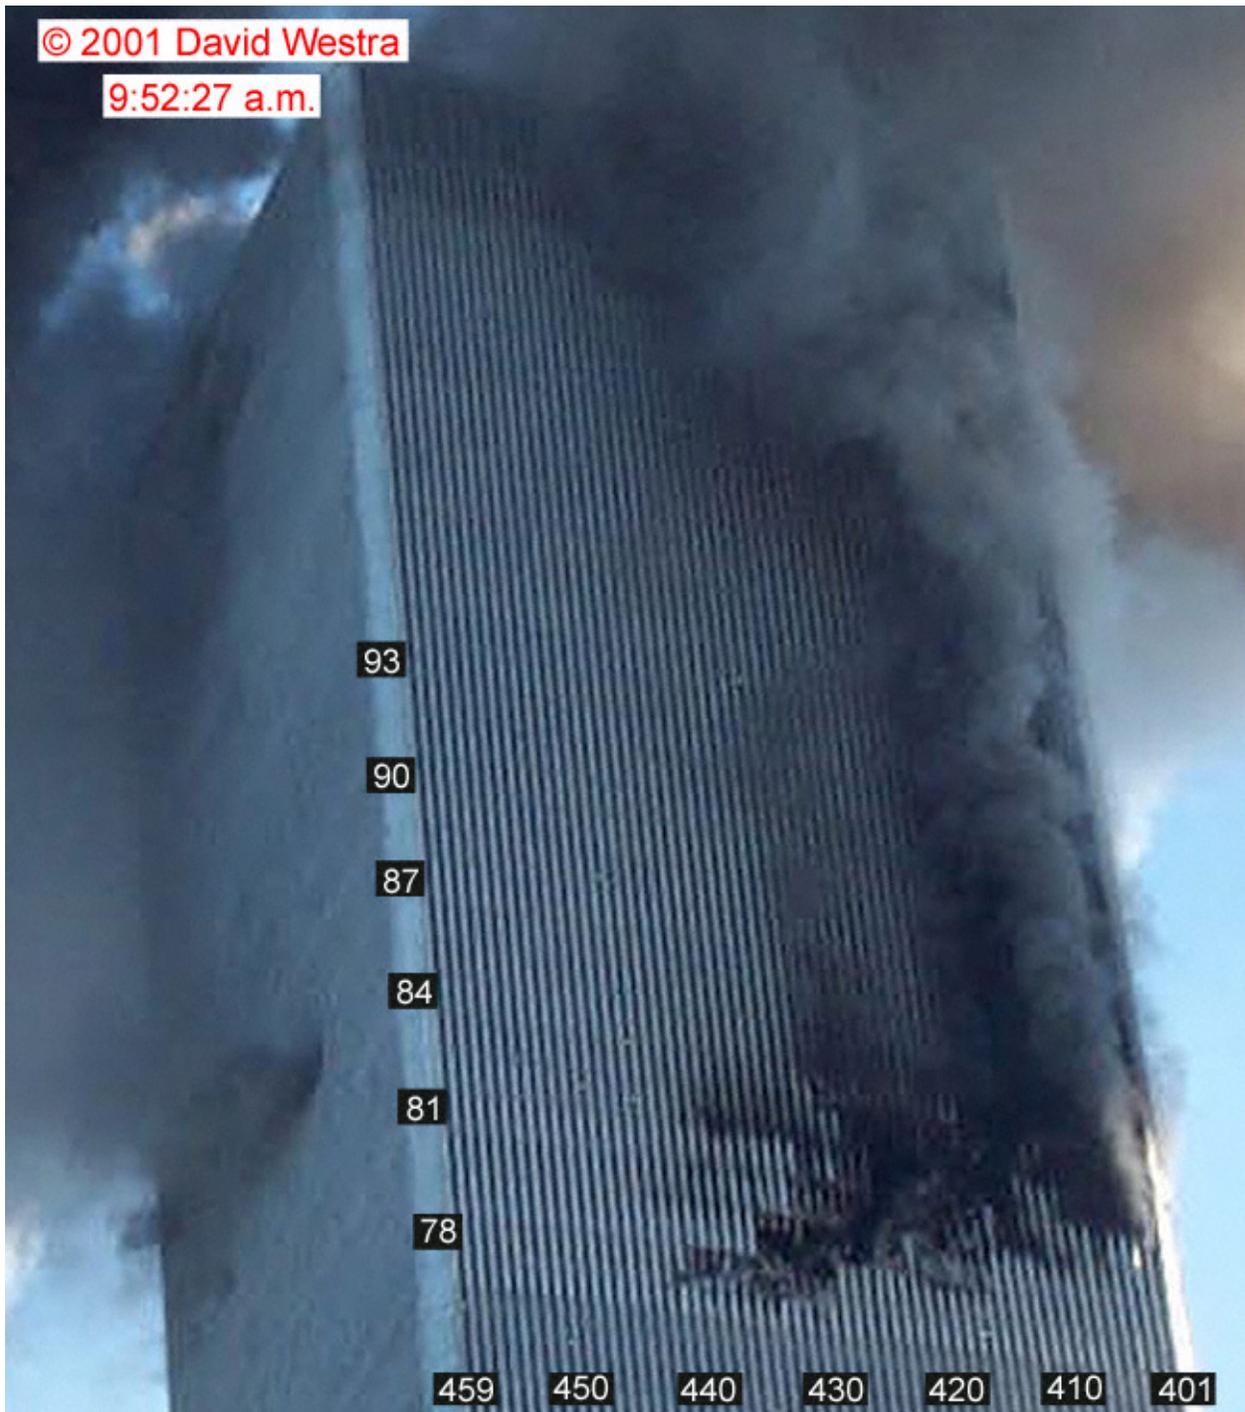
**Figure 9-84.** This cropped photograph shows the south and west faces of WTC 2 at 9:52:27 a.m. The intensity levels have been adjusted, and floor numbers have been added.

Views of the west face of WTC 2 at 9:52:27 a.m. and 9:57:49 a.m. are provided in Figure 9–84 and Figure 9–86, respectively. Smoke is coming from many of the open windows previously identified earlier as possibly having been broken by people. There are no indications of additional windows having opened, and no flames are visible. The visual evidence indicates that fires capable of breaking out window glass had not reached the west face of WTC 2 prior to the collapse.

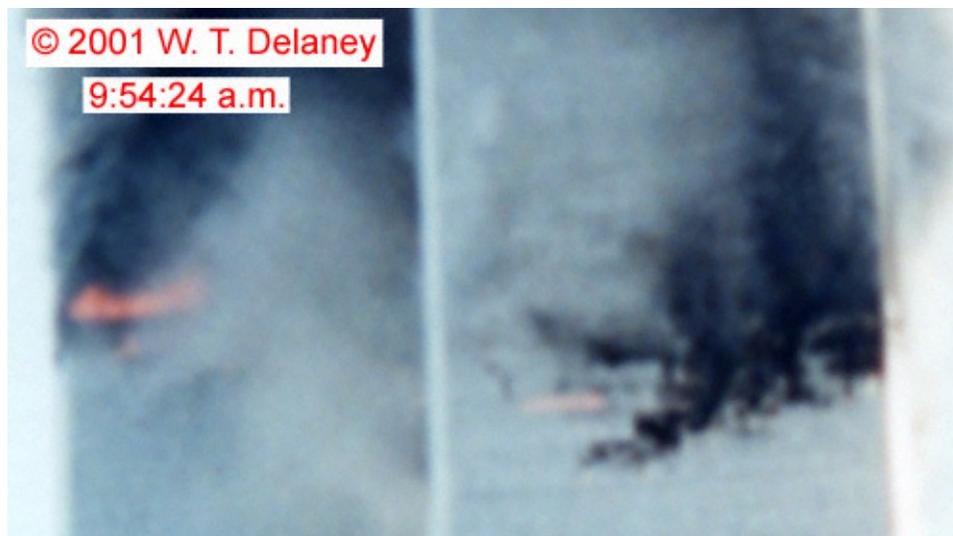
The video shot from the news helicopter shows that over the next few minutes the line of fire on the 80th floor had a steady appearance similar to that in Figure 9–85. Smoke flow from the fire area was generally light, even though there were occasionally streams of smoke released from various windows along the observed fire length. This situation changed at 9:56:44 a.m., when a heavy release of smoke lasting over 20 s took place from windows along the entire length of the fire. At this time the smoke appeared to be coming from as far west as window 80-454. Within 5 s of the start of the heavy smoke flow, large flames erupted from several windows centered near window 80-442. There was also a short flame flare from near window 80-450.

**Figure 9-85. This cropped image shows the south faces of WTC 1 and WTC 2 at 9:54:24 a.m. The intensity levels have been adjusted.**

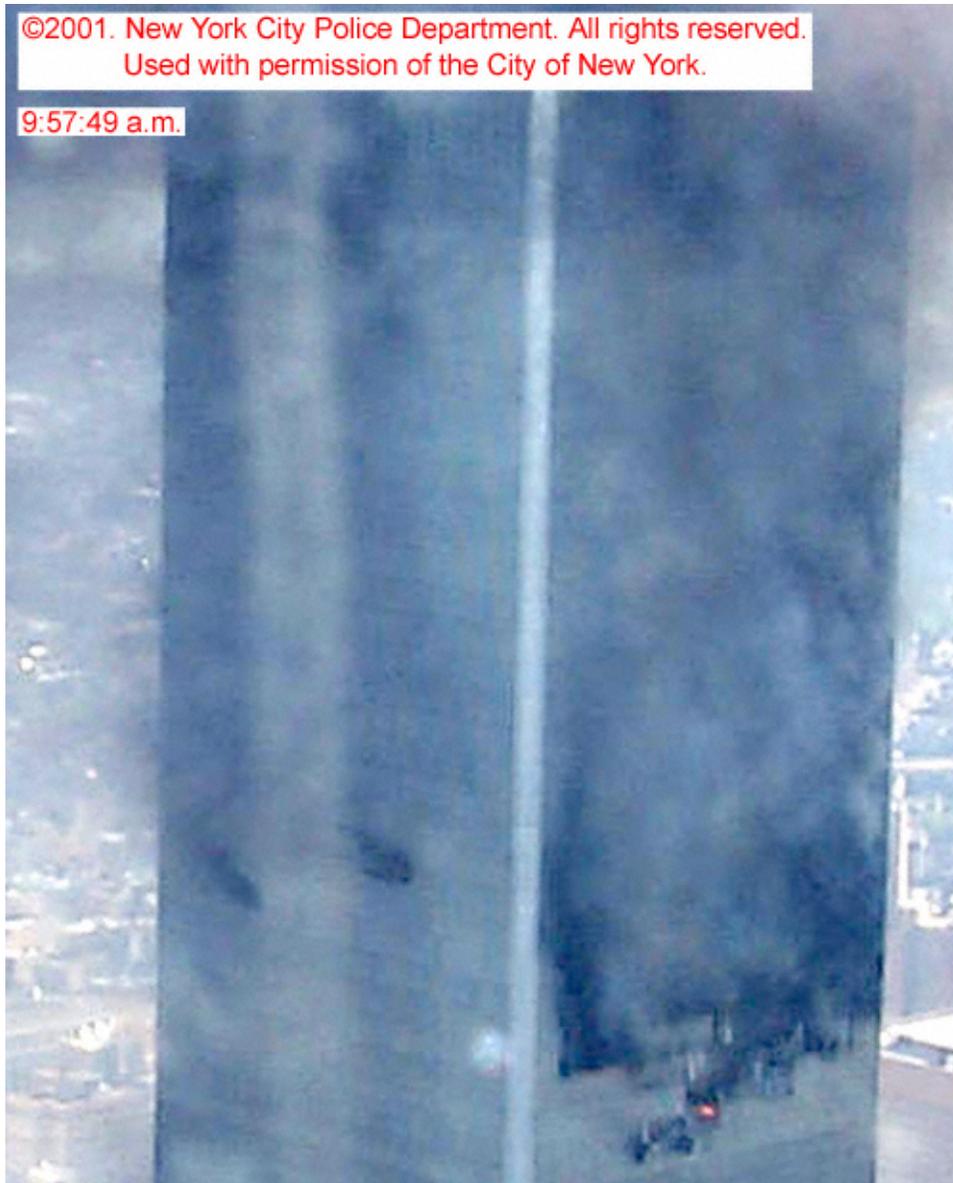
By 9:57:49 a.m. the smoke and flames on the 80th floor of the south face had subsided somewhat. The view of the south and west faces of WTC 2 at 9:57:49 a.m. shown in Figure 9–86 was taken from a NYPD helicopter looking down on the tower from the southwest. The line of smoke and flame to the west of the aircraft impact cavity on the south face is visible extending nearly to the west edge. Heavy smoke also appears to be coming from the 81st floor. There is a bright flame region visible near the 79th floor inside the aircraft impact cavity. Flames were observed in this general vicinity in several ground-based images including those in Figure 9–26 (9:23:08 a.m.) and Figure 9–41 (9:30:19 a.m.), even though such a large fire was not evident.

**Figure 9-86.** This cropped photograph showing the west and south faces of WTC 2 was shot from a helicopter at 9:57:49 a.m. The intensity levels have been adjusted.

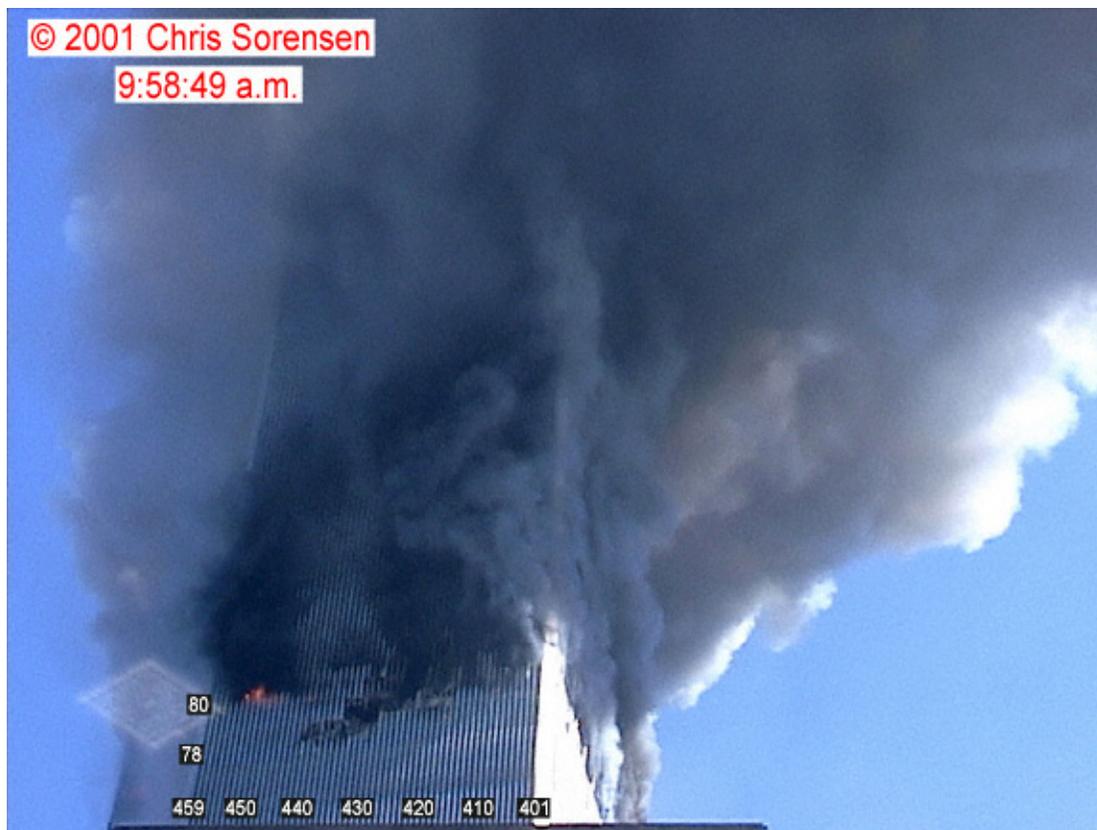
A view of the south face of WTC 2 captured from a video at 9:58:49 a.m. is shown in Figure 9–87. It was taken just 10 s before the start of the collapse of the tower. Flames are visible on the 80th floor from windows 80-440 to 80-452, and smoke is flowing from open windows 80-438 to 80-455. The aerial video shows that the bright region of flame near window 80-450 flared up briefly for several seconds around this time. There are no distinct flames visible at other locations on the face. In particular, the flames visible inside the aircraft impact cavity in Figure 9–86 are not seen from this angle.

**Figure 9-87.** This image of the south face of WTC 2 is a frame captured from a video recorded at 9:58:49 a.m. The intensity levels have been adjusted, and column and floor numbers have been added.
