## Chapter 9

# FIRE BEHAVIOR IN WORLD TRADE CENTER 2

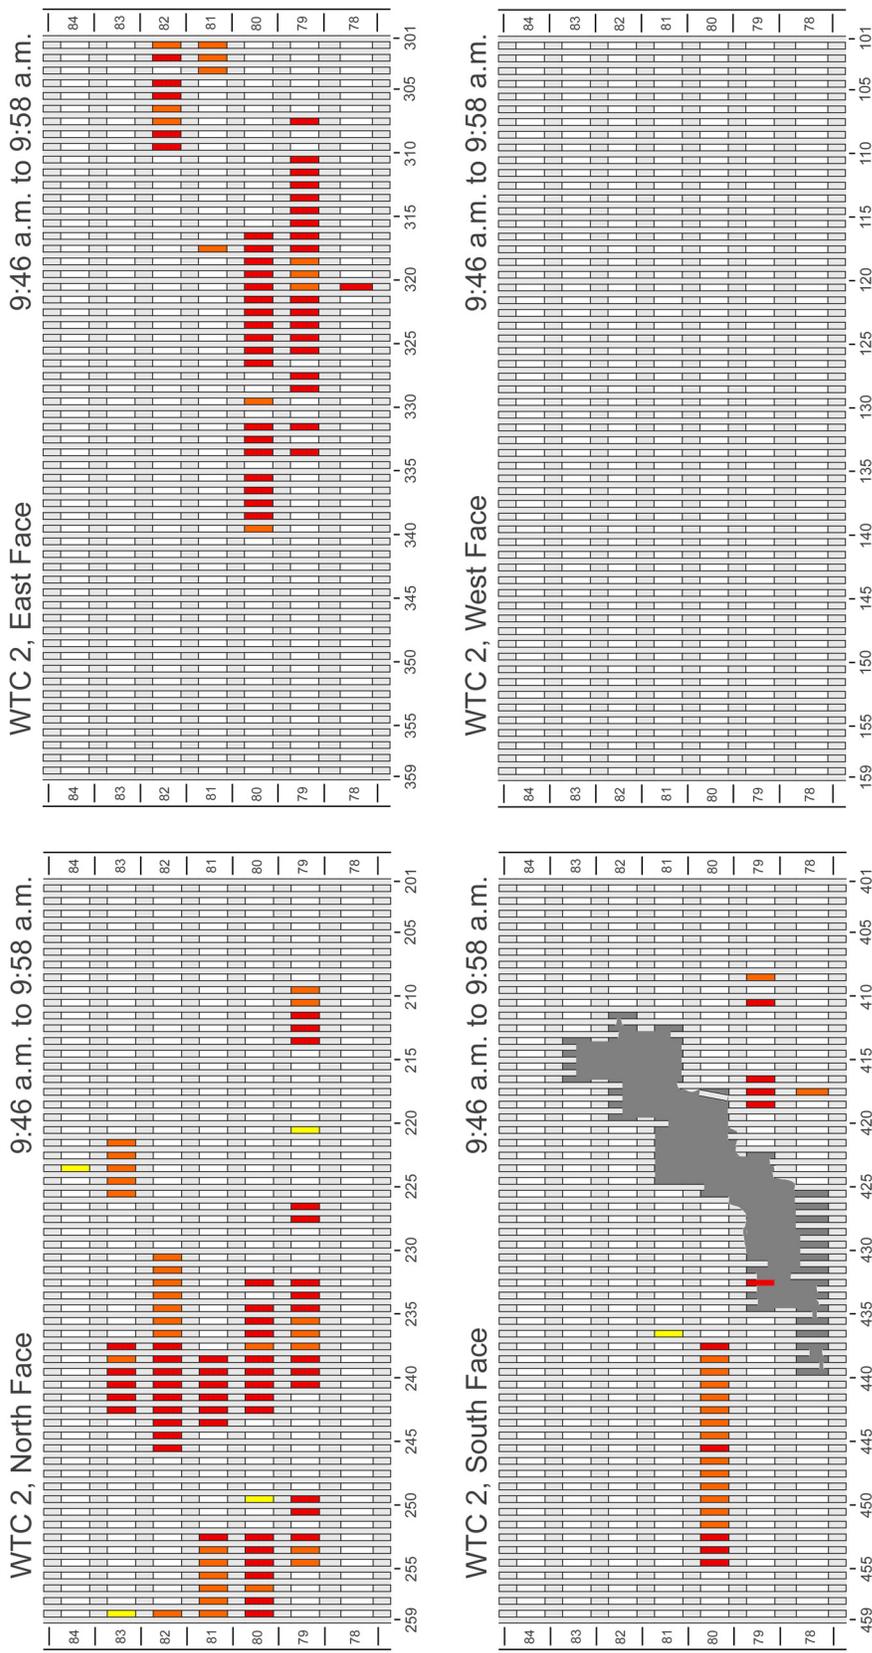
Façade maps of integrated fire intensities for the period from 9:45 a.m. to 9:59 a.m. are shown in Figure 9–88. Comparison with the corresponding maps for the 9:29 a.m. to 9:45 a.m. period shown in Figure 9–60 is helpful for tracking the changes in fire distributions during the current period.

Many of the fires observed during earlier periods were either no longer visible or were dying down during the final interval prior to the tower collapse. Fires dying down included those burning on debris piles located in the northeast corner of the tower and near the center of the north face on the 79th floor, a fire that had earlier burned from south to north across the 82nd floor on the east face, and numerous small fires ignited around the aircraft impact cavity on the south face.

At the same time, fires spread to areas of the faces that had not been involved earlier, including the north face toward the west on the 79th, 82nd, and 83rd floors. There was also an indication that fire may have spread upward on the north face from the 83rd to the 84th floor. The fire growth and local spread on the 79th floor of the north face appeared to be rapid and took place at a location that was apparently removed from earlier fires. This may be an indication that fire spread to this area on the faces occurred from interior locations within the tower that were not visible from outside. The new areas of fire which appeared on both the 79th and 83rd floors developed rapidly and remained localized at a few windows. These behaviors suggest that these fires had spread into rooms with walls that terminated at nearby façade columns and limited further fire spread. On the 79th floor, flames were seen in window 79-209 to window 79-212. A floor plan layout for the 79th floor is shown in Figure B-10 in Appendix B. It indicates that a room was not present behind these windows. A room is indicated in the northwest corner with walls at columns 79-208 and 79-154. The fire on the 83rd floor appeared in windows 83-221 to 83-225. Unfortunately, a floor plan layout for this floor is not available for comparison. The visual evidence indicates that none of the spreading fires on the north face reached as far as the west face prior to the tower collapse.

**Figure 9-88. Maps of integrated fire observations between 9:45 a.m. and 9:59 a.m. are shown for the four faces of WTC 2. Colors represent the highest intensity fire observed in a window using the color scale defined in Figure 5-1.**

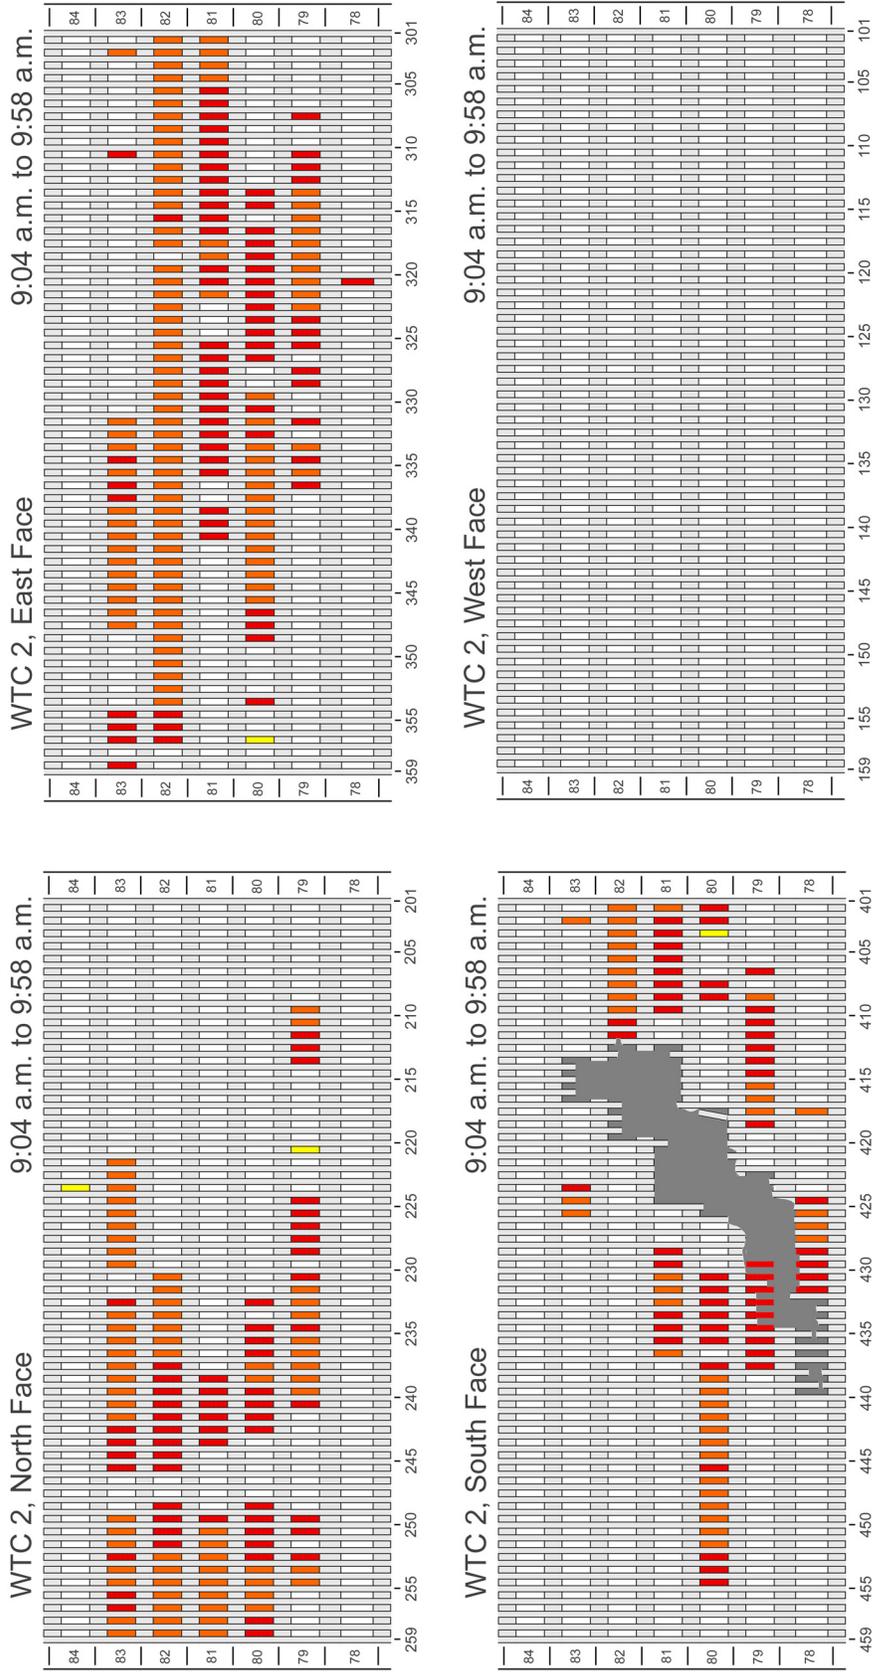
Compared to WTC 1, the amount of fire spread in WTC 2 was less extensive during the 56 min between the impact of United Airlines Flight 175 and the collapse of the tower. One approach for characterizing the fire spread in WTC 2 is to compare integrated façade maps for the entire period from 9:03 a.m. to 9:59 a.m. with the initial fire distributions shortly after the aircraft impact. Figure 9–89 shows fire maps for the four faces obtained by integrating the fire datasheets over the entire period. These maps are compared with the corresponding fire distributions around 9:04 a.m. in Figure 9–90.

**Figure 9-89. Maps of integrated fire observations between 9:03 a.m. and 9:59 a.m. are shown for the four faces of WTC 2. Colors represent the highest intensity fire observed in a window using the color scale defined in Figure 5-1.**

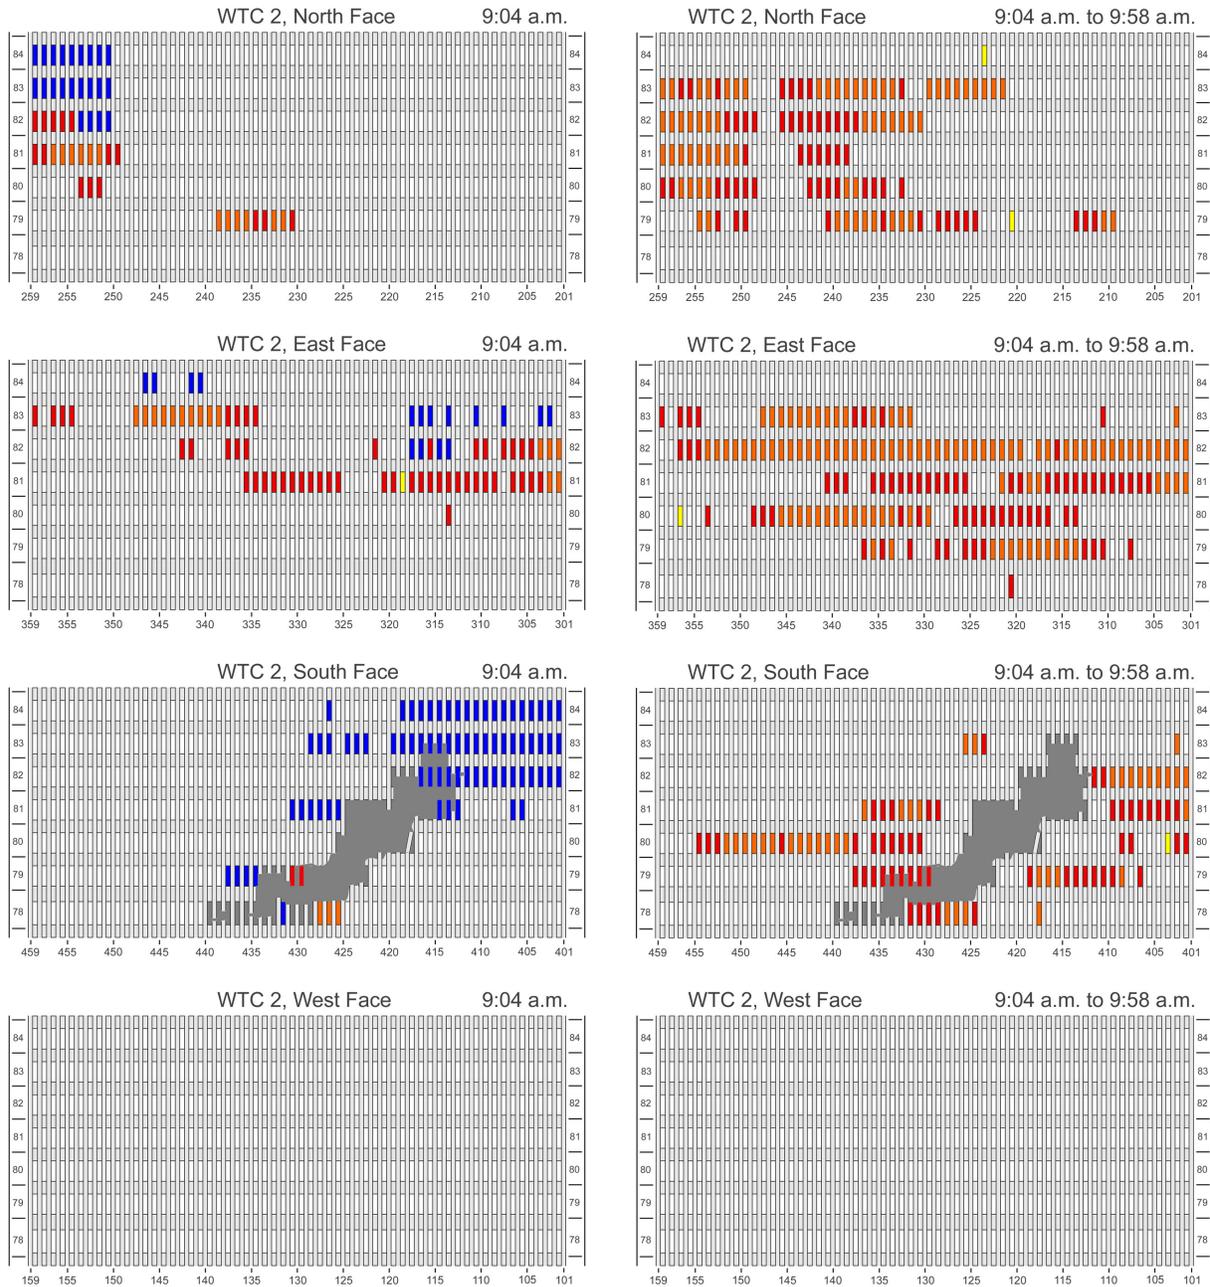
**Figure 9-90. Maps of observed fire distributions on the four faces of WTC 2 shortly after the aircraft impact (near 9:04 a.m.) are compared with the corresponding integrated fire observations for the entire period between 9:03 a.m. and 9:59 a.m. The data for 9:04 a.m. are represented using the color scale in Figure 5-1. For the integrated results, the same color scale is used to represent the highest intensity fire observed in a given window during the period.**

On the north face significant fire spread took place on the 79th, 82nd, and 83rd floors. The effects of this fire spread are revealed by areas of fire (Figure 9–90) and opened windows (Figure 9–91) on the west sides of the areas of fire and open windows that were present shortly following the aircraft impact and fireballs. On the 79th floor this fire growth took place from the large fire burning on a pile of debris just to the east of the center of the face. Despite the presence of this sustained fire, westward fire spread on this floor was relatively slow and sporadic. The fire spread on the 82nd floor occurred just to the west of the cold spot (an area on the 80th, 81st, and 82nd floors between columns 238 and 250). Fire spread into this area was not observed until around 9:54 a.m. On the 83rd floor fire spread occurred in discrete segments that suggested fire was spreading across a series of rooms. The first large fire appeared just above the cold spot around 9:29 a.m. None of the fires that spread to the west on the north face appeared to reach the western edge of the tower by the time of collapse.

The fire behavior observed on the south face of WTC 2 seemed to be determined to a large extent by the locations of small fires ignited in and around the aircraft impact cavity by the fireball following the impact. The locations of some of these initial fires are indicated by the fire distribution map for the face around 9:04 a.m. included in Figure 9-90.

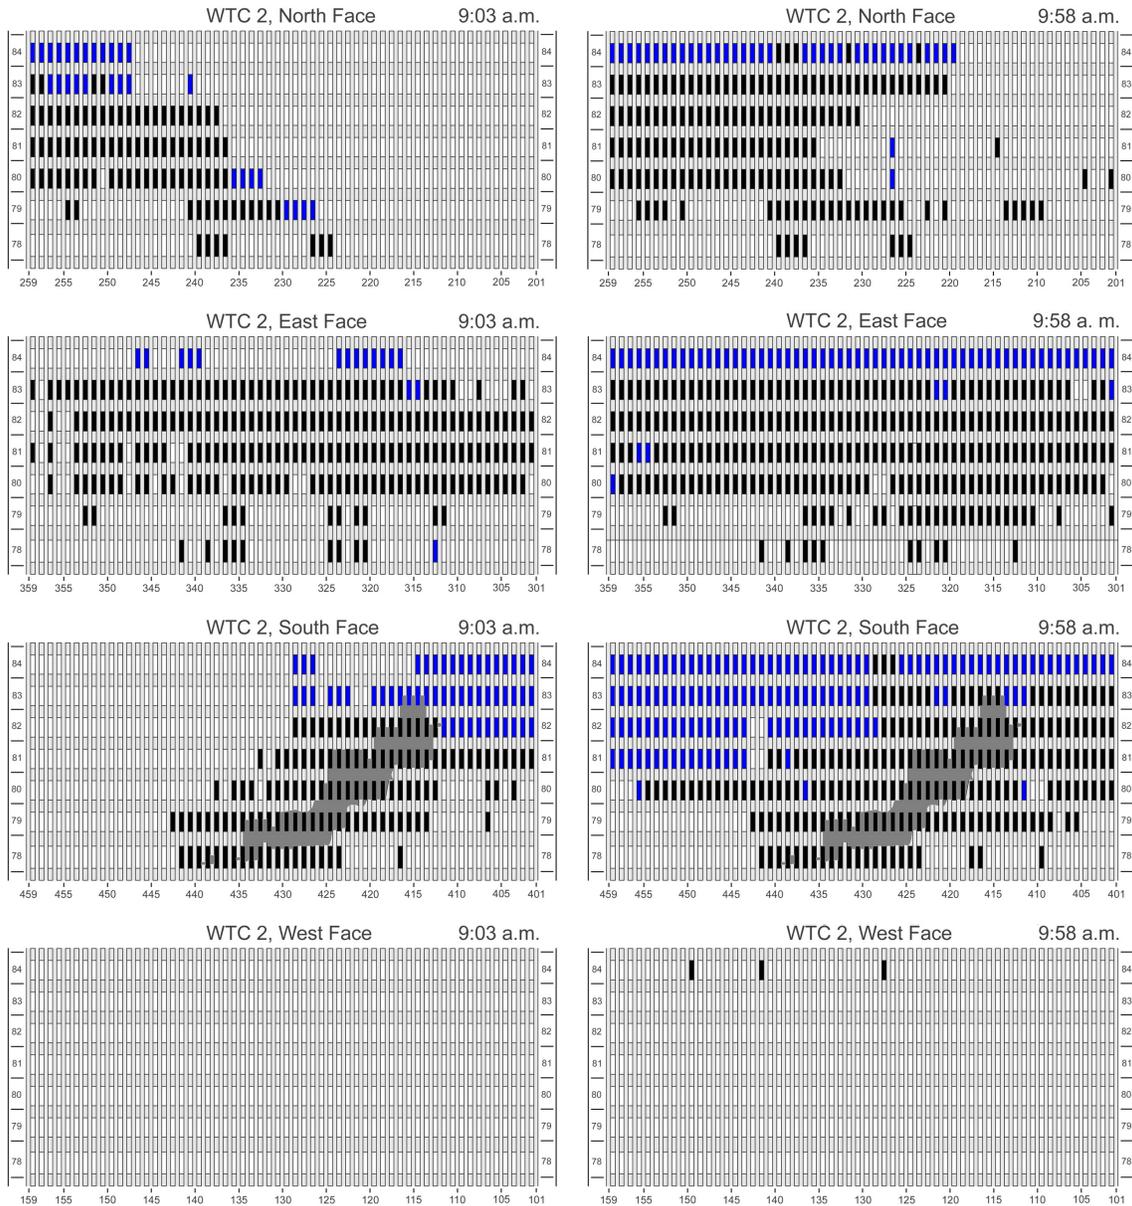
Similar to the analyses included in Chapter 8, changes in window condition can also be used as a rough indicator of fire spread. This analysis method has been used to complement the integrated fire data. The results are shown in Figure 9–91. It should be kept in mind that this approach only reveals fire spread that occurs to locations where windows were originally unopened. This is particularly important for WTC 2 because the number of windows opened by the aircraft impact and subsequent fireballs was much larger than for WTC 1. Even so, the analysis does provide a good estimate for fire spread into areas where window glass was still in place immediately following the aircraft impact.

**Figure 9-91. Maps for the 78th through the 84th floors compare missing window glass for the four faces of WTC 2 at two times, immediately following the aircraft impact at 9:02:59 a.m. and just prior to the collapse of WTC 1 at 9:58:59 a.m.**

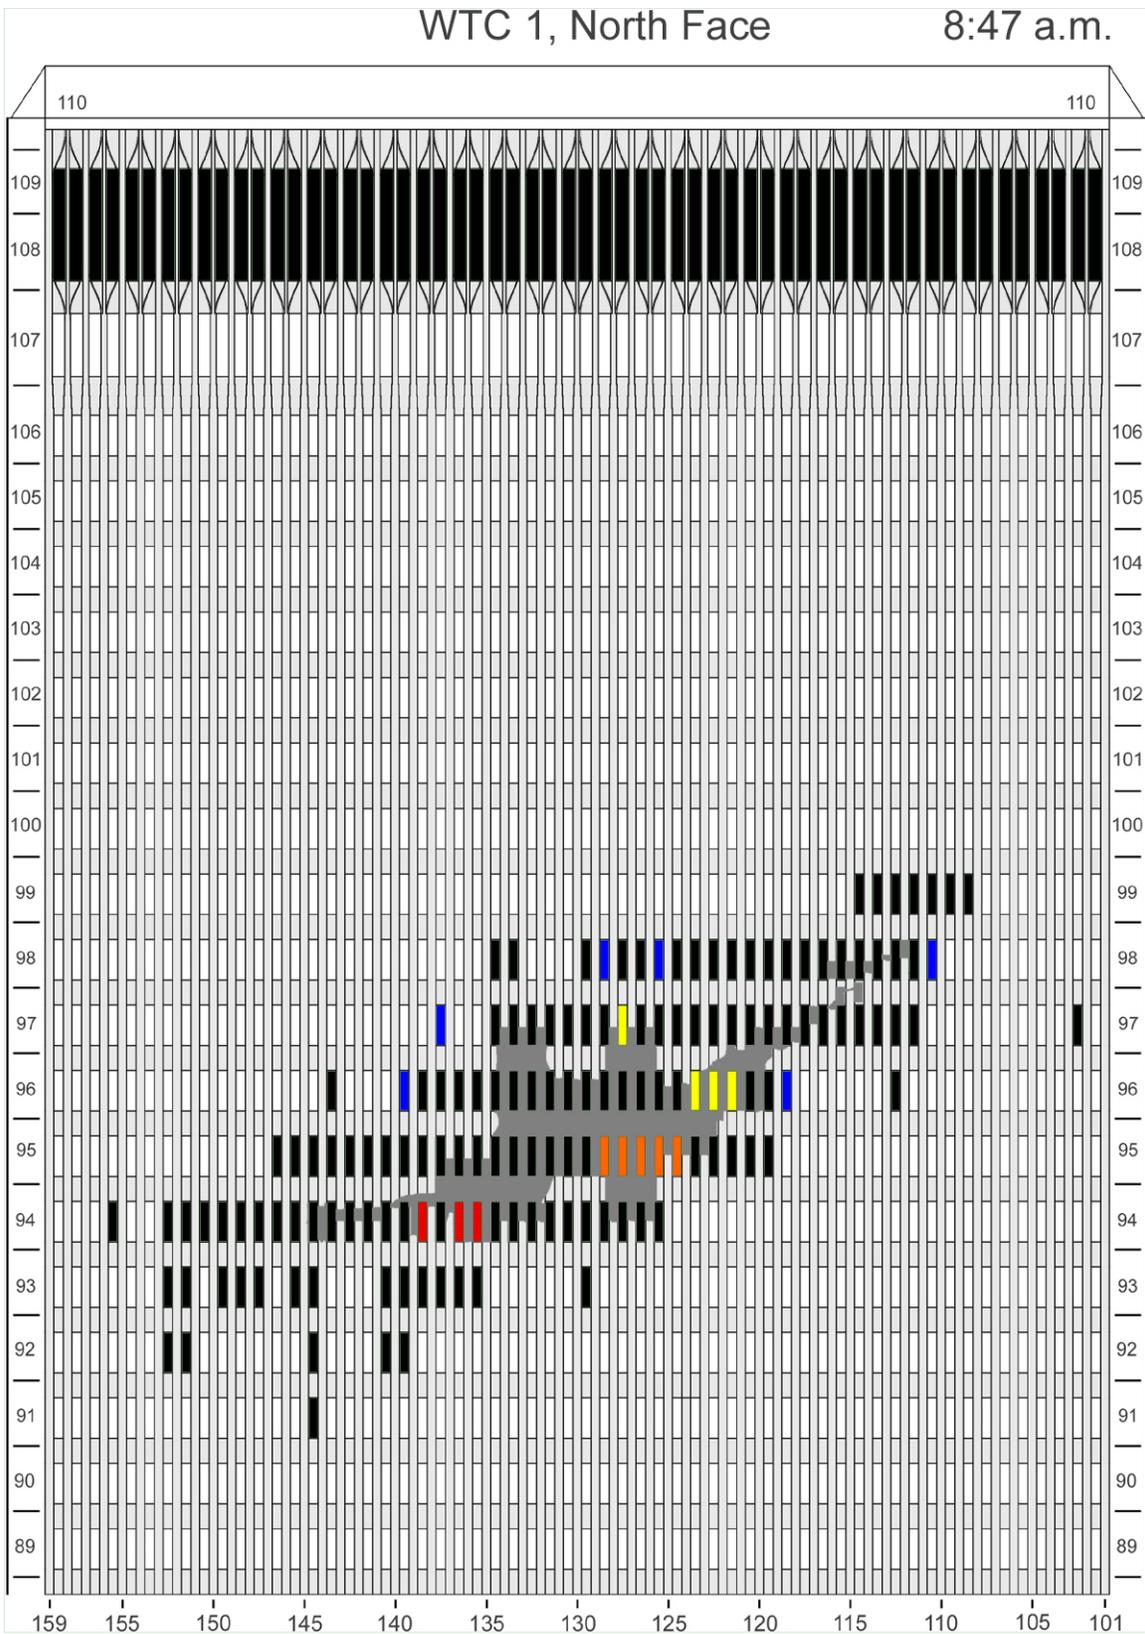
Figure C-1. Diagram of the north face of WTC 1 for floors 89 to 110 at 8:47 a.m. showing the condition of windows and locations of fires.

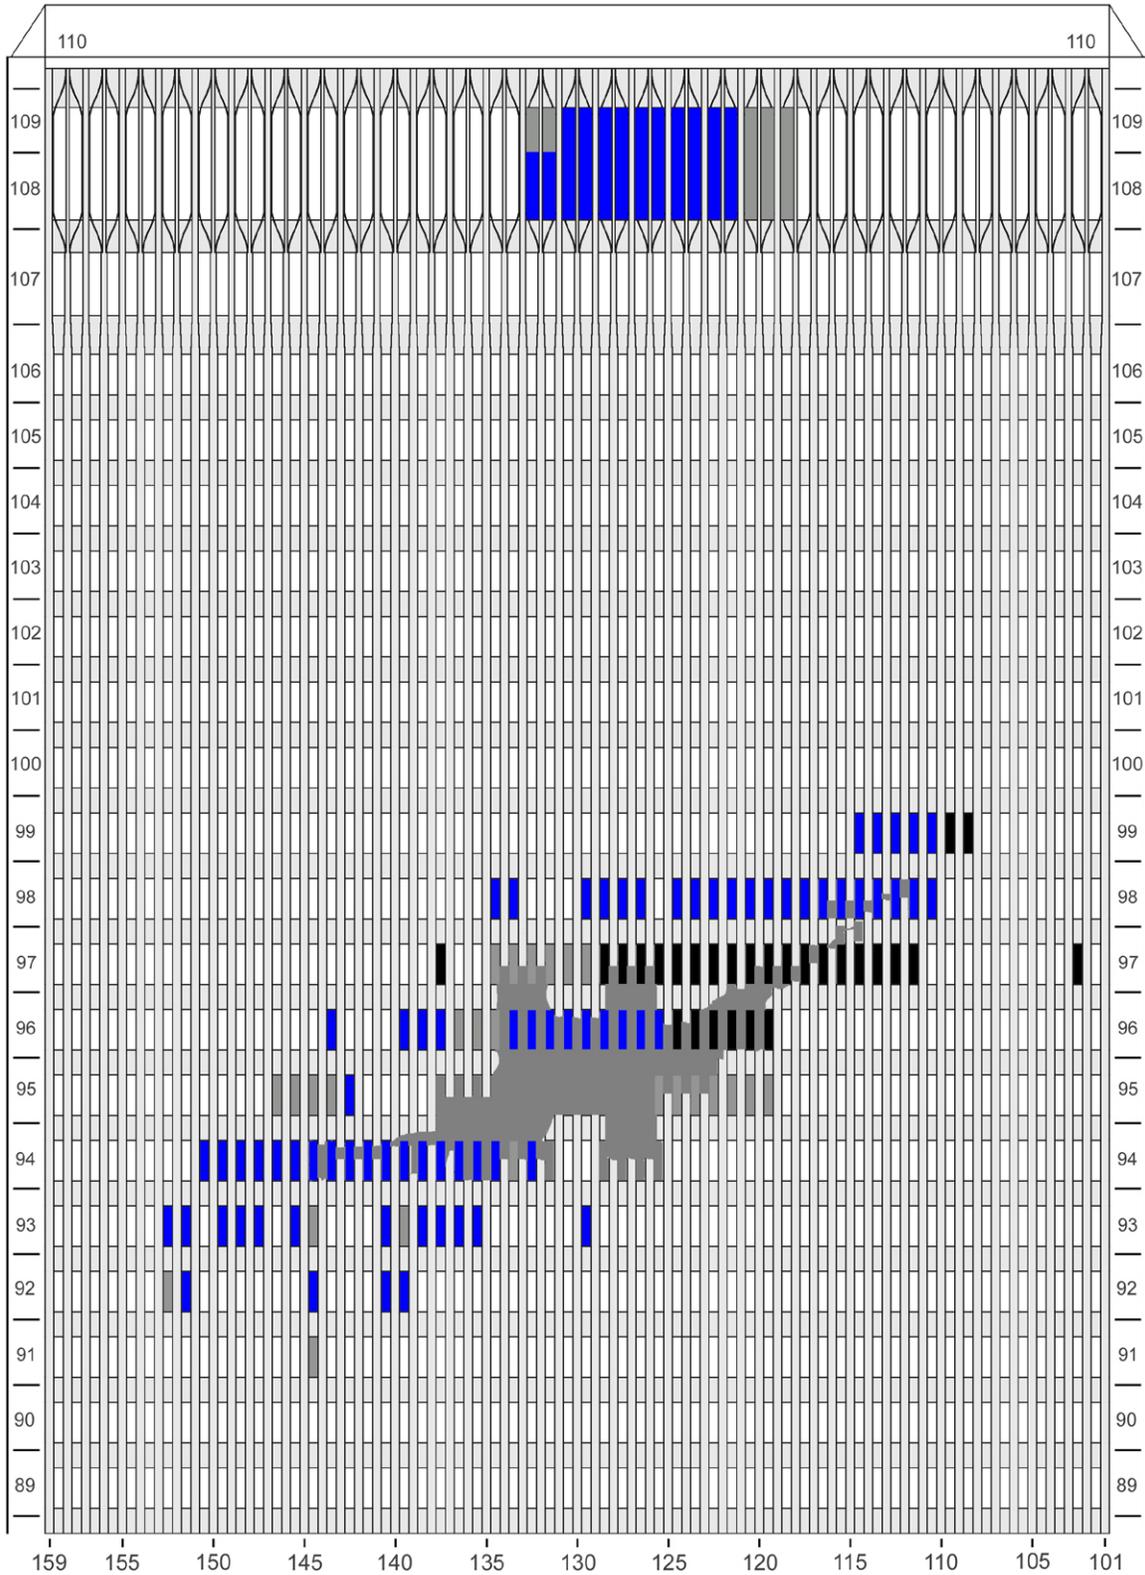
Figure C-2. Diagram of the north face of WTC 1 for floors 89 to 110 at 8:47 a.m. showing windows where smoke was observed and those that were hidden from view.

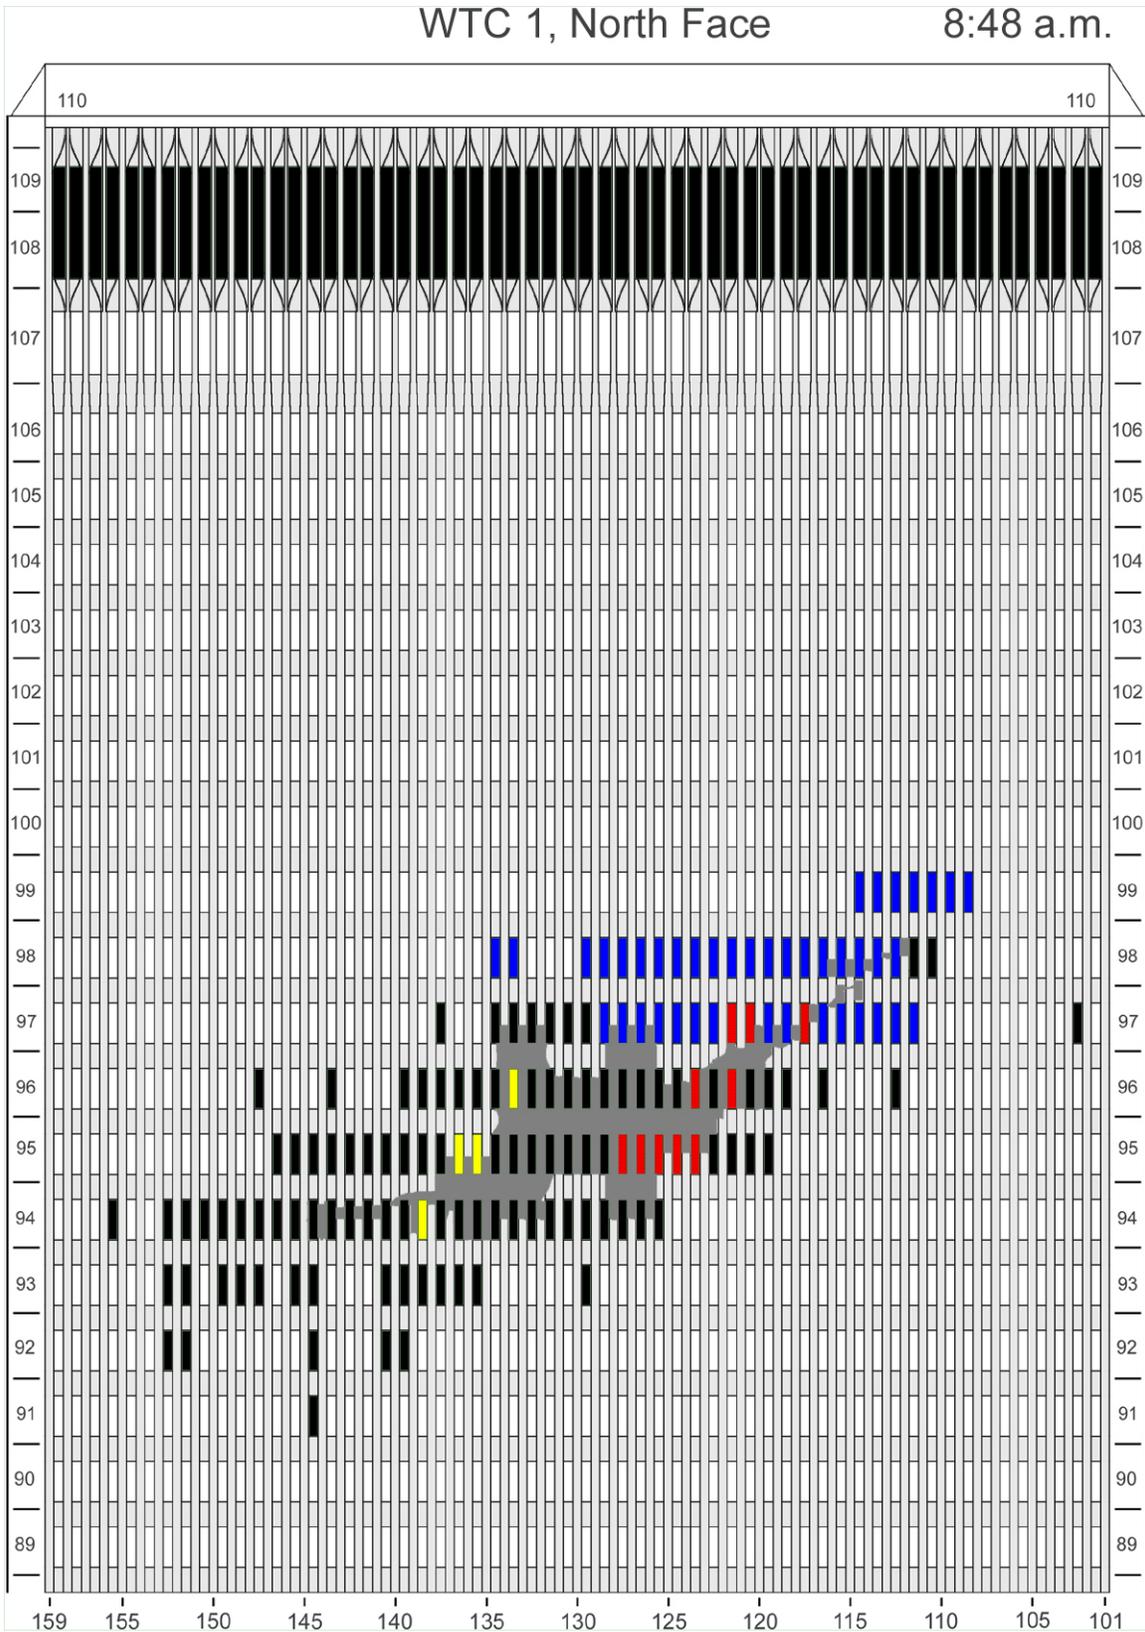
**Figure C-3. Diagram of the north face of WTC 1 for floors 89 to 110 at 8:48 a.m. showing the condition of windows and locations of fires.**

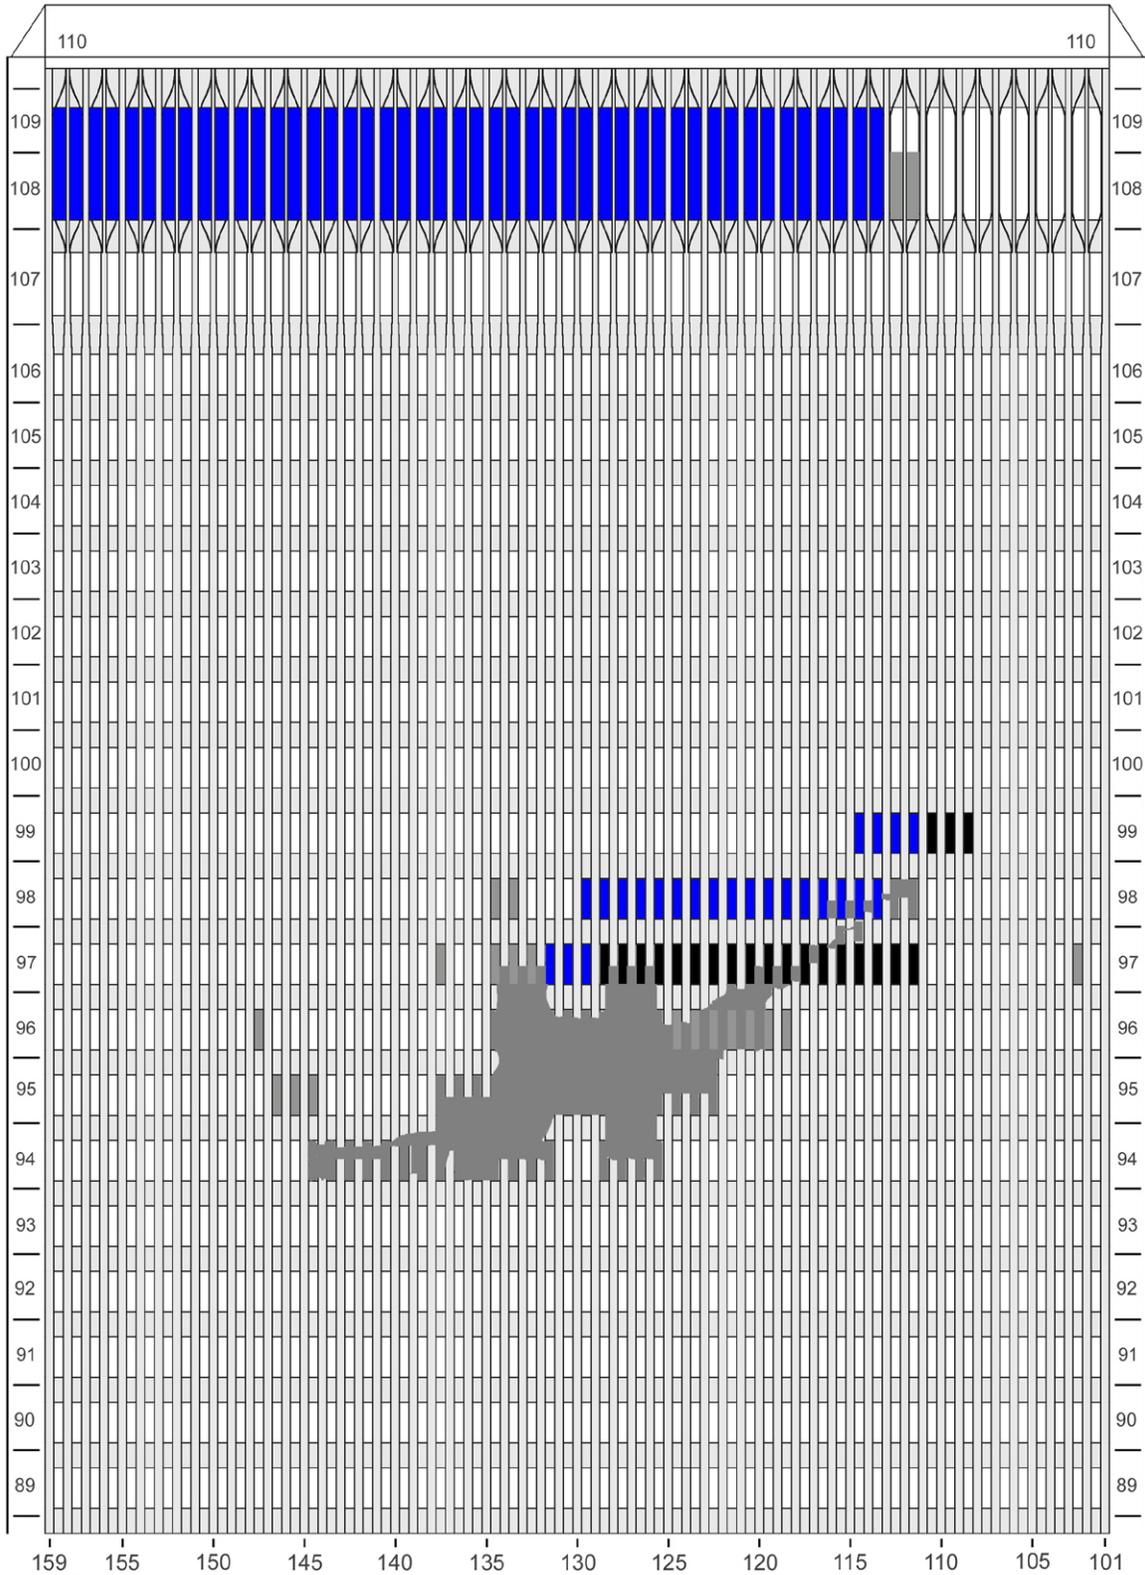
**Figure C-4. Diagram of the north face of WTC 1 for floors 89 to 110 at 8:48 a.m. showing windows where smoke was observed and those that were hidden from view.**

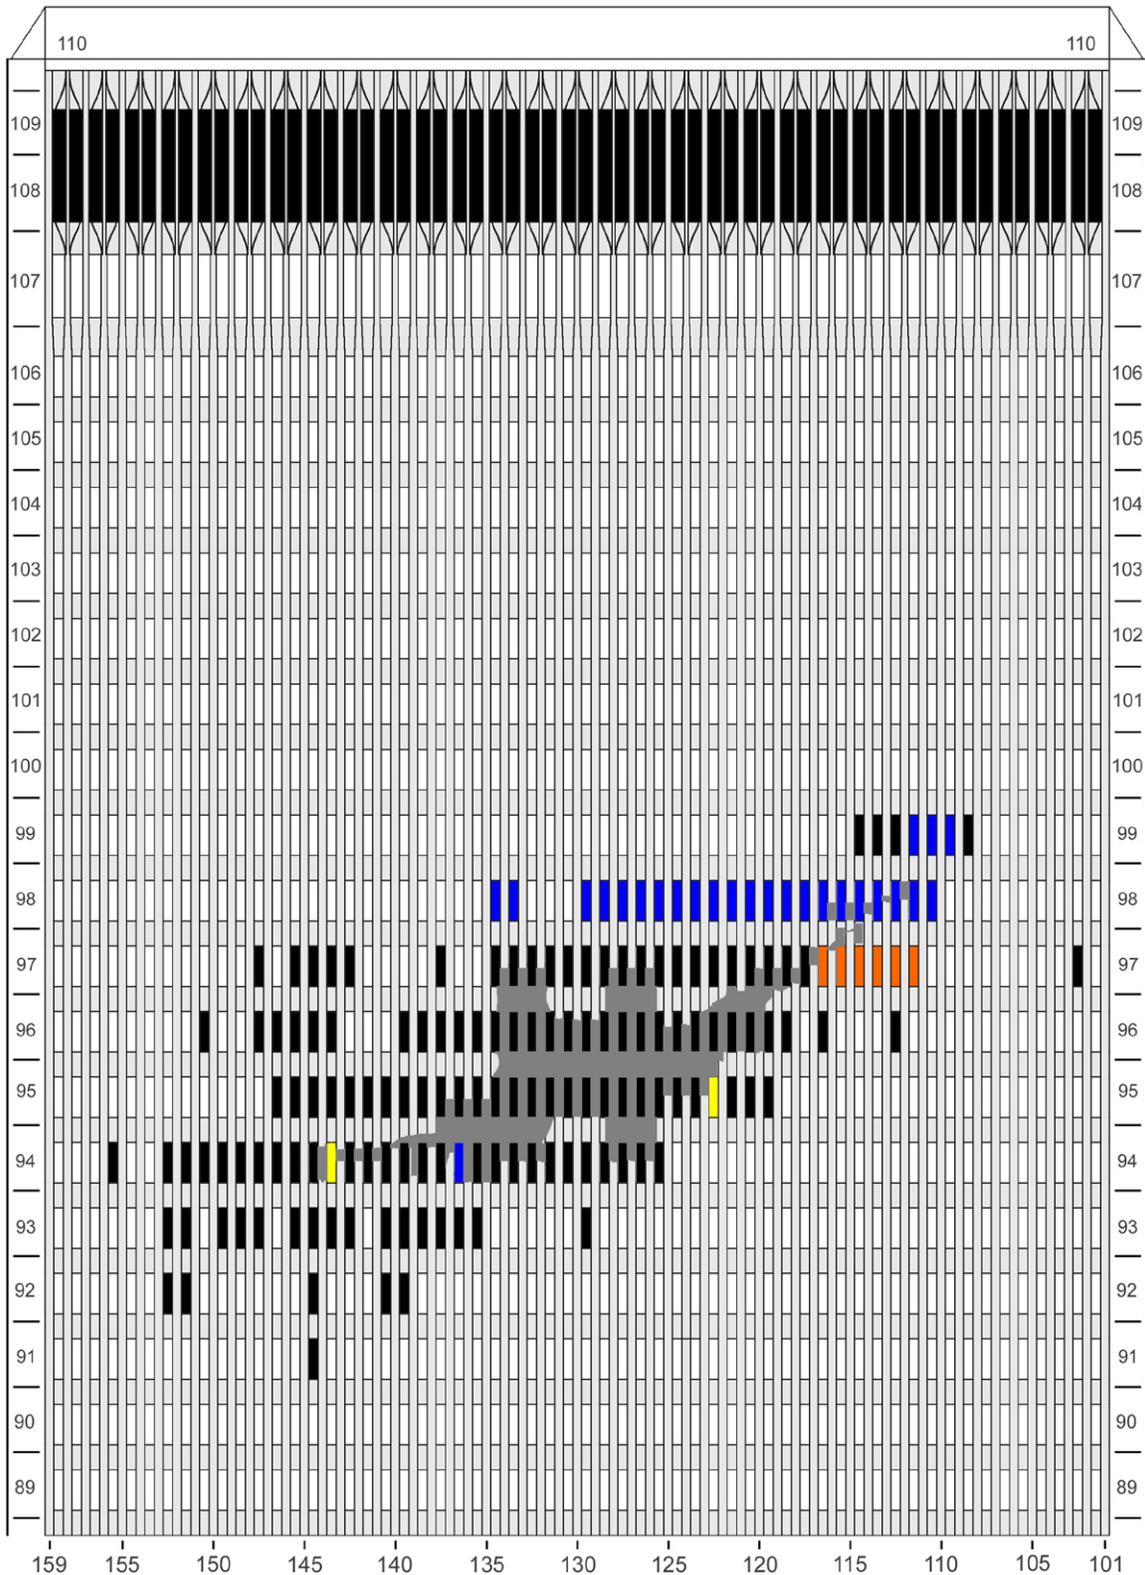
**Figure C-5. Diagram of the north face of WTC 1 for floors 89 to 110 at 8:50 a.m. showing the condition of windows and locations of fires.**

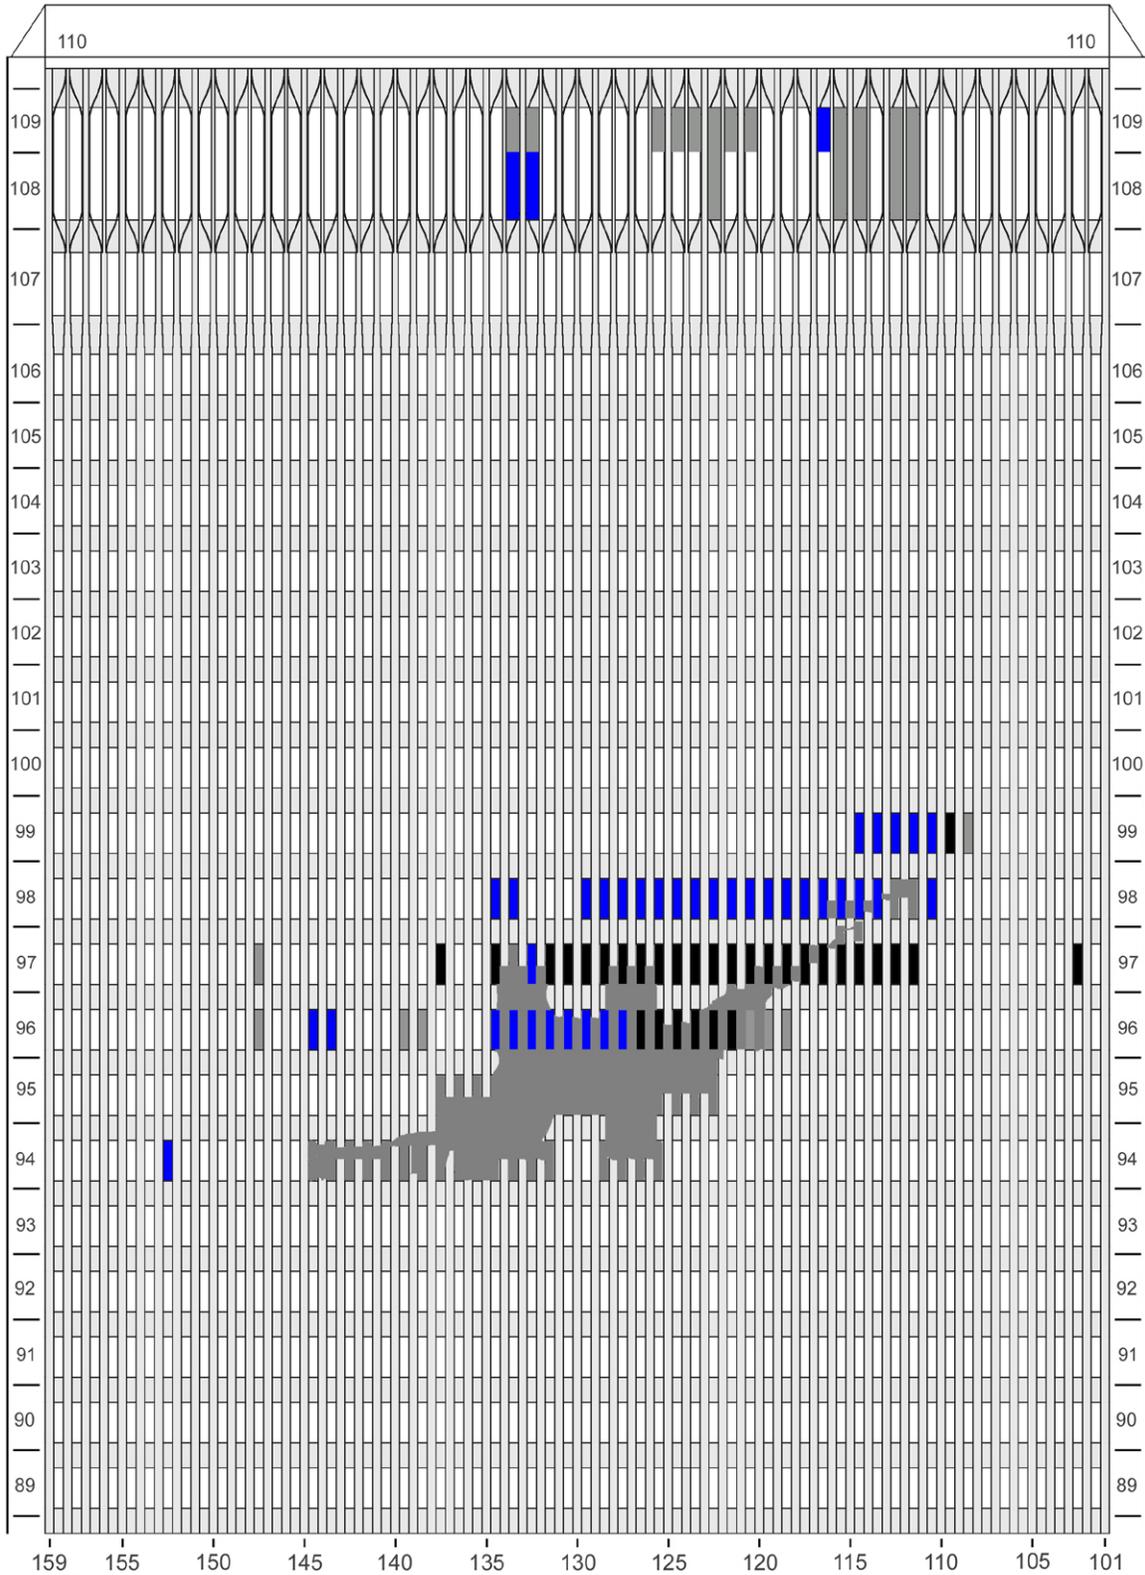
**Figure C-6. Diagram of the north face of WTC 1 for floors 89 to 110 at 8:50 a.m. showing windows where smoke was observed and those that were hidden from view.**

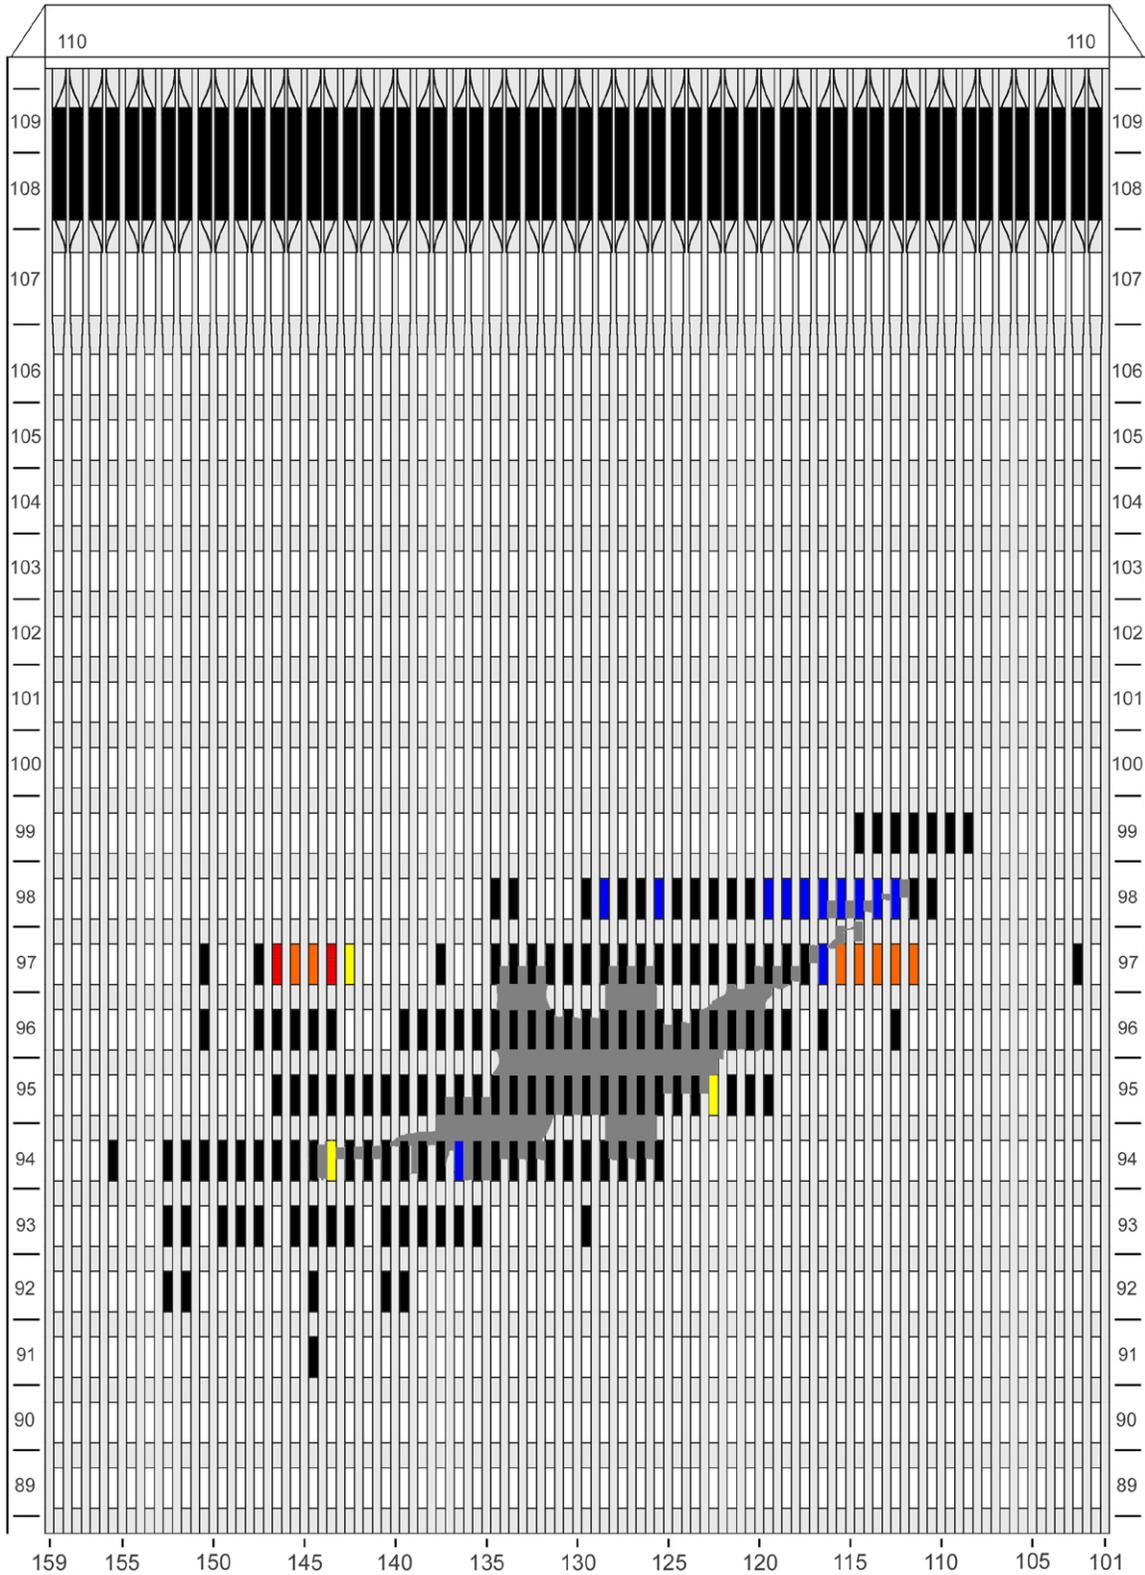
Figure C-7. Diagram of the north face of WTC 1 for floors 89 to 110 at 8:52 a.m. showing the condition of windows and locations of fires.

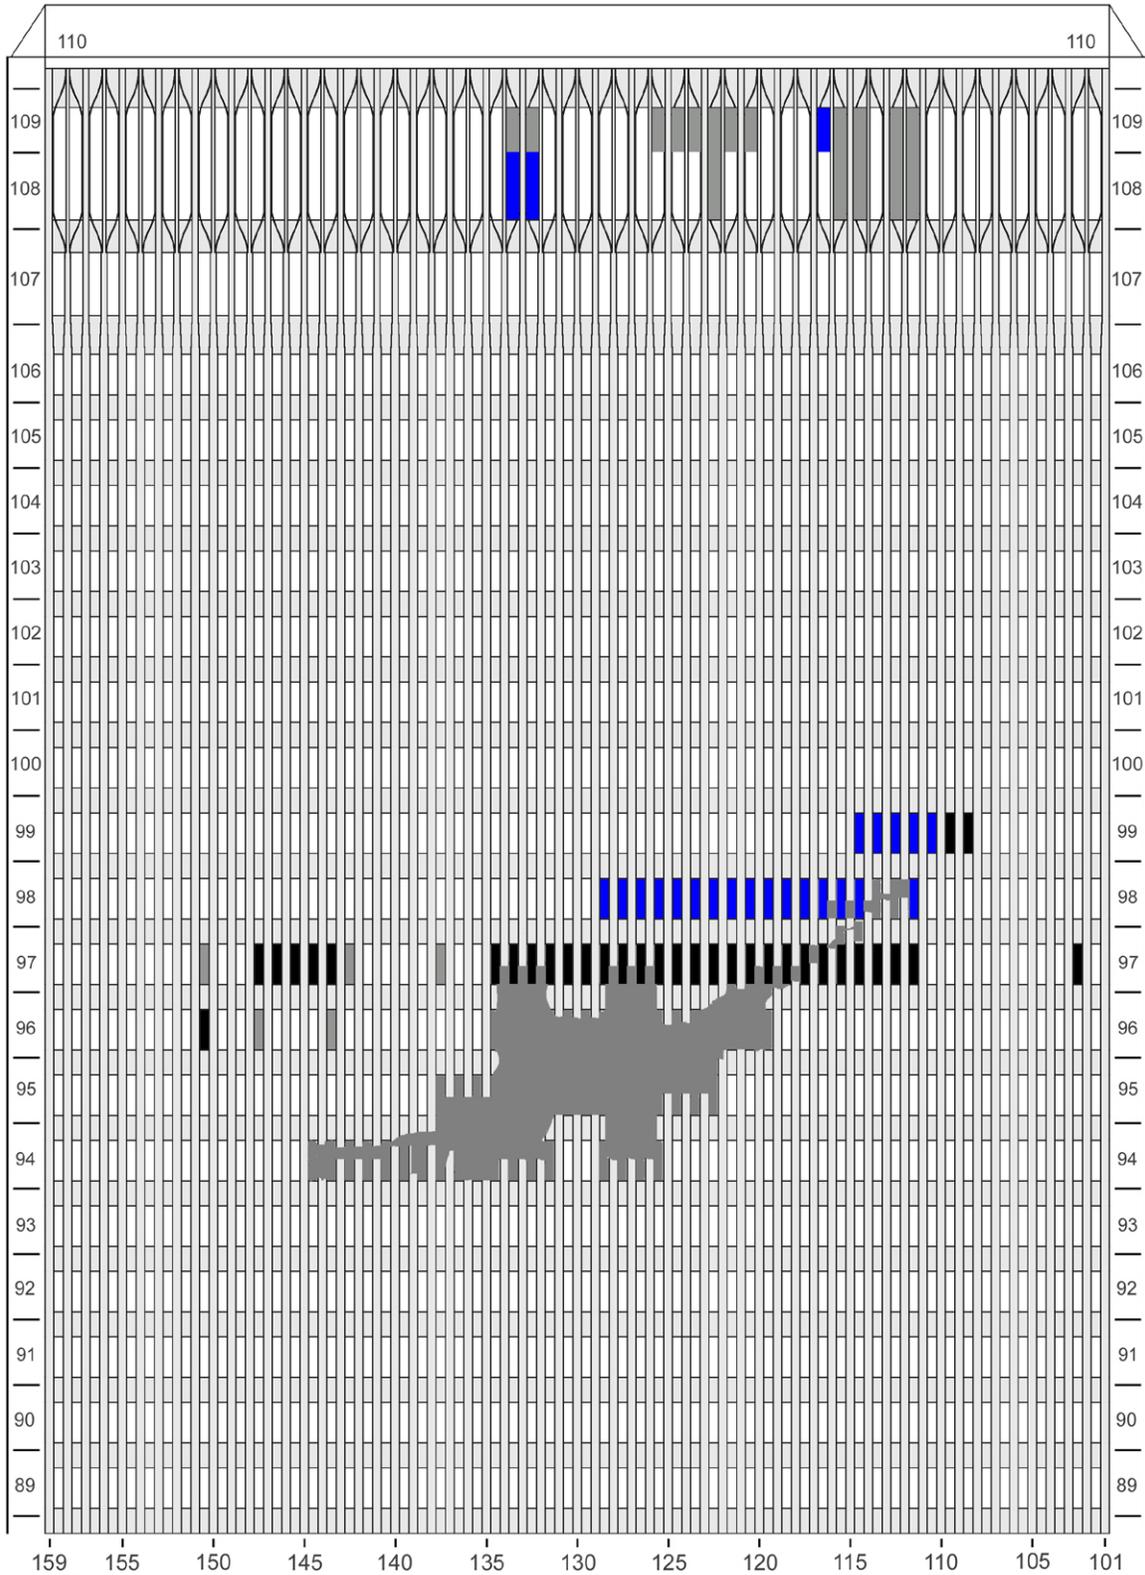
Figure C-8. Diagram of the north face of WTC 1 for floors 89 to 110 at 8:52 a.m. showing windows where smoke was observed and those that were hidden from view.
