## Chapter 9

# FIRE BEHAVIOR IN WORLD TRADE CENTER 2

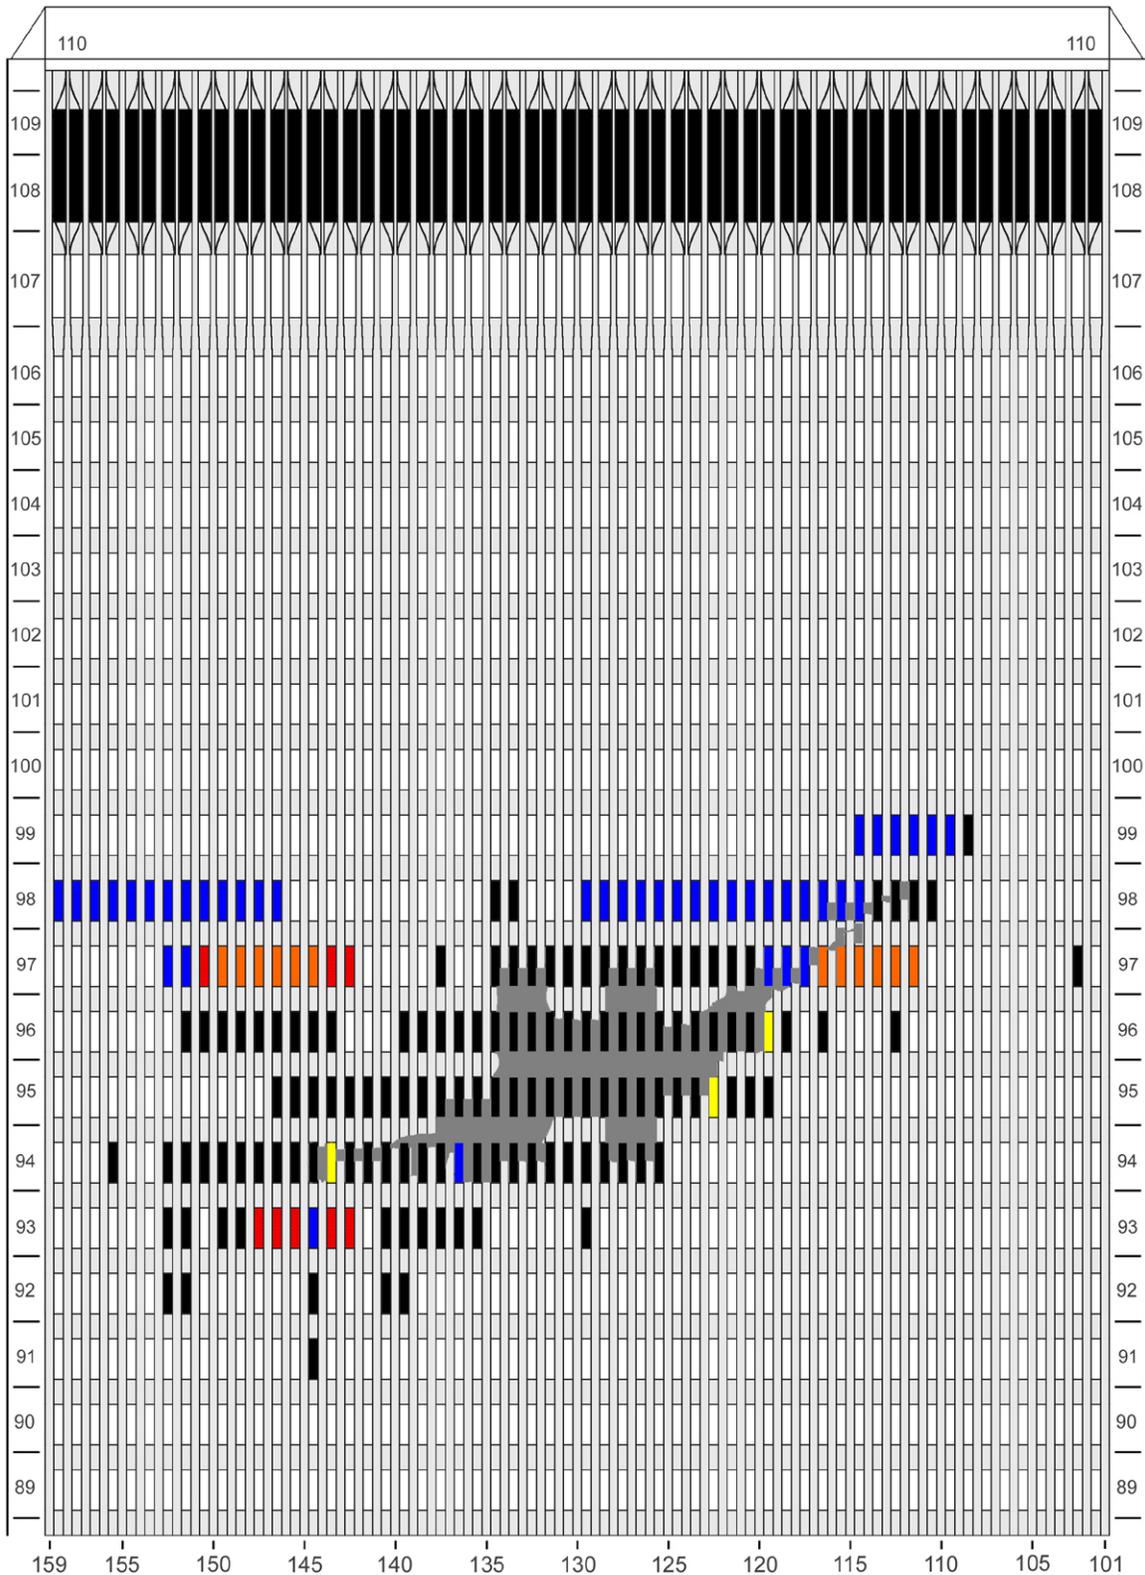
Figure C-9. Diagram of the north face of WTC 1 for floors 89 to 110 at 8:54 a.m. showing the condition of windows and locations of fires.

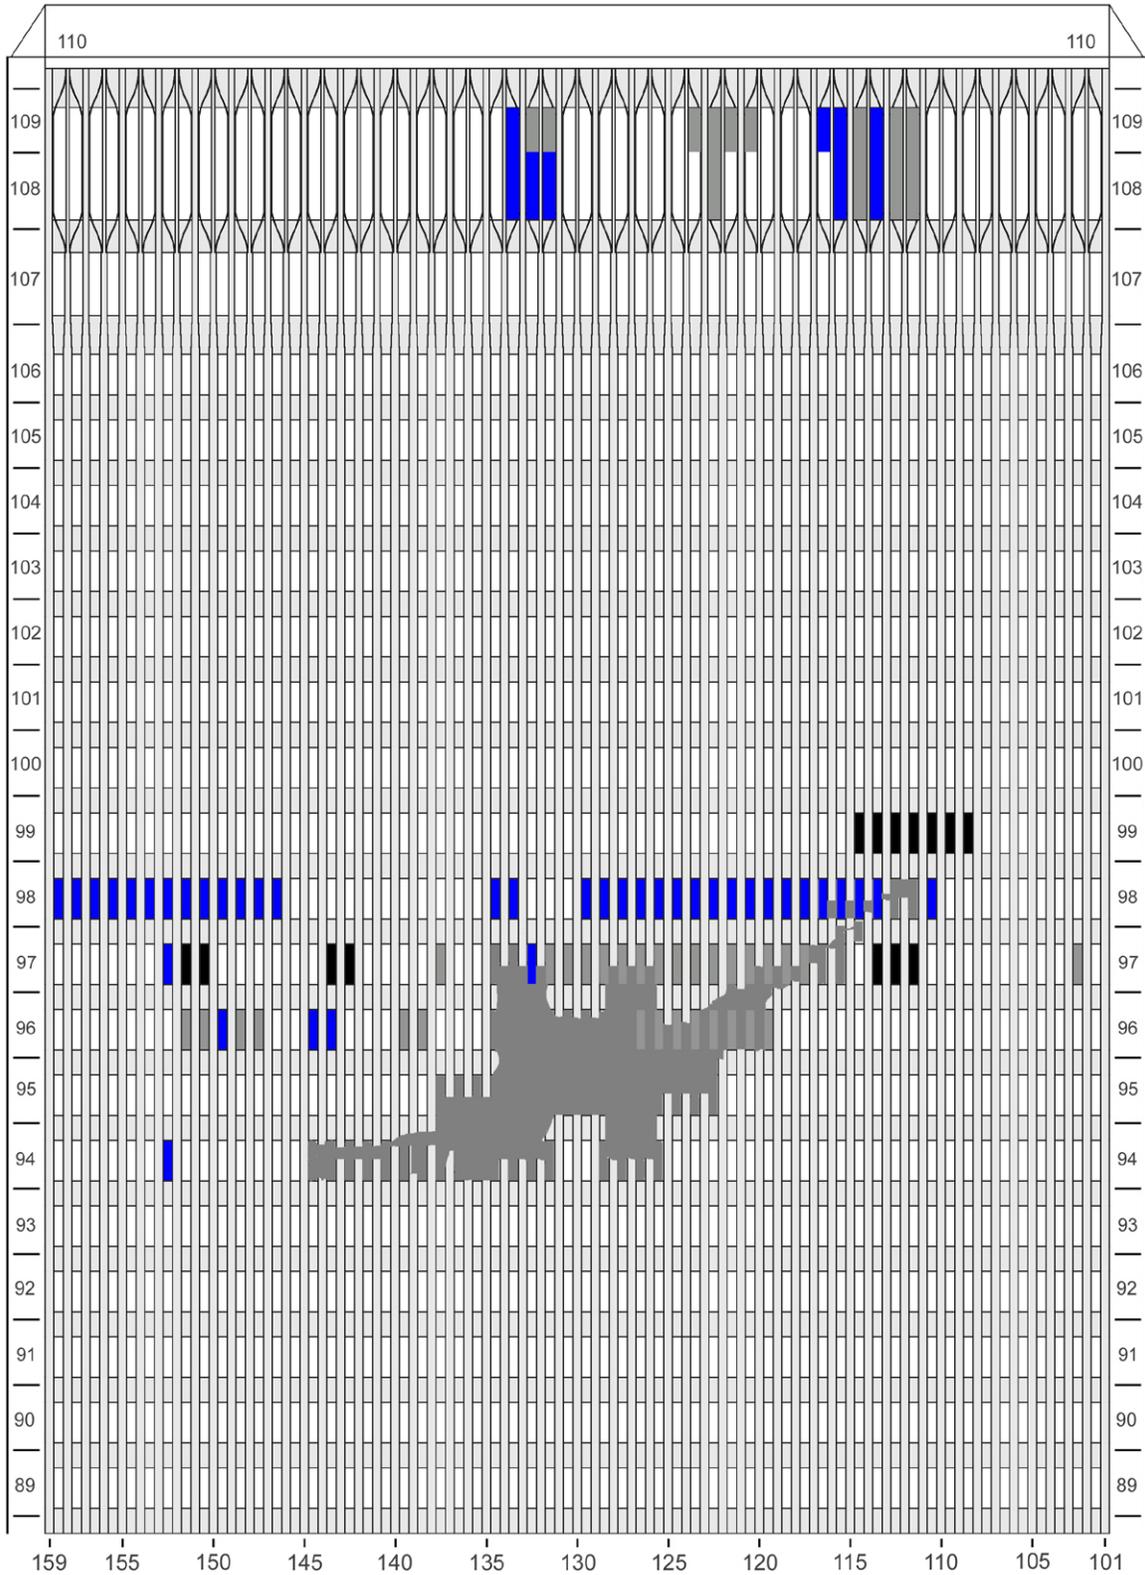
**Figure C-10. Diagram of the north face of WTC 1 for floors 89 to 110 at 8:54 a.m. showing windows where smoke was observed and those that were hidden from view.**

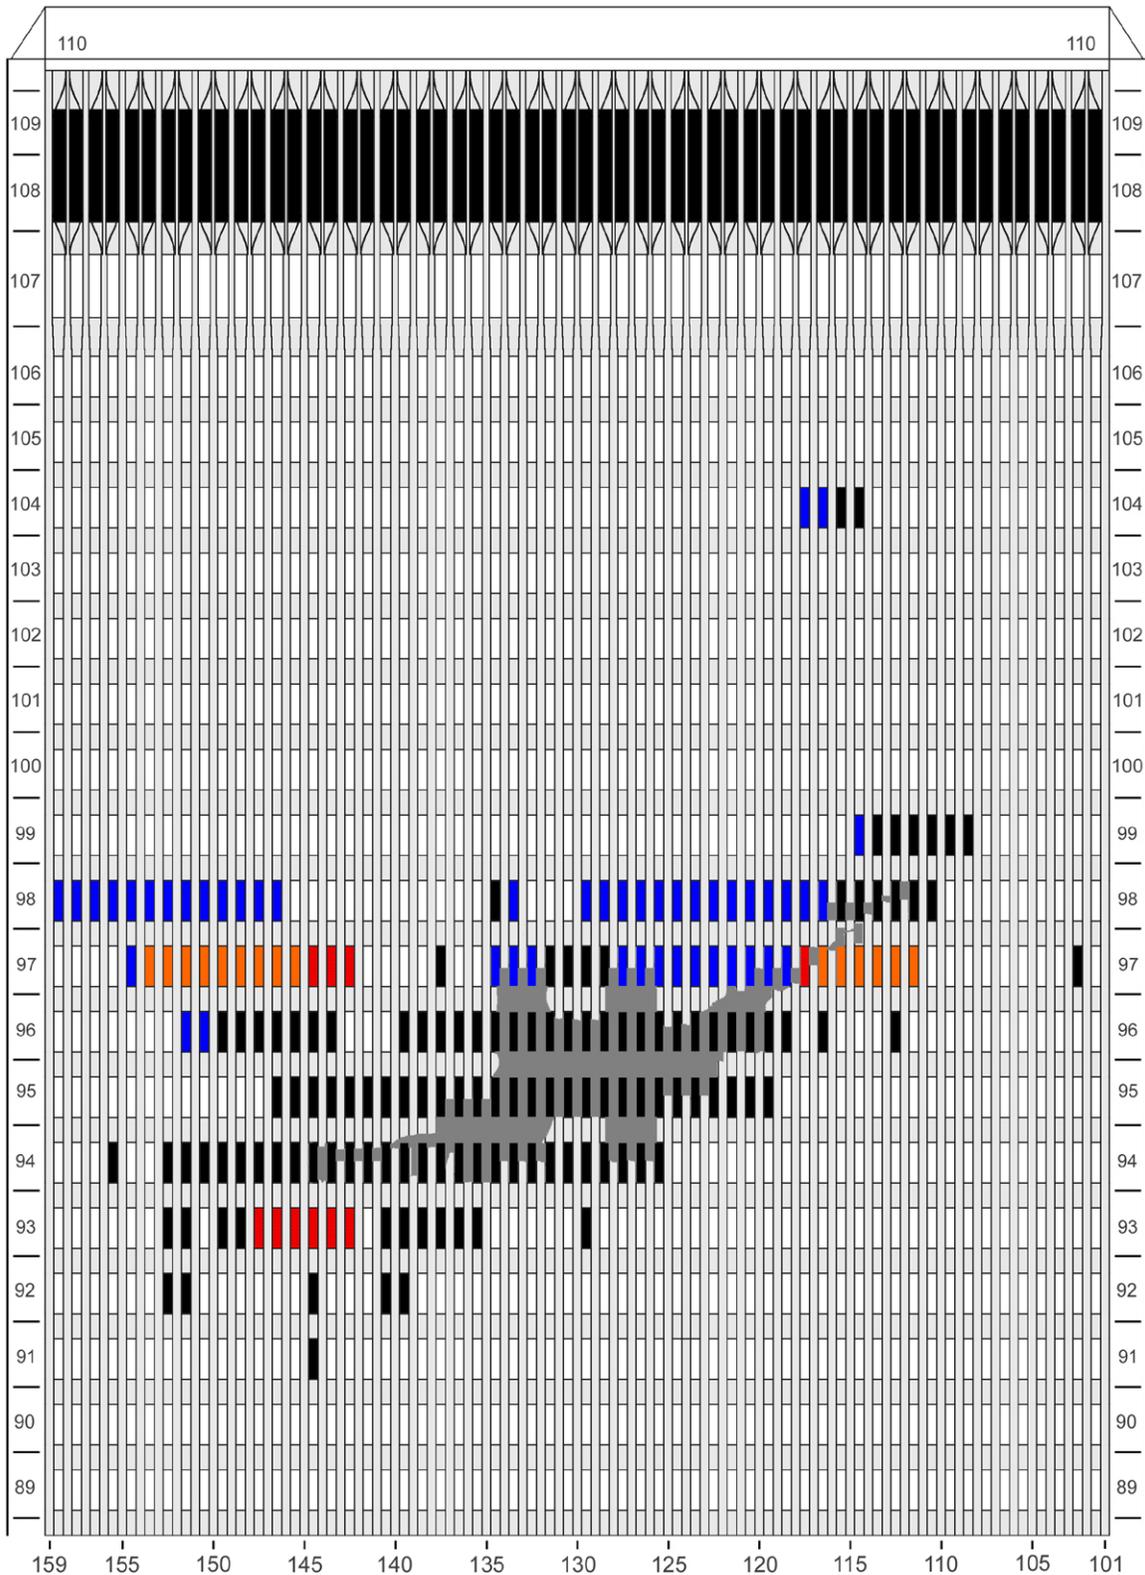
Figure C-11. Diagram of the north face of WTC 1 for floors 89 to 110 at 8:56 a.m. showing the condition of windows and locations of lines.

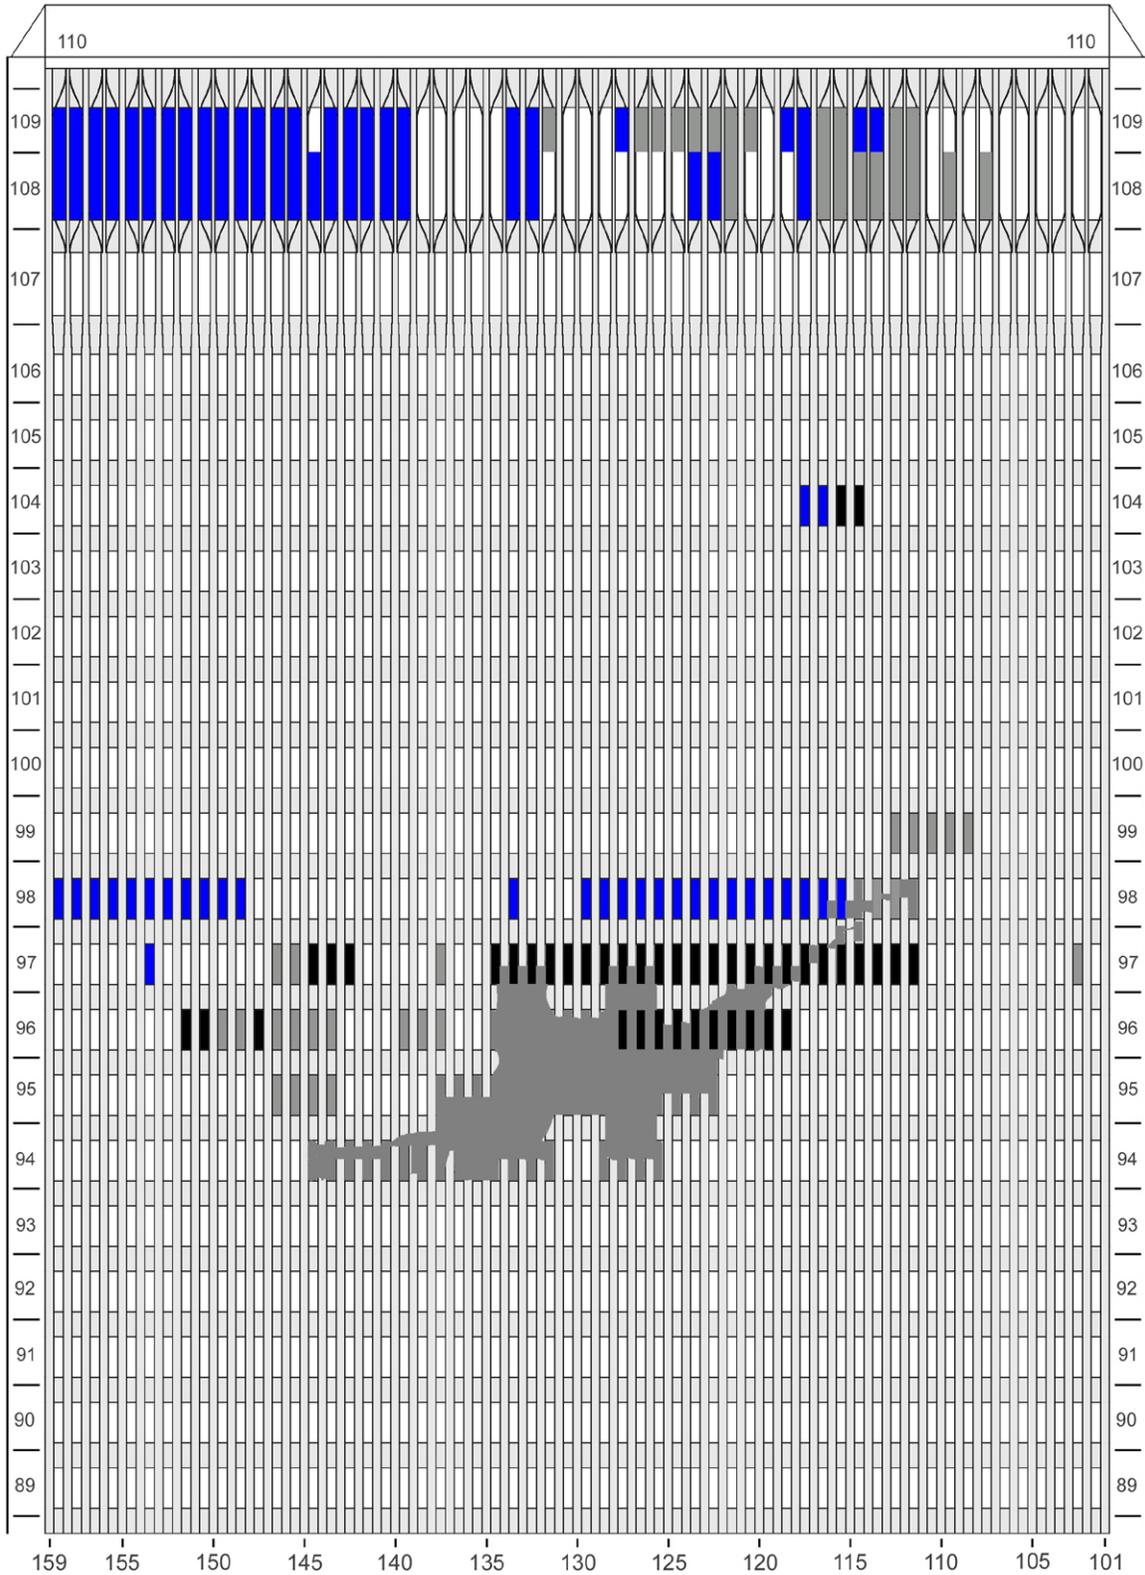
Figure C-12. Diagram of the north face of WTC 1 for floors 89 to 110 at 8:56 a.m. showing windows where smoke was observed and those that were hidden from view.

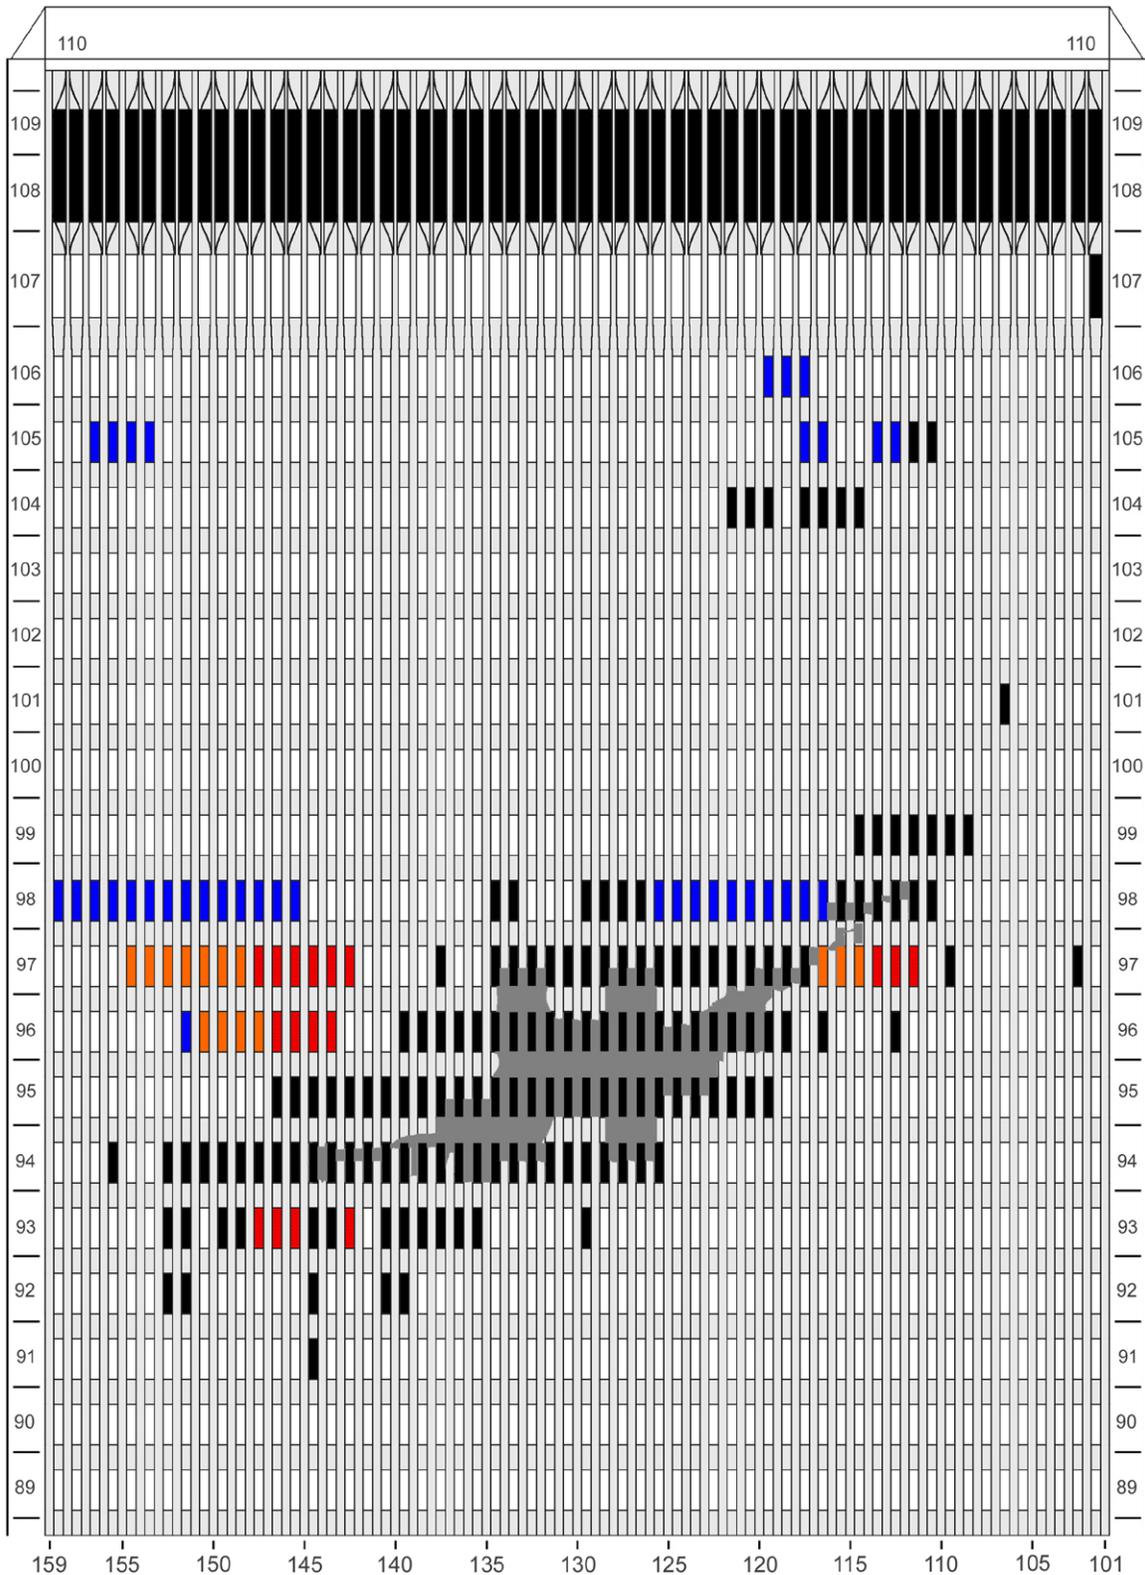
Figure C-13. Diagram of the north face of WTC 1 for floors 89 to 110 at 8:58 a.m. showing the condition of windows and locations of fires.

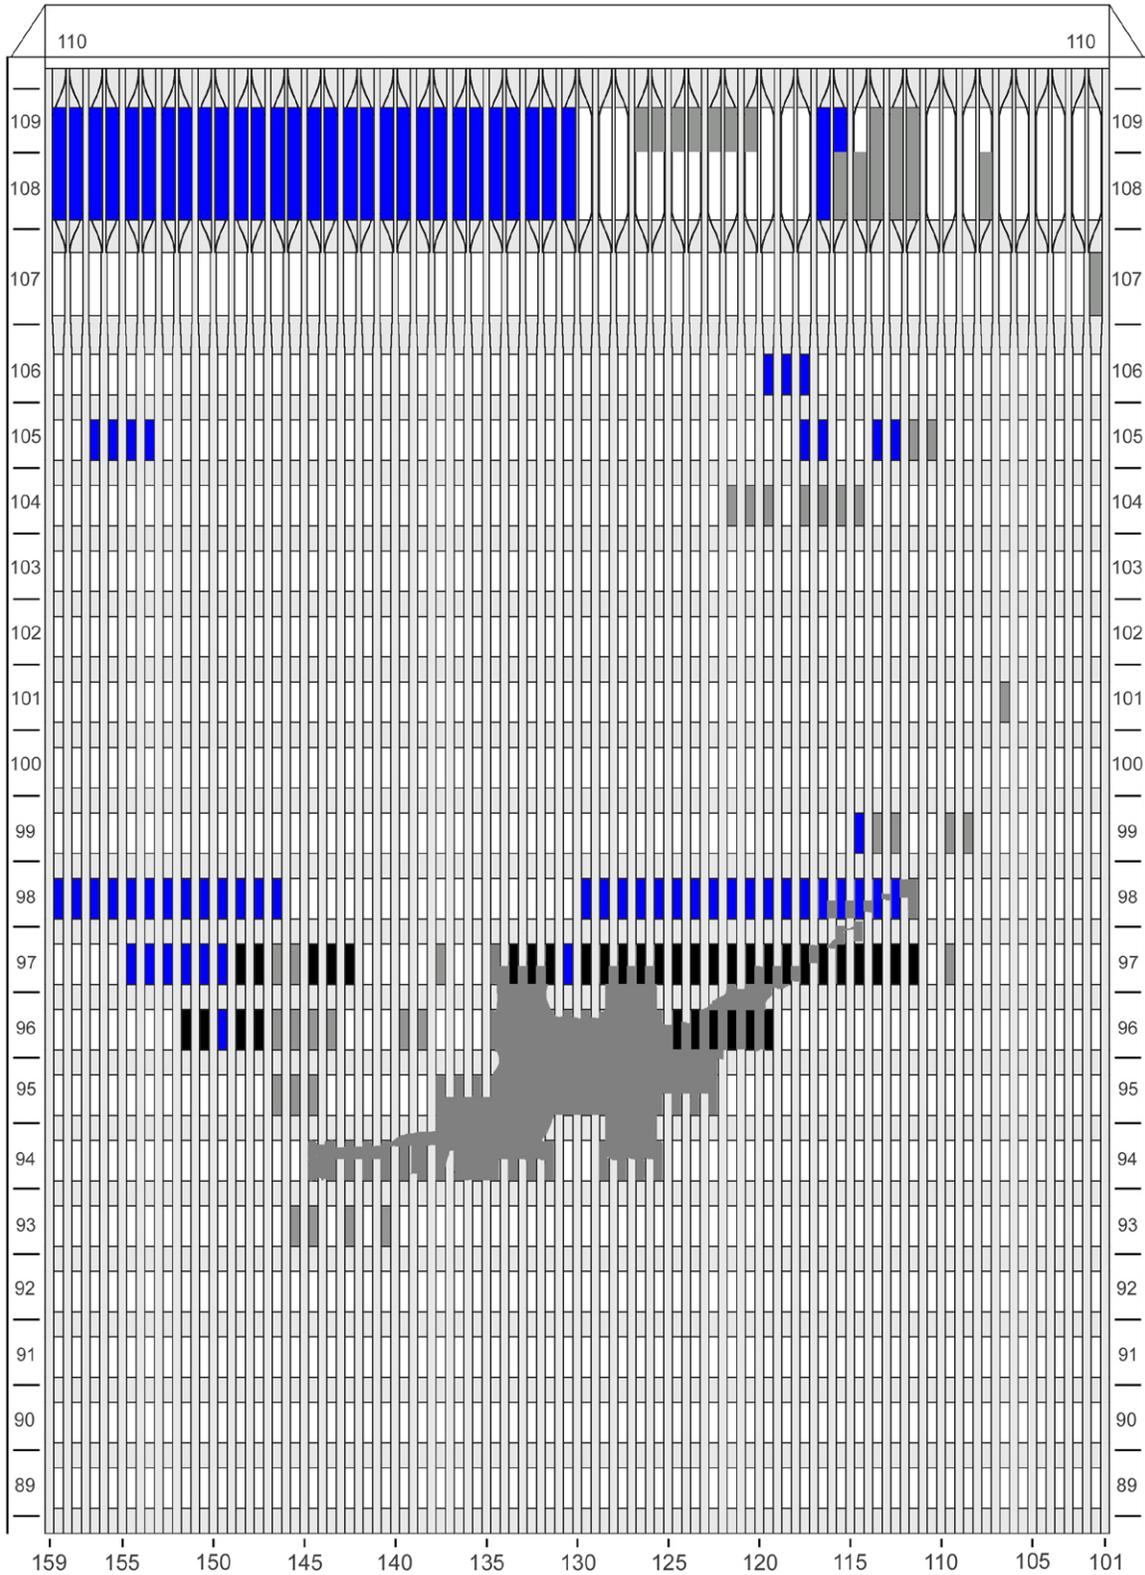
Figure C-14. Diagram of the north face of WTC 1 for floors 89 to 110 at 8:58 a.m. showing windows where smoke was observed and those that were hidden from view.

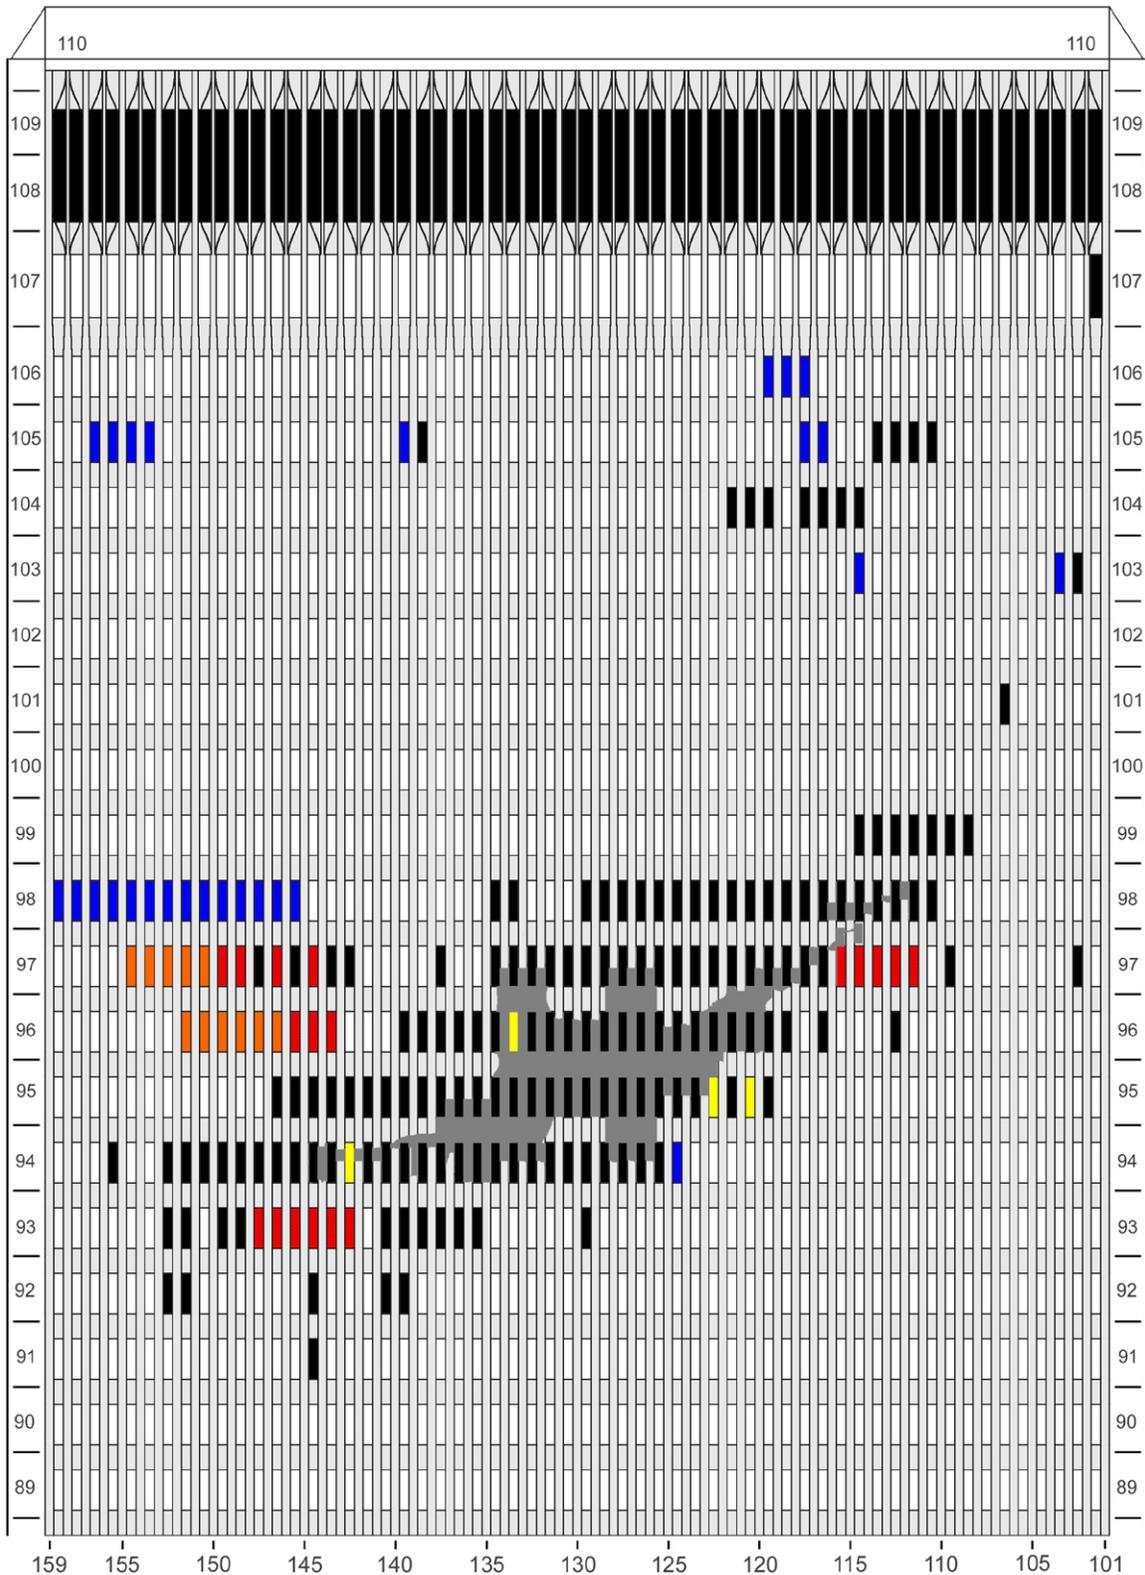
Figure C-15. Diagram of the north face of WTC 1 for floors 89 to 110 at 9:00 a.m. showing the condition of windows and locations of fires.

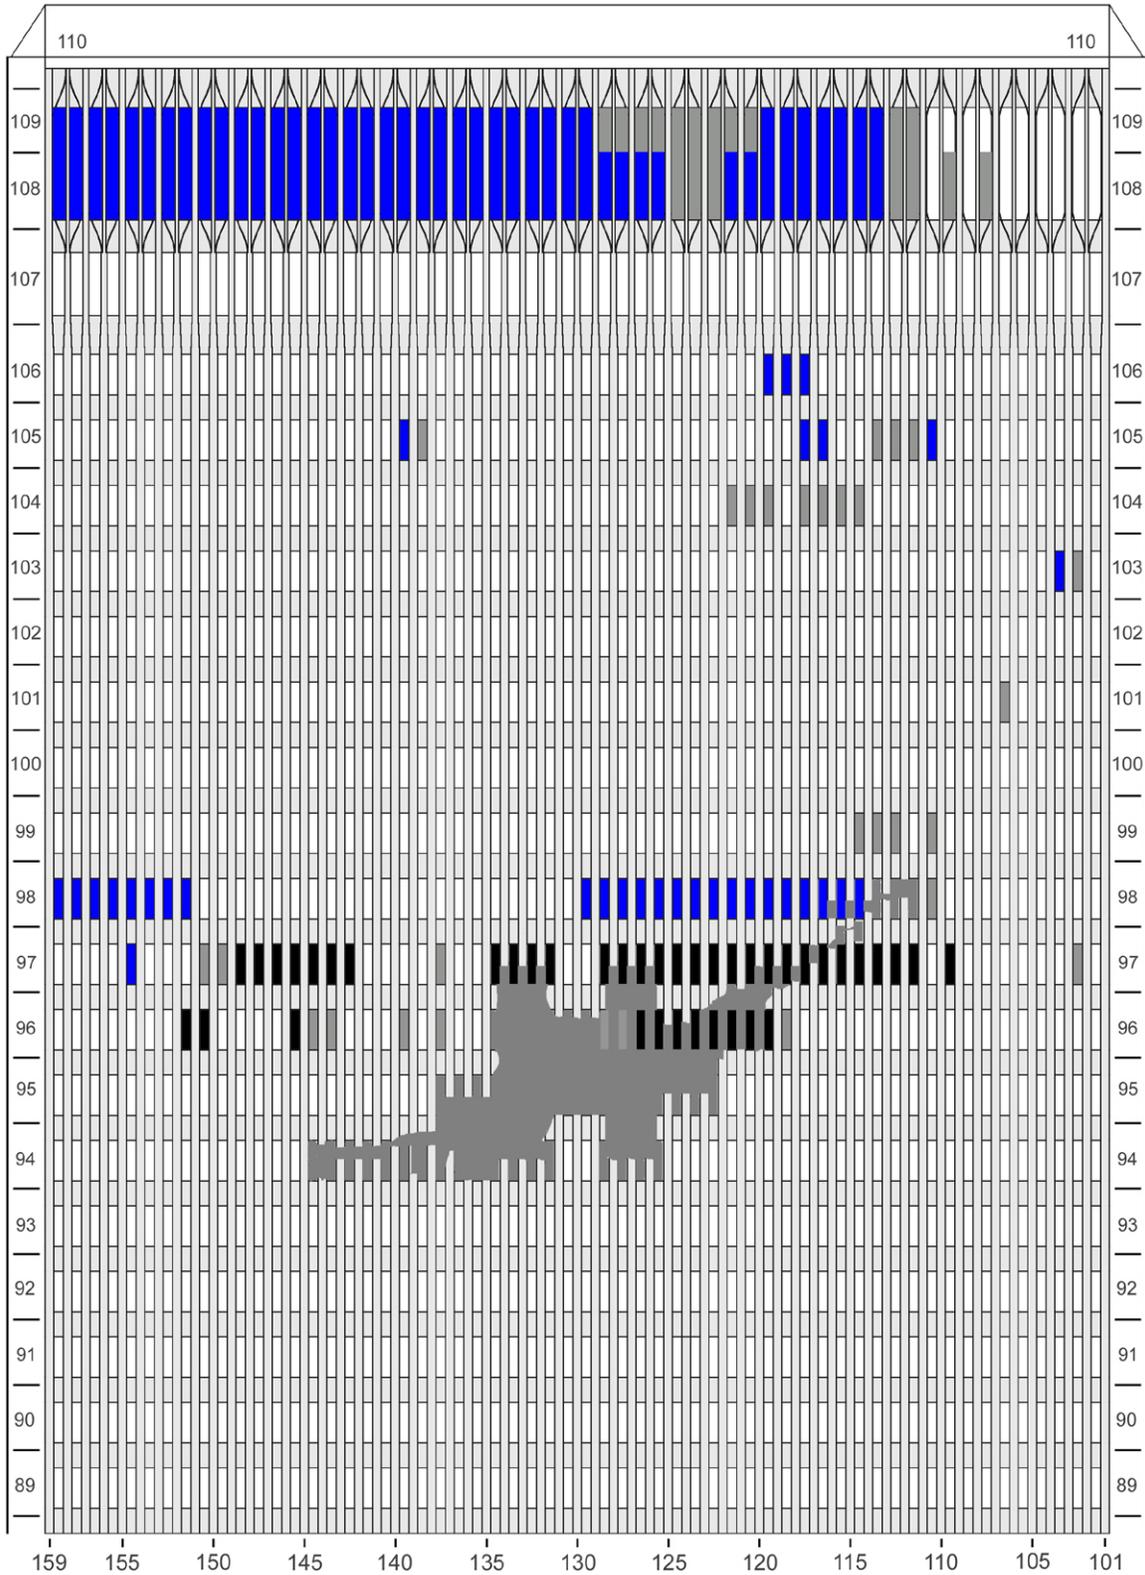
Figure C-16. Diagram of the north face of WTC 1 for floors 89 to 110 at 9:00 a.m. showing windows where smoke was observed and those that were hidden from view.

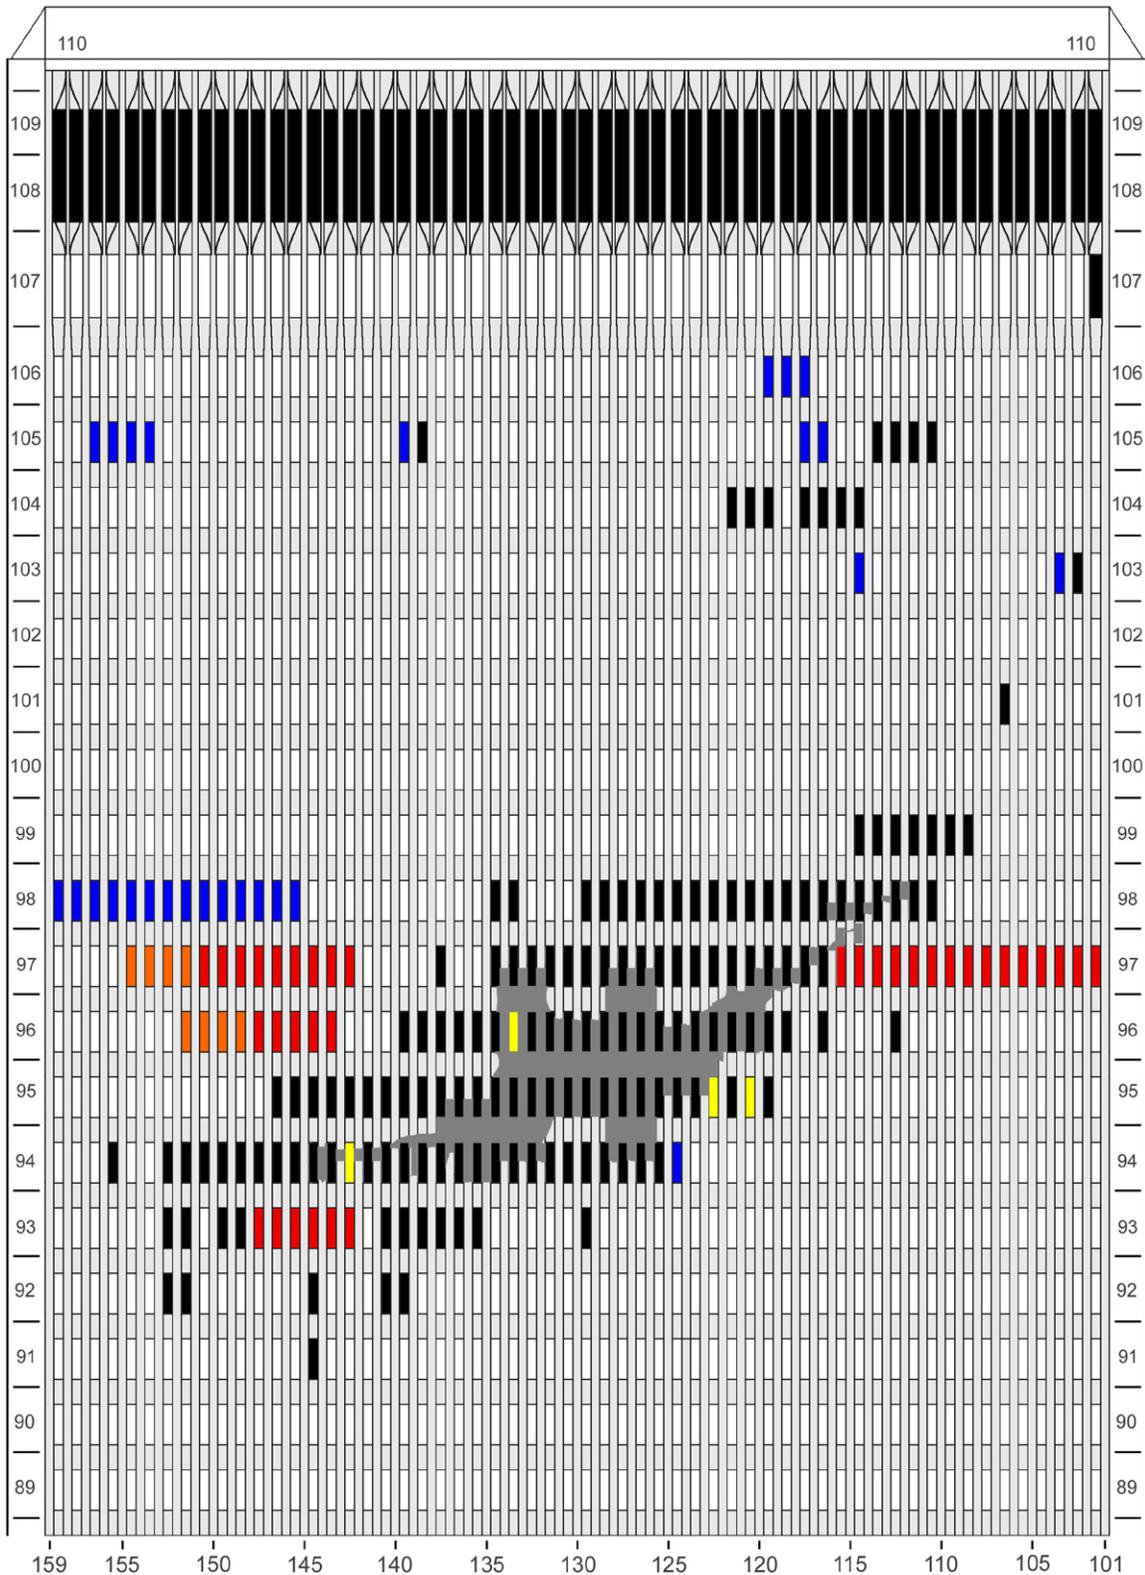
Figure C-17. Diagram of the north face of WTC 1 for floors 89 to 110 at 9:02 a.m. showing the condition of windows and locations of fires.

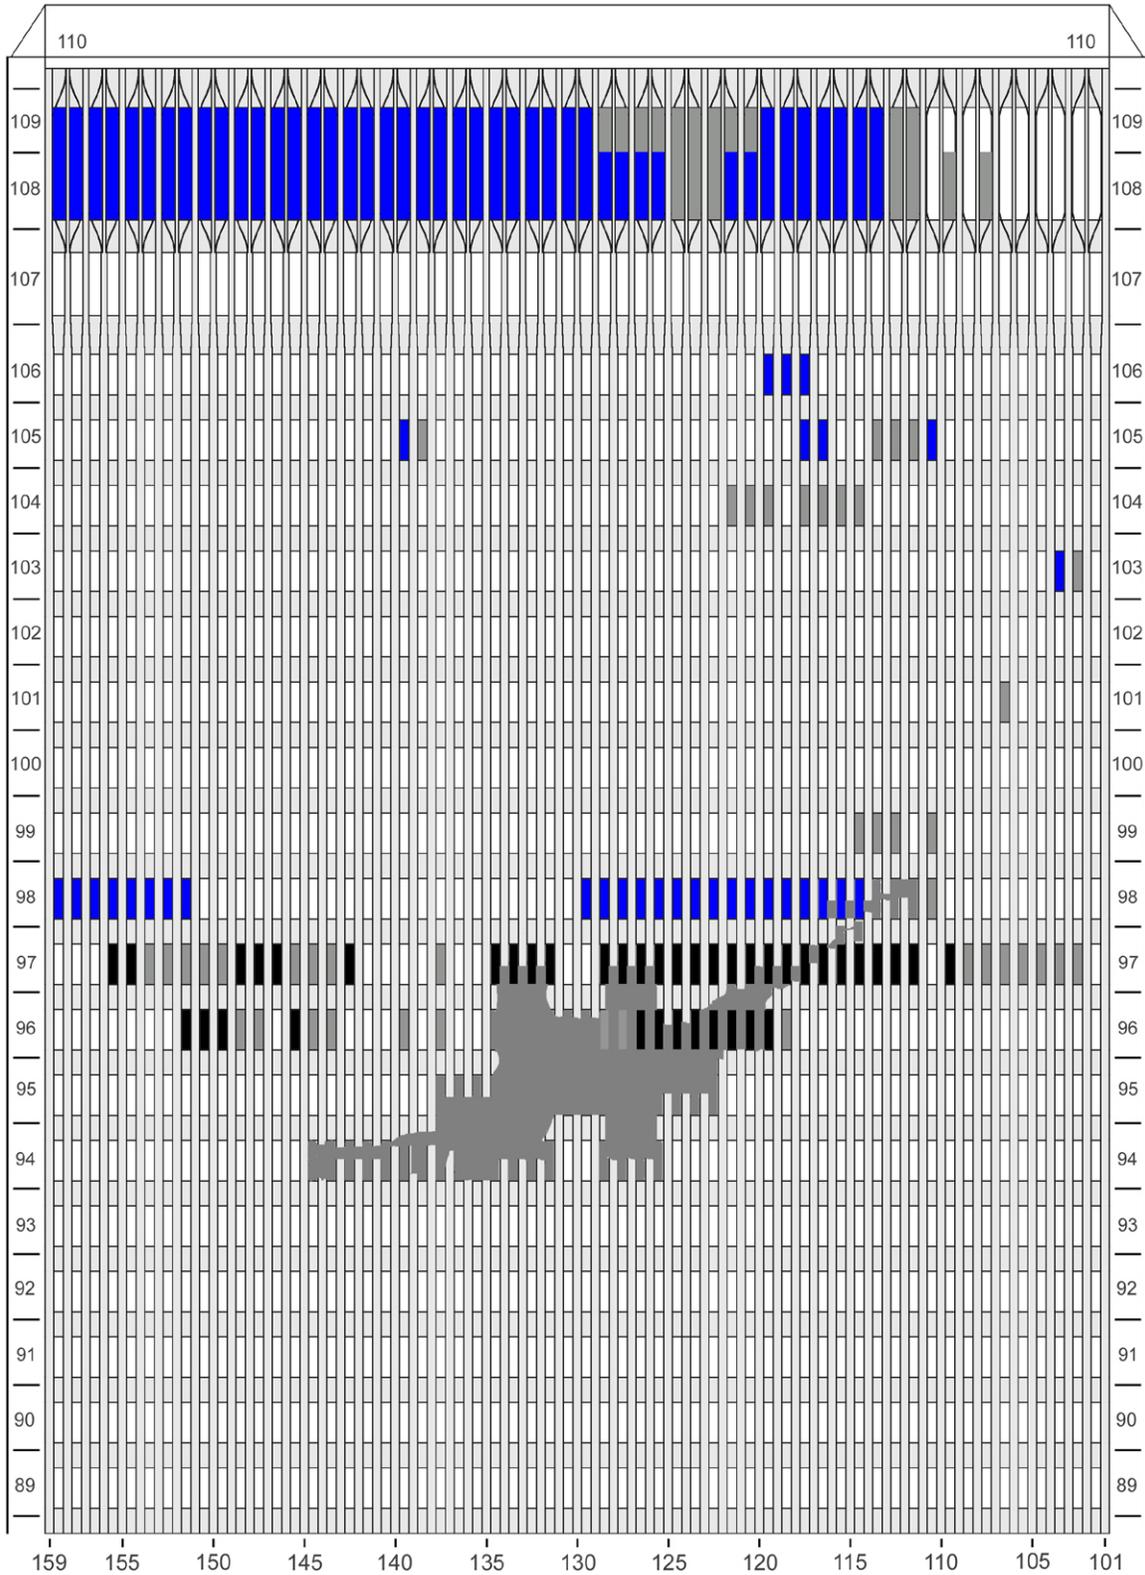
Figure C-18. Diagram of the north face of WTC 1 for floors 89 to 110 at 9:02 a.m. showing windows where smoke was observed and those that were hidden from view.

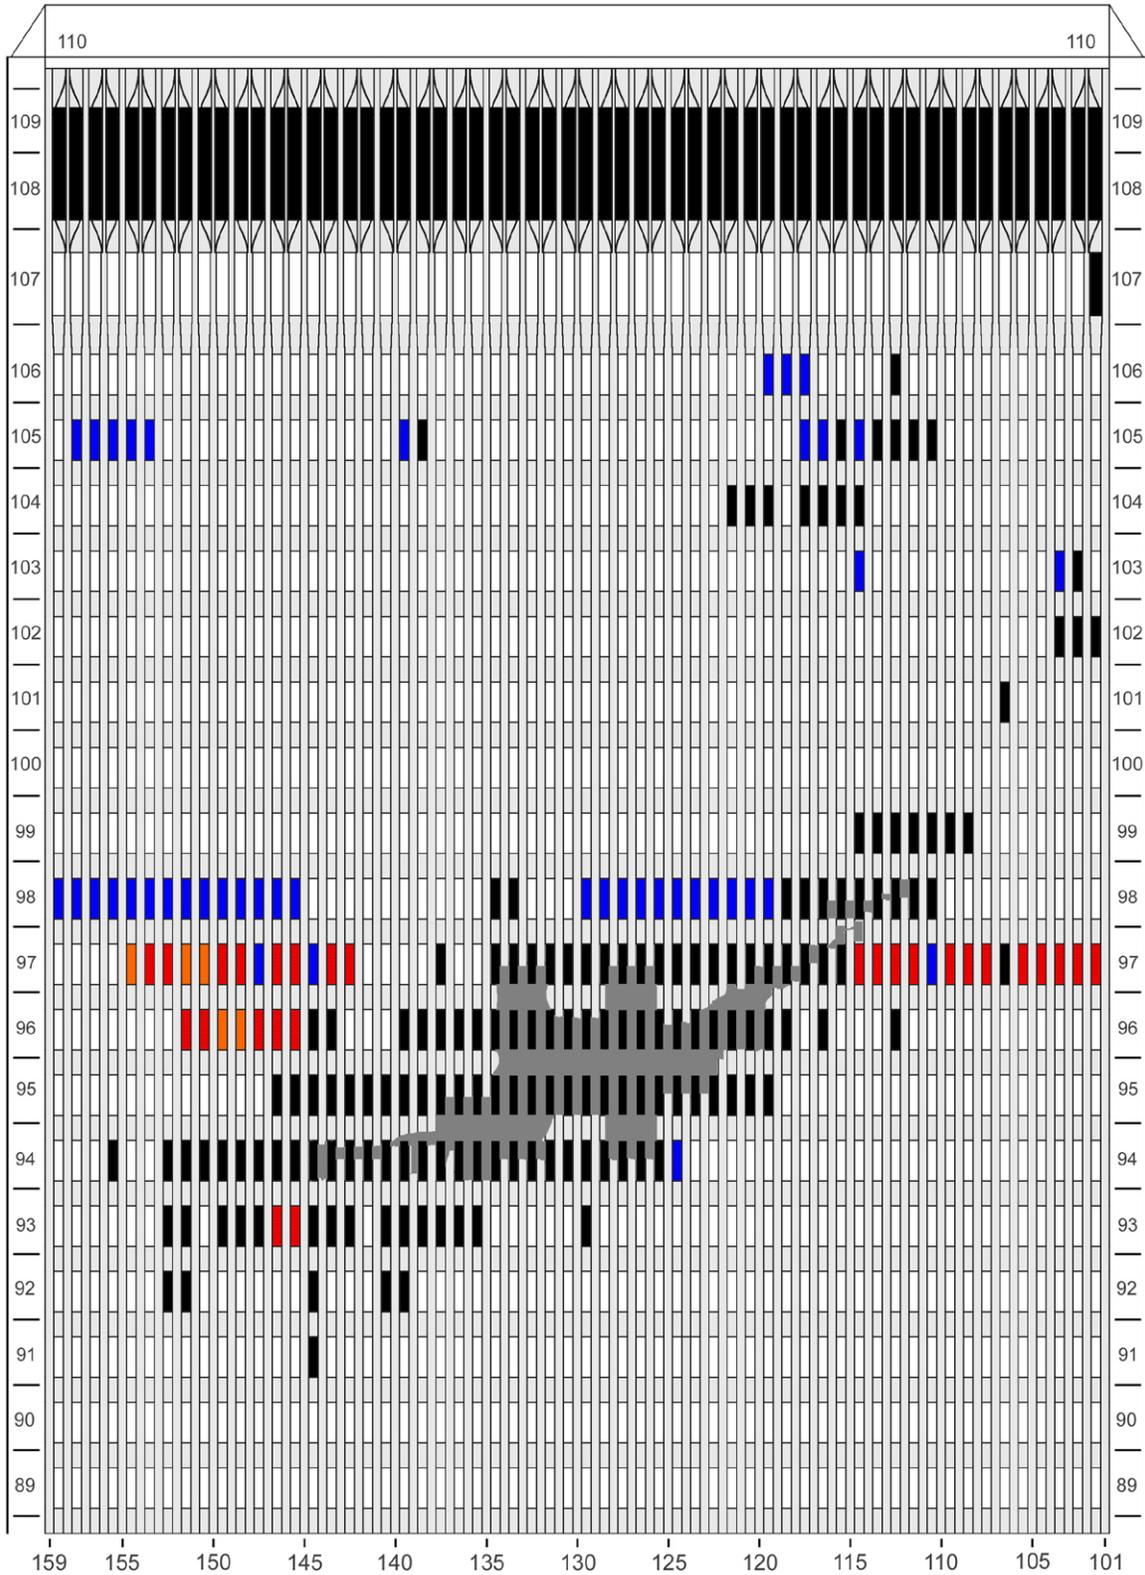
Figure C-19. Diagram of the north face of WTC 1 for floors 89 to 110 at 9:04 a.m. showing the condition of windows and locations of fires.

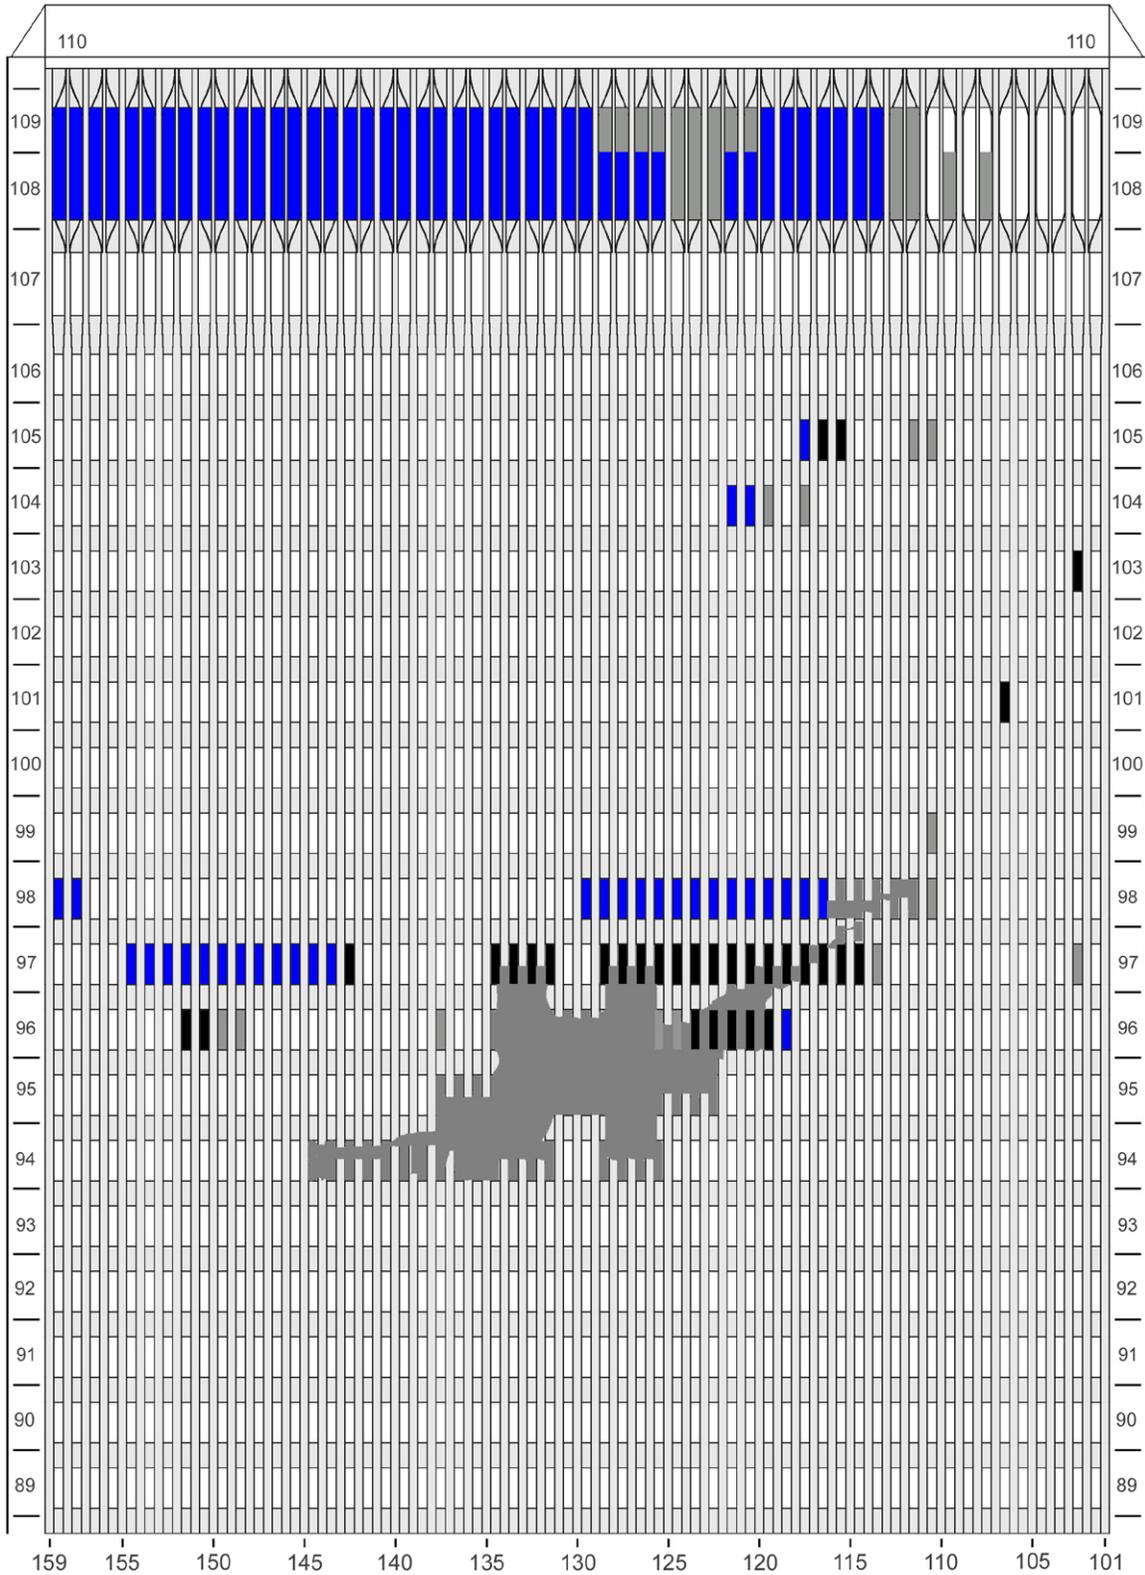
Figure C-20. Diagram of the north face of WTC 1 for floors 89 to 110 at 9:04 a.m. showing windows where smoke was observed and those that were hidden from view.
