## Chapter 9

# FIRE BEHAVIOR IN WORLD TRADE CENTER 2

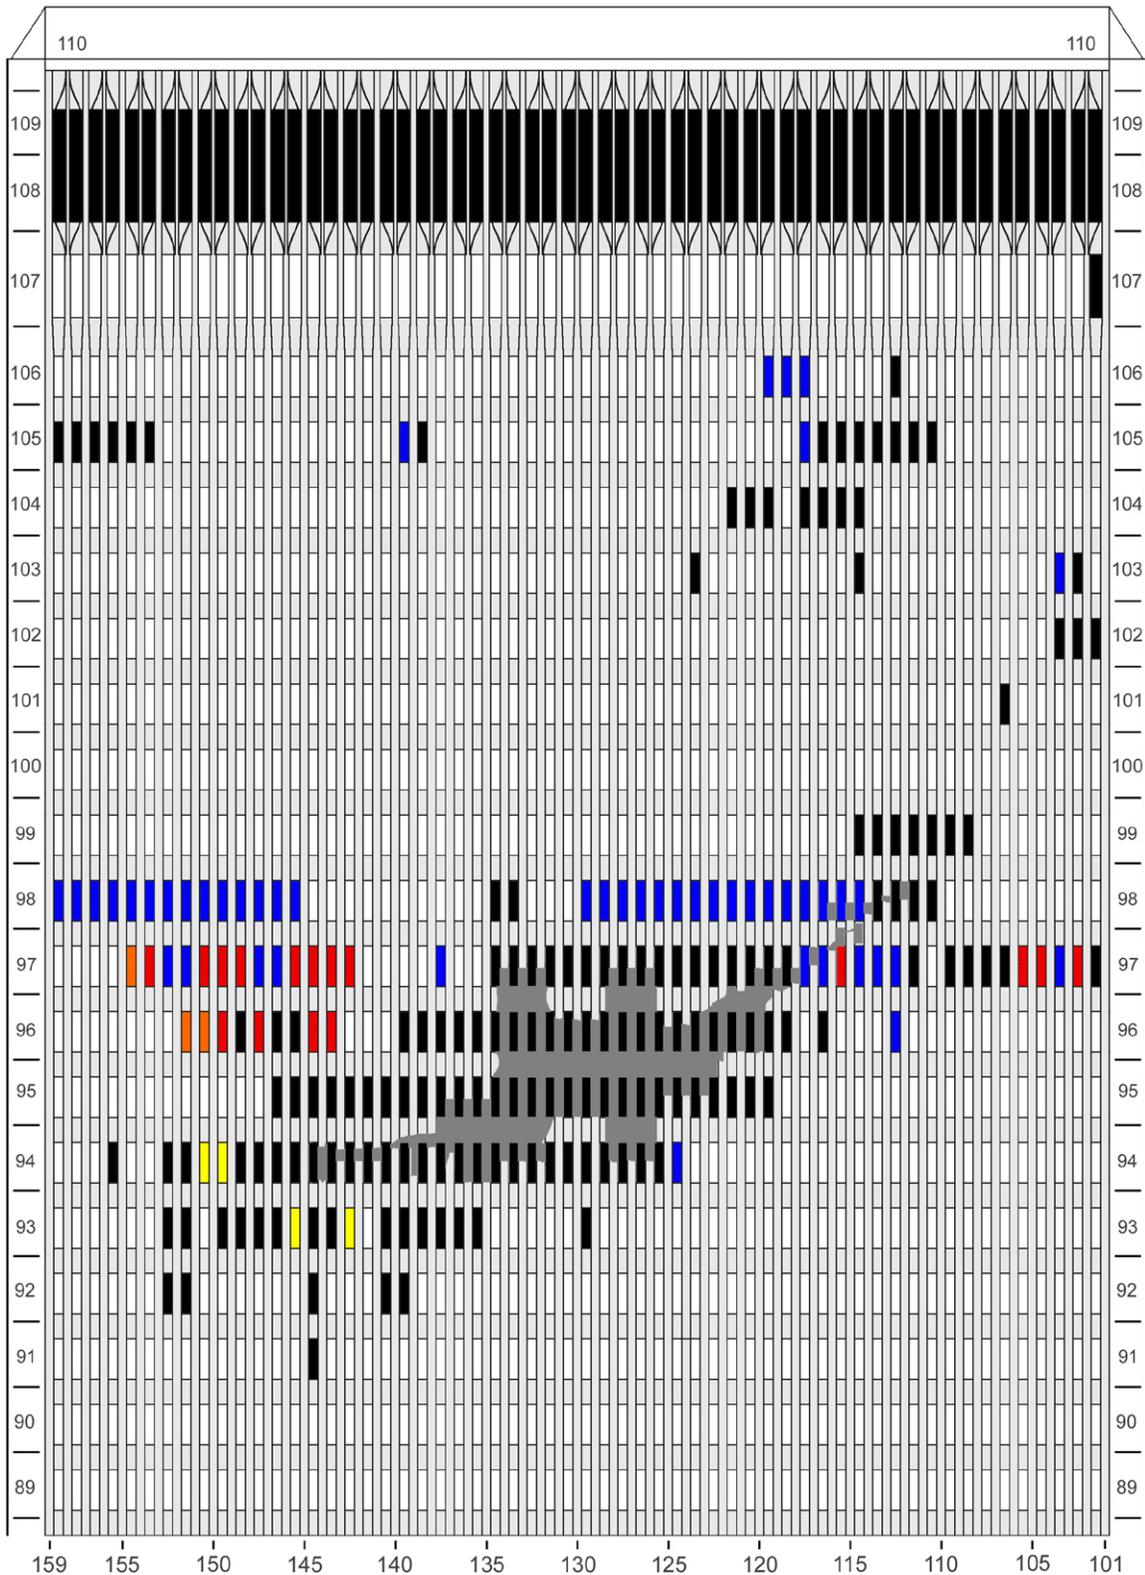
Figure C-21. Diagram of the north face of WTC 1 for floors 89 to 110 at 9:10 a.m. showing the condition of windows and locations of fires.

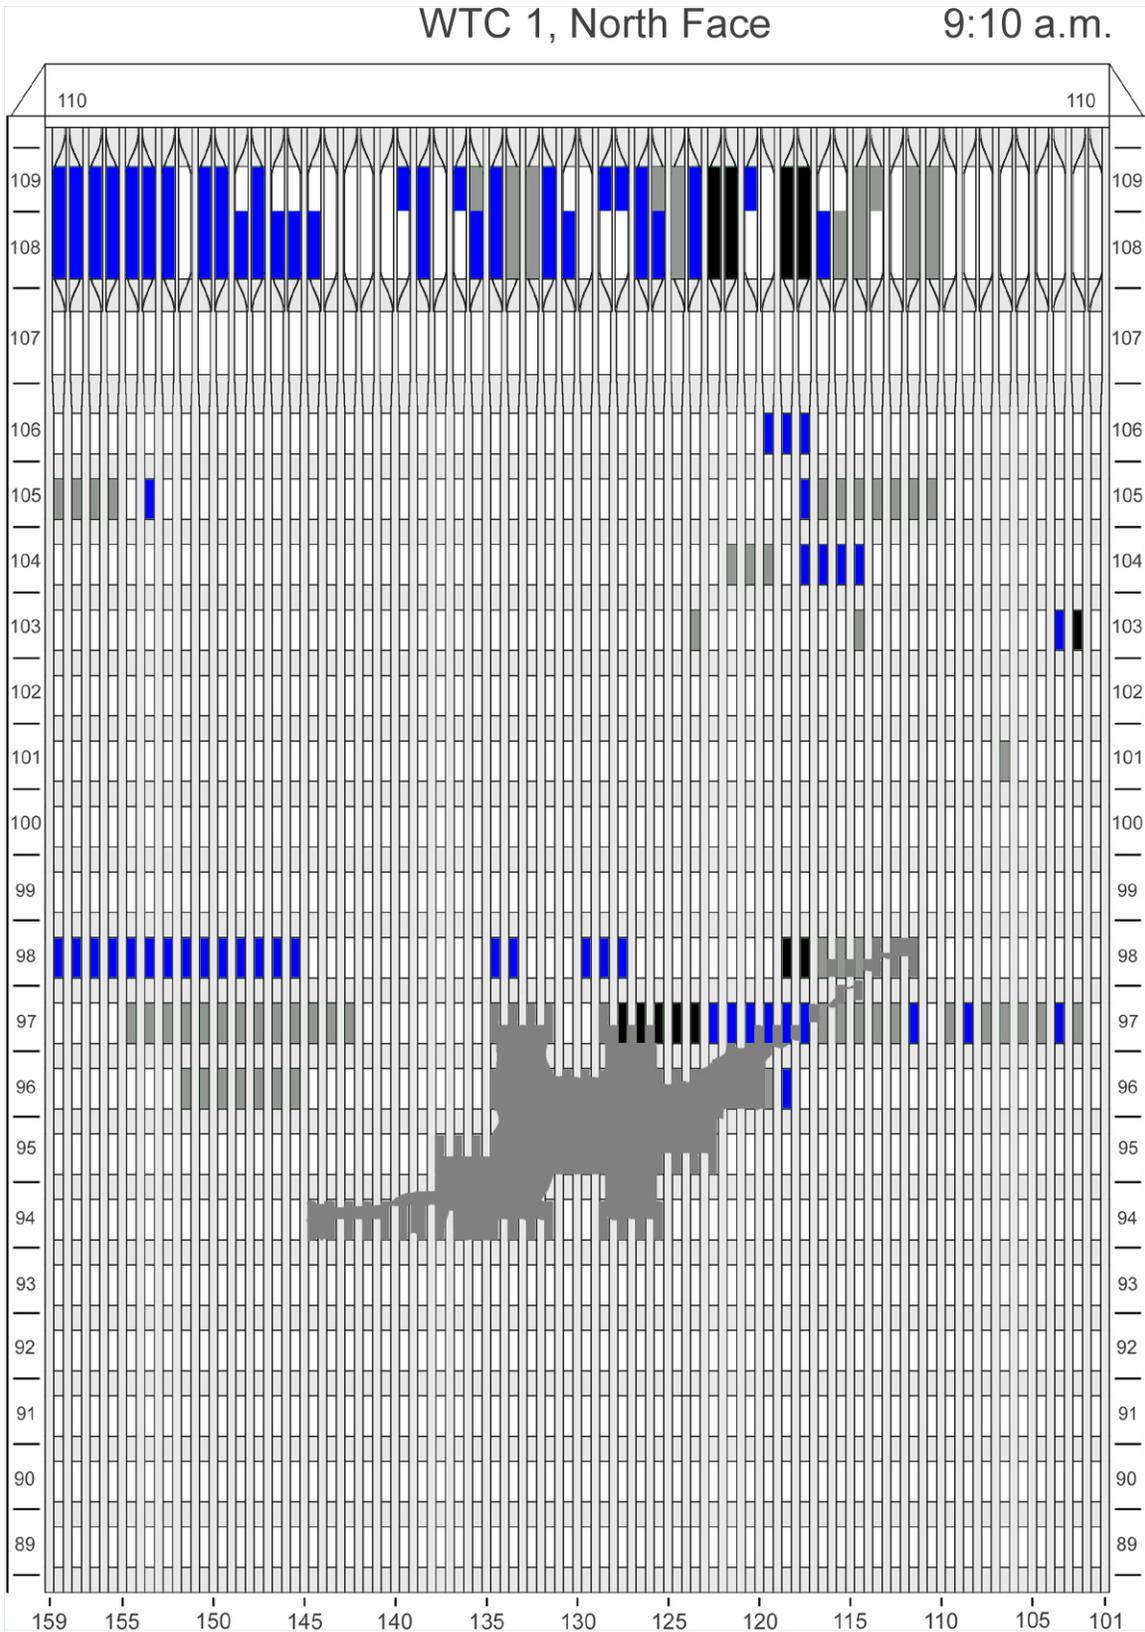
Figure C-22. Diagram of the north face of WTC 1 for floors 89 to 110 at 9:10 a.m. showing windows where smoke was observed and those that were hidden from view.

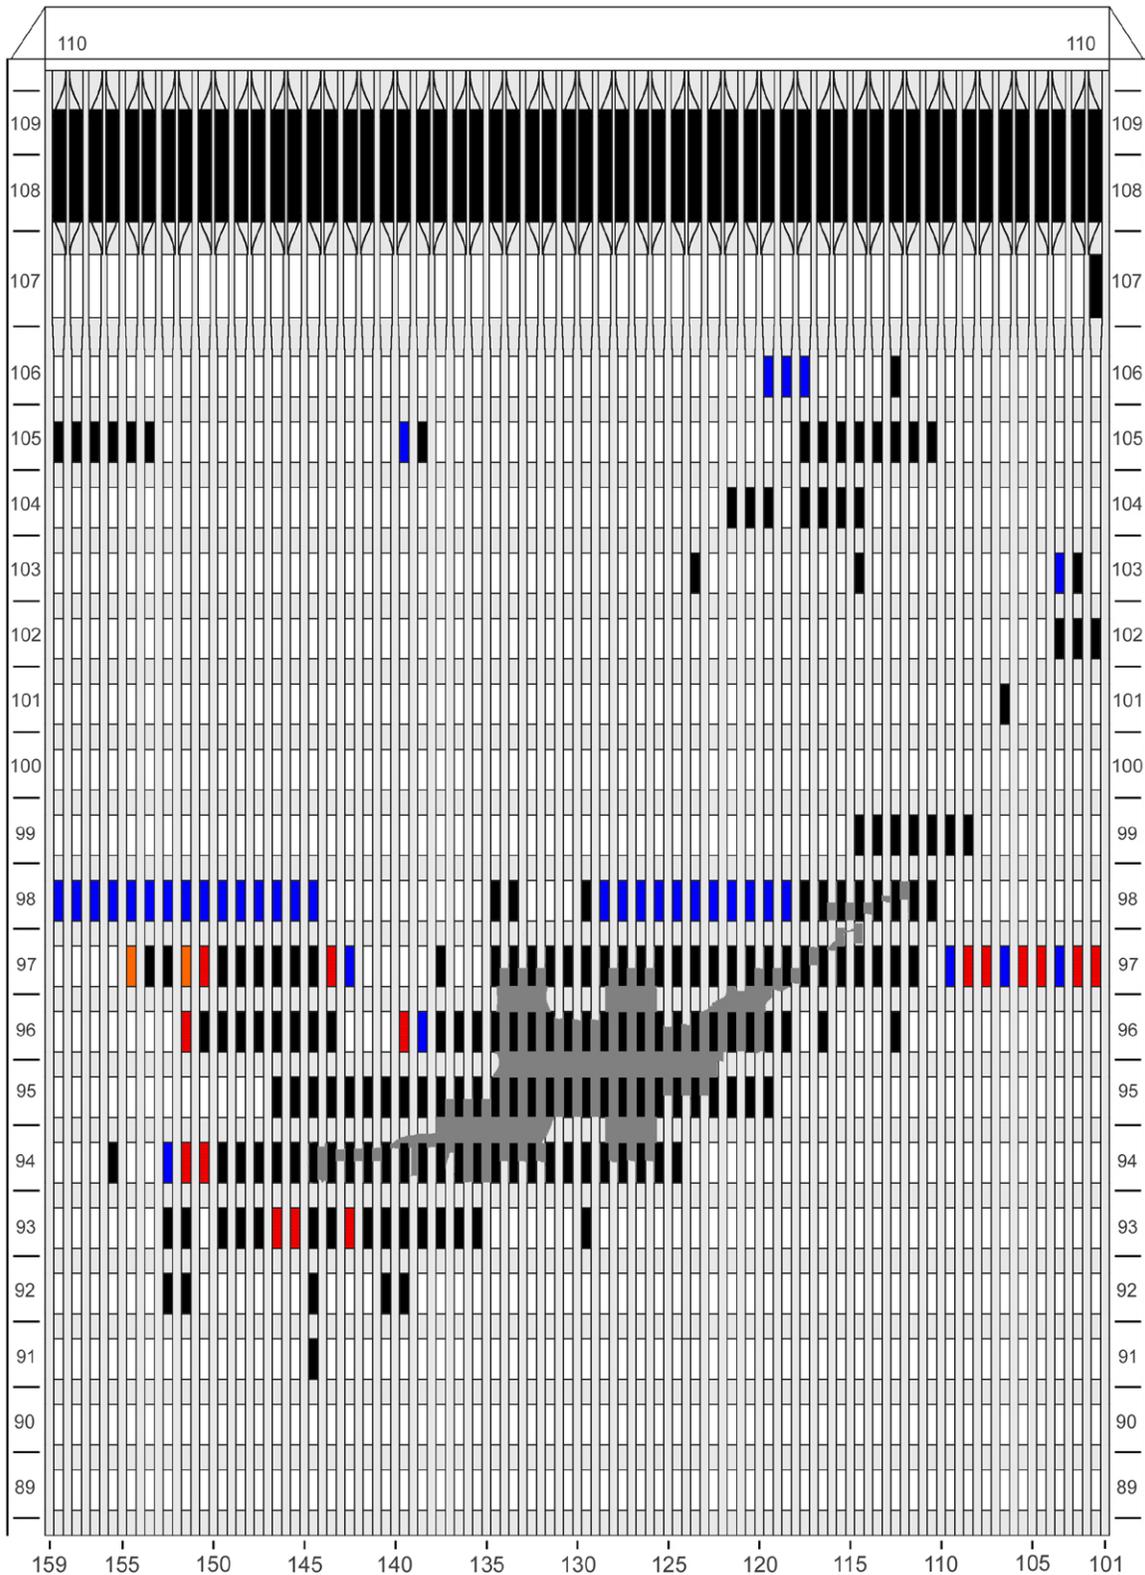
**Figure C-23. Diagram of the north face of WTC 1 for floors 89 to 110 at 9:14 a.m. showing the condition of windows and locations of fires.**

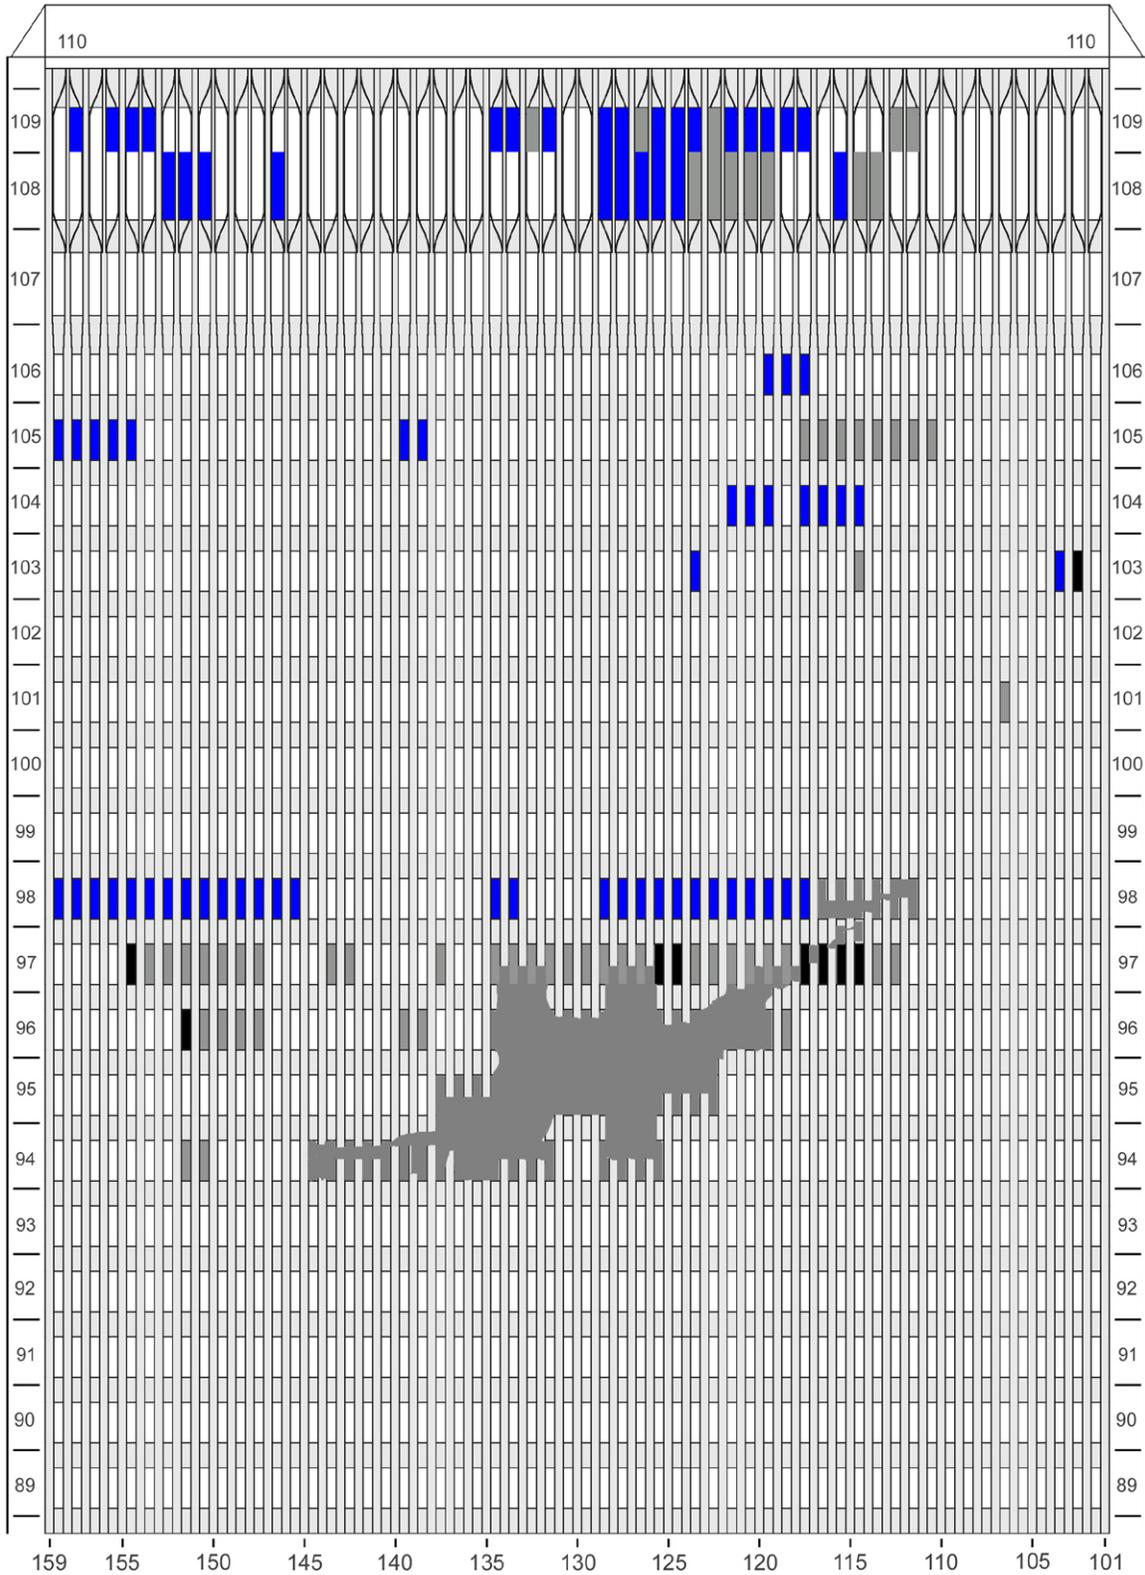
Figure C-24. Diagram of the north face of WTC 1 for floors 89 to 110 at 9:14 a.m. showing windows where smoke was observed and those that were hidden from view.

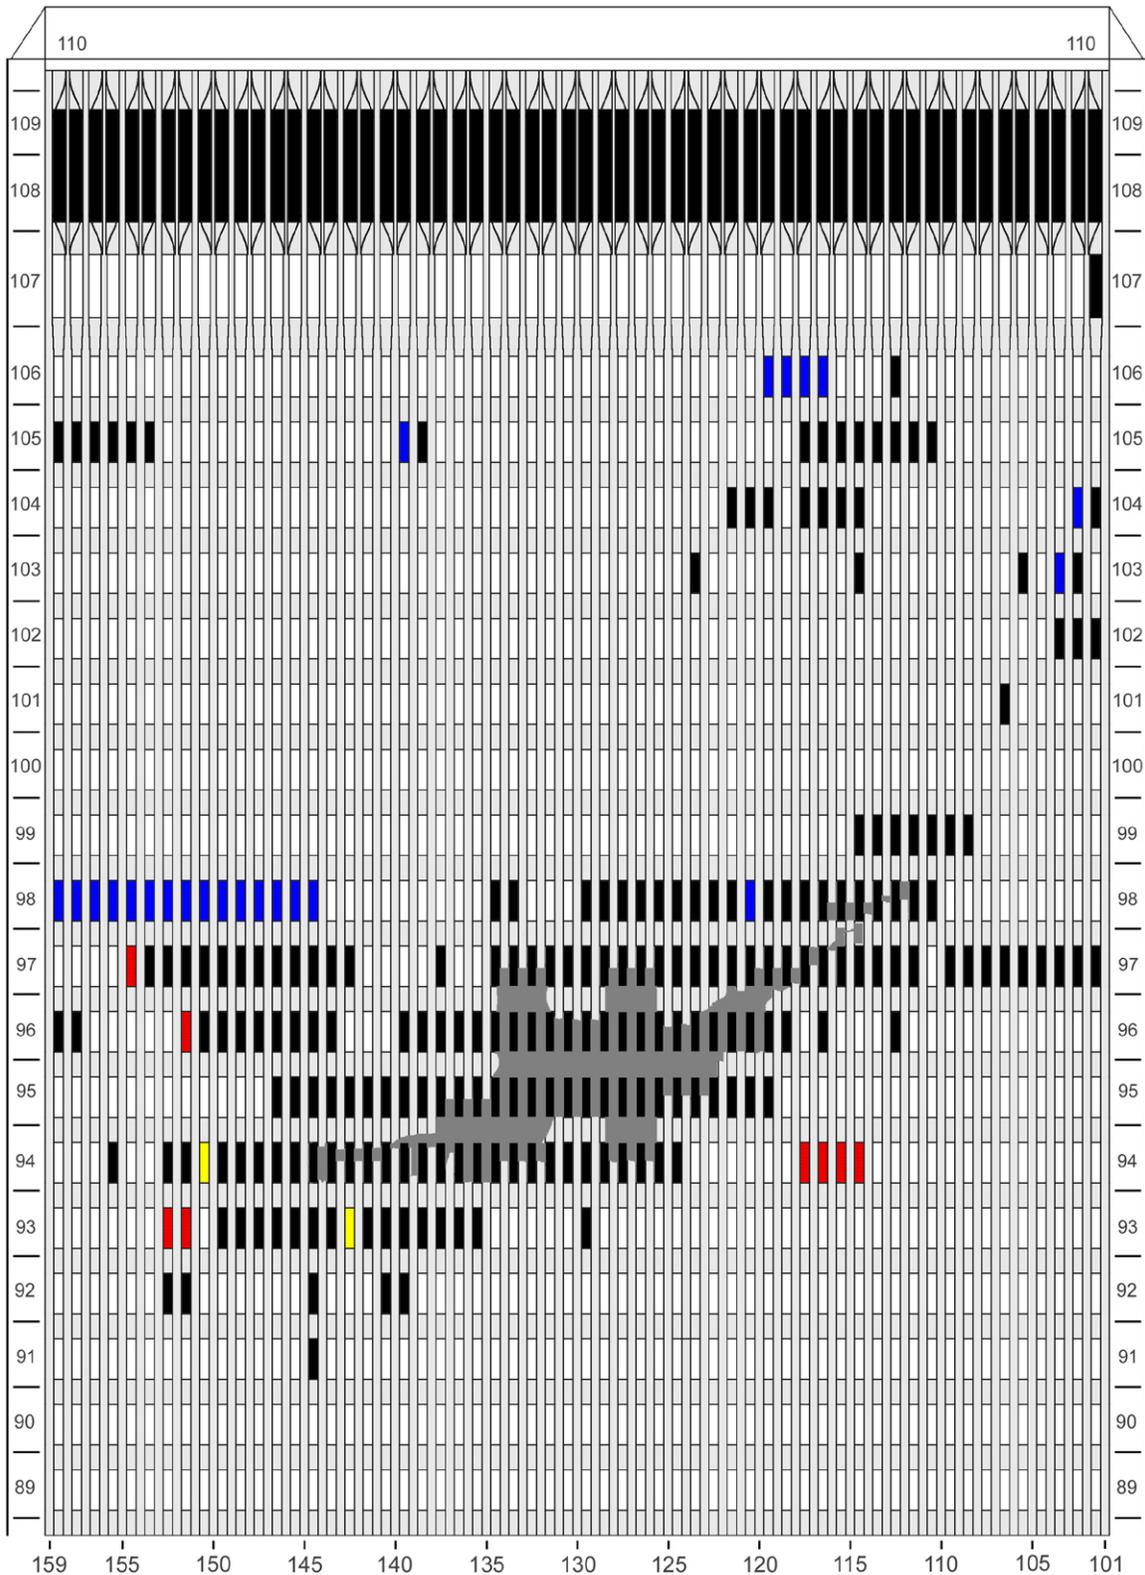
Figure C-25. Diagram of the north face of WTC 1 for floors 89 to 110 at 9:18 a.m. showing the condition of windows and locations of fires.

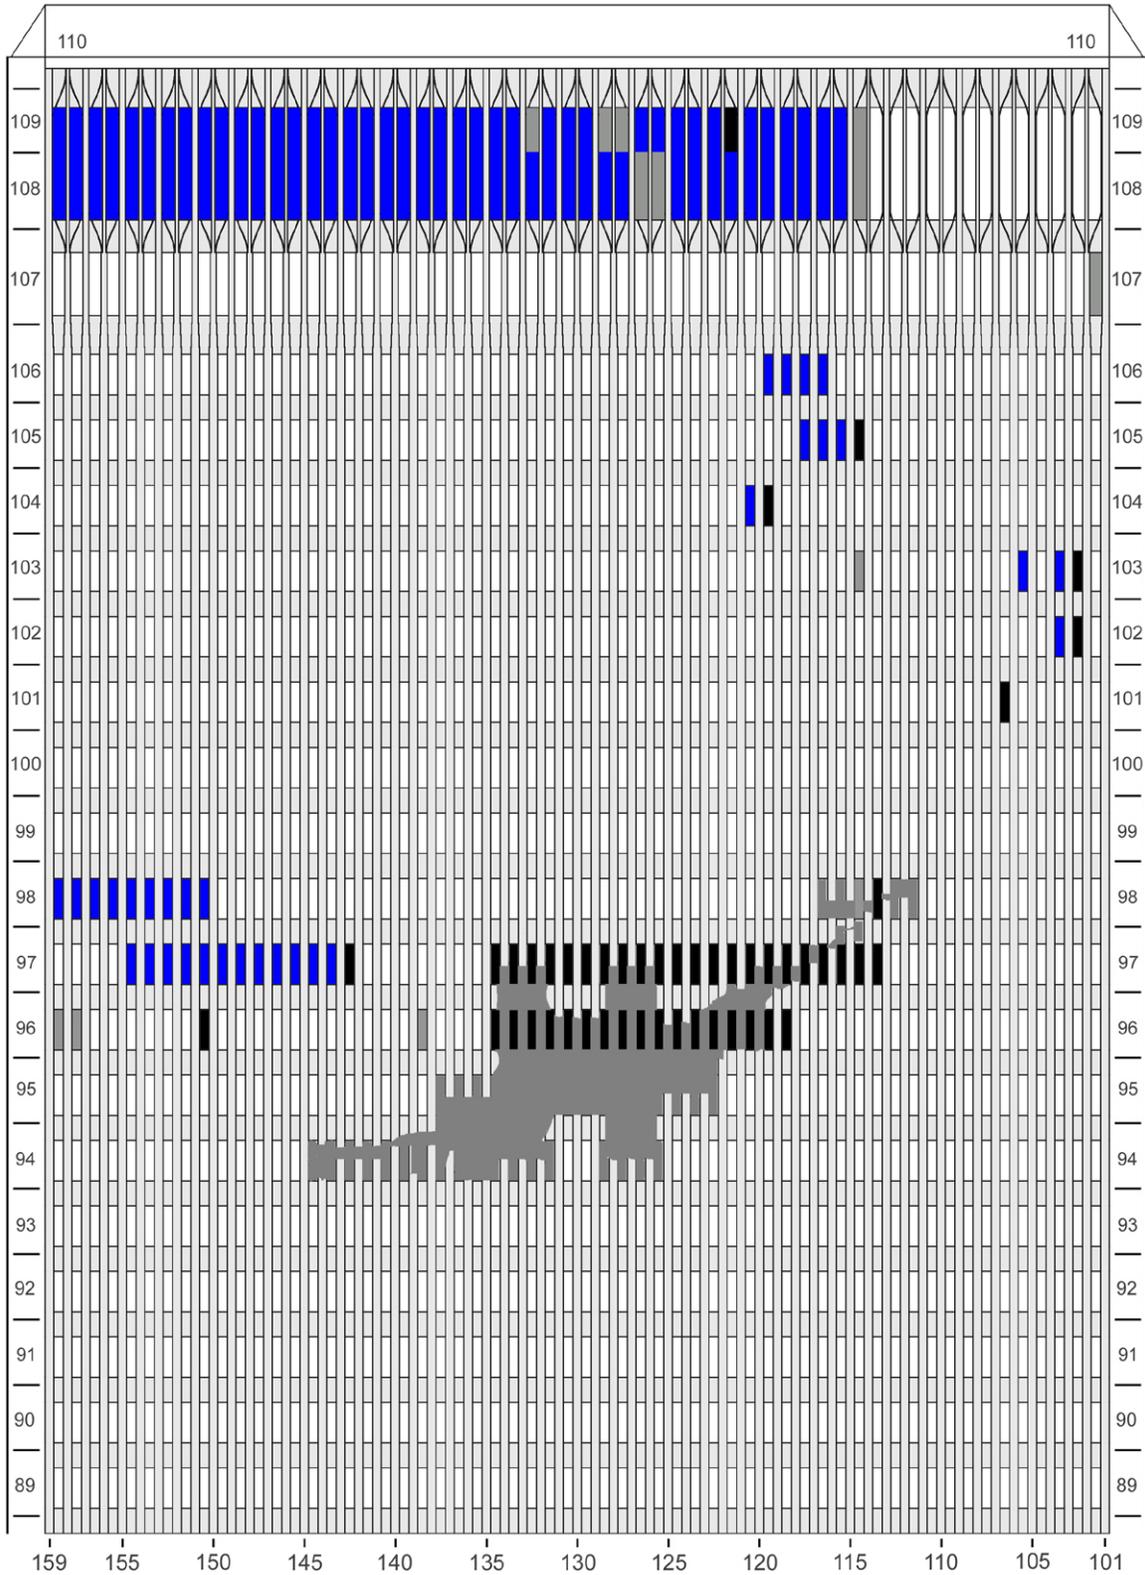
Figure C-26. Diagram of the north face of WTC 1 for floors 89 to 110 at 9:18 a.m. showing windows where smoke was observed and those that were hidden from view.

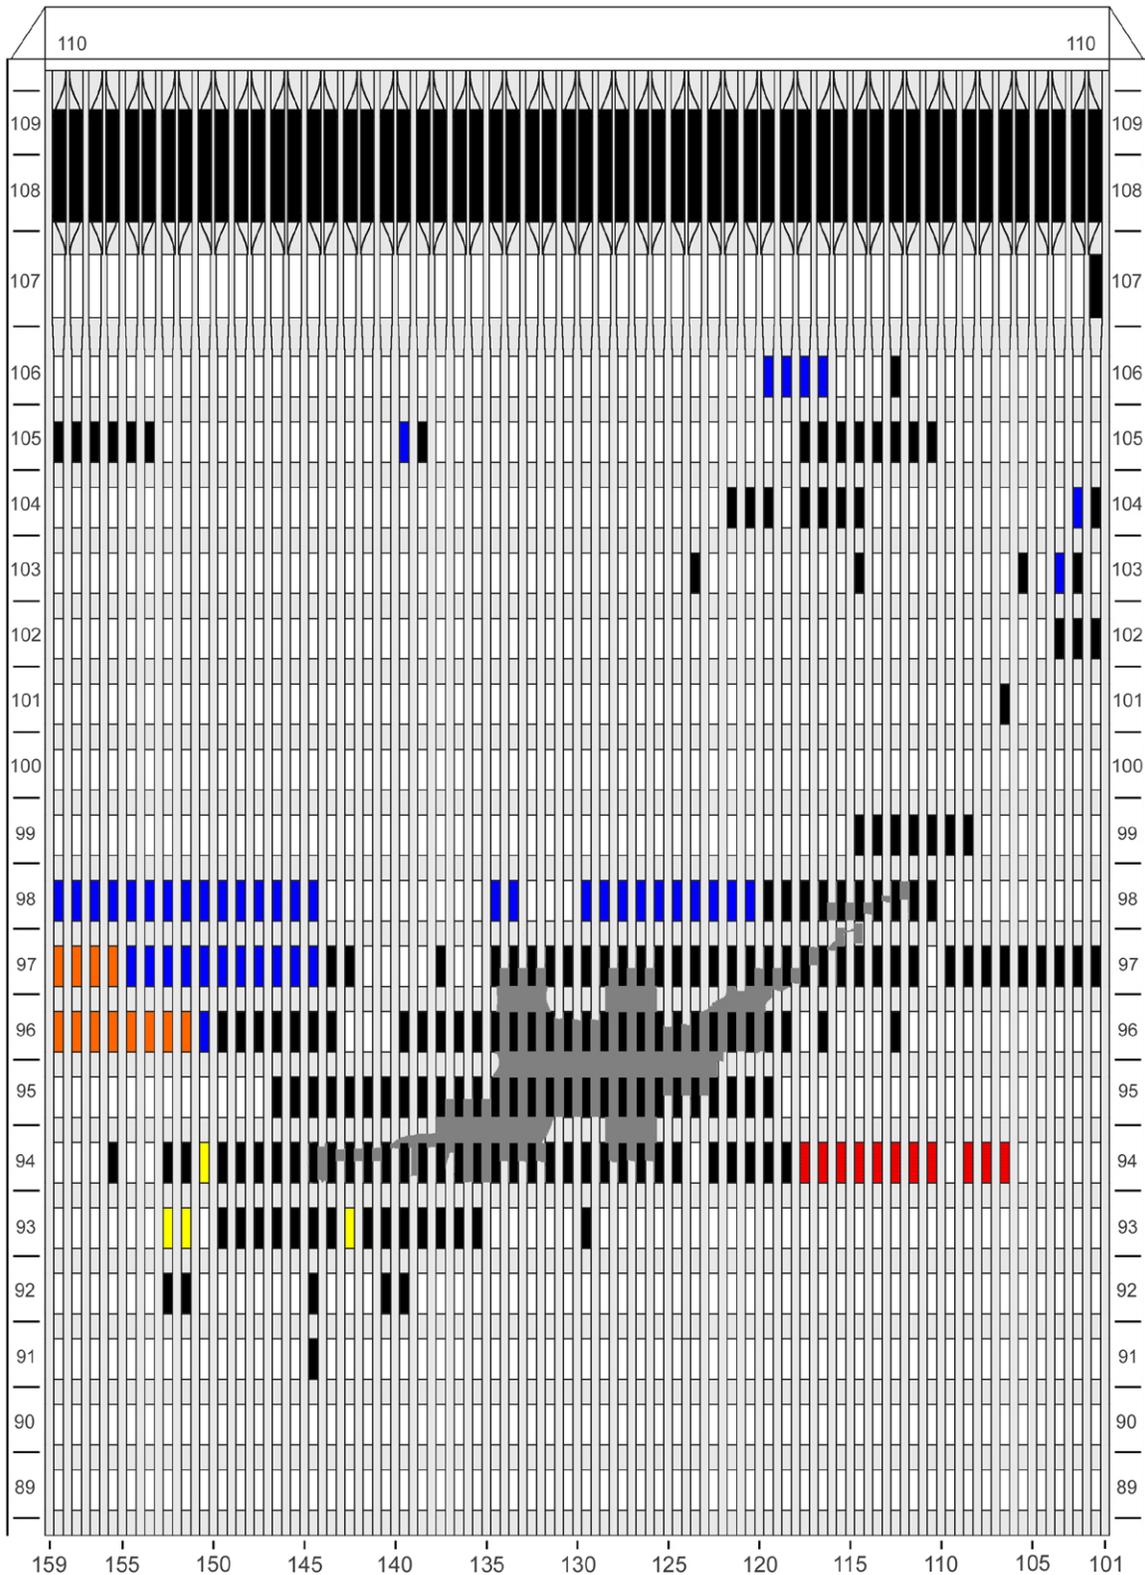
**Figure C-27. Diagram of the north face of WTC 1 for floors 89 to 110 at 9:20 a.m. showing the condition of windows and locations of fires.**

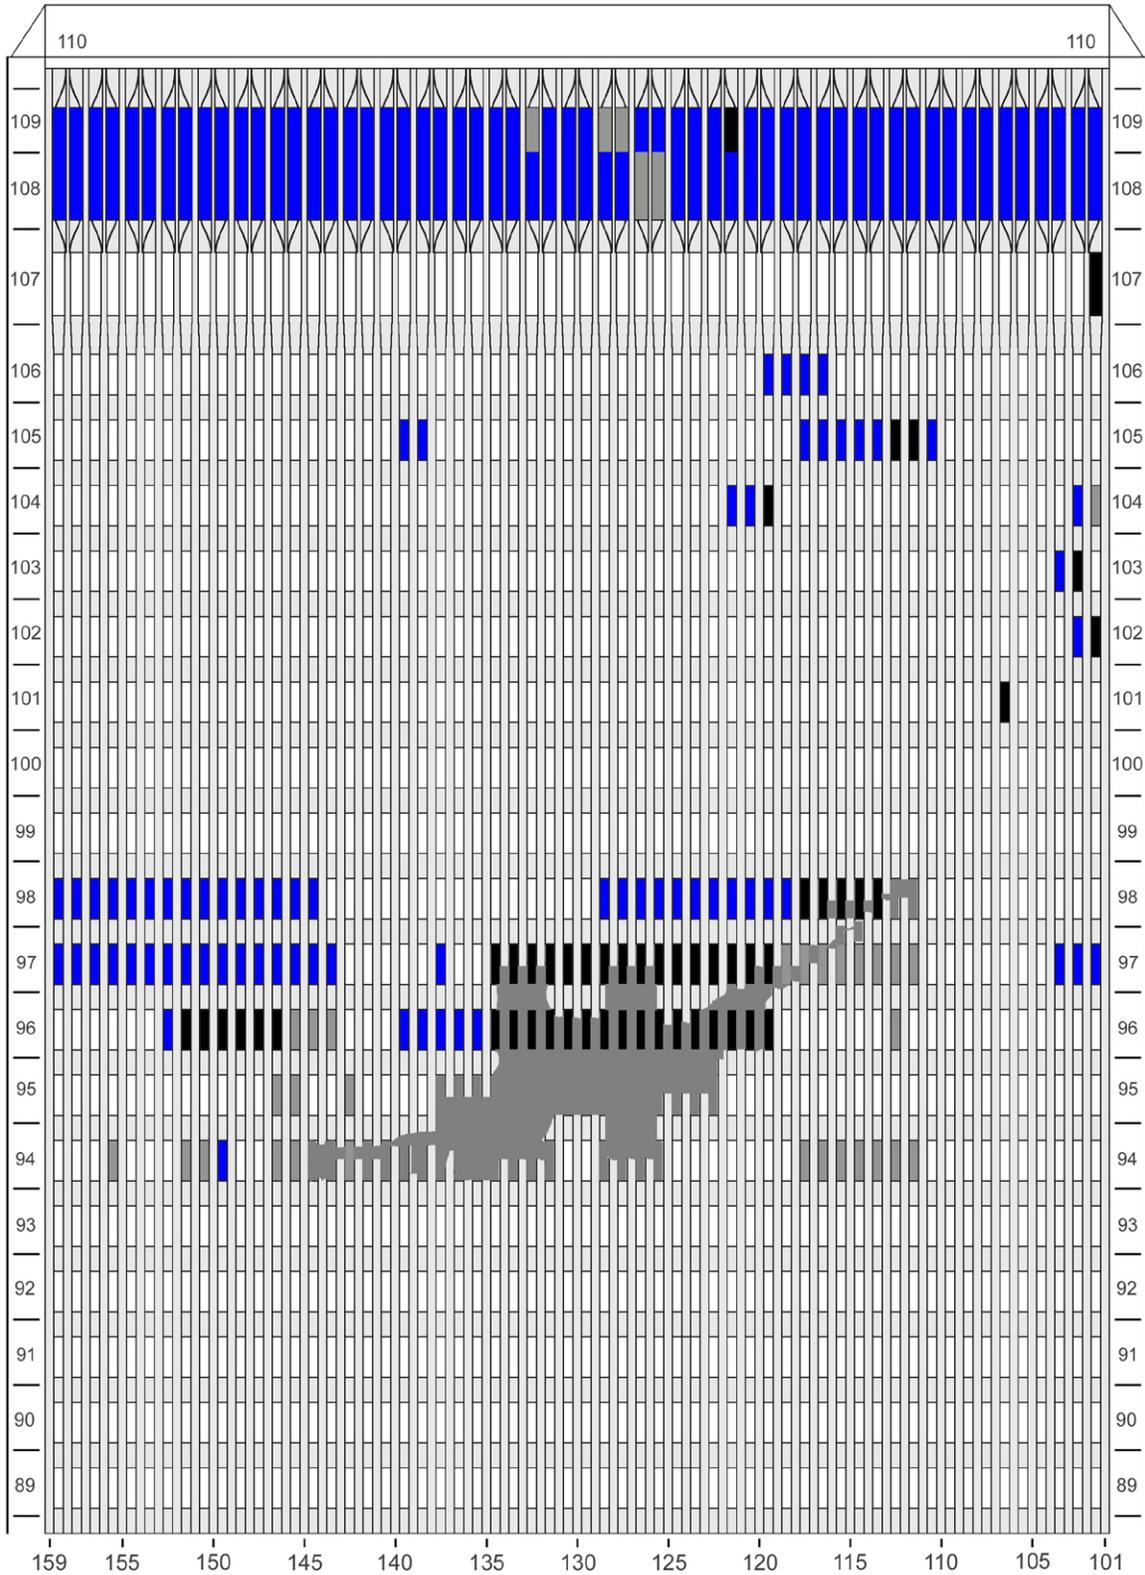
Figure C-28. Diagram of the north face of WTC 1 for floors 89 to 110 at 9:20 a.m. showing windows where smoke was observed and those that were hidden from view.

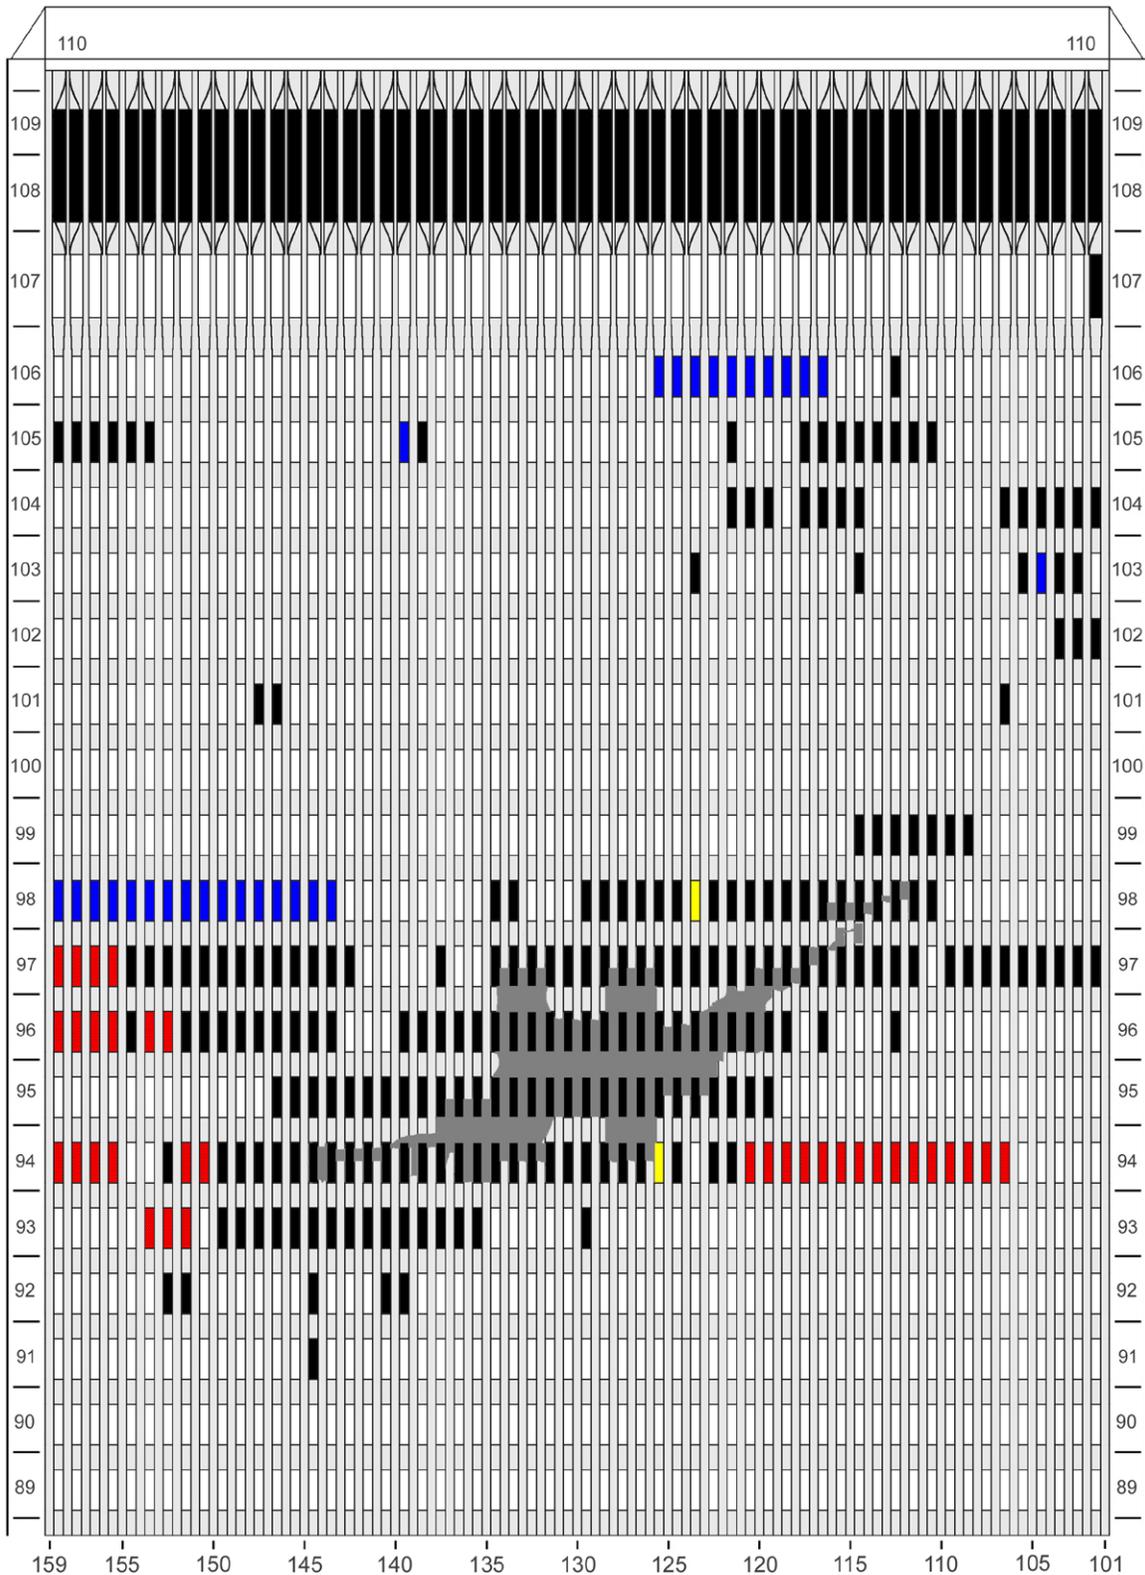
Figure C-29. Diagram of the north face of WTC 1 for floors 89 to 110 at 9:26 a.m. showing the condition of windows and locations of fires.

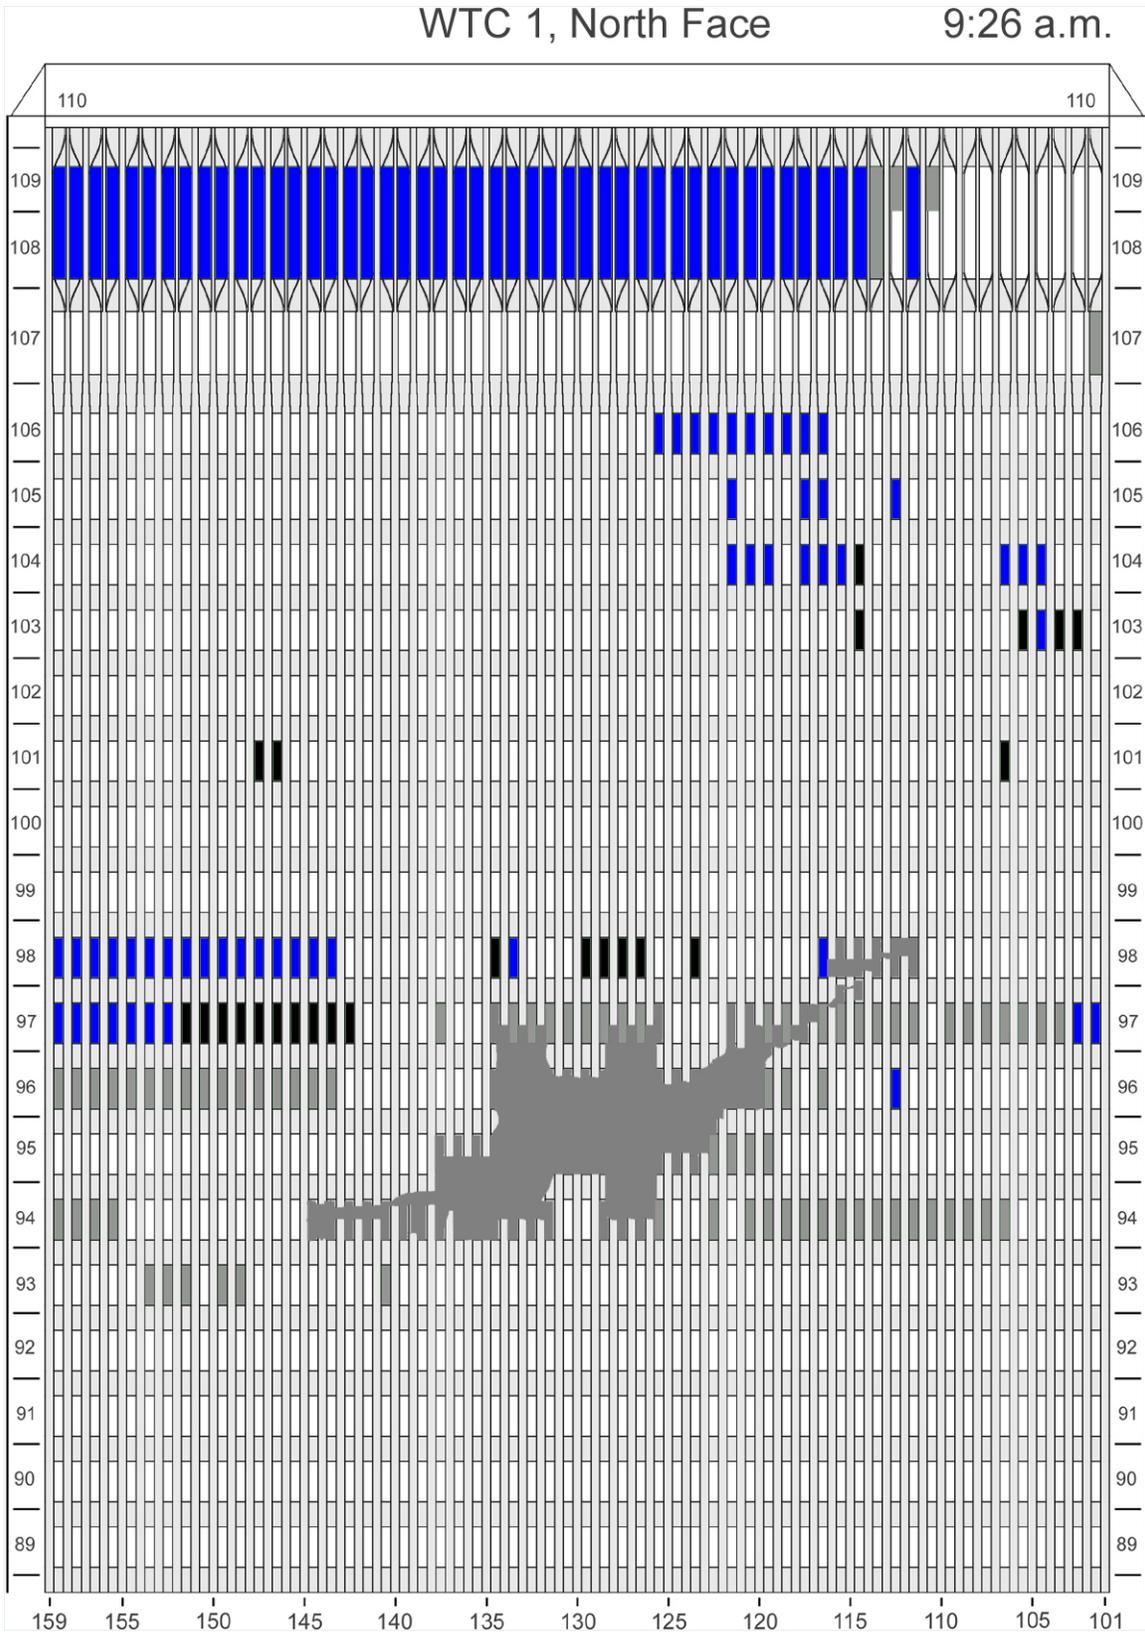
Figure C-30. Diagram of the north face of WTC 1 for floors 89 to 110 at 9:26 a.m. showing windows where smoke was observed and those that were hidden from view.

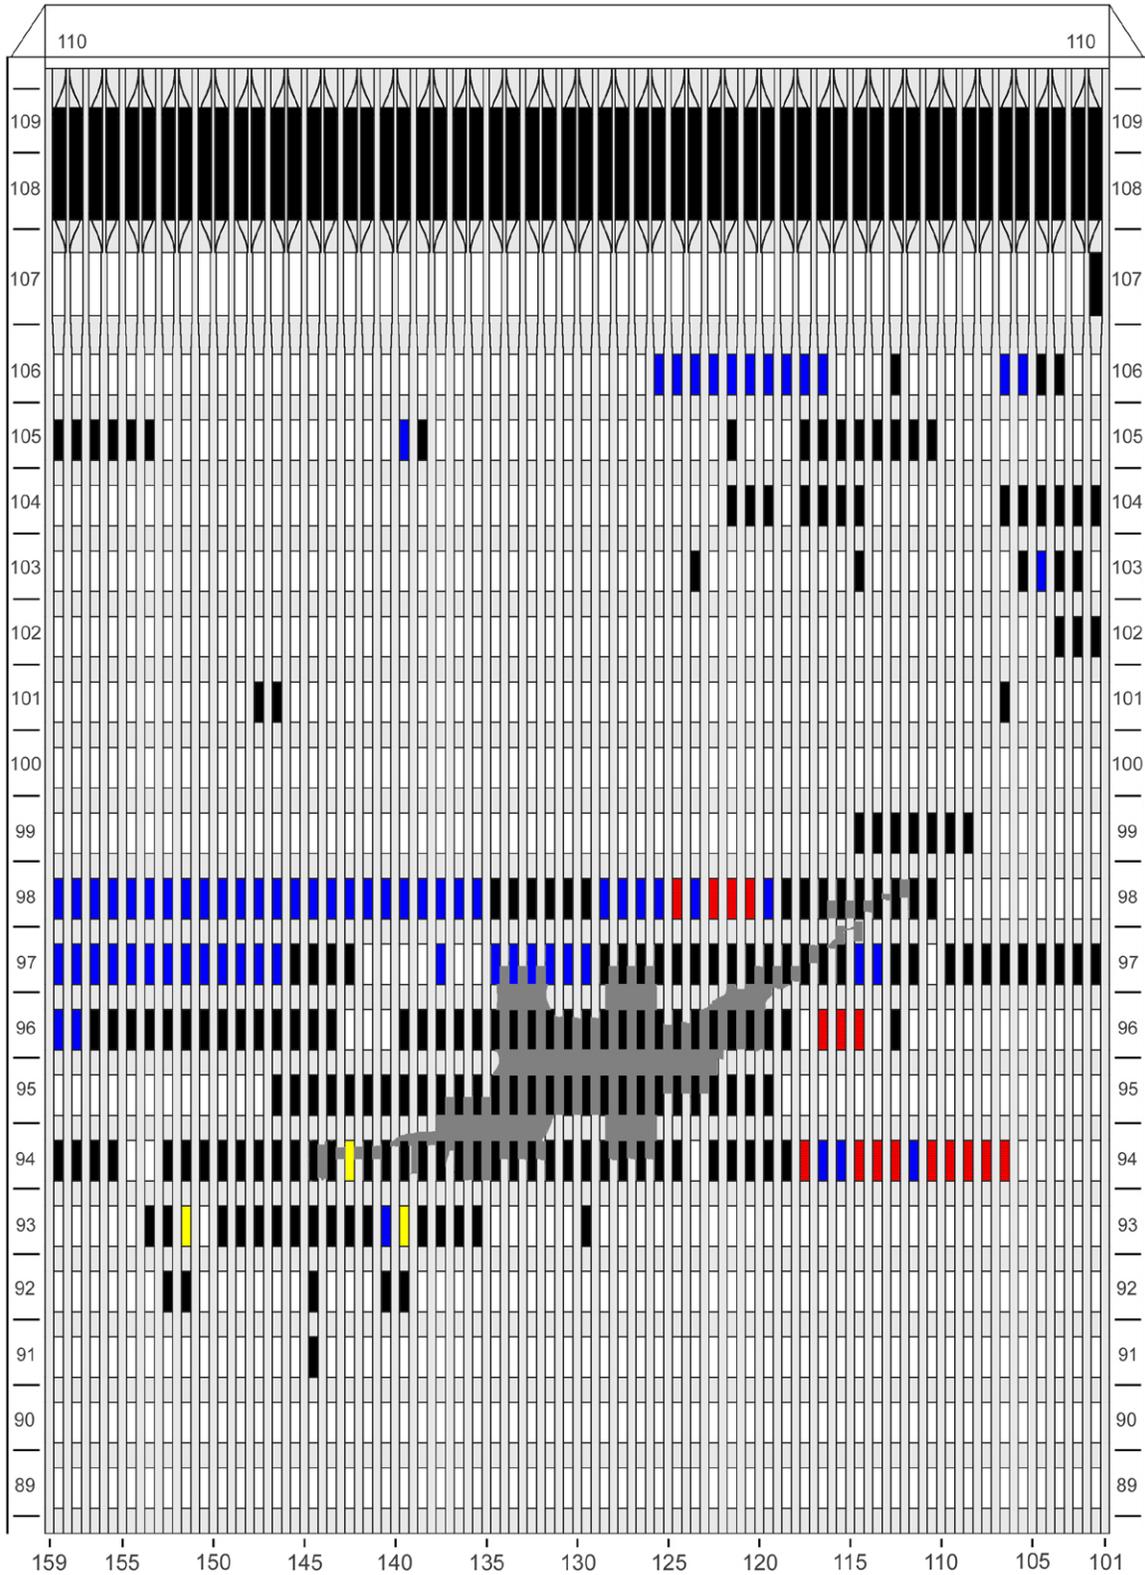
Figure C-31. Diagram of the north face of WTC 1 for floors 89 to 110 at 9:32 a.m. showing the condition of windows and locations of fires.

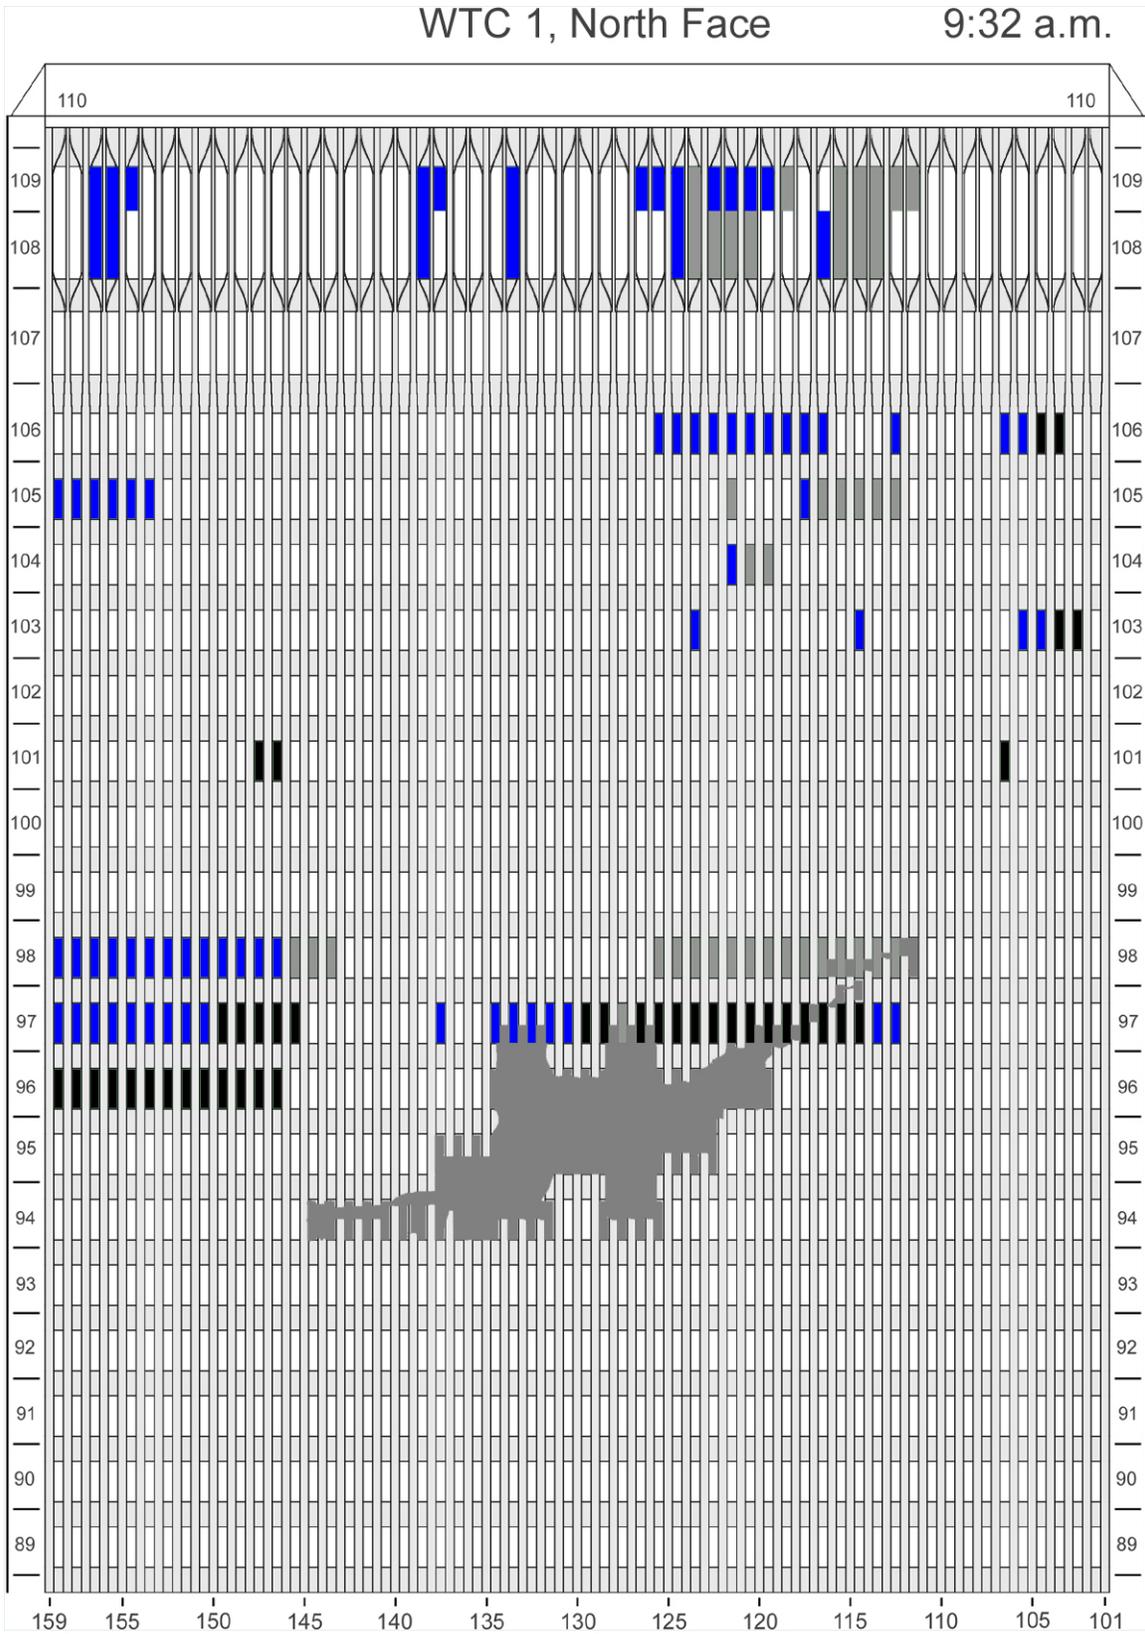
Figure C-32. Diagram of the north face of WTC 1 for floors 89 to 110 at 9:32 a.m. showing windows where smoke was observed and those that were hidden from view.
