## Chapter 9

# FIRE BEHAVIOR IN WORLD TRADE CENTER 2

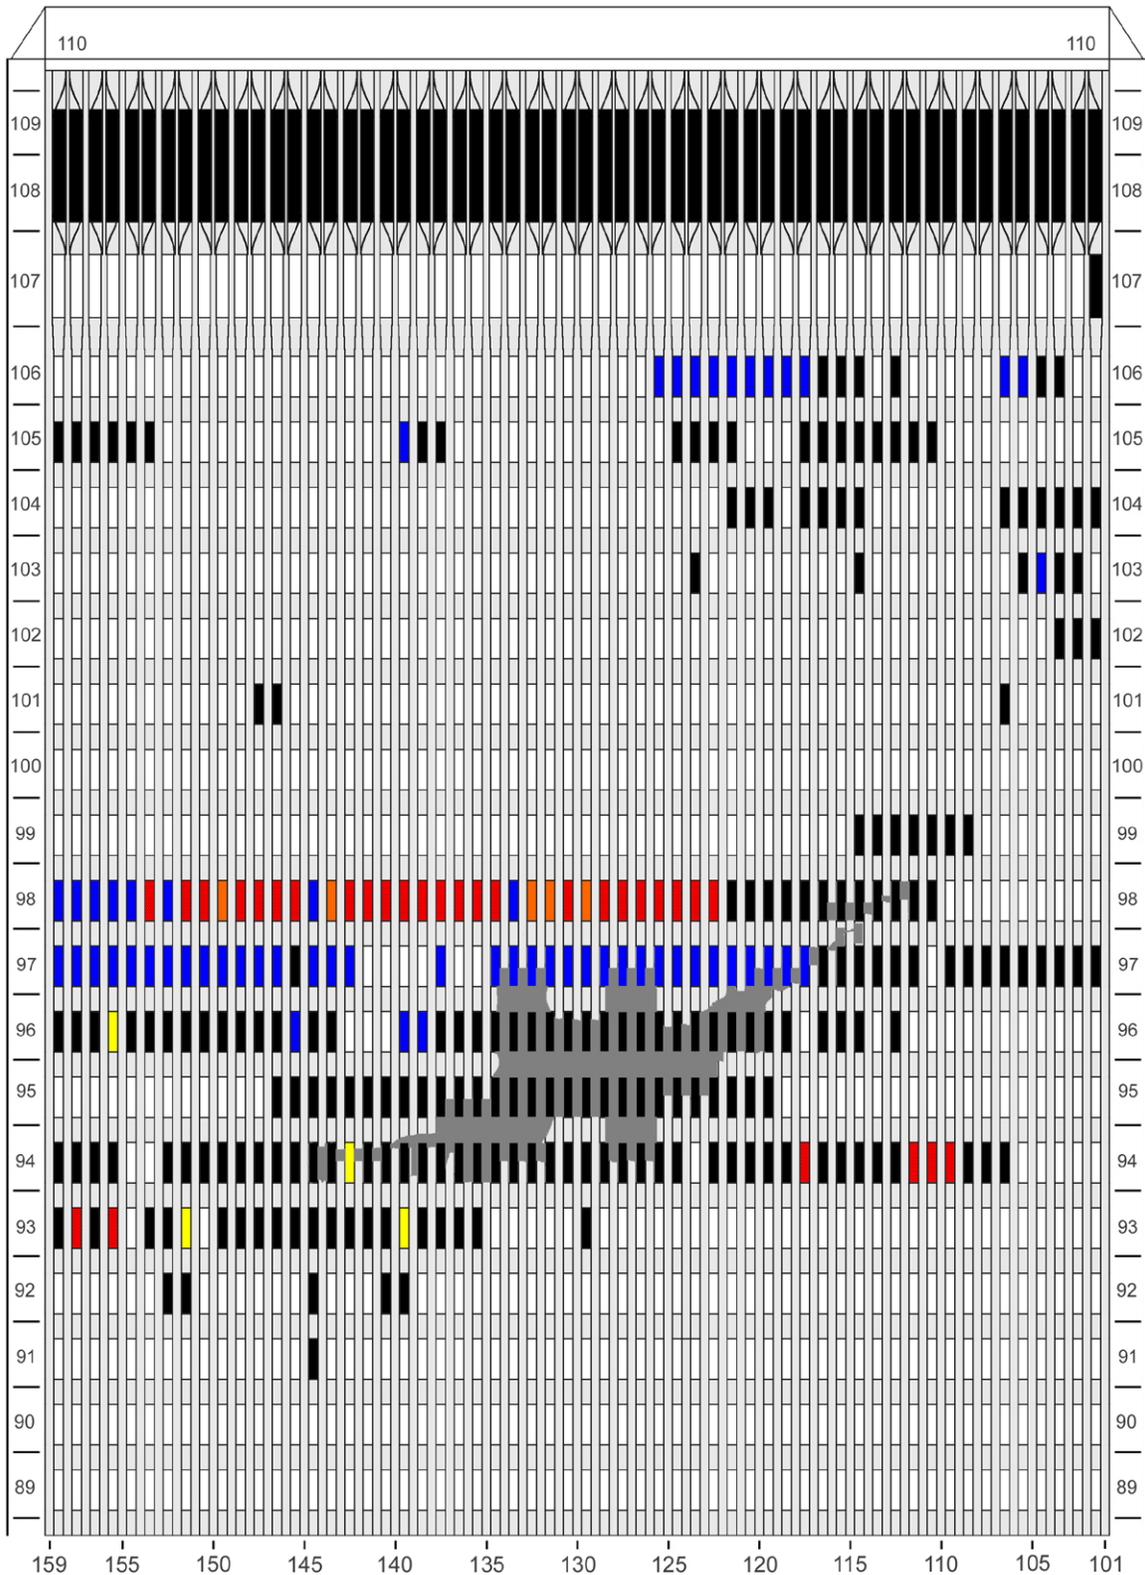
Figure C-33. Diagram of the north face of WTC 1 for floors 89 to 110 at 9:38 a.m. showing the condition of windows and locations of fires.

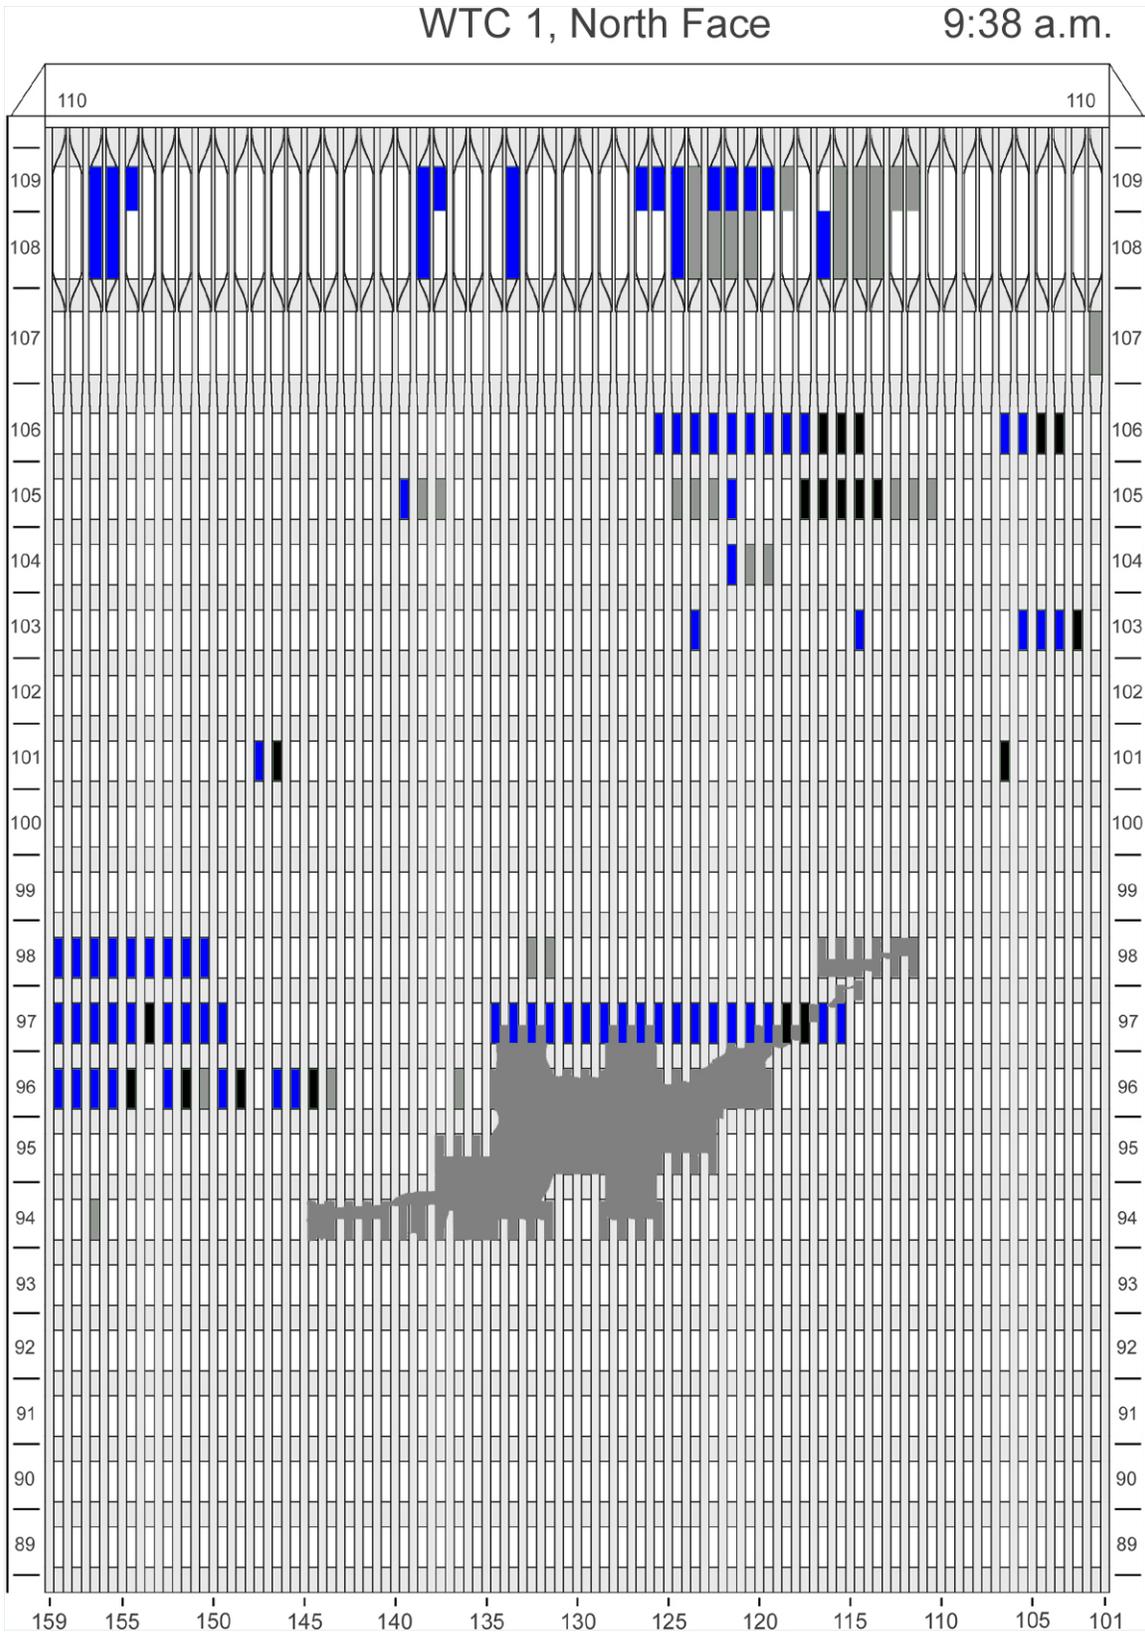
Figure C-34. Diagram of the north face of WTC 1 for floors 89 to 110 at 9:38 a.m. showing windows where smoke was observed and those that were hidden from view.

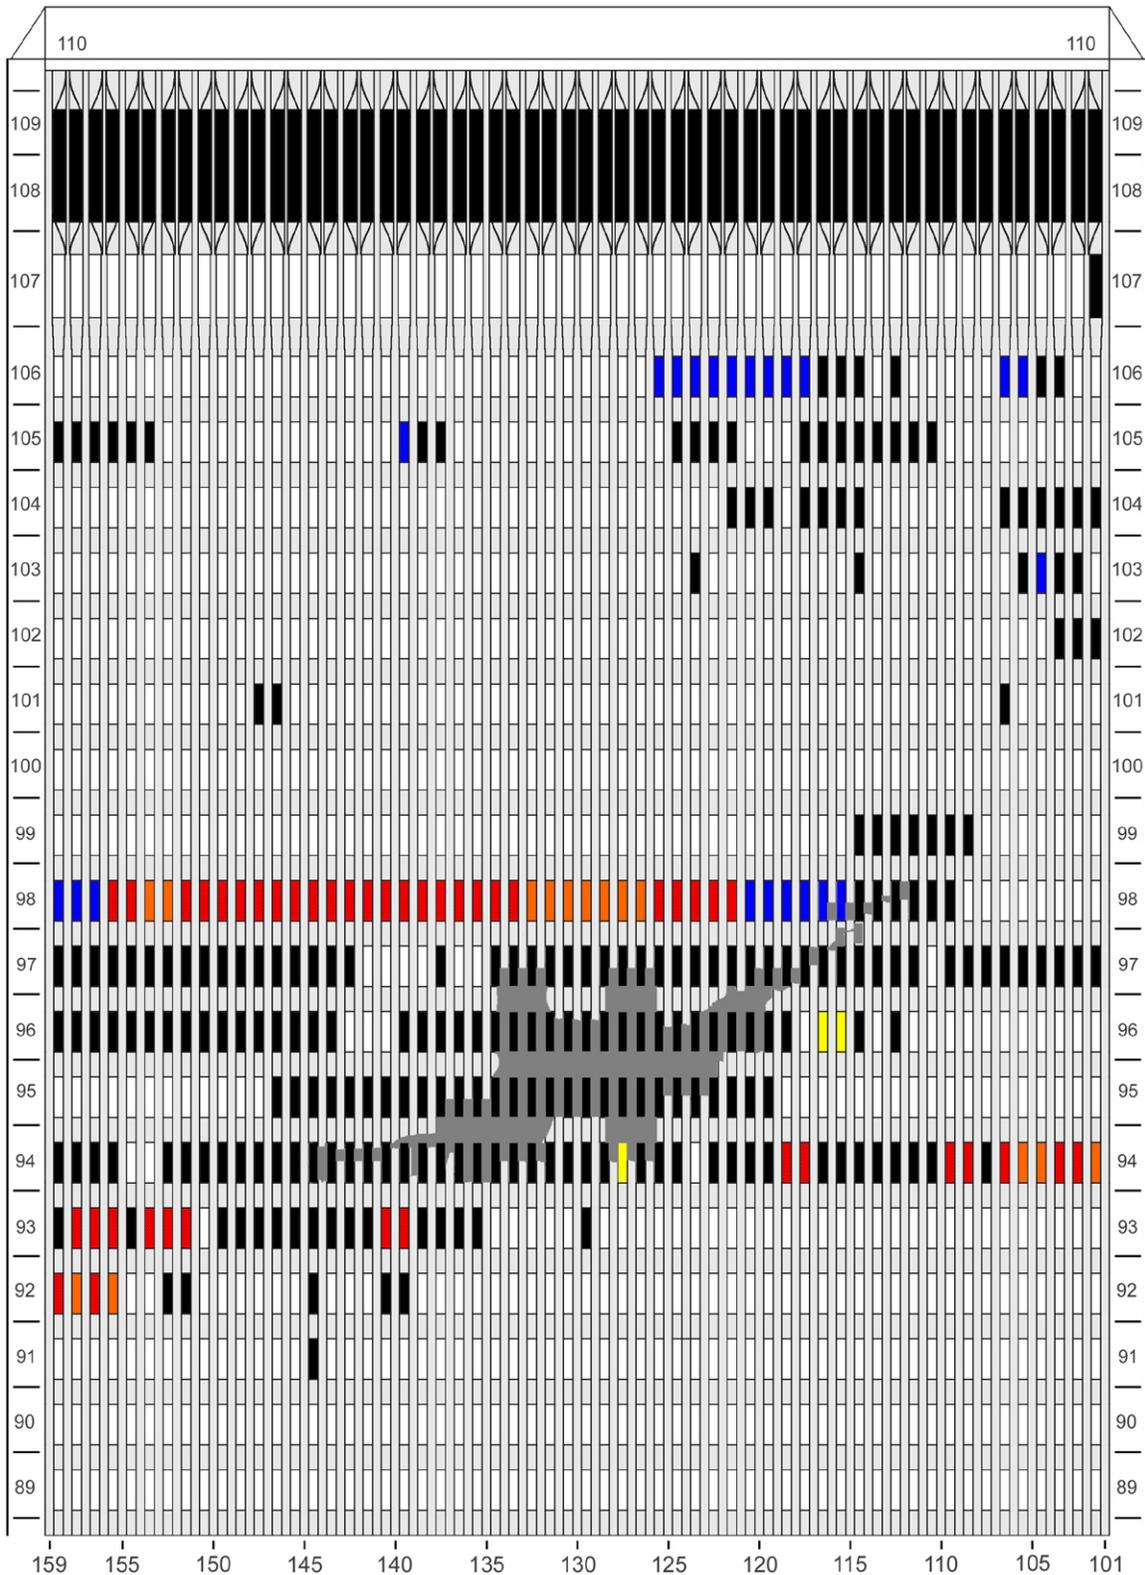
Figure C-35. Diagram of the north face of WTC 1 for floors 89 to 110 at 9:42 a.m. showing the condition of windows and locations of fires.

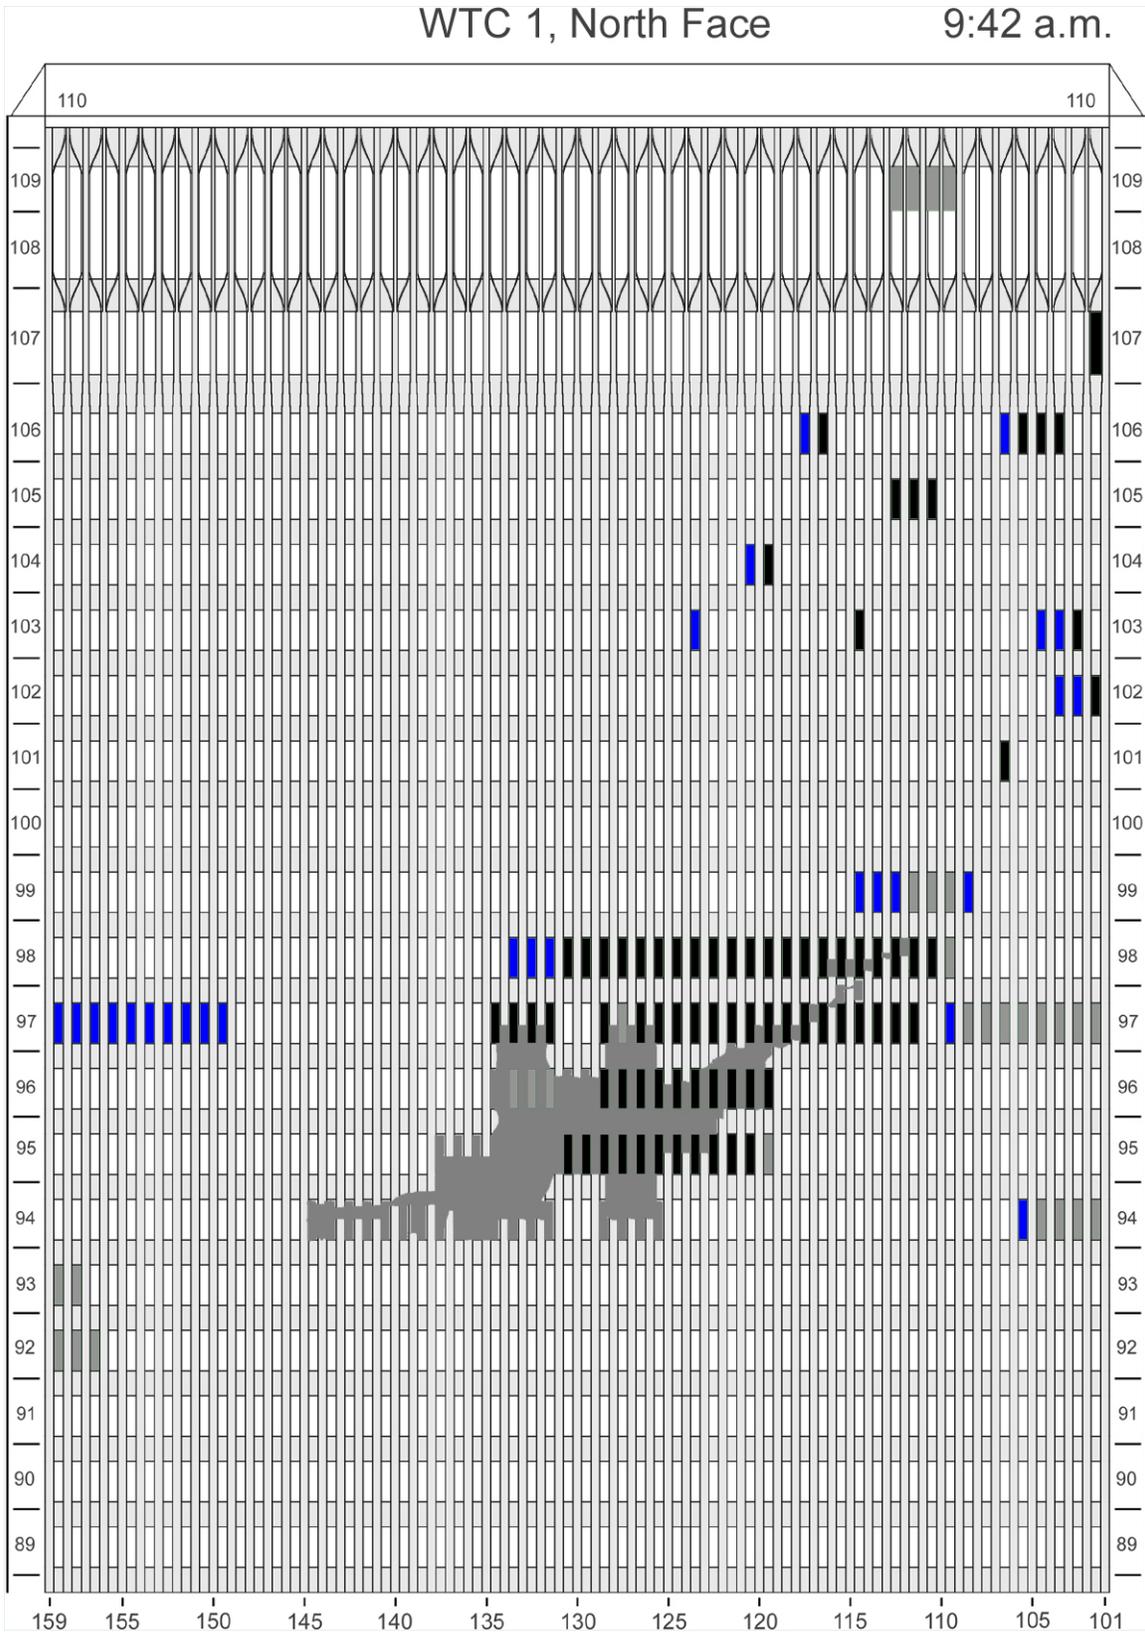
Figure C-36. Diagram of the north face of WTC 1 for floors 89 to 110 at 9:42 a.m. showing windows where smoke was observed and those that were hidden from view.

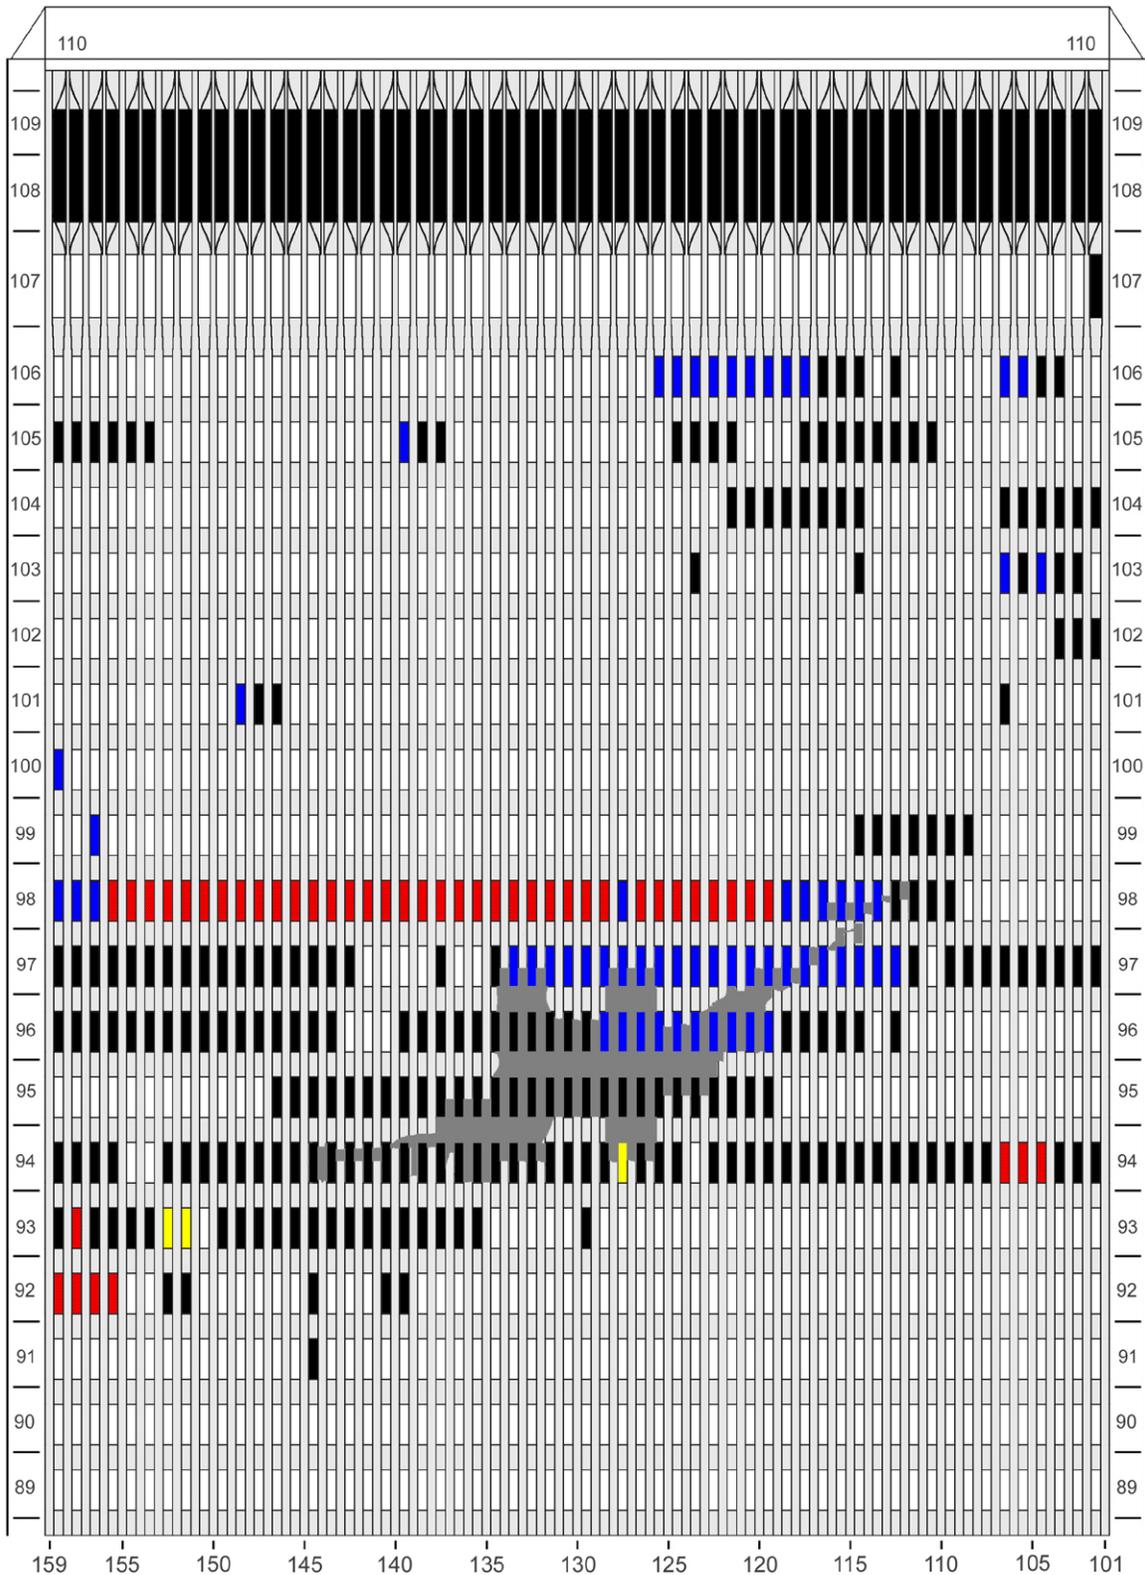
Figure C-37. Diagram of the north face of WTC 1 for floors 89 to 110 at 9:46 a.m. showing the condition of windows and locations of fires.

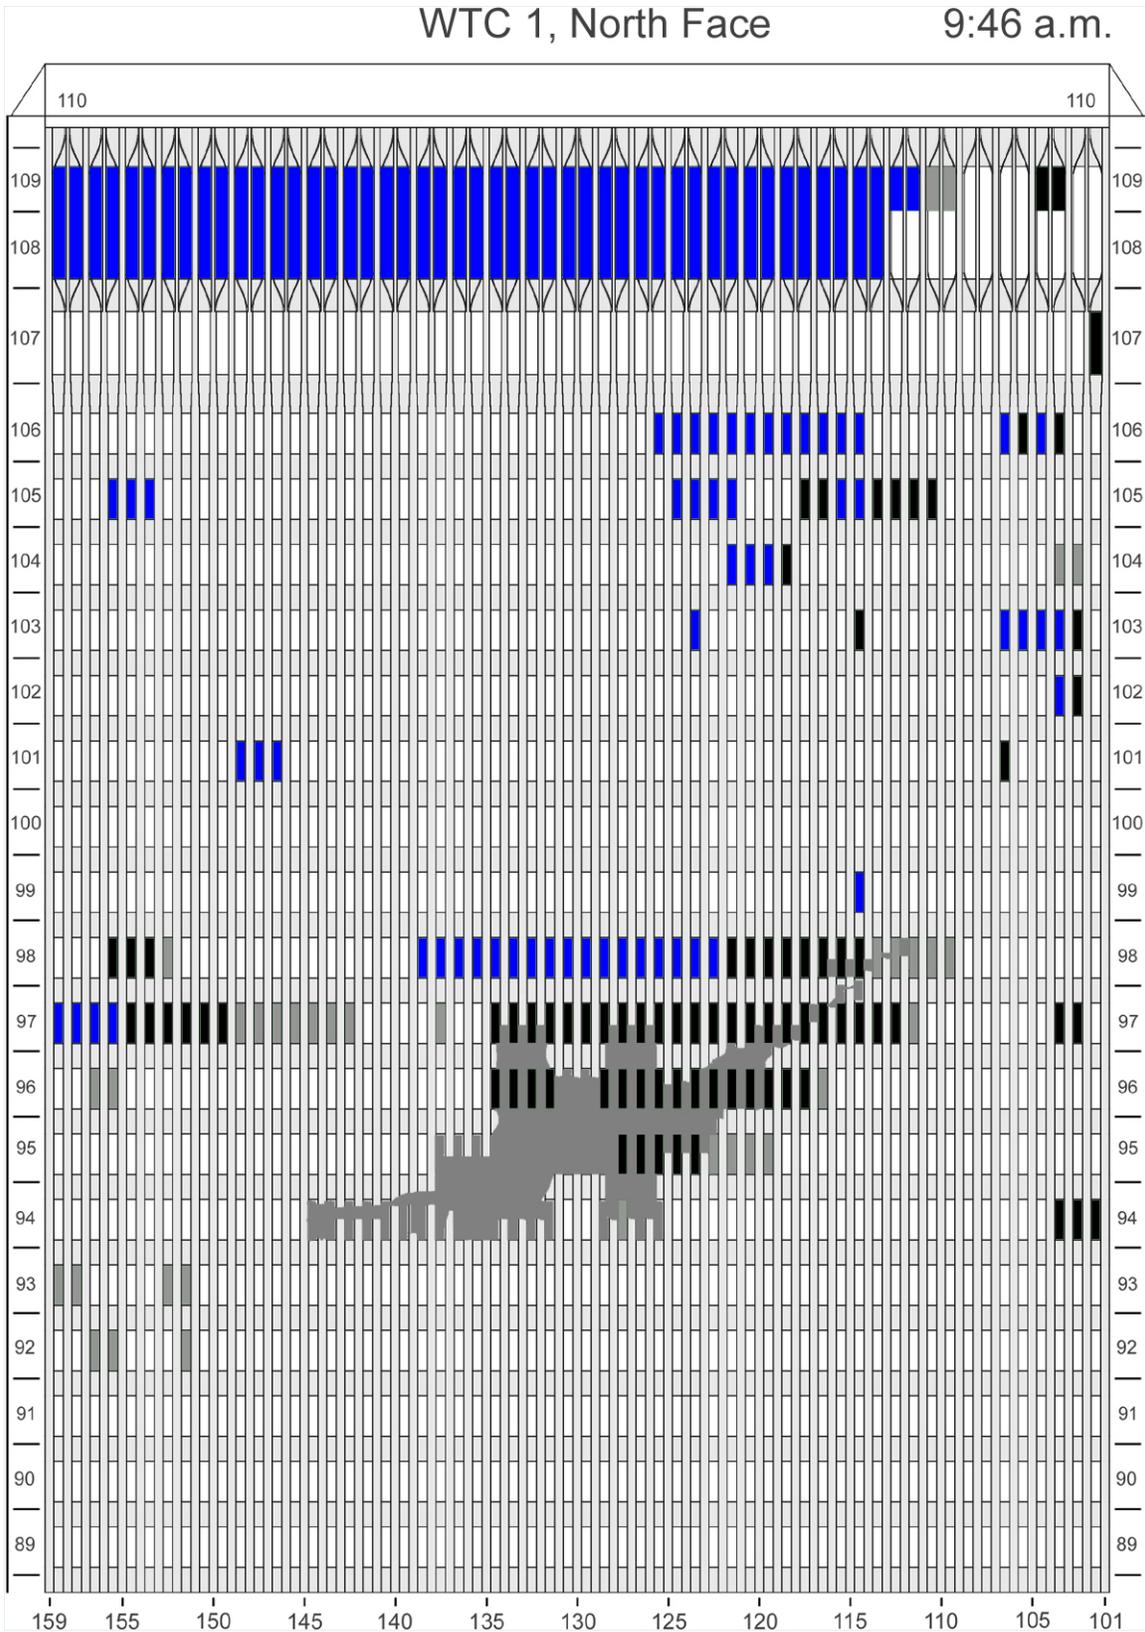
Figure C-38. Diagram of the north face of WTC 1 for floors 89 to 110 at 9:46 a.m. showing windows where smoke was observed and those that were hidden from view.

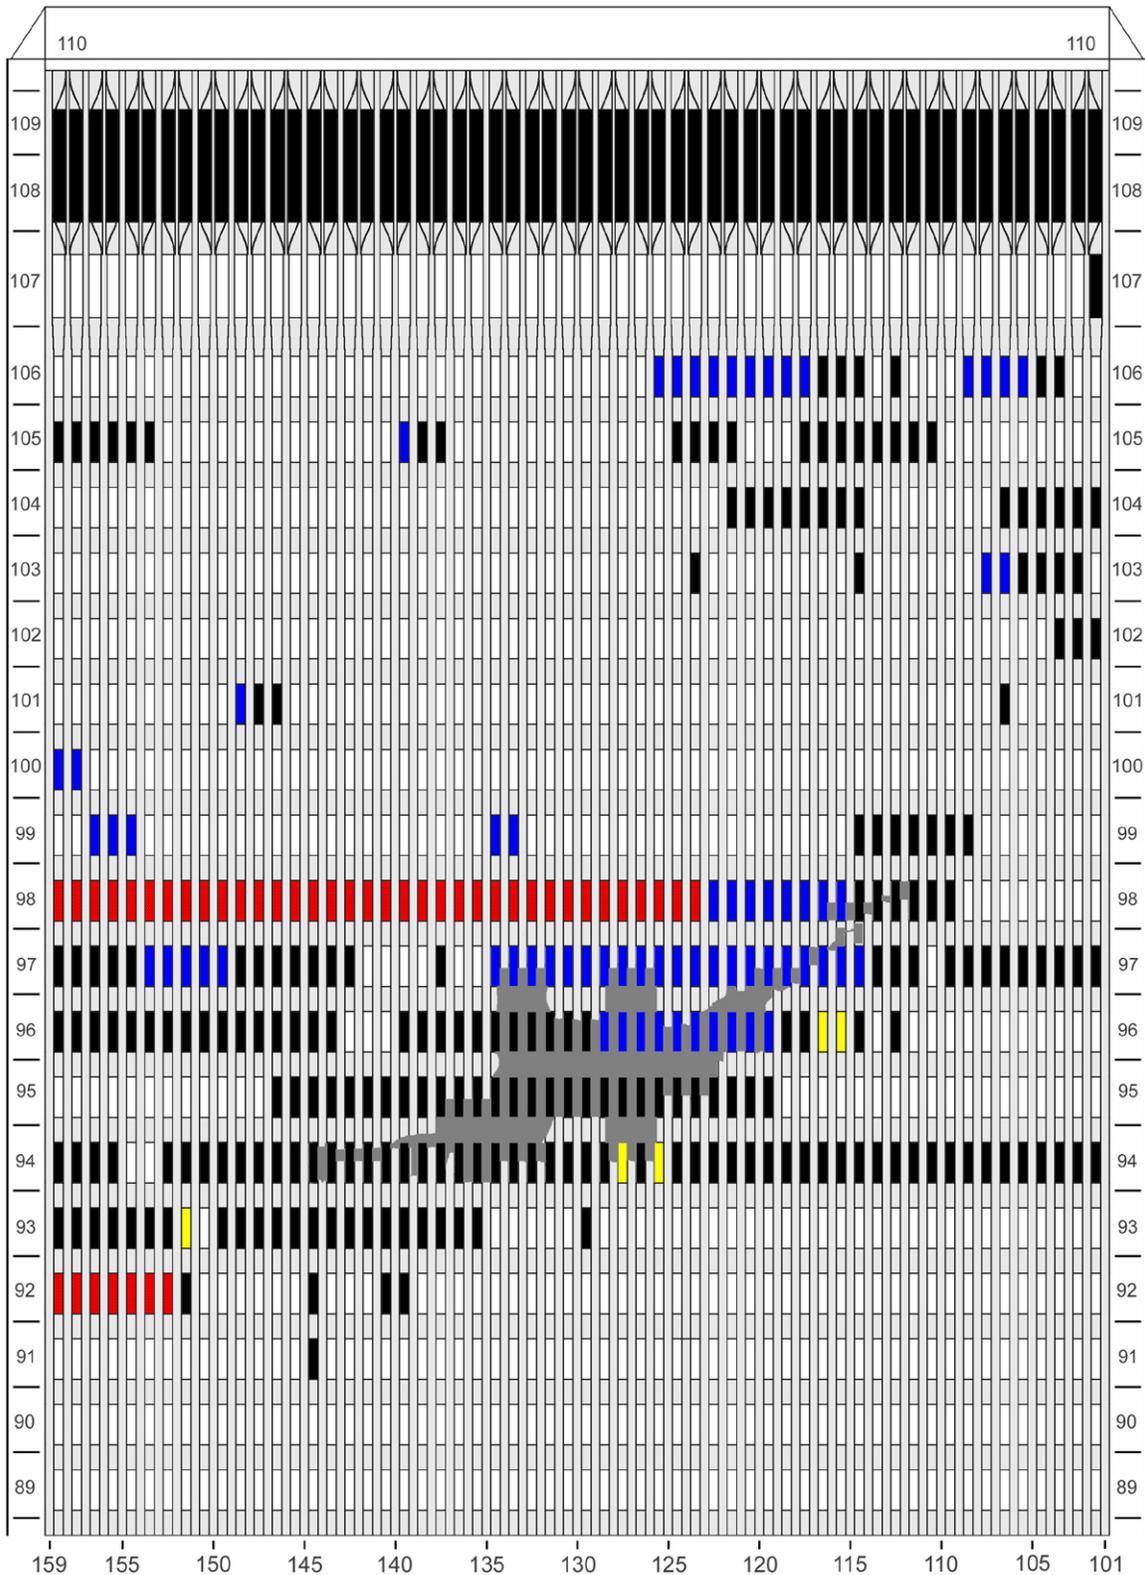
Figure C-39. Diagram of the north face of WTC 1 for floors 89 to 110 at 9:52 a.m. showing the condition of windows and locations of fires.

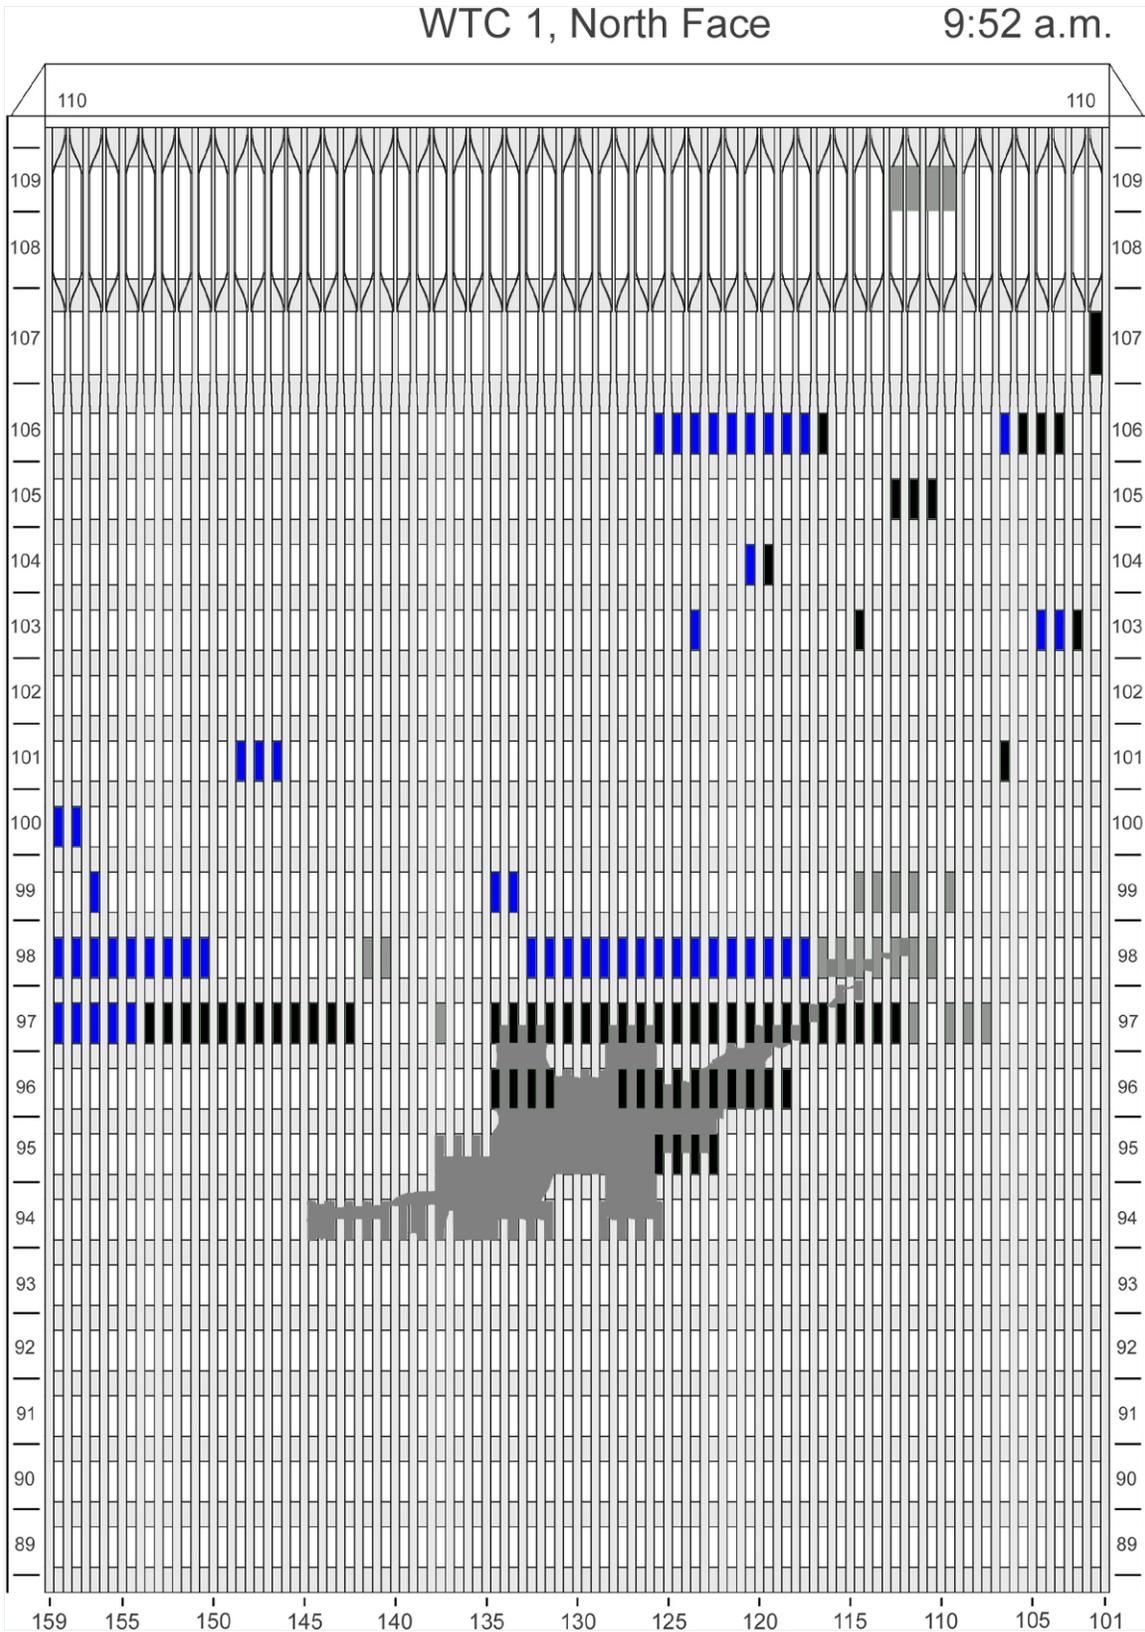
Figure C-40. Diagram of the north face of WTC 1 for floors 89 to 110 at 9:52 a.m. showing windows where smoke was observed and those that were hidden from view.

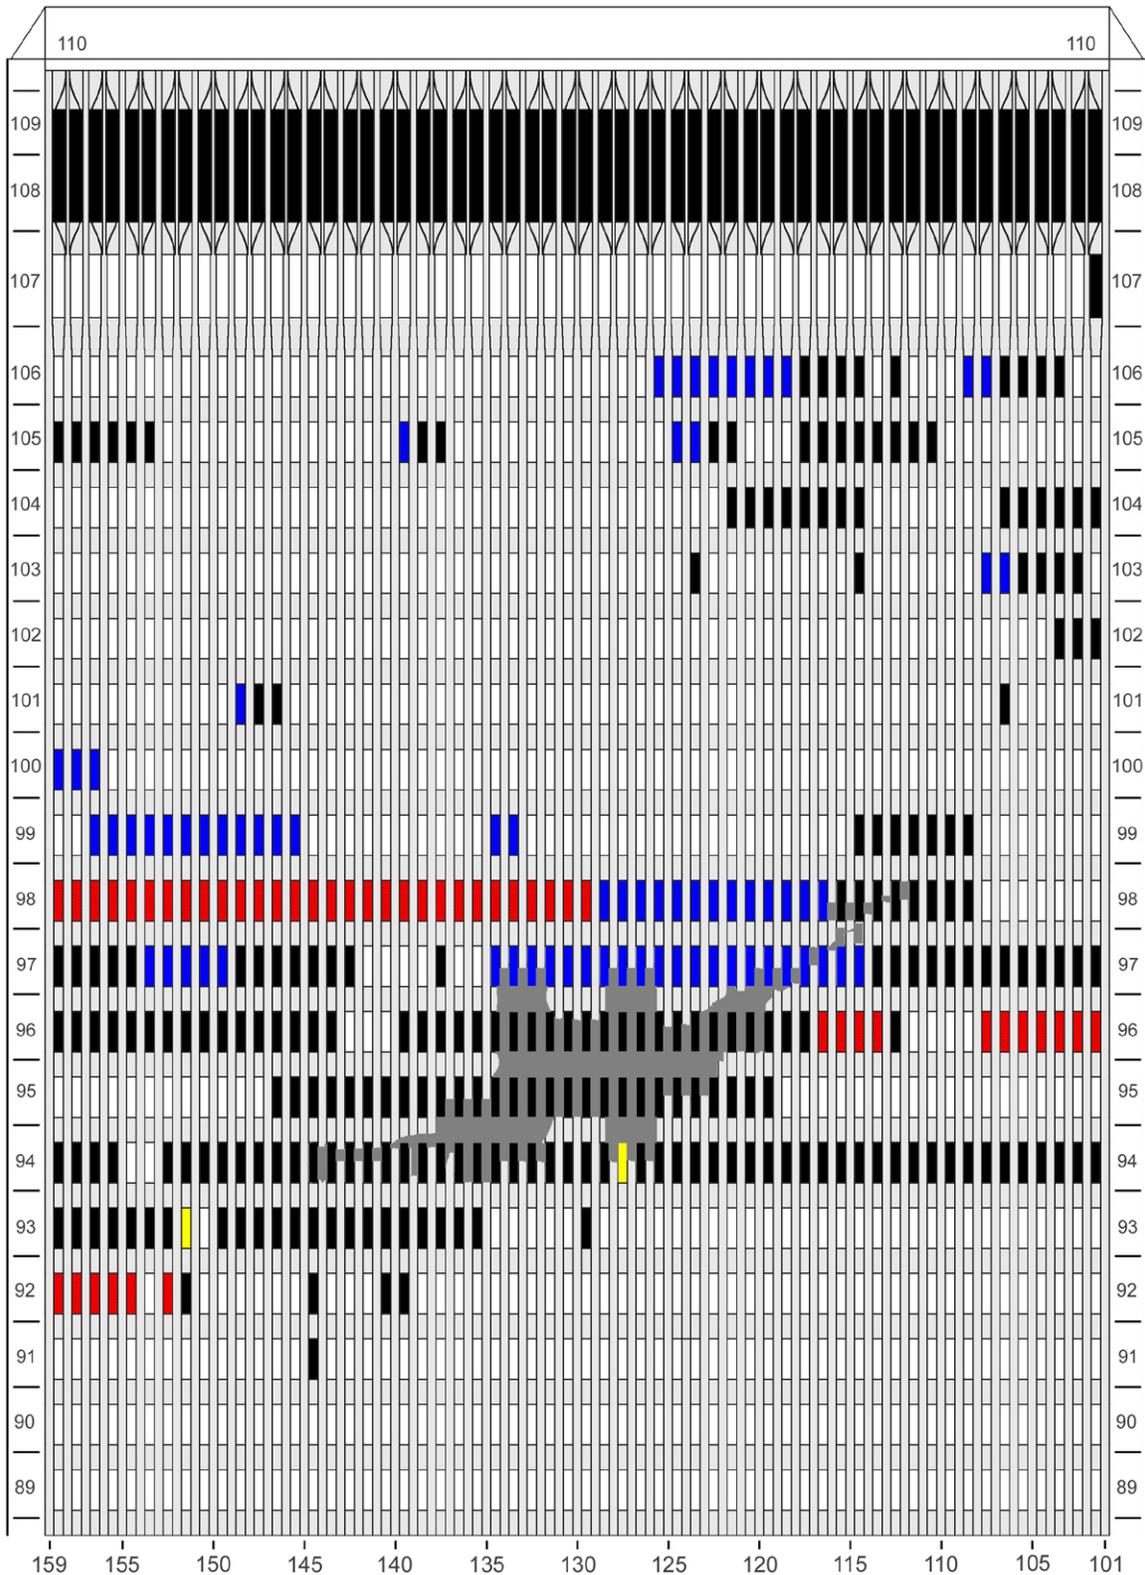
Figure C-41. Diagram of the north face of WTC 1 for floors 89 to 110 at 9:54 a.m. showing the condition of windows and locations of fires.

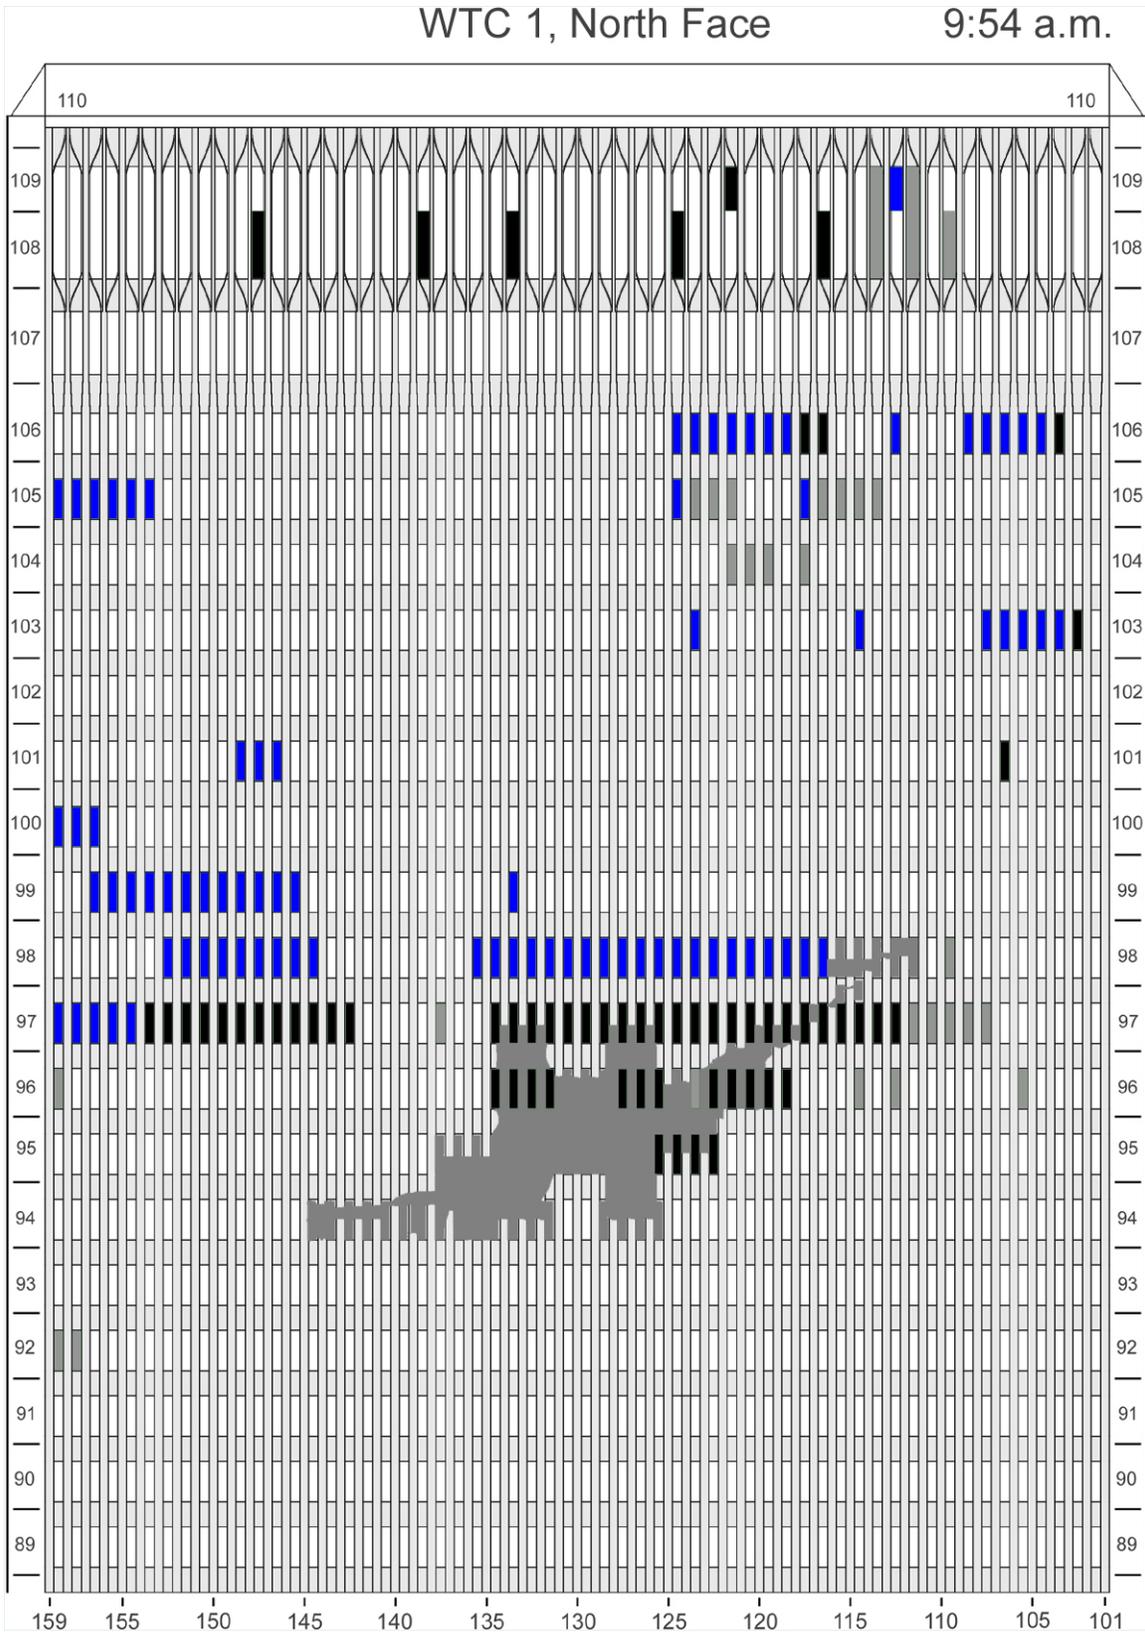
Figure C-42. Diagram of the north face of WTC 1 for floors 89 to 110 at 9:54 a.m. showing windows where smoke was observed and those that were hidden from view.

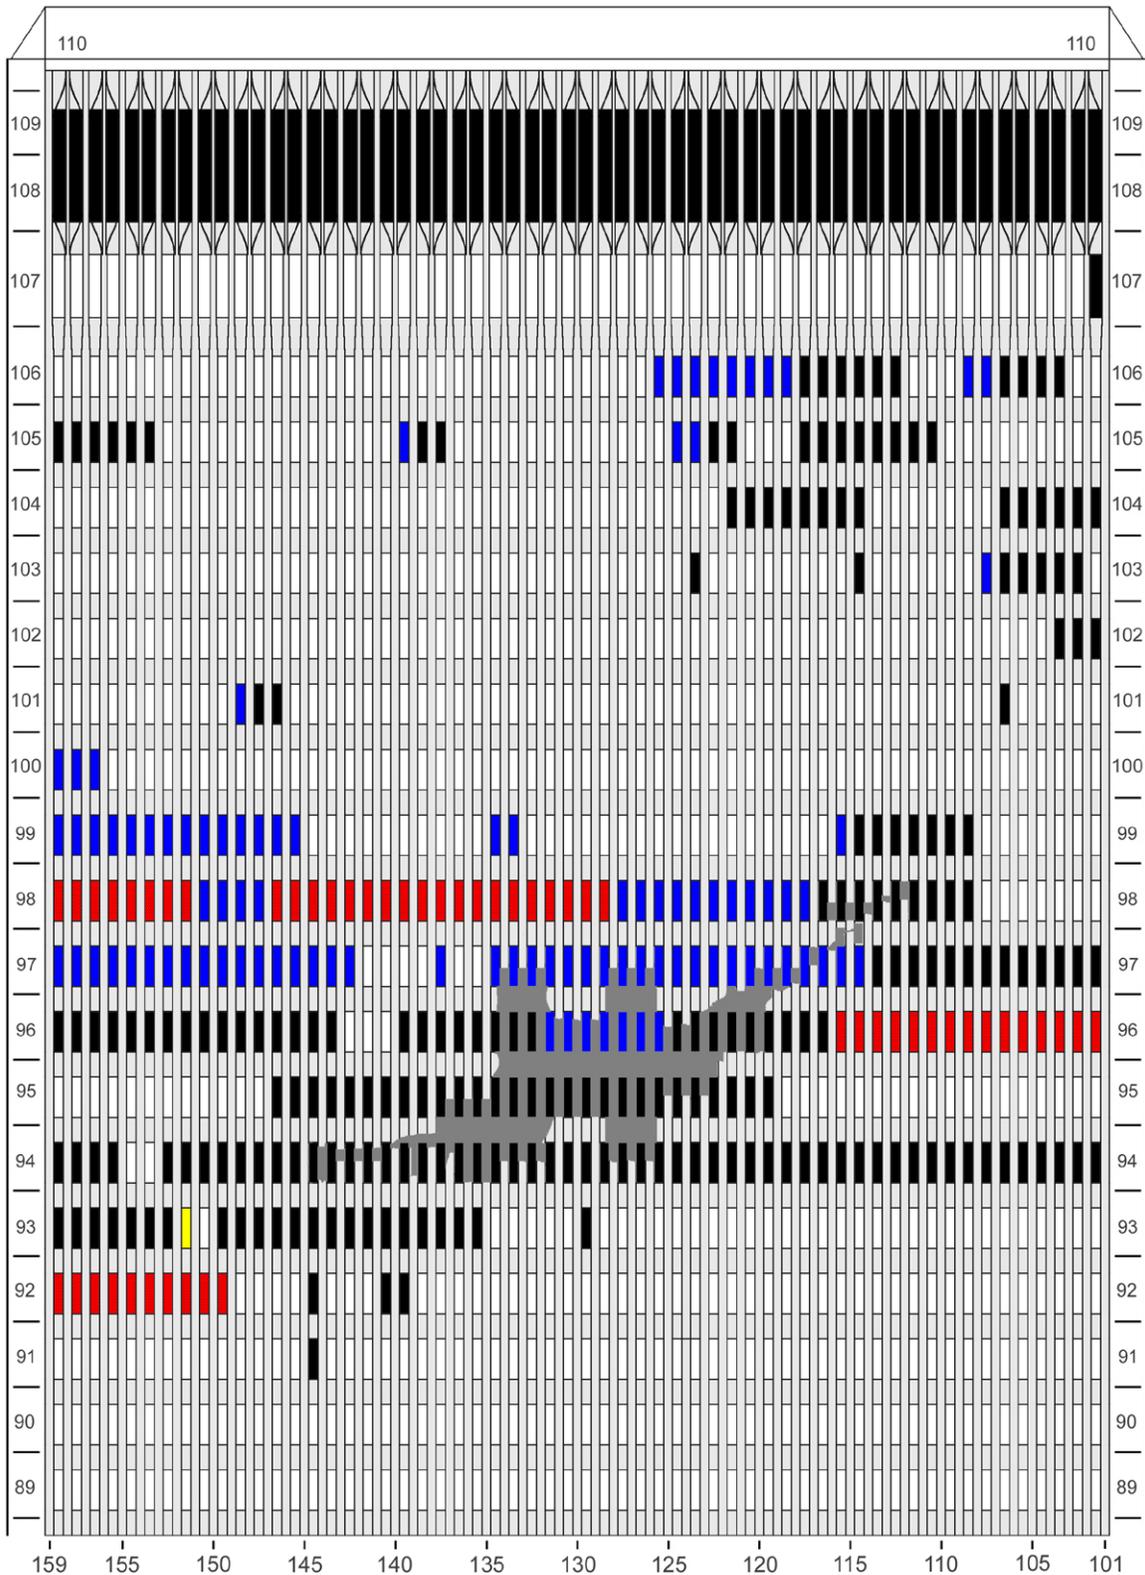
Figure C-43. Diagram of the north face of WTC 1 for floors 89 to 110 at 9:58 a.m. showing the condition of windows and locations of fires.

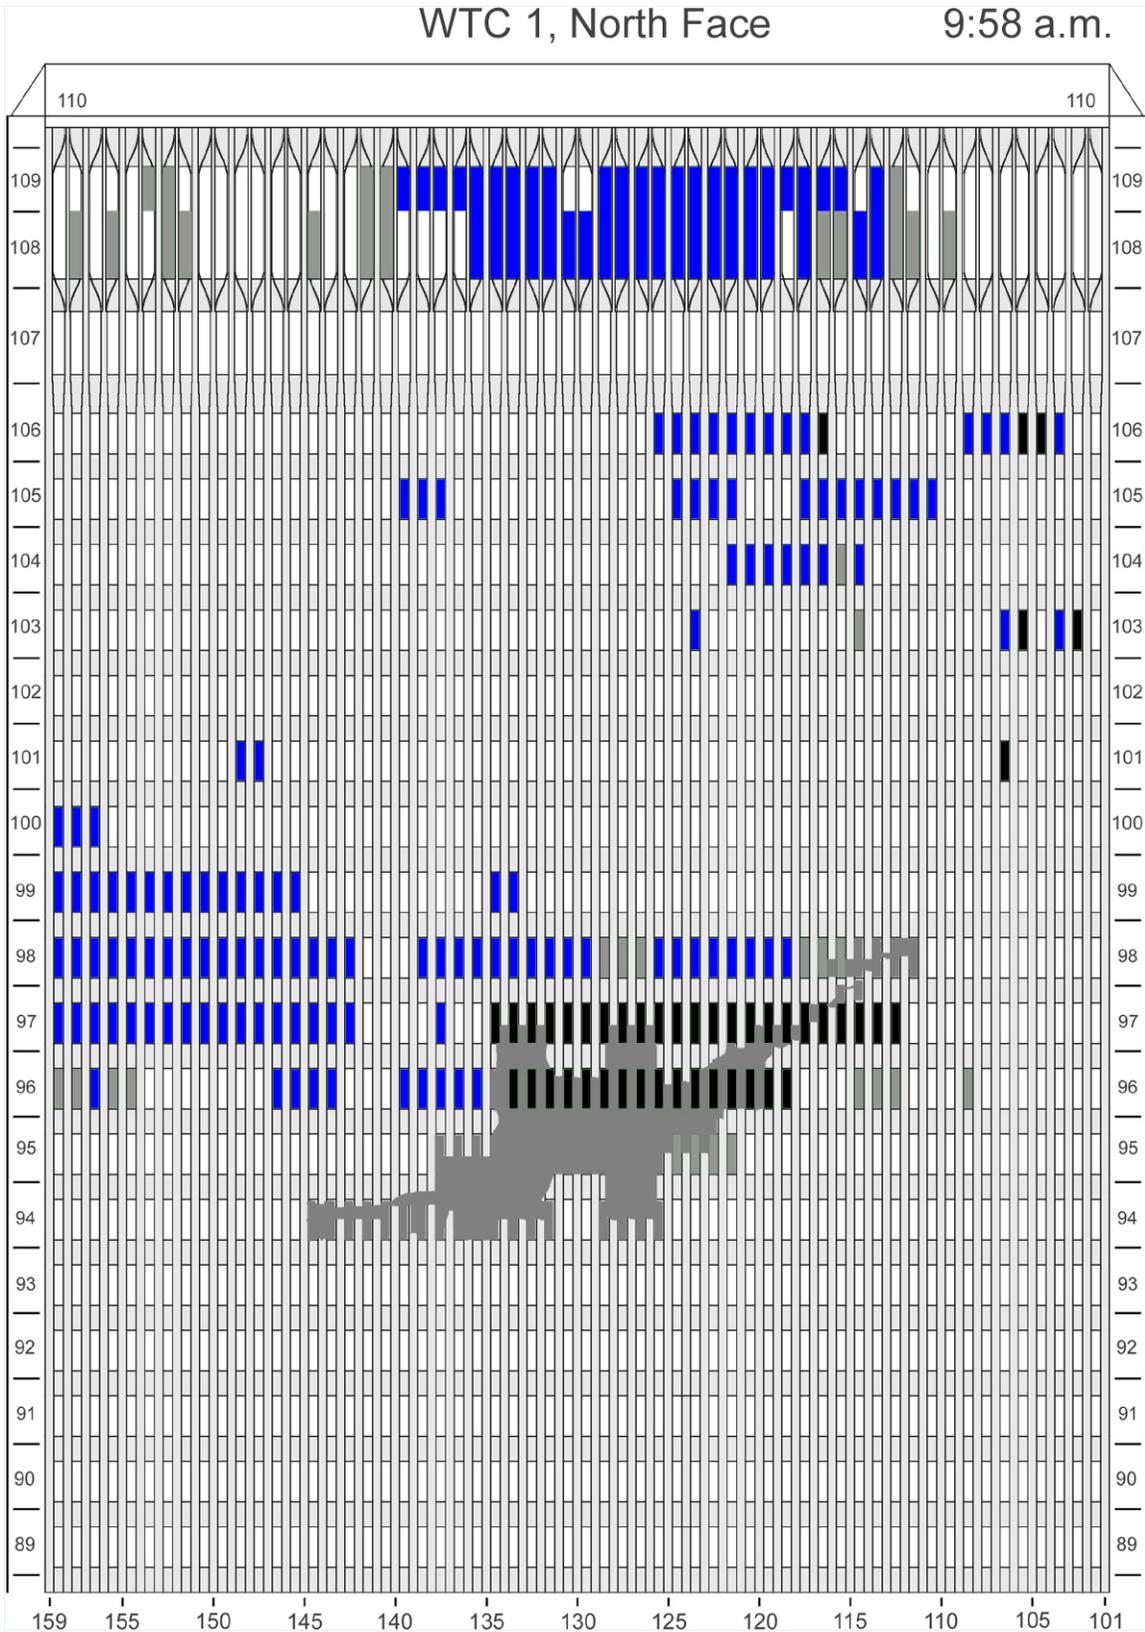
Figure C-44. Diagram of the north face of WTC 1 for floors 89 to 110 at 9:58 a.m. showing windows where smoke was observed and those that were hidden from view.
