## Chapter 9

# FIRE BEHAVIOR IN WORLD TRADE CENTER 2

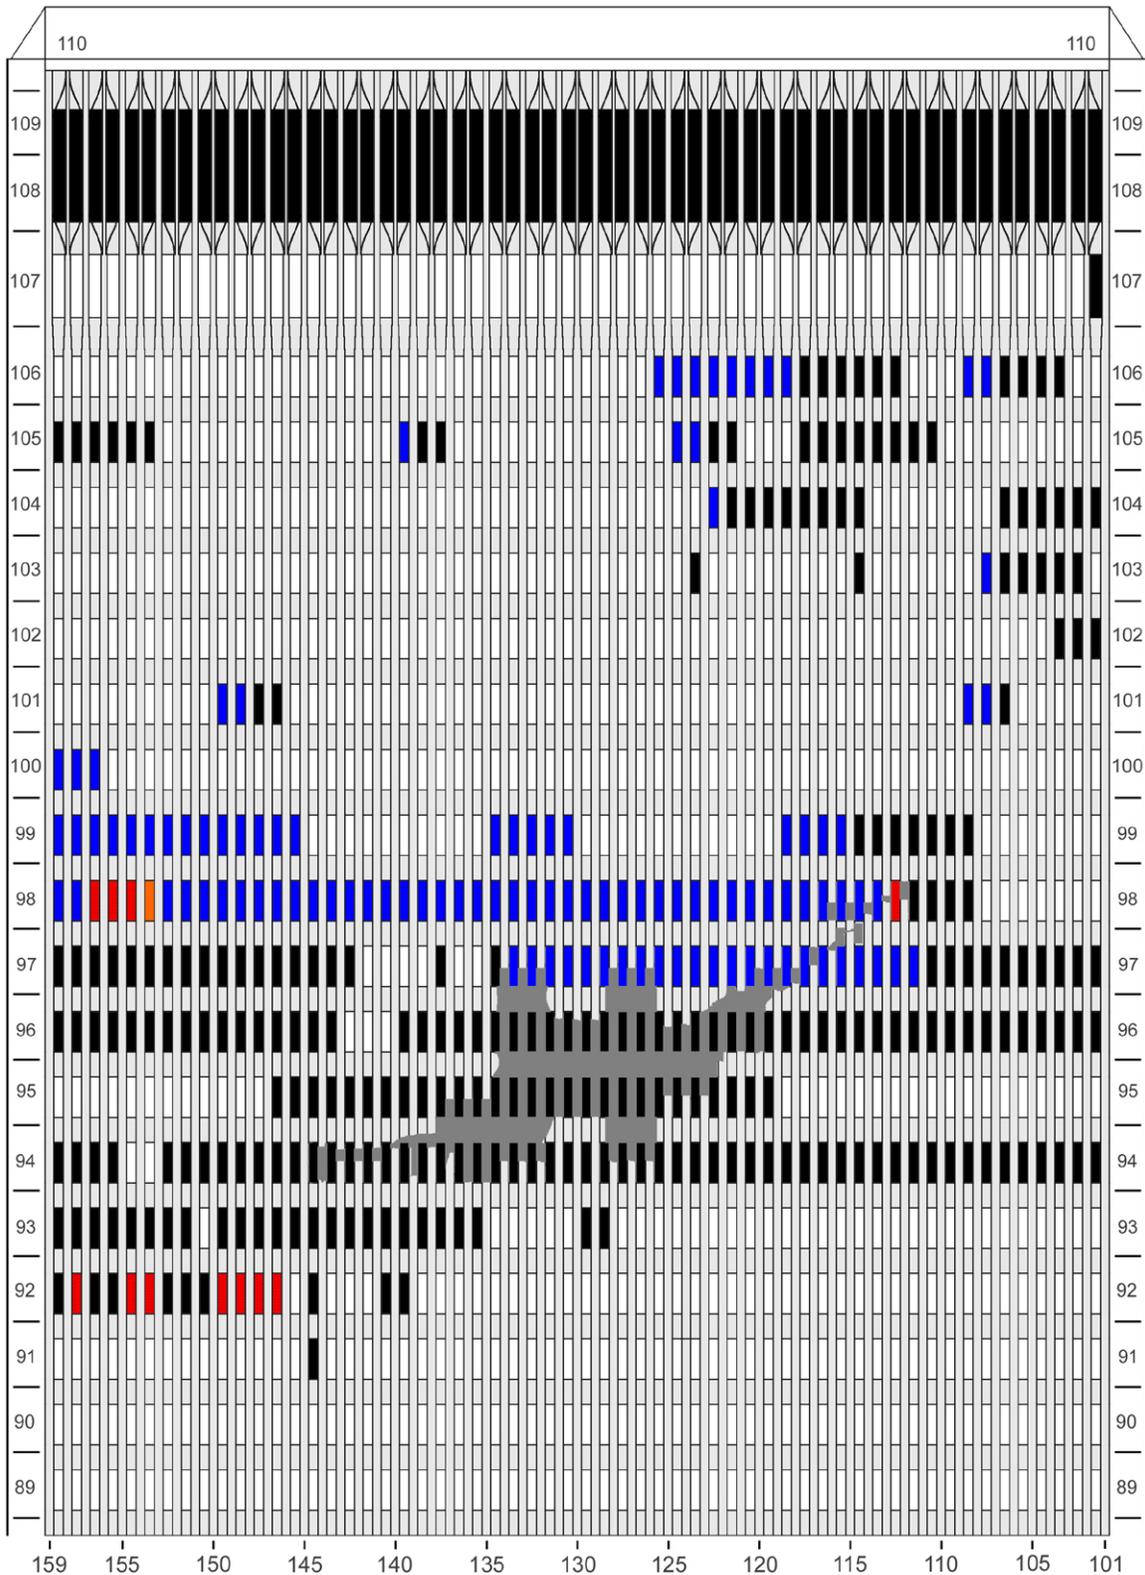
Figure C-45. Diagram of the north face of WTC 1 for floors 89 to 110 at 10:04 a.m. showing the condition of windows and locations of fires.

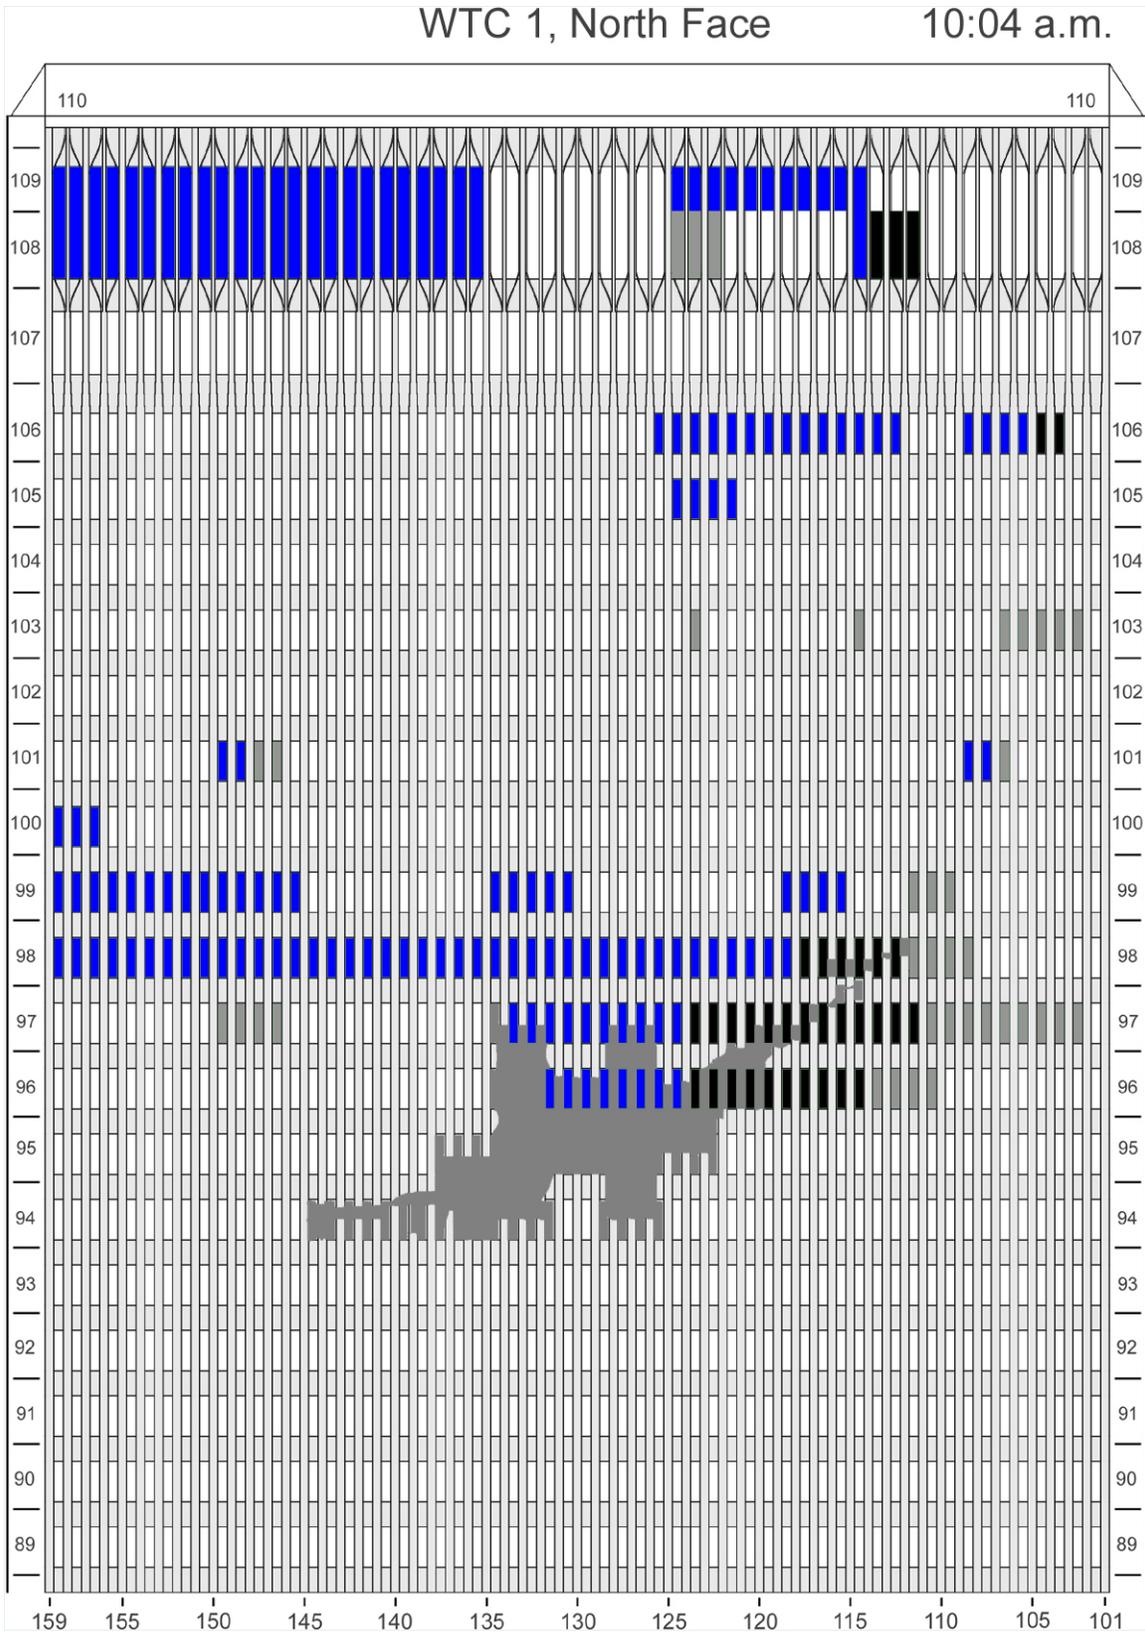
Figure C-46. Diagram of the north face of WTC 1 for floors 89 to 110 at 10:04 a.m. showing windows where smoke was observed and those that were hidden from view.

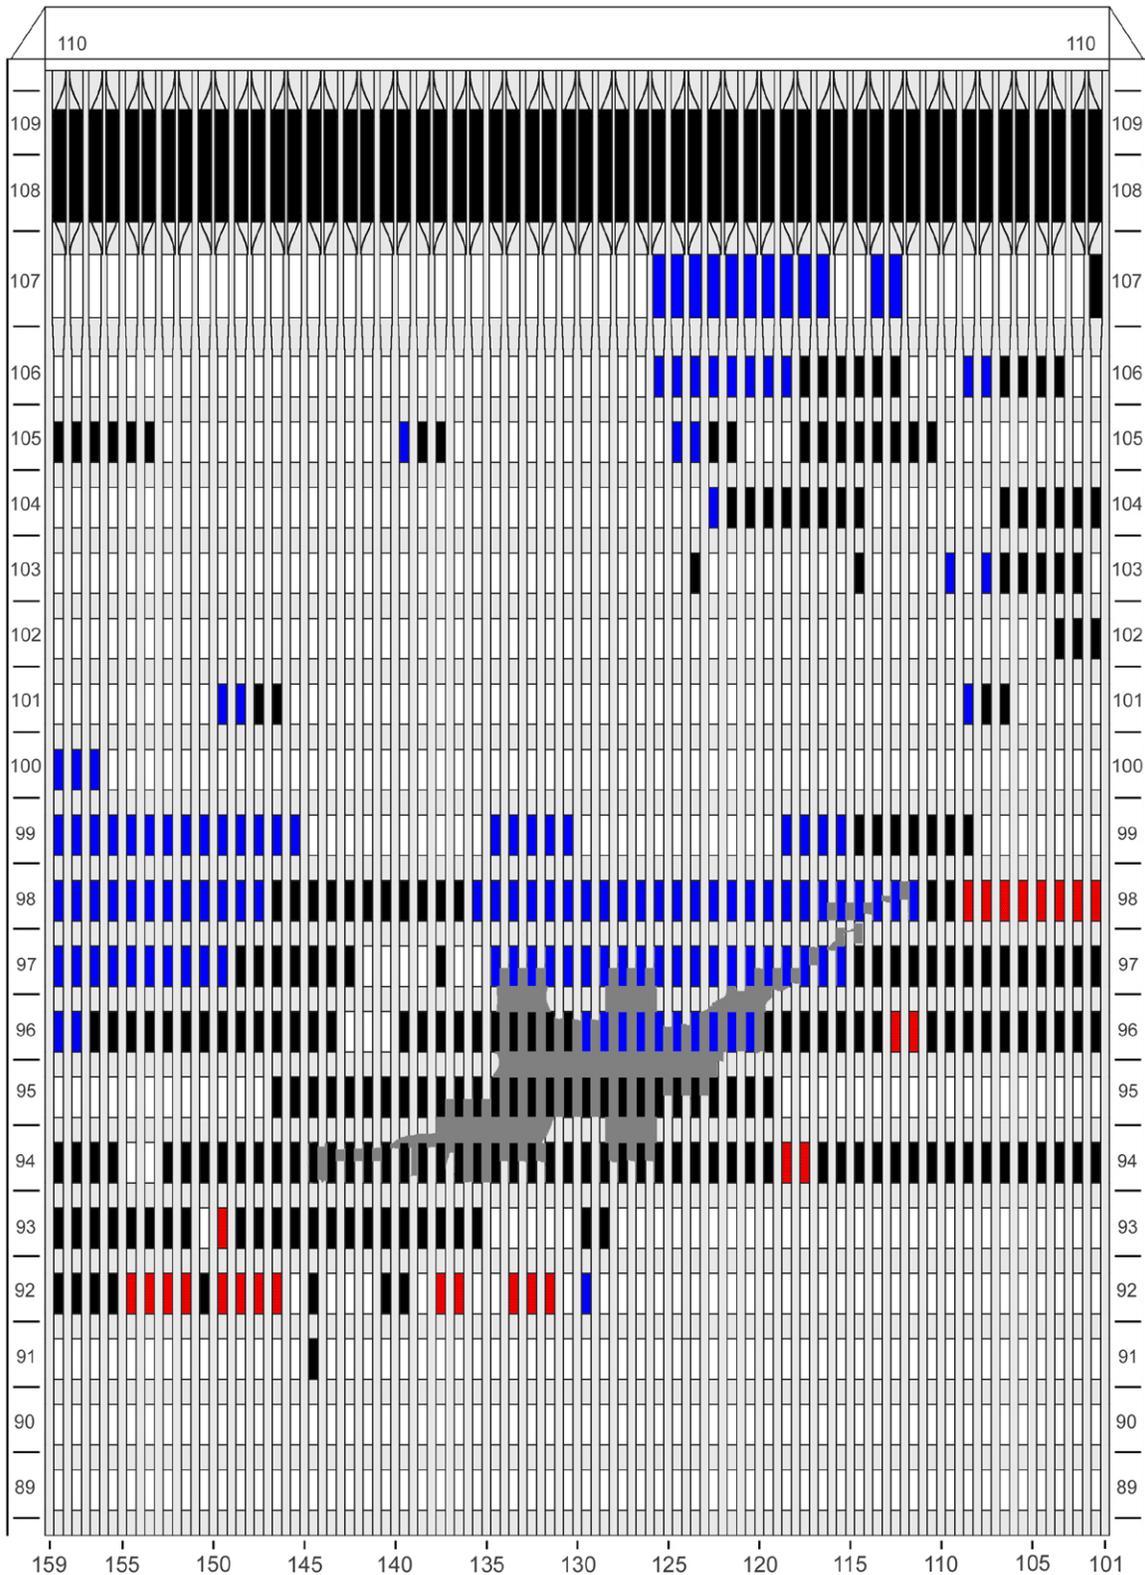
Figure C-47. Diagram of the north face of WTC 1 for floors 89 to 110 at 10:10 a.m. showing the condition of windows and locations of fires.

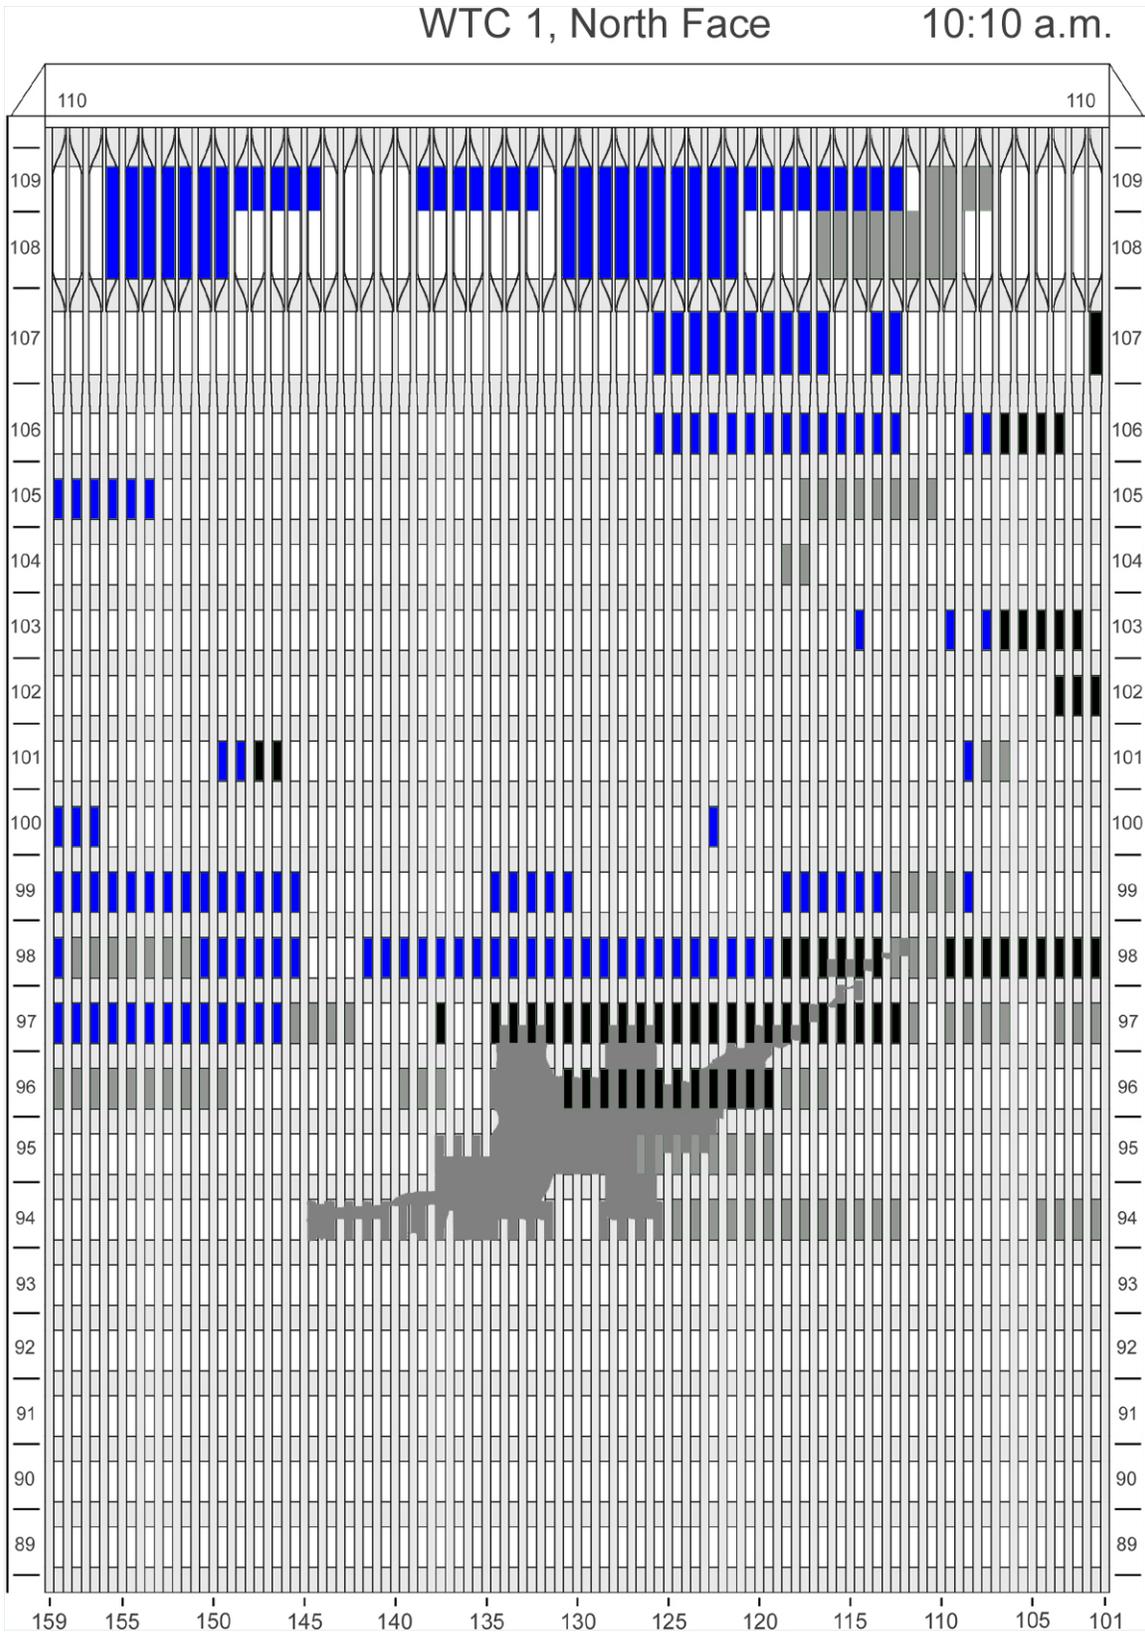
Figure C- 48. Diagram of the north face of WTC 1 for floors 89 to 110 at 10:10 a.m. showing windows where smoke was observed and those that were hidden from view.

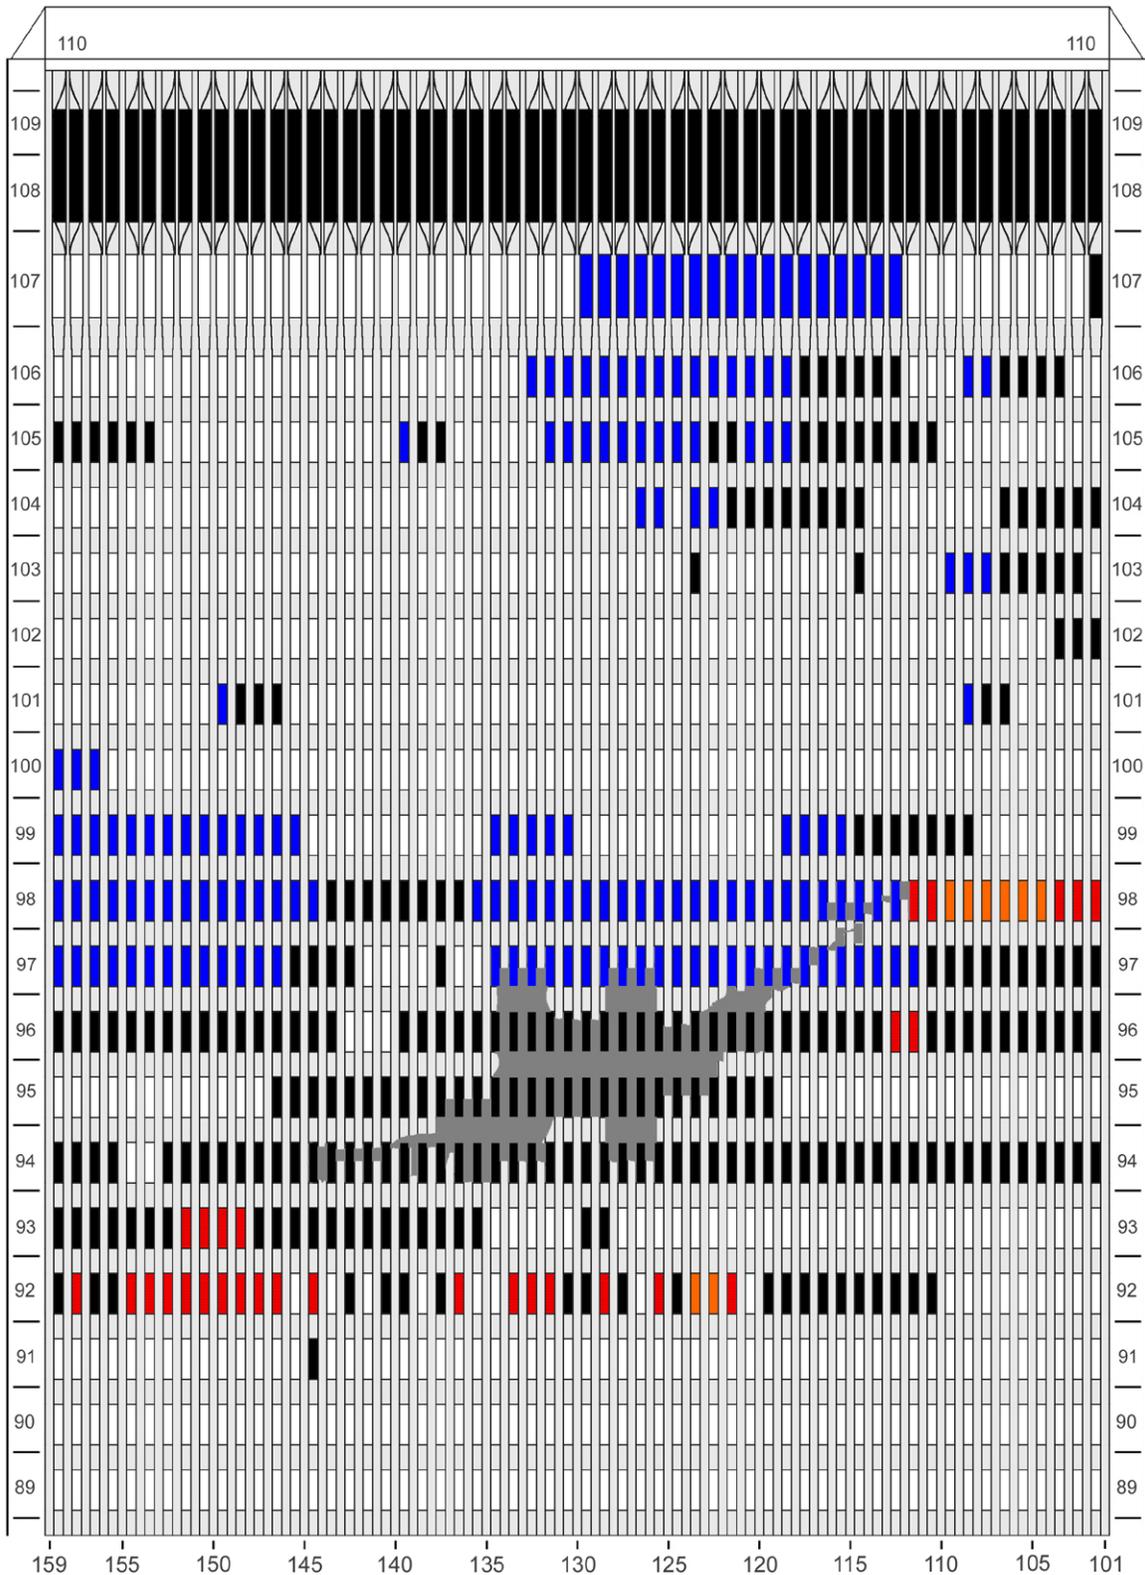
Figure C-49. Diagram of the north face of WTC 1 for floors 89 to 110 at 10:14 a.m. showing the condition of windows and locations of fires.

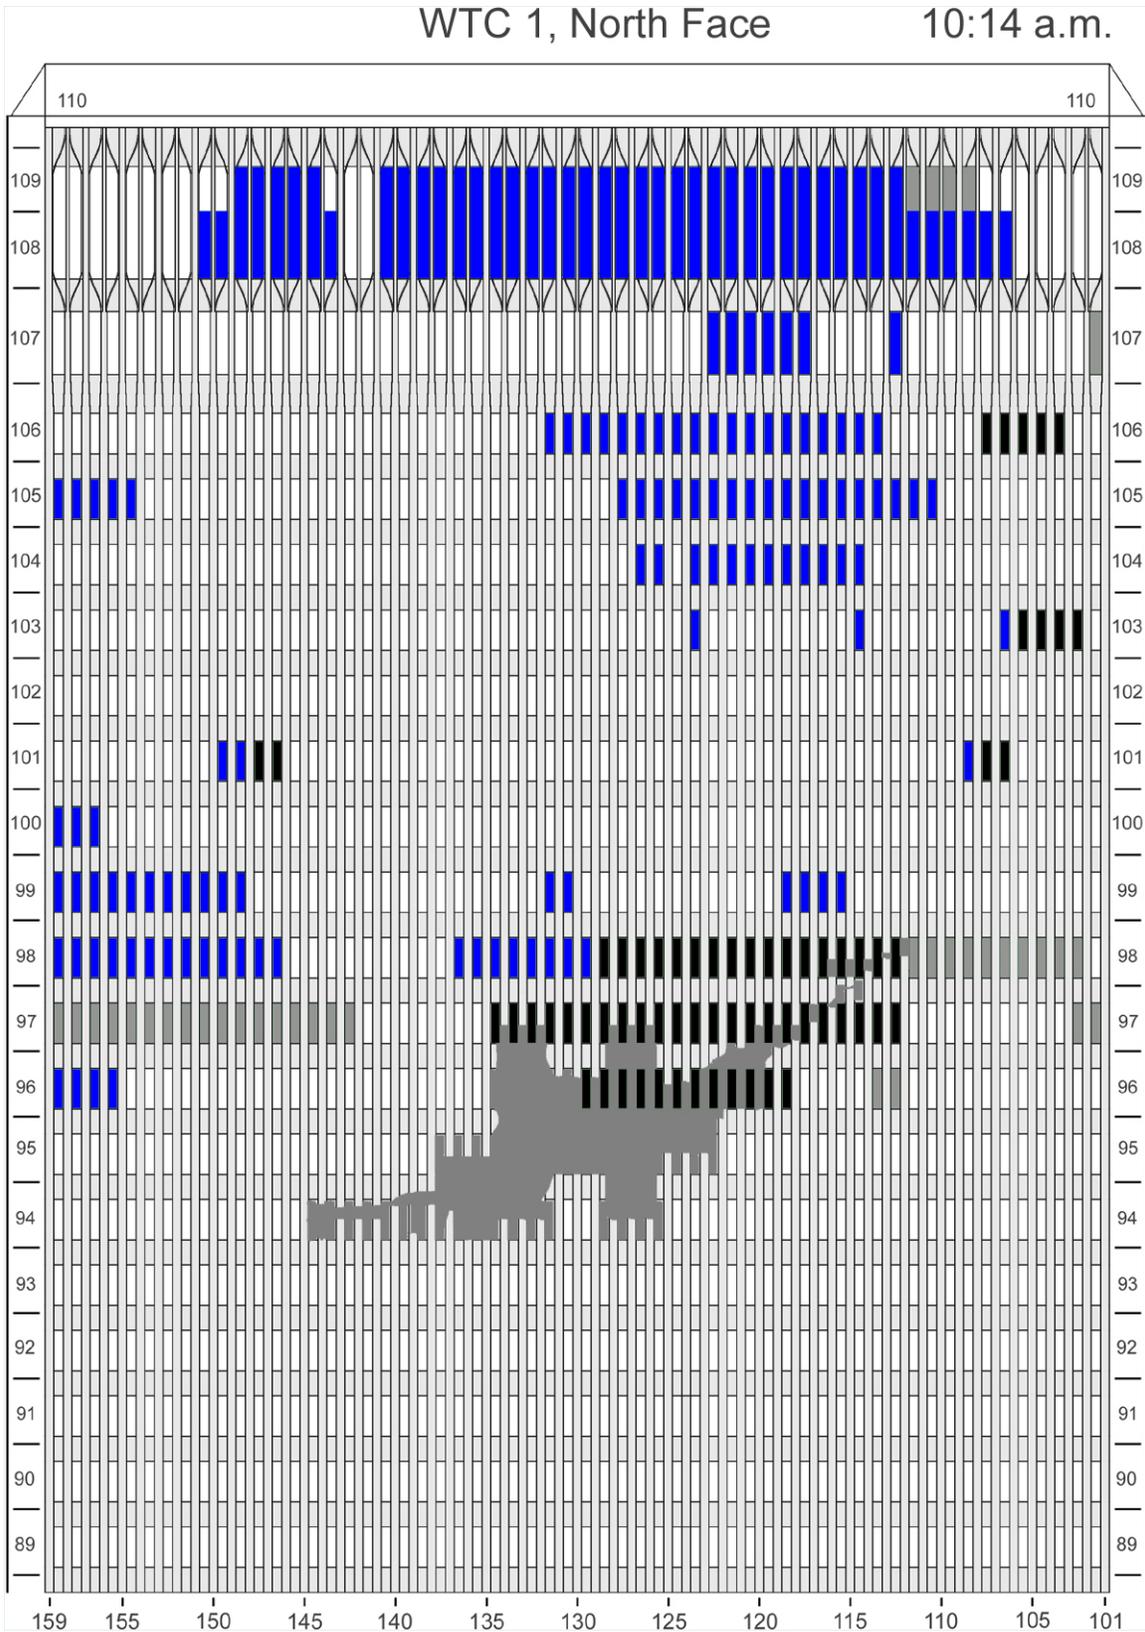
Figure C-50. Diagram of the north face of WTC 1 for floors 89 to 110 at 10:14 a.m. showing windows where smoke was observed and those that were hidden from view.

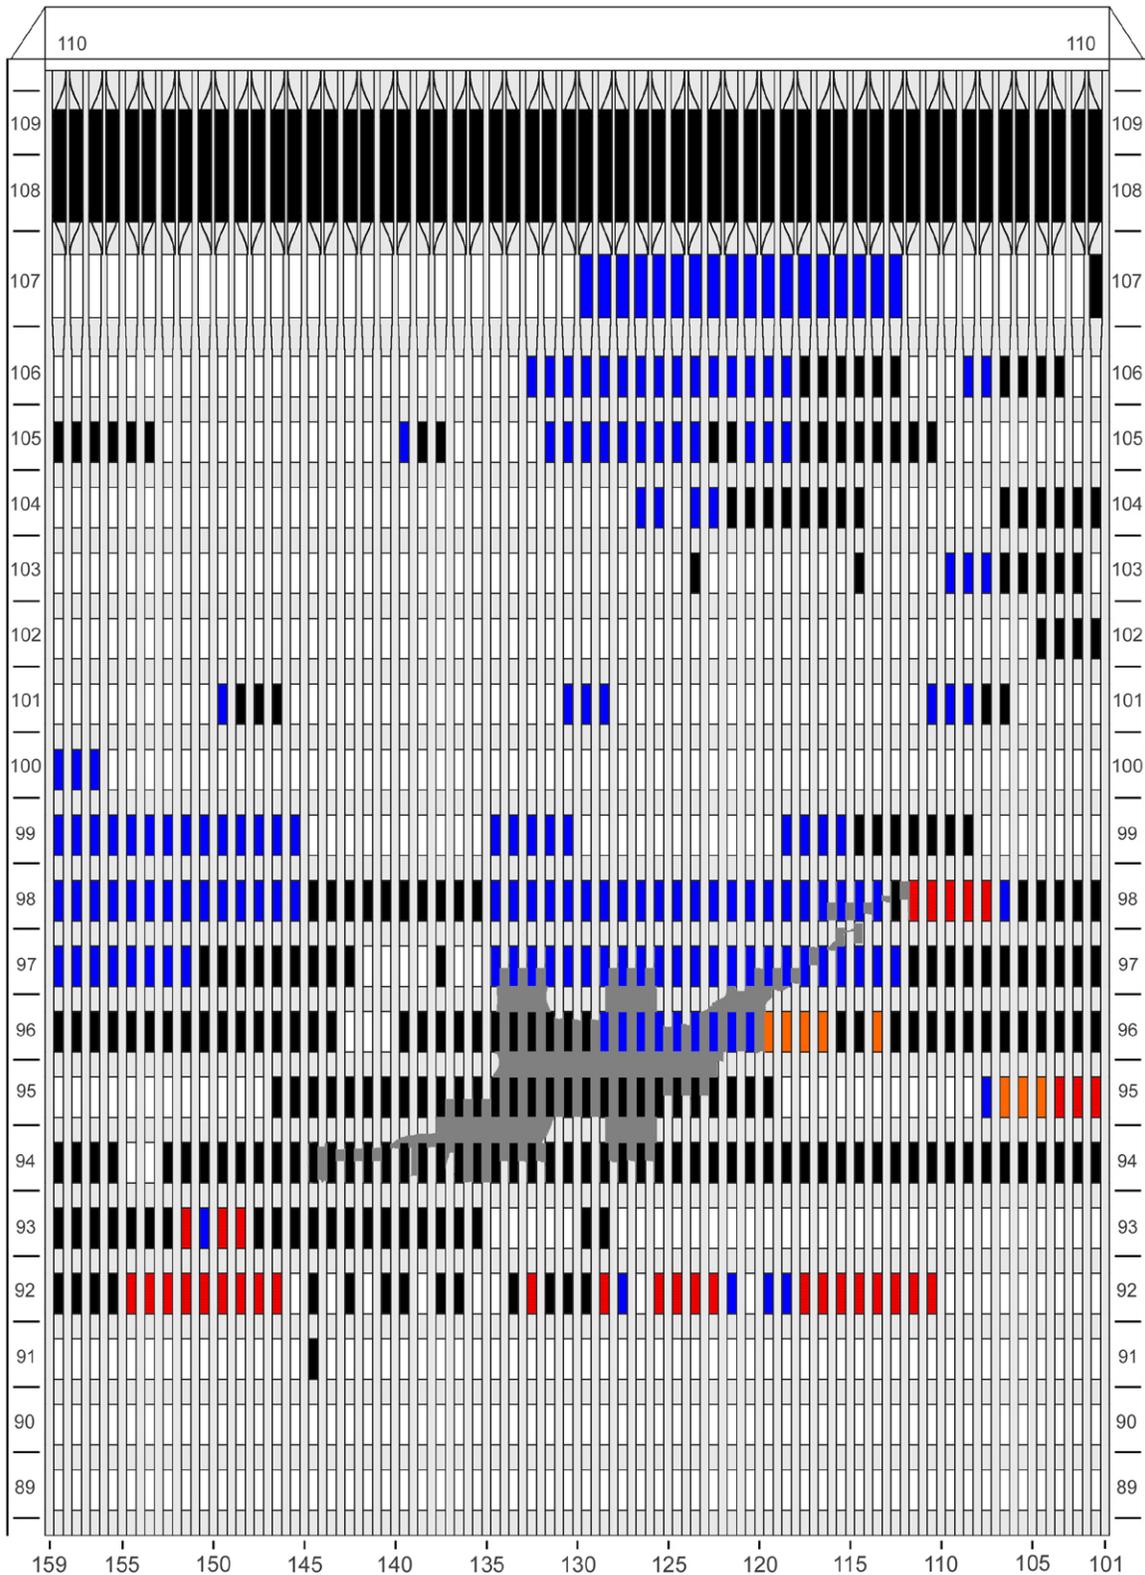
**Figure C-51. Diagram of the north face of WTC 1 for floors 89 to 110 at 10:18 a.m. showing the condition of windows and locations of fires.**

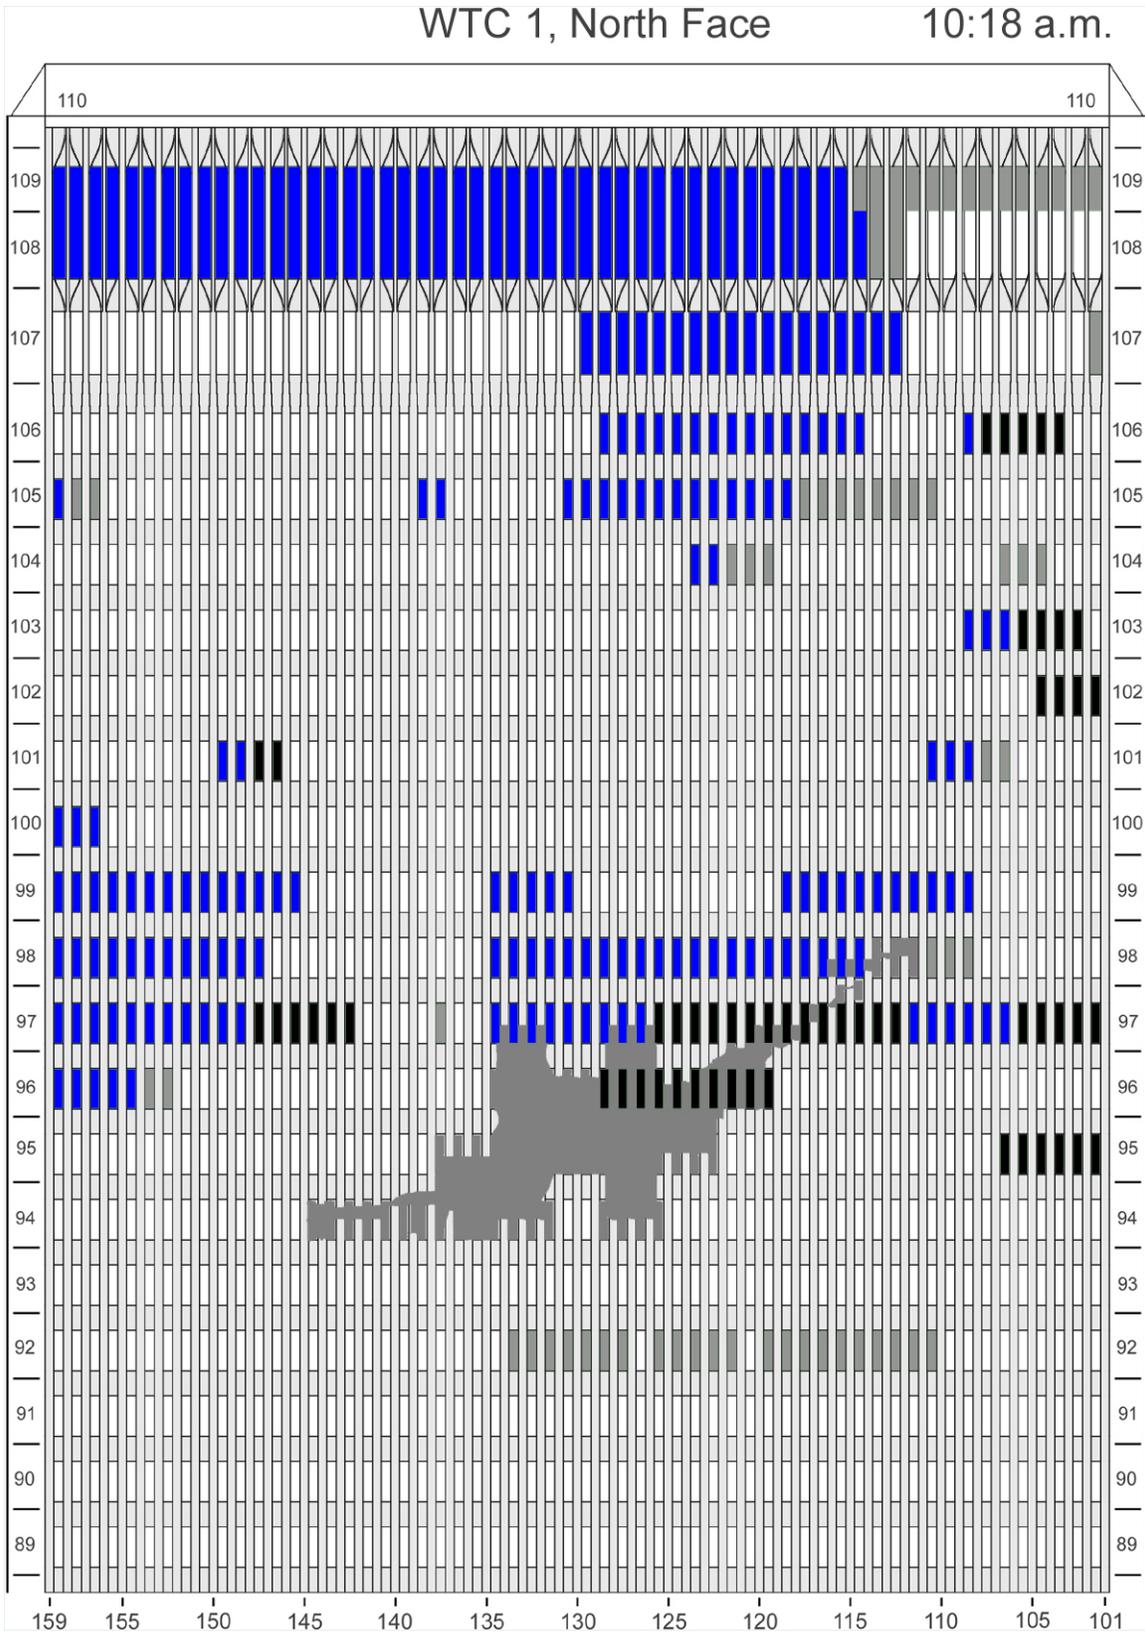
Figure C-52. Diagram of the north face of WTC 1 for floors 89 to 110 at 10:18 a.m. showing windows where smoke was observed and those that were hidden from view.

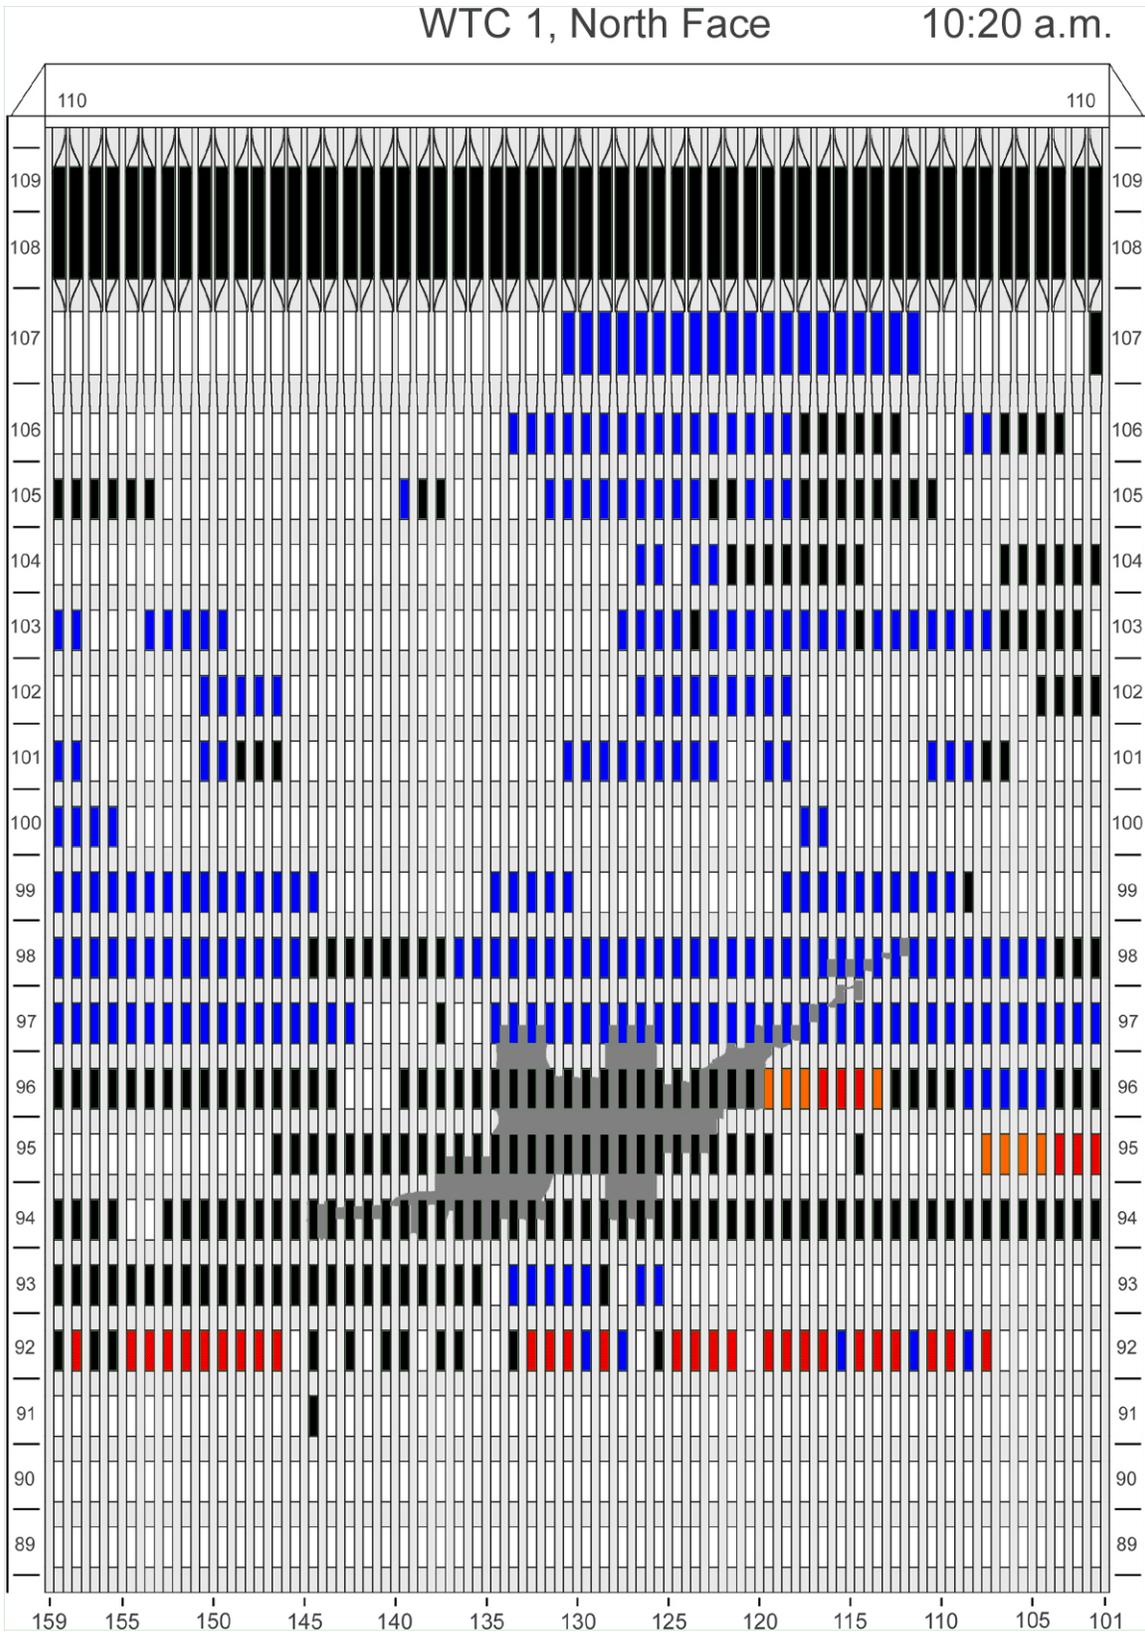
**Figure C-53. Diagram of the north face of WTC 1 for floors 89 to 110 at 10:20 a.m. showing the condition of windows and locations of fires.**

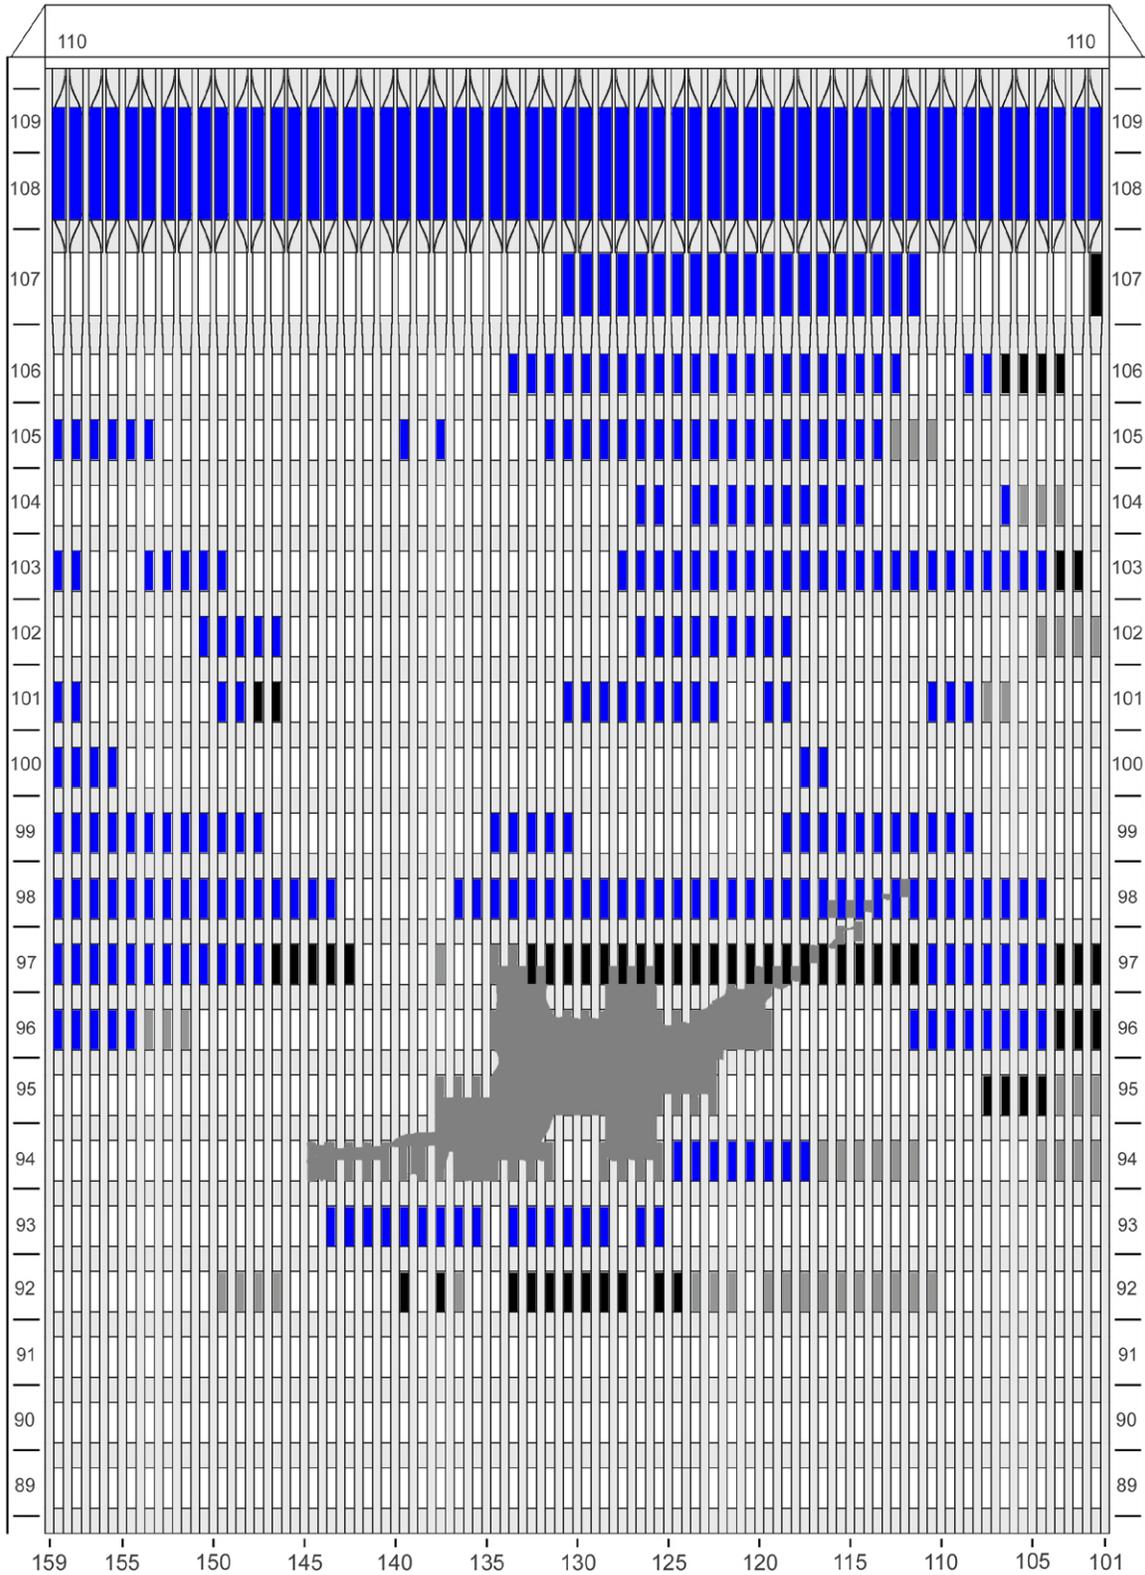
Figure C-54. Diagram of the north face of WTC 1 for floors 89 to 110 at 10:20 a.m. showing windows where smoke was observed and those that were hidden from view.

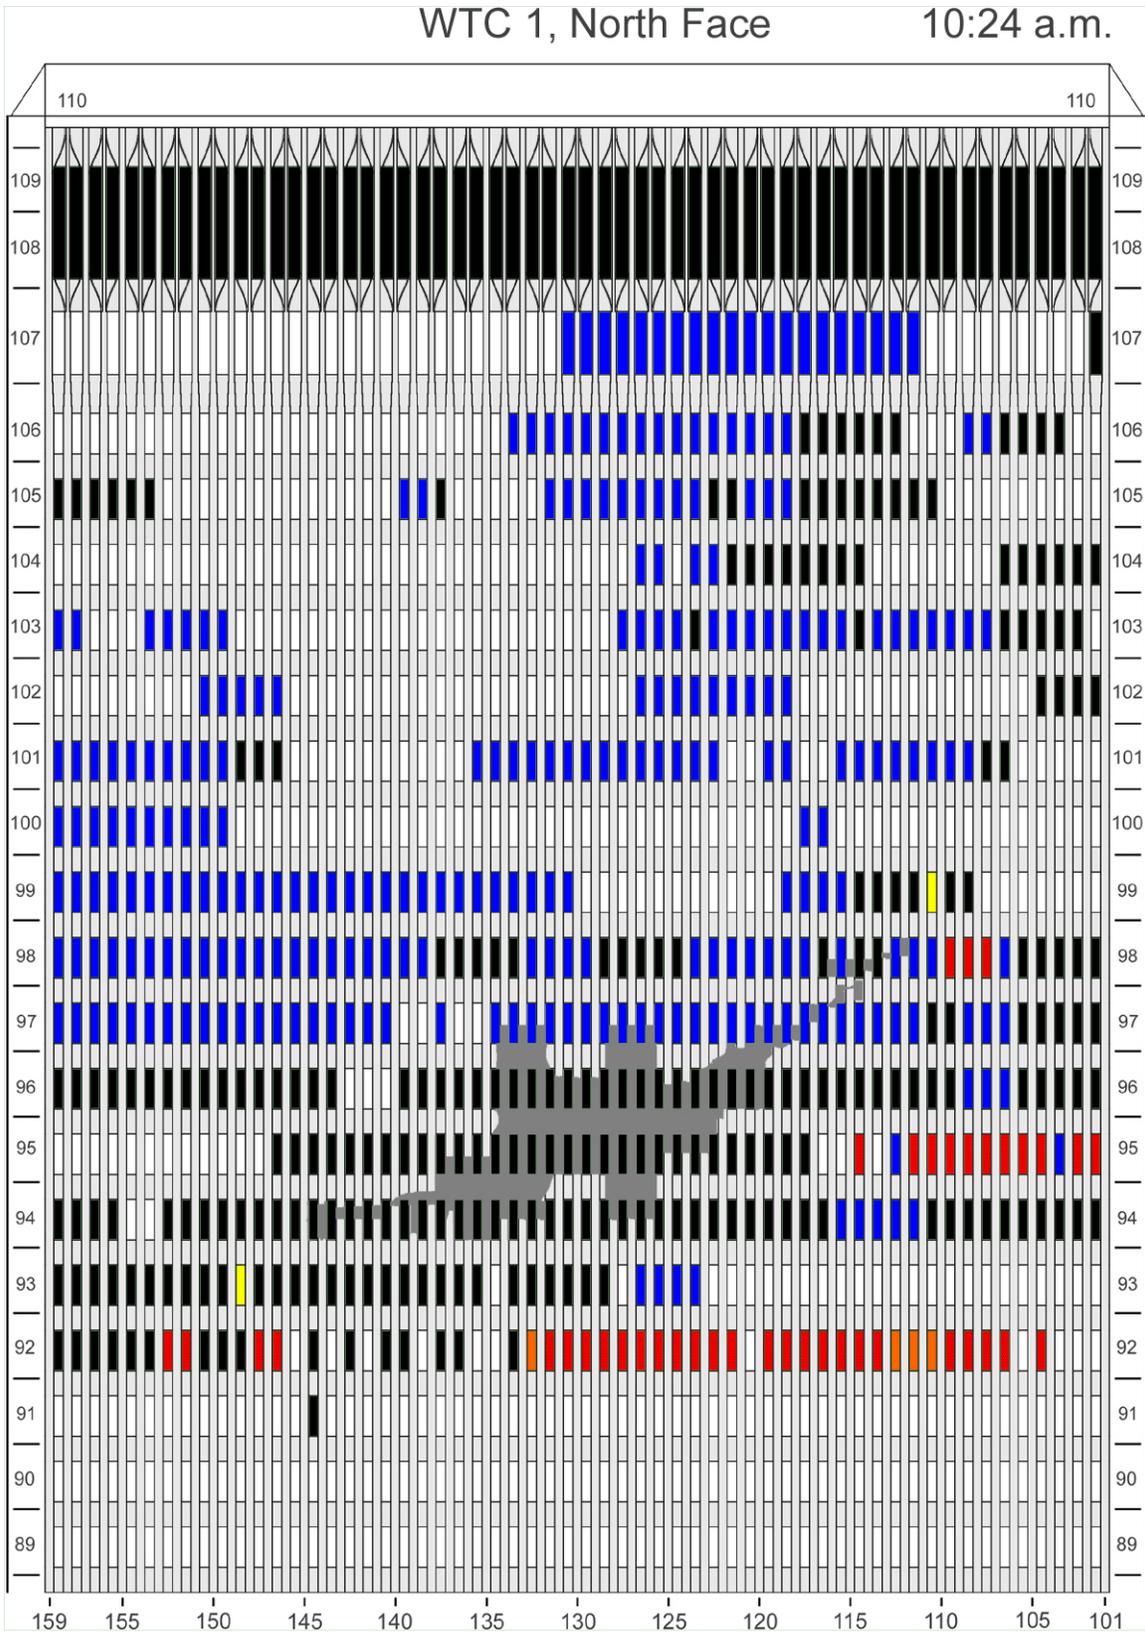
Figure C-55. Diagram of the north face of WTC 1 for floors 89 to 110 at 10:24 a.m. showing the condition of windows and locations of fires.

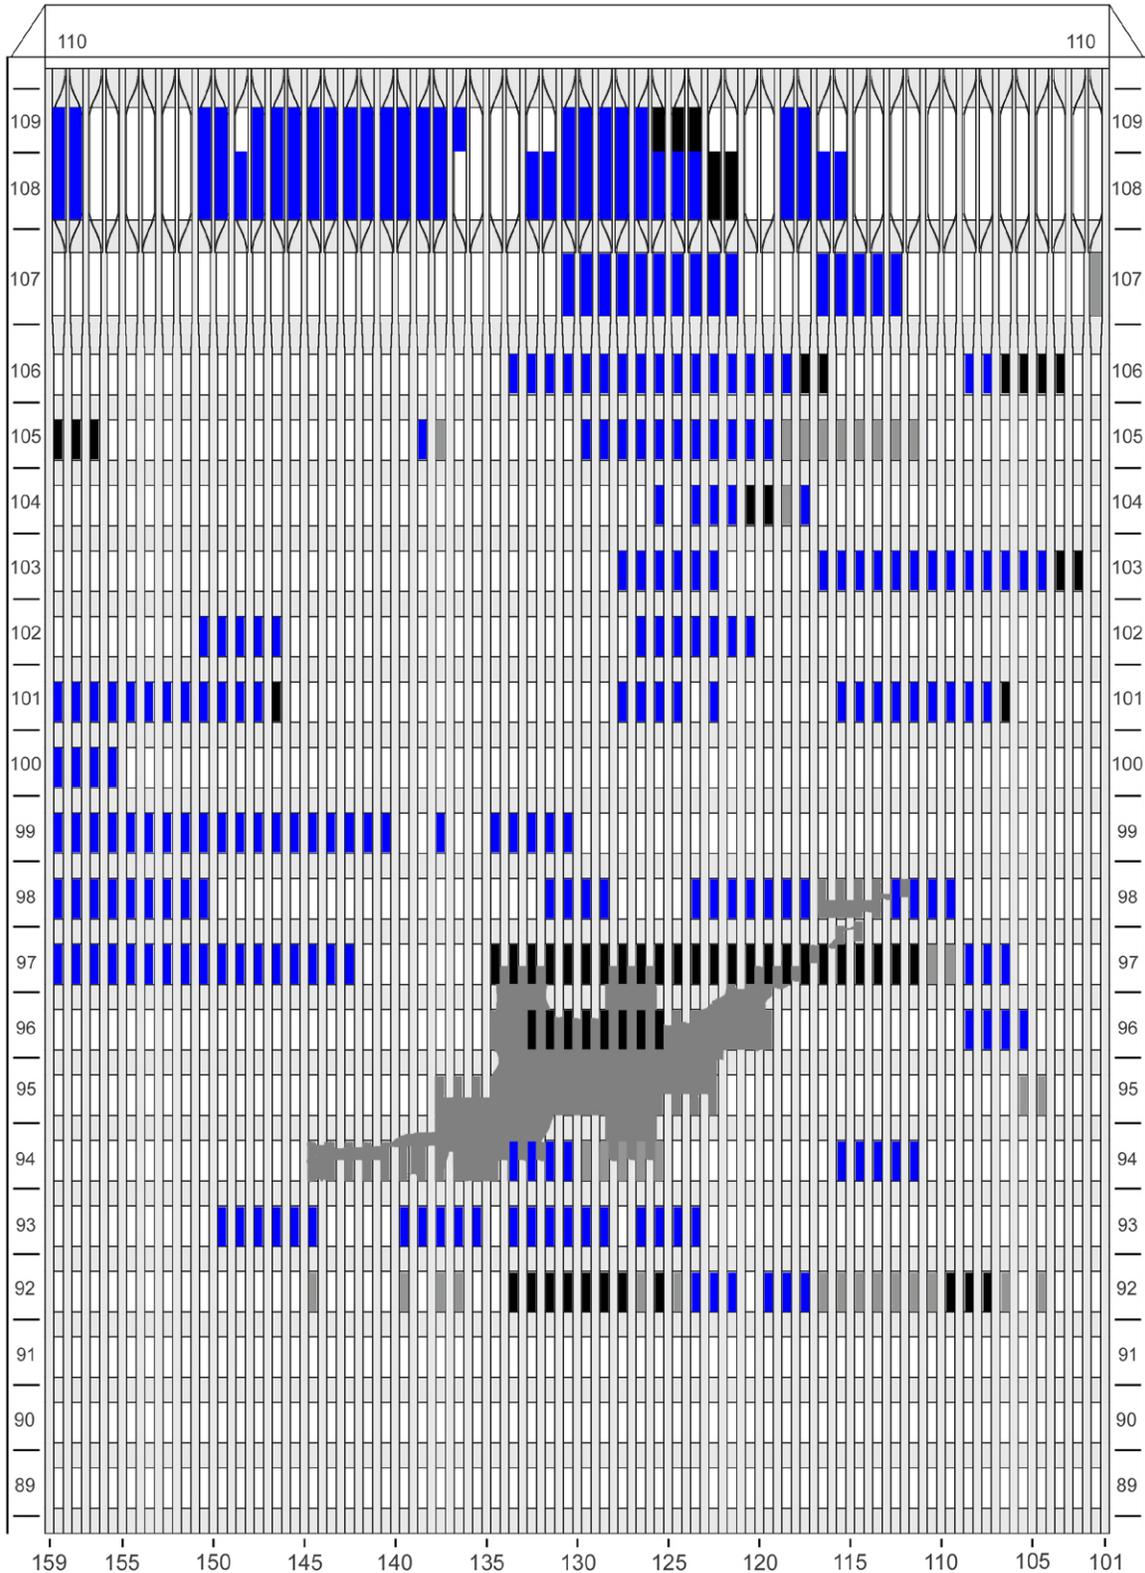
**Figure C-56. Diagram of the north face of WTC 1 for floors 89 to 110 at 10:24 a.m. showing windows where smoke was observed and those that were hidden from view.**
