## Chapter 9

# FIRE BEHAVIOR IN WORLD TRADE CENTER 2

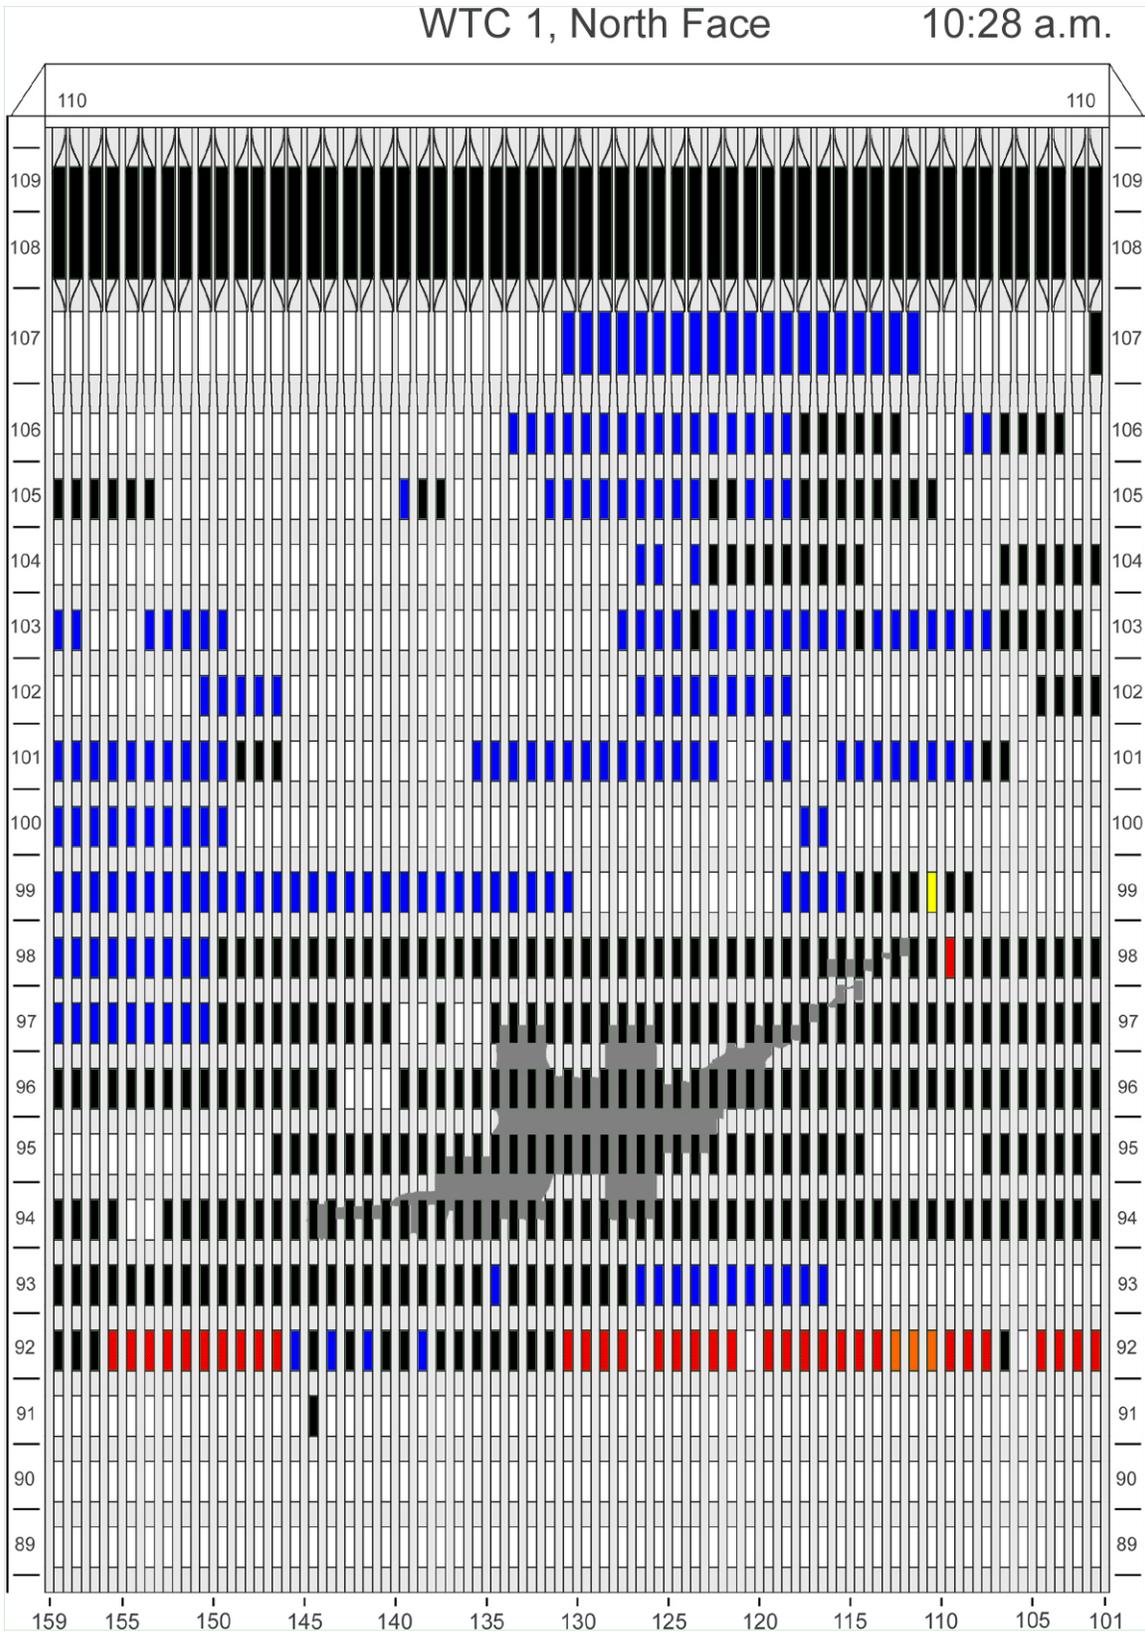
Figure C-57. Diagram of the north face of WTC 1 for floors 89 to 110 at 10:28 a.m. showing the condition of windows and locations of fires.

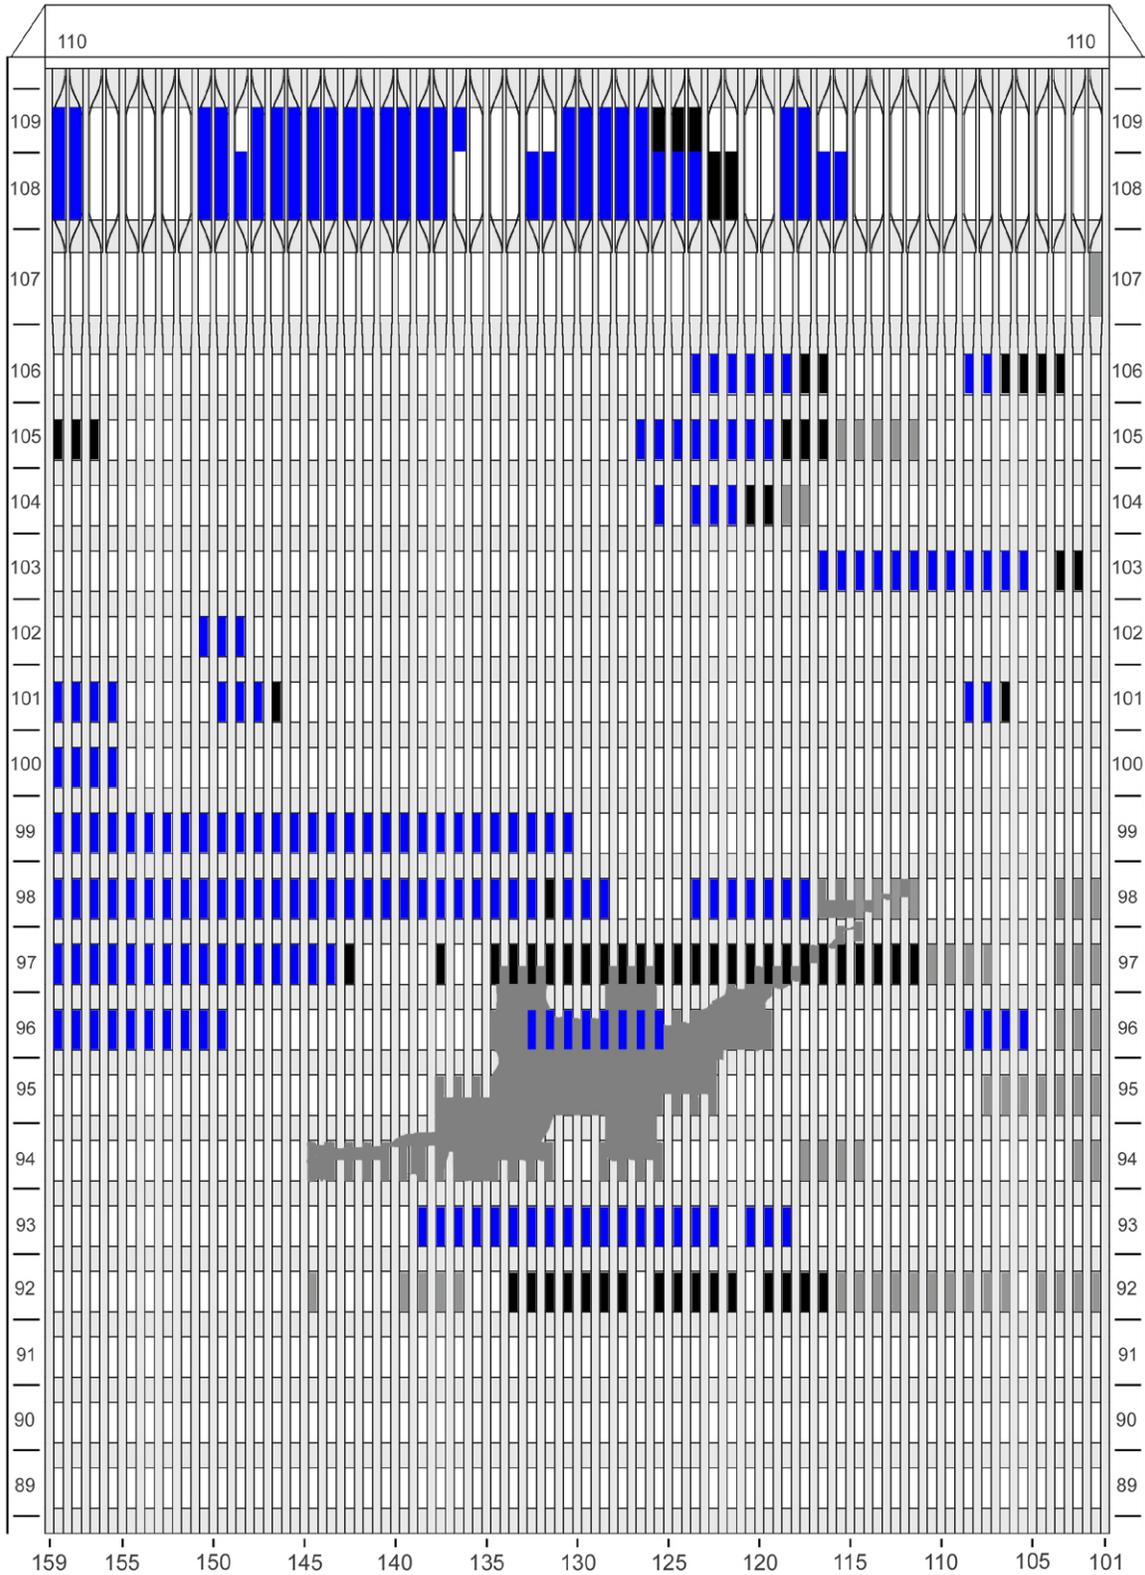
Figure C-58. Diagram of the north face of WTC 1 for floors 89 to 110 at 10:28 a.m. showing windows where smoke was observed and those that were hidden from view.

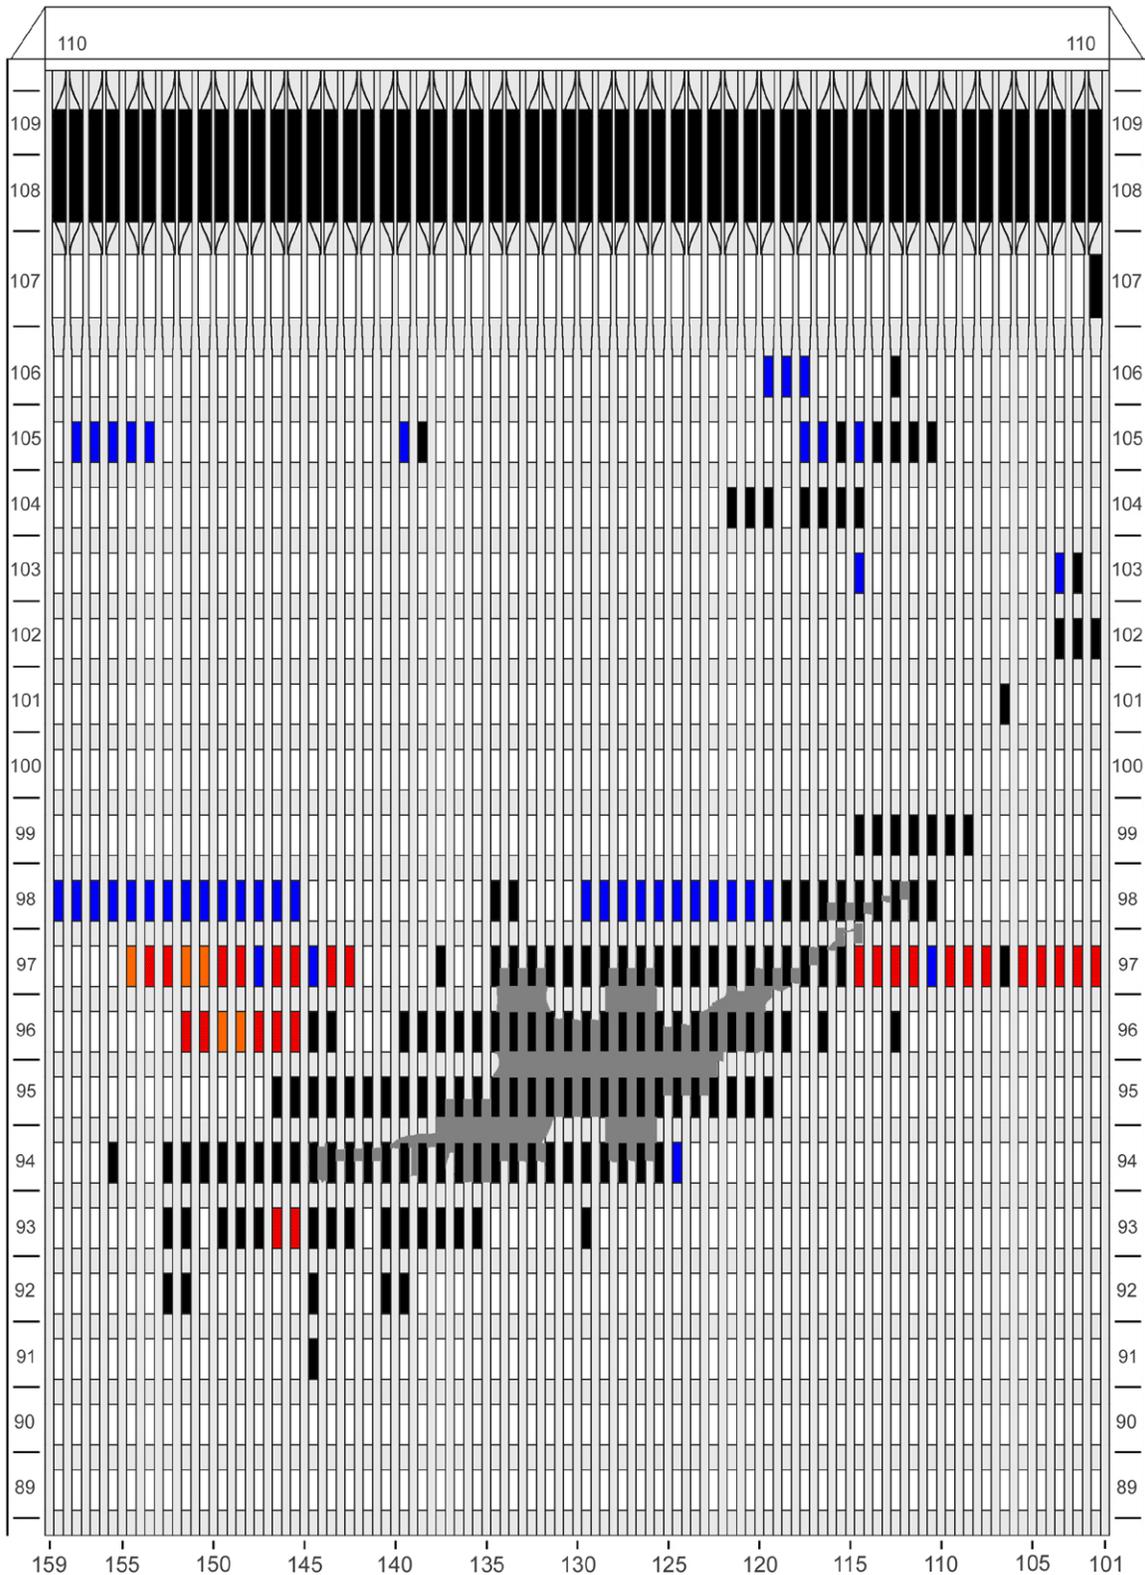
**Figure C-19. Diagram of the north face of WTC 1 for floors 89 to 110 at 9:04 a.m. showing the condition of windows and locations of fires.**

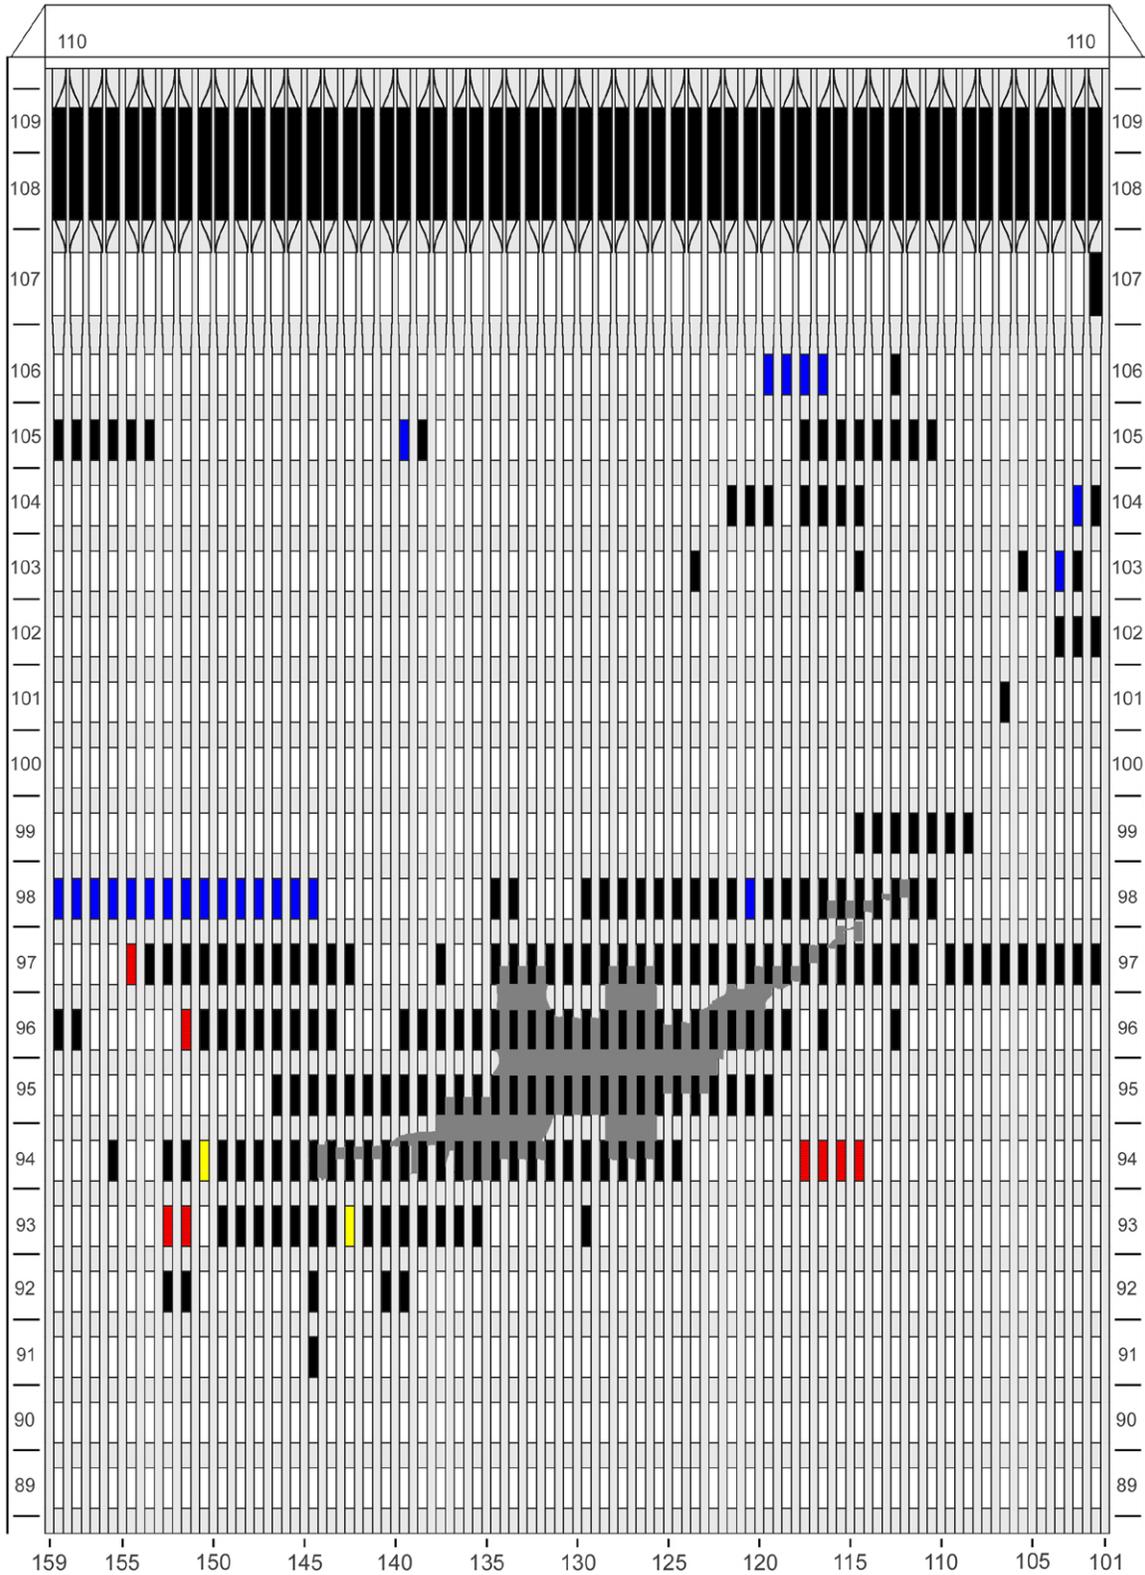
Figure C-25. Diagram of the north face of WTC 1 for floors 89 to 110 at 9:18 a.m. showing the condition of windows and locations of fires.

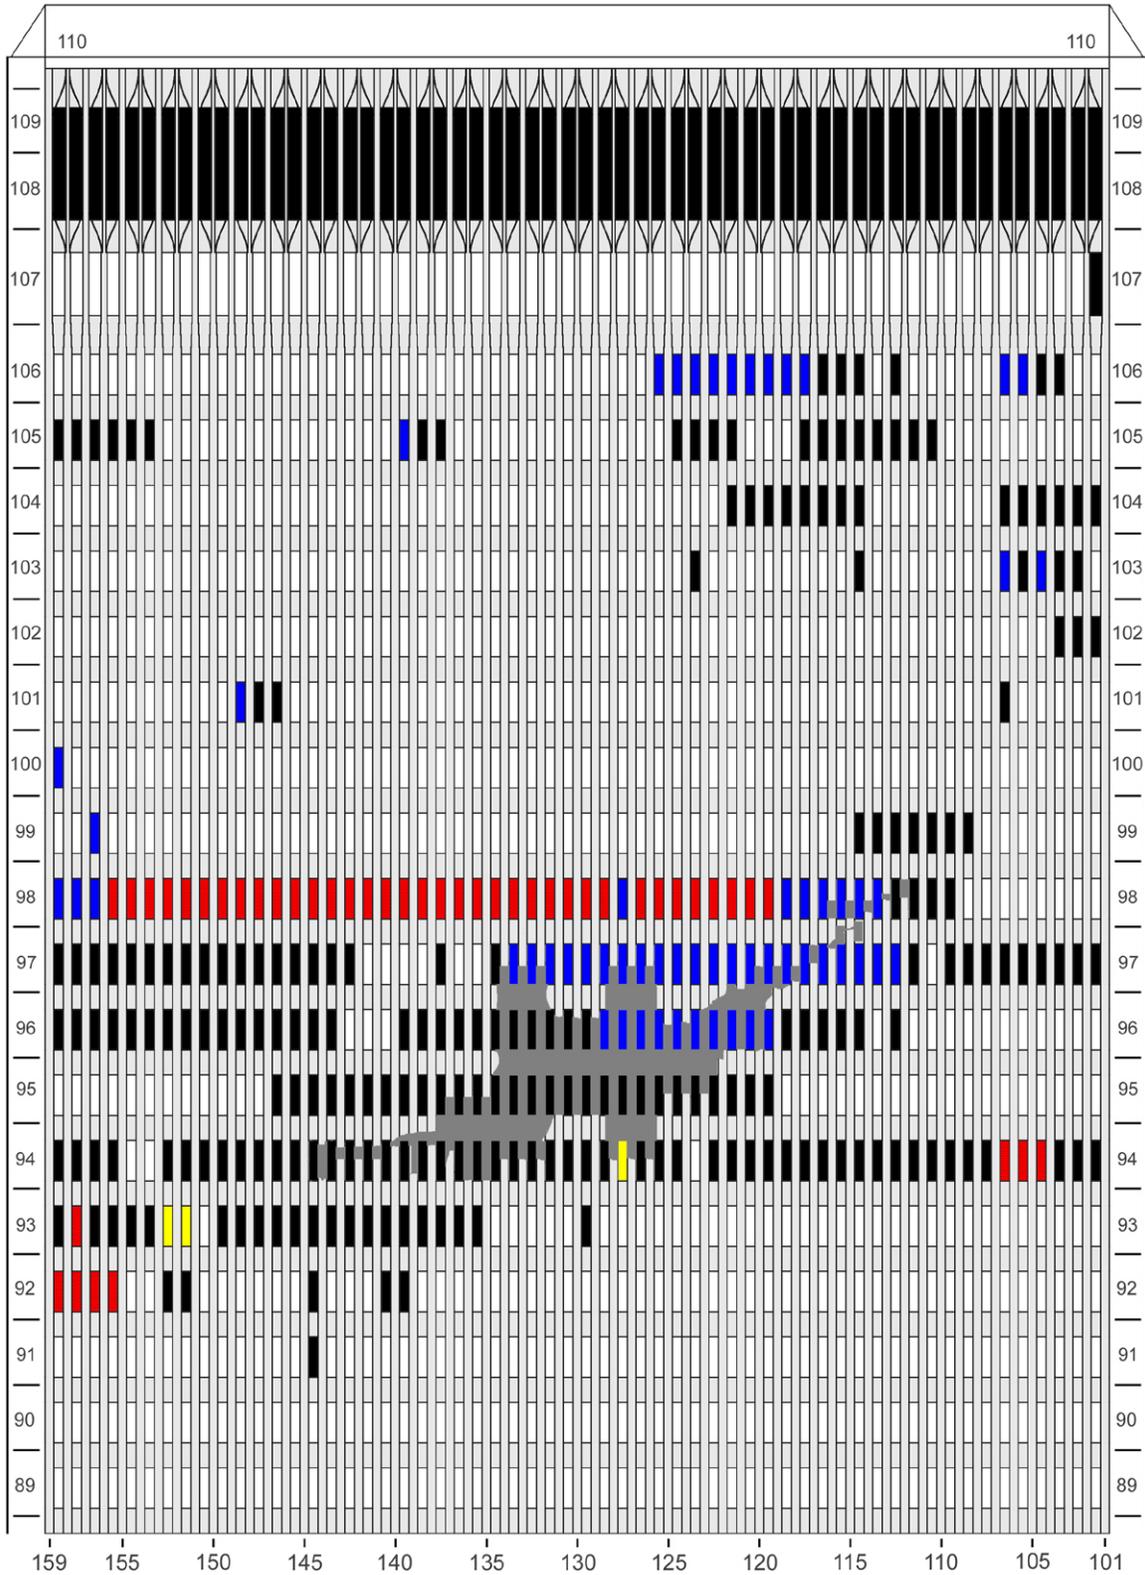
Figure C-37. Diagram of the north face of WTC 1 for floors 89 to 110 at 9:46 a.m. showing the condition of windows and locations of fires.

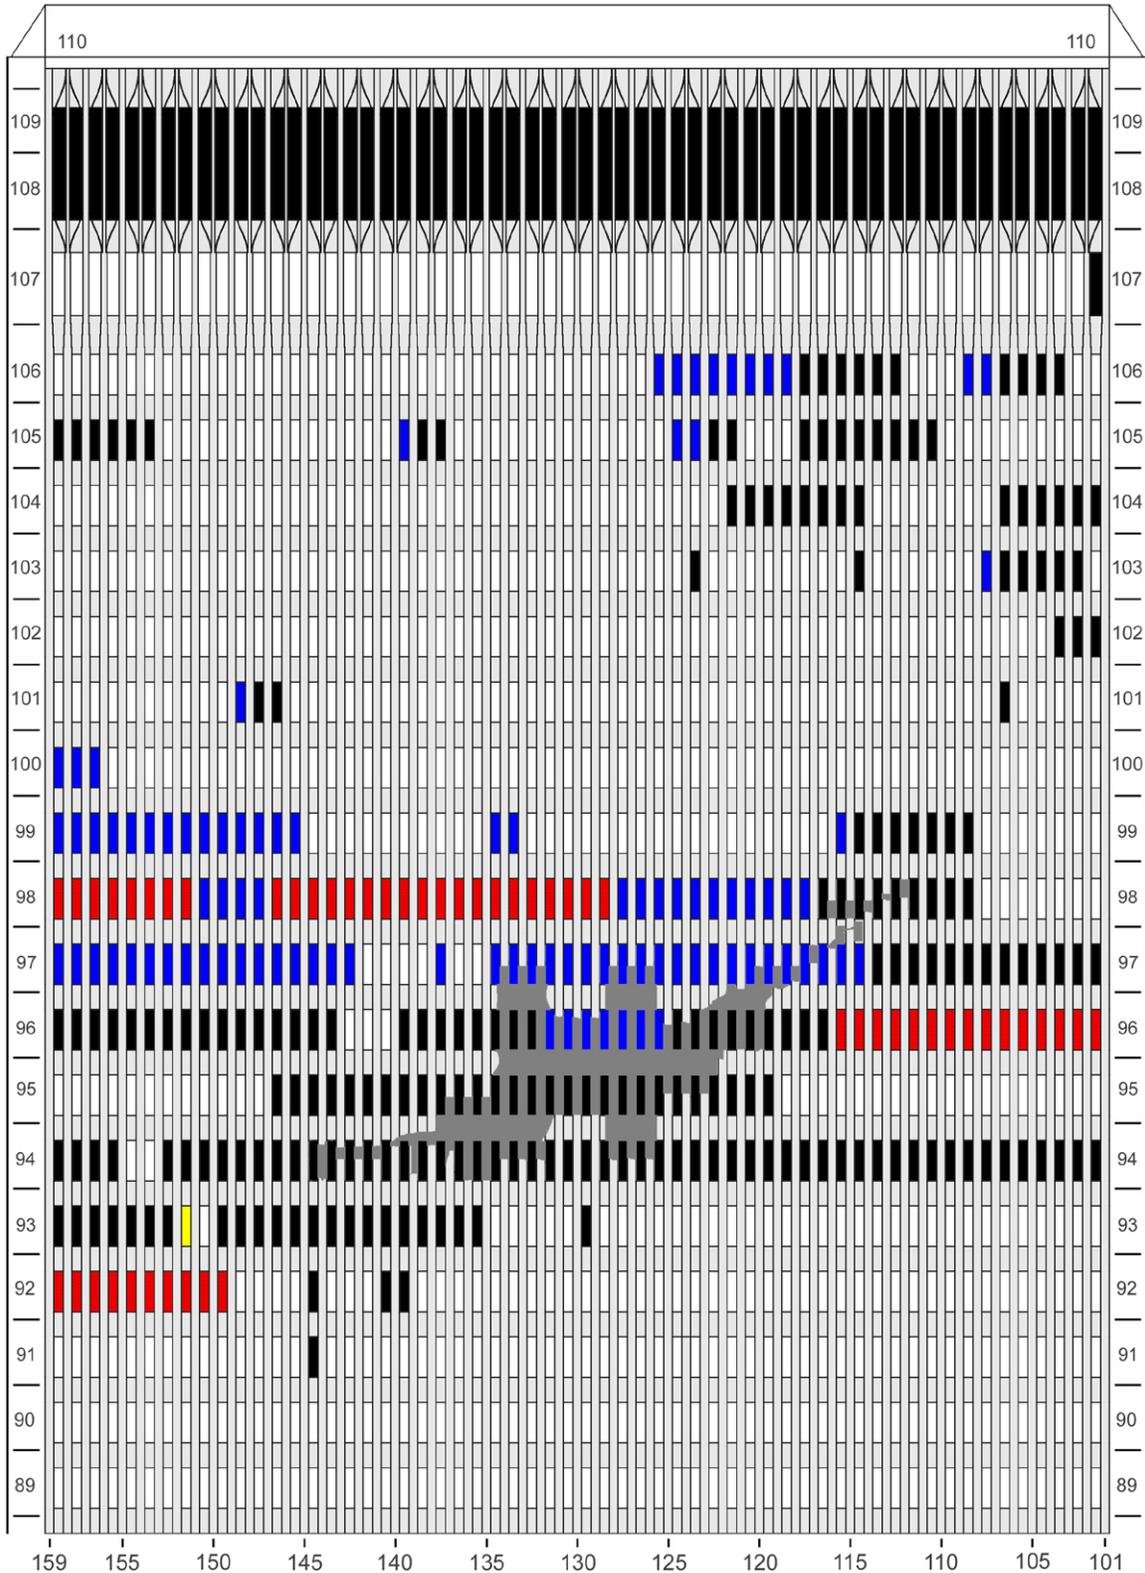
**Figure C-43. Diagram of the north face of WTC 1 for floors 89 to 110 at 9:58 a.m. showing the condition of windows and locations of fires.**

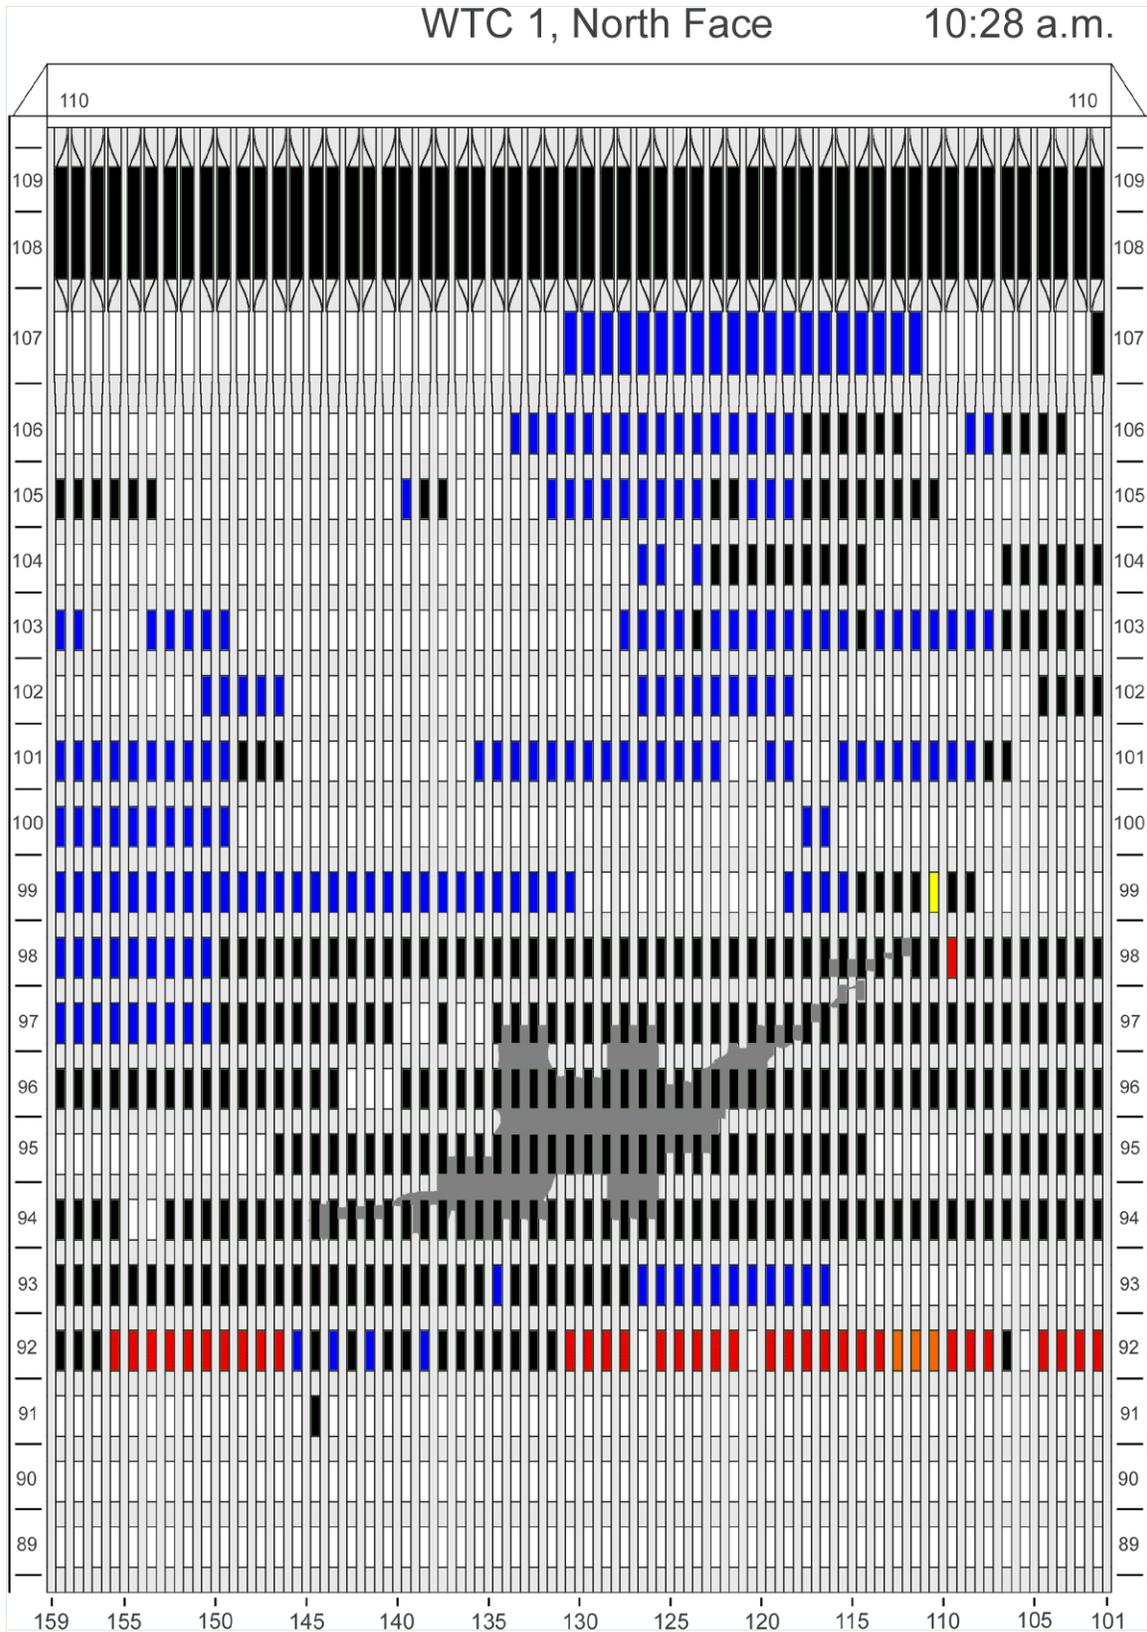
**Figure C-57. Diagram of the north face of WTC 1 for floors 89 to 110 at 10:28 a.m. showing the condition of windows and locations of fires.**
