**Federal Building and Fire Safety Investigation of the
World Trade Center Disaster**

**Structural Fire Response and
Probable Collapse Sequence of
World Trade Center Building 7**

VOLUME 1

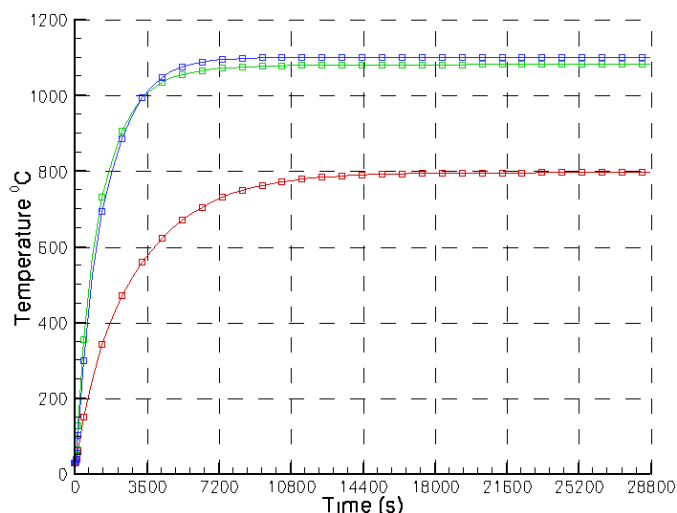
Each composite floor, with one of three representative beam sections, was exposed to an 1100 °C air temperature from below. Figure 4–6 shows the result of heating the floor with the insulated lightest steel section. The lower flange of the steel reached compromising temperatures in about 15 min, the upper flange in about 1 h. Figure 4–7 and Figure 4–8 show the slower temperature rises in the insulated midweight and heaviest beams, respectively. The lower flange temperatures are virtually identical to the web plate temperatures. Figure 4–9 shows the temperatures reached at the top and bottom of a typical floor slab at the thinnest sections located at the top of the steel deck corrugation.

Figure 4-6. Calculated temperature rise in a W14 x 22 floor beam in an insulated composite floor assembly exposed to 1100 °C air from below.
Blue: lower flange; green, web plate, red: upper flange.

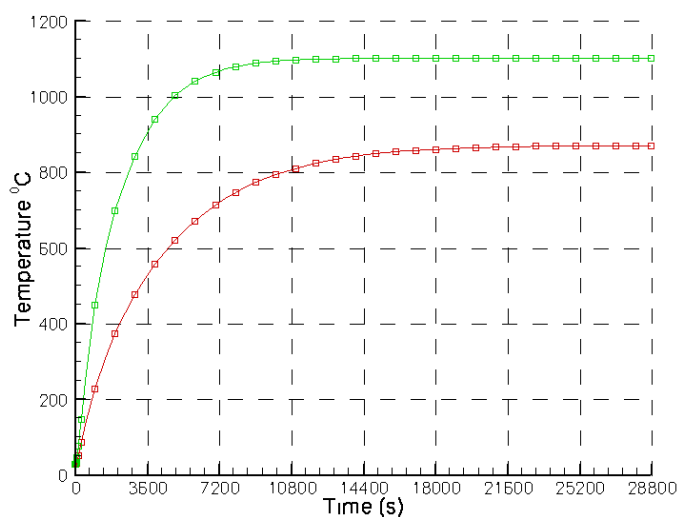
Figure 4-7. Calculated temperature rise in a 24WF x 55 floor beam in an insulated composite floor assembly exposed to 1100 °C air from below.
Green, lower flange and web plate, red: upper flange.

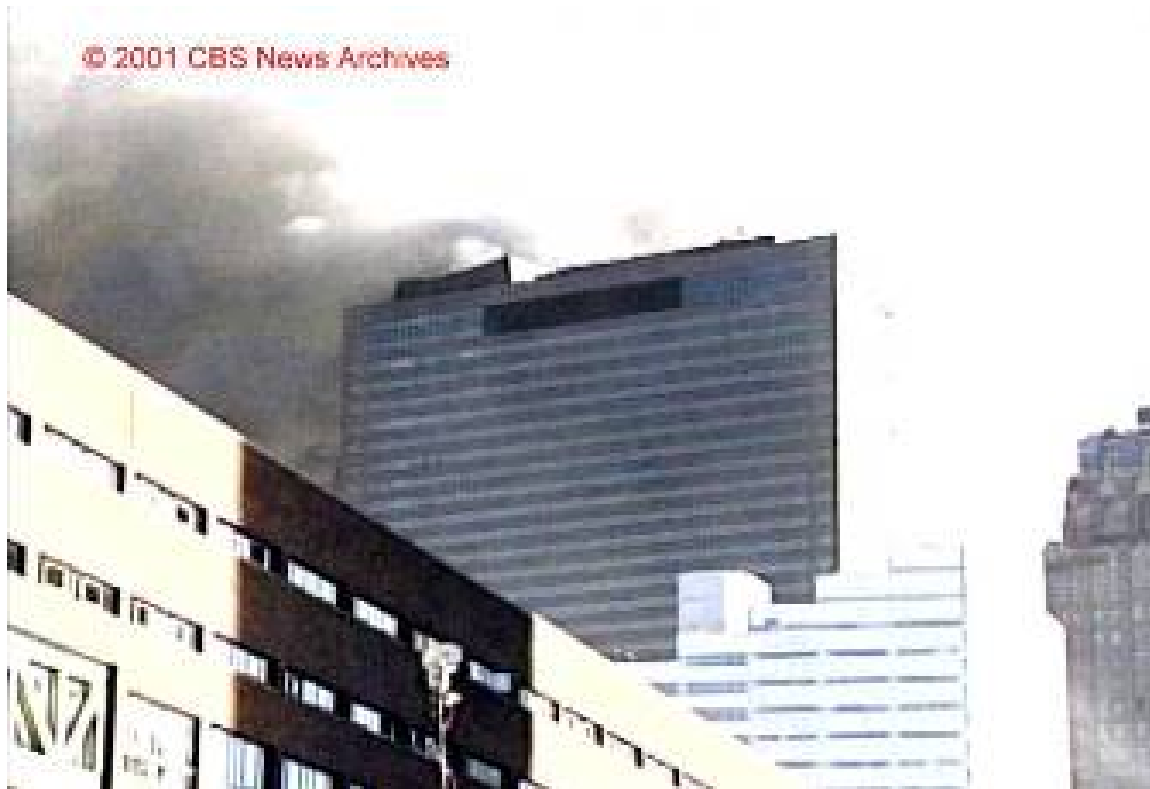
Figure 5–1. A photograph (top) and a frame from a video clip (bottom) showing the east penthouse of WTC 7 beginning to sink into the building.

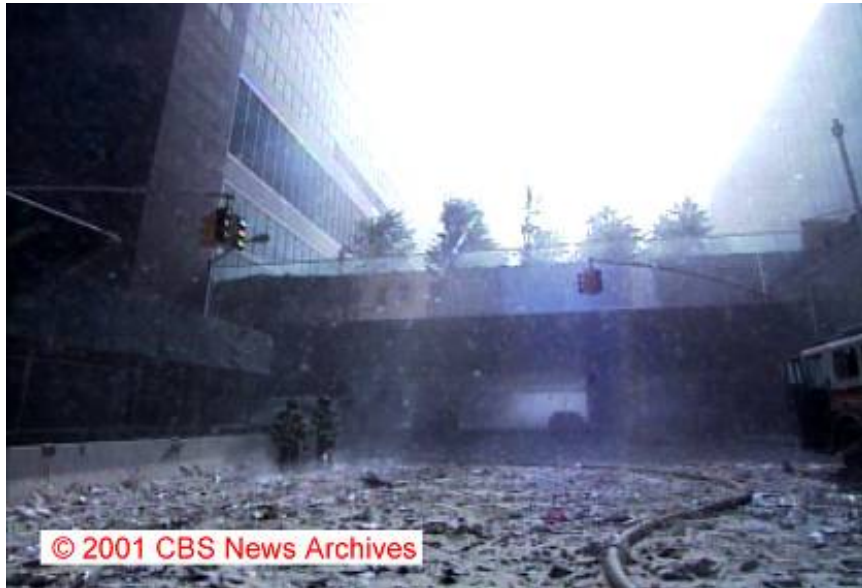
Figure 5–18. An image from a video, shot from Vesey Street and looking toward the east, shows the south face of WTC 7 and the Promenade crossing over to WTC 6. The video was recorded around 10:15 a.m. on September 11. The intensity levels of the image have been adjusted.

A frame taken from this video is reproduced in Figure 5–18. Even though the street is passable, a large amount of dust and small debris, such as paper, has been deposited on the street. The trees on the Promenade are upright and appear unharmed. Windows on several floors above the Promenade appear to be intact.

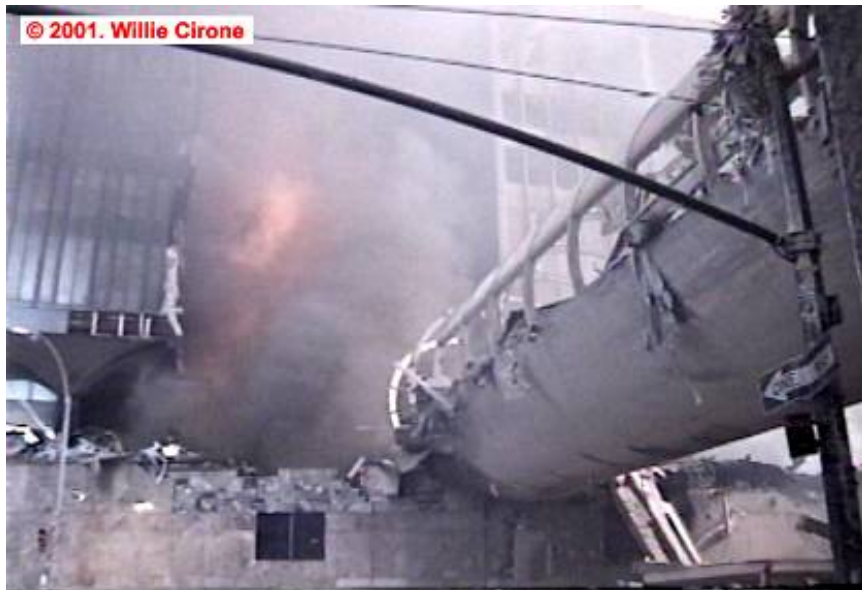
Figure 5–19. Image of the Pedestrian Bridge taken from a video shot shortly after the collapse of WTC 1 from near the corner of West Broadway and Vesey Street. The buildings across Vesey Street are WTC 5 (left) and WTC 6 (right). The image intensity has been adjusted.

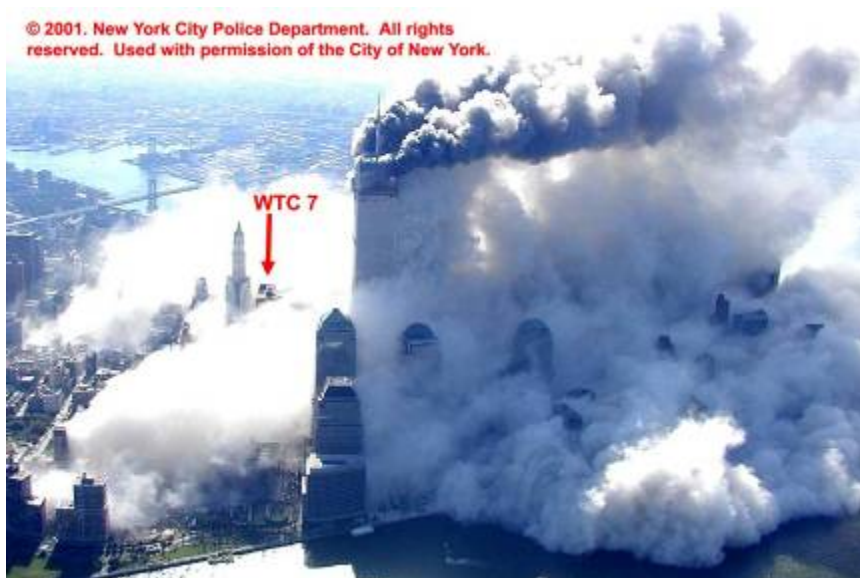
Figure 5–27. Cropped photograph showing the dust cloud created by the collapse of WTC 2.

The image was shot from the west at 10:03:56 a.m. WTC 7 can barely be seen above the cloud. The intensity levels of the photograph have been adjusted.

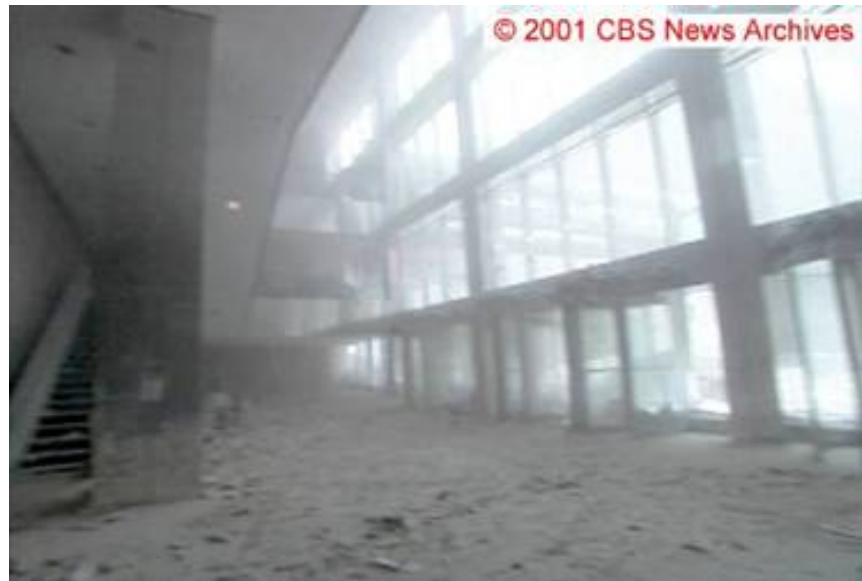
On exiting the building, the videographer again shot the interior of the 1st floor lobby. Figure 5–39 shows a view looking across the four story high atrium from the northwest towards the southeast. Some of the broken windows on the south face are visible. Columns 24 to 27 are visible, and it is clear that they have not sustained significant damage.

Figure 5-39. Video frame looking across the 1st floor lobby on the south side of WTC 7, taken around 10:15 a.m. The intensity levels have been enhanced.

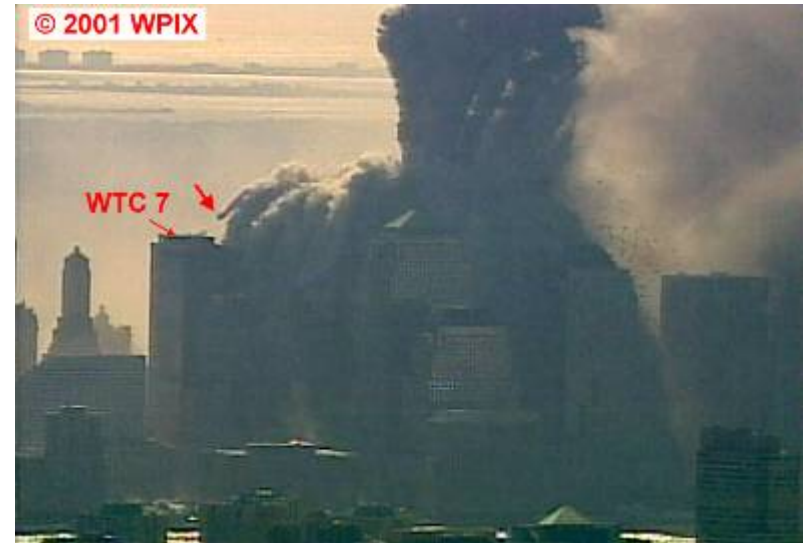
The next pair of images was recorded 12.17 s after the collapse started. The arcing path formed by the object observed at 10.43 s is visible from both directions (marked with arrows), even though the object itself has moved behind WTC 7 by this time in the north view. Note that this object appears to have passed behind WTC 7 at a location roughly halfway between the end of the west penthouse and the edge of the building. The two arrows to the left in the north view indicate additional objects that are just beginning to emerge from the dust cloud. These objects are also visible in the west view. The upper object is the same as observed for the three latest times in Figure 5–40. It ultimately formed the distinct arc seen in the images taken at 12.77 s that seemed to travel further outward. The videos show that the debris marked by the lower arrows in the images taken at 12:17 also arced downwards and had apparently disappeared behind WTC 7, just to the west of the building center, by 12.77 s.

Figure 5–41. Three pairs of frames taken from videos shot from the north and west, showing the collapse of WTC 1.
 Times are relative to the start of the collapse. Arrows indicate large objects that were projected toward WTC 7.
 The intensities of the video frames have been adjusted.

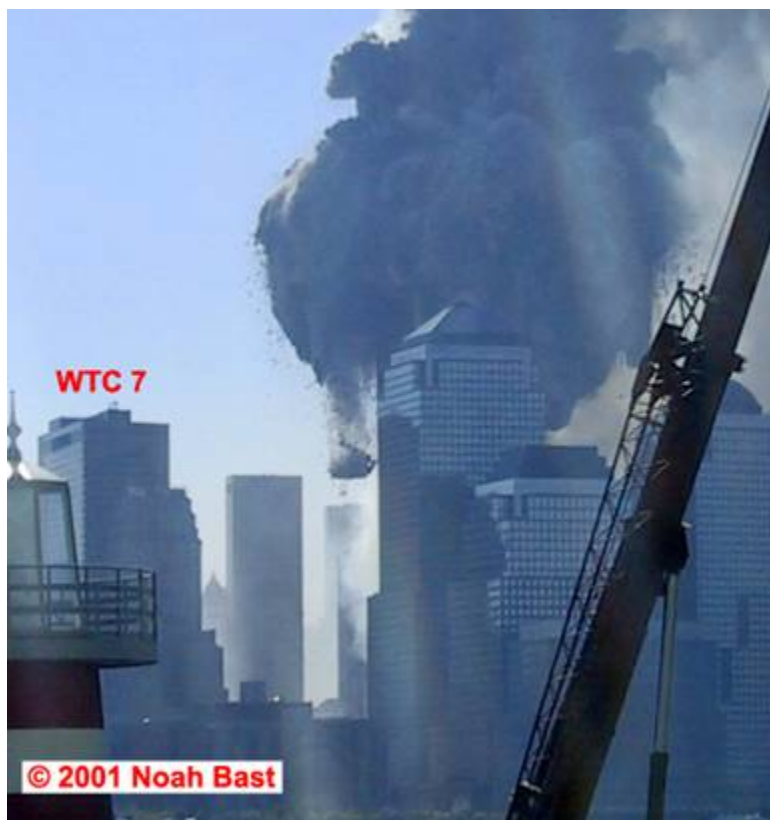
that was taken from just north of due west about 7.3 s after the collapse started. This is shortly after the second pair of images shown in Figure 5–40. WTC 7 is indicated. The building visible between WTC 1 and WTC 7 is the Millennium Hotel, and the taller building in the foreground on the right is World Financial Center 3. (See Figure 5–2 for locations.) A large piece of falling debris is visible. The image has sufficient resolution to identify the individual columns and spandrels that formed the external wall of WTC 1. This particular piece appears to be at least two panel sections high and six panel sections wide, corresponding to about 18 m × 18 m (60 ft × 60 ft).

Figure 5–43. Cropped photograph showing the collapse of WTC 1, taken from just north of west of the WTC site 7.3 s ± 0.2 s after initiation of the collapse.

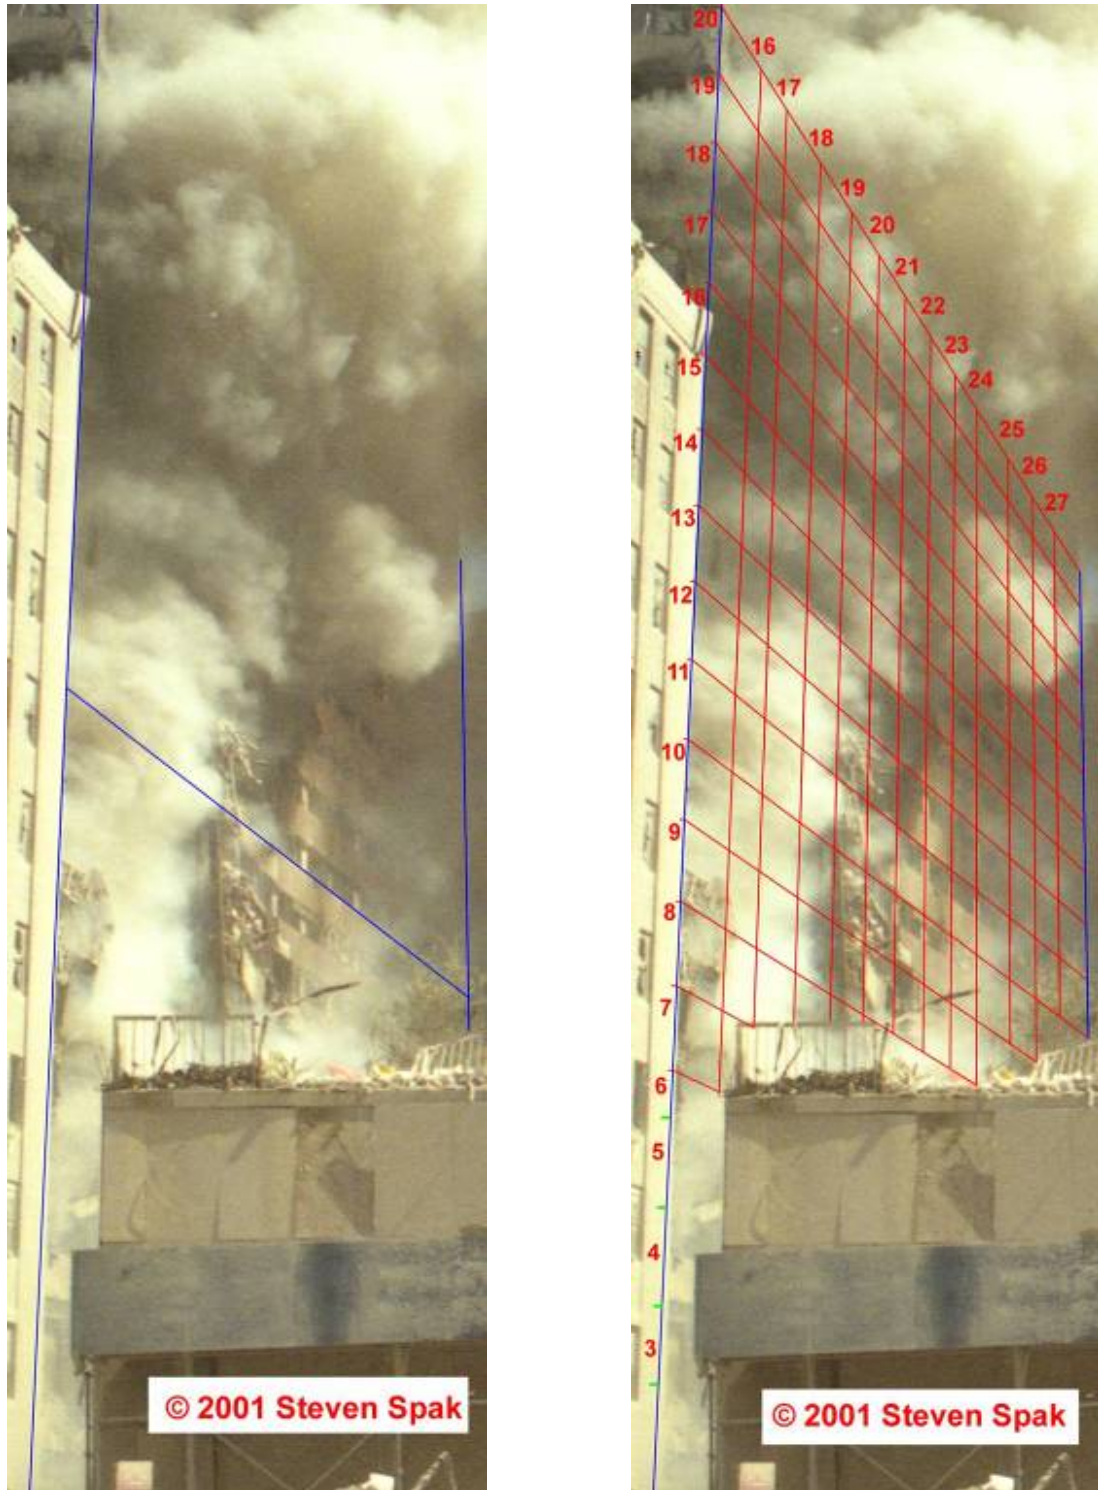
Figure 5-49. Enlarged sections of the photograph shown in Figure 5-47.

In Figure 5-49, the area to the immediate right of Column 20 on the 11th and 12th floors appeared dark, as if it was an opening, while the higher floors were hidden by smoke. However, it is clear from Figure 5-63 that the columns between Column 20 and Column 23 were intact on the 11th through 14th floors, along with the spandrel beams and at least part of the granite cladding on the 12th through 14th floors. In Figure 5-49, the granite cladding appears to be damaged below the 13th floor near Column 23.

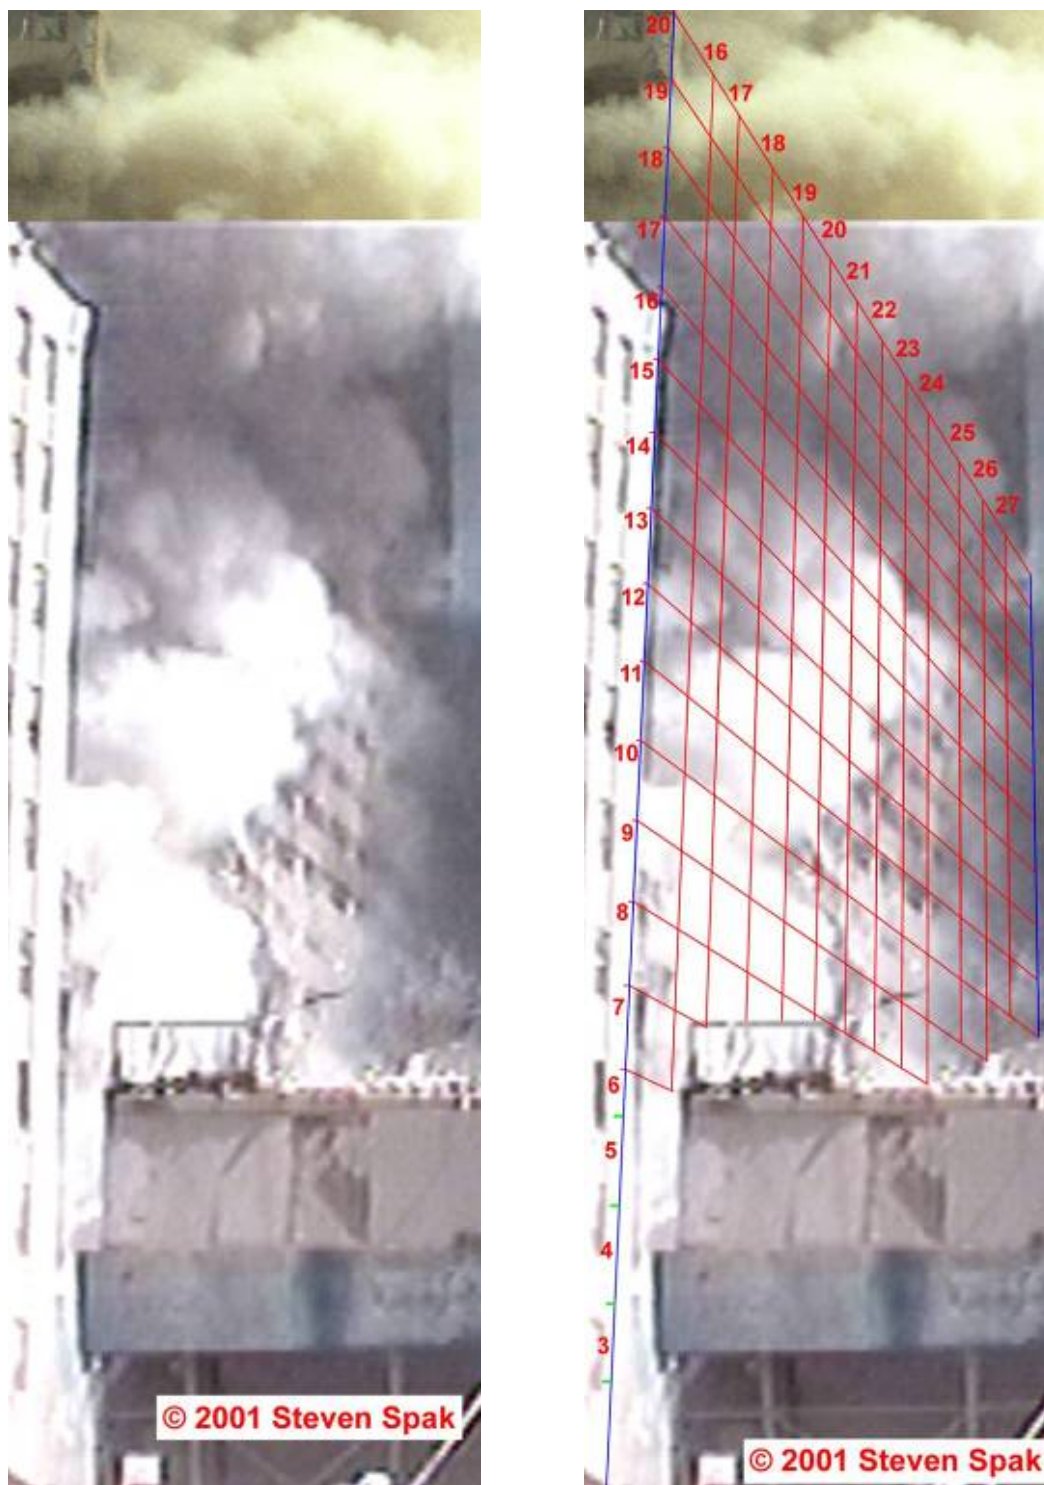
Figure 5–50 shows an enlargement of the damaged south face from the video frame shown in Figure 5–48 overlaid on the photograph shown in Figure 5–49. On the right, the grid taken from Figure 5–49 has been superimposed on the same image. While the image has a relatively low resolution, it is clear that the columns and spandrels to the right of the damaged area were essentially intact, but that most of the window glass had been broken out.

Figure 5–50. An enlarged section of the south face of WTC 7 from the video frame in Figure 5–48.

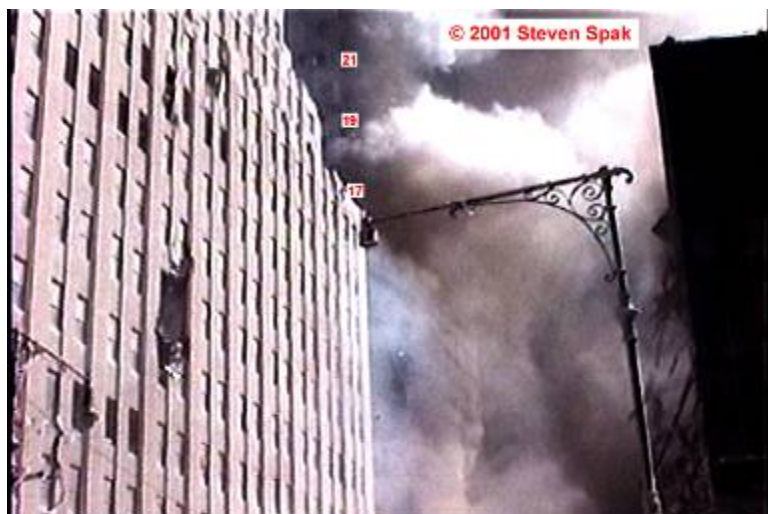
Another frame from a video clip showing the south face of WTC 7 taken looking up Vesey Street is shown in Figure 5–59. Visible floors along the south edge of the west face are indicated. The hole near the center of the south face is only partly visible, but this image is noteworthy because the smoke is clear enough to confirm that the spandrels and columns are intact over a large area to the east of the hole. By using lines running along the tops of the windows to extrapolate to the west edge, it was possible to identify this area as extending from the 11th floor to the 15th floor.

Figure 5-59. Frame from a video clip shot shortly after 12:30 p.m. showing the south face of WTC 7 framed by the Verizon Building and WTC 6. The intensity levels have been adjusted and floor numbers have been added.

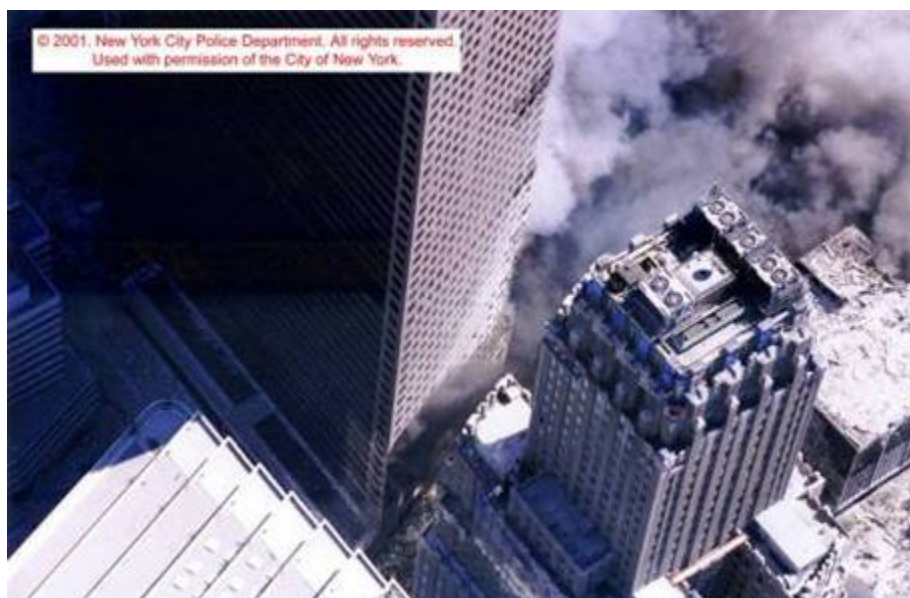
Figure 5-64 shows a photograph of WTC 7 shot from a helicopter between 2:15 p.m. and 2:45 p.m. Damage is visible low on the southwest corner of the building. This area has been enlarged in Figure 5-65, and arrows and numbers have been added that identify the floors corresponding to given rows of windows.

Figure 5–64.
Photograph showing
the north and west
faces of WTC 7, shot
from a helicopter
between 2:15 p.m.
and 2:45 p.m.

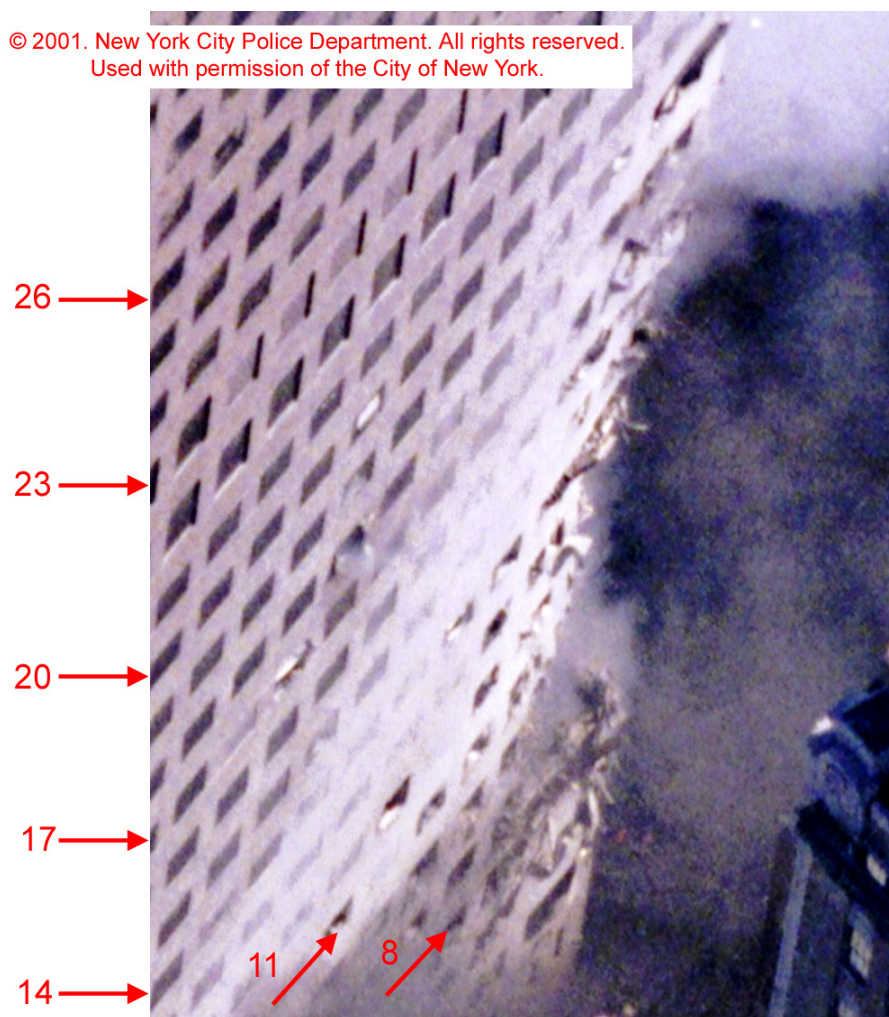
Figure 5–65.
Enlargement of an
area from the
photograph in Figure
5–64 showing part of
the west face of
WTC 7.
The image intensity
has been adjusted, and
arrows and floor
numbers have been
added for the
corresponding rows of
windows.

The image shows considerable damage to the southwest corner, starting at the 17th floor and extending downward to at least the 8th floor. Below the 17th floor, the corner of the building appears to be missing. At a minimum, the granite cladding and its supports have been removed. Figure 5–66 shows a photograph taken at 12:48 p.m. from West Street showing the same area of WTC 7 and an enlargement of the southwest corner. In this image, it is clear that the corner granite has been removed, and it appears that the corner Column 15 (Figure 5–20 and Figure 5–26) has been exposed, but is still in place down to the 12th floor. This column was located just behind the southwest corner. The dull color of the steel indicates that its insulation had been stripped away.

In Figure 5–65, it can be seen that damage to the corner of the 14th floor extends further along the west wall than on higher floors. It is clear in Figure 5–68 that the corner at this floor had been pushed inward,

and that there was considerable façade damage. The aerial views in Figure 5–65 and Figure 5–68 suggest that there was substantial damage between Column 14 and the south edge on the 13th floor. There is no sign of corner Column 15 in these images. Although this column appears to be present in ground shots shown in Figure 5–63 and Figure 5–66, it was likely displaced.

In Figure 5–66, the southwest corner is not visible below the 13th floor. In Figure 5–65, the corner column certainly appears to be absent from the 12th floor down to the 9th floor. Closer inspection of this image provides strong evidence that this is the case. The southwest corner area of WTC 7 from Figure 5–64 is enlarged further in Figure 5–69, and circles and arrows have been added indicating features discussed in the following paragraphs.

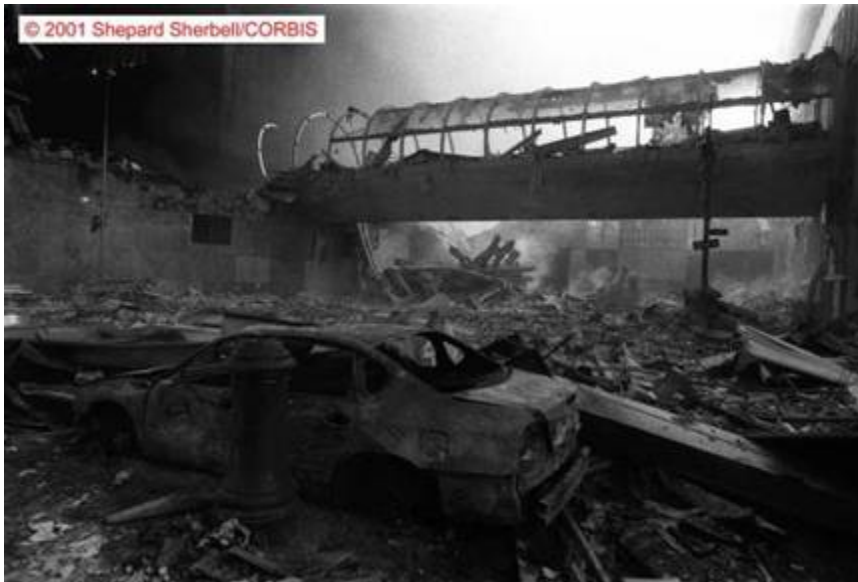
The Promenade is visible behind the Pedestrian Bridge. There is a large pile of steel formed by several panel sections from WTC 1 located between the Pedestrian Bridge and the Promenade near the base of WTC 6 on the south side of the street. There appears to be either a part of or a single panel section located near the center of the street. There is also a single piece of large debris visible near the base of the Pedestrian Bridge that seems to be leaning against the south face. It is not clear if this is structural steel from the towers. These are the only indications of large steel pieces between the Promenade and the corner of West Broadway and Vesey Street. The large pieces of steel observed on Vesey Street from the west are beyond the view of this photograph.

Figure 5–70. Black and white photograph shot from the corner of Vesey Street and West Broadway looking west down Vesey Street.

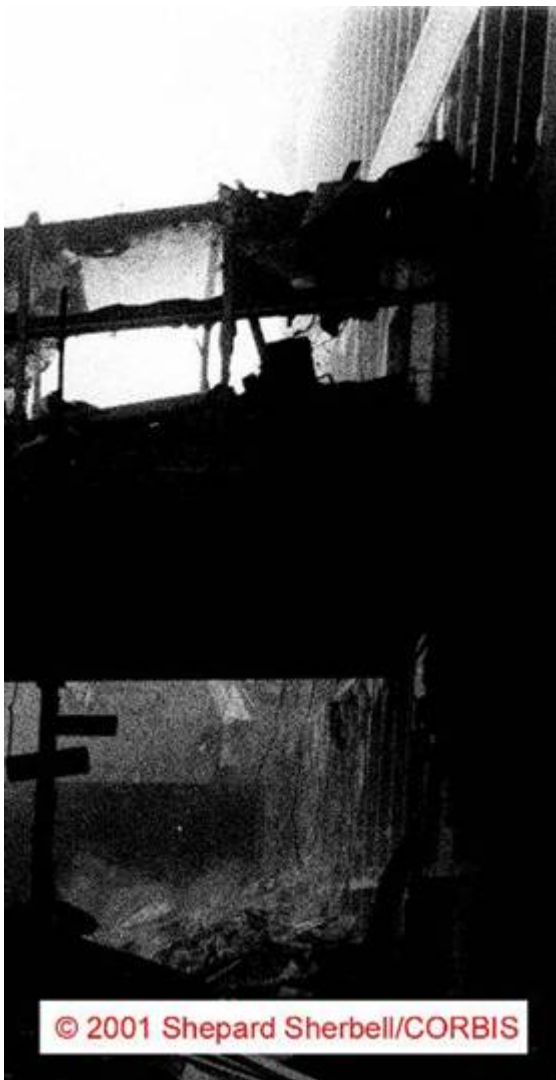
An enlarged and enhanced section of Figure 5–70 showing the south face of WTC 7 is included in Figure 5–71. The debris deposited near the south face of WTC 7 is nearly one story high. Many columns can be discerned on the south face looking under the Pedestrian Bridge. The spacing and size of these columns indicate that these were part of the nonstructural system used to support glass and doors in the four story atrium area. (See Figure 5–15, Figure 5–16, Figure 5–36, and Figure 5–37.) The glass was apparently broken out between the columns based on the depth visible. It is also possible to discern some of the horizontal supports for the glass façade. Even though it is not possible to identify individual columns

Figure 5–71. Enlargement of the photograph in Figure 5–70 showing the south face of WTC 7.

The area visible above the granite in Figure 5–71 starts just to the left of the Pedestrian Bridge and extends towards the west at least as far as the fifteenth support column from the east edge. As can be seen in Figure 5–20, these columns nearly span the distance from the east edge of the face to the Promenade. Structural steel Columns 23 to 28 were located on this section of the face (see Figure 5–20). Since these columns were located behind the glass and louver support systems, these observations indicate that there was likely no structural damage to these columns on the 1st through 6th floors.

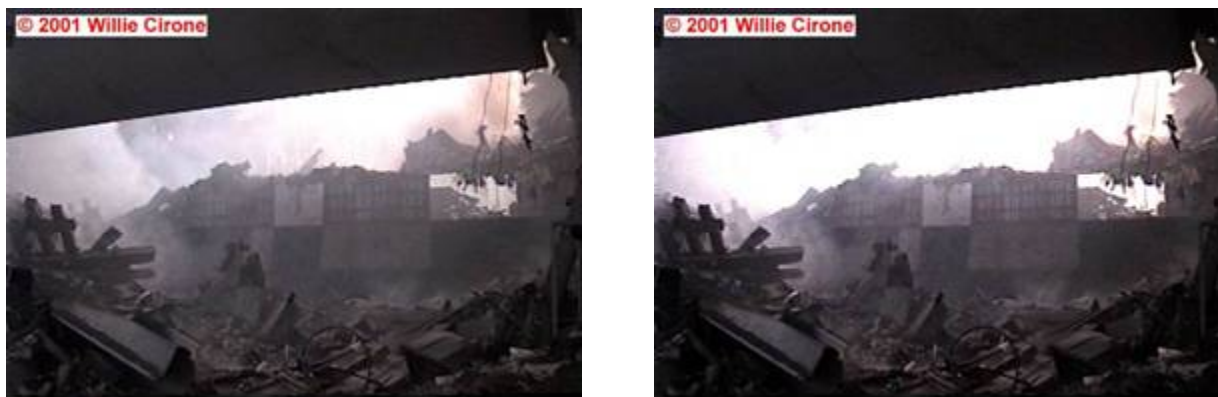
A second view of Vesey Street and the Promenade taken from a short video clip is shown in Figure 5–72. The dark area at the top of the image is the bottom of the Pedestrian Bridge. In the unaltered left view, large amounts of smoke are visible on the far side of the Promenade. In the right view, the intensity levels have been adjusted to emphasize the darker areas in the image. A number of steel panel sections are visible on the left side of the street between the Pedestrian Bridge and the Promenade. It is also possible to see that several panel sections landed on or near the south end of the Promenade, and this end may be partially collapsed. The portion of a panel section near the center of the street is visible, but is not as easily identified as in Figure 5–70. A part of the large piece of debris observed earlier leaning up against the south face of WTC 7 is visible at the far right of the image. The size and shape of the object suggest that it was a steel column or beam. In all, the main portion of the east side of the Promenade, with the possible exception of the far south end, was not collapsed by the steel from WTC 1, although the raised side structures had suffered considerable damage.

Figure 5–72. Two versions of a frame from a video taken from the corner of Vesey Street and West Broadway in the early afternoon.

The south face of WTC 7 was just beyond the right side of this image. Nonetheless, a pile of debris several stories high is visible rising above the Promenade at the right hand edge of Figure 5–72. Recall that there was evidence of debris in the same area from ground and aerial views taken from the west. The presence of this debris is consistent with the south face damage observed at higher floors at roughly the same location.

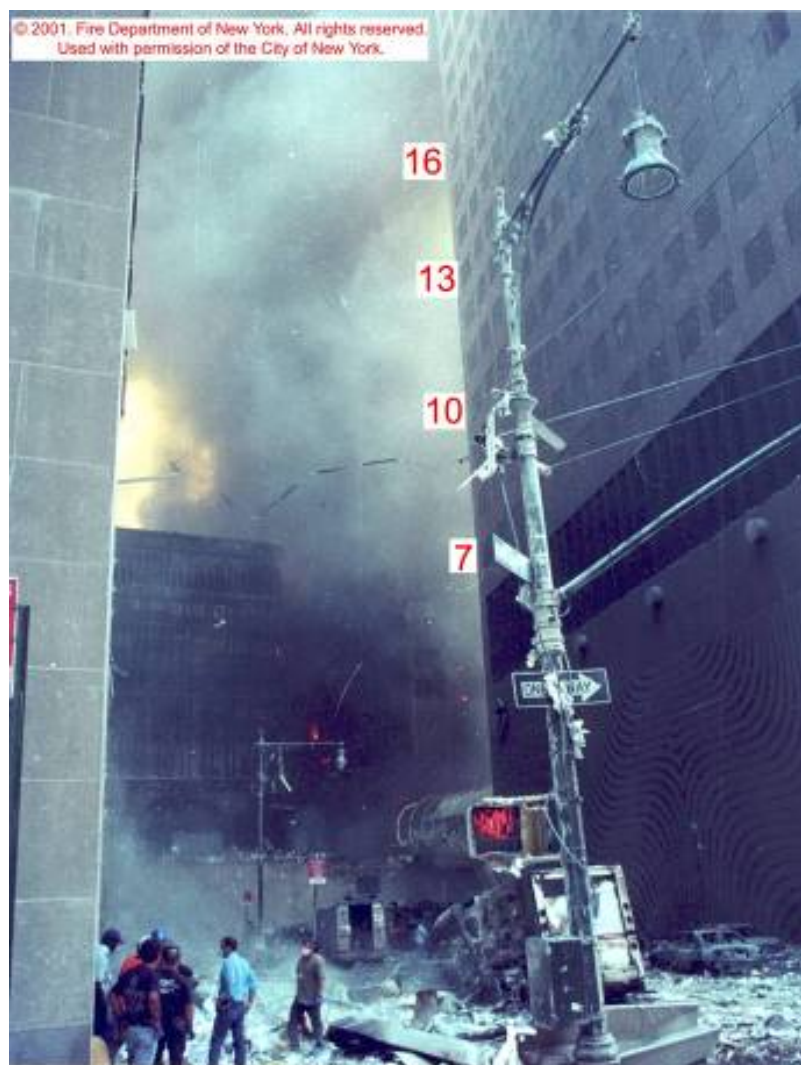
Figure 5–90. Photo showing the east face of WTC 7, taken from the southeast corner of Barclay Street and West Broadway looking down West Broadway, likely around 12:00 p.m.

In Figure 5–90, windows are visible on a portion of the east face up to the 20th floor. There is no indication of façade damage or, with one exception, broken window glass in the image. The only broken glass is the center window on the 8th floor, to the right of Column 36. This open window is also visible in Figure 5–22. Investigation interviews indicated that this window was broken out by people who were trapped on this floor when WTC 1 collapsed (Chapter 6). Video clips in the database show one of these people inside an open window (8-42A) on the eastern edge of the north face.

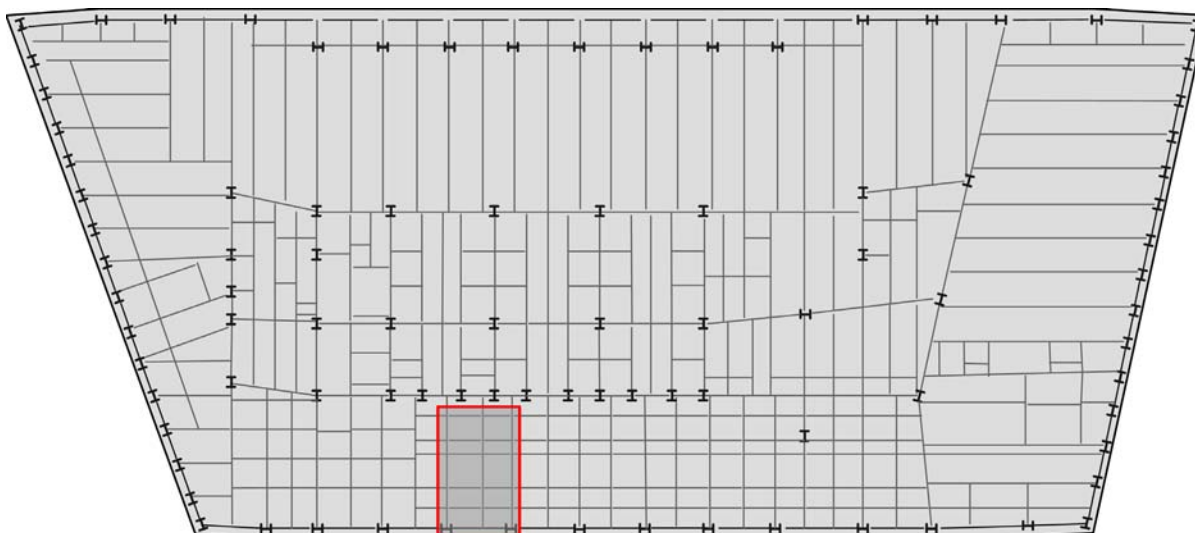
Figure 5-94 Estimated debris impact damage to Floors 5 and 6 of WTC 7.
Marked area indicates removed columns and floor segments.

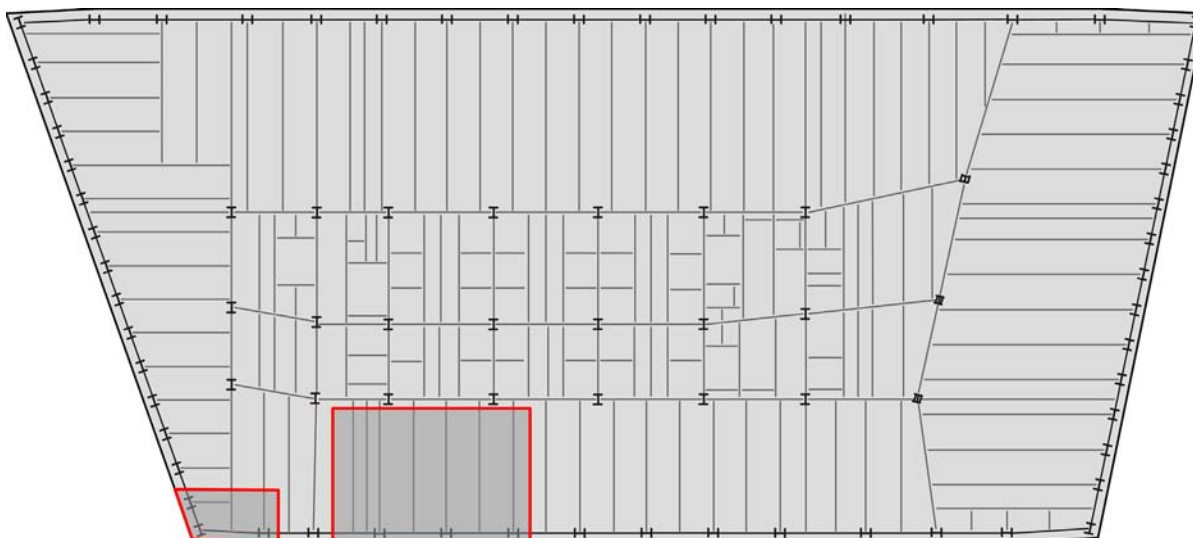
Figure 5–98 Estimated debris impact damage to Floors 10 and 11 of WTC 7.

Marked areas indicate removed columns and floor segments.

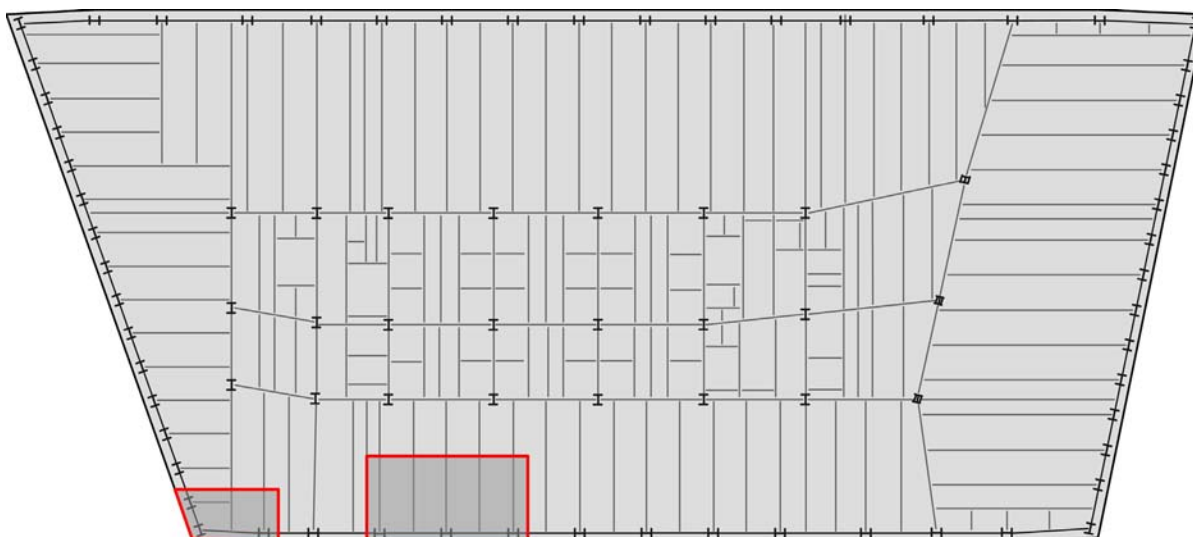
Figure 5–99 Estimated debris impact damage to Floors 12 to 14 of WTC 7.

Marked areas indicate removed columns and floor segments.

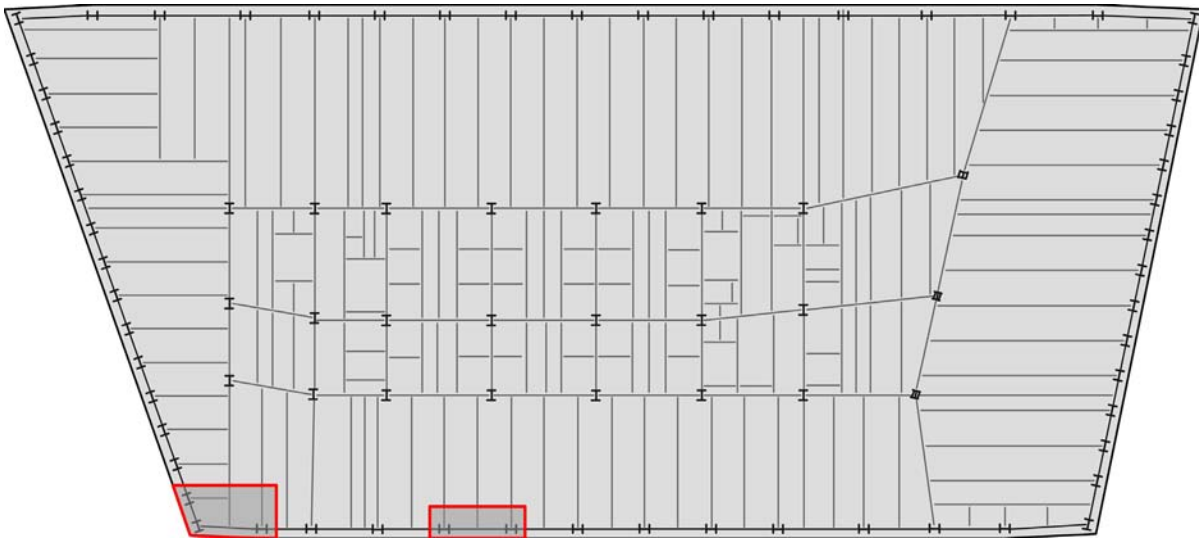
Figure 5-100 Estimated debris impact damage to Floors 15 to 17 of WTC 7.
Marked areas indicate removed columns and floor segments.

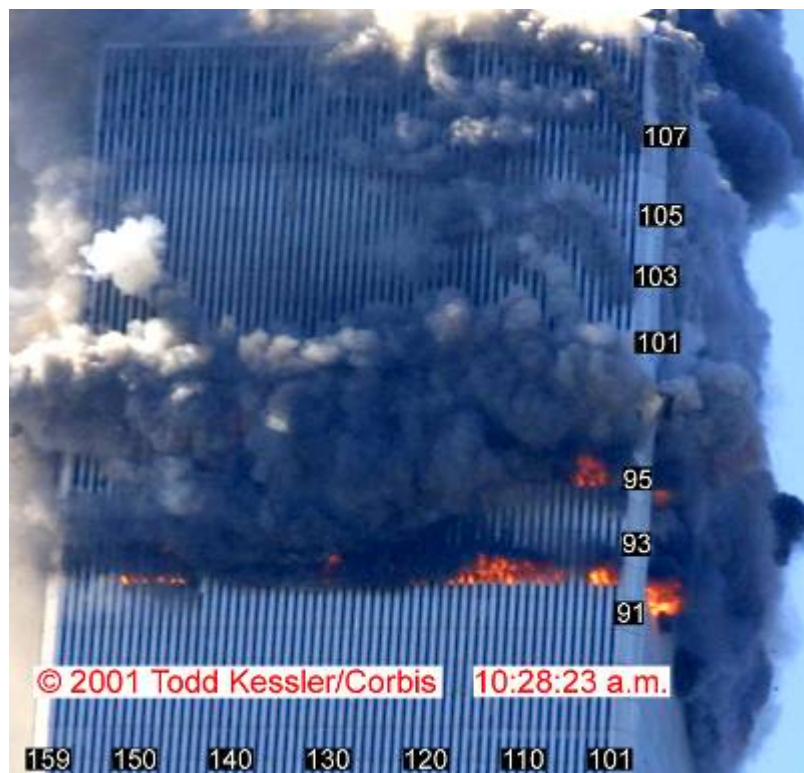
windows, thus revealing the extent of the fires. This is evident in Figure 5–102 which shows the upper floors of WTC 1 roughly one second after the collapse started. The significant fire on the west side of the 92nd floor is evident. The expelled flames formed a large fireball before extinguishing.

Figure 5–102. Cropped photograph showing the north face of WTC 1 at 10:28:23 a.m.

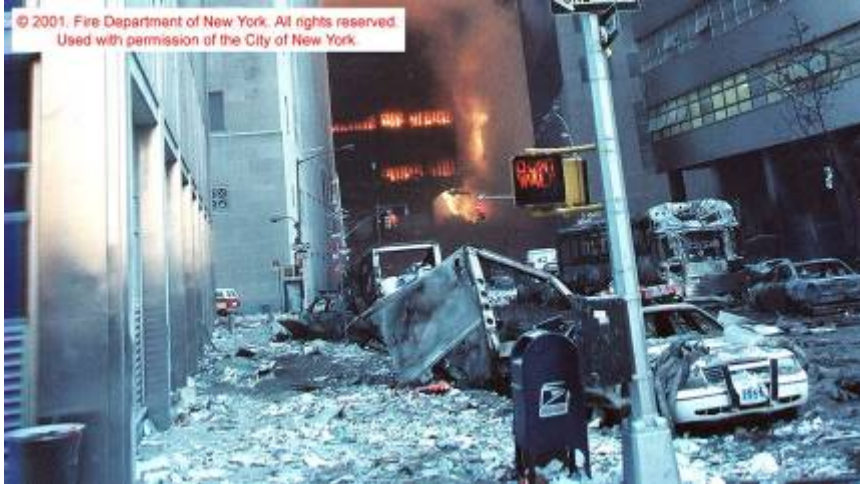
Figure 5–106.
Photograph taken
looking down West
Broadway towards WTC 7
from its corner with Park
Place.

The burning buildings in the background are WTC 5 and WTC 6. The intensity levels have been adjusted.

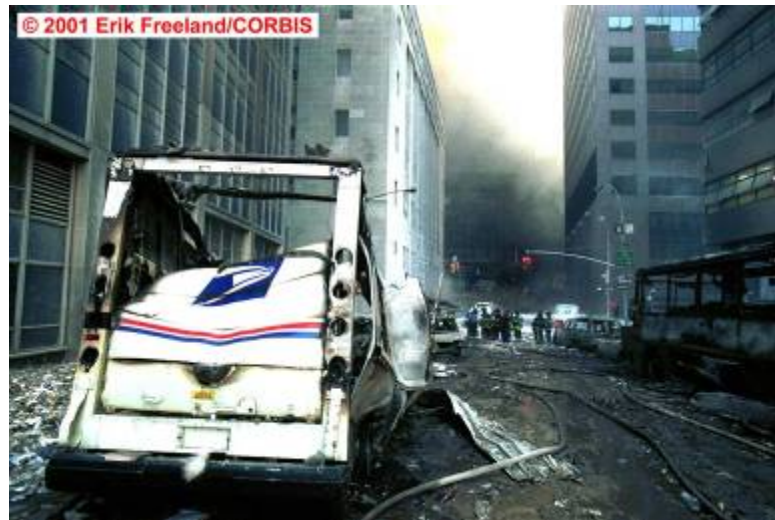
Figure 5–107. Photograph taken
looking down West Broadway
towards WTC 7 from near its
corner with Park Place.

Several fire hoses are visible on the street in Figure 5–107. One of the photographers who provided images for the Investigation reported that he was a fireman visiting from out of town and had joined with a FDNY engine company to extinguish the burning vehicles along West Broadway. They started at the corner of Park Place and West Broadway and moved south until they reached Vesey Street. Based on the smoke plume observations, this must have taken place between roughly 11:00 a.m. and 12:00 p.m.

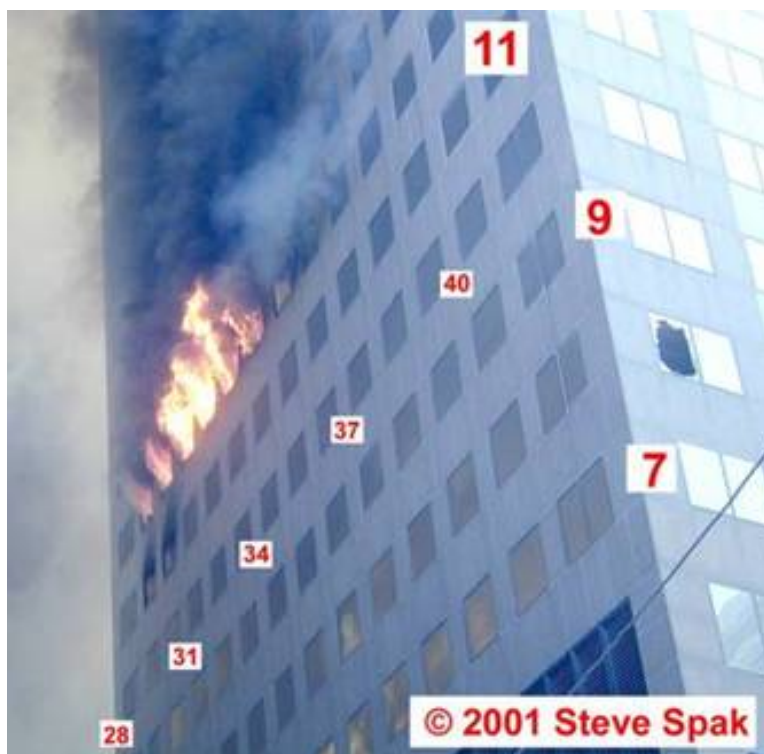
Two windows, 11-29 and 11-30, were also open on the 11th floor at 2:11:09 p.m. Upon closer inspection, it is possible to identify a dull red glow through these open windows. The smoke patterns visible above these windows indicate that a more intense fire had burned there earlier and had subsequently died down. The floor plan for the 11th floor (Chapter 3) was similar to that for the 12th floor, and interior walls were present on either side of these two windows. Apparently, these walls slowed the fire spread into enclosed spaces on either side.

Figure 5–115. Cropped photograph showing fires on the east face of WTC 7 at 2:11:09 p.m. ± 1 s.

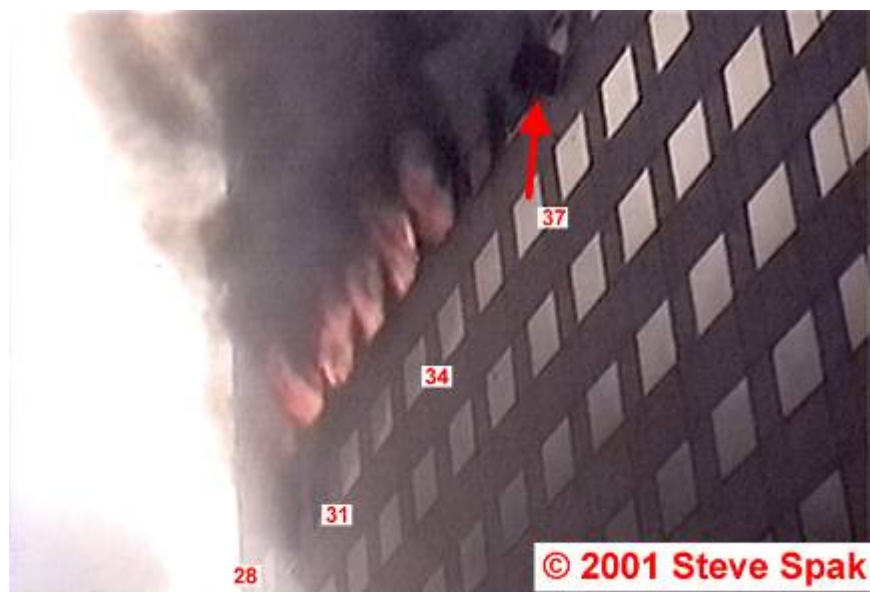
Several video clips showing the east face of WTC 7 are available between 2:15 p.m. and 2:29 p.m. The exact times for these clips are not known. In the clip shot immediately after the one shown in Figure 5–116, window 11-32 on the 11th floor had already broken, and the glass in window 11-33 suddenly fell outward. Low intensity flames appeared in window 11-32 shortly afterwards. By the time the next clip started, windows 11-31 and 11-34 were open, and growing flames were visible through windows 11-31 to 11-34. In this clip, heavy smoke appeared, and flames erupted from window 11-34, likely an indication that flashover occurred at that time. Heavy smoke and flames continued to come from these four windows over the next several minutes.

Figure 5-116. Frame from a video showing a portion of the east face of WTC 7 between 2:15 p.m. and 2:27 p.m.

The intensity levels have been adjusted, and column numbers are indicated. The arrow indicates a large piece of glass falling from window 12-37.
