**Federal Building and Fire Safety Investigation of the
World Trade Center Disaster**

**Structural Fire Response and
Probable Collapse Sequence of
World Trade Center Building 7**

VOLUME 1

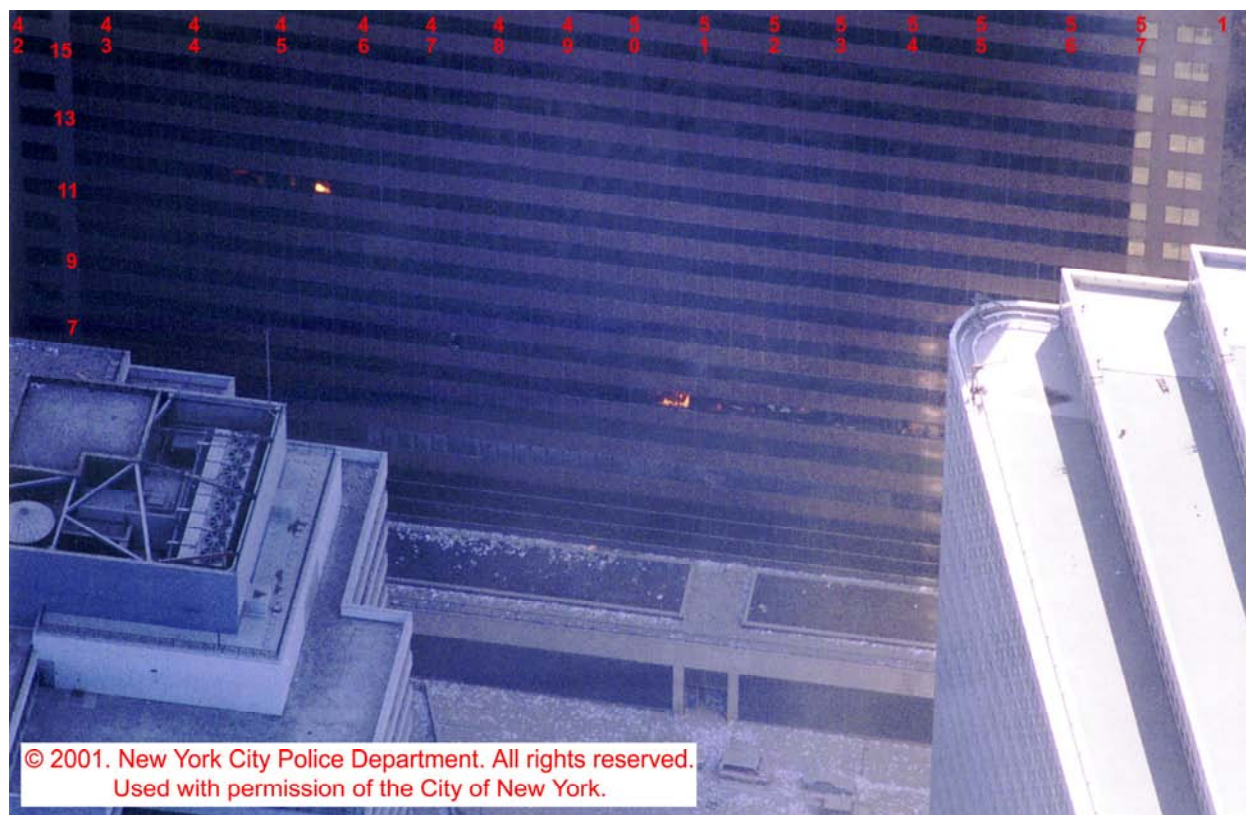
The observations indicate that a relatively low intensity fire with sufficient heat release to break nearby windows spread rapidly across the north edge of the building on the 7th floor. As noted earlier in this chapter, the tenants had been relocated from the western half of the floor, probably reducing the fuel load.

Consistent with this, the apparent low fire intensities suggest that the fuel load or burning rate was insufficient to induce flashover in this large space.

Figure 5–119. Photograph showing the north face of WTC 7 taken from a helicopter around 2:57 p.m. \pm 5 min.

Only very light smoke can be seen coming from the open windows on the 7th and 12th floors. Even though the fires were relatively small, they would be expected to release much more smoke than was observed. It is likely that this smoke was being vented elsewhere from the building, perhaps at locations on the east or south faces. This would be the expected behavior if internal flow pathways were available to these faces due to the positive pressure created at the open windows on the north side by the ambient wind flowing over this face and the corresponding low pressure areas created on the leeward faces.

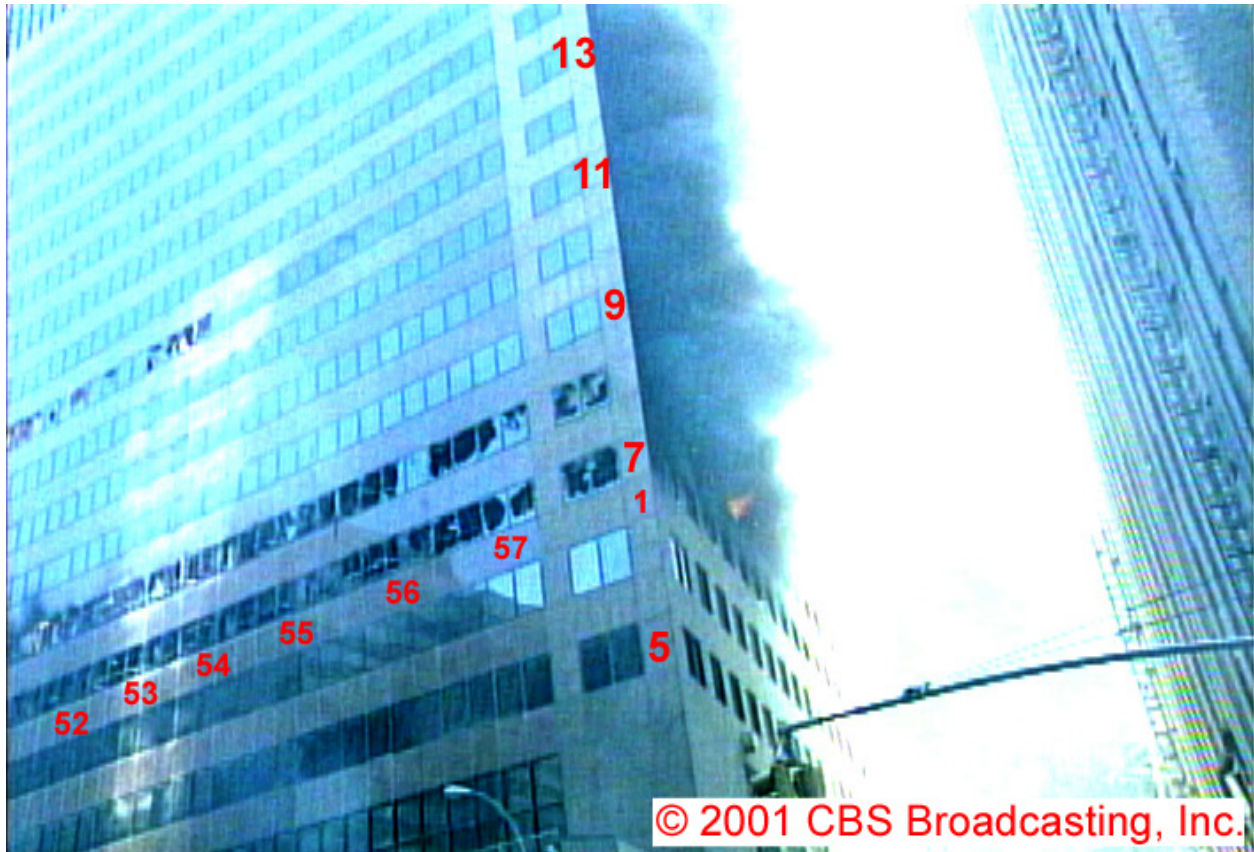
Figure 5–132. View of the northwest corner of WTC 7 from a video recorded from inside the lobby of 123 Barclay Street around 3:42 p.m. ± 5 min.

The intensities have been adjusted, and column and floor numbers have been added.

On the north face, every window on the 7th and 8th floors to the west of Column 51, with the exception of window 8-56A, was open at the time Figure 5–132 was taken. This is the first visual evidence that fires had burned on these floors between Column 54 and the west edge of the face. The only locations where flames can be seen are near Column 51 on the 8th floor. Other clips shot around the same time show fire in windows 8-57B and 8-57C. In Figure 5–130, intense burning was present between Columns 51 and 54. The fact that these fires had died down by the time of the later video clip indicates that many minutes separate the images in Figure 5–130 and Figure 5–132. This is consistent with the assigned times.

Even though the open windows on the north sides of the 7th and 8th floors visible in Figure 5–132 were clearly subjected to high temperatures, little blackening of the building façade above the windows is evident. The only substantial blackening was near Column 51 on the 8th floor. As observed at other

locations on the north face, the fires burning in this area apparently vented on other faces as a result of the pressure distribution created by the ambient wind, in these cases most likely from the south face. Recall that large areas of the south face on these floors were opened during the collapse of WTC 1. Interior pathways from the north side of WTC 7 to the south must have been available on these floors.

Closer inspection of Figure 5–132 reveals that while the glass in window 12-55C was still in place, it had apparently cracked. This is an early indication that fire was nearby. Another video clip taken from the same location a short while later shows that windows 12-55B and 12-55C had opened and flames filled both windows. After a brief lull, the fires burning on the north side of the 12th floor continued their spread to the west. As noted earlier, the fires on this floor seemed to occasionally skip some closed windows and appear further west. This suggests that instead of spreading continuously along the north edge, the fires were penetrating a series of offices and then growing to the point where windows were broken. Each of these office fires was apparently somewhat independent, which is consistent with the floor plan shown in Figure 3–4.

Figure 5–132 and Figure 5–134 together show that every window on the 7th floor between Column 47 and the western edge of the north face was broken out at this time. No flames are visible on this floor in either image. As shown by Figure 5–127, fire had spread as far east as window 7-47A as early as 3:13 p.m. No further eastward fire spread was observed over the following 45 min, and the fires appeared to have died down.

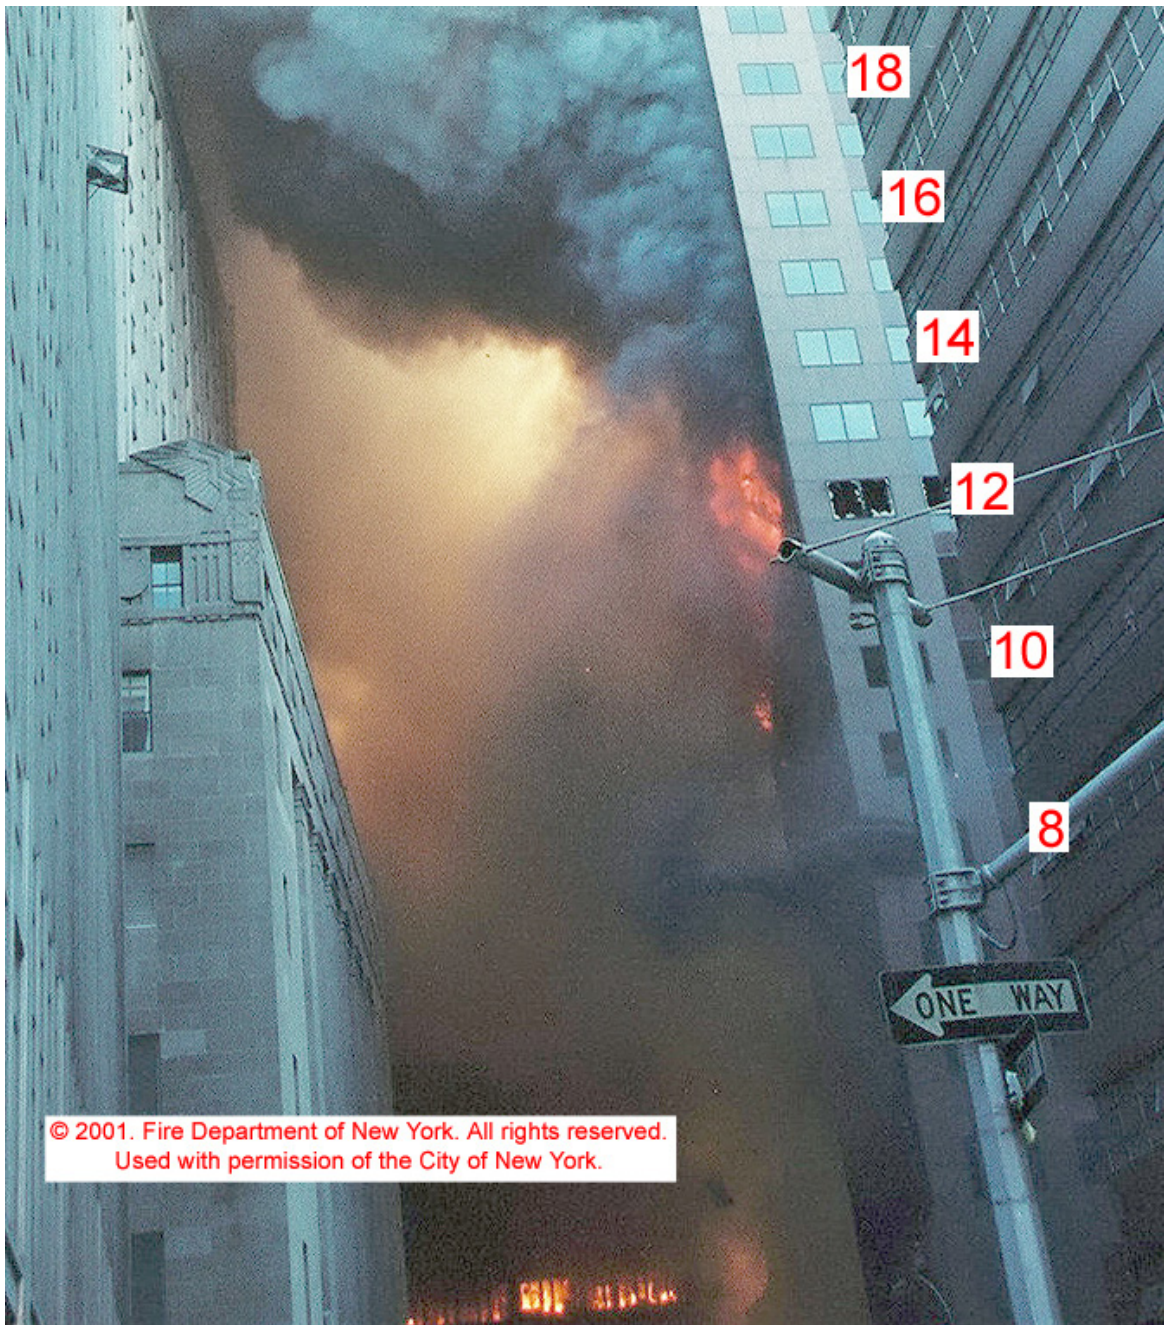
It is difficult to identify how fire moved onto the north side of the 13th floor from Figure 5–130 and Figure 5–134. A photograph (Figure 5–135) taken at an unknown earlier time, estimated as between 3:20 p.m. and 3:40 p.m., provides an important clue. This image, shot from near the corner of West Broadway and Park Place, shows an oblique view of the east face. Intense flames appear to be coming from windows 13-39 to 13-41 on the 13th floor. A much smaller flame can be seen in window 13-41A. Despite the steep viewing angle, there seems to be a line of flames extending across most of the east face on the 13th floor. Heavy smoke is rising from these fires. There also appears to be lighter smoke lower down on the east face, but it is not possible to identify its source.

Windows at the east edge of the north face are also visible in Figure 5–135. Windows 13-42A to 13-42C still have glass in place on the 13th floor, which means that this image was taken prior to Figure 5–134. The heavy smoke pouring from open window 8-42A on the 8th floor indicates that a significant fire was burning on this floor at this time, even though it is clear from Figure 5–134 that nearby windows still have intact glass. Windows 12-42A to 12-42C are open on the 12th floor with no sign of flames nearby, indicating that this photograph was taken well after the aerial view in Figure 5–123, which was taken around 3:10 p.m. and shows heavy flames in these corner windows.

Figure 5–135. Cropped photograph showing the east edge of the north face and an oblique view of the east face of WTC 7, taken from near the corner of West Broadway and Park Place.

It was likely taken between 3:20 p.m. and 3:40 p.m. The buildings burning in the background are WTC 5 (left) and WTC 6 (right), and the U.S. Post Office is on the left. Floor numbers have been added and intensity levels have been adjusted.

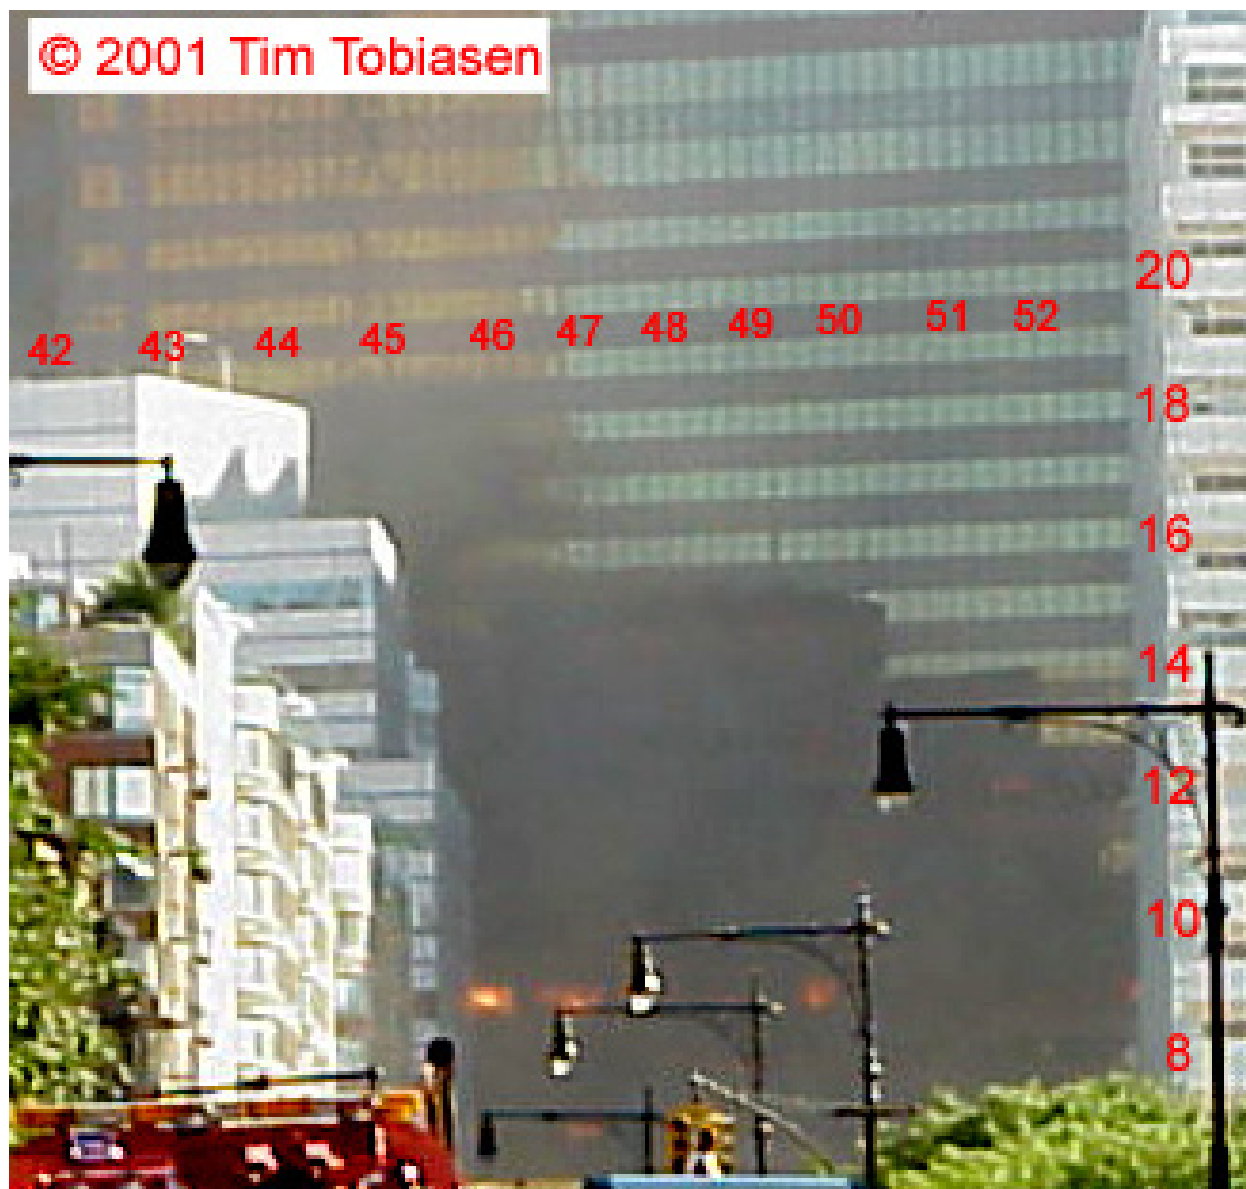
Low intensity flames continue to burn on the 8th floor between Columns 47 and 49. Similar flames are also visible on the 12th floor between Columns 51 and 52. In Figure 5–145 it appeared that some of the glass was still in place for some of these windows. This seems to be no longer the case in Figure 5–146.

The amount of fire spread and growth between the times when the images in Figure 5–145 and Figure 5–146 were taken would be expected to require many minutes. Assuming a period of 10 min yields a crude estimate of 4:20 p.m. for the timing of Figure 5–146.

Close inspection of Figure 5–146 reveals that there is an area of flame on the 7th floor between Columns 46 and 47. After a long period of inactivity, fire has clearly made its way to the other side of the obstacle that had earlier halted its spread across the face. Note that there is no indication of how fire arrived at this location. It could have spread from the west, south, or east.

Figure 5–146. Cropped photograph showing the north face of WTC 7 from near the corner of Greenwich and Harrison Streets at a roughly estimated time of 4:20 p.m.
The intensities have been adjusted, and column and floor numbers have been added.

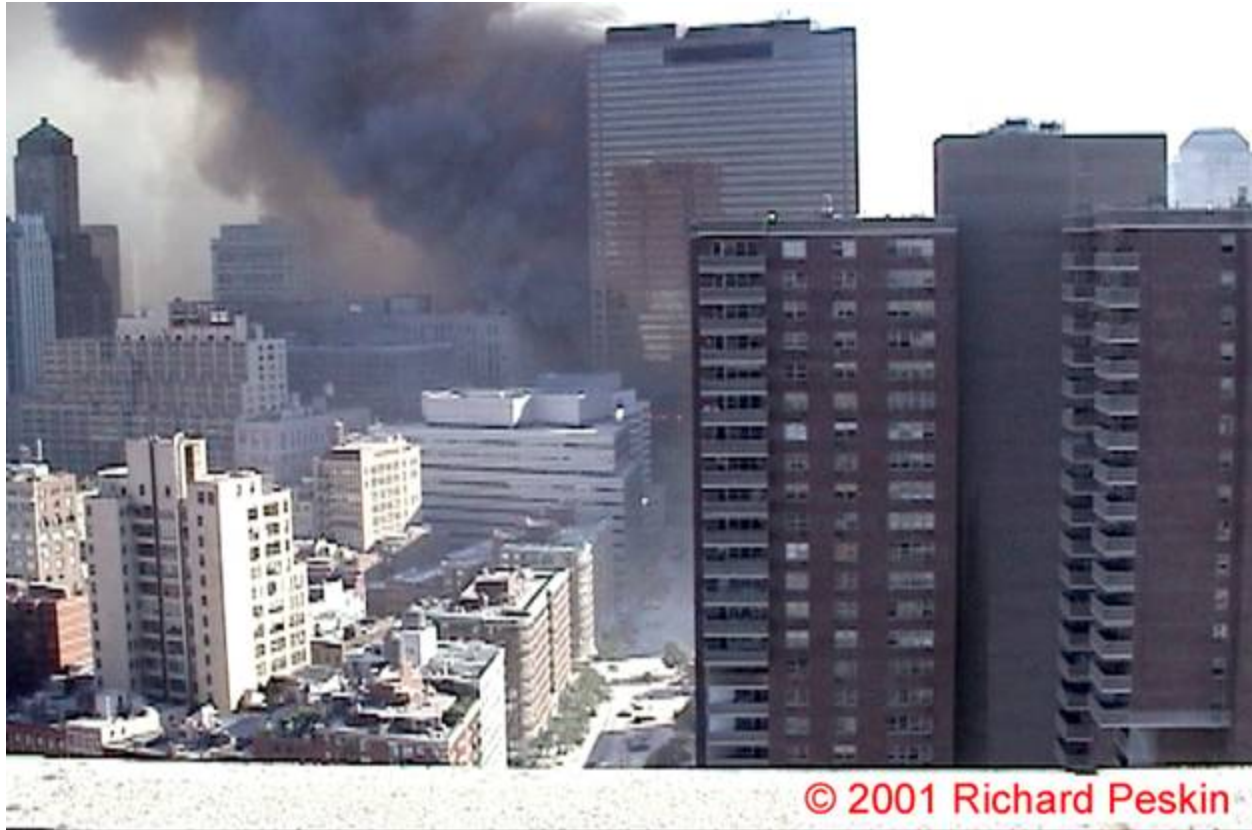
Figure 5–147 provides a view of the north face of WTC 7. The image is a frame taken from a digital video that was accurately timed. This frame was recorded just before 4:38 p.m. Even from the long distance from which the video was filmed, it is possible to see a heavy fire burning on one of the floors. Little or no smoke is evident on the north face, but dense black smoke is rising from the east face. This appears to be another example of fires burning on the north face exhausting through openings on a different face of the building.

Figure 5-147. Frame from a video clip shot from the top of a nearby building to the northwest, providing a view of the north face of WTC 7 at 4:37:46 p.m. \pm 1 s.

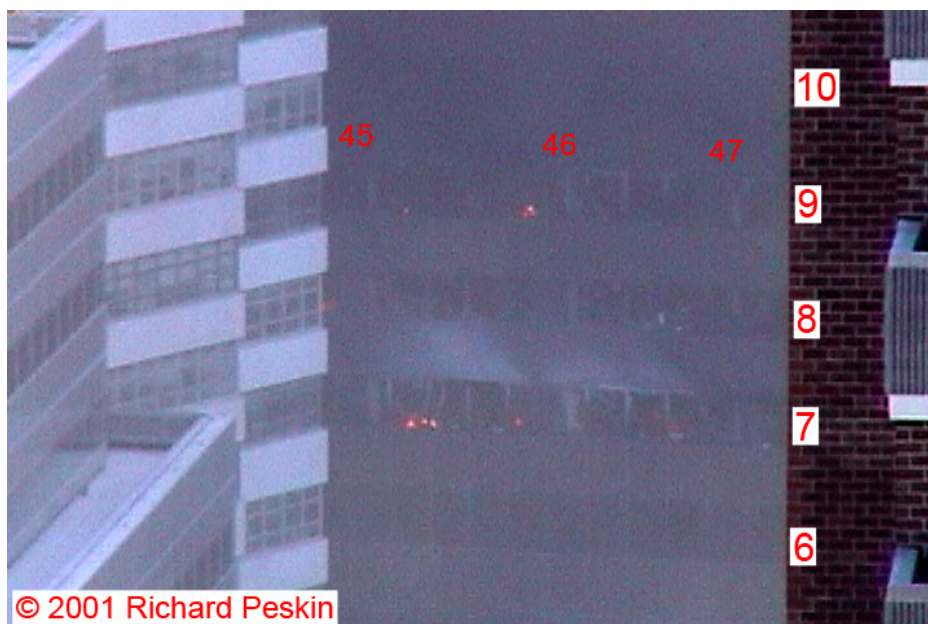
The videographer zoomed in on the north face of WTC 7 during the same clip from which the frame in Figure 5-147 was taken. Figure 5-148 and Figure 5-149 are two spatially overlapping close-up frames that, taken together, show portions of the 6th through 14th floors just after 4:38 p.m. In Figure 5-149, the visible lengths of the floor extend from just east of Column 45 to just west of Column 47. All of the visible windows on the 7th, 8th, and 9th floors were open at this time, while all of the windows on the 6th and 10th floors still had glass in place. Small spot fires are visible at numerous locations on the three floors with open windows.

In Figure 5-146, intense fires were visible on the 7th and 9th floors in the same windows visible in the video around 4:38 p.m. A less intense fire was also present on the 8th floor. All of these fires had died down significantly by the time Figure 5-148 was recorded roughly 25 min later. Since the typical intense flaming peak for most of the fires observed in WTC 7 lasted about 20 min, it seems safe to conclude that the photograph shown in Figure 5-146 could not have been taken later than 4:28 p.m., consistent with the estimate of 4:20 p.m. for the earlier image.

Figure 5-148. Frame from a video clip showing a close up view of the north face of WTC 7 at 4:38:11 p.m. \pm 1 s. The video was shot from the same location as the frame in Figure 5-147. The image intensities were adjusted, and column and floor number have been added.

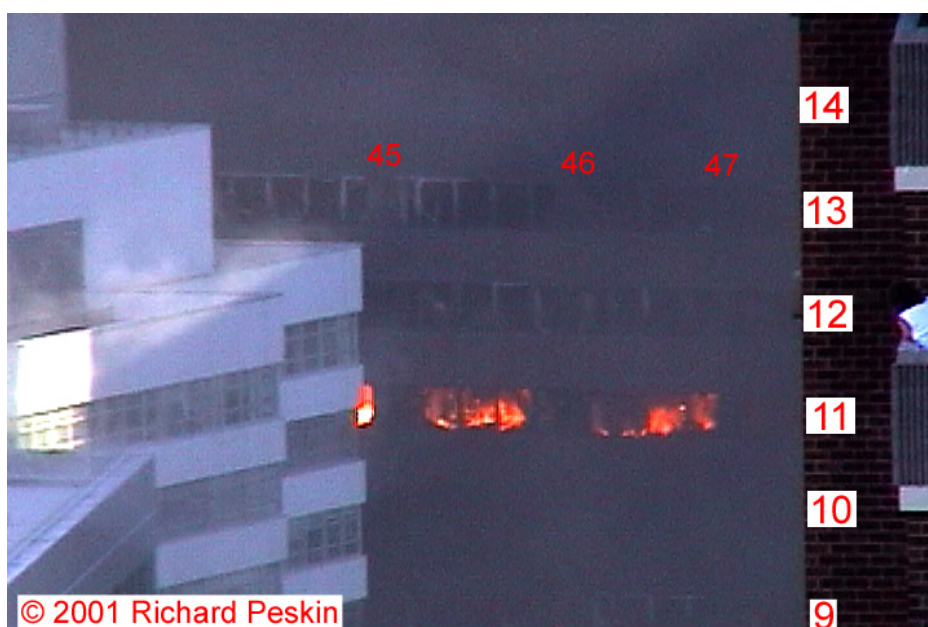
Figure 5-149. Frame from a video clip showing a close up view of the north face of WTC 7 at 4:38:14 p.m. \pm 1 s. The video was shot from the same location as the frame in Figure 5-147. The image intensities were adjusted, and column and floor number have been added.

Figure 5-149 shows the visible portions of the 9th to 14th floors. The most prominent feature is the extensive fire present on the 11th floor between windows 11-44E and 11-46D. A dull red glow is visible through window 11-47A. This image provides the earliest evidence that the fire on this floor had reached the north face. There was no sign of a fire on this face in earlier images. Recall that a growing fire was observed on the east side of this floor as early as 2:08 p.m. It is remarkable that nearly two and a half hours were required for fire to finally appear on the north side. Even though there is substantial fire present on the floor, no smoke is visible coming from the open windows. This is another example where the fires were venting elsewhere.

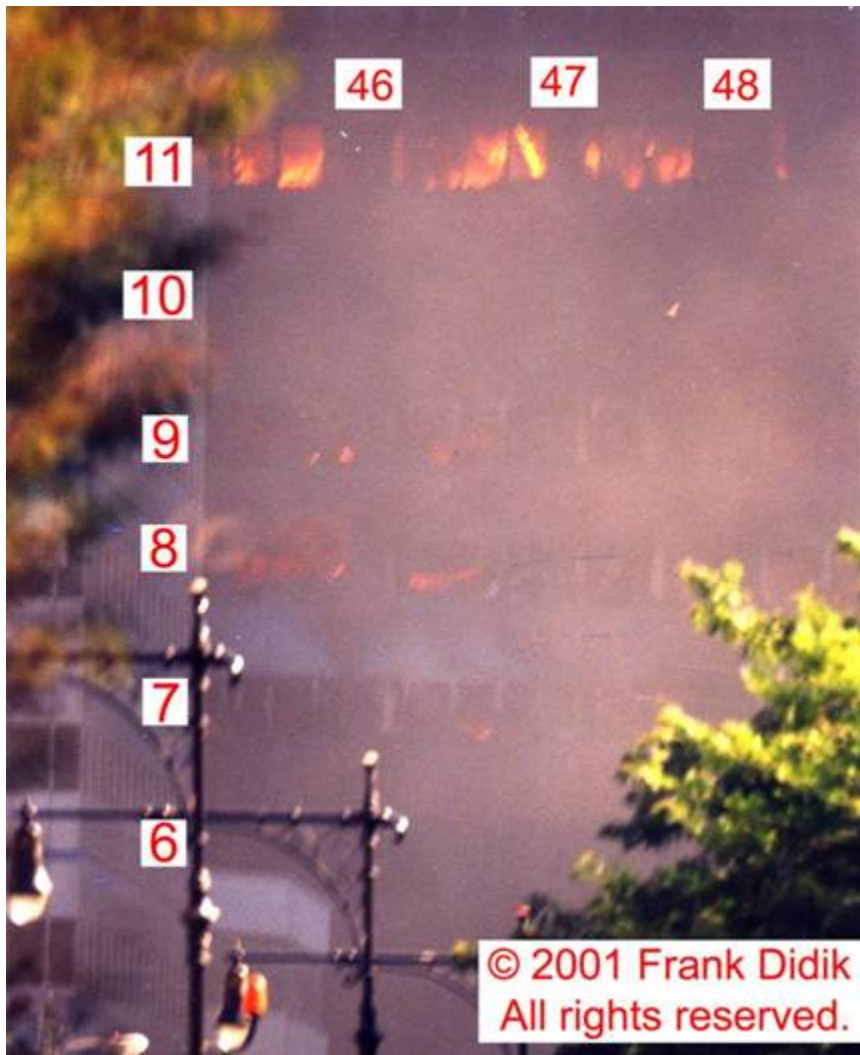
Another partial view of the north face taken from street level at nearly the same time as Figure 5–148 and Figure 5–149 is shown in Figure 5–150. The photograph was shot on film, so a precise time could not be assigned. However, the same photographer shot an accurately timed digital photograph from nearly the same location at 4:39:19 p.m. The time for the film picture was therefore assigned as 4:39 p.m. with an uncertainty of ± 2 min. In Figure 5–149, the intense fire on the 11th floor did not extend beyond Column 47, while in Figure 5–150 it appears to have moved beyond Column 48, suggesting that the photograph may actually have been shot after the video frames.

More flames are evident on the 7th, 8th, and 9th floors in the ground-level photograph than in the video frames shot looking down on the face. In Figure 5–150, the flames on these floors appear to be reddish and to be well removed from the windows. It is possible that these fires were actually so deep inside the building that they were hidden from the view looking down through the windows. As before, there are no indications of burning on the 10th floor in Figure 5–150.

Figure 5–150. Cropped photograph showing part of the north face of WTC 7, shot from near the corner of Harrison and Greenwich Streets at 4:39 p.m. ± 120 s.

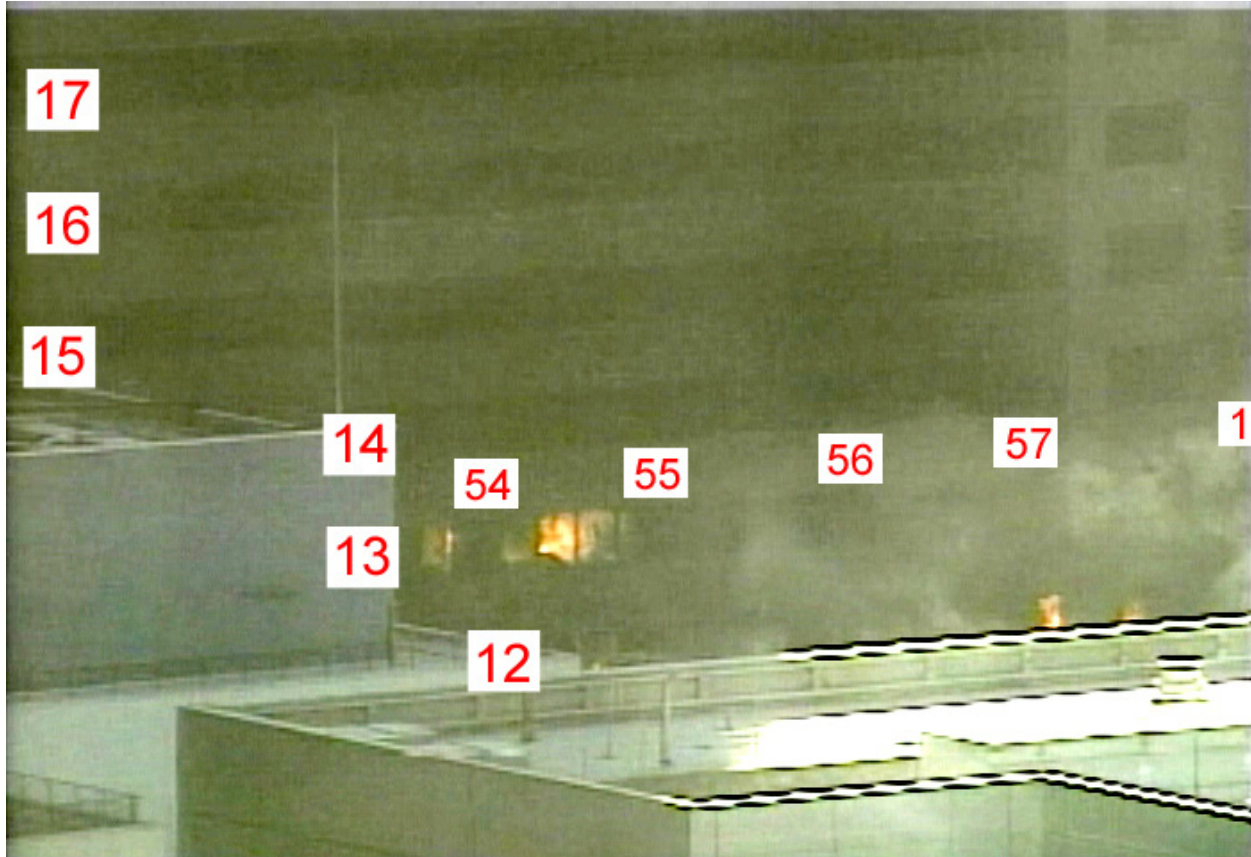
Figure 5–152 shows a limited view of the north face shot from the northeast over the tops of the two buildings to the north of WTC 7. The time was crudely estimated as being around 5:00 p.m. based on the pattern of sunlight and shadow on the building to the immediate north of WTC 7. Only the 12th to 17th floors are visible. Fires are burning on the 12th and 13th floors. On the 12th floor, the fires that were slowly spreading across the north face to the west have reached the northwest corner, with flames barely visible in windows 12-57A and 12-57B. Recall that fire was observed between Columns 55 and 56 around 4:00 p.m. At 2:00 p.m., the 12th floor was burning near the southeast corner. Apparently it took roughly three hours for fire to spread all of the way from the southeast corner to the northwest corner.

Figure 5–152. Frame taken from a video clip shot over the buildings at 30 West Broadway and 70 Murray Street, showing the western edge of the north face of WTC 7 at about 5:00 p.m.

The fire on the 13th floor has burned westward as far as Column 55. In Figure 5–144, which was estimated to have been taken around 3:55 p.m., flames were observed as far west as Column 50. This fire was continuing to work its way to the west. There are no indications of fire burning in this area on floors higher than the 13th floor. In the video clip, some light smoke was visible blowing across the north face, but there was apparently little smoke coming from the open windows on the 12th and 13th floors, consistent with earlier observations that the effluent for fires on these floor vented at remote locations on other faces.

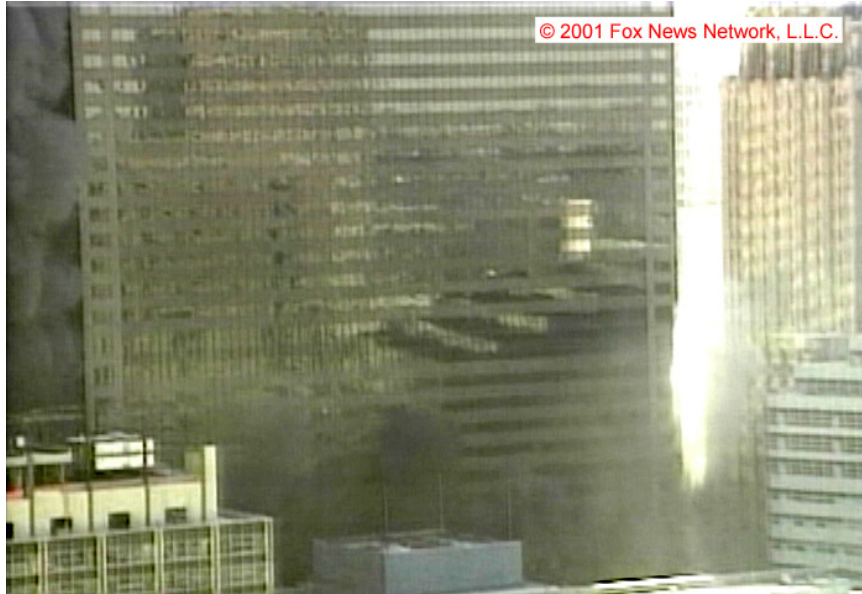
Figure 5–157. Frame taken from a video clip shot from the northeast, showing the north face of WTC 7 within a few minutes of the WTC 7 collapse at 5:20:52 p.m. The intensity levels have been adjusted.

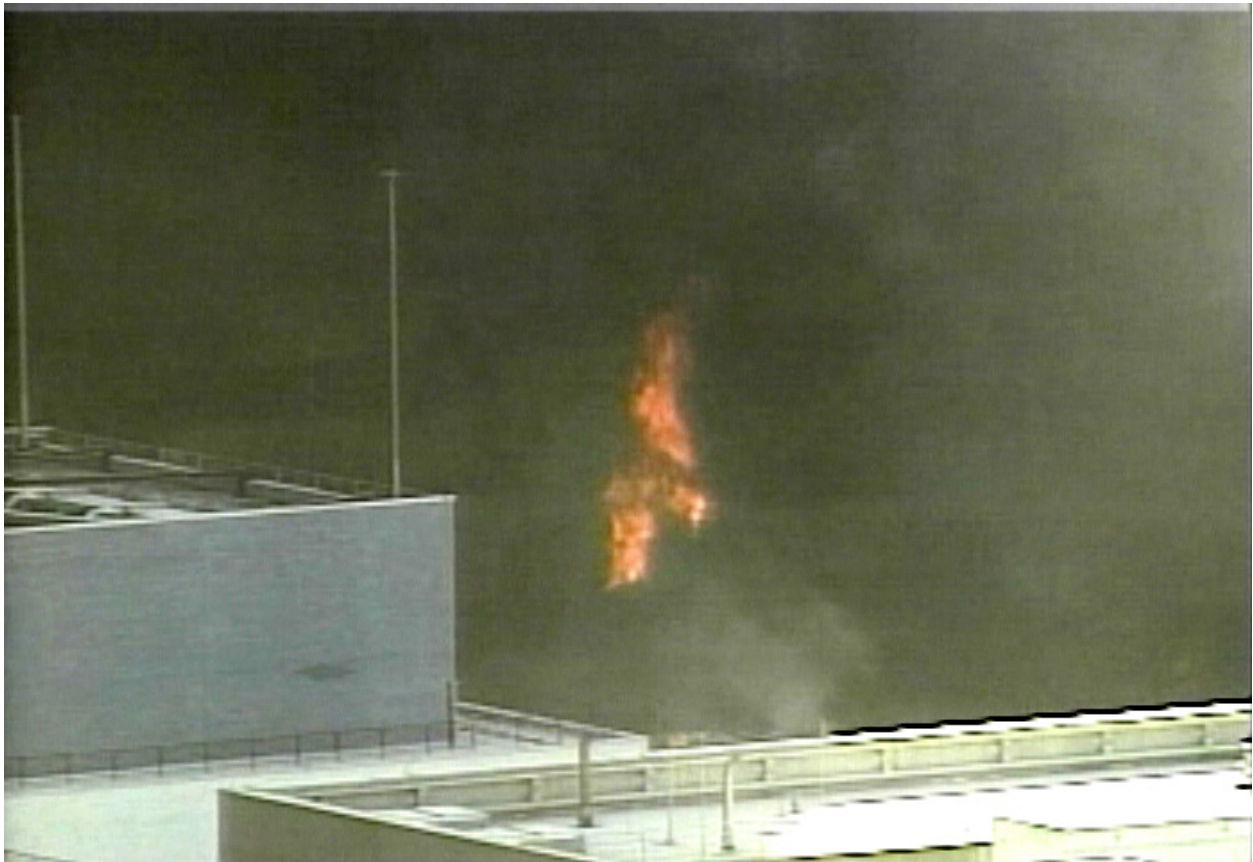
Figure 5–158. Frame taken from a video clip shot over the buildings at 30 West Broadway and 70 Murray Street, showing the western edge of the north face of WTC 7 within a few minutes of the WTC 7 collapse at 5:20:52 p.m.

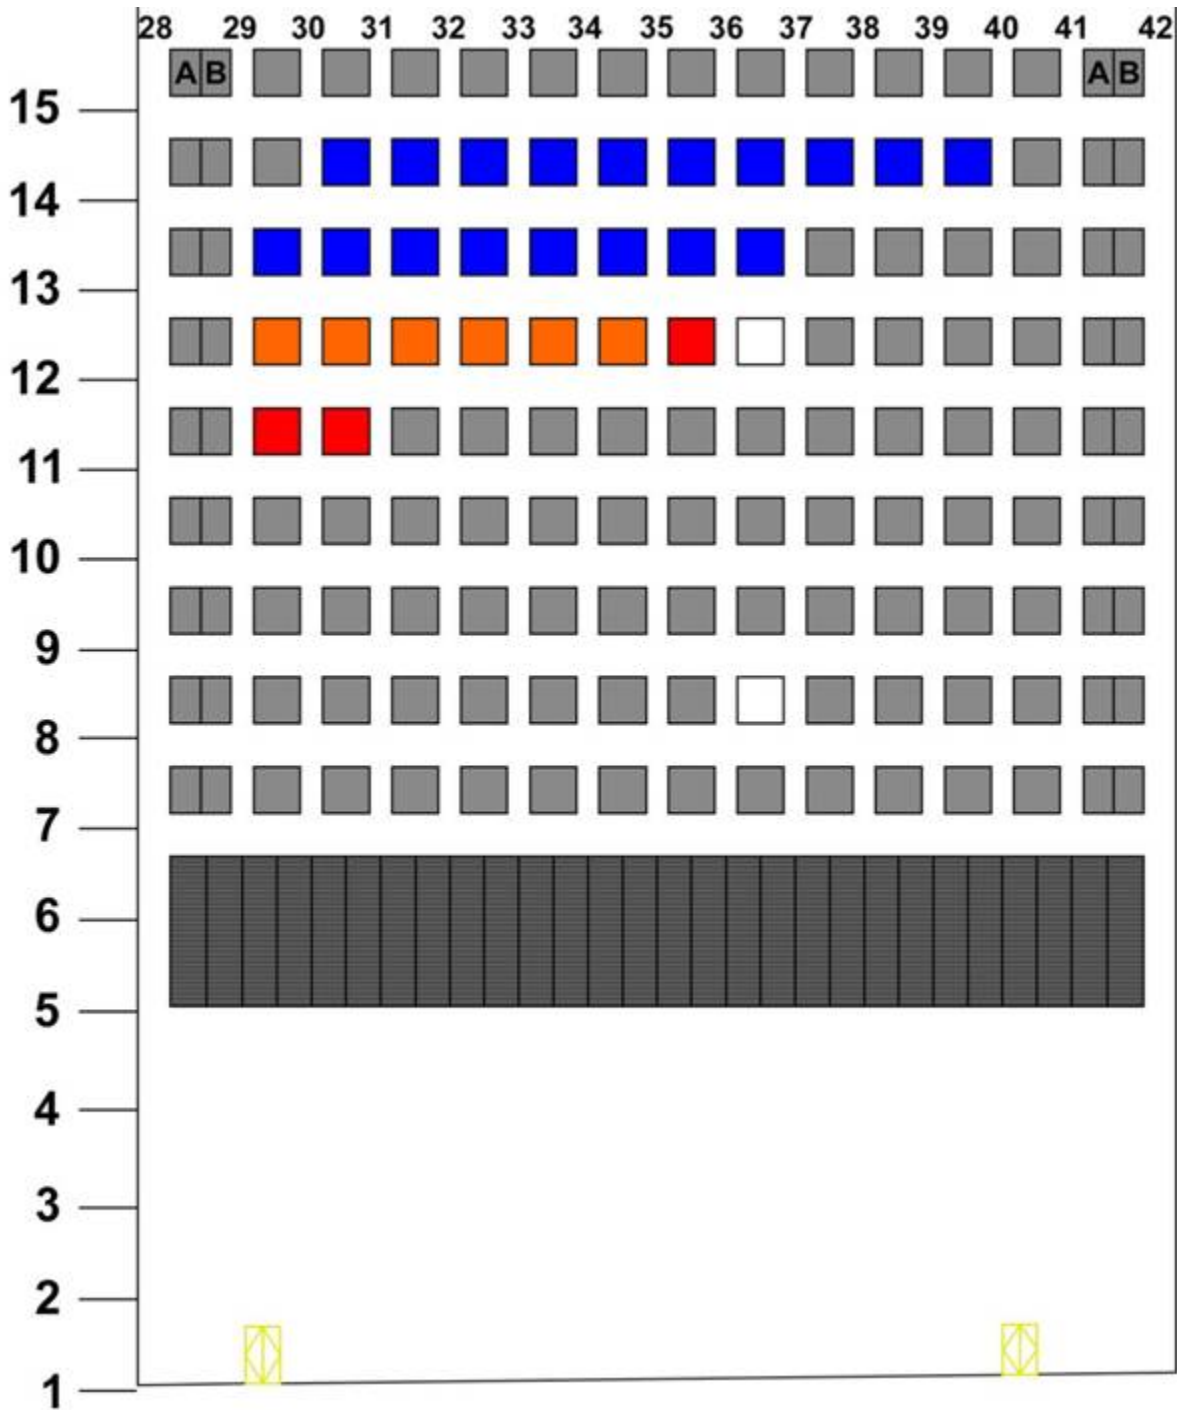
Figure 5–160. Façade map summarizing observations of fires and open windows on the east face of WTC 7 around 2:10 p.m.

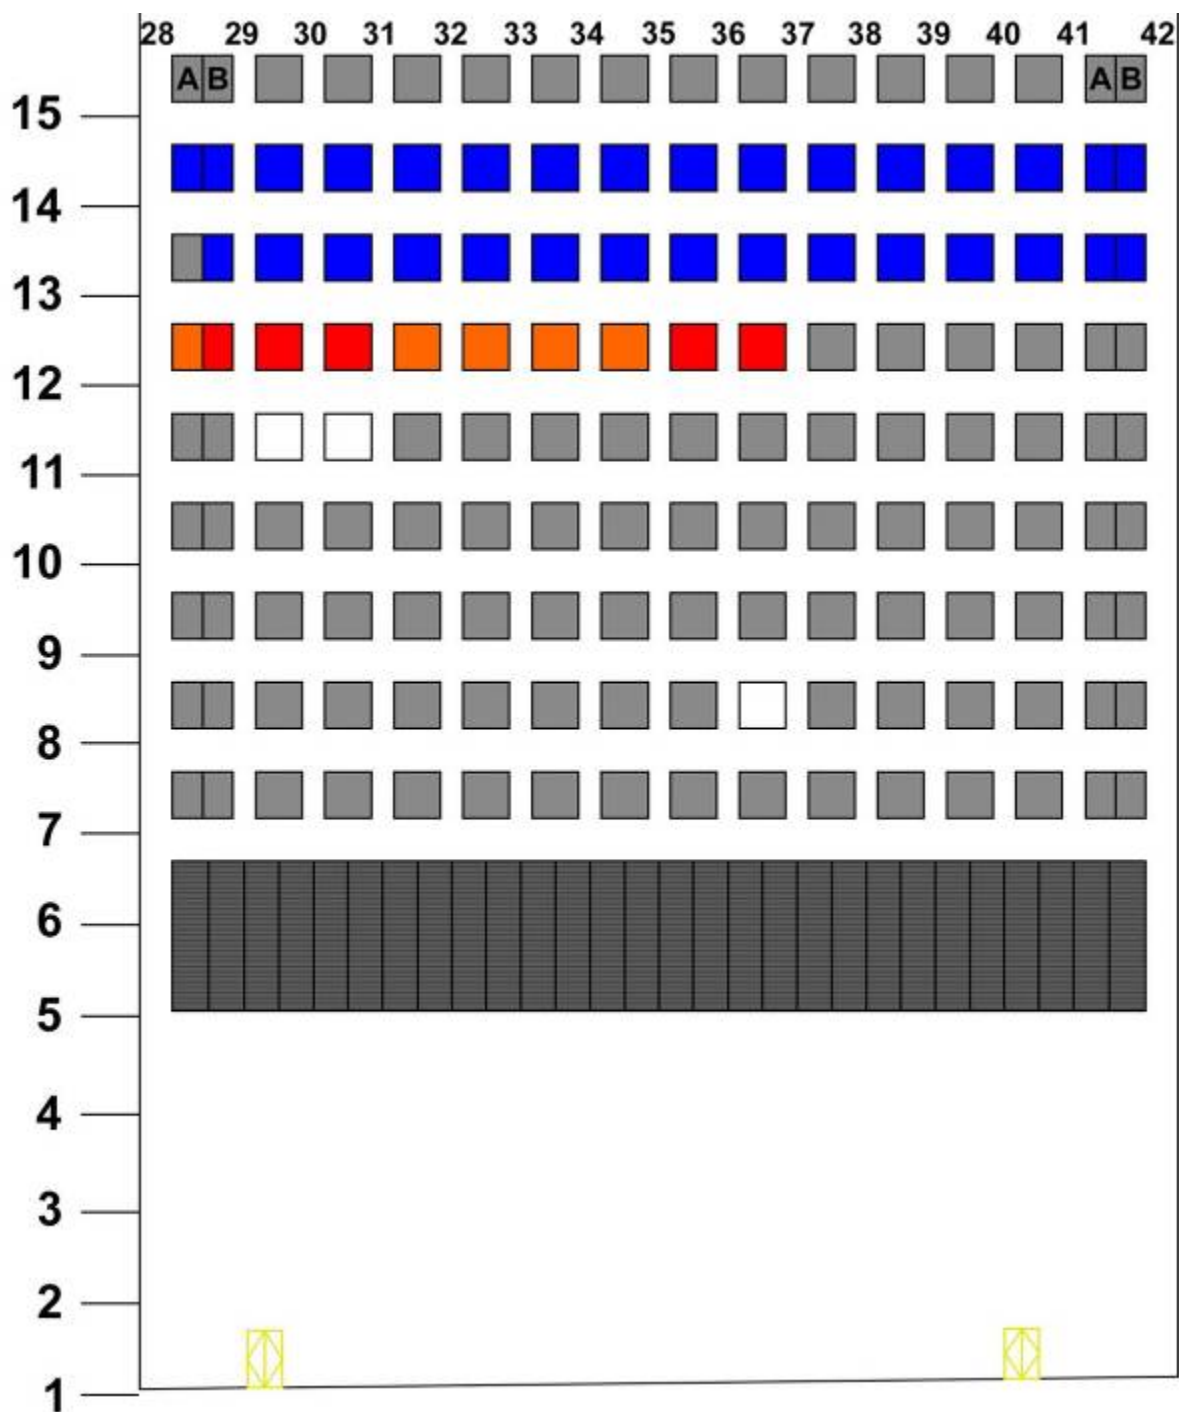
Figure 5–161. Façade map summarizing observations of fires and open windows on the east face of WTC 7 around 2:14 p.m.

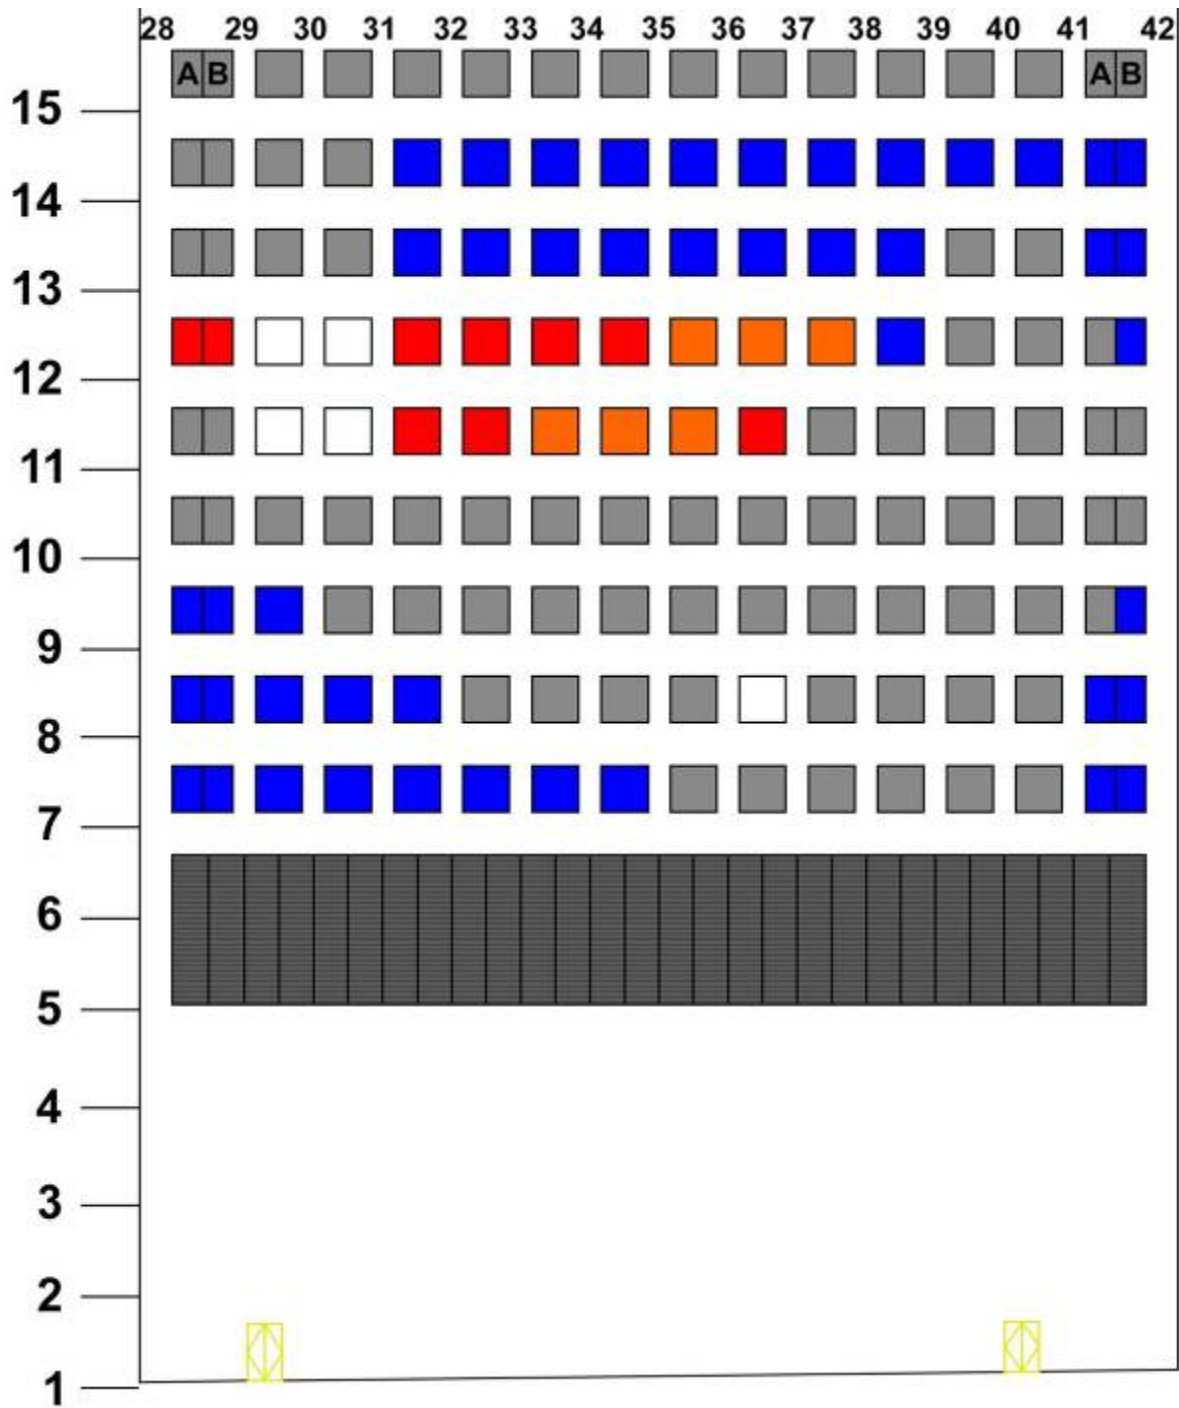
Figure 5–162. Façade map summarizing observations of fires and open windows on the east face of WTC 7 around 2:30 p.m.

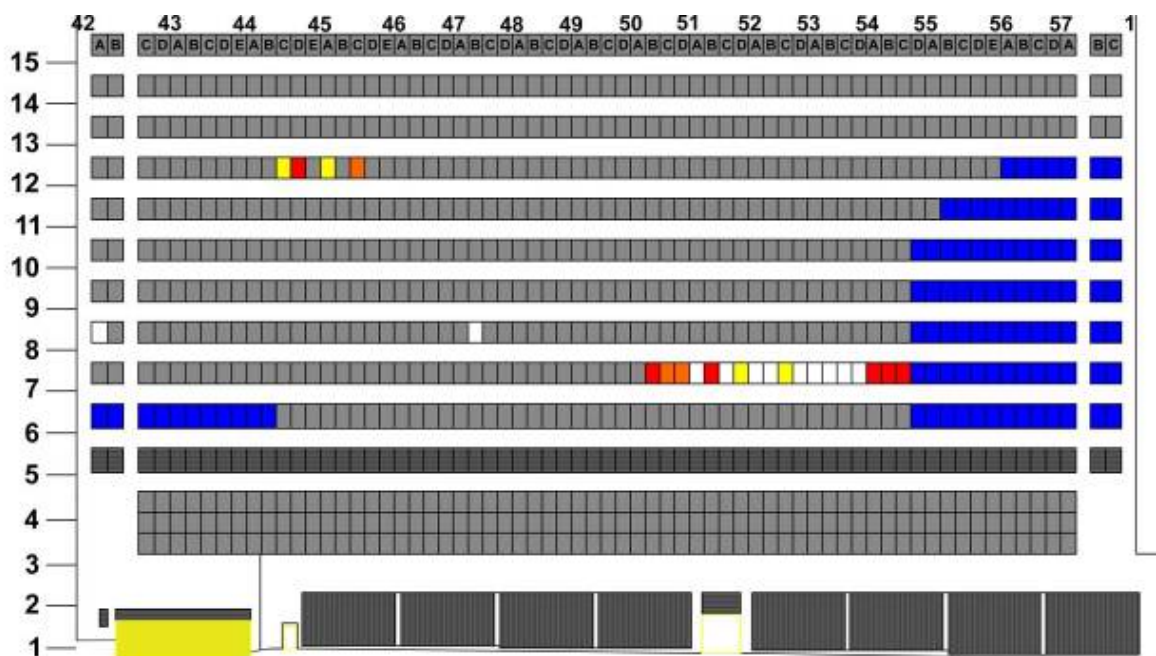
Figure 5-163. Façade map summarizing observations of fires and open windows on the north face of WTC 7 around 2:57 p.m.

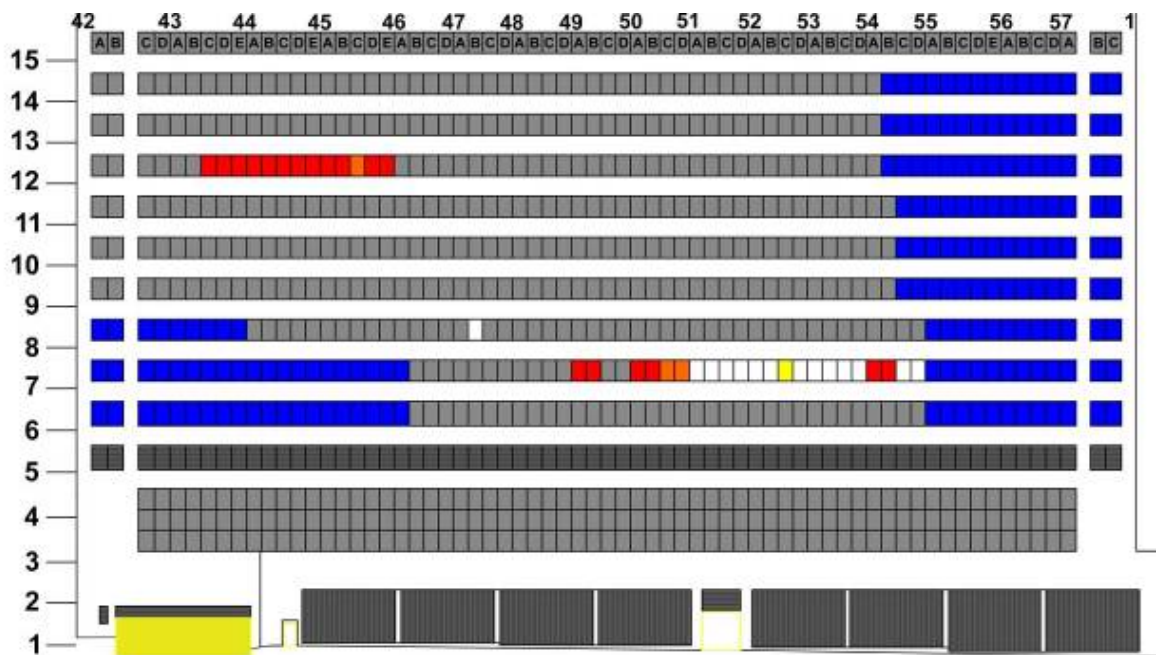
Figure 5-164. Façade map summarizing observations of fires and open windows on the north face of WTC 7 around 3:05 p.m.

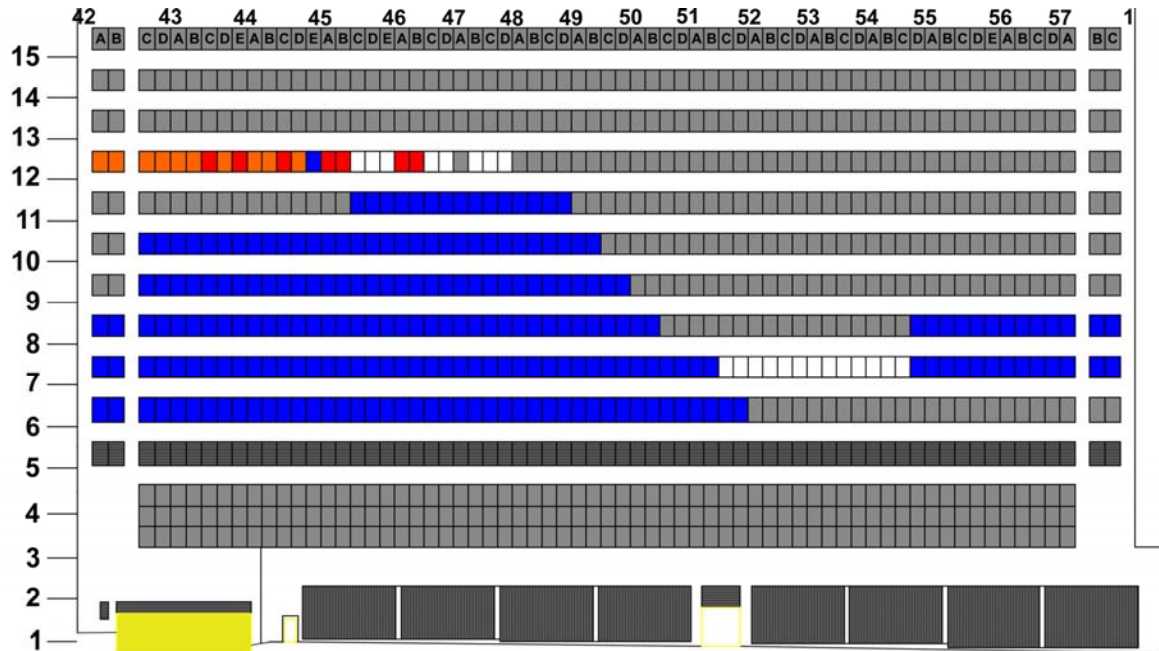
Figure 5-165. This façade map summarizes observations of fires and open windows on the north face of WTC 7 around 3:10 p.m.
