**Federal Building and Fire Safety Investigation of the
World Trade Center Disaster**

**Structural Fire Response and
Probable Collapse Sequence of
World Trade Center Building 7**

VOLUME 1

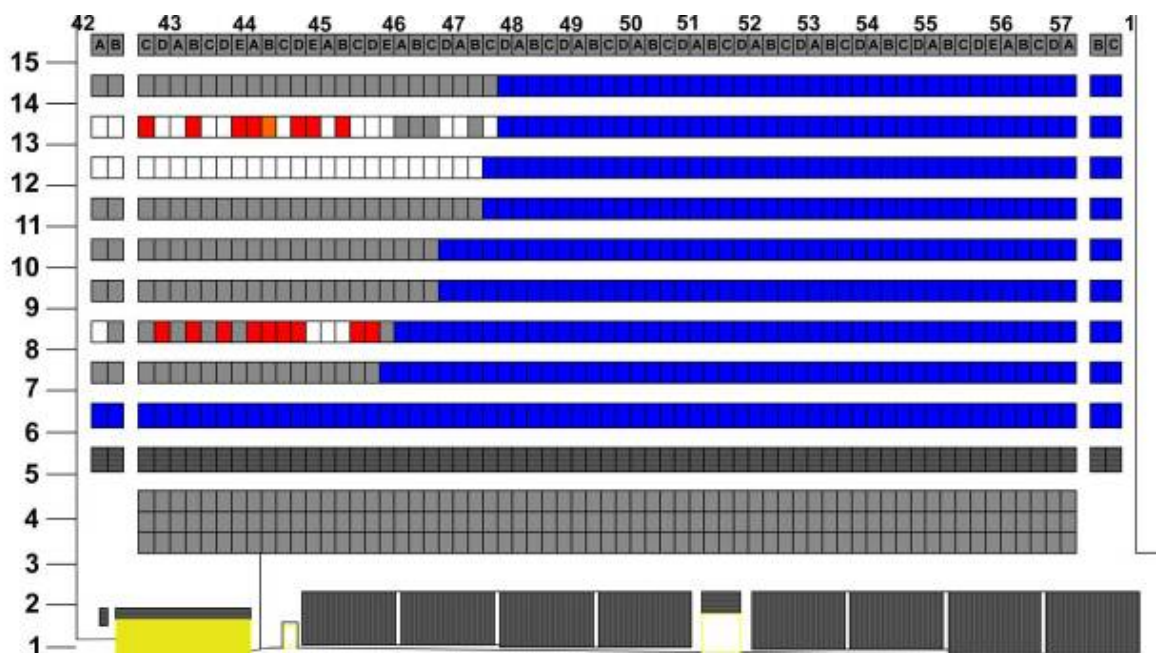
Figure 5-171. Façade map summarizing observations of fires and open windows on the north face of WTC 7 around 3:55 p.m.

Based on Figure 5-144.

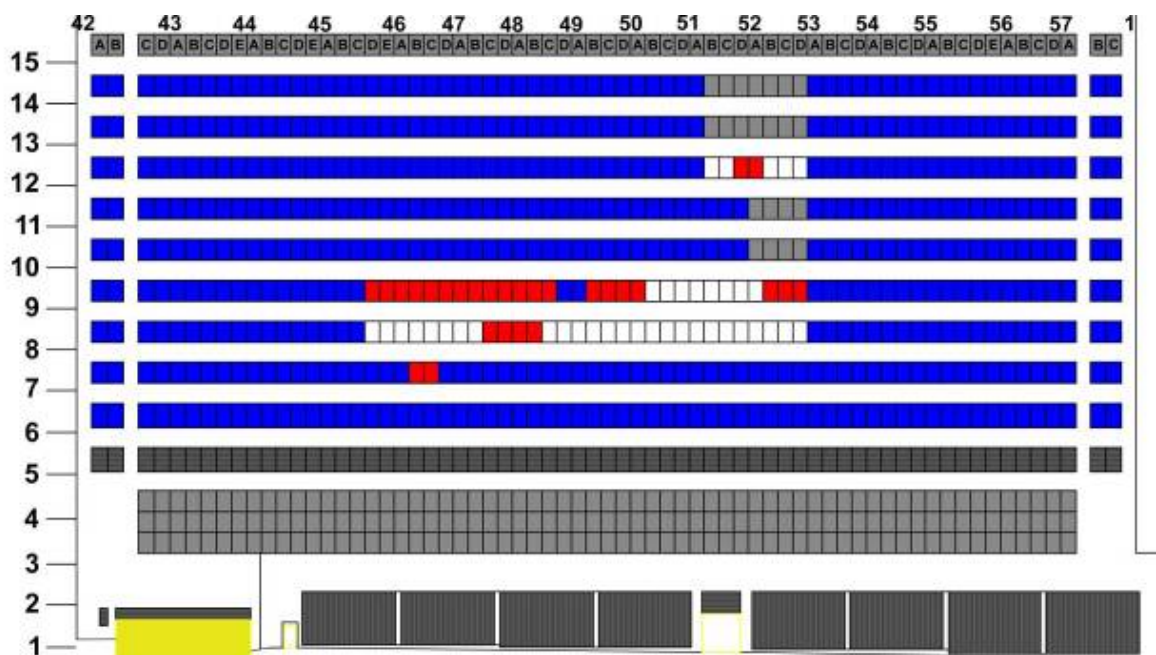
Figure 5-174. Façade map summarizing observations of fires and open windows on the north face of WTC 7 around 4:10 p.m.

Small isolated flames are evident at several locations on the 7th floor in Figure 5-145. This is somewhat surprising since the fires on this floor had stopped spreading and died down much earlier. There is still no indications that fire has spread to the east beyond Column 47. No fires or broken windows are apparent on the 6th, 10th, and 11th floors.

Based on Figure 5-145 and the video clip from which it was taken.

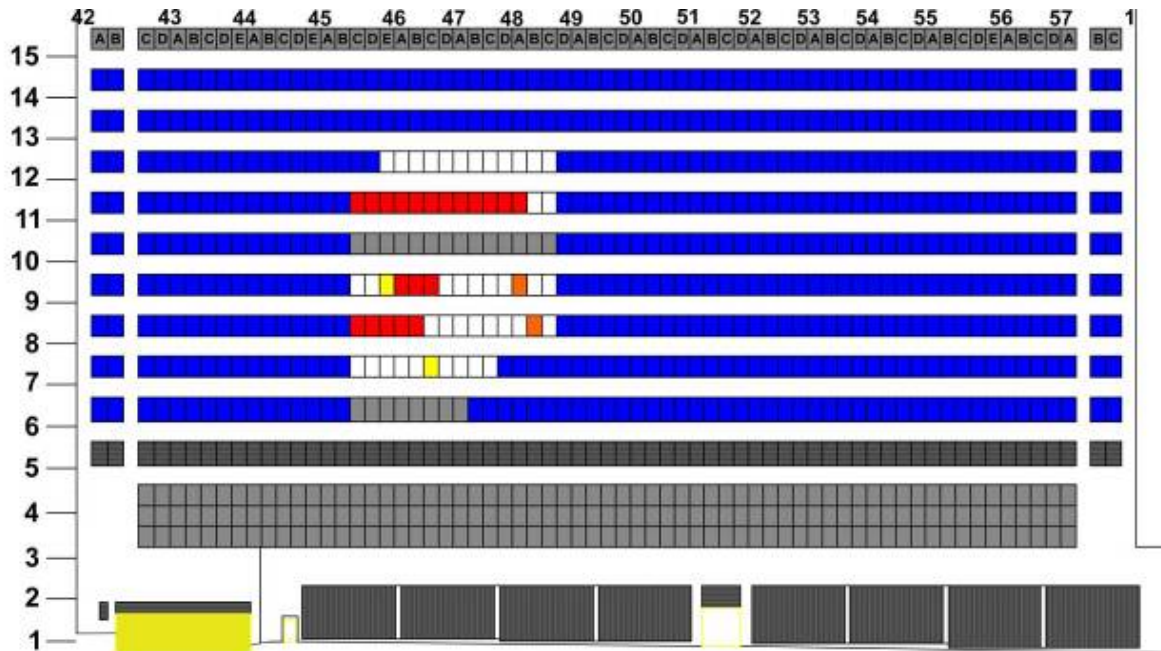
Figure 5-176. Façade map summarizing observations of fires and open windows on the north face of WTC 7 at 4:38:11 p.m.

The videographer zoomed in on the north face of WTC 7 during the same clip from which the frame in Figure 5-147 was taken. Figure 5-148 and Figure 5-149 are two spatially overlapping close-up frames that, taken together, show portions of the 6th through 14th floors just after 4:38 p.m. In Figure 5-149, the visible lengths of the floor extend from just east of Column 45 to just west of Column 47. All of the visible windows on the 7th, 8th, and 9th floors were open at this time, while all of the windows on the 6th and 10th floors still had glass in place. Small spot fires are visible at numerous locations on the three floors with open windows.

Figure 5-149 shows the visible portions of the 9th to 14th floors. The most prominent feature is the extensive fire present on the 11th floor between windows 11-44E and 11-46D. A dull red glow is visible through window 11-47A. This image provides the earliest evidence that the fire on this floor had reached the north face. There was no sign of a fire on this face in earlier images. Recall that a growing fire was observed on the east side of this floor as early as 2:08 p.m. It is remarkable that nearly two and a half hours were required for fire to finally appear on the north side. Even though there is substantial fire present on the floor, no smoke is visible coming from the open windows. This is another example where the fires were venting elsewhere.

Based on Figure 5-148 and Figure 5-149 and the video clip from which these frames were taken.

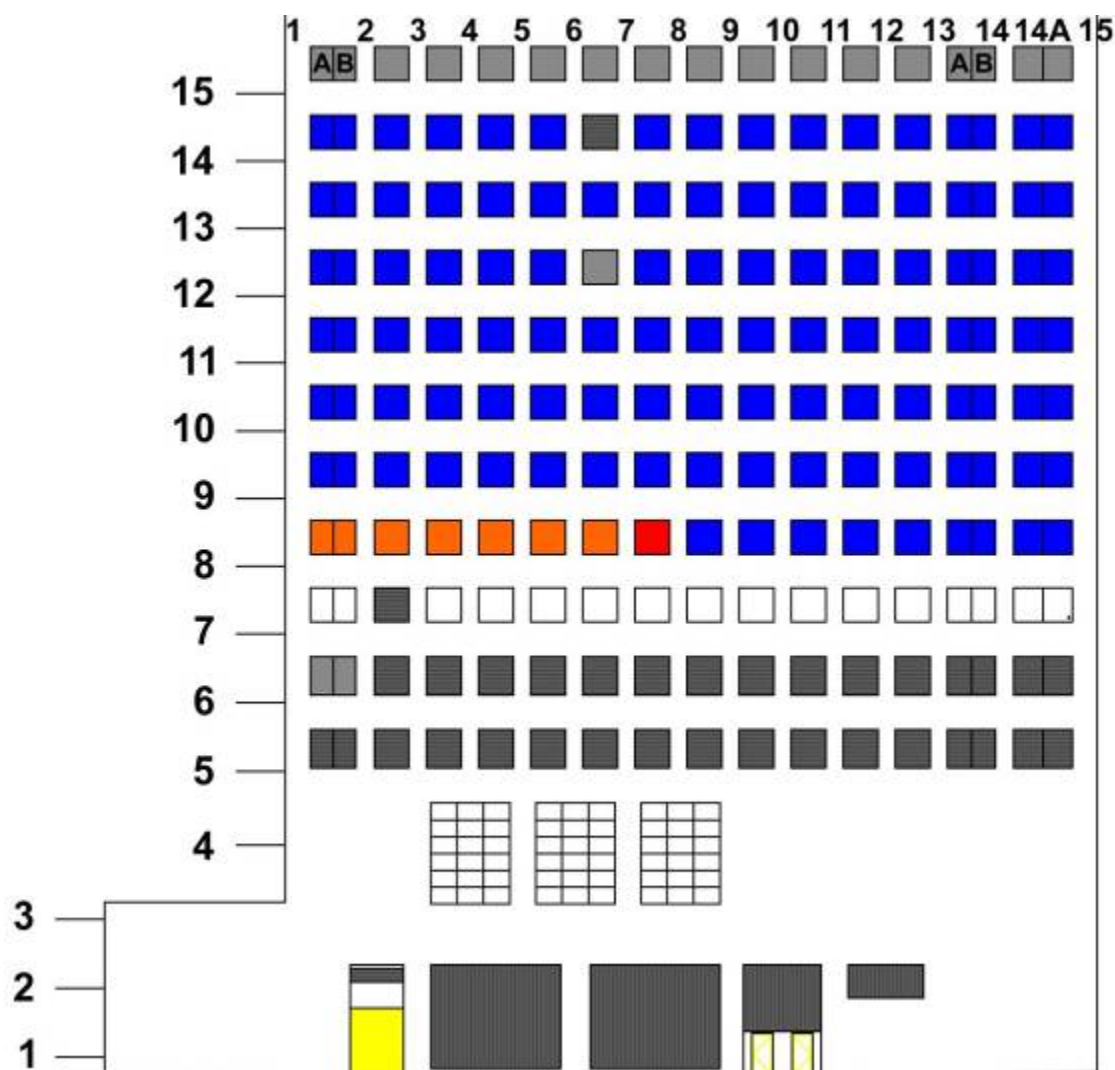
Figure 5–179. This façade map summarizes observations of fires and open windows on the west face of WTC 7 around 3:52 p.m.

Based on several video clips including the one from which Figure 5–132 and Figure 5–133 were taken.

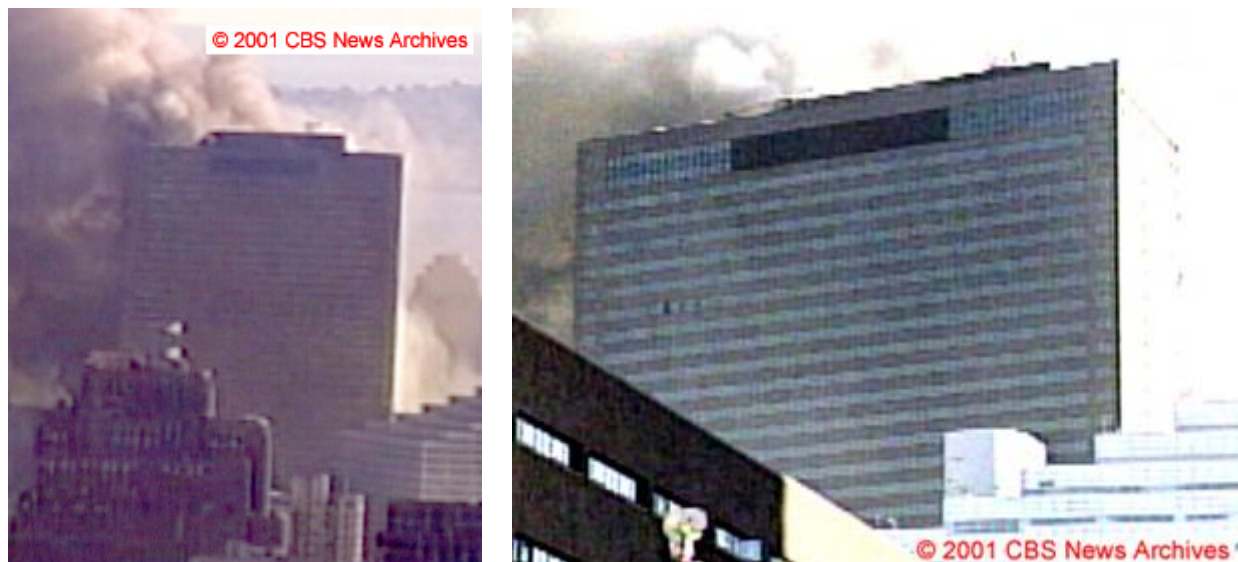
Figure 5–196. Cropped frames from the Camera 2 video clip and the Camera 3 video clip, showing the north face of WTC 7 $2.0 \text{ s} \pm 0.1 \text{ s}$ after the east penthouse began to move downward.
The intensities have been adjusted.

Just prior to the time that Figure 5–196 was taken (at 3.5 ± 0.1 s), an additional failure was observed on the roof of WTC 7 in the Camera 2 video clip. A relatively small piece of screenwall or mechanical equipment in the vicinity of the east end of the screenwalls began to move and appeared to rotate downward toward the south or west. It disappeared from view in about 2 s.

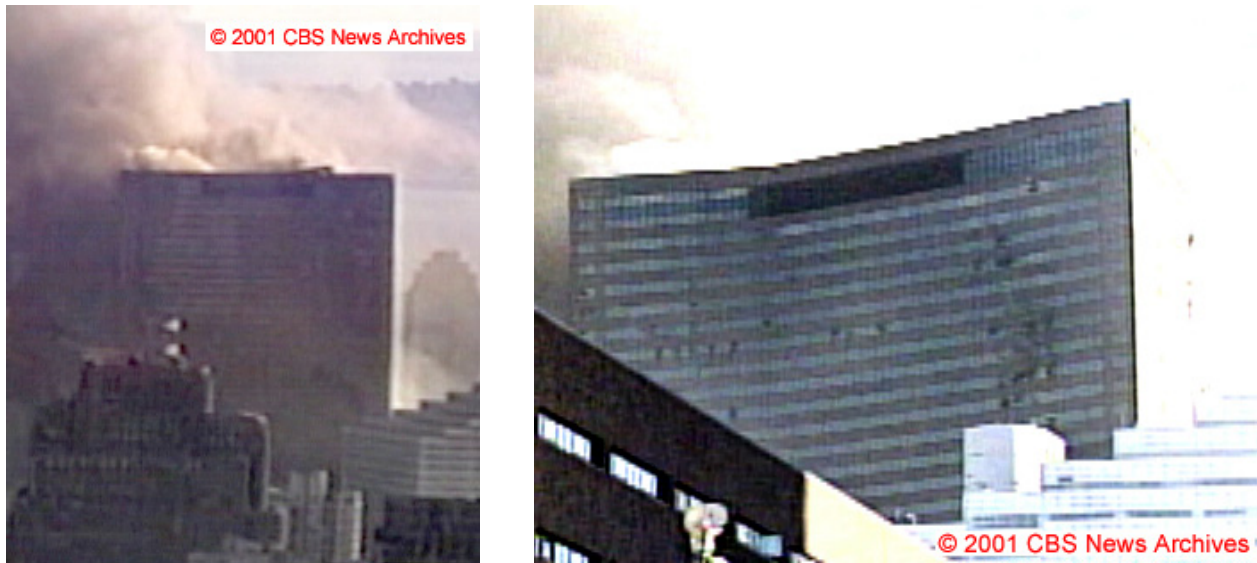
Figure 5–203. Cropped frames from the Camera 2 video clip in Figure 5–185 and the Camera 3 video clip in Figure 5–186, showing the north face of WTC 7 $9.0 \text{ s} \pm 0.1 \text{ s}$ after the east penthouse began to move downward.
The intensities have been adjusted.

Camera 2 and Camera 3 views of the north face of WTC 7 recorded 0.9 s after those in Figure 5–202, i.e., 9.0 s after the east penthouse began to move, are shown in Figure 5–203. By this time, the entire north face that is visible above the foreground buildings was clearly falling as a unit. By counting the visible floors above the foreground building in the view from West Street, it was found that WTC 7 had fallen nearly two stories in the 2.1 s since the global collapse started. The façade damage on the west side of the face has increased and seems to extend over most of the visible floors between Columns 54 and 55. What appears to be dust has begun to flow from the open windows. A few additional windows have opened near the center of the face since the frame in Figure 5–202 was taken. The distribution of open east-side windows looks similar at the two times. The rotation of the east edge of the north face has become more evident, and a distinct kink has begun to develop just to the left of the east end of the louvers on the 46th and 47th floors. This location is close to perimeter Column 47.

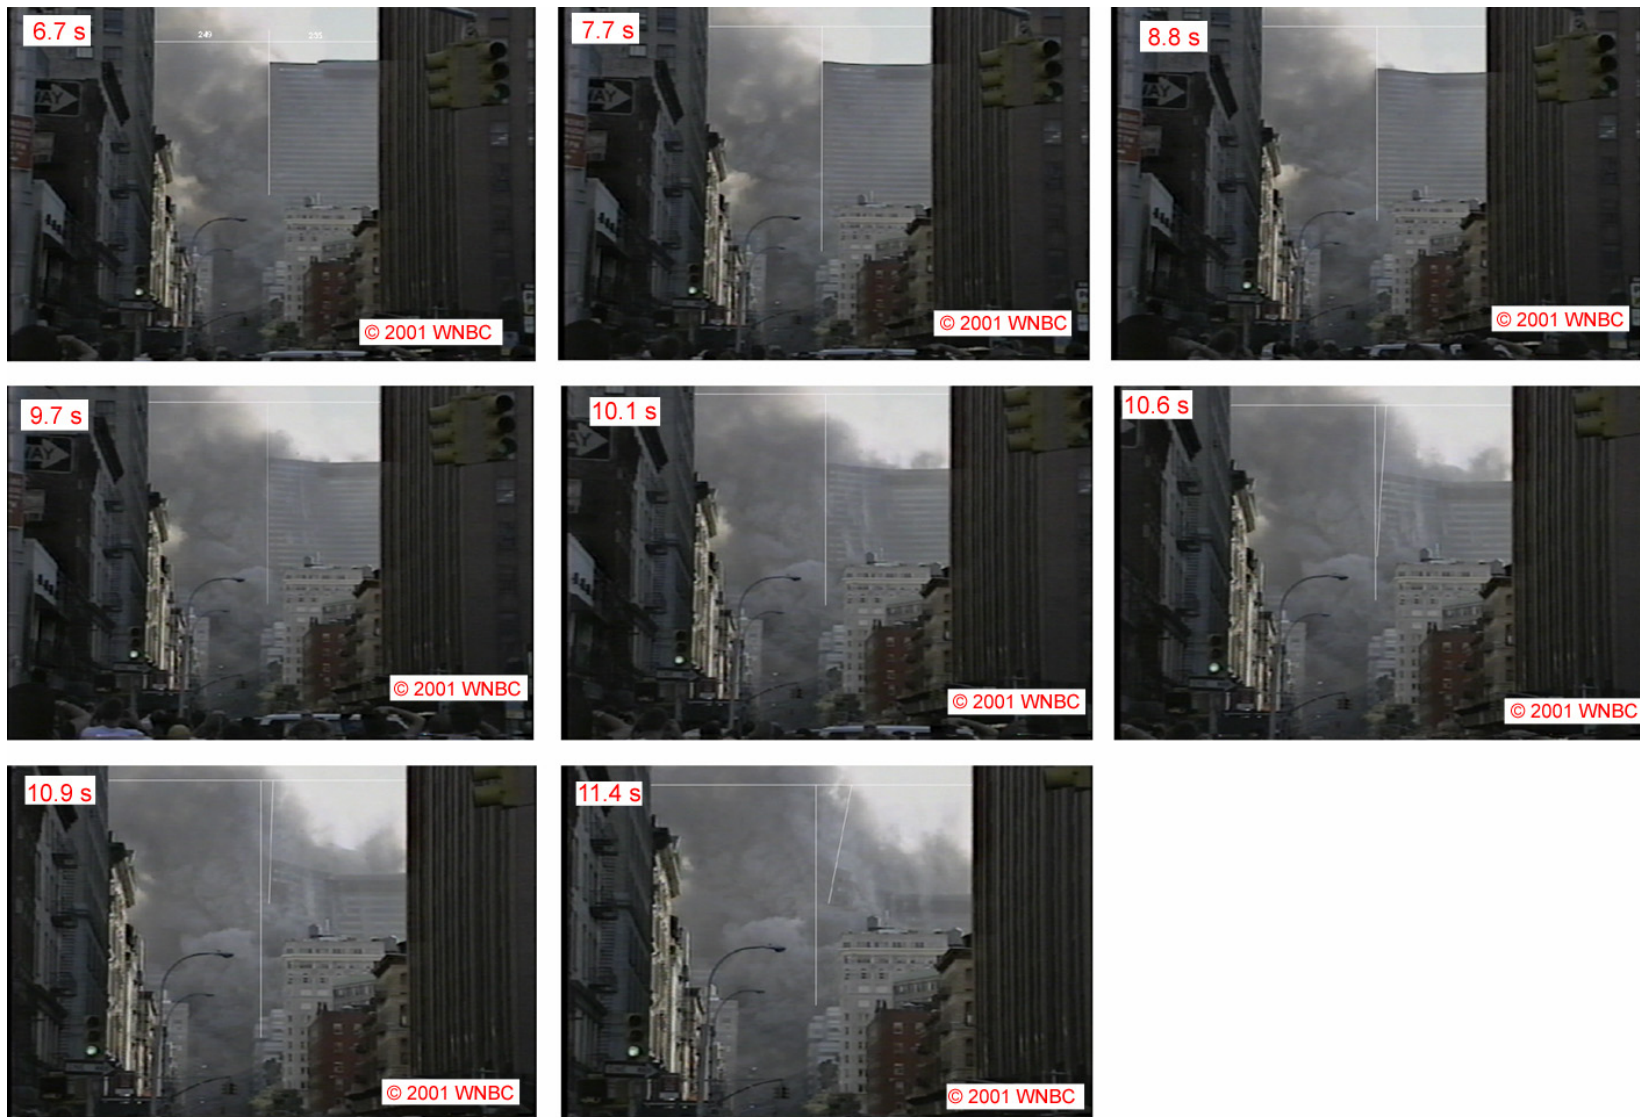
Figure 5–204. Images from the Camera 4 video clip showing relative movement of the northeast edge of WTC 7 during its global collapse.

By utilizing video clips from the Camera 3 and Camera 4 videos it was possible to characterize the motions of the northeast and northwest edges of WTC 7 in more detail. A sequence of images from the Camera 4 video is shown in Figure 5–204. This camera was hand held, and during the collapse the camera moved and the operator began to zoom in. As a result, the line corresponding to the pre-collapse location of the northeast edge of WTC 7 moved within the video frames with time. However, the two buildings in the foreground were fixed and provided a means to identify this location in frames after the collapse began. In the first image of Figure 5–204, a vertical line has been drawn tracing the northeast edge of WTC 7, and a horizontal line was drawn to the two buildings in the foreground. Using the foreground building edges as guides, these same lines were imposed on subsequent frames, in effect

identifying the original location of the northeast edge in the frame. Onto each subsequent image, the same lines have been added that trace the evolving location of the northeast edge of the building. In the first five frames the original line and the edge of WTC 7 at the later time coincide within the resolution of the image, showing that the visible northeast edge had not moved perpendicular to a line running between the camera position and the edge of the building. During this time, WTC 7 had begun to collapse, and the roofline had already descended about 10 stories. Thus, well into the building collapse, the northeast corner of the building fell either straight down, directly toward, or directly away from the video camera. In the next frame at 10.6 s following initial movement of the east penthouse, the top of the northeast corner of the building has tilted sharply to the west, and it appears that the building has begun to break apart. This motion continued to grow until the northeast edge became hidden by the rising dust cloud.

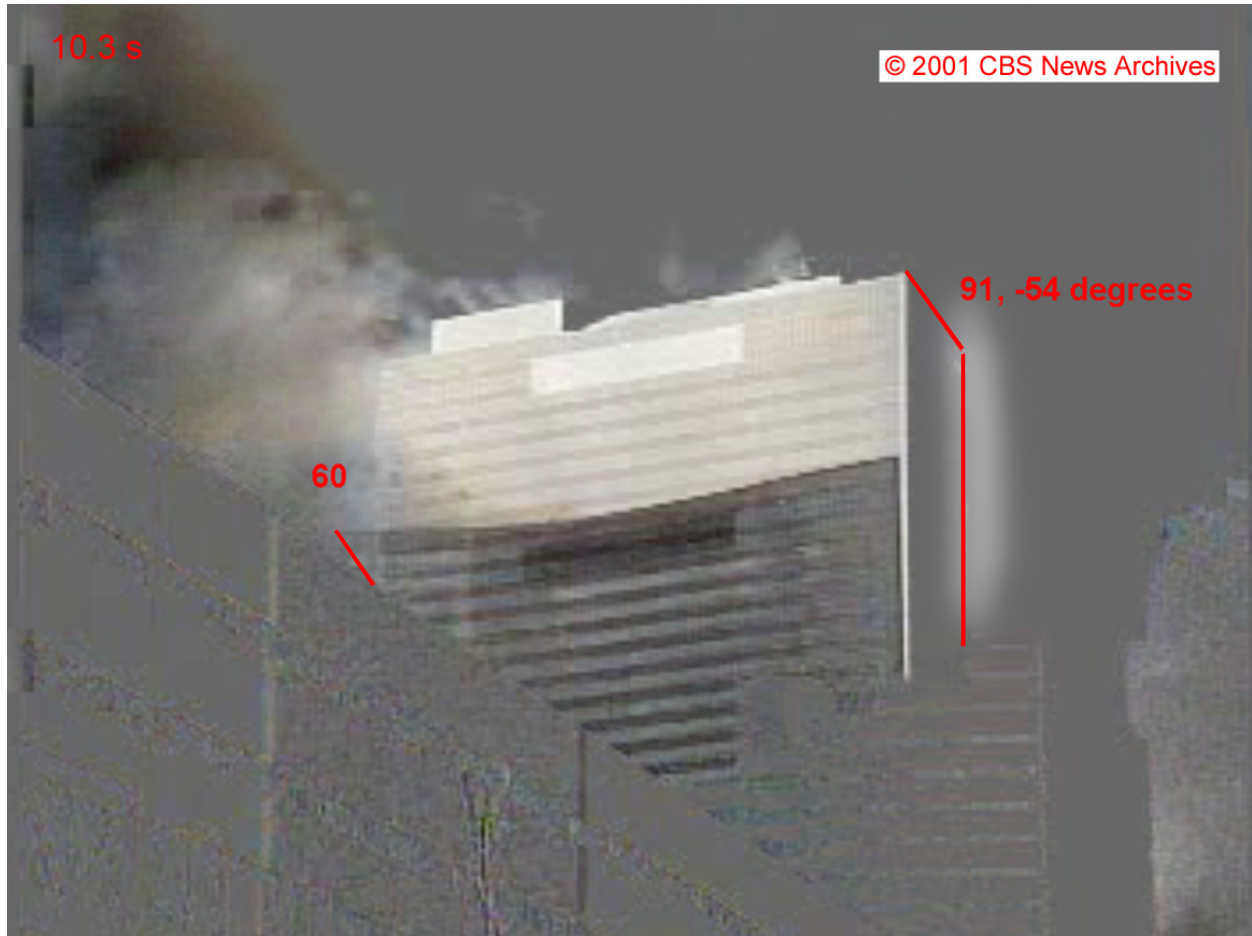
Figure 5–206. Heavily processed difference frame from the camera 3 video, used to estimate the lateral distance the northeast corner of WTC 7 moved from its original footprint during the collapse.

The extent of the northeast edge motion was estimated using the Camera 3 video frame in Figure 5–206, at which time the top of the building had descended about seven stories. The two red lines on the right trace the west roofline and the southwest edge of WTC 7. The red line at the left is parallel to the west roofline and passes through the top of the northeast corner of the descending roofline. A geometric calculation was performed, involving the angle between these two lines, the dimensions of the building, the distance between the camera and the building, and the viewing angles of the northeast and southwest corners. The calculation led to an estimate that, at this point in the collapse, the top of the northeast corner roofline was displaced $11 \text{ m} \pm 3 \text{ m}$ from its original footprint. In combination with observations from Figure 5–204, it is possible to determine that the motion was primarily due north.

It was recorded 10.3 s after the east penthouse began to move down.

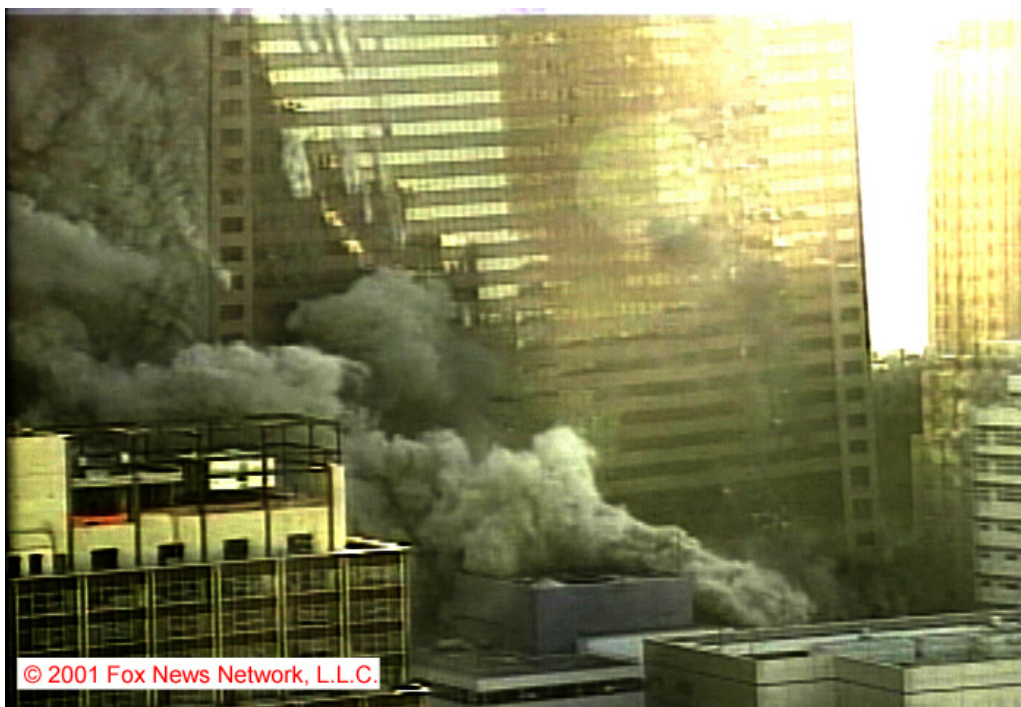
Figure 5–209 shows a frame from Camera 6 of the north face of WTC 7 recorded 10.0 s after the east penthouse began to collapse. Dust trails are flowing from the open windows on the east and west sides of the building. Numerous windows are open near the center of the face, but no dust flows are evident from these windows. The kink in the face near Column 47 observed near the top of building in Figure 5–208 appears to extend at least as far down as the mechanical floors on the 22nd and 23rd floors.

Figure 5–209. Frame from the Camera 6 video clip in Figure 5–189, showing the north face of WTC 7 $10.0 \text{ s} \pm 0.2 \text{ s}$ after the east penthouse began to descend. The intensities have been adjusted.

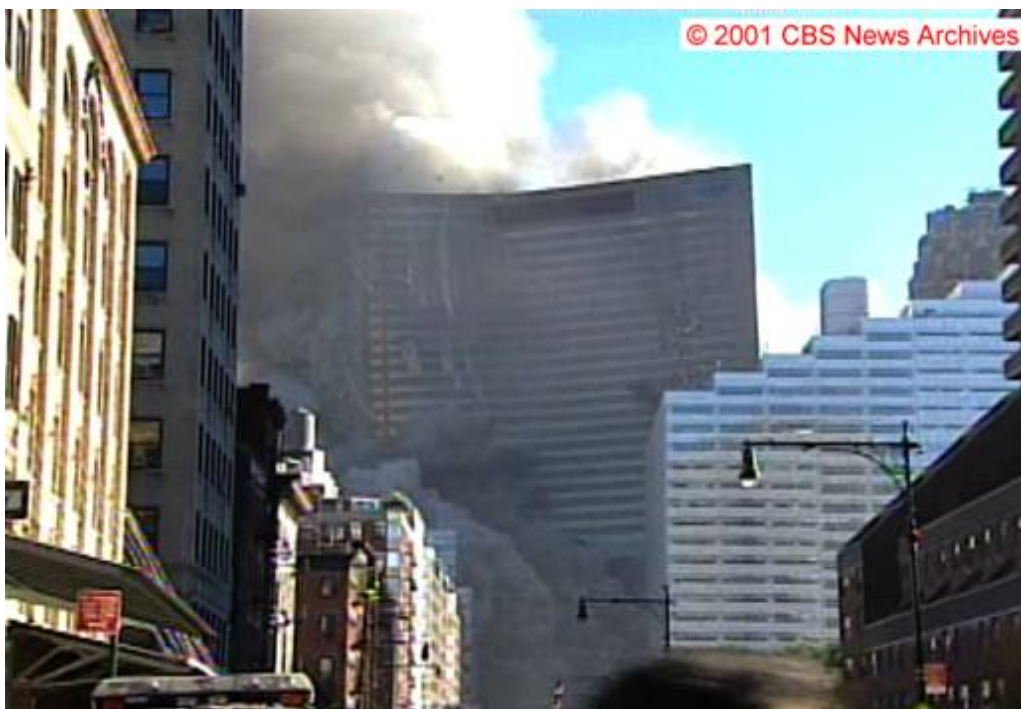
Figure 5–210 is a frame from the Camera 9 video showing the collapse at the same time looking up Greenwich Street. The appearance of the collapsing north face is consistent with the descriptions above. The appearance of the dust cloud at the base of the building has not changed markedly from that seen in Figure 5–192.

Figure 5–210. Frame from the Camera 9 video clip in Figure 5–192, showing the north face of WTC 7 $10.0 \text{ s} \pm 0.2 \text{ s}$ after the east penthouse began to move downward. The intensities have been adjusted.

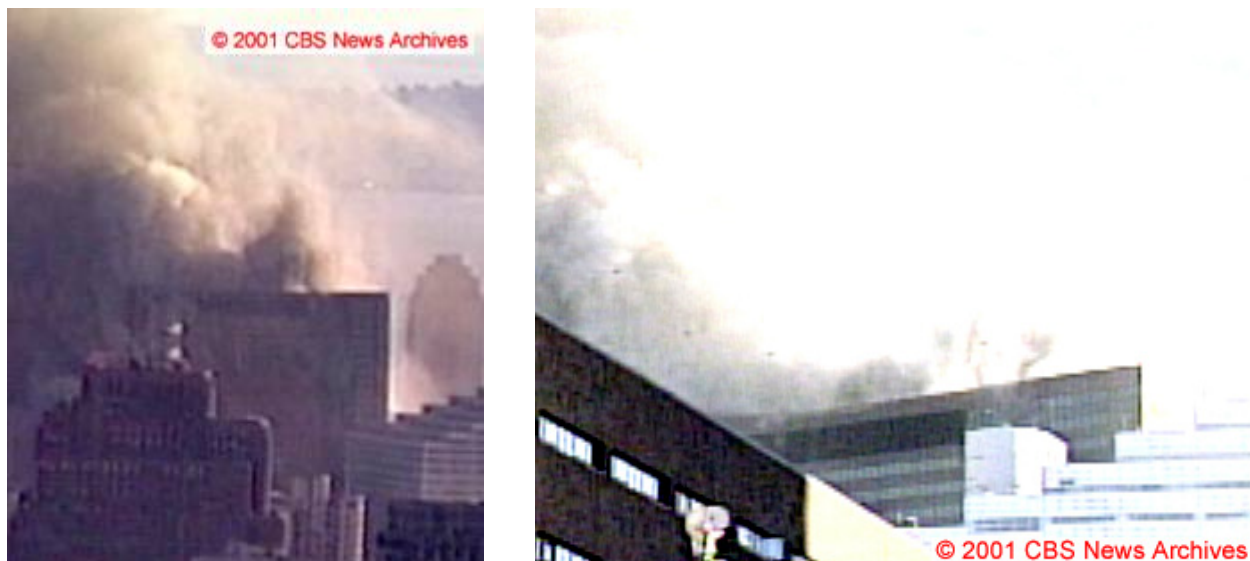
During the next second, the north face of WTC 7 moved downward nearly 6 stories. Figure 5–211 shows the Camera 2 distant and Camera 3 West Street views at 11.0 s following the initial downward movement of the east penthouse. WTC 7 is just about to pass out of sight behind the foreground building in the West Street view. While dust clouds continue to pass over the face, it is remarkable how many windows are still intact at the top of the building. The amount of dust pouring from the open windows of the falling north face is more evident in the distant view. It is also clear that a large amount of dust has been ejected through the roof at the two locations on the east side and near the center.

Figure 5–211. Cropped frames from the Camera 2 video clip in Figure 5–185 and the Camera 3 video clip in Figure 5–186, showing the north face of WTC 7 $11.0 \text{ s} \pm 0.1 \text{ s}$ after the east penthouse began to move downward.
The intensities have been adjusted.

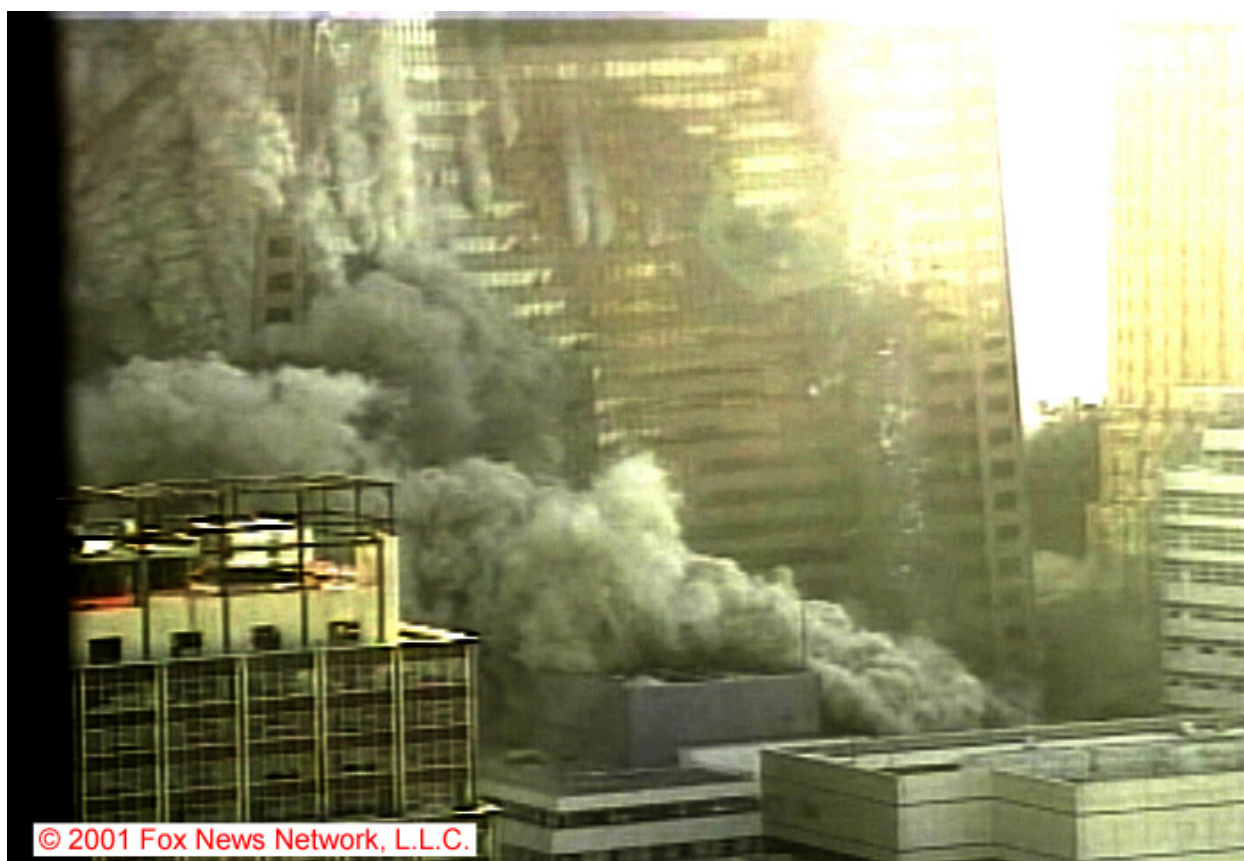
Figure 5–212. Frame from the Camera 6 video clip in Figure 5–189, showing the north face of WTC 7 $11.0 \text{ s} \pm 0.2 \text{ s}$ after the east penthouse began to move downward.
The intensities have been adjusted.

Figure 5–212 and Figure 5–213 show frames from the northeast (Camera 6) and Greenwich Street (Camera 9) video clips for the same time as the images in Figure 5–211. In both frames, the distortions of the falling building stand out. The kink near Column 47 is prominent in Figure 5–213, while in Figure 5–212, a strong distortion is present near the east edge of the north face. Both frames also show the large amount of dust being pushed out of open windows higher up in the building and the huge dust clouds forming near its base. In Figure 5–212, large amounts of dust have been pushed from near the base of the building on the east, north, and west sides. A prominent feature in Figure 5–213 is the large pulses of dust flowing upward through the roof on the east side and near the center.

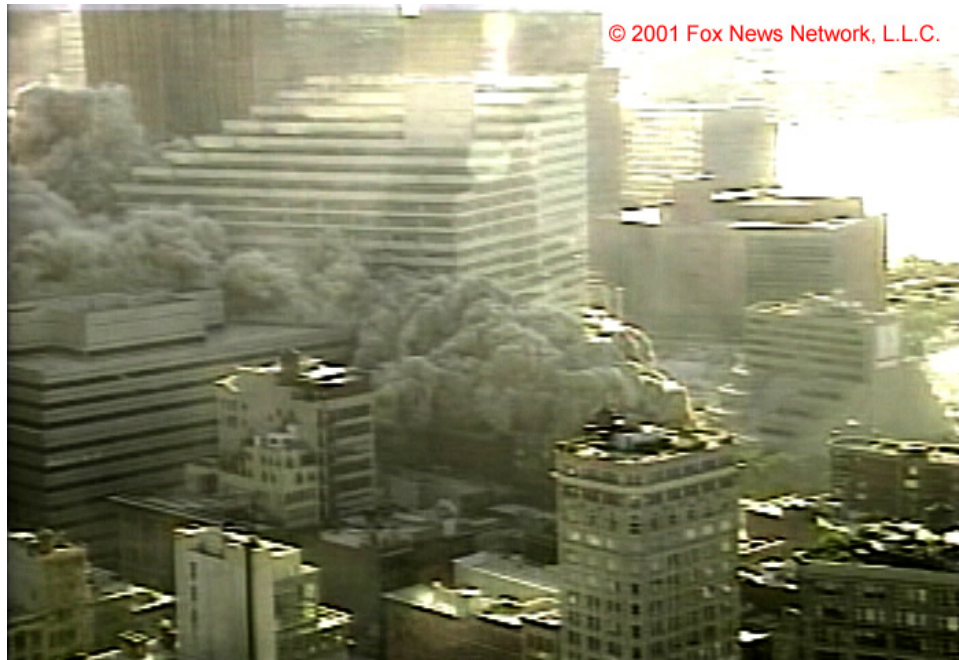
When WTC 7 collapsed, the dust that was generated mixed with air to create a dense mixture that flowed away from the site. The resulting dust- and debris-laden flow spread over many blocks of lower Manhattan. Figure 5–217 and Figure 5–218 show two views of the dust cloud as it spread northward along Greenwich Street after being channeled between the taller buildings at 123 Barclay Street on the west side and 30 West Broadway and 70 Murray Street on the east side.

Figure 5–217. Frame from the Camera 6 video clip in Figure 5–189, showing the dust-laden flow generated by the collapse of WTC 7, $22.0\text{ s} \pm 0.2\text{ s}$ after the east penthouse began to move downward. The intensities have been adjusted.

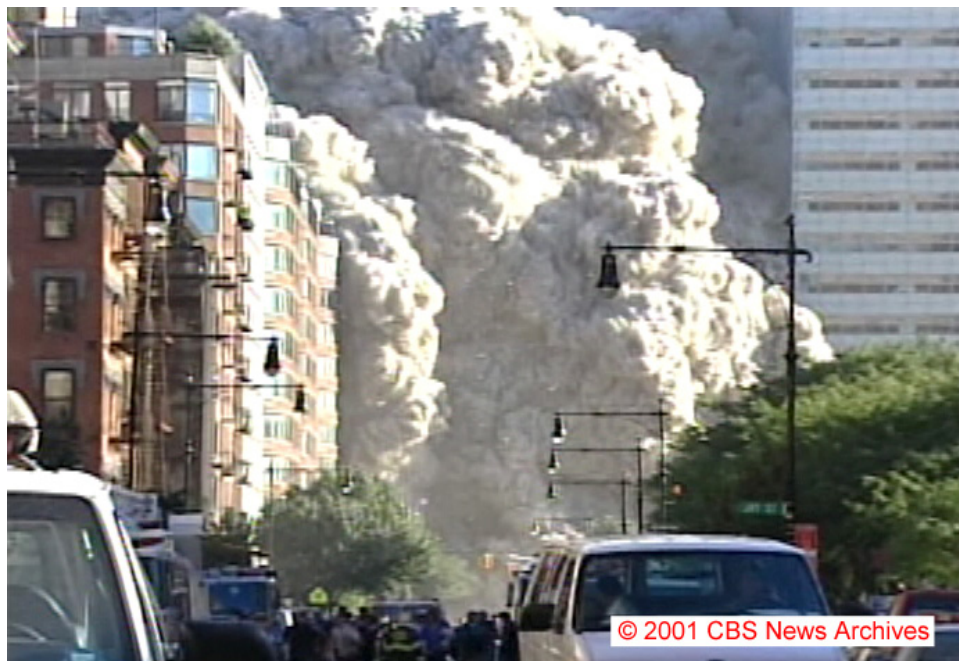
Figure 5–218. Frame from the Camera 9 video clip in Figure 5–192, showing the dust-laden flow created by the collapse of WTC 7, $22.0\text{ s} \pm 0.2\text{ s}$ after the east penthouse began to move downward. The intensities have been adjusted.

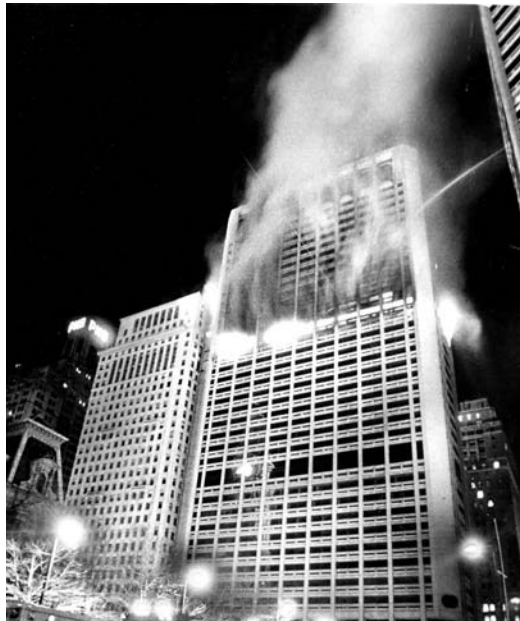
At approximately 8:30 p.m., February 23, 1991, a fire was reported at One Meridian Plaza, a 38 story office building in Philadelphia (Figure 8–9). The fire, which started on the 22nd floor, ultimately consumed the 21st through 29th floors. Fire fighting operations were suspended when it was determined that there was a possibility of a major structural collapse; the fire was extinguished only when it reached the 30th floor, which had a functioning automatic sprinkler system. Information regarding this fire, taken largely from Eisner and Manning (1991), Klem (1991), and Routley et al. (1991), is summarized here.

Figure 8–9. One Meridian Plaza fire, Philadelphia, 1991.

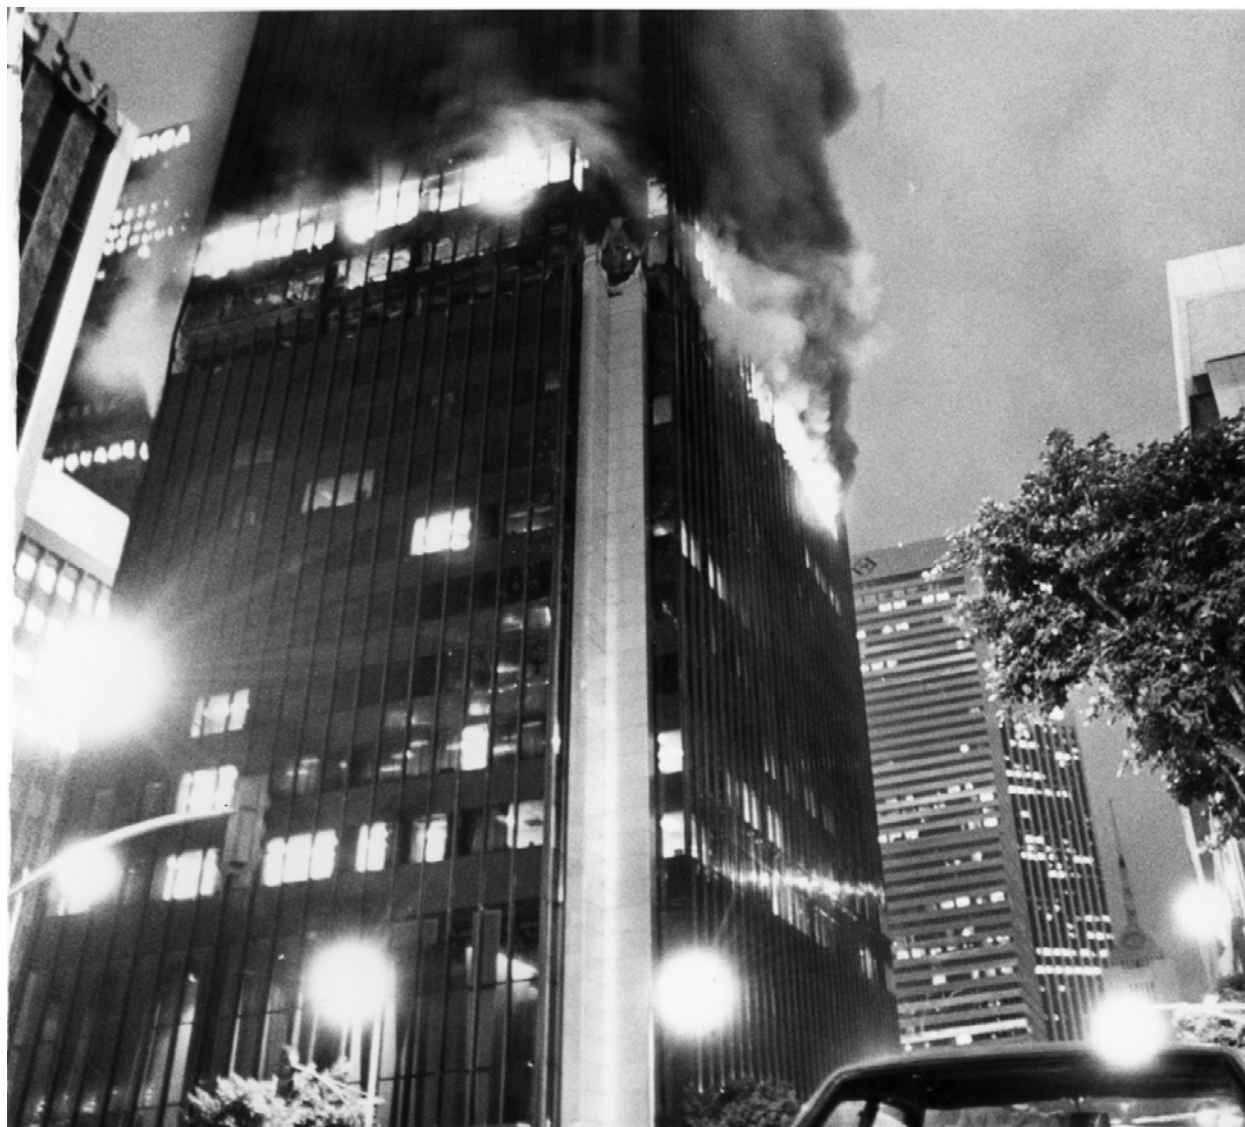
On May 4, 1988, fire broke out in the First Interstate Bank Building in downtown Los Angeles, burning out four floors and damaging a fifth (Figure 8–11). Fire originated on the 12th floor and was believed to have been caused by an electrical problem, although the source of ignition was never determined (Routley 1988). The fire was eventually controlled by the Los Angeles City Fire Department that had summoned 64 companies, totaling 383 firefighters and support personnel. Information regarding this fire has been reported in United States Fire Administration Technical Report USFA-TR-022 (Routley 1988) and in (Nelson 1989) and is summarized here.

Figure 8–11. First Interstate Bank fire, Los Angeles, 1988.

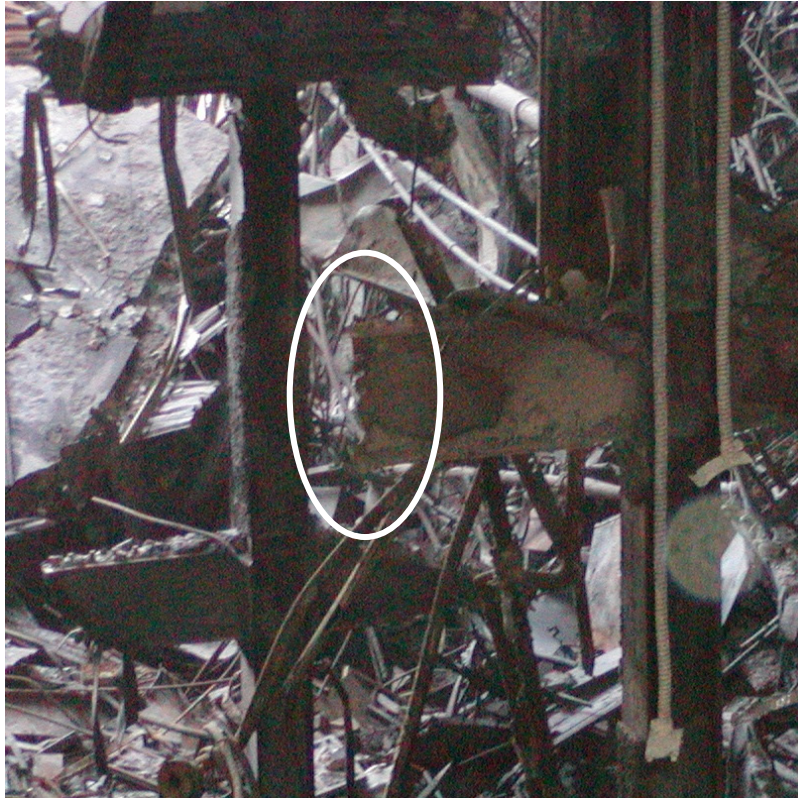
Figure 8–14. Tear-out of beam web due to uncontrolled fires.

The World Trade Center Building 5 (WTC 5) was a 9 story office building located on the northeast corner of the World Trade Center Plaza. The collapse of WTC 1 caused damage to WTC 5 and started fires in it (McAllister 2002). The uncontrolled fires resulted in complete burnout of most floors and partial collapse of four floors. The building was steel frame construction with field-bolted connections between floor beams and column tree assemblies. Failure of large sections of floor, in areas not damaged by falling debris from WTC 1, resulted from bolt tear-out at these connections as a result of the uncontrolled fires (Figure 8–14). Photographs of two recovered samples of floor beams (Figure 8–15) show how the field bolts tore out from the beam web weakened by the fires (McAllister 2002).

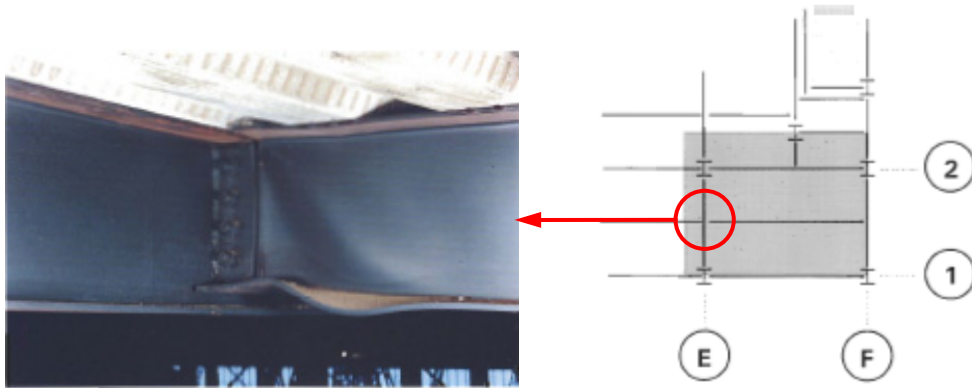
Figure 8–17. Floor beam buckling at symmetrical framing to girder.

example, Cardington Test No. 3 exposed one bay to a wood crib fire resulting in gas temperatures that reached almost 1000 °C. The floor beam in this test framed into a girder on column line E, and into a spandrel beam on the building exterior on column line F (Figure 8–17). Thermal expansion of the floor beam framing into the girder on column line E was resisted by a floor beam framing from the opposite side (the floor beam spanning between column lines D and E), resulting in forces sufficient to buckle the bottom flange. The top flange of the beam did not buckle, since both the primary and secondary beams were tied to the slab using shear studs.

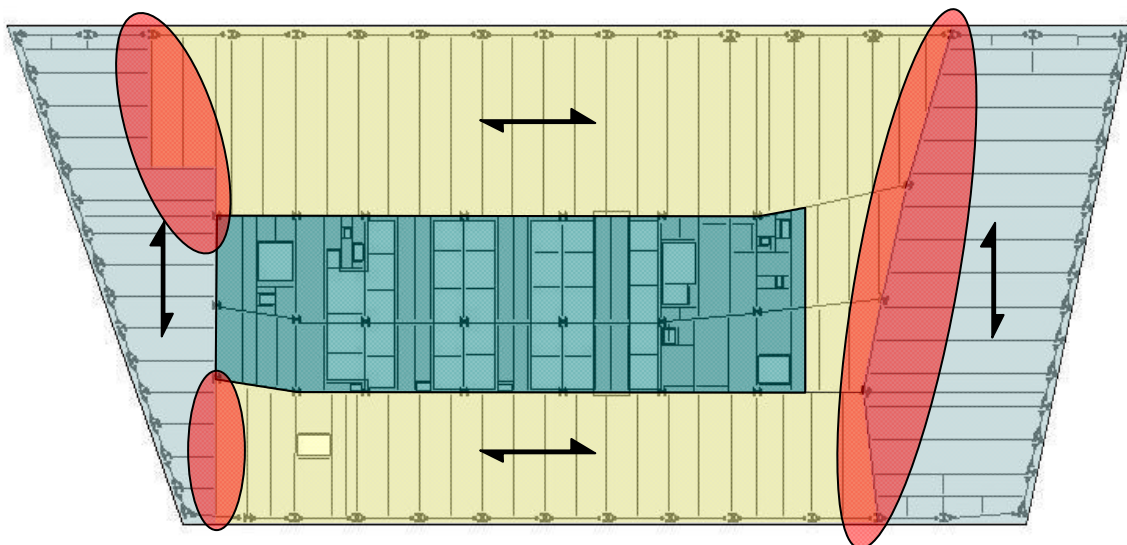
Figure 8–18. Floor framing where beams frame into only one side of the girder.

Floor beams framed into only one side of a girder in several locations in WTC 7, as shown in the highlighted areas in Figure 8–18. (Arrows indicate directions that the metal deck spanned.) Of particular interest was the northeast corner of the building. The relevance of this framing condition, in concert with the presence (or absence) of shear studs, and the use of seated connections under the effect of fire-induced thermal expansion is covered next.

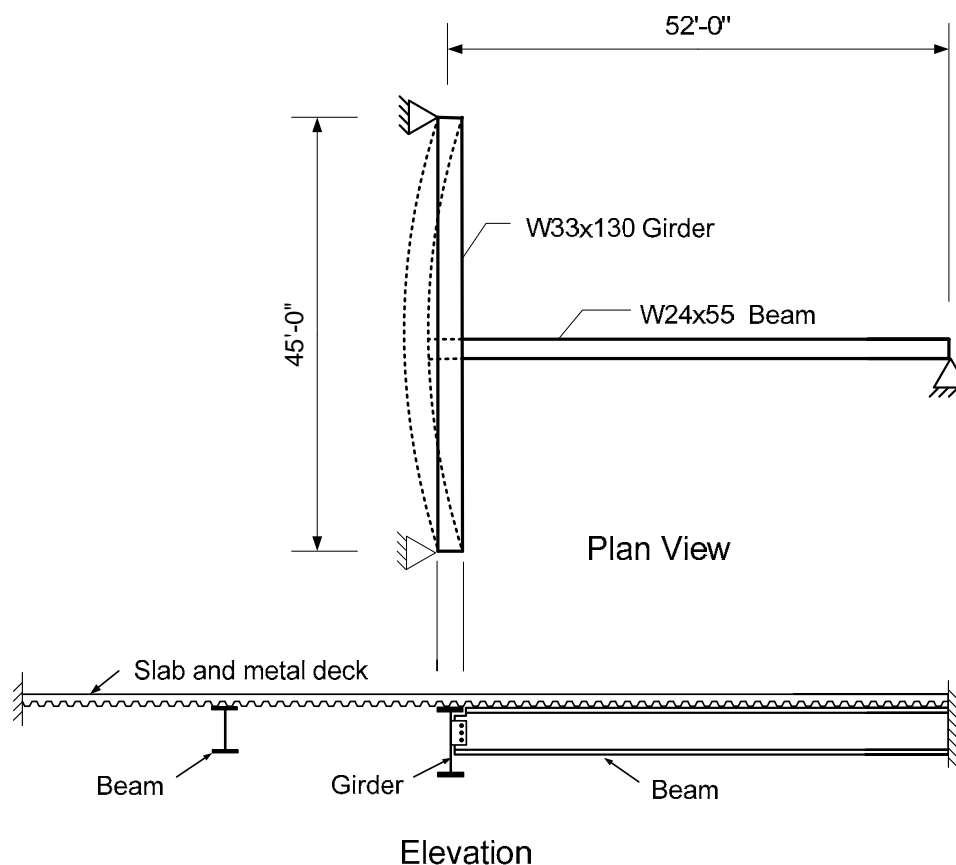
Figure 8–19. Thermal expansion of floor beams

Consider a simple floor beam-to-girder arrangement as found in the northeast corner of WTC 7 (Figure 8–19). In this example, the floor slab was restrained at both ends and the floor beam was restrained at the exterior column. In-plane restraint of the floor slab assumes that either the slab was not heated or that surrounding cooler sections of floor slab restrained expansion. This boundary condition is assumed for illustrative purposes and to produce a maximum force in the shear studs. This simple analysis helped to determine whether or not the failure of shear studs needed to be accounted for in the detailed ANSYS analysis of the lower 16 stories of WTC 7 (Chapter 11). In the detailed finite element analysis, the floor slabs were not restrained and the heating of the concrete slab and steel beams was determined by thermal analysis (Chapter 10).

is attached with shear studs is restrained due to its in-plane stiffness, the shear studs will fail and the floor beam will have little resistance to thermal expansion or to lateral-torsional buckling.

In those locations where there is asymmetric framing of the floor beams into the girders, an absence of shear studs on the girders combined with the failure of shear studs on the floor beams, leads to a floor system which has little restraint to free thermal expansion and little resistance to lateral-torsional buckling.

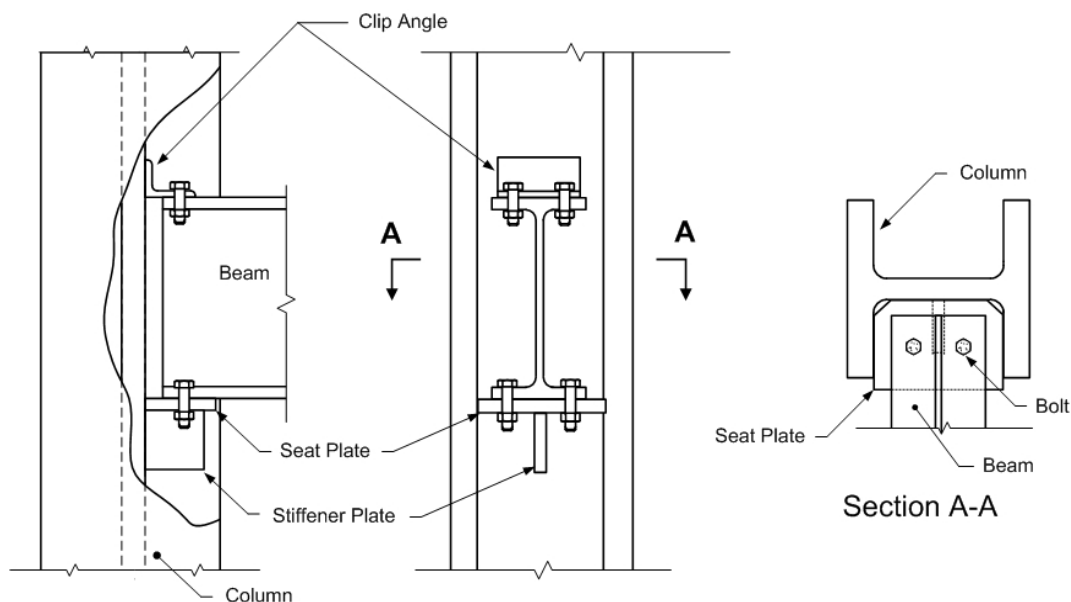
Figure 8–20. Seat connection at exterior column on the north face.

Seat connections to exterior columns where the floor beam framing was perpendicular to the exterior moment frame were as shown in Figure 8–20. Where the floor beam framed into an exterior column at a skew angle, the seat angle was replaced by a plate. Figure 8–21 shows the seat connection at Column 79 that supported the girder spanning to Column 44 on the exterior. The details of the connections of the other two girders that framed into Column 79 are not shown.

In a seated connection, the beam or girder was supported by the seat, which was welded to the column. Bolts were installed that fasten the beam or girder to the seat for erection purposes. These erection bolts did not carry any gravity load; rather, they were installed to insure that the beam or girder was held in place during erection. NIST found no evidence that the girders or beams in WTC 7 were welded to the seats. In a similar way, an angle or plate was bolted to the top flange to prevent the beam or girder from twisting, but there was little restraint to bending in the plane of the beam.
