**Federal Building and Fire Safety Investigation of the
World Trade Center Disaster**

**Structural Fire Response and
Probable Collapse Sequence of
World Trade Center Building 7**

VOLUME 2

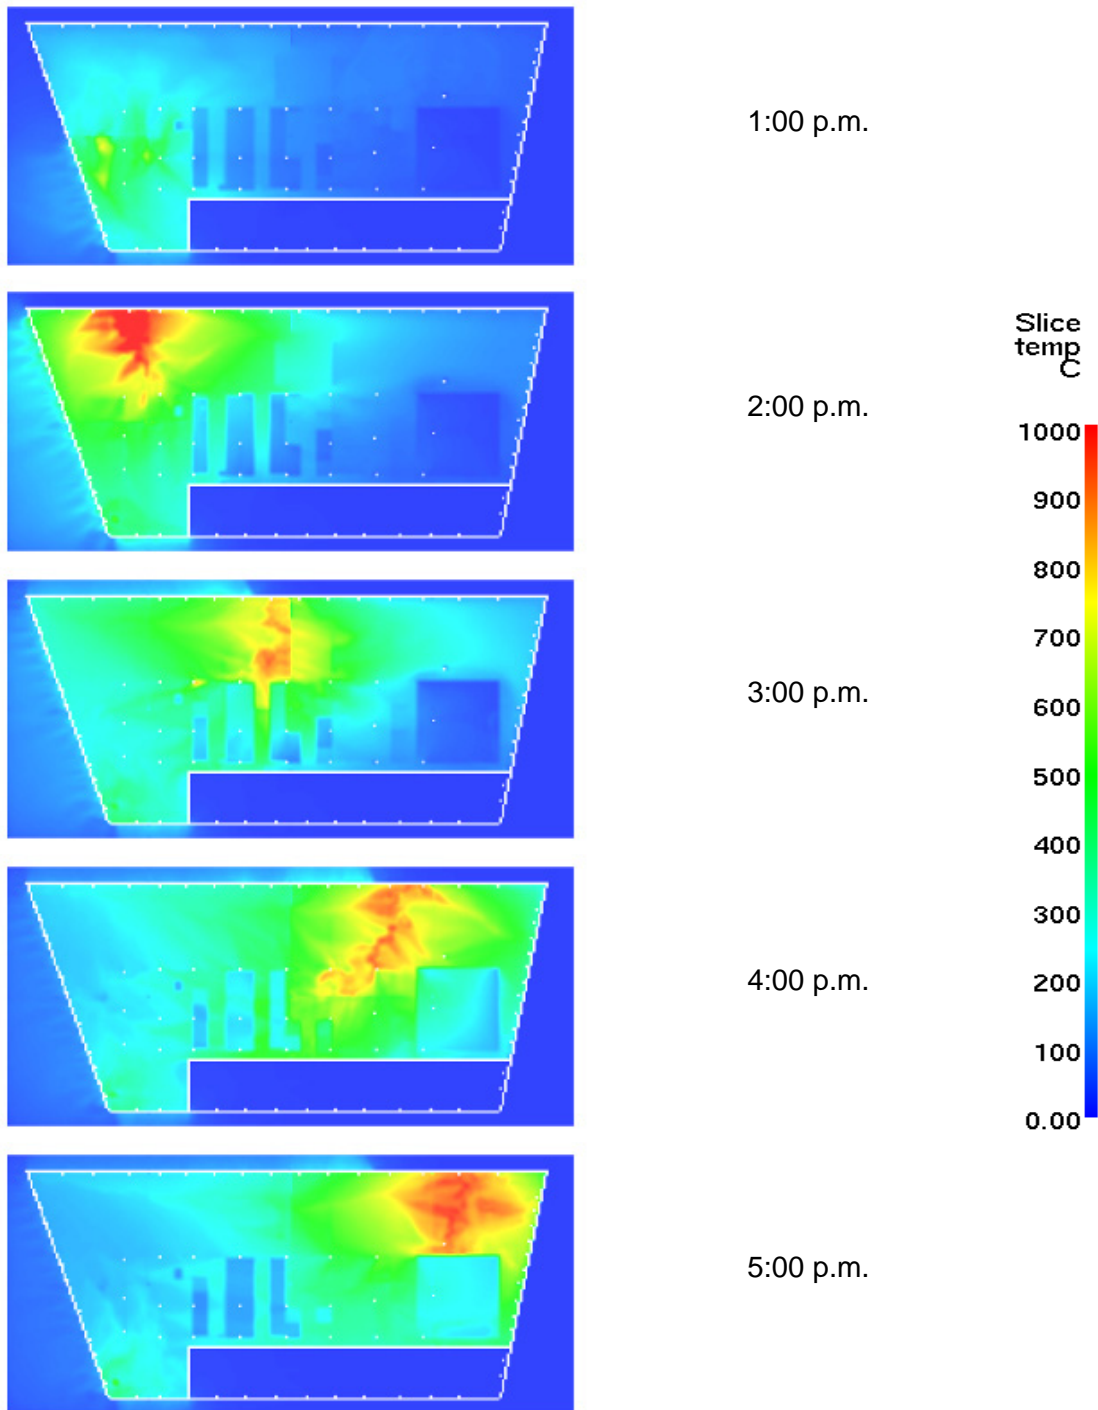
Figure 9–9 displays hourly snapshots of the upper layer temperatures predicted by the model. The simulations indicated that the clusters of workstations burned out in about 20 min to 30 min. The cold, rectilinear areas along the south wall and the east wall are the mechanical areas described in Chapter 3. Their fire-rated walls would have effectively resisted any significant heating of the contained space. The walls also impeded fire spread along the south face, explaining the clockwise movement of the fire. Figure 9–1 shows the location of Columns 79, 80, and 81 relative to the mechanical area on the east side of the building.

The spread rate and intensity of the observed fire and the simulated fire were similar. The simulated fire reached the north face of the building a little later and spread a little more slowly to the east than the visuals indicated. (Note that the start time of the simulated fires was defined as 12:00 p.m., for lack of visual evidence, and that the visuals only indicated burning near the windows, not in the building interior.) The principal difference between the photographs and the simulation was that, unlike the actual fire on Floor 7, which stopped and then flared up to the east, the simulated fire slowed briefly near the middle of the north face and then continued toward the east. (There were office walls in this vicinity, but doors were left open in the simulation, and the fire eventually passed through the middle section of the building and moved to the east face, where it finally consumed the remainder of the furnishings.) The effect of these differences on the thermal environment would have been small.

Figure 9–9. Progression of simulated fire on Floor 7 of WTC 7.
Upper layer gas temperatures are shown.

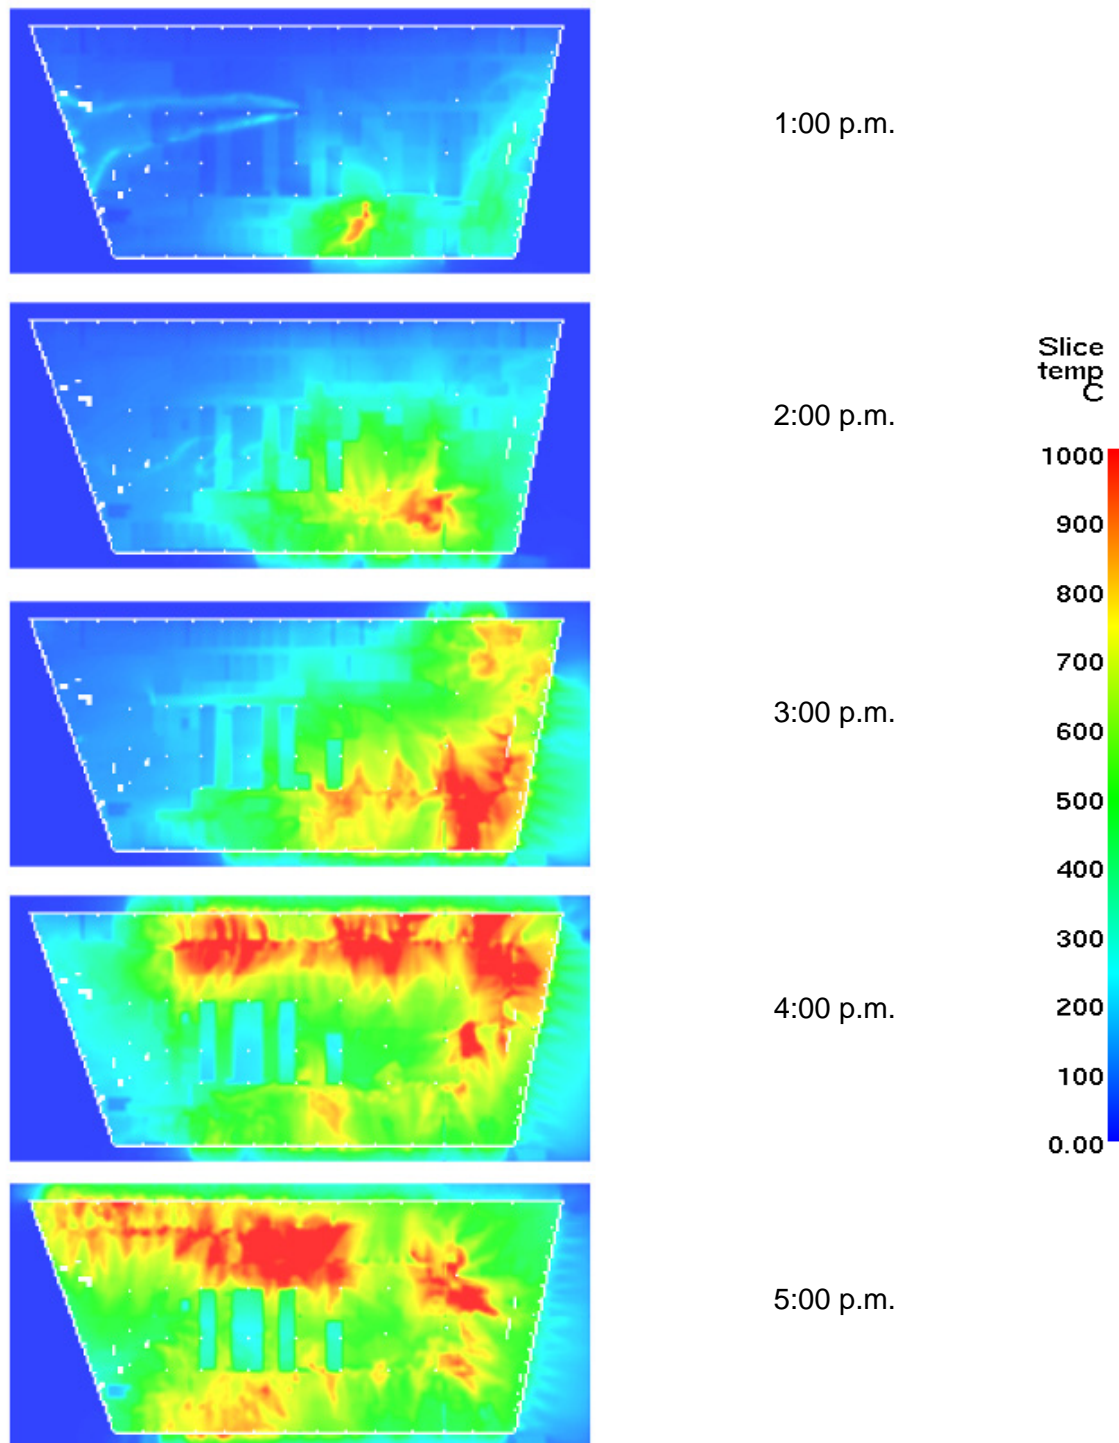
Figure 9–11. Progression of simulated fire on Floor 12 of WTC 7.
Upper layer gas temperatures are shown.

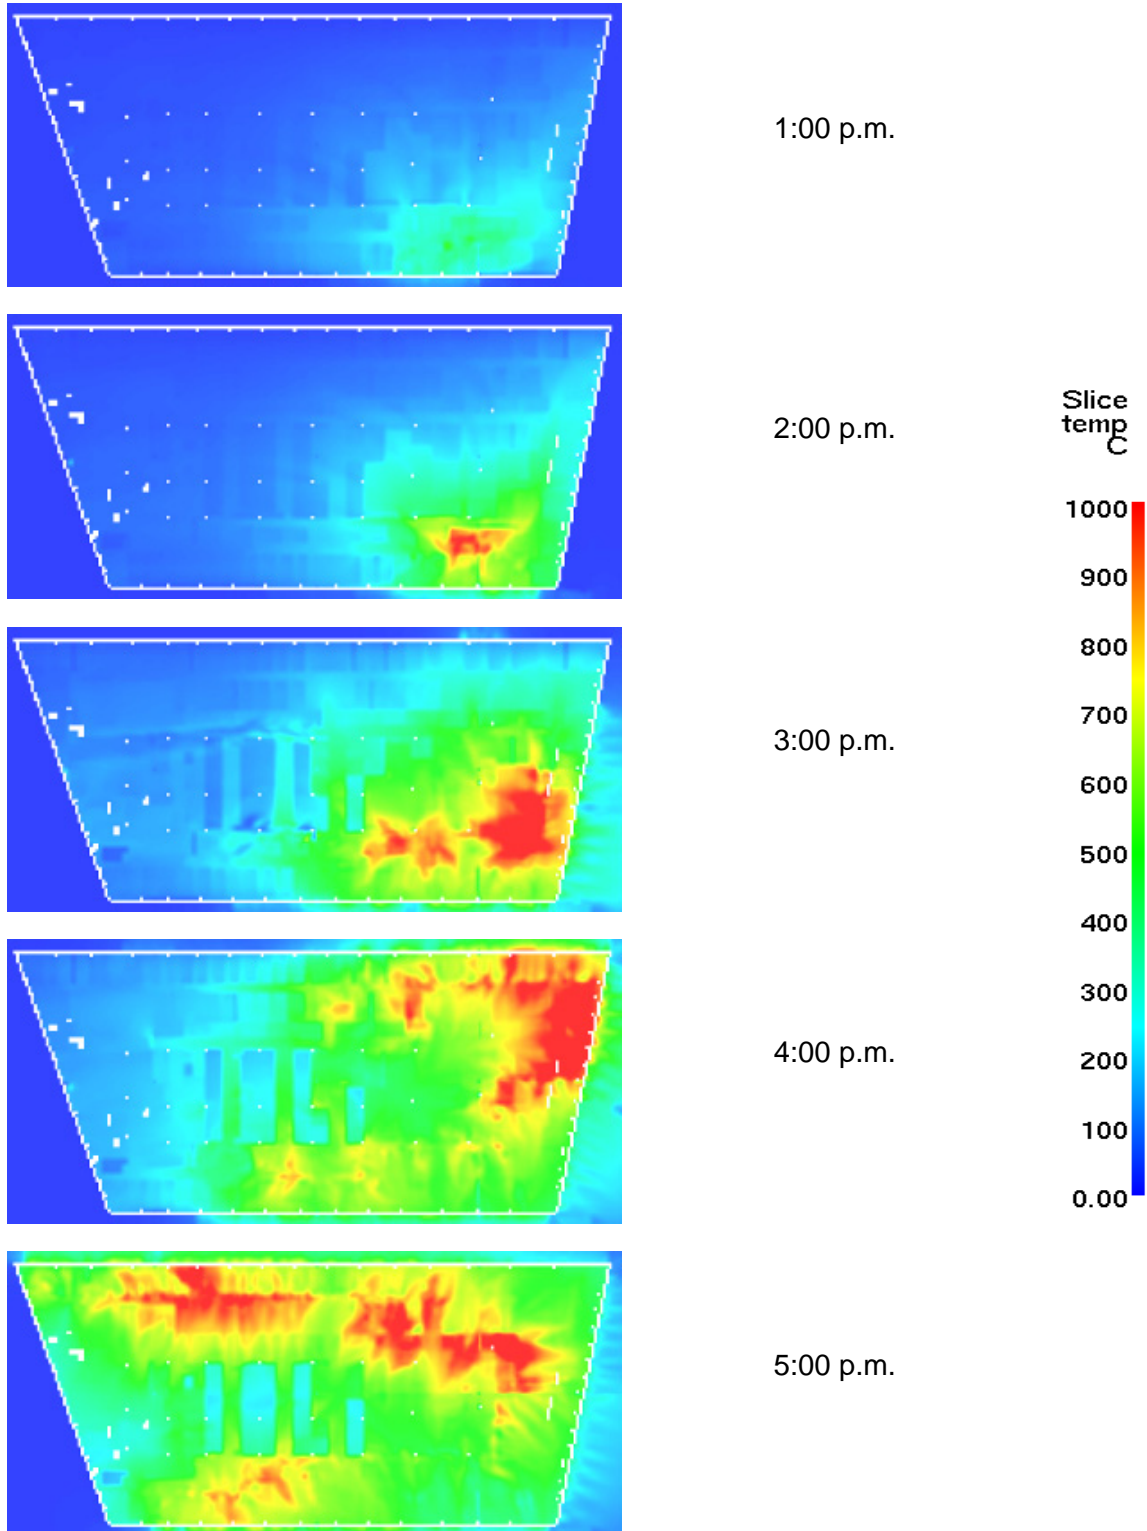
- Decreasing the combustible load on the 12th floor from 32 kg/m² to 20 kg/m² and doubling the strength of the ceiling tiles (Figure 9–12). This floor was heavily segmented into individual offices, and this change effectively slowed the fire movement past the walls and into adjacent offices. This fire spread rate was lower than in the visual evidence.

Figure 9–12. Progression of simulated fire on Floor 12 of WTC 7, with more durable ceiling tile system.

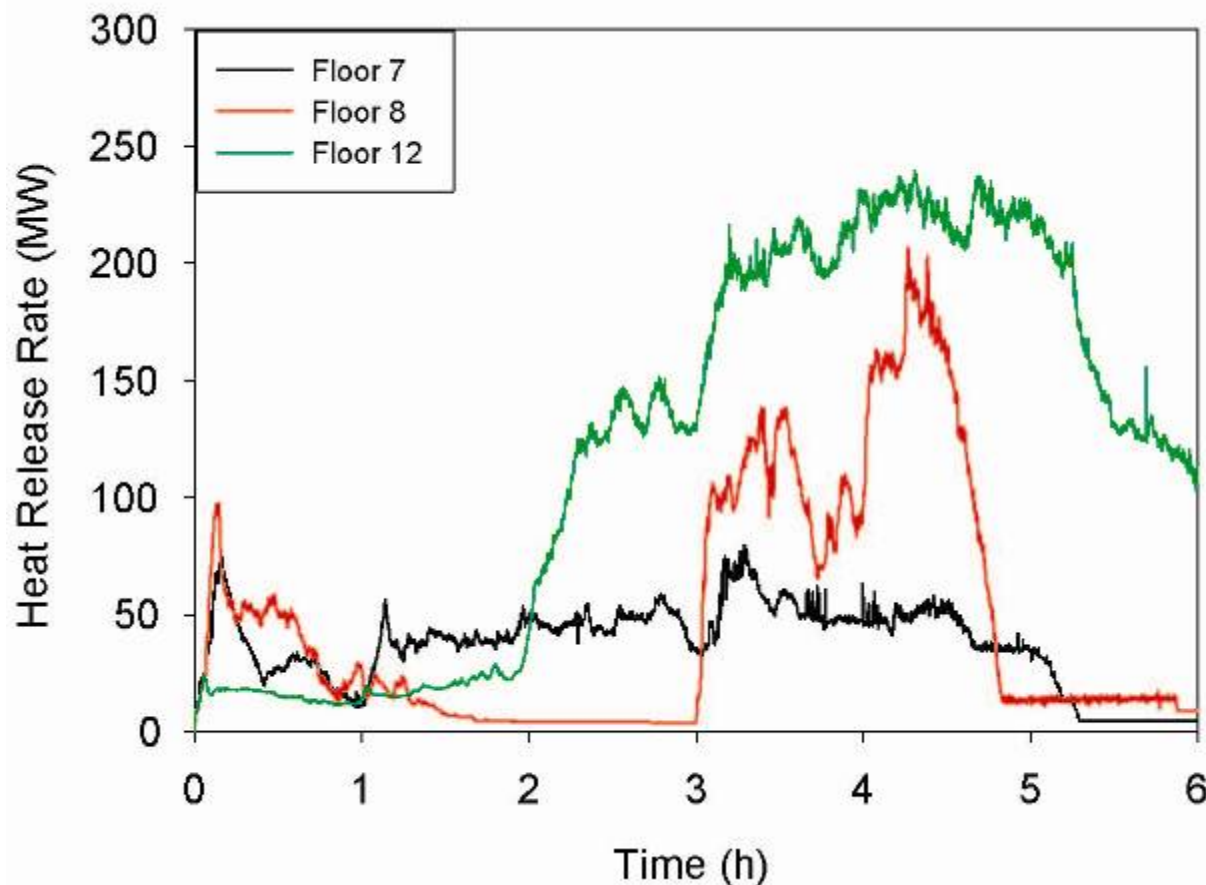
In the computations, the fire on the 12th floor, and thus the derivative fires on the 11th and 13th floors, generated significantly more heat than the fire on the 7th or 8th floor. This was in large part due to the higher fuel load in the simulations of the 11th, 12th, and 13th floors and the larger burning area of the fires on these floors (i.e., the west and north floor areas on the 7th and 8th floors were smaller than the south and east areas of the 11th, 12th, and 13th floors).

Figure 9–13. Rates of heat release of simulated fires in WTC 7.

The rate of heat release shown in Figure 9–13 indicates only what the FDS analysis predicted to have burned. All the combustibles were not consumed in the simulations. Floors 7 and 8 had nominally the same fuel load, but the layout of furnishings was different, the window breakage history was different, and consequently the total amount of combustibles consumed was different. Floor 12 was assumed to have a higher combustible loading, and the layout of the floor was different from Floors 7 and 8. Also, the simulated fires spread along the south face of Floor 12, as well as along the east and north faces, whereas the simulated fires on Floors 7 and 8 spread along the west, then north, then east faces. There is no visual evidence to confirm that there was any substantial fire spread along the south face, but nothing was deliberately added to the model to spread or not spread fire along the south face.

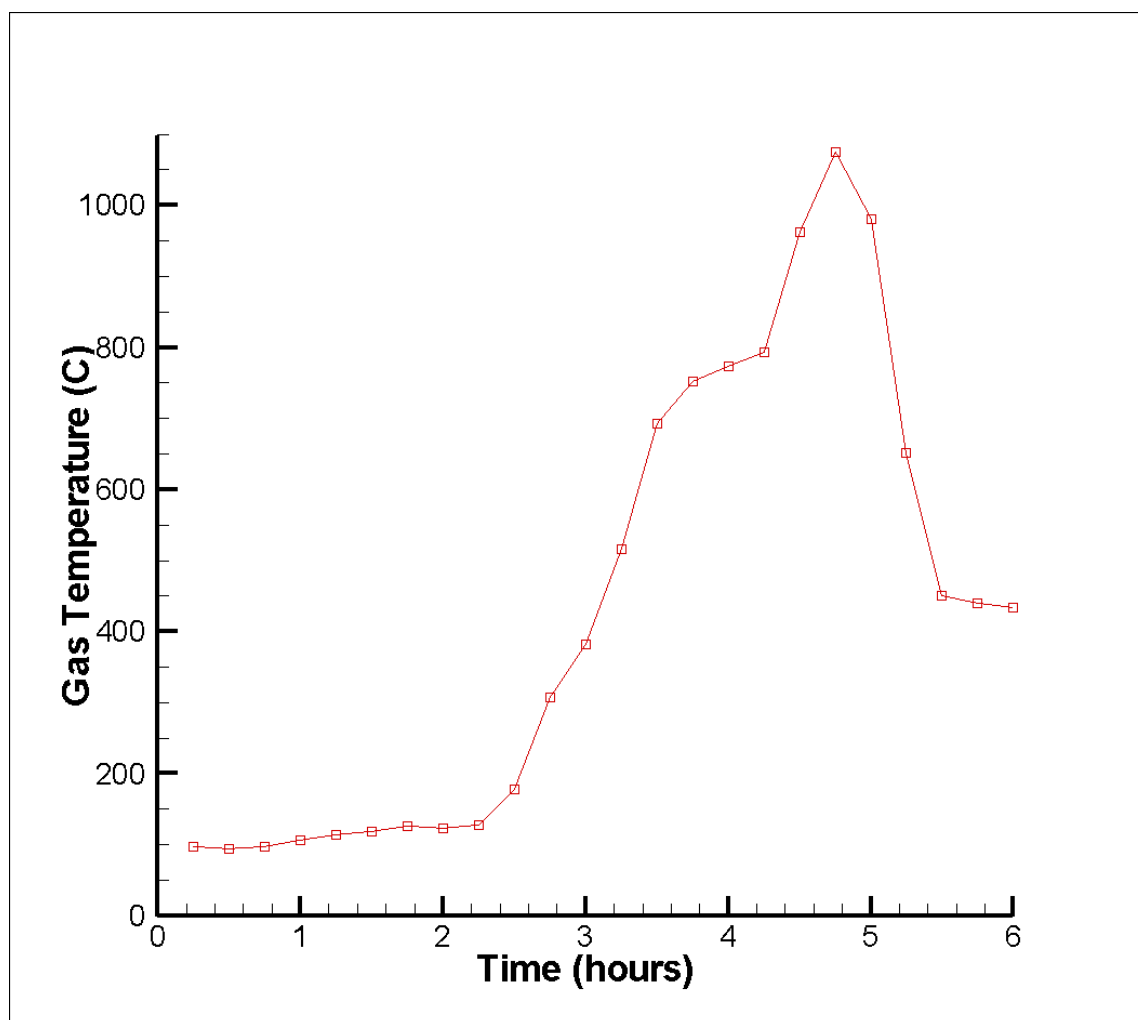
Figure 10–1 Gas temperature time history for Floor 12 near the ceiling by Column 79 and the northeast corner.

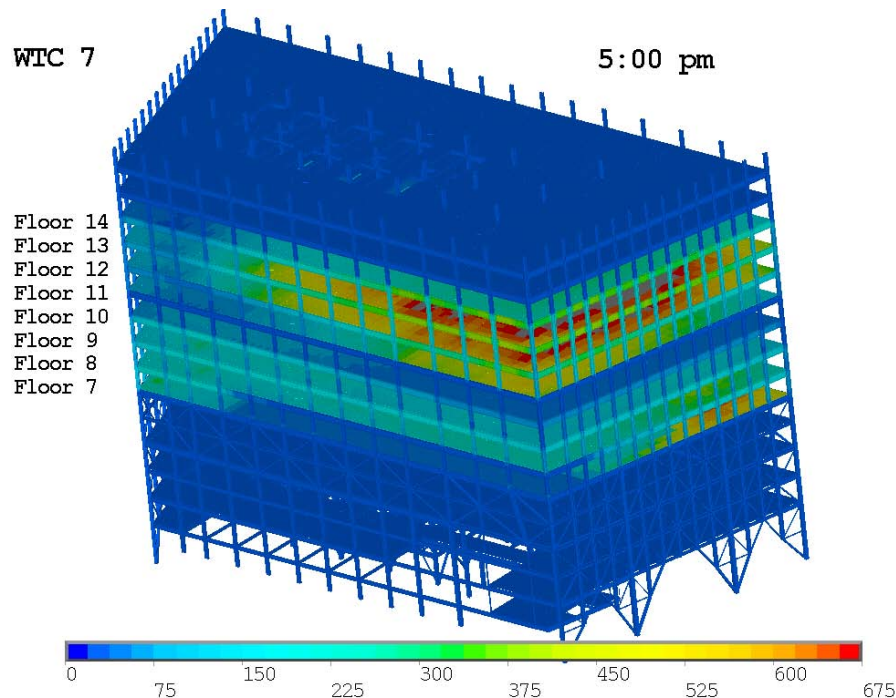
Figure 10–2. View from the southeast of the computed thermal loading of the 16 lower floors of WTC 7 at 5:00 p.m. (Case A).

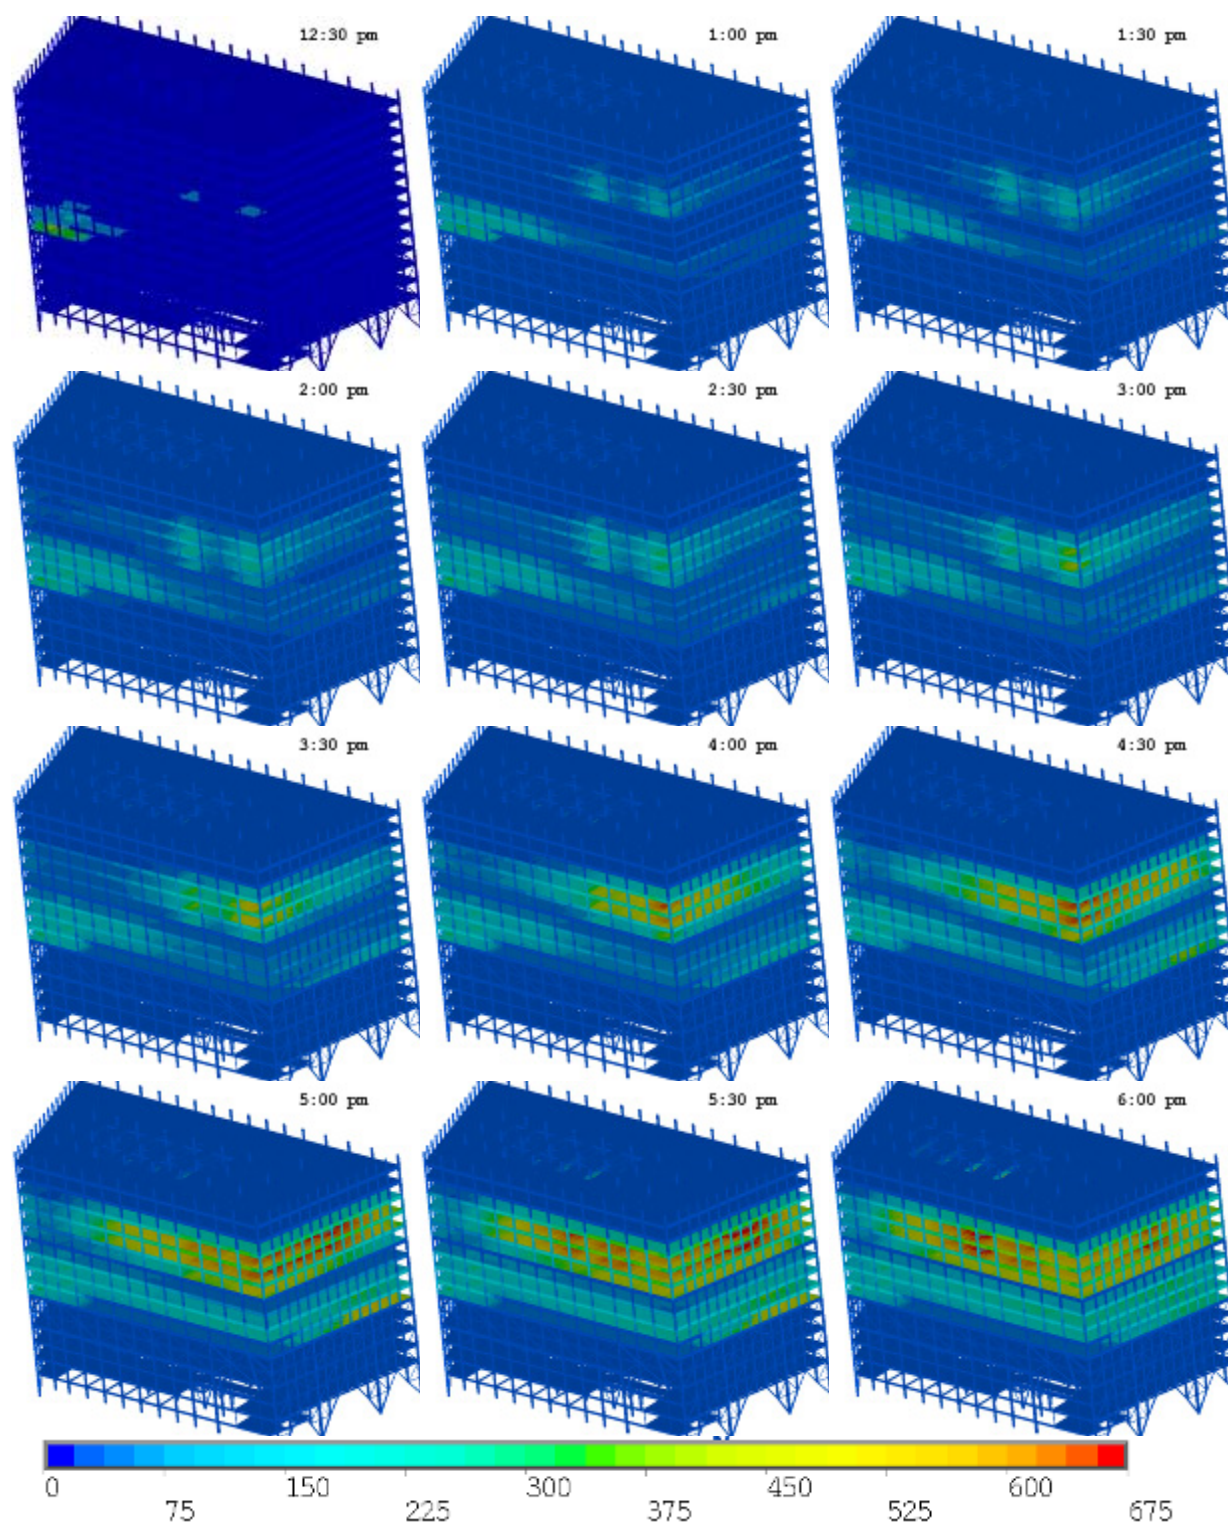
Late in the day, the most intense heating was in the northeast sector and the center of the south wall, just east of where there was extensive debris damage.

Figure 10–4. View from the southeast of the computed thermal loading of the lower 16 floors of WTC 7 at 12 different instants in time (Case A).

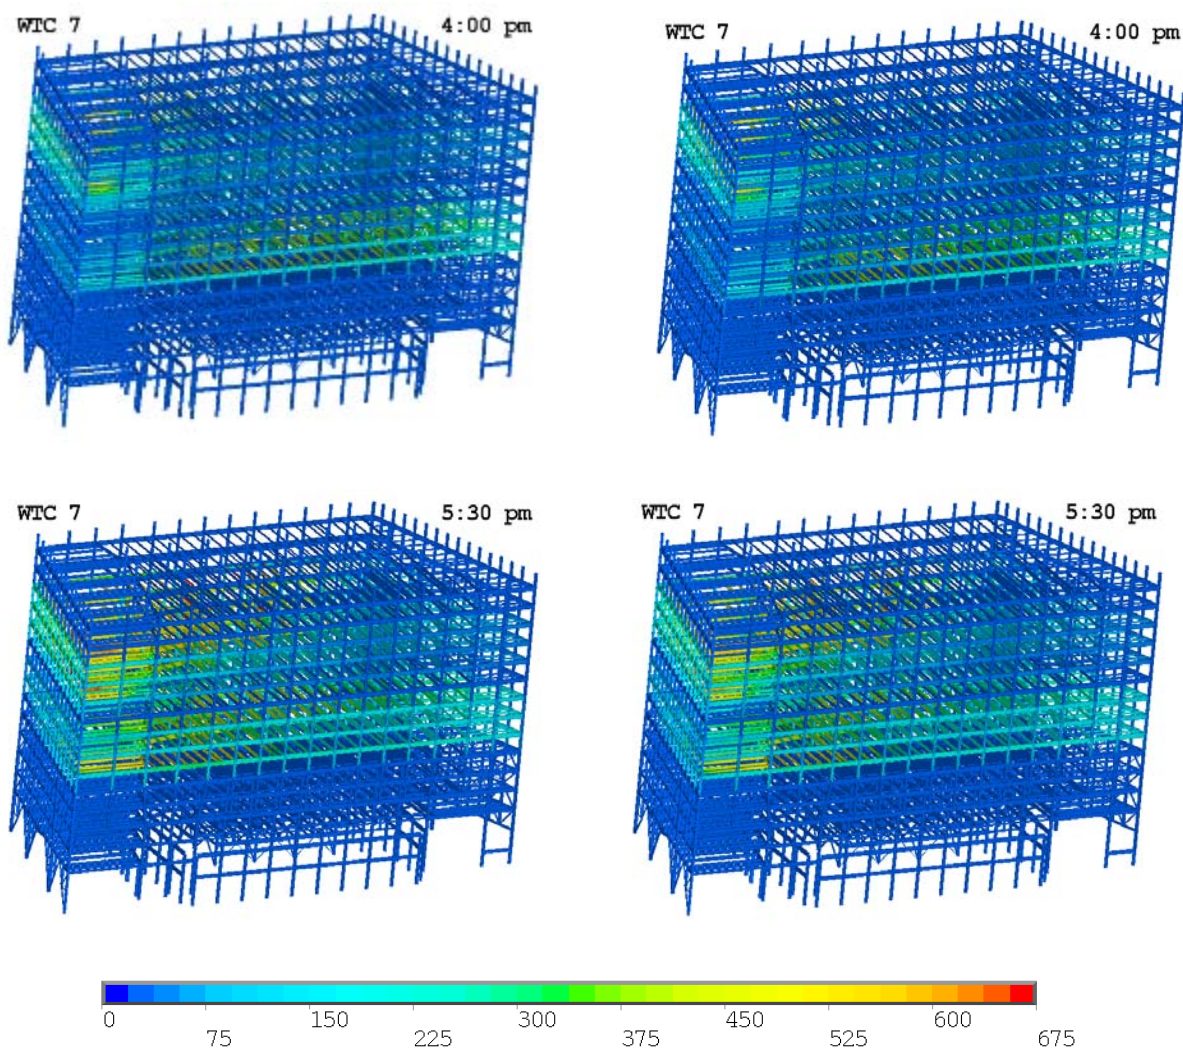
For Case C, the air temperature increase at each location on Floors 7 through 14 was assumed to be 10 percent lower than that computed from the FDS simulation of Case A, which was within the expected range of reasonable and realistic fire-generated temperatures. Figure 10–42 and Figure 10–43 compare the temperatures of the building at two times for these two cases. Case A is on the left, and Case C is on the right. As expected, Case C resulted in mildly lower temperatures in the steel and concrete, narrower hot zones, and lesser overlap of hot zones between adjacent floors.

Figure 10–43. View from the northeast of the 16 lower floors of WTC 7, comparing Case A (left) and Case C (right) temperatures at two different times (floor slabs removed).

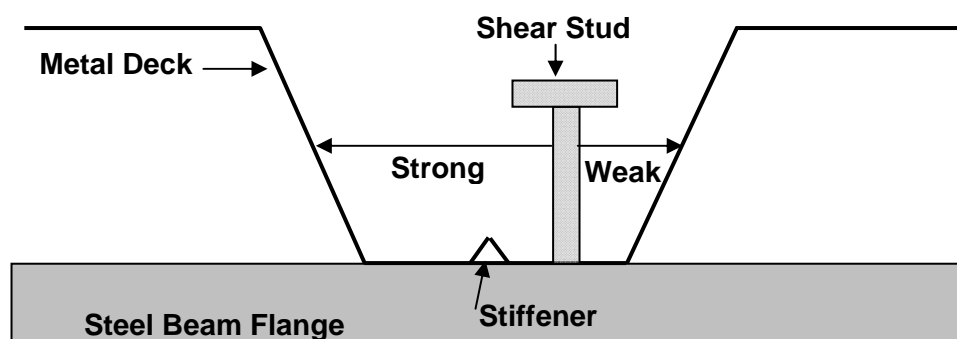
Figure 11–8. Schematic of shear stud placement relative to the metal deck.

Metal decks typically have stiffeners in the center of the rib section that rests on the steel beam flange, as shown in Figure 11–8. The stiffener requires that the shear stud be placed off center from the center of the rib, which affects the strength of the shear connection perpendicular to the span of the metal deck. This is because the amount of concrete between the steel deck and the stud depends on the direction of the load that the stud can bear on when transferring the shear load between the slab and the floor beam. The direction of load transfer is termed “strong” or “weak” to refer to the relative load capacity associated with each direction, as shown in Figure 11–8.

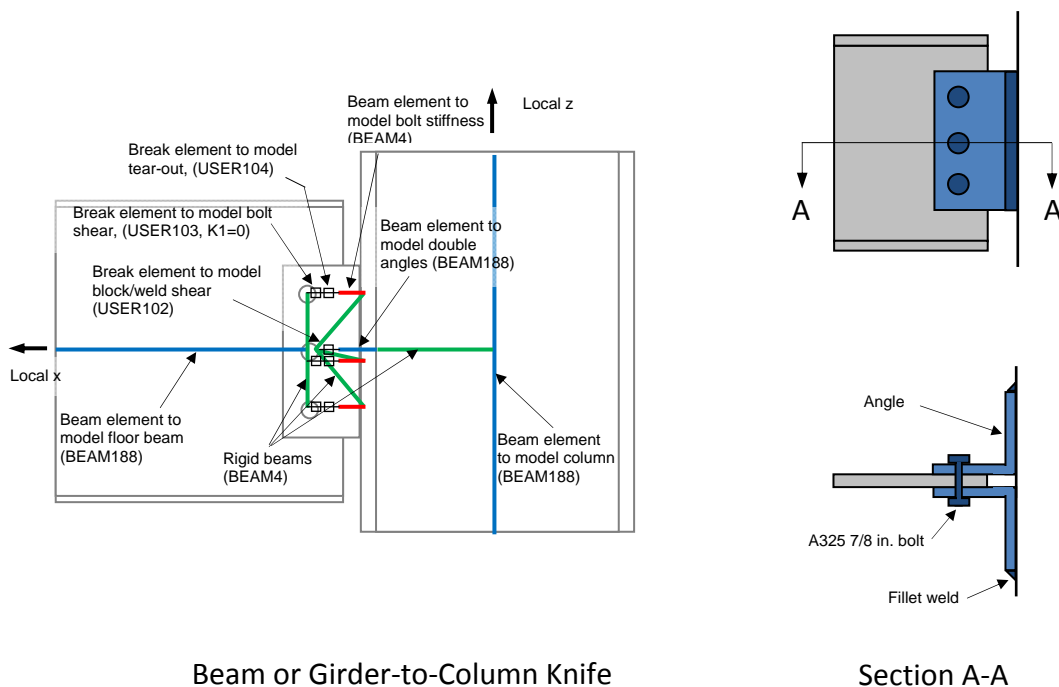
Figure 11-11. Analytical model for a knife connection.

The analytical model used for the knife connection is depicted in Figure 11-11. The model shown has three bolts, but knife connections in WTC 7 had up to 8 bolts. The connection model accounted for: (1) shear failure of individual bolts, (2) tear-out failure at each bolt location, (3) vertical block shear failure of the double angles, (4) horizontal block shear failure of the web or angles, and 5) vertical and horizontal failure of the angle-to-column fillet welds.

The analytical model for the knife connection was the same as that for the fin connection. The only differences were that the two outstanding legs of the angles, and fillet welds at the toes of the angles that replaced the double-sided fillet weld at the connection plate.

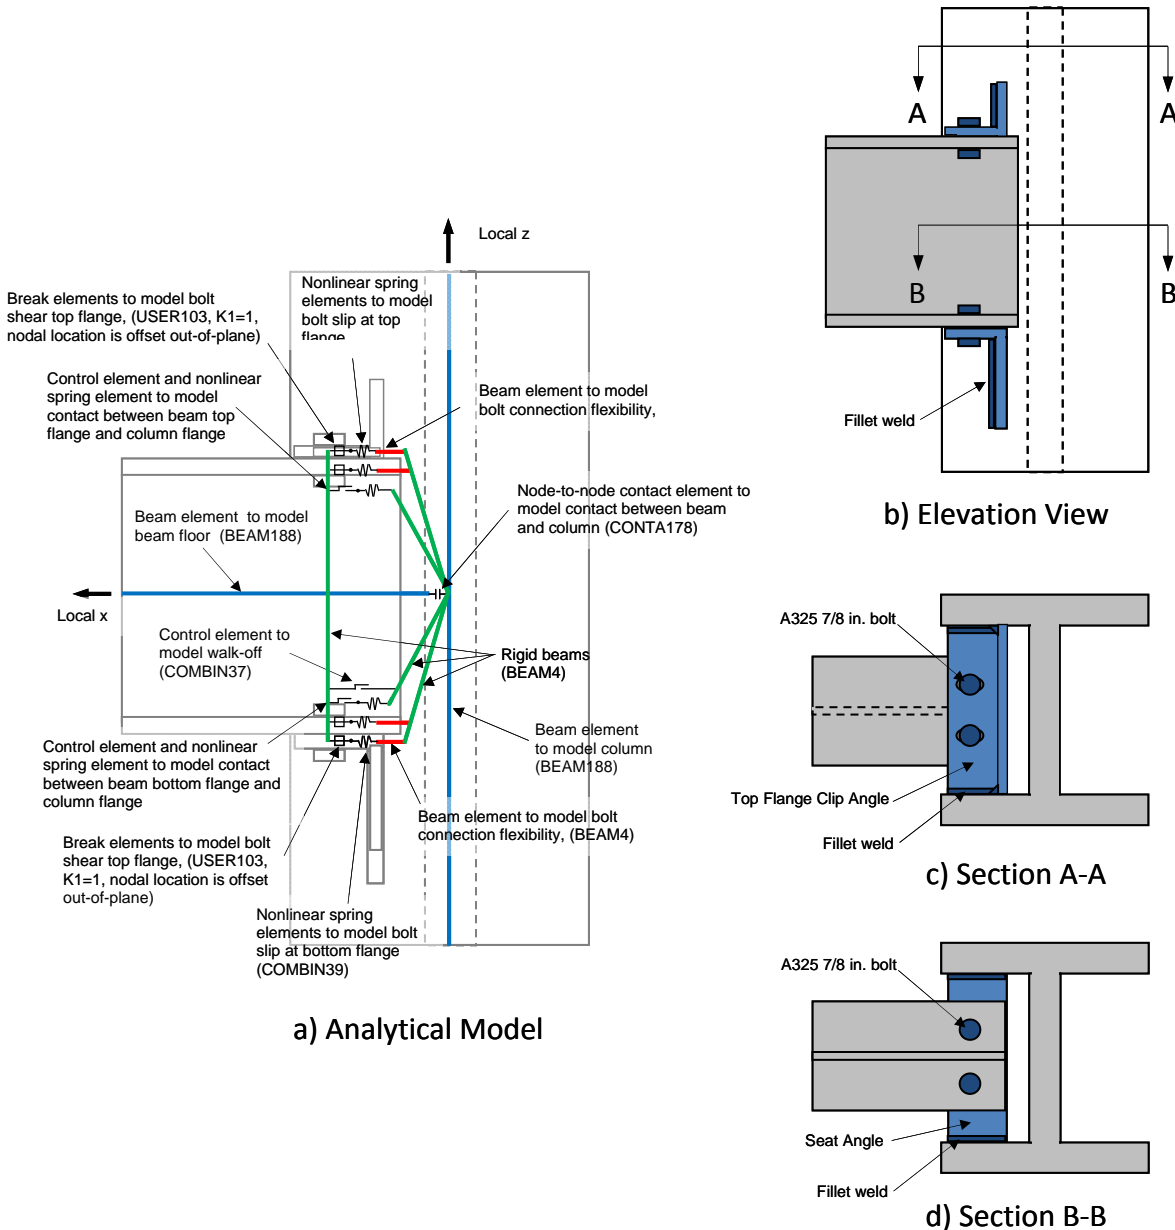
Figure 11-14 Analytical model for seated connections at exterior columns.

The analytical model for seated connections at exterior columns is depicted in Figure 11–14. The north and south face columns had STC connections and the east face columns had STP connections. The STC connection at Column 26 and the STP connection at Column 44 were slightly different, as the girder framed into the column at a different angle and the bolts had a different location. Other differences, such as the use of a top plate in lieu of a clip angle at the top of beam, did not affect the structural response of the connection, because both the top plate and clip angle were welded along their side edges to the column flanges of the exterior columns. The shear strength of the clip angle or the top plate was much greater than the shear strength of the bolts, so only the bolt shear failure mode was included at the top of the beam. Therefore, the failure of the seated connection at the exterior columns was governed by bolt

shear, followed by beam walk off of the seat. The analytical model accounted for: 1) shear failure of individual bolts, and 2) beam walk off of the seat.

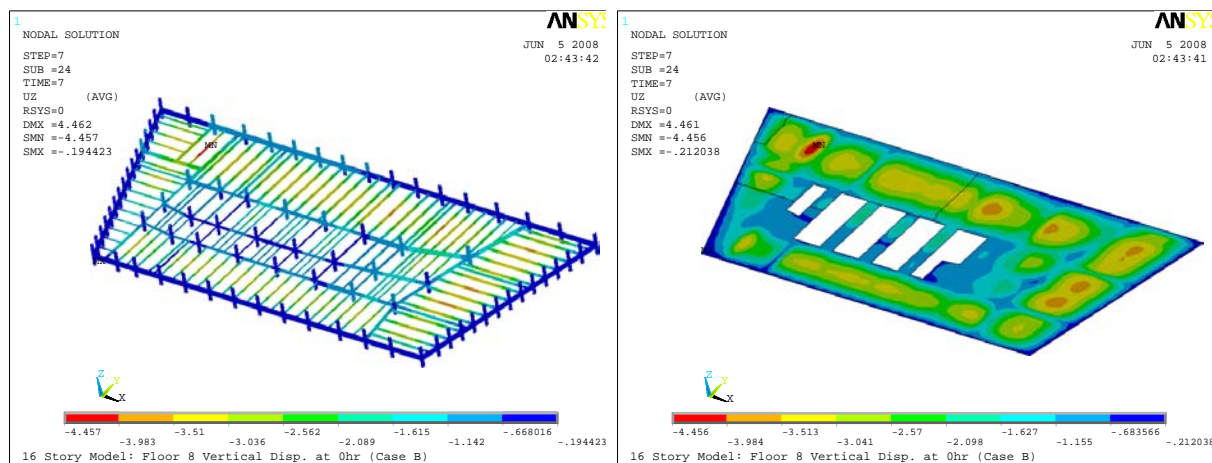
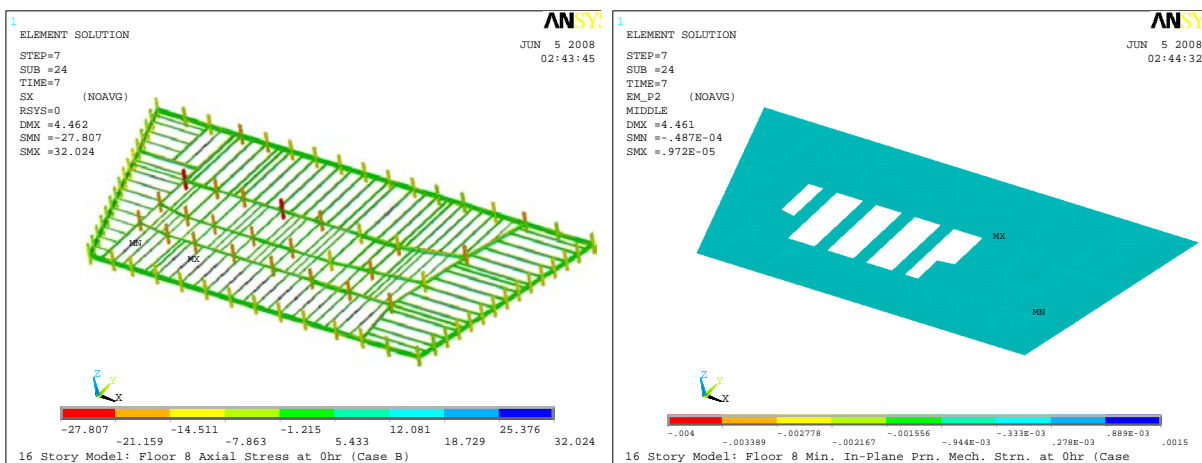
Figure 11–20. Structural response of Floor 8 to gravity loads.

Axial stresses from axial forces in the floor beams and in-plane slab strains were small, as expected for gravity load conditions. The stress in the floor beams due to axial loads was less than 1 ksi (floor beams had a nominal yield strength of 50 ksi). The in-plane slab strains were less than -5×10^{-5} (concrete failure strain in compression was -4×10^{-3} and failure strain in tension was 1.5×10^{-3}).

Axial column stresses (Figure 11–20c) ranged from 15 to 28 ksi in the interior columns and in exterior Columns 44 and 55 on the north face. The axial column stress in the other exterior columns ranged from 8 to 15 ksi.

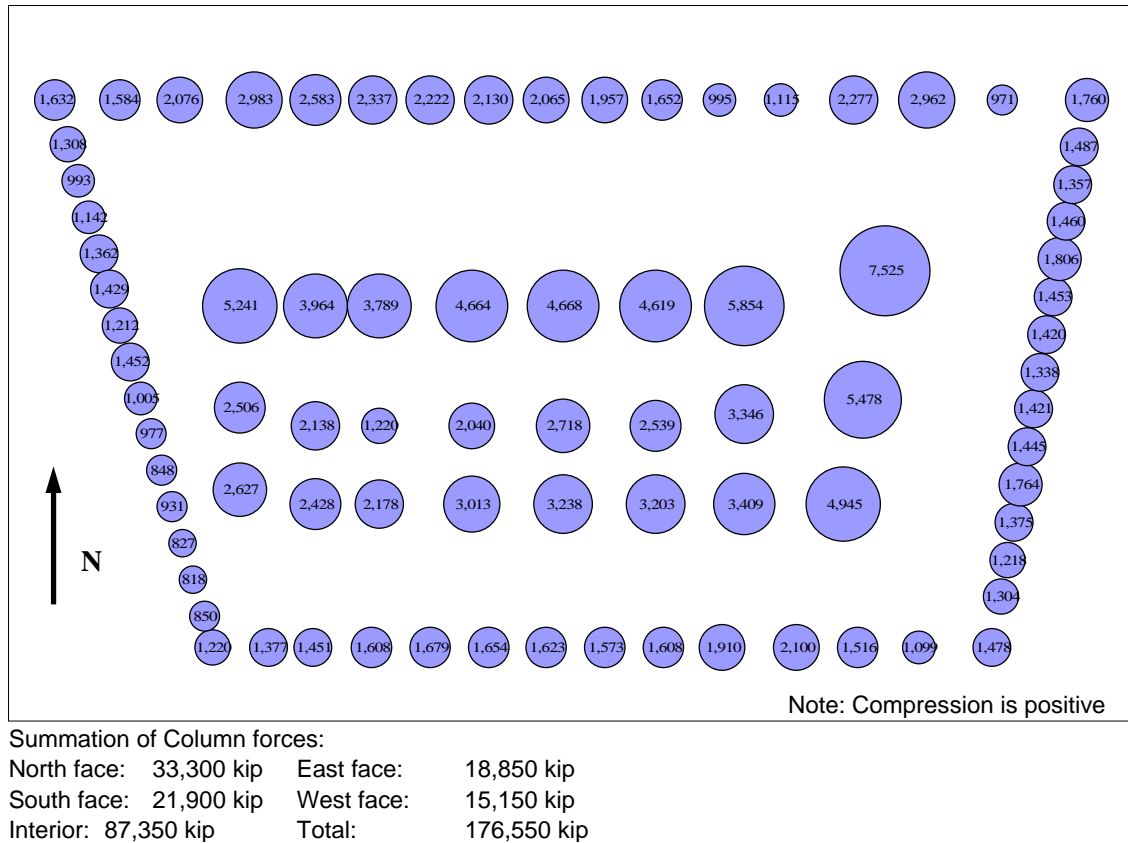
Figure 11–21. Column forces (kip) above Floor 8 for gravity loads.

Column Forces. The column forces at Floor 8 are presented for comparison to the column forces at 3.5 h and 4.0 h of heating, which are presented at the end of Sections 11.3.2 and 11.3.3. Axial forces in the columns at Floor 8 are shown in Figure 11–21. The size of the circle at each column indicates the magnitude of the load. The maximum column force of 7,525 kip was at Column 79. The axial force ranged from 2,000 kip to 5,000 kip in the rest of the interior columns and 1,000 kip to 3,000 kip in the exterior columns. The sum of all column forces was 176,500 kip, with the interior and exterior columns carrying these forces in about equal parts. Based on the design drawings, the sum of all column forces for a loading condition of dead loads and service live loads was 174,100 kip.

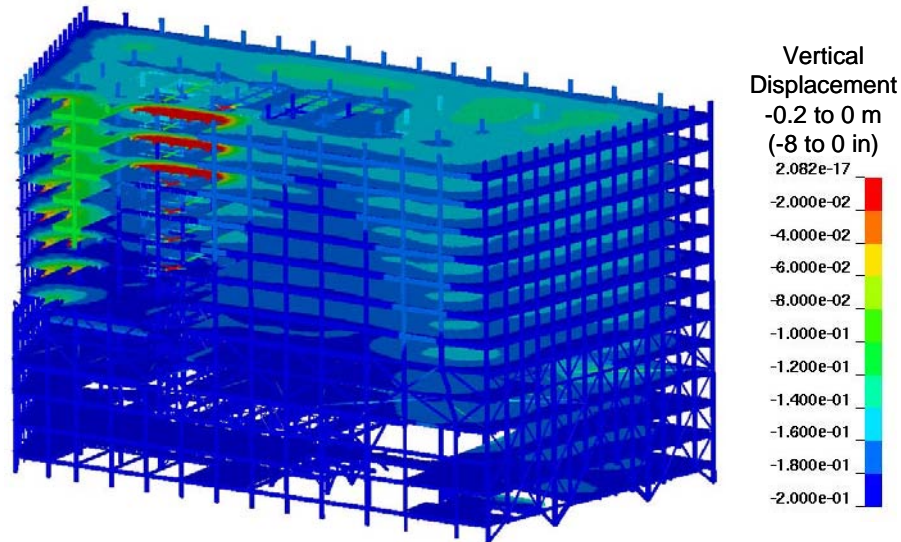
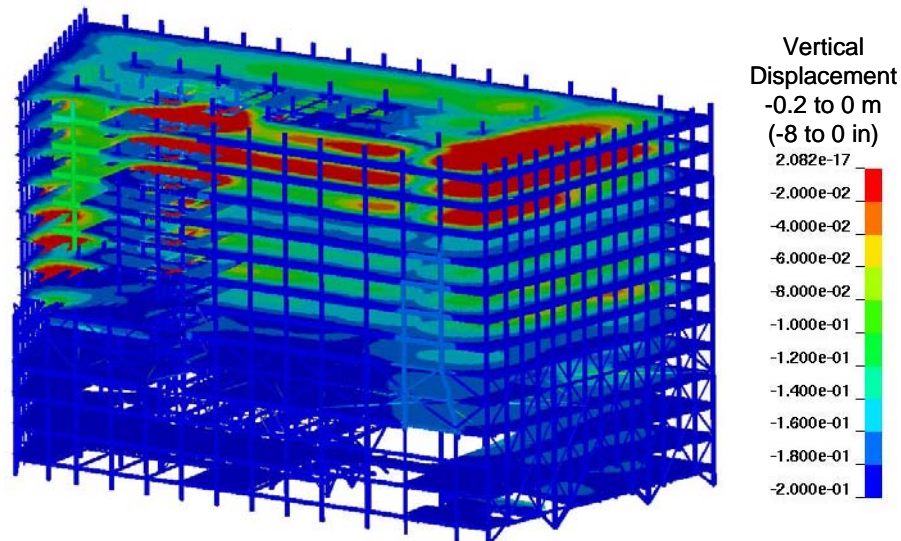
temperature application. This figure illustrates where the heated floors displaced vertically due to damaged floor framing and connections. The analysis also showed that the combination of the impact damage and thermal loading produced significantly higher stress states throughout the lower floors of the building.

Figure 12–41. Detailed comparison of vertical displacements after damage and temperature initializations.

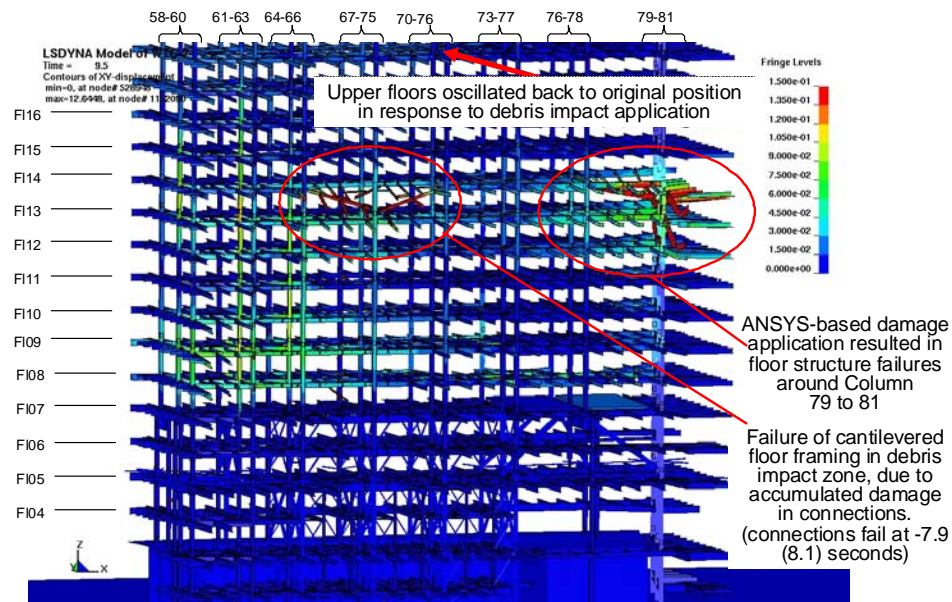
After the fire-induced ANSYS damage was applied, floor sections surrounding Columns 79 to 81 on Floors 13 and 14 collapsed to the floors below, as shown in Figure 12–42. The LS-DYNA analysis calculated the dynamic response of the structure to the floor failures and resulting debris impact loads on the surrounding structure. The thermally weakened floors below Floors 13 and 14 could not withstand the impact from the collapsing floors, resulting in sequential floor collapses. The floor systems progressively failed down to Floor 5, where the debris accumulated, as shown in Figure 12–43.

Figure 12–42. The collapse of Floors 13 and 14 in the northeast region [Time: -6.5 (9.5) s]

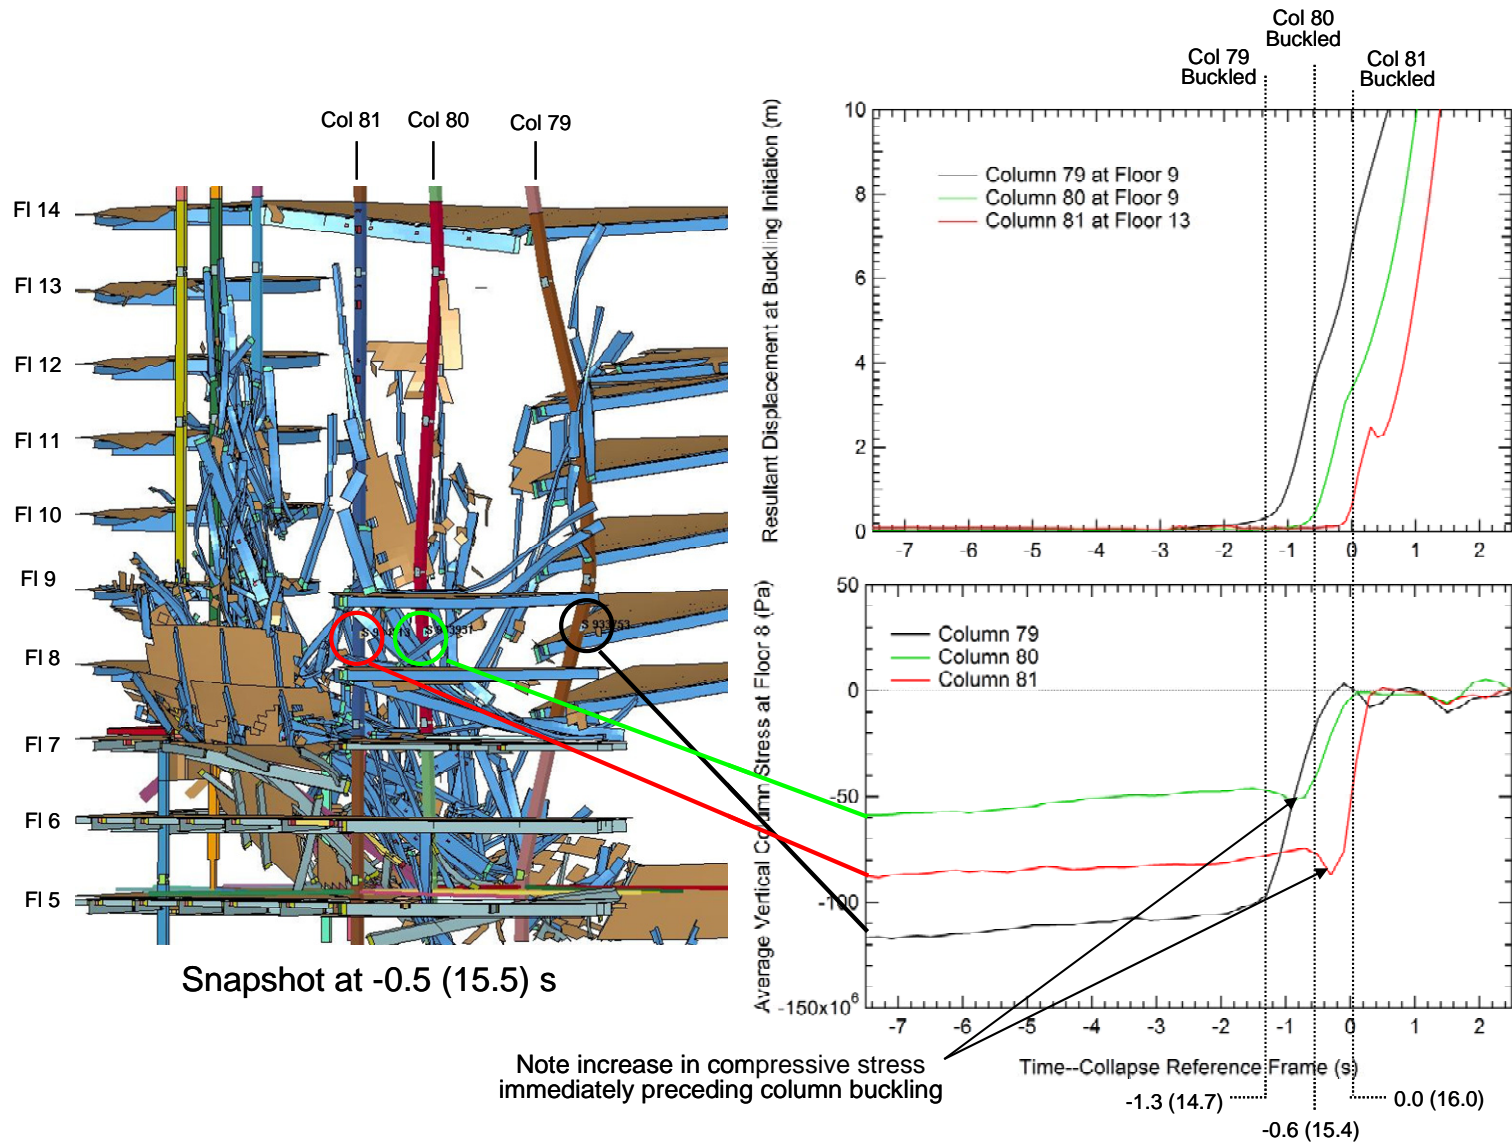
Figure 12–43 shows a cutaway view that illustrates the structural condition surrounding Column 79 as it buckled to the east. Figure 12–43 includes resultant lateral displacements and column axial stress histories for Columns 79 to 81. The plots show that Column 79 buckled 1.3 s before the kink was observed in the east penthouse roof framing (which occurred at 0 s (16.0 s) in the analysis). The rapid increase in lateral displacement indicates column buckling. Likewise, the axial column stresses indicated a rapid loss of stress at the time, signifying column buckling. Column 79 was laterally unsupported in the

east-west and south directions between Floors 5 and 14. There was still some lateral support in the north direction at Floors 8 to 12 and Floor 14, as the erection bolts in the seated connections had all failed at these girder ends, but the girders had not walked off the bearing seats. Thus, these girder connections possibly prevented lateral displacement in the north direction, but did not resist lateral displacements in the east, west, or south direction. At Floor 14, the girder to the west of Column 79 (between Column 79 and 76) was still attached and provided lateral restraint from the west. Figure 12–44 illustrates the girder-to-column connection status at the time of buckling of Column 79.

Figure 12-43. Column 79 to 81 stress and displacements.

The cascading failures of the floors surrounding Column 79 on Floors 6 to 14 led to increased unsupported length in Column 80. Column 80 became laterally unsupported, as shown in Figure 12–47. Column 80 buckled about 0.8 s after Column 79 buckled, as shown in Figure 12–43.
