**Federal Building and Fire Safety Investigation of the
World Trade Center Disaster**

**Structural Fire Response and
Probable Collapse Sequence of
World Trade Center Building 7**

VOLUME 2

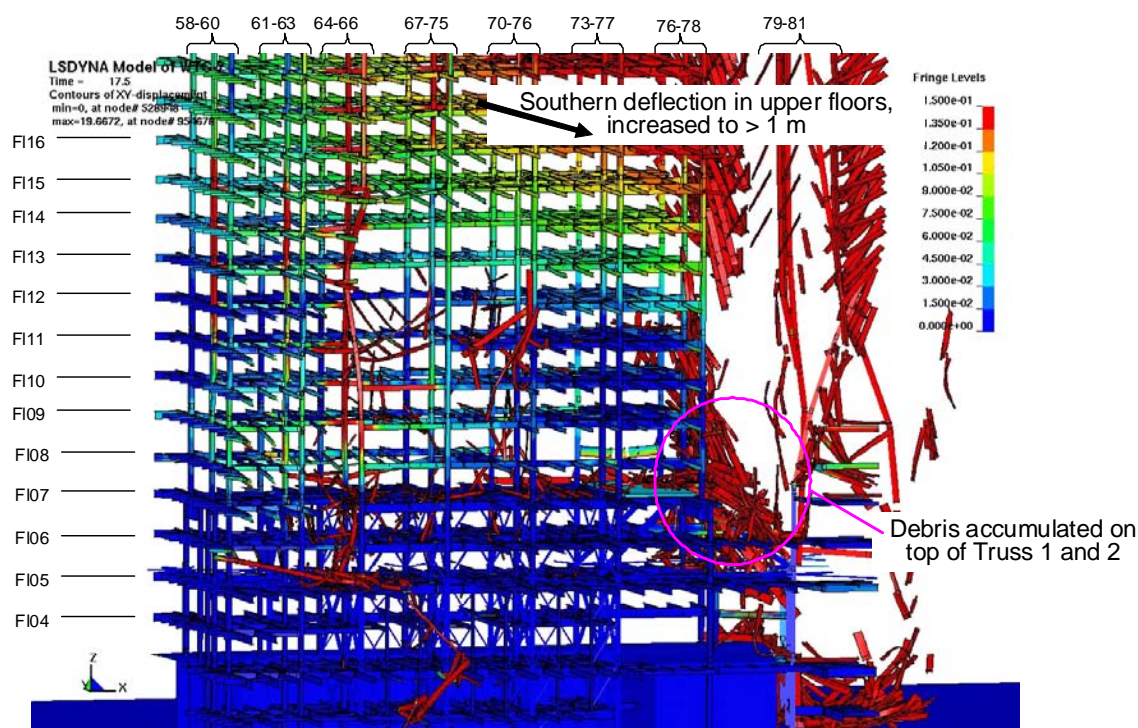
During the vertical failure progression, the falling floors pulled on adjacent columns until the floor connections failed on the east side of Columns 76, 77, and 78, resulting in a loss of lateral support on the east side, as shown in Figure 12-49. Additionally, debris from floor systems and columns fell from the upper floors, and impacted adjacent intact columns and floors, including Truss 1 and Truss 2. The accumulation of debris and debris impacts eventually caused Truss 2 to fail, as shown in Figure 12-50 and Figure 12-51.

Figure 12-49. Debris from the vertical progression falling onto the lower floors, Trusses 1 and 2, and Columns 76, 77, and 78 [Time: 1.5 (17.5) s].

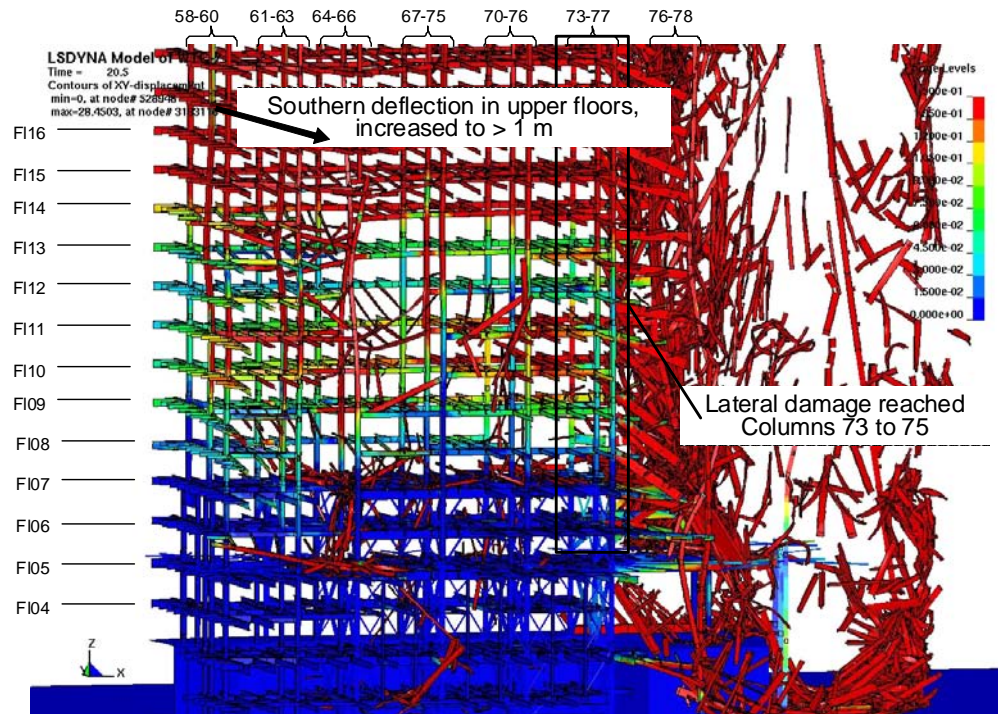
Columns 73 to 75 buckled in the next second, as shown in Figure 12–54, as the process continued where there were sequential failures of each north-south row of interior columns, due to loss of lateral support as floor connections failed, impact of falling debris, and load redistribution from adjacent failing columns.

Figure 12-54. Failure of Columns 73 to 75 from the load redistribution and debris impact [Time: 4.5 (20.5) s].

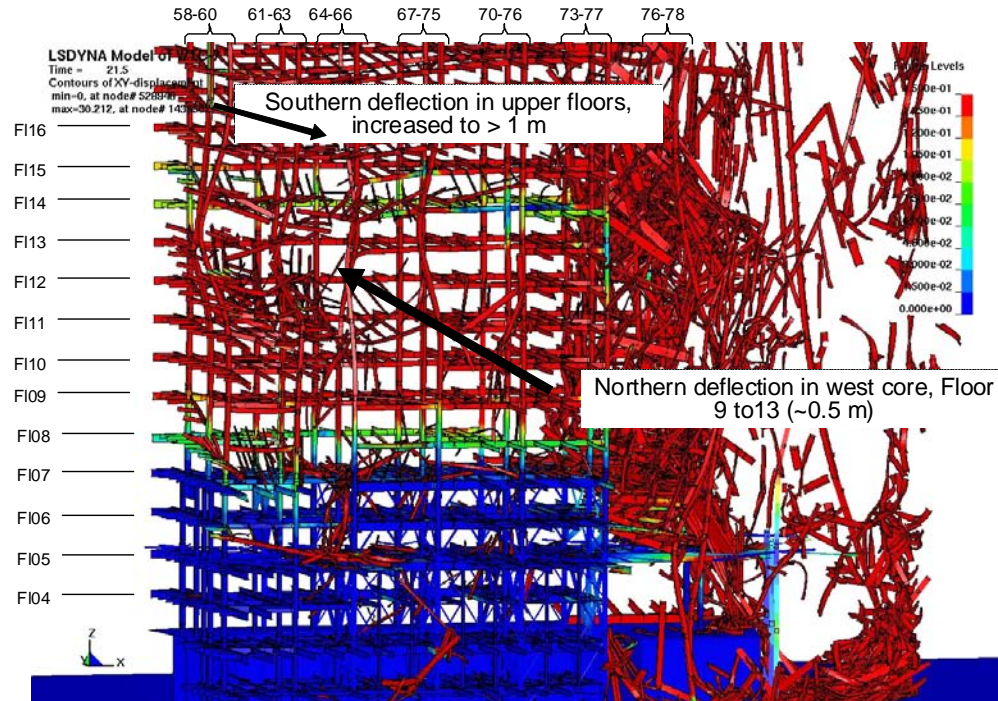
Column buckling and floor failures continued to propagate from east to west across the core in the lower floors, until all the interior columns buckled between Floors 9 and 14. This occurred 6.5 s after the kink was observed in the east penthouse, and 6.7 s after Column 79 buckled, as indicated by Figure 12–55.

Figure 12-55. Buckling of all interior columns [Time: 6.5 (22.5) s].

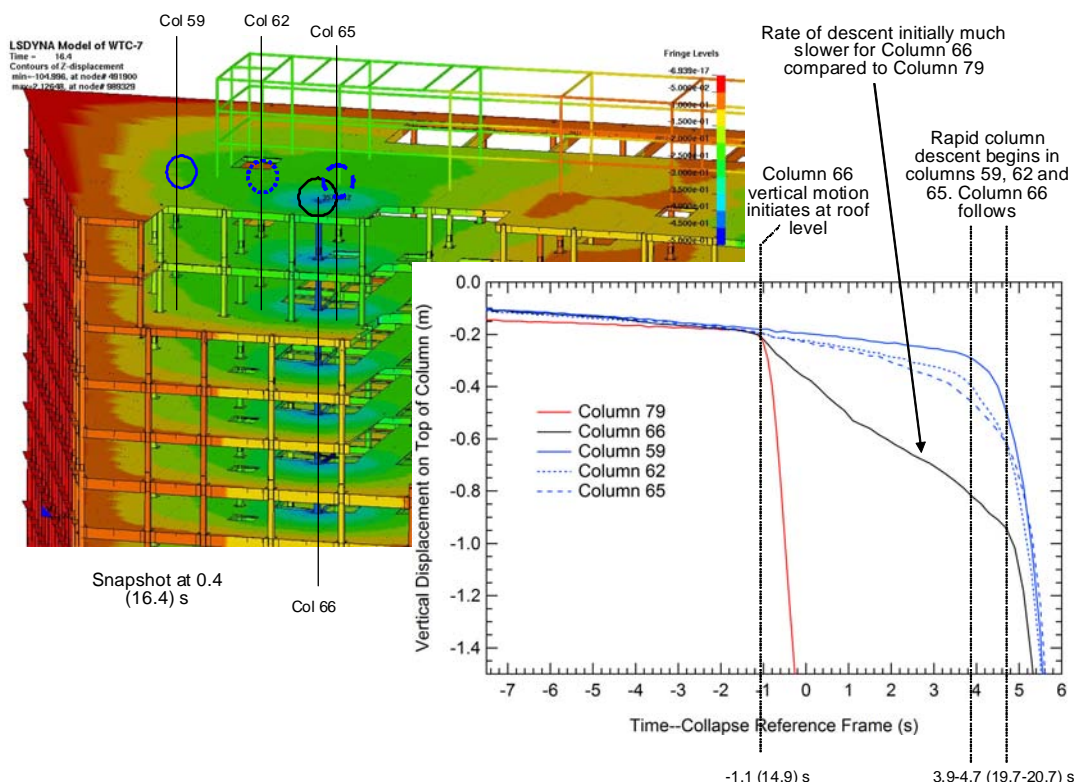
Figure 12–56 shows that west interior Columns 59, 62, 65, and 66, which had damaged floor connections after the debris impact by WTC 1 and by the fires, did not buckle until 4.7 s after the kink was observed in the east penthouse, or 6 s after Column 79 buckled. The west interior columns did not buckle until they were affected by the horizontal progression of failures. They also buckled due to loss of lateral support as floor connections failed, impact of falling debris, and the load redistribution from adjacent failing columns.

Figure 12-56. Western core column vertical displacements (contours: -0.5 to 0 m).

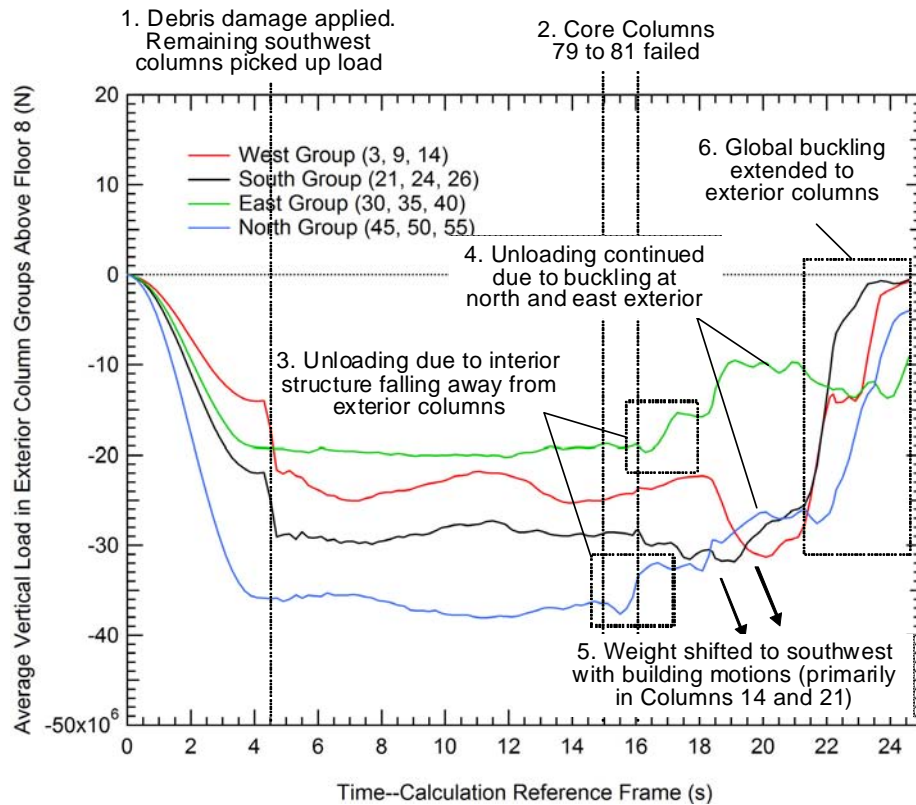
Figure 12–61 shows that selected exterior column forces increased as gravity loads were applied (compressive loads are negative). As indicated at 4.5 s (LS-DYNA calculation time), there was an increase in compressive forces on the west and south faces of the building after debris impact damage was applied. As Columns 79, 80, and 81 buckled and the floor systems failed on the east side of the building (at 15 s to 16 s), column forces reduced in the north and east faces. The west face column forces were dominated by the forces in Column 14, which was adjacent to the severed columns in the southwest corner. At 21.5 s, exterior column buckling began at Column 14, between Floors 10 and 12. The exterior columns adjacent to the (seven) columns severed in the southwest region due to the collapse of WTC 1 were the first to buckle due to the increased forces in these columns following the debris impact damage. The south and west face columns buckled first, followed by the north and east face columns.

Figure 12–61. Average exterior column forces by group.

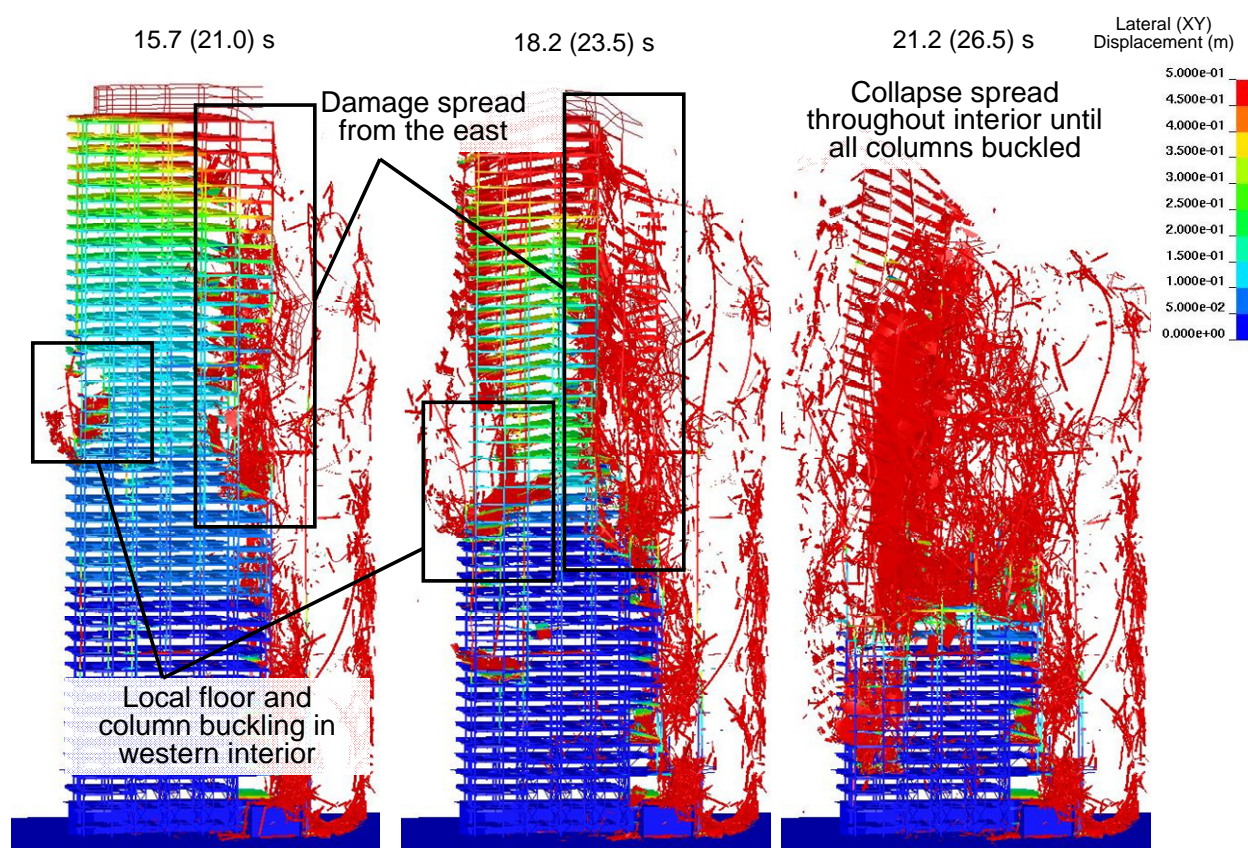
Figure 12–72 shows the structural response of the interior columns between 15.7 s (21.0 s) and 21.2 s (26.5 s). Column damage continued to spread westward with Column 73 buckling at about 15.0 s (20.3 s) between Floors 35 and 37. Column 58 buckled at 14.7 s (20.0 s), following a column splice failure at Floor 31 that occurred 8 s earlier, at about 6.9 s (12.2 s), but did not cause column failure. The column splice initially failed due to relative twisting and shearing motions between floors that were most acute in the northwest corner of the building. The global building motions grew in response to the column and floor structure failures in the eastern interior. The relative motions at the Column 58 splice were magnified compared to other surrounding columns due to the relatively large area supported by Column 58 and the limited shear stud connections in the northwest corner of the building, which together provided relatively less twisting resistance from the composite floor slab. As a result, the Column 58 splice above Floor 31 and some surrounding framing connections sustained damage, which continued to accumulate with subsequent building motions.

Figure 12–72. Collapse of the north interior columns from 15.7 s (21.0 s) to 21.2 s (26.5 s). Contours of resultant lateral displacement 0 in. to 16 in. (0 m to 0.4 m).

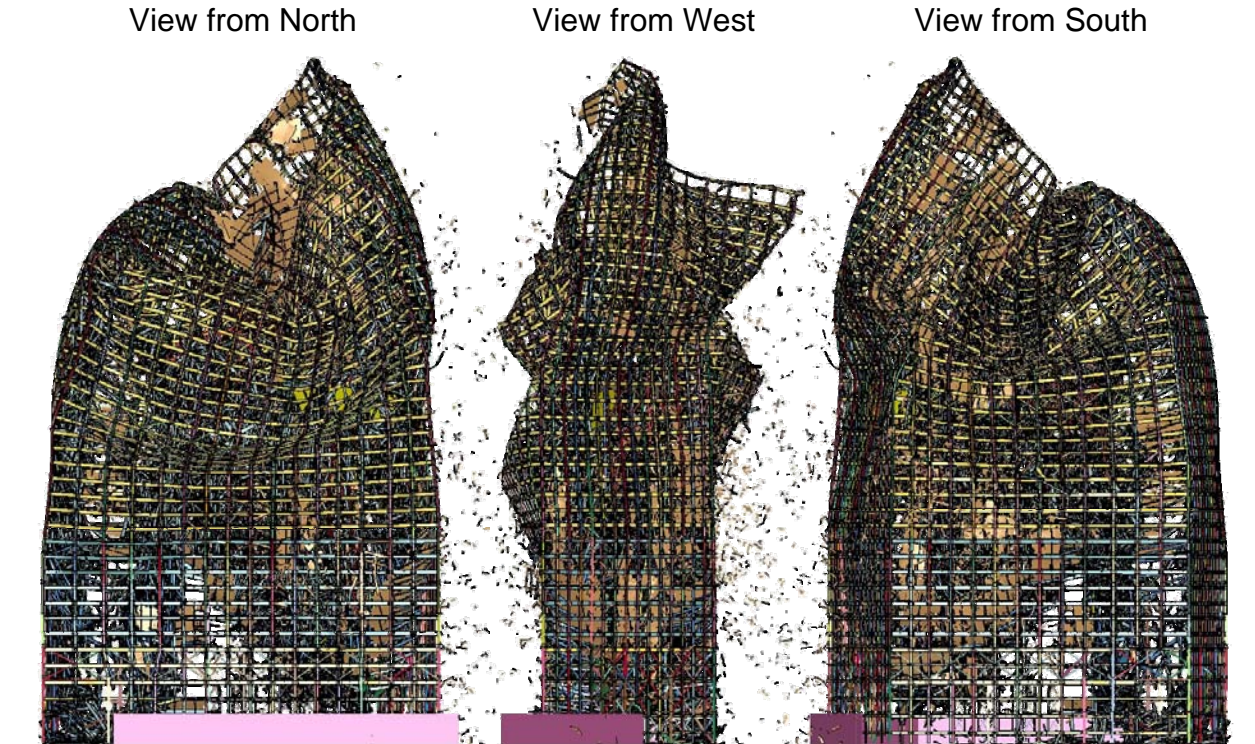
After Column 58 buckled, floor and column collapse propagated horizontally throughout the interior. By 21.2 s (26.5 s), all the interior columns had buckled above Floor 23, and the west penthouse and screening wall had fallen into the building, as indicated in Figure 12–73. Vertical motion at the roofline indicated buckling of the exterior columns, and the start of global collapse.

Figure 12-73. Exterior column buckling after initiation of global collapse for progressive collapse analysis without debris impact and fire-induced damage (slabs removed from view).

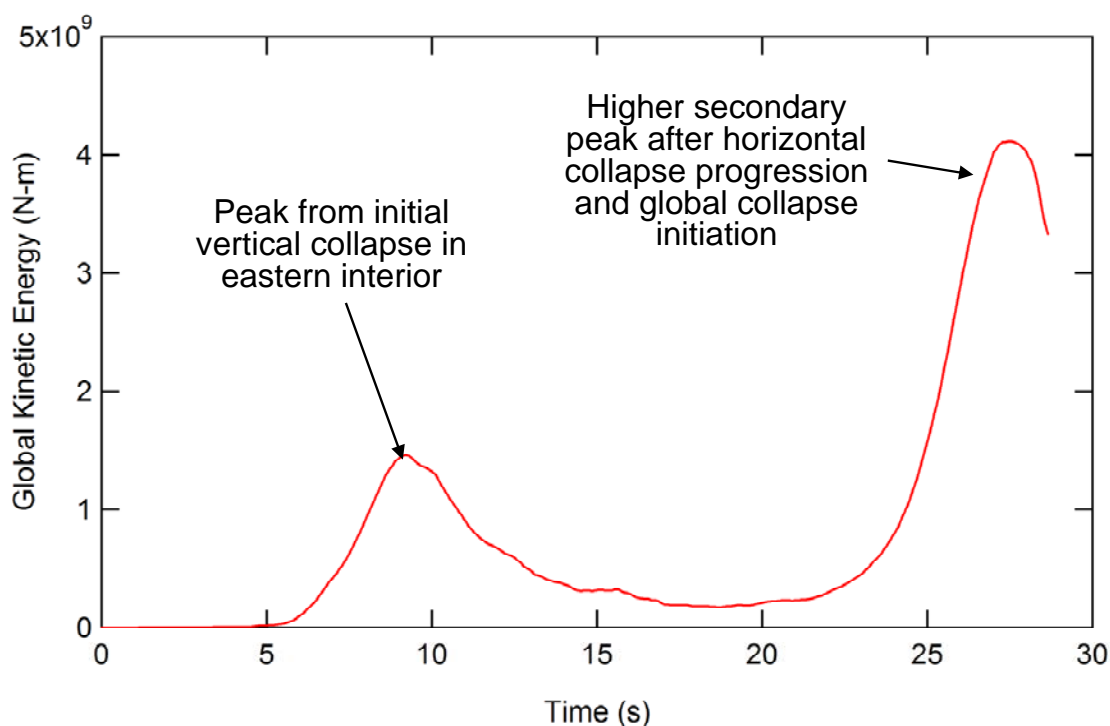
Figure 12-74 is a plot of the kinetic energy in the global model during the analysis, where the kinetic energy is due to falling debris and debris impact. An initial peak kinetic energy occurred around 3.7 s (9.0 s), when Columns 79, 80, and 81 had buckled between 1.3 s (6.6 s) to 5.1 s (10.4 s) and the surrounding floors and columns were falling. After the debris had fallen, the collapse progression slowed, as Columns 76, 77, and 78 did not buckle until 10.8 s (16.1 s) to 14.0 s (19.3 s), respectively. The kinetic energy levels decreased during this period until between 14.7 s (20.0 s) to 16.7 s (22.0 s), after which all the interior columns buckled and led to a sharp increase in kinetic energy.

The bi-modal kinetic energy plot illustrates the complex structural system interactions that affected global stability of the building. Had the analysis been stopped at some time between 6.7 s (12.0 s) and 14.7 s (20.0 s), an incorrect and non-conservative conclusion would have been drawn that the structural damage would have been limited to the east side of the building. This type of analysis should be continued until the structure reaches a point of equilibrium (i.e., global stability) and the kinetic energy drops to zero.

Figure 12–74. Global kinetic energy during the analysis without fire or debris impact damage.

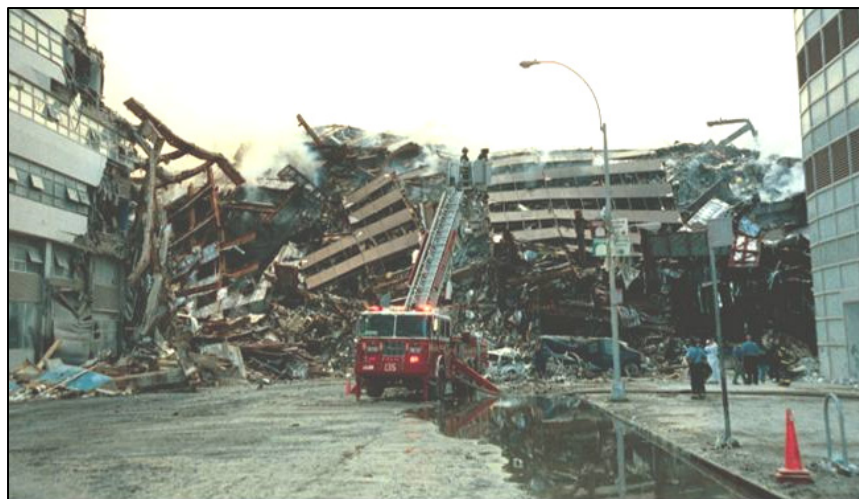
The collapse of WTC 7 buried the Con Edison structure and all the equipment in it. Figure A-6 shows the collapsed building at the beginning of the salvage and clean up operations, viewed looking south from Greenwich Street.

Figure A-6. Debris pile from collapse of WTC 7 onto the Con Edison substation, viewed looking south from Greenwich Street, date undetermined.

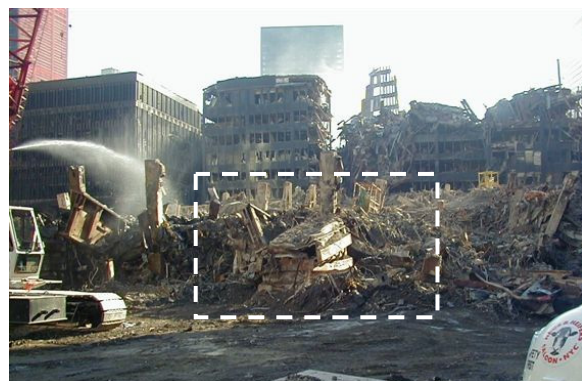
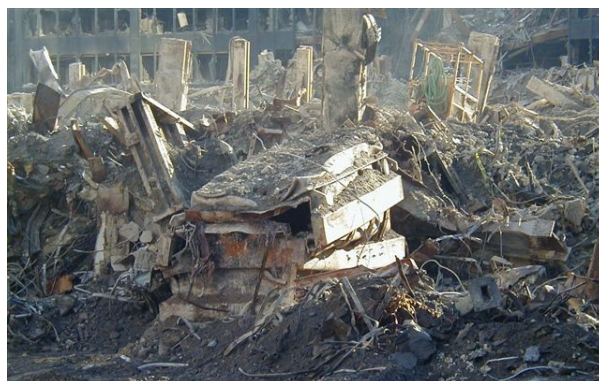
The left photograph in Figure A-7 was taken about five weeks after September 11, 2001. It shows the remnants of the Con Edison substation after the removal of much of the debris. The area outlined in a dotted white line is enlarged in the right photograph in Figure A-7A. From its location in the pile, this appears to be transformer #4, but also may be #8 or #9. The interior of this transformer was described as being severely thermally damaged, possibly by fire³.

Figure A-7. Photographs taken on mid-October, 2001, showing Con Edison transformer #4 (or #8 or #9) uncovered from the debris pile of WTC 7.

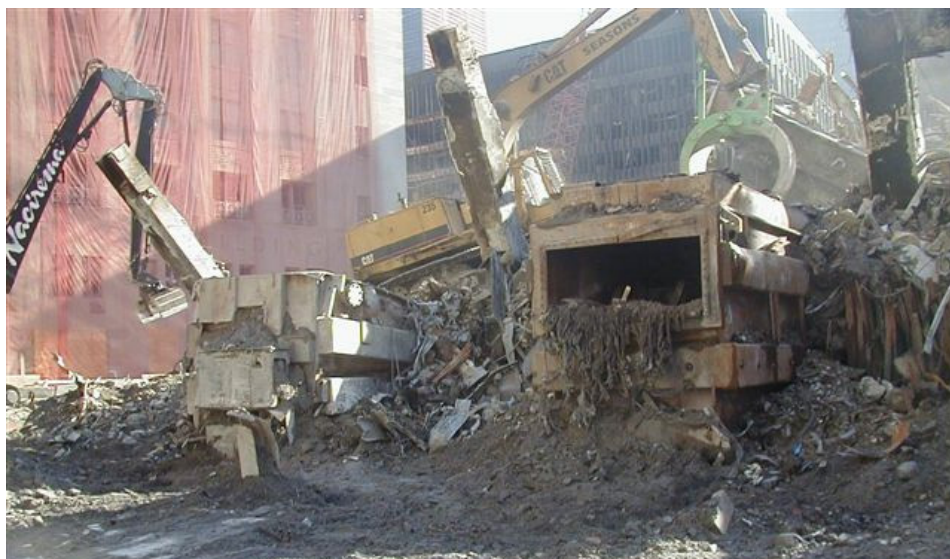
A similar assessment of thermal damage was made for transformer #1, shown on the right in Figure A-8. This is in contrast to transformer #6, which is the unit on the left in Figure A-8. The gray paint on transformer #6 is clearly evident, with little indication of rust or excessive heat.

Figure A-8.
Photograph taken
in mid-October,
2001, showing
Con Edison
transformers #6
and #1 uncovered
from debris pile of
WTC 7.

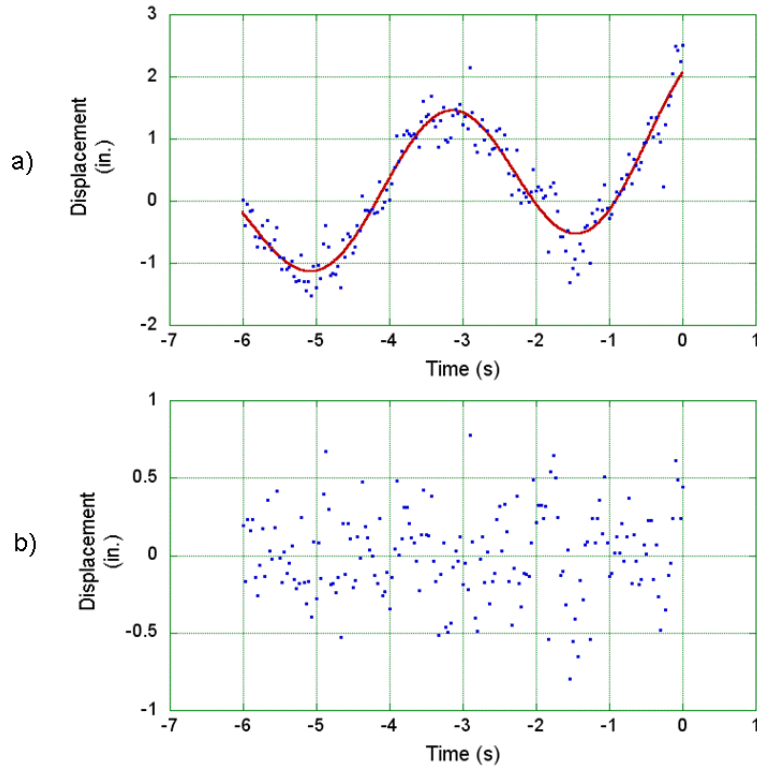
Figure C-10. a) Comparison of oscillation mode with data for 6 s period before the east penthouse began to move downward, b) residual after mode was subtracted from data.

For the 6 s period from the beginning of oscillatory motion in the data to when the penthouse began to fall, the harmonic motion was found to have a period of 3.61 s, an amplitude of 1.3 in., and an approximately zero decay rate. The total standard deviation from the nonlinear fit to this data (the square root of the estimated variance) was $\sigma = 0.3$ in. The total uncertainty, with a confidence level of 95 percent, equaled twice the standard deviation in both positive and negative directions, or ± 0.6 in. Figure C-10(a) shows this mode superimposed on the original data. Subtracting the mode from the data resulted in the residual data shown in Figure C-10(b). The residual appeared random. If an oscillatory pattern had appeared in the residual, it would have suggested that a secondary vibration mode is present. In this case, the first mode found did a good job of matching the data.

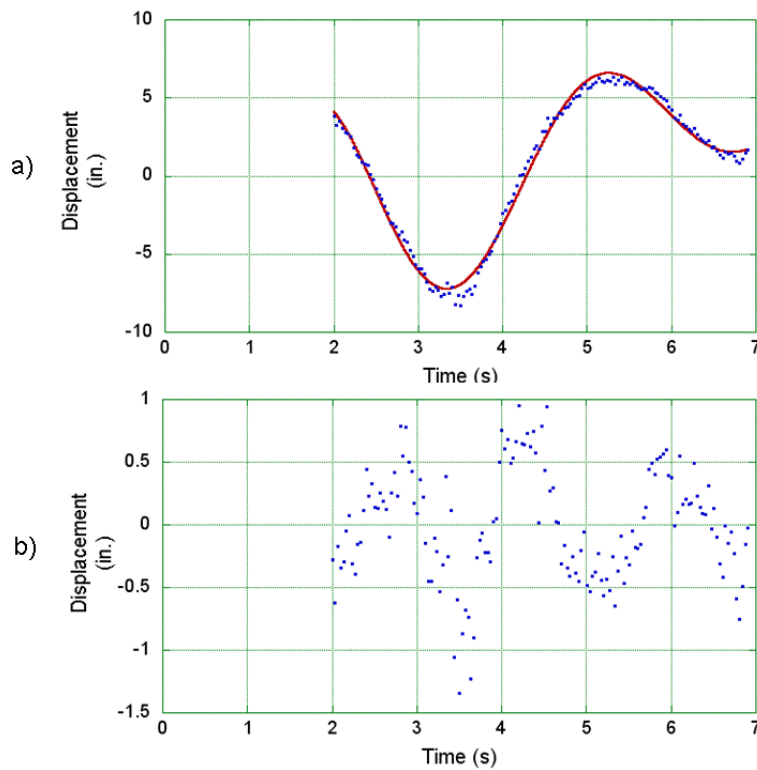
Figure C-11. a) Comparison of mode with data for period from $t = 2.0$ s to $t = 6.9$ s, and b) residual.

The next modal analysis was performed for the time period from $t = 2.0$ s, at the time when the penthouse was observed to completely disappear from the roof WTC 7, to $t = 6.9$ s, when the main collapse began. The primary mode has a period of 3.46 s, an amplitude of 12 in., and a decay rate of $0.19 s^{-1}$. The total uncertainty was ± 0.9 in. Figure C-11(a) shows a good comparison between the mode and the data. The residual, Figure C-11(b), indicates a secondary mode with a period of 1.65 s, amplitude of 0.7 in., and zero decay rate. This is plotted in Figure C-12(a). The residual, after the combination of these two modes had been subtracted from the original data, is shown in Figure C-12(b). By adding these two modes together, the total uncertainty was reduced to ± 0.5 in., slightly better than the results for the time period before the fall of the penthouse.

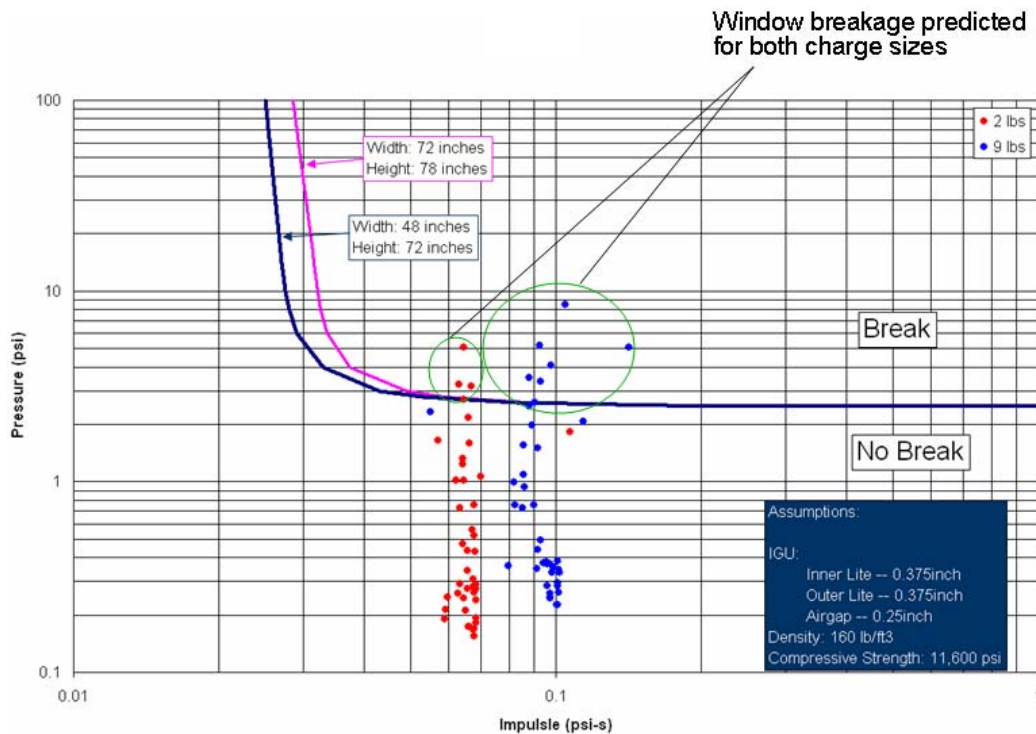
Key results from the Phase II blast analyses are shown in Figure D-9 through Figure D-14. Figure D-9 and Figure D-10 illustrate the predicted pressure-impulse levels at each window location around the building perimeter for Layouts 2 and 3, respectively. Two blast initiating charge sizes are shown: the minimum recommended 9 lb of RDX explosive from Phase I, and a smaller 2 lb charge to examine the sensitivity of the window breakage to charge size. The P-I values at each window location are overlaid on the predicted break/no-break criteria from the window fragility analysis conducted earlier in Phase II. Failure pressure-impulse curves are commonly used in blast analyses to illustrate system failure sensitivity to transient pressure loads.

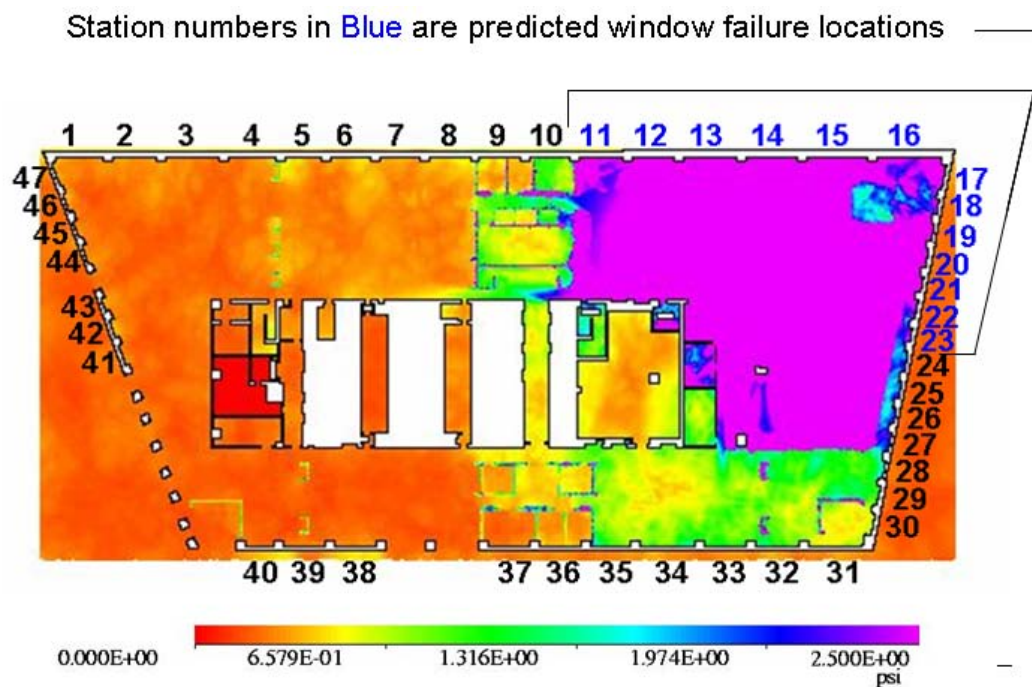
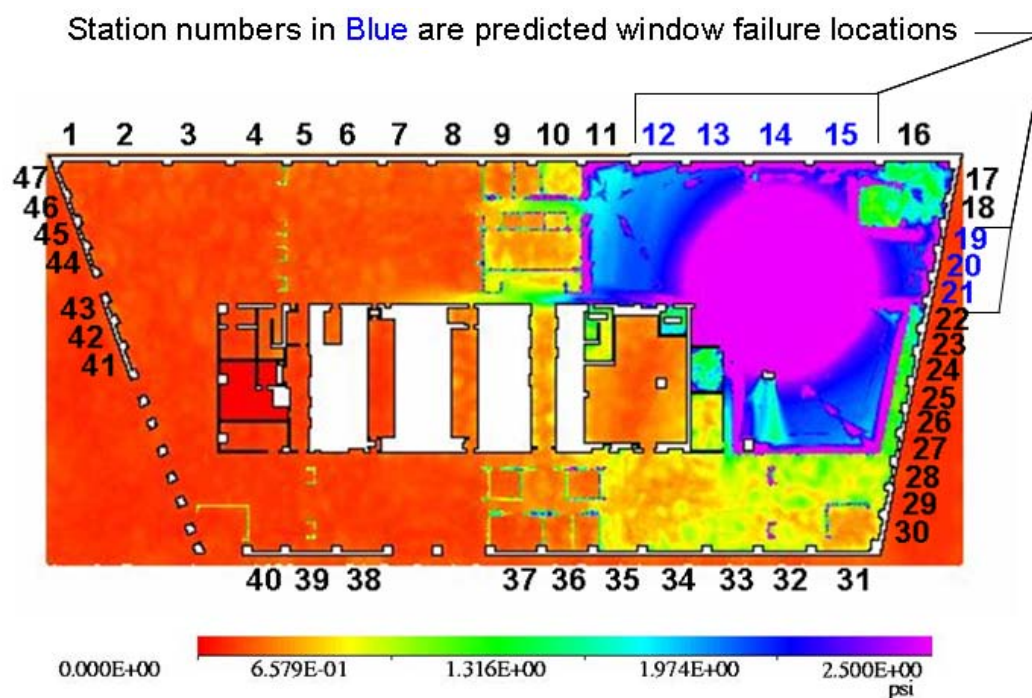
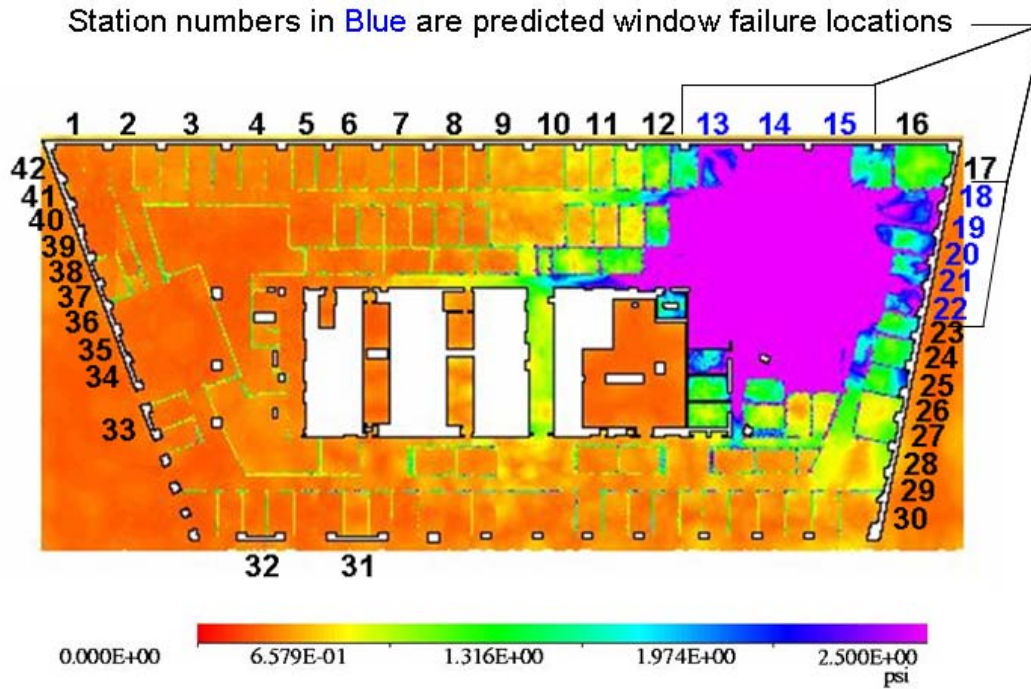
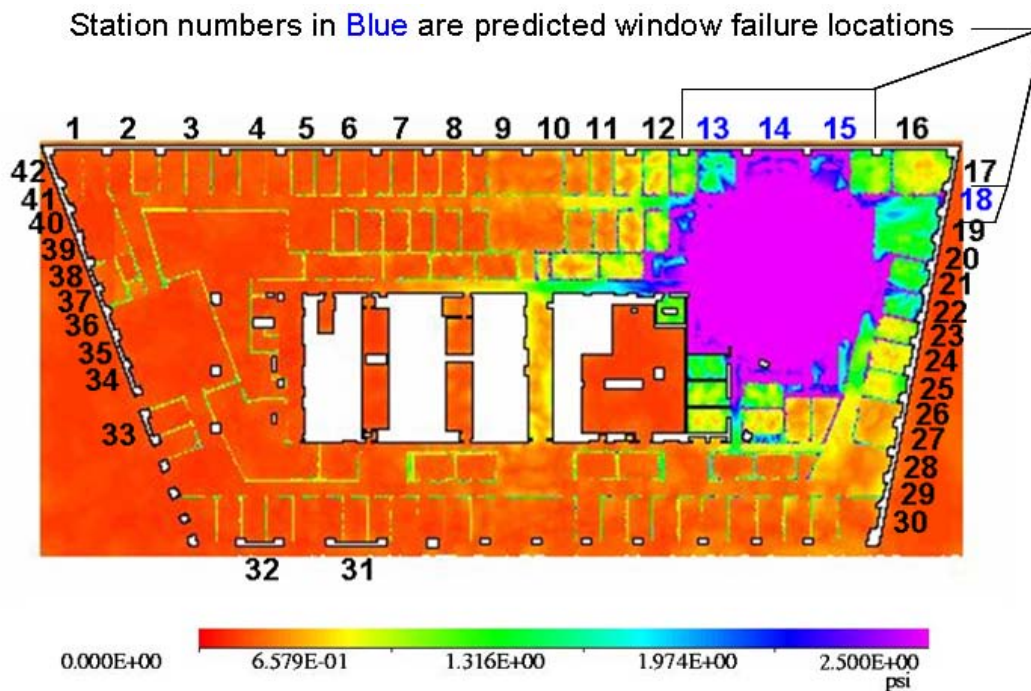
Figure D-11 through Figure D-14 show plan views of the 2-D SHAMRC results for predicted window failure locations. Contours of peak overpressure are shown, as well, to illustrate pressure propagation throughout the floor. The maximum contour value, shown as purple, was set at 2.5 psi, which corresponds to the minimum overpressure required to break a window. Any area displayed as purple experienced overpressures at or above the 2.5 psi threshold, but did not necessarily experience the minimum required impulse. Only station numbers shown in blue experienced the necessary combination of pressure and impulse to exceed the failure threshold.

As expected, the more open Layout 2 resulted in more predicted window failure locations for a given charge size, compared to the more extensively built-out Layout 3. Furthermore, the larger 9 lb explosive charge resulted in more window failures than the corresponding 2 lb charge analyses, predominantly on the east face of the building.

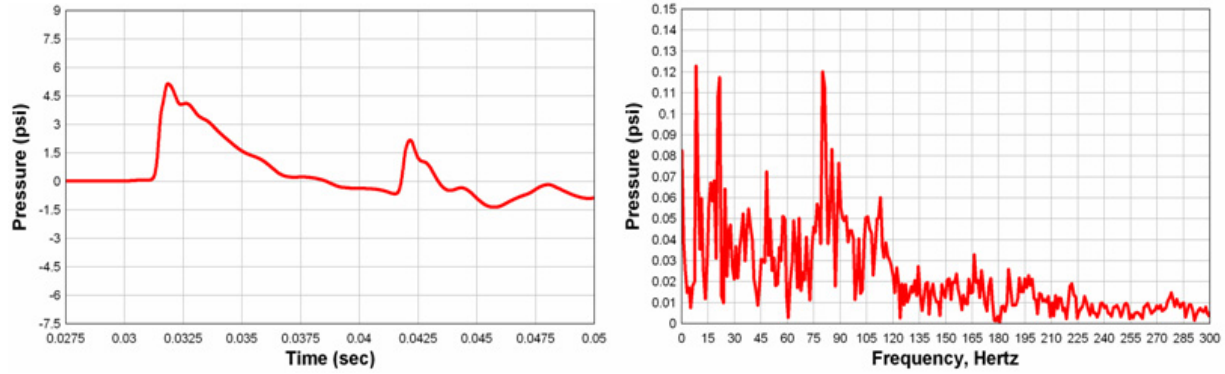
Figure D-15. Typical waveform and corresponding Fourier transformation at a broken window location.

Figure D-15 shows a typical waveform at a broken window location and its Fourier transformation. Most of the sound lies below 200 Hz. Approximately 40 Hz is the lower limit for human audible perception. In this frequency range, the blast would sound like a low rumble. Figure D-16 illustrates a typical waveform in the vicinity of the open window locations in the southwest corner.

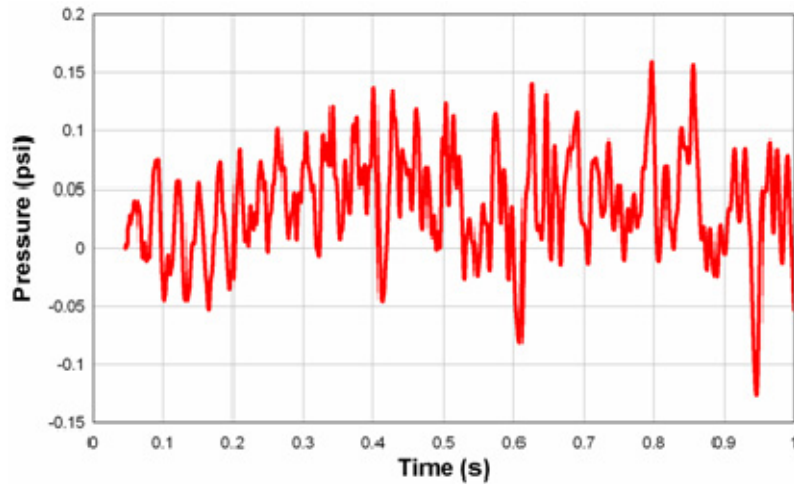
Figure D-16. Typical waveform in the southwest corner near the debris damaged windows.

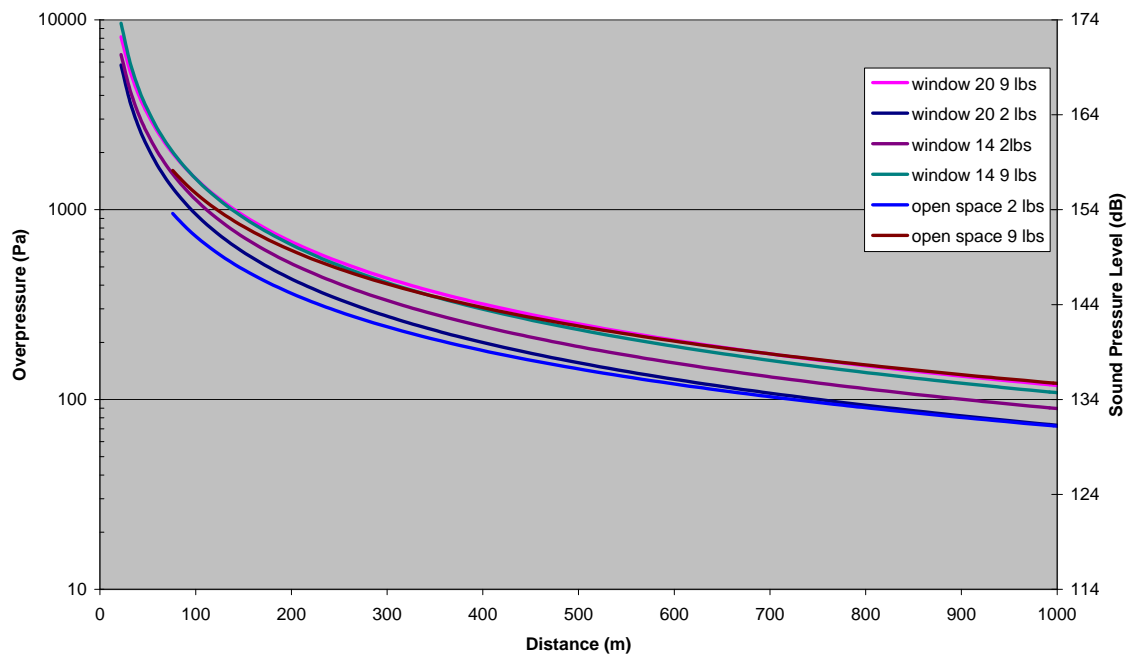
Figure D-17. Layout 2 acoustic overpressure-distance predictions.

In Phase III, an acoustic analysis was performed to assess the distance from the building that the blast would have been audible. Analyses were performed for both layout scenarios, using the pressure history and window failure location predictions generated during Phase II. For all scenarios and charge sizes, significant audible sound was predicted from all building faces. For locations where sound propagation was unobstructed, the sound level from all building perimeter openings at 1 km would have been approximately 130 dB to 140 dB.

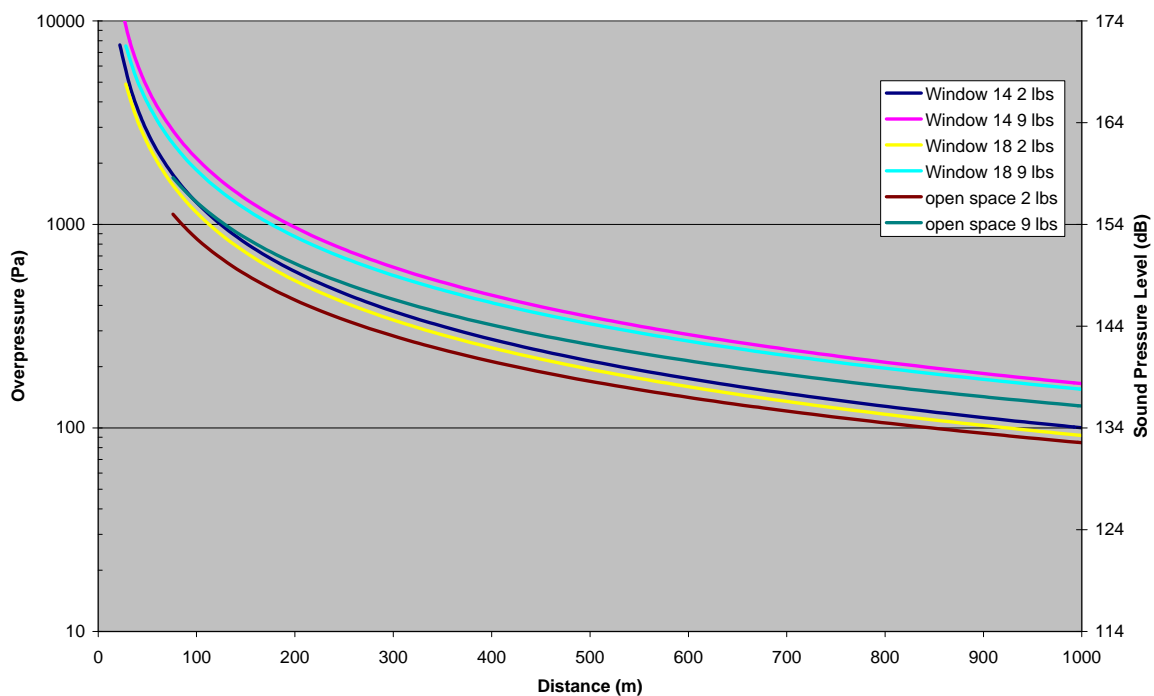
Figure D-18. Layout 3 acoustic overpressure-distance predictions.

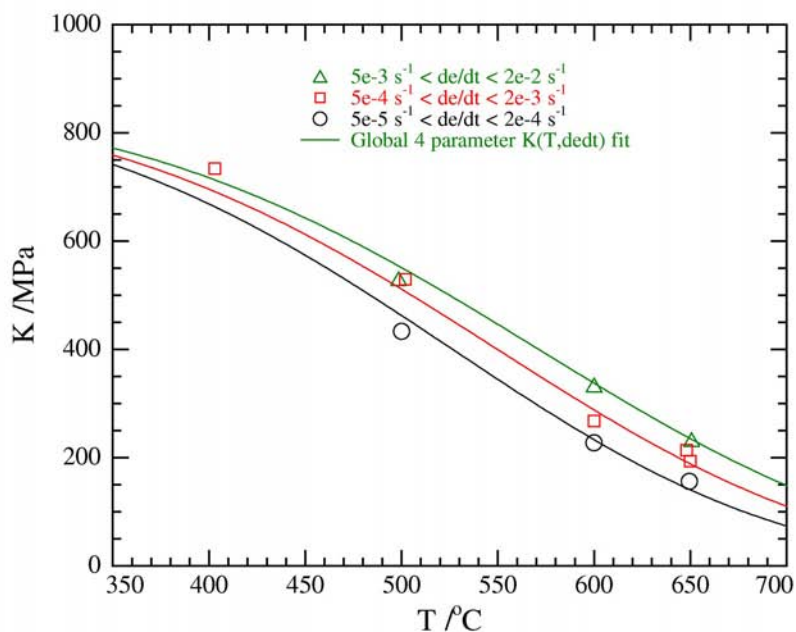
The parameter n_0 sets the room temperature value. The parameter n_2 sets the transition temperature where $n(T)$ begins to drop quickly, and the shape factor parameter n_1 sets the steepness of the transition.

Figure E-1. Behavior of $K(T)$ and $n(T)$.

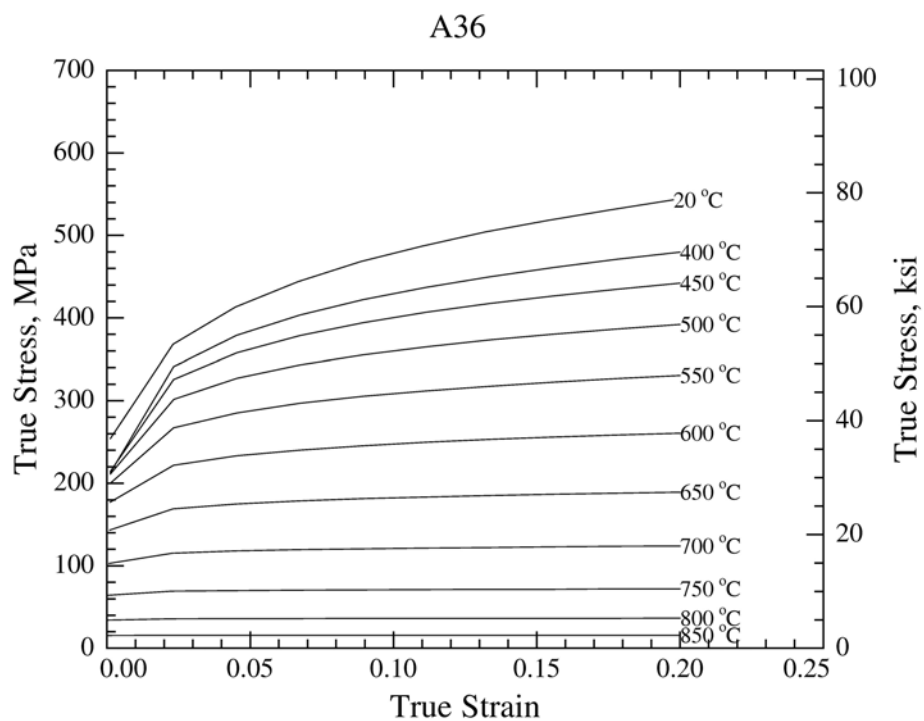
Figure E-4. Elevated-temperature stress-strain curves for $d\varepsilon / dt = 10^{-2} \text{ s}^{-1}$ for A 36 steel.

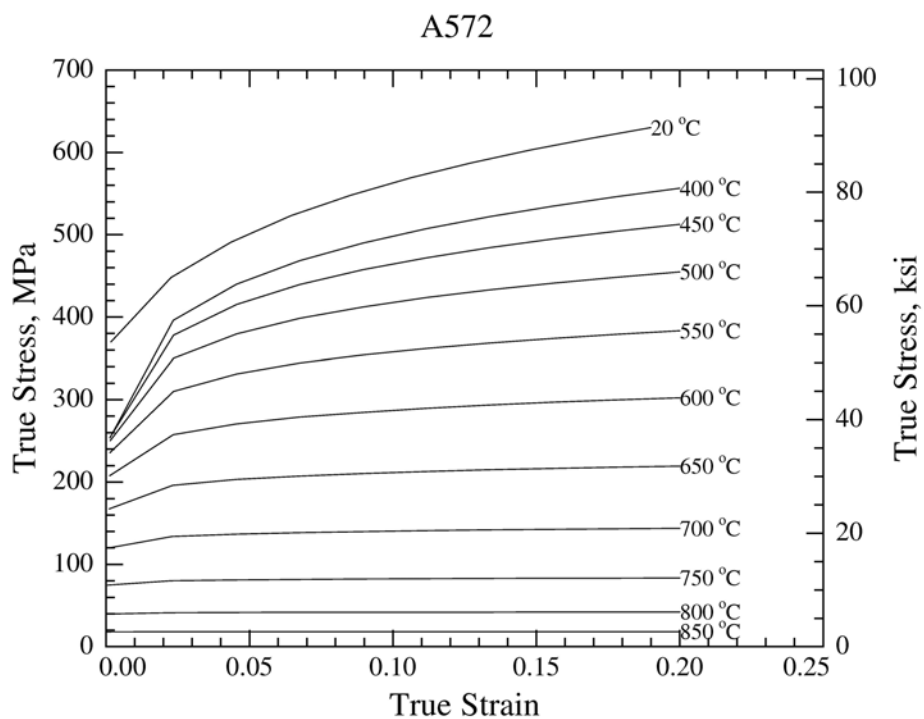
Figure E-5. Elevated temperature stress-strain curves for $d\varepsilon / dt = 10^{-2} \text{ s}^{-1}$ for A 572 steel.

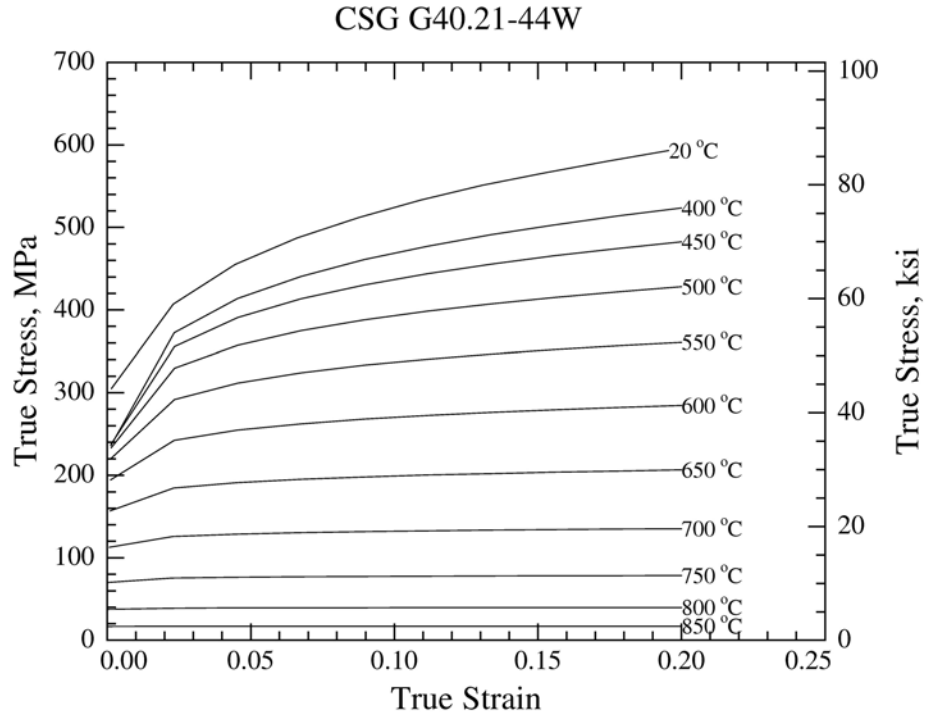
Figure E-6. Elevated-temperature stress-strain curves for $d\varepsilon/dt = 10^{-2} \text{ s}^{-1}$ for CSA G40.21-44W steel.

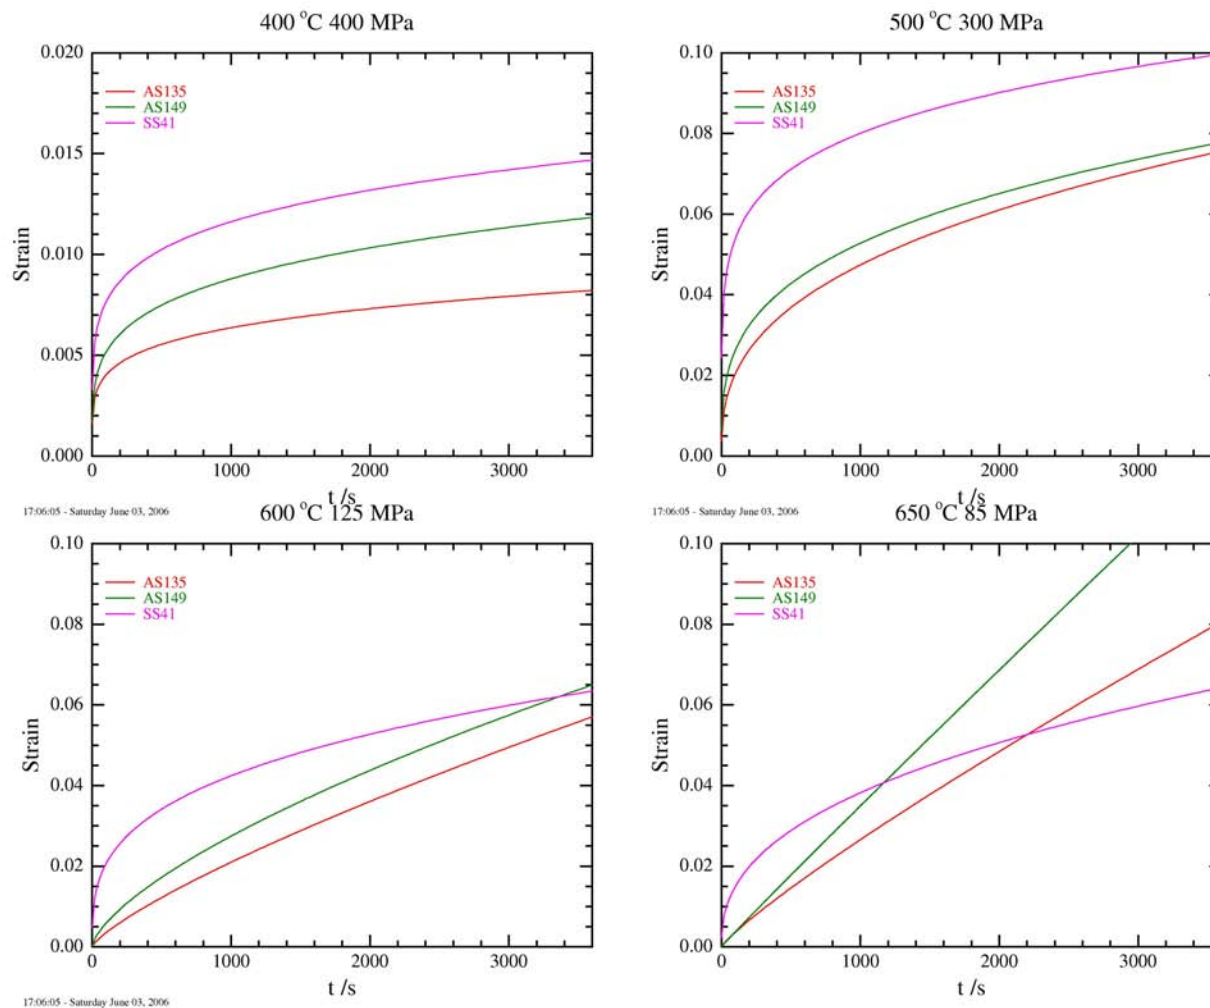
Figure E-7 shows that the creep properties of the 36 ksi steels, taken from the models of Williams-Leir (1983) were remarkably similar. Figure E-8 shows that the creep behavior of the higher strength steels, also taken from the models of Williams-Leir (1983) was less consistent.

Figure E-7. Creep curves for various 36 ksi steels, from the fits of Williams-Leir, evaluated at convenient temperatures and stresses.
