**Federal Building and Fire Safety Investigation of the
World Trade Center Disaster**

**Structural Fire Response and
Probable Collapse Sequence of
World Trade Center Building 7**

VOLUME 2

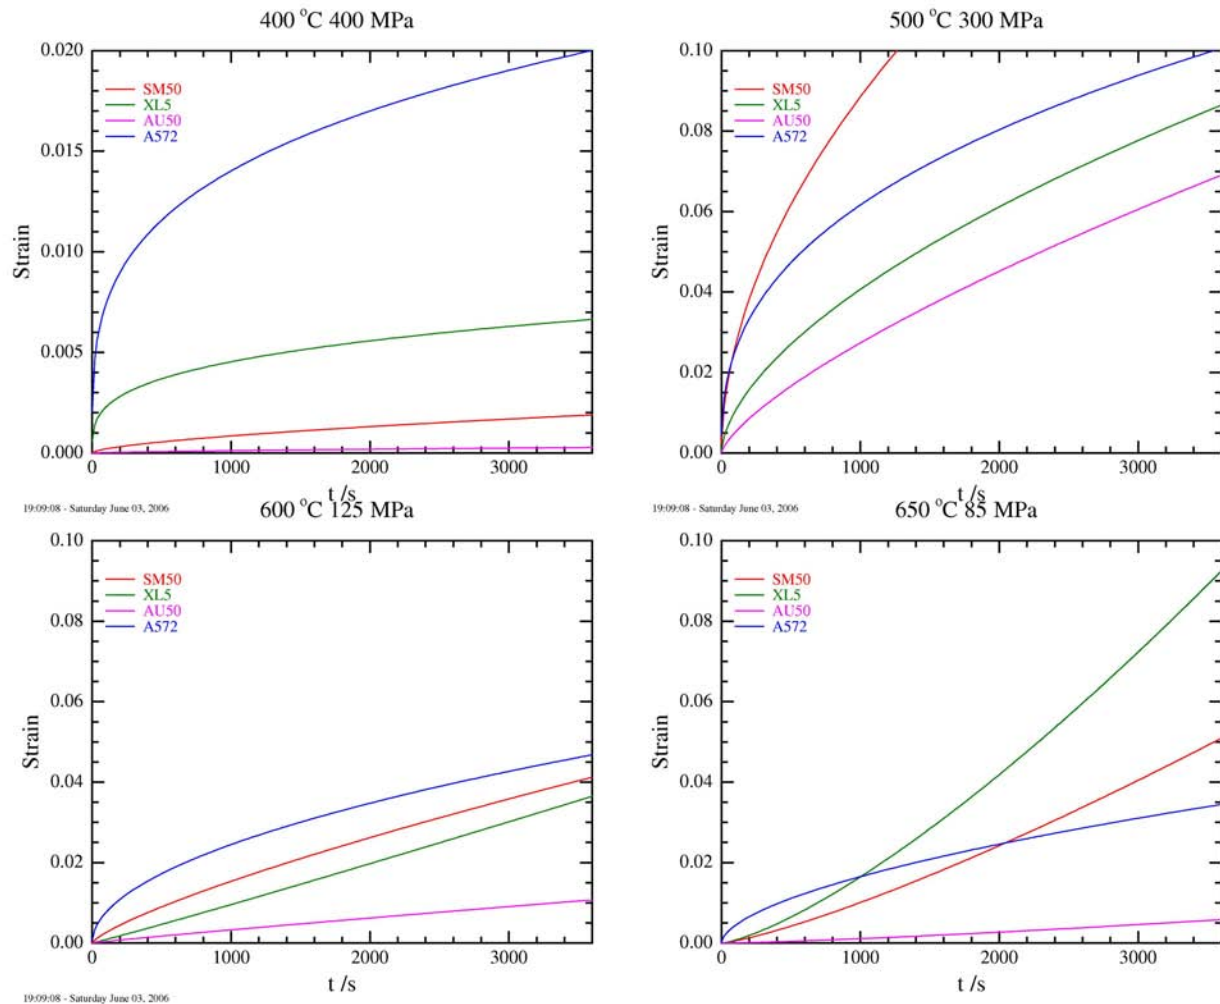
Figure E-7 shows that the creep properties of the 36 ksi steels, taken from the models of Williams-Leir (1983) were remarkably similar. Figure E-8 shows that the creep behavior of the higher strength steels, also taken from the models of Williams-Leir (1983) was less consistent.

Figure E-8. Creep curves for various high-strength structural steels, evaluated at other convenient temperatures and stresses.

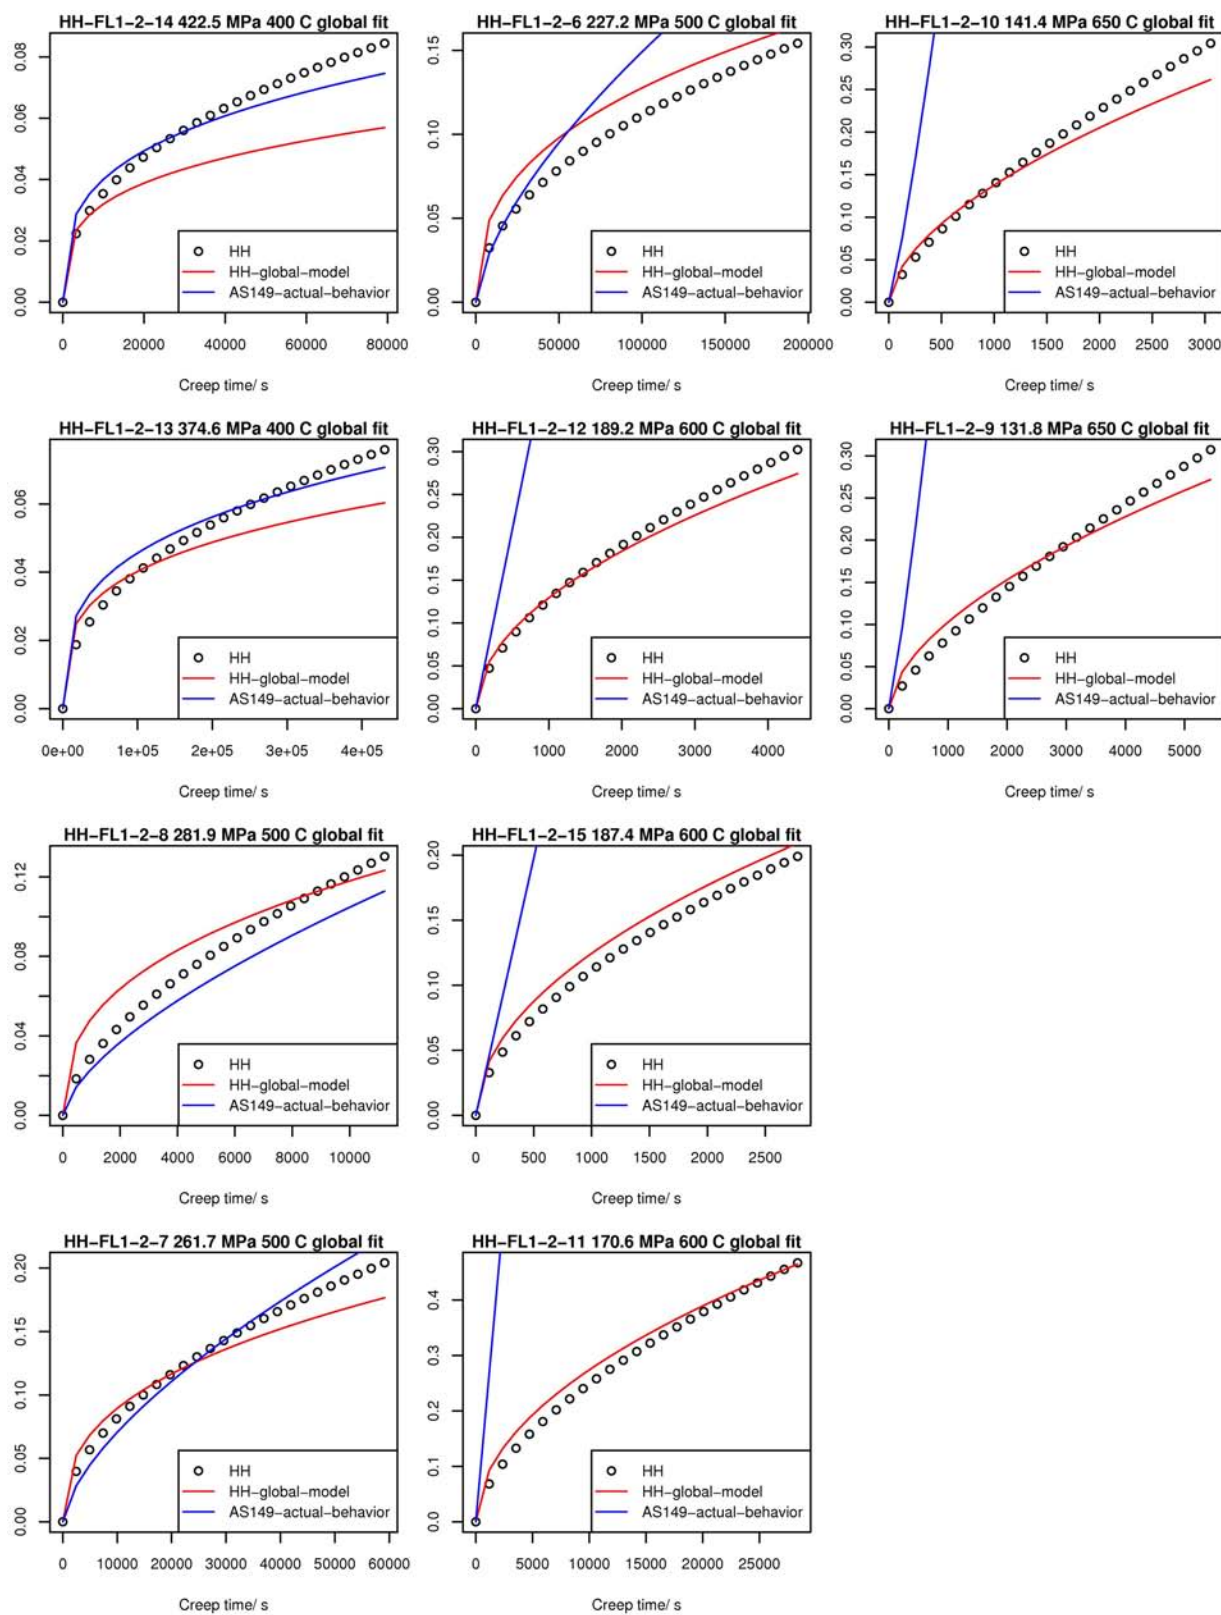
The A 36 steel creep behavior using the data from the WTC A 572 steel (specimen HH) was scaled using the tensile strength ratio method developed for the WTC investigation, but produced unacceptable results. Figure E-9 compares the A 572 creep data, the global model for creep strain of A 572, and the predicted creep strain for AS149 under those conditions, using the Fields (1989) model. Figure E-10 compares the predicted data for AS149, under the same conditions, using the Fields (1989) model, to the predicted creep behavior using the tensile strength scaling model based on the A 572 steel. The agreement for temperatures above 500 °C was unsatisfactory.

Figure E-9. Comparison of A 572 creep with predictions for AS149 steel.

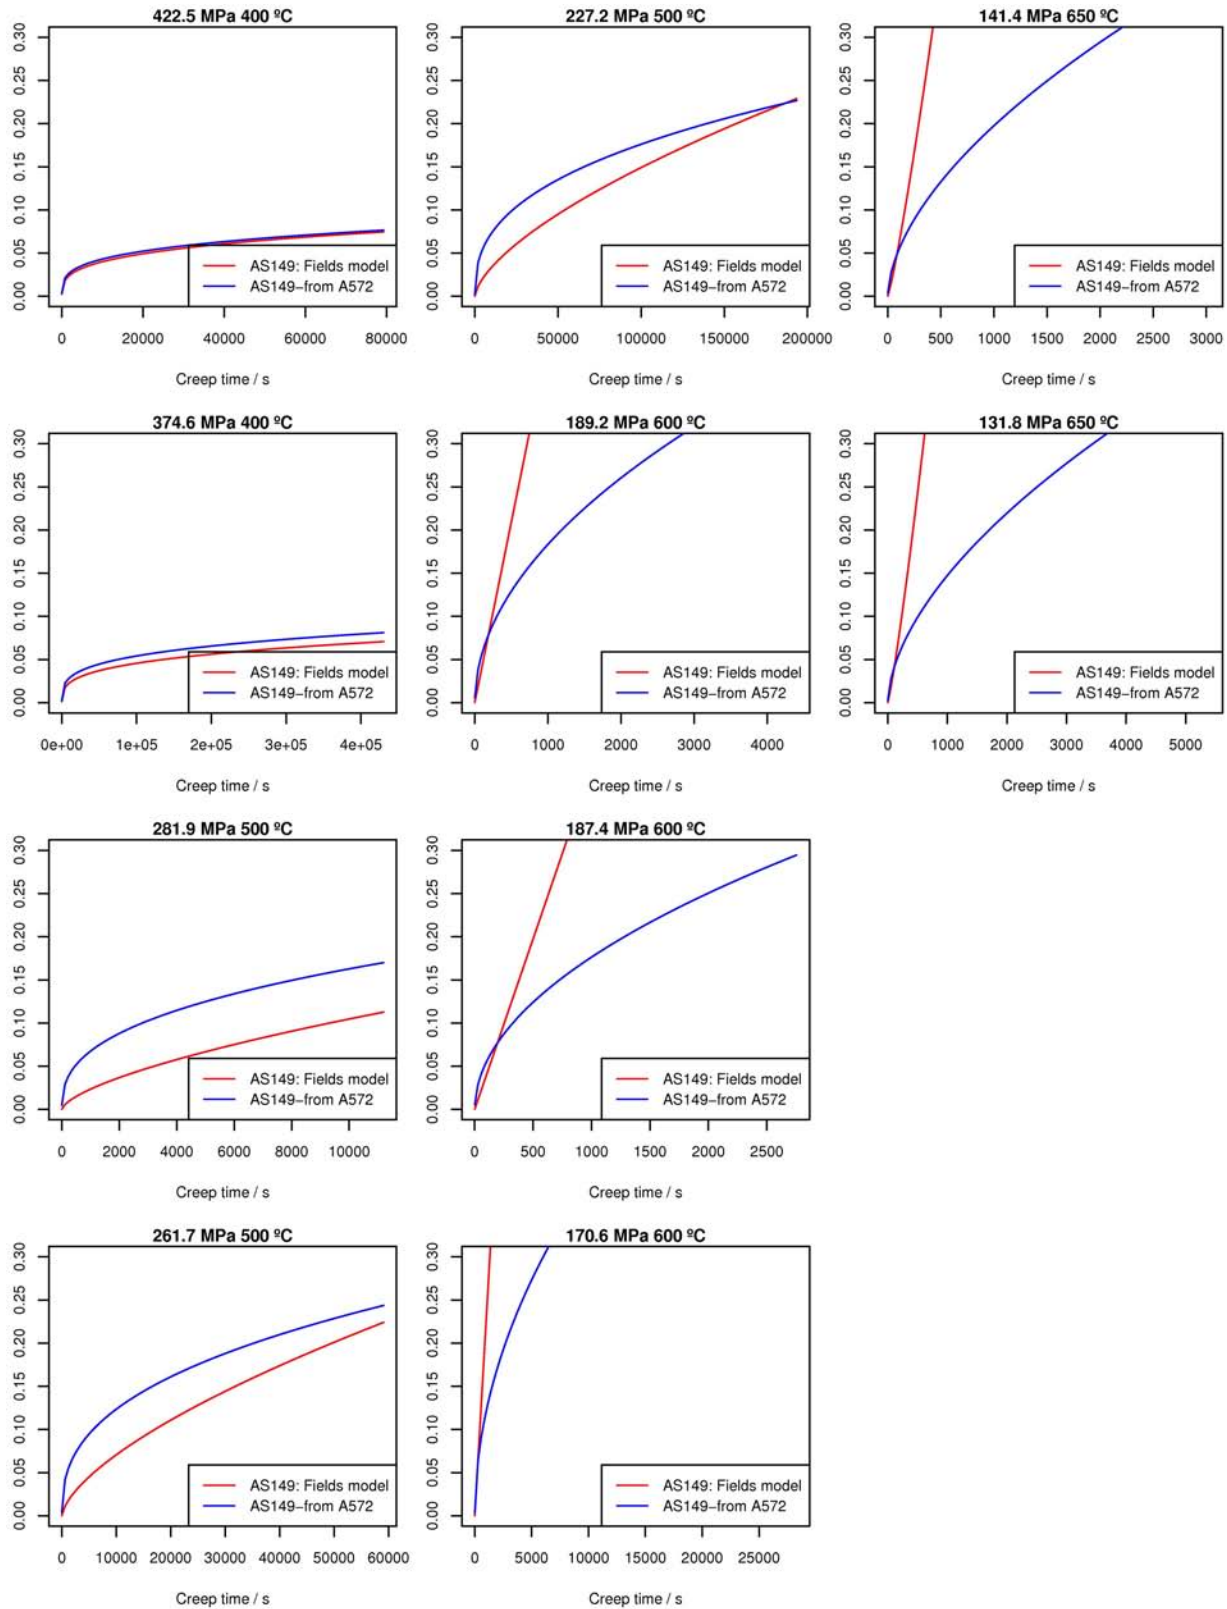
Predicting the behavior of the CSA G40.21 steel plate was even more difficult, because no experimental data existed for comparison. Given the lack of data, it was expedient to assume that the creep properties of CSA G40.21-44W were identical to the A 572. Both steels were specified with $TS \geq 65$ ksi, even though the yield strength of CSA G40.21 is only $YS = 44$ ksi (300 MPa). Furthermore, the chemistry specification for CSA G40.21-44W admits both V and Nb, which indicates that its chemistry is more like A 572 than A 36.

Figure E-10. Comparison of AS149 creep data with predicted data based on A 572 data and tensile strength scaling.
